## Summary

### A1. Exterior: Wall Cladding

#### A1-1 Main House

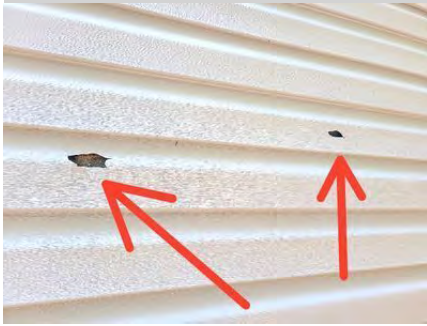
**(A1-1.5) Main House**

Additional photo of damaged siding at the rear of the home.

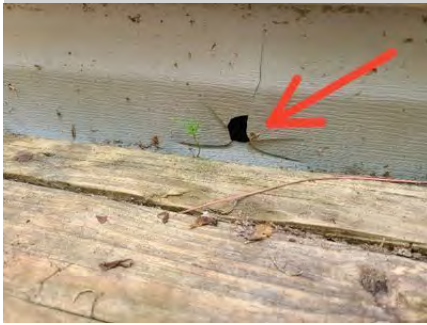
**(A1-1.6) Main House**

Additional photo of damaged siding at the rear deck area of the home.

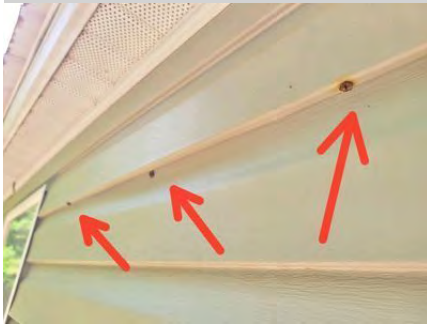
**(A1-1.9) Main House**

Additional photo of improper repair to the vinyl siding with exposed fasteners.

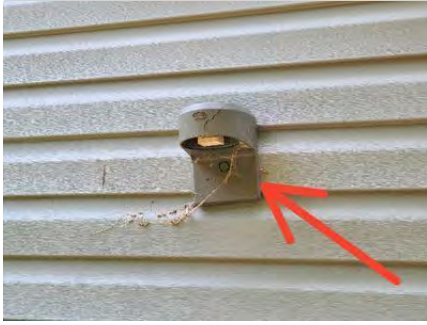
**(A1-1.10) Main House**

The exterior light fixture at the right rear of the home was missing a bulb and not operational at the time of the inspection. Corrective repairs are needed.

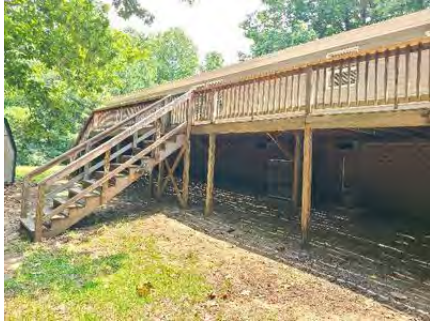
The elevated deck was found to be in poor condition and in need of immediate evaluation and repair. It is recommended that the deck system is NOT USED until repairs are made by a licensed general contractor. The following concerns were noted at the time of the inspection:

1. The deck system is not self supported and is improperly installed and should be considered UNSAFE FOR USE - Deck, porch and stair systems on the exterior of a manufactured home must be self supporting.
2. The decking surface is poor condition with uneven surfaces, lifted boards, split wood, raised/loose fasteners.
3. The steps are in poor condition, damaged treads, loose handrailings and poorly supported.
4. The deck support posts exhibit evidence of advanced decay. .
5. The deck post are not braced and or secured against up lift (over 4 feet)
6. Improper fasteniers and fastening methods are used throughout the deck system.

A licensed general contractor should be consulted for a complete evaluation of the deck step system and to make necessary repairs/replacement to ensure safe and functional use of the deck.

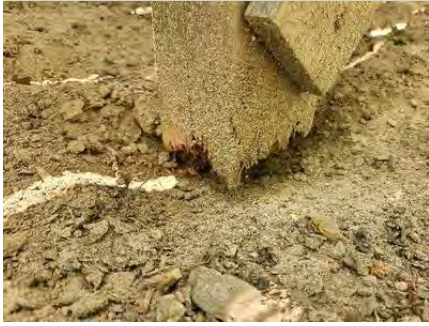
Additional photo of a rear deck support post completely decayed and not making contact with the ground.

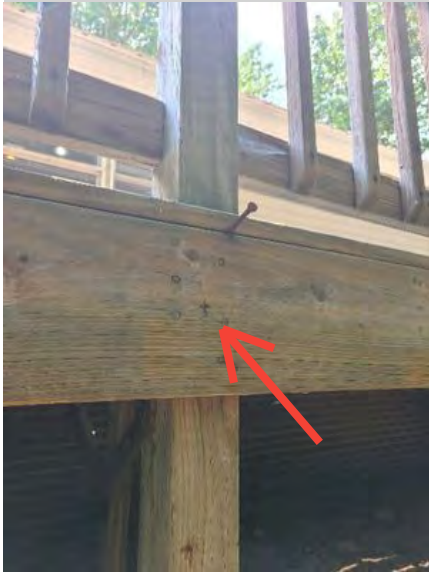
Additional photo of improperly fastened flooring system without through bolting.

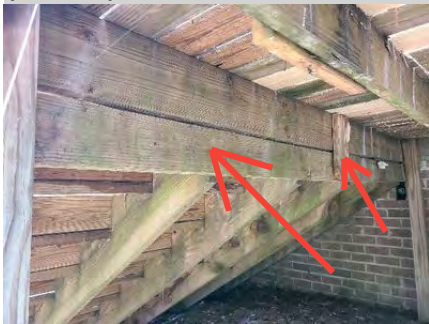
Additional photo of improperly fastened stair system without through bolting.

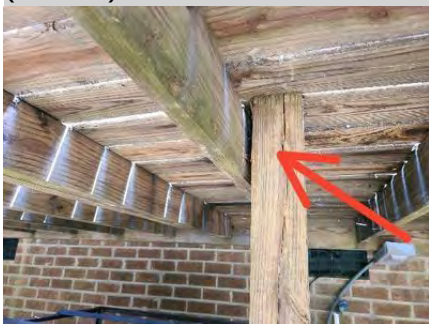
Additional photo example of loose/ improperly fastened support post without through bolting or fastener strap/bracket

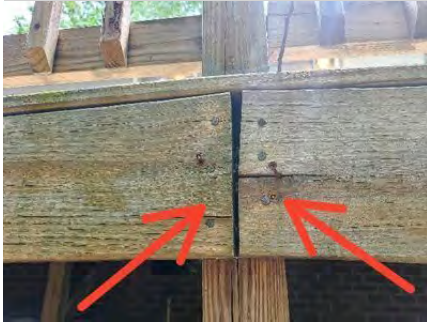
Additional photo - Improperly fastened perimeter band for the flooring system on the rear deck.

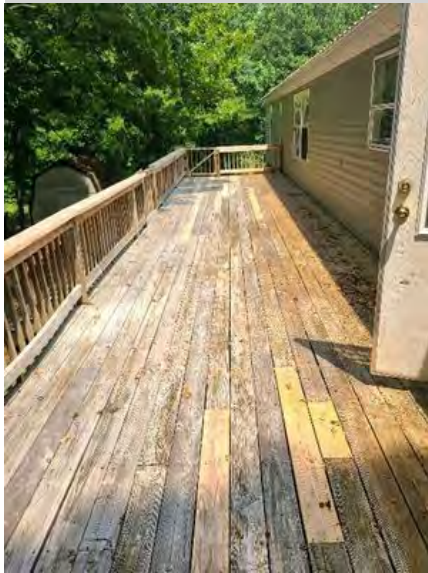
Additional photo of the flooring system for the deck at the rear of the home which has an uneven surface throughout the flooring system

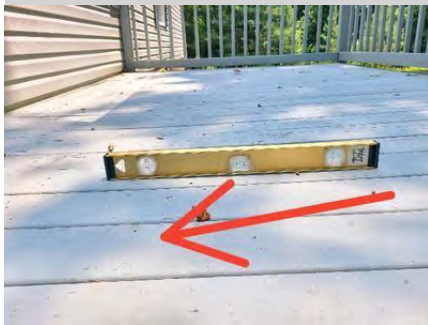
The surface of the front porch has a significant negative slope towards the home. This condition can allow for water to be diverted towards the foundation of the home which can lead to undesirable conditions in the crawl space as well as damage to the foundation system. Additionally, the uneven surface can cause a trip and fall safety concern for egress in and out of the home. A licensed general contractor should be consulted for a complete evaluation and any necessary repairs/replacement of the front porch system to ensure it is safe for use as intended.

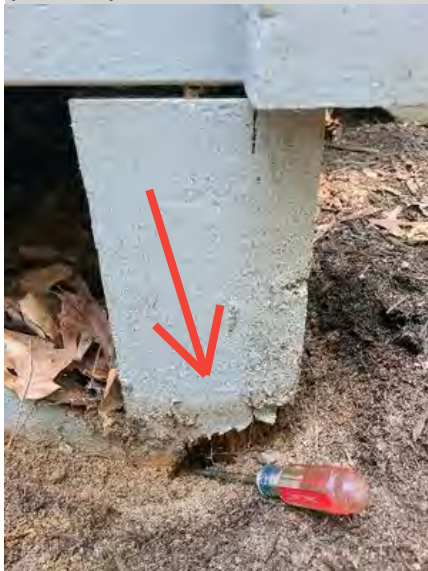
The front porch system is in need of repair. The structural support post at the front left corner exhibits evidence of advanced decay. As with the other items noted in the report the entire front porch system should be evaluated and repaired by a licensed general contractor to ensure safe use of the porch system.

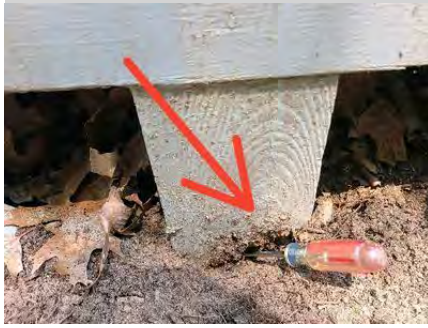
Additional photo of the front center support post for the deck system exhibits evidence of advanced decay.

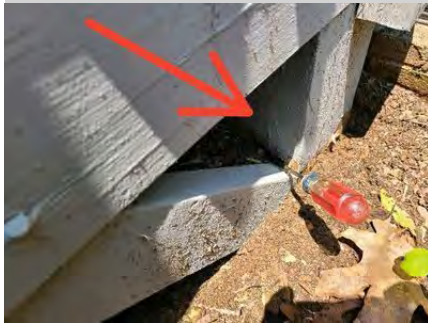
Additional photo of the right rear corner support post for the deck system exhibits evidence of advanced decay.

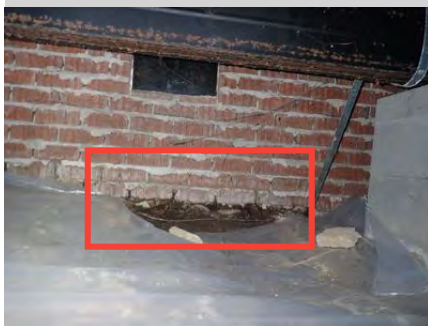
In the crawl space, the foundation walls at the front of the home were wet and the soil adjacent to the foundation was muddy from direct water penetration in the area. Direct water penetration damages the foundation, the wood structure, and creates an undesirable environment in the crawl space areas that encourages insects and or fungal growths such as mold/mildew. Water in the crawl space indicates an absent or damaged waterproofing and foundation drain system. Repairs are needed to prevent water penetration. A licensed general contractor should be consulted for further evaluation to determine the source of the moisture and to make necessary repairs.

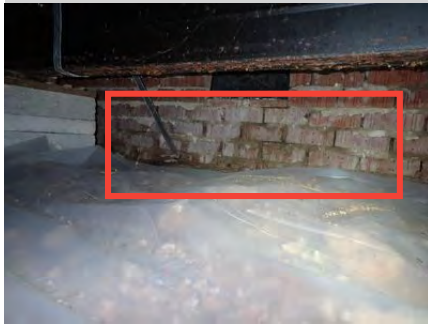
Additional photo - wet perimeter brick at front of home from direct water penetration.

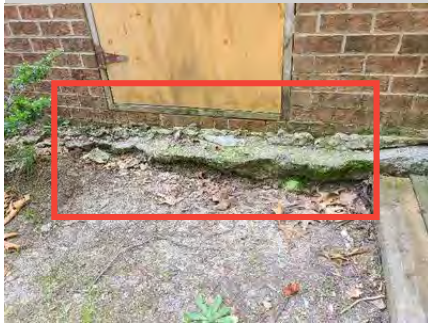
The house does not have a gutter and downspout system to divert water away from the foundation. At the rear of the home the foundation footing is exposed in many areas from what appears to be erosion of the soil. Such erosion can lead to damage of the foundation system. A licensed general contractor should be consulted to evaluate the level of concern and determine what repairs are required to ensure the structural integrity of the home.

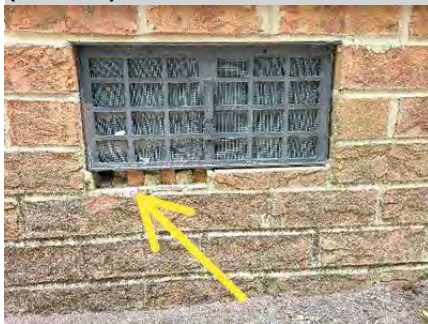
At the front of the home beneath a foundation vent a section of masonry brick is damaged which exposes an opening into the crawl space area. This can allow for pest and water penetration into the crawl space. A specialist should be consulted for evaluation and repair.

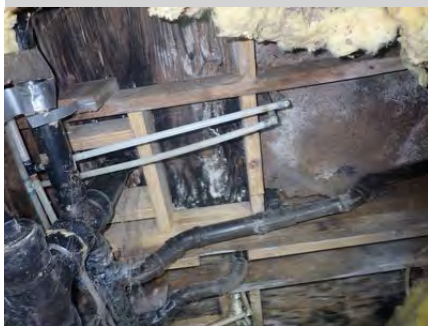
A large area of the floor framing and subflooring under the master bathroom/laundry area was noted to exhibit evidence of water damage. Evidence suggests direct water penetration. A licensed general contractor should be consulted for an invasive investigation to determine the source of the water penetration and the extent of the decay make necessary repairs to prevent further damage and undesirable conditions.

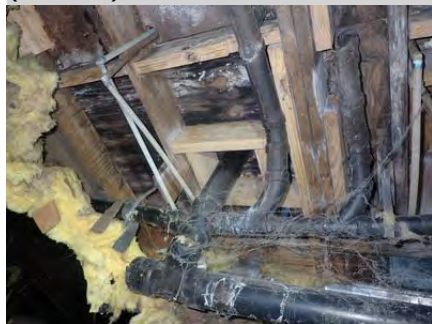
Additional photo - damaged flooring under master bathroom/laundry area.

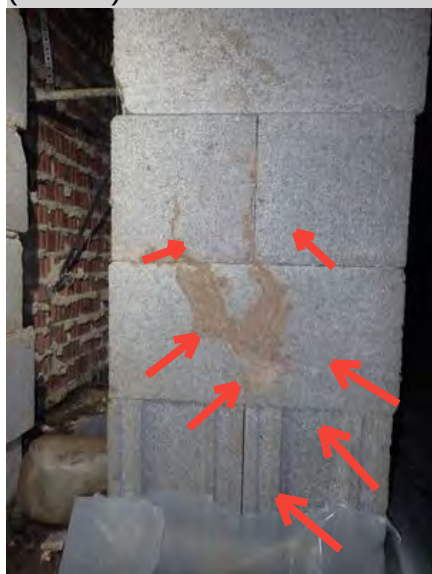
Mud tunnel etchings (stains) typical of termites were noted on a foundation pier at the left rear area of the home. Termite damage is often hidden and requires invasive inspection to determine the extent of the damage. A licensed general contractor should be consulted for a complete evaluation and to make any necessary repairs if needed. A licensed pest inspector should also be consulted to determine activity level for the insects and if treatment is required.

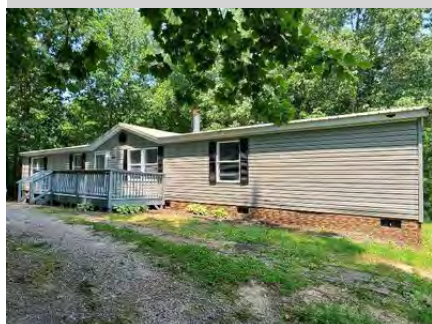
This home does not have a system such as gutters to control roof drainage. Direct drainage to the foundation and cladding from the roof system can result in water penetration into the foundation area and foundation deterioration.. It is recommended that a gutter system with extended downspouts be installed to protect the wall cladding and foundation areas of the home. A licensed general contractor should be consulted for evaluation and installation.

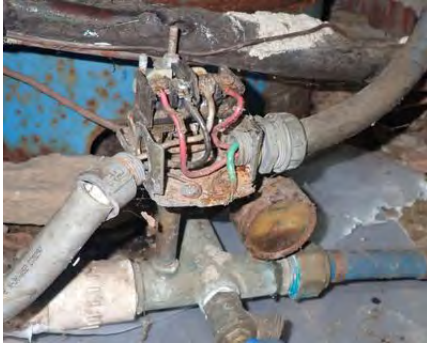
The pressure switch for the well storage tank is rusted and in poor condition. Additionally, the protective cover for the switch is missing which poses an electrical safety hazard. The pressure gauge is filled with water and is leaking. The failure of the pressure switch will result in poor/no water pressure. The storage tank system for the well system is in need of further evaluation, repair or replacement. A licensed plumbing or well contractor should be consulted for evaluation and repair.

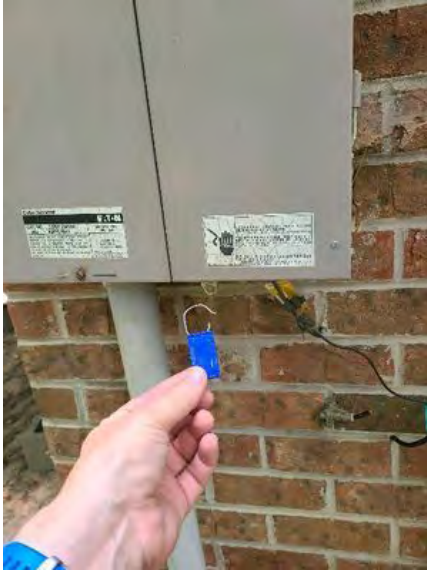
The power company tamper tag for the electrical service meter panel has been removed or cut. The damaged seal indicates that the meter has been tampered with and this condition presents a safety hazard that could result in serious personal injury and or property damage. The Power Company should be consulted to determine the significance of this concern and if repairs are needed.

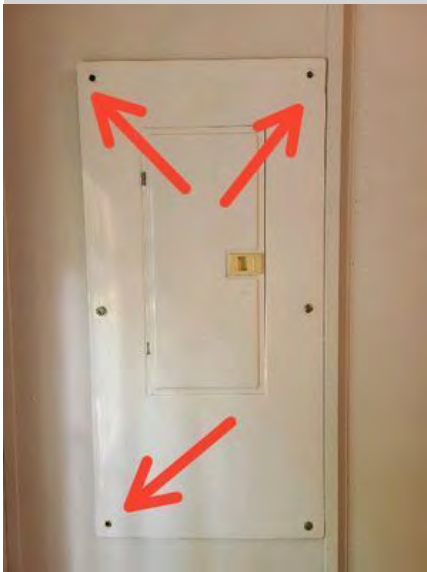
The main electrical service panel cover is missing fasteners that secure the cover to the enclosure. The door/cover prevents direct contact with hot electrical circuits and contains the electrical energy of the electrical system in the event of a short or electrical explosion; therefore the cover must be secured with the correct type (not pointed screws), size and number of fasteners. This condition presents a safety hazard that could result in serious personal injury or death. A licensed electrical contractor should be consulted for a complete inspection of the electrical system and for repair/replacement of the panel to ensure that it is safe and functioning properly.

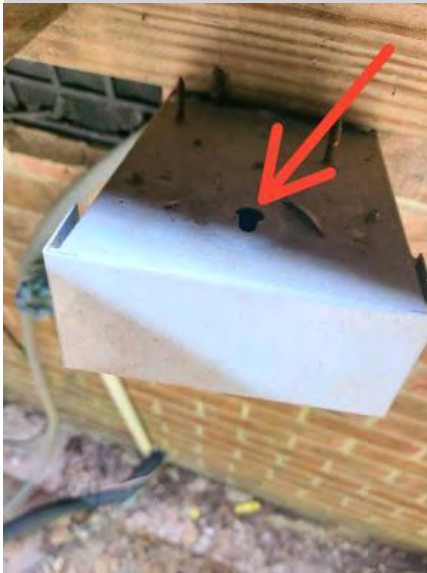
Additional photo exhibiting evidence of an open hole on the back of the air conditioning disconnect electrical box which will allow for direct water penetration and can lead to corrosion and cause an electrocution hazard.

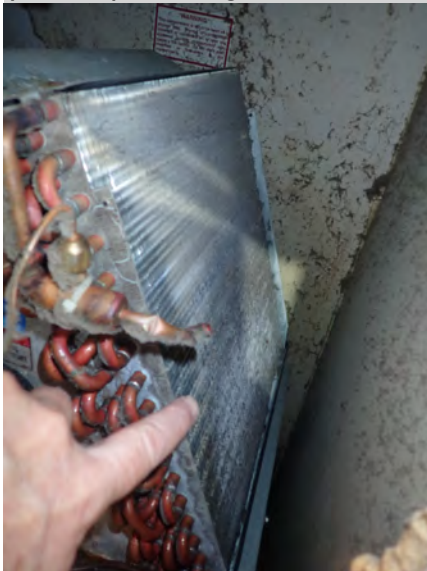
The interior coils of the HVAC system were noted to be dirty at the time of the inspection. This condition can effect the overall operation and efficiency of the HVAC system. An HVAC specialist should be consulted for a complete evaluation of the system and make any necessary repairs to ensure proper operation of the system.

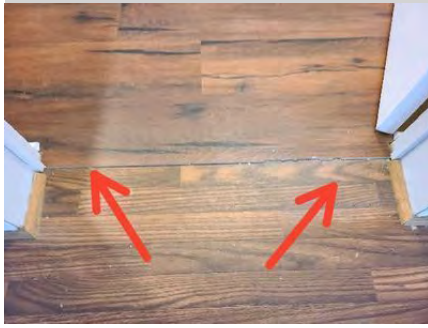
The transition between the flooring system of the master bedroom and the master bathroom is missing a threshold piece to prevent a toe grab/trip concern from the difference in floor levels. Corrective repairs by a specialist are needed.

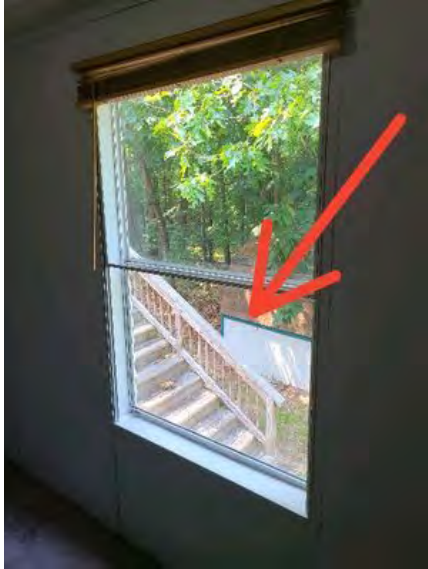
The inside lower storm window for the right rear bedroom was missing at the time of the inspection. A specialist should be consulted for evaluation and repair.

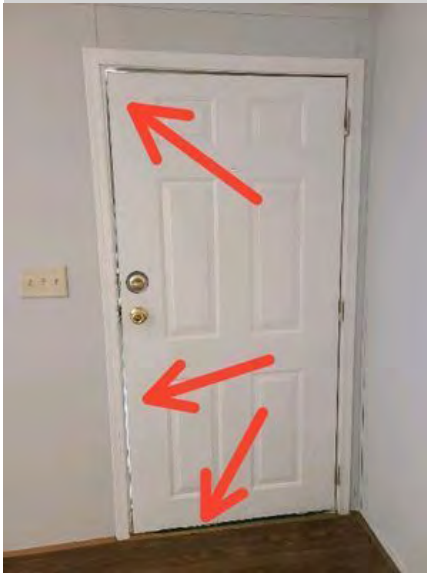
The front entrance door to the home does not have a weather tight seal around the perimeter and the bottom of the door rubs heavily on the threshold. A specialist should be consulted for evaluation and repair.

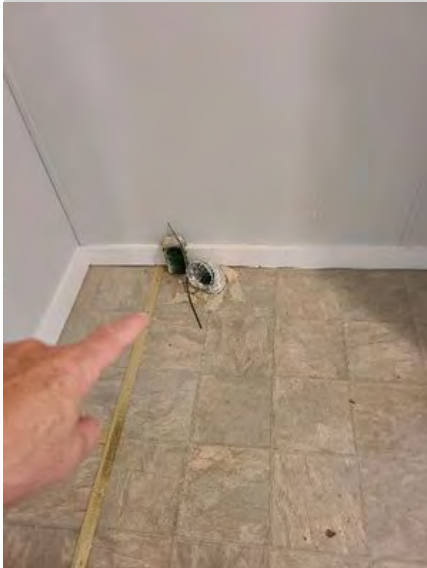
The dryer duct is damaged/missing/disconnected and exiting into the foundation area. The dry exhaust exposes the wood framing and other systems in the foundation area to excessive moisture and lint build-up. Electrical and mechanical systems can pose a fire hazard when exposed to lint. Improper dryer exhaust duct installation can result in condensation and lint build up that will cause the dryer to overheat creating a fire hazard. A licensed general contractor or general repair specialist should be consulted for further evaluation and repair to make sure the duct is properly installed and vented to the outside of the home. Rigid galvanized duct pipe should be used for the repair.

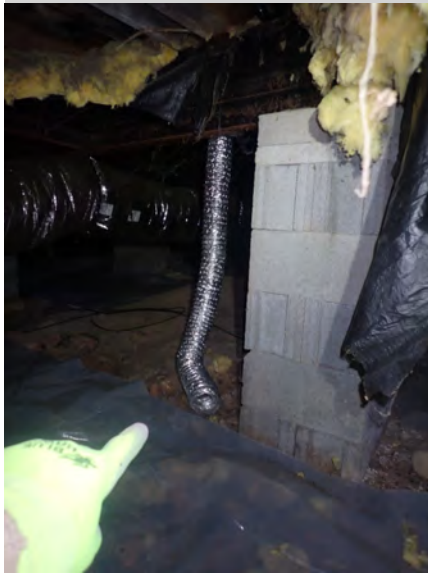
Additional photo - dryer duct venting into the crawl space.

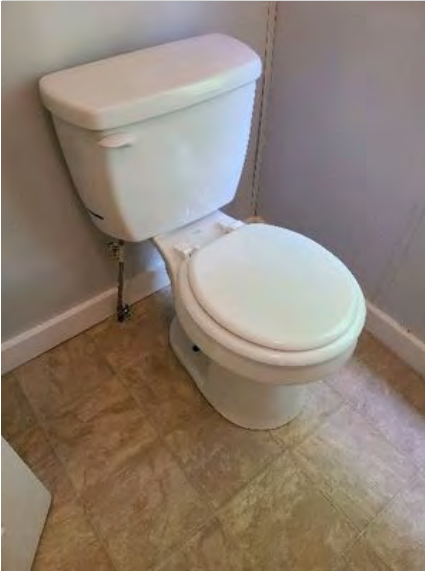
The toilet in the second bathroom was not functional at the time of the inspection. It appears the water to the unit is turned off. A licensed plumber should be consulted for further evaluation and repair to ensure the toilet functions as intended.

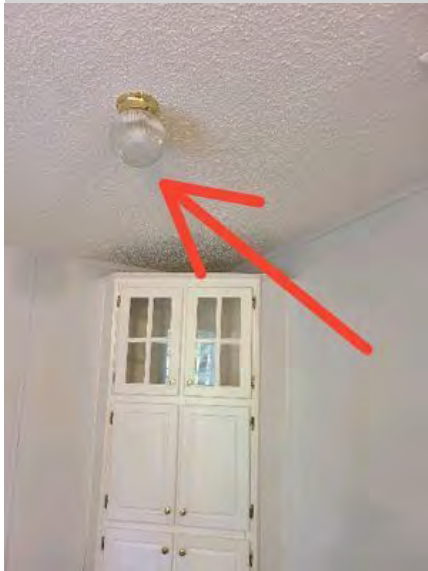
The overhead light in the master bathroom was not operational at the time of the inspection. Corrective repairs are needed.

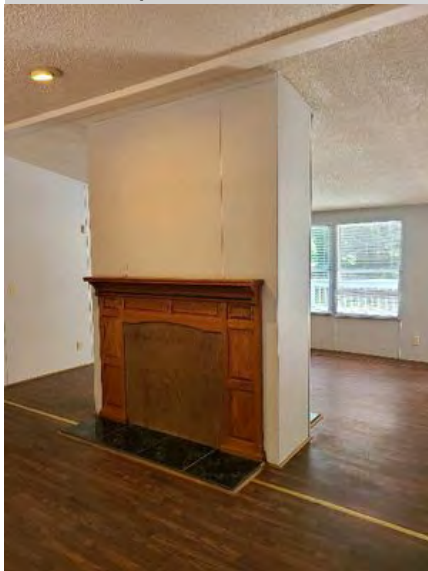
The fireplace area has covers blocking the front on both sides, therefore, the fireplace area could not be inspected. Seller disclosure is advised as to the reasoning for the covering of the fireplace area. Before use of the fireplace system, a licensed Chimney Specialist should be consulted for a complete evaluation of the fireplace firebox, damper system and chimney system to ensure it is clear and safe for use.

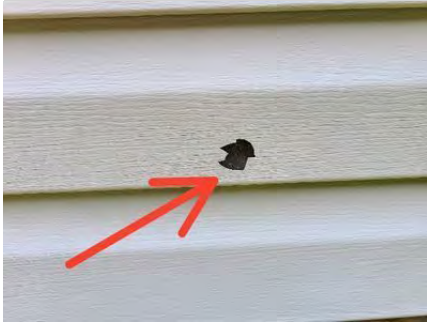
Additional photo of hole in the siding on the right side of the home in need of repair.

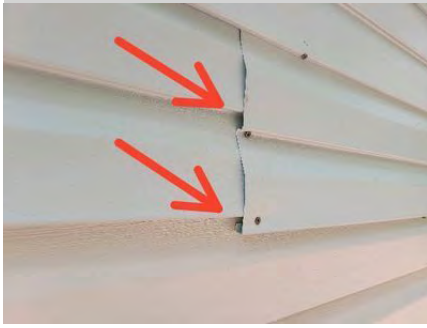
Additional photo of improper repair of the siding system at the rear of the home. This repair allows for water penetration into the siding system.

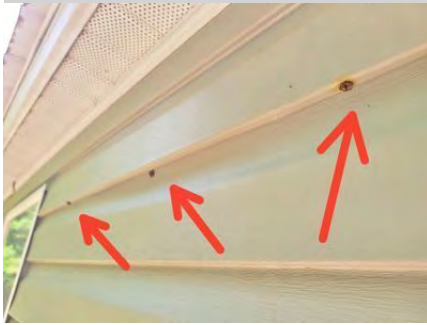
Additional photo of improper repair to the vinyl siding with exposed fasteners.

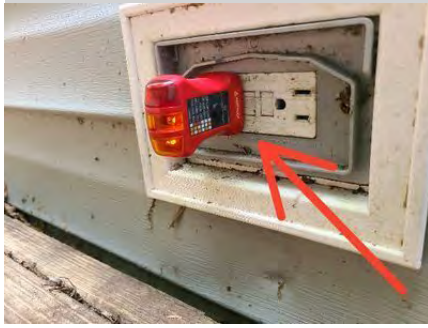
The GFCI receptacle at the rear of the home was not functional at the time of the inspection. The unit would not trip when tested. This is an important safety device. A licensed electrician or specialist should be consulted for evaluation and repair.

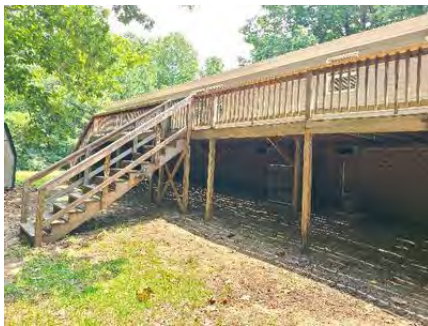
The elevated deck was found to be in poor condition and in need of immediate evaluation and repair. It is recommended that the deck system is NOT USED until repairs are made by a licensed general contractor. The following concerns were noted at the time of the inspection:

1. The deck system is not self supported and is improperly installed and should be considered UNSAFE FOR USE - Deck, porch and stair systems on the exterior of a manufactured home must be self supporting.
2. The decking surface is poor condition with uneven surfaces, lifted boards, split wood, raised/loose fasteners.
3. The steps are in poor condition, damaged treads, loose handrailings and poorly supported.
4. The deck support posts exhibit evidence of advanced decay. .
5. The deck post are not braced and or secured against up lift (over 4 feet)
6. Improper fasteniers and fastening methods are used throughout the deck system.

A licensed general contractor should be consulted for a complete evaluation of the deck step system and to make necessary repairs/replacement to ensure safe and functional use of the deck.

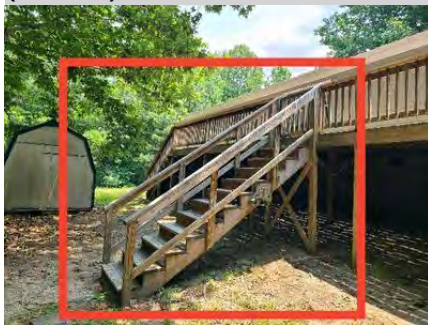
Additional photo, The rear steps leading to the deck should be considered a safety hazard and not be used. The entire stair system is loose and unstable and poses an immediate safety hazard.

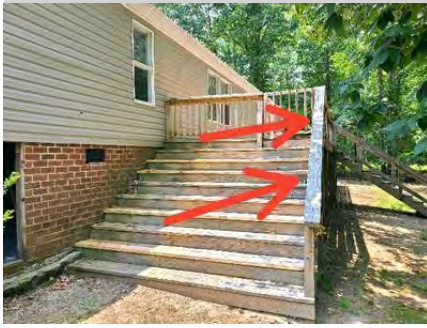
The top plate or grip that is installed on the handrails for the deck steps is too wide. The top plate should be within a size and thickness so that it can be easily gripped to prevent a fall.

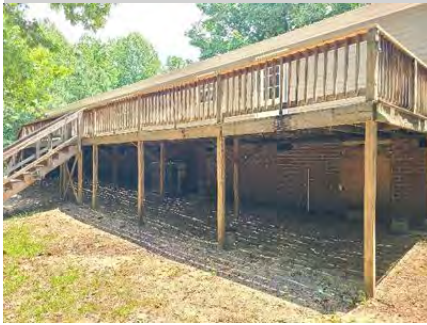
Additional photo exhibiting evidence of missing cross bracing between the support posts for the entire elevated rear deck system.

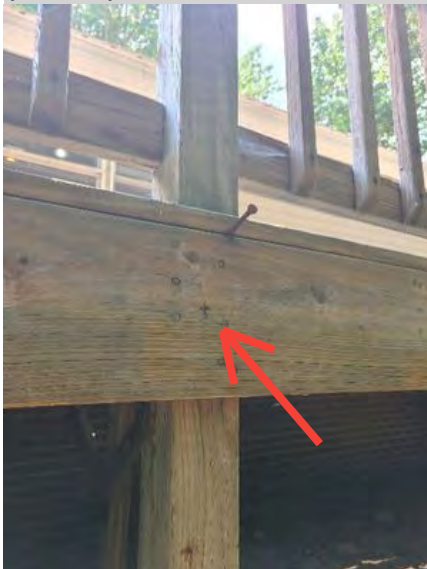
Additional photo of improperly fastened flooring system without through bolting.

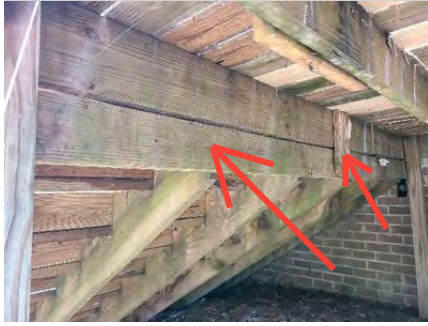
Additional photo of improperly fastened stair system without through bolting.

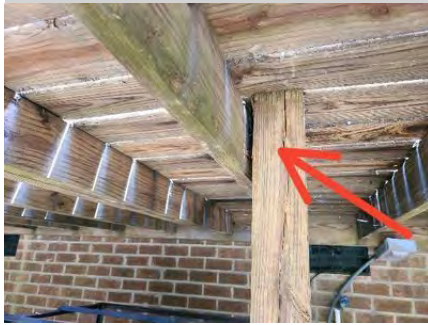
Additional photo example of loose/ improperly fastened support post without through bolting or fastener strap/bracket

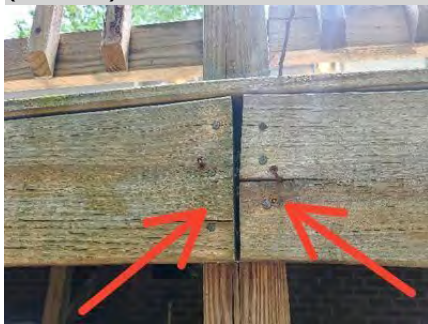
Additional photo - Improperly fastened perimeter band for the flooring system on the rear deck.

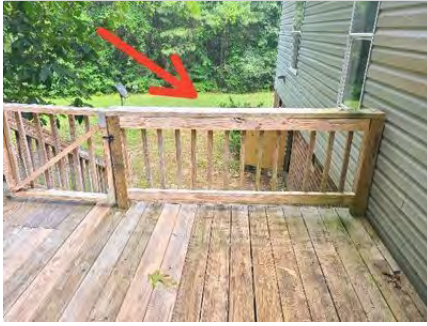
Additional photo of loose railing system at the rear deck.

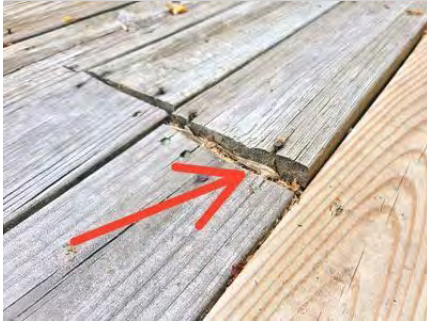
Additional photo typical of the poor floor board system on the rear deck with raised nails and loose boards and uneven walking surface throughout the flooring system.

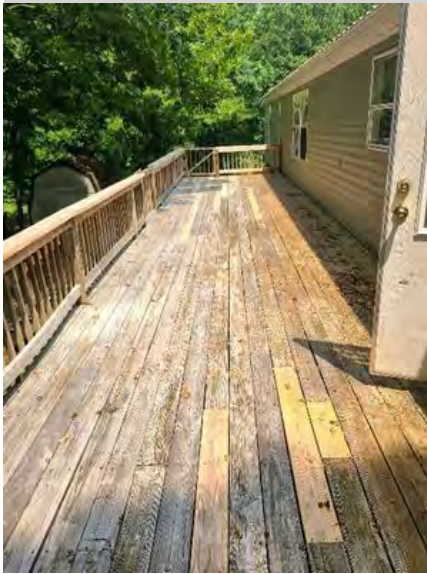
Additional photo of the flooring system for the deck at the rear of the home which has an uneven surface throughout the flooring system

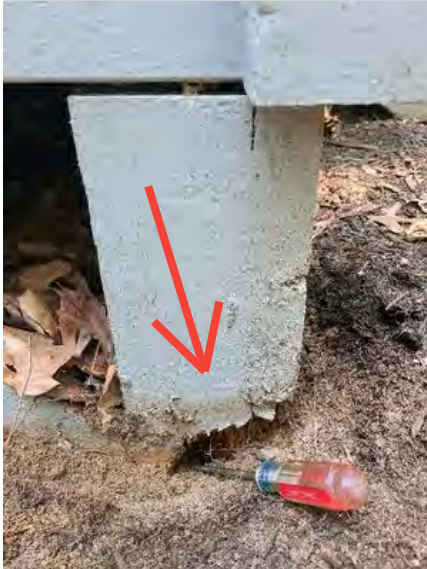
The front porch system is in need of repair. The structural support post at the front left corner exhibits evidence of advanced decay. As with the other items noted in the report the entire front porch system should be evaluated and repaired by a licensed general contractor to ensure safe use of the porch system.

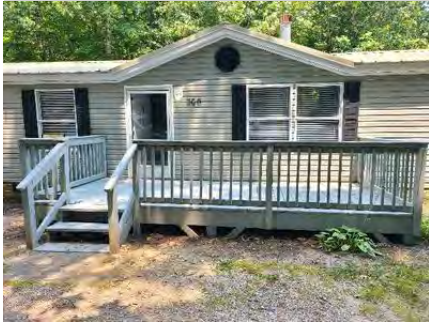
Limitation, due to the low height of the front porch system it is not possible to completely evaluate the flooring system. Also, could not confirm if the porch system is self supporting, as required for manufactured homes.

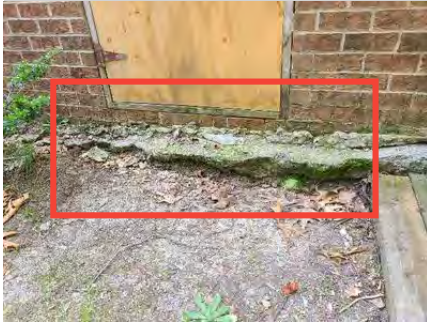
The house does not have a gutter and downspout system to divert water away from the foundation. At the rear of the home the foundation footing is exposed in many areas from what appears to be erosion of the soil. Such erosion can lead to damage of the foundation system. A licensed general contractor should be consulted to evaluate the level of concern and determine what repairs are required to ensure the structural integrity of the home.

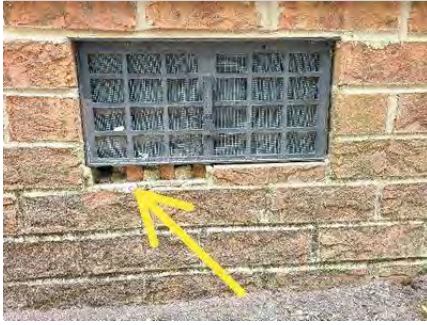
At the front of the home beneath a foundation vent a section of masonry brick is damaged which exposes an opening into the crawl space area. This can allow for pest and water penetration into the crawl space. A specialist should be consulted for evaluation and repair.

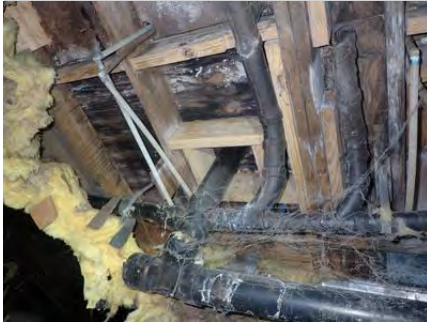
Additional photo - damaged flooring under master bathroom/laundry area.

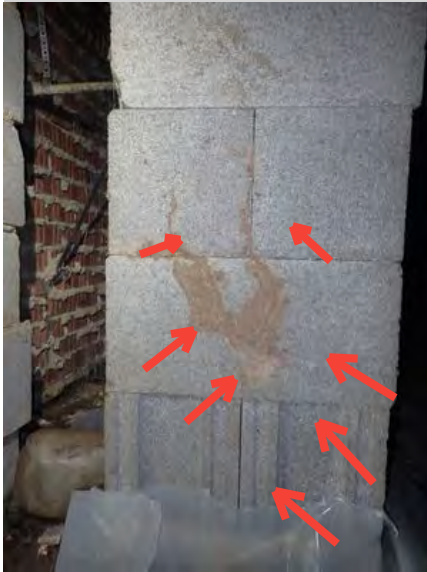
Mud tunnel etchings (stains) typical of termites were noted on a foundation pier at the left rear area of the home. Termite damage is often hidden and requires invasive inspection to determine the extent of the damage. A licensed general contractor should be consulted for a complete evaluation and to make any necessary repairs if needed. A licensed pest inspector should also be consulted to determine activity level for the insects and if treatment is required.

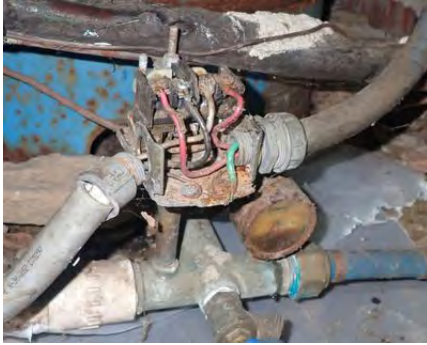
The pressure switch for the well storage tank is rusted and in poor condition. Additionally, the protective cover for the switch is missing which poses an electrical safety hazard. The pressure gauge is filled with water and is leaking. The failure of the pressure switch will result in poor/no water pressure. The storage tank system for the well system is in need of further evaluation, repair or replacement. A licensed plumbing or well contractor should be consulted for evaluation and repair.

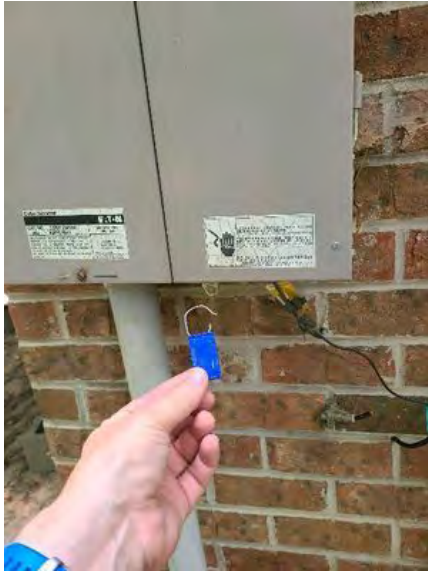
The power company tamper tag for the electrical service meter panel has been removed or cut. The damaged seal indicates that the meter has been tampered with and this condition presents a safety hazard that could result in serious personal injury and or property damage. The Power Company should be consulted to determine the significance of this concern and if repairs are needed.

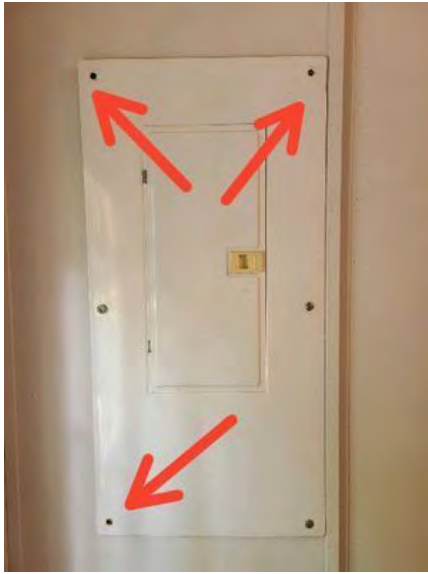
The main electrical service panel cover is missing fasteners that secure the cover to the enclosure. The door/cover prevents direct contact with hot electrical circuits and contains the electrical energy of the electrical system in the event of a short or electrical explosion; therefore the cover must be secured with the correct type (not pointed screws), size and number of fasteners. This condition presents a safety hazard that could result in serious personal injury or death. A licensed electrical contractor should be consulted for a complete inspection of the electrical system and for repair/replacement of the panel to ensure that it is safe and functioning properly.

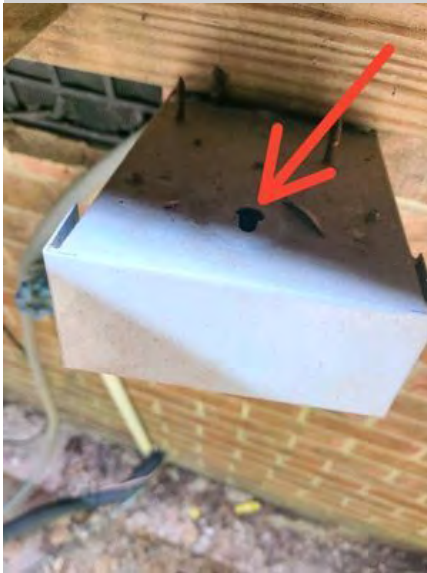
Additional photo exhibiting evidence of an open hole on the back of the air conditioning disconnect electrical box which will allow for direct water penetration and can lead to corrosion and cause an electrocution hazard.

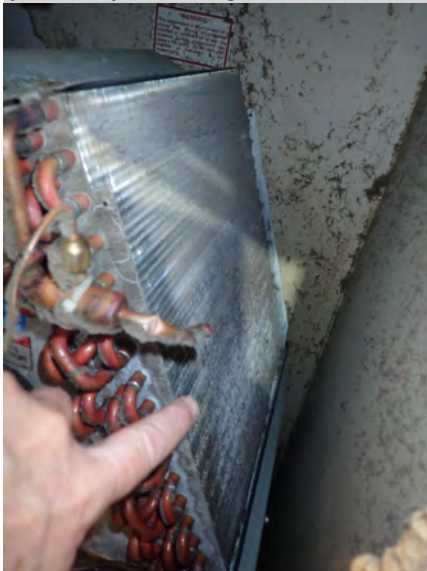
The interior coils of the HVAC system were noted to be dirty at the time of the inspection. This condition can effect the overall operation and efficiency of the HVAC system. An HVAC specialist should be consulted for a complete evaluation of the system and make any necessary repairs to ensure proper operation of the system.

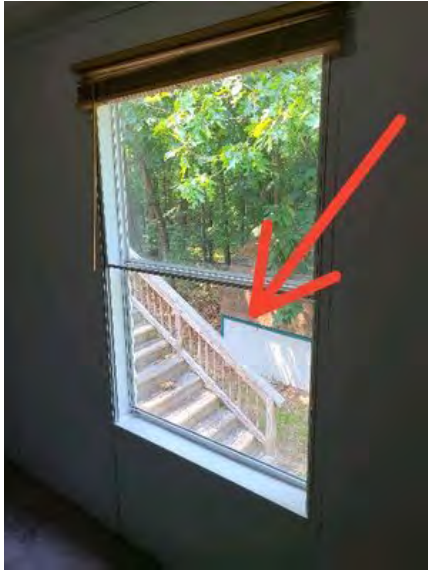
The inside lower storm window for the right rear bedroom was missing at the time of the inspection. A specialist should be consulted for evaluation and repair.

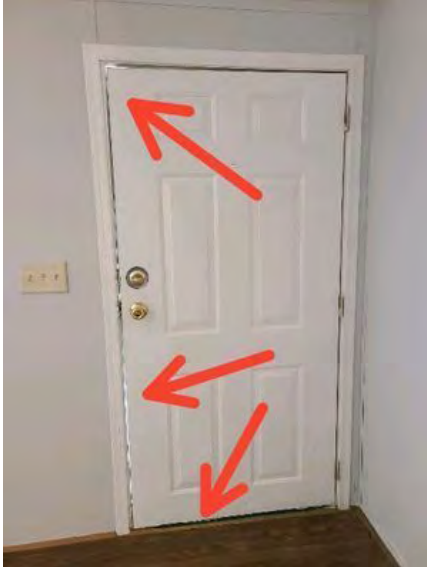
The front entrance door to the home does not have a weather tight seal around the perimeter and the bottom of the door rubs heavily on the threshold. A specialist should be consulted for evaluation and repair.

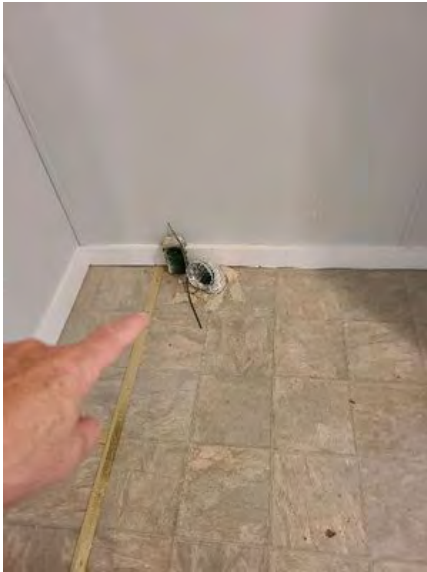
The dryer duct is damaged/missing/disconnected and exiting into the foundation area. The dry exhaust exposes the wood framing and other systems in the foundation area to excessive moisture and lint build-up. Electrical and mechanical systems can pose a fire hazard when exposed to lint. Improper dryer exhaust duct installation can result in condensation and lint build up that will cause the dryer to overheat creating a fire hazard. A licensed general contractor or general repair specialist should be consulted for further evaluation and repair to make sure the duct is properly installed and vented to the outside of the home. Rigid galvanized duct pipe should be used for the repair.

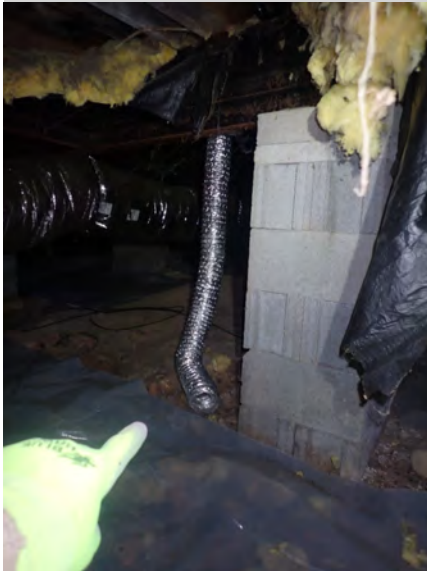
Additional photo - dryer duct venting into the crawl space.

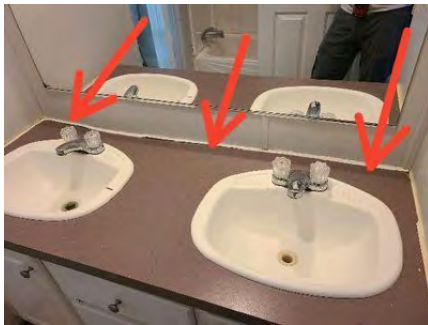
The countertop in the second bathroom for the vanity is verylooset and buckled behind both sinks for the entire span of the countertop. This suggests there may have been water damage. A specialist should be consulted for a complete evaluation and repair/replacement as needed to ensure the vanity system is functioning as intended
