# TABLE OF CONTENTS

HSR Inspection Services, LLC is pleased to submit the enclosed report. This report is our professional opinion based on a visual inspection of readily accessible areas and components of the Home. This report is neither an engineering inspection nor an exhaustive technical evaluation.

**Information: Foundation Type**  
Crawlspace, Manufactured home

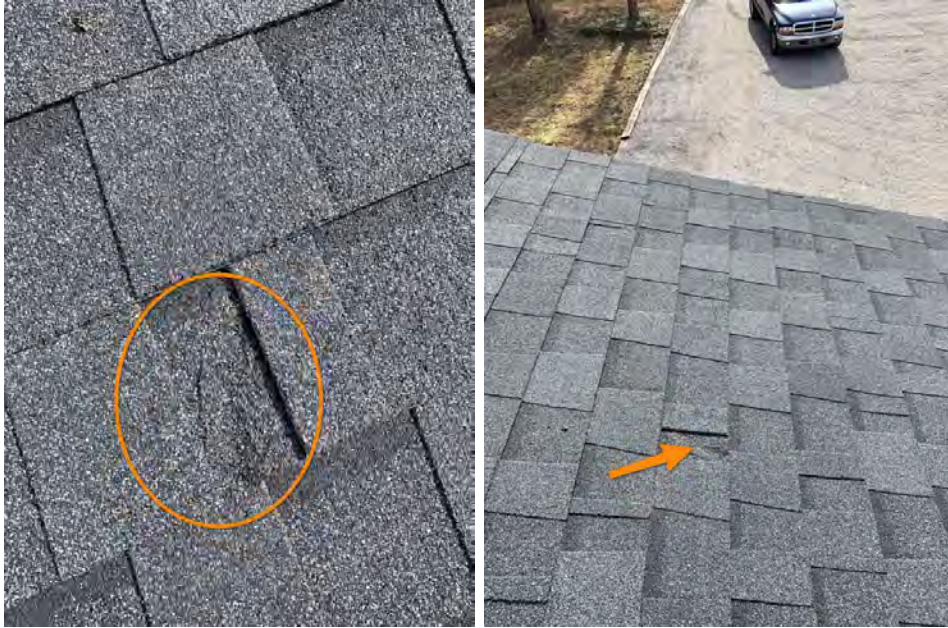
#### SHINGLES- MINOR DAMAGE

CRACKED SHINGLE ON LEFT-SIDE OF CROSS GABLE

Minor Deficiencies

Noted one or more composition shingles were damaged/ deteriorated, which is conducive to water intrusion into the structure. Recommend a Licensed roofing contractor repair all damaged singles and evaluate surrounding areas during the repair.

Contact a qualified roofing professional.

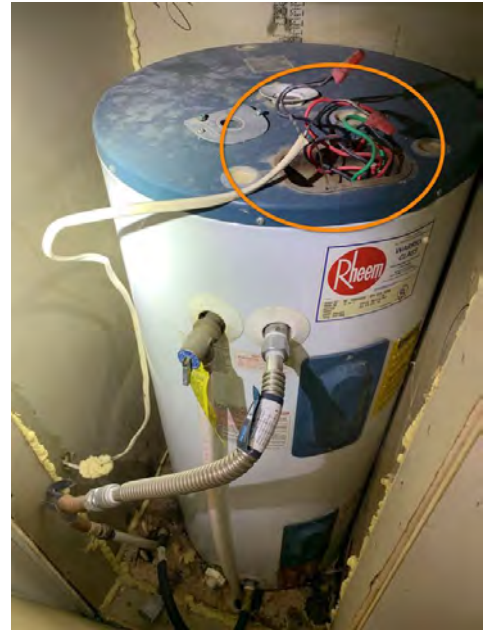
Noted exposed wiring splices, which should be contained in a junction box to avoid any potential hazards. Recommend a qualified professional for correction..

Minor Deficiencies

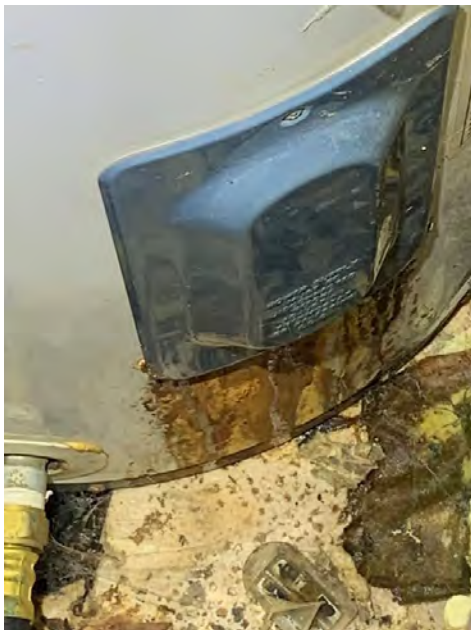
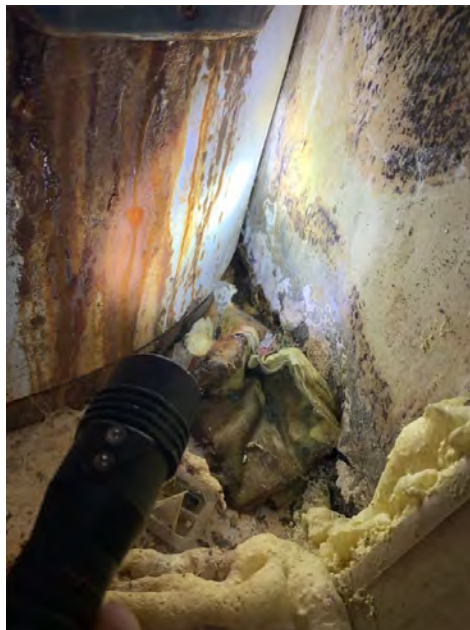
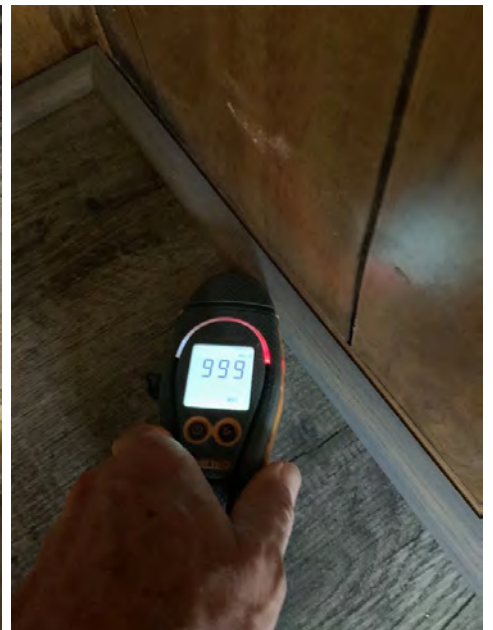
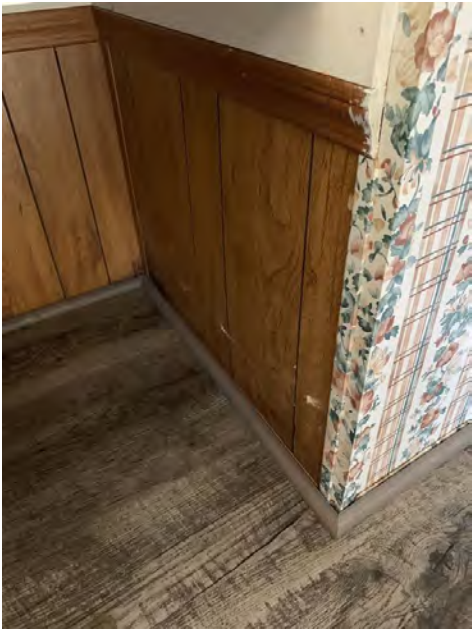
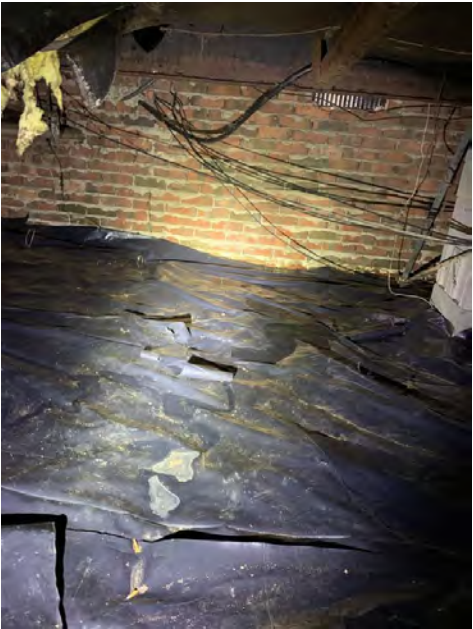
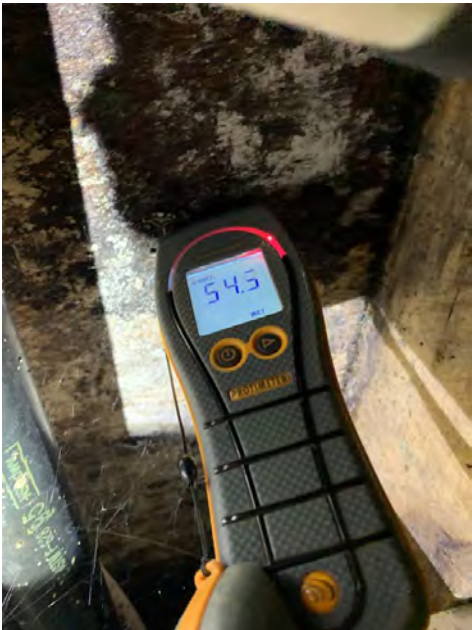
### 7.1.2 Water Heater

#### WATER HEATER- ACTIVE LEAK WITHOUT CATCH PAN

Noted water heater tank had an active leak without an emergency catch pan, which could possibly cause major damage to the floor structure and should be an immediate priority. Recommend a qualified professional evaluate all surrounding areas for damage after removal and make all repairs before new heater replacement. Emergency catch pan with a drain to the outside should be installed as an upgrade.

Safety Concerns/ Major Deficiencies

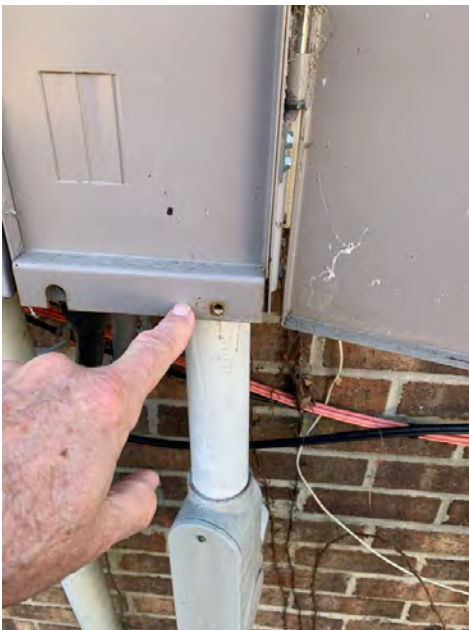
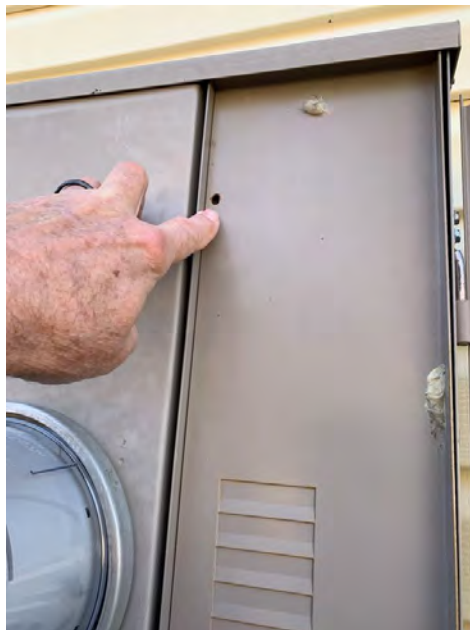
#### **DEAD FRONT- MISSING SCREWS**

Noted missing panel screws, which may not allow proper seating. Recommend qualified contractor to repair as necessary.

Minor Deficiencies

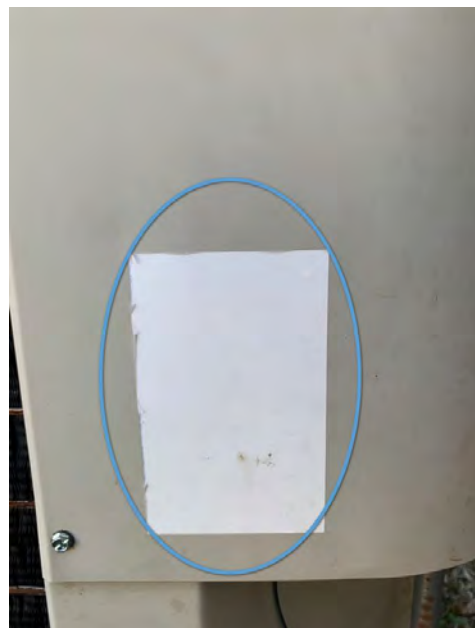
The estimated useful life for air conditioning/heat pump compressors is 8 to 15 years. This unit appears to have exceeded this age and may need replacing at any time. Recommend budgeting for a replacement in the near future. It is recommended to have a Licensed HVAC technician complete a more invasive inspection.

Recommend monitoring.

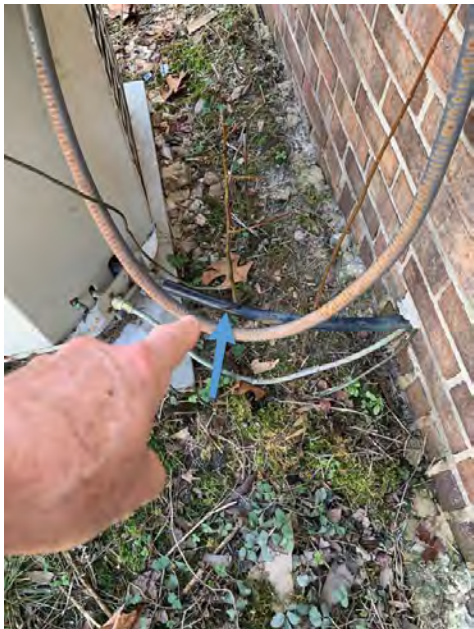
9.2.2 Condensing Unit

**LINE-SET INSULATION**

Noted Insulation was damaged/ deteriorated/ missing on the refrigerant lines, which may allow energy loss and allow mechanical damage to line-set. Recommend licensed HVAC technician repair or replace insulation.

Contact a qualified professional.

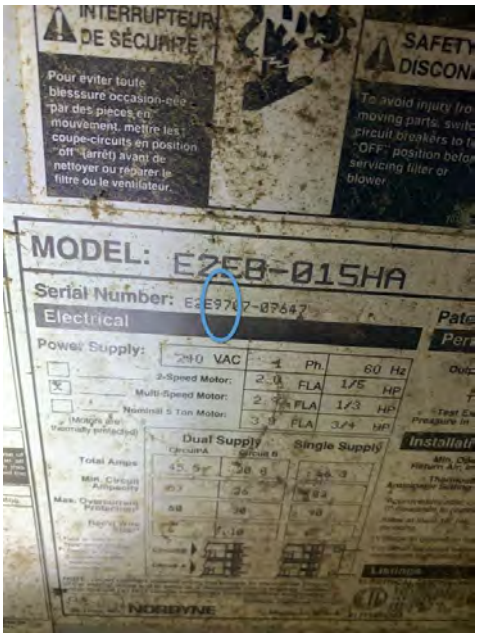
9.3.1 Air Handler

EXCEEDS LIFE EXPECTANCY

A-COIL APPEARS TO HAVE BEEN REPLACED SINCE ORIGINAL MANUFATRE DATE

Noted unit appears to have exceeded its normal life expectancy, which unit may fall in the near future. Recommend a qualified professional for further evaluation and budgeting for future replacement.

Recommend monitoring.

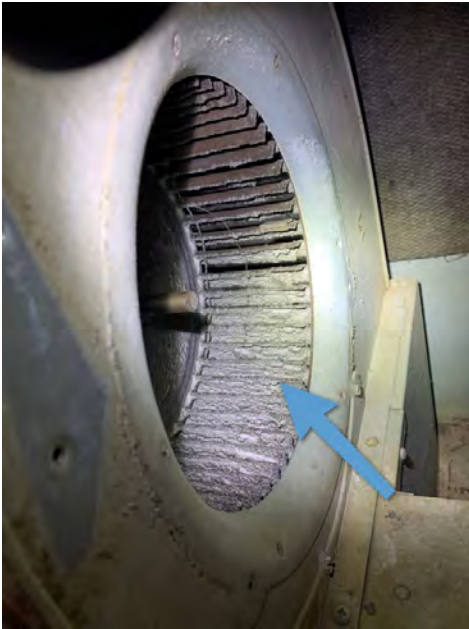
9.3.2 Air Handler

NOISE OR VIBRATION

FAN MOTOR

The air handler is noisy or is vibrating excessively when operating. A qualified heating and cooling contractor should evaluate and repair as necessary.

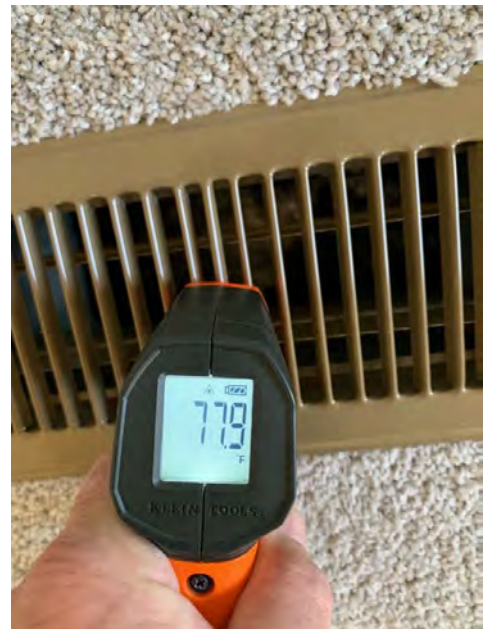
#### 9.4.1 Duct Work

### REGISTER NOT COOL/ WARM

Register was not producing enough warm/cool air compared with the other registers in the home, which may indicate a issue in the ductwork distribution system. Recommend HVAC contractor evaluate and repair as necessary.

Contact a qualified heating and cooling contractor

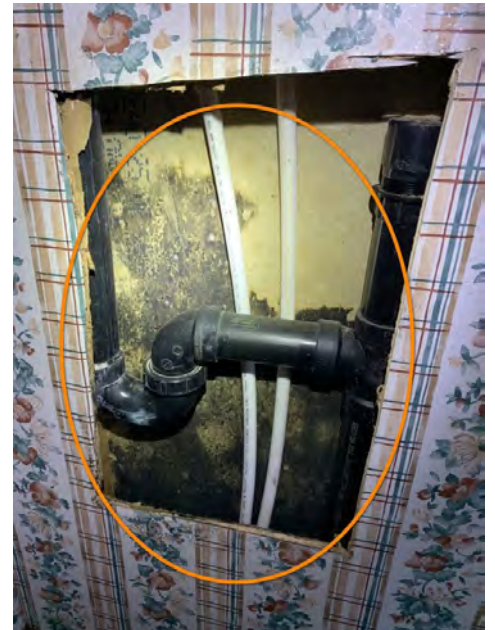
There is possible microbial growth on the ceiling/wall in one or more areas, which did not show elevated moisture levels at time of inspection. Areas like this may need to be further evaluated, cleaned and monitored.

Contact a qualified professional.

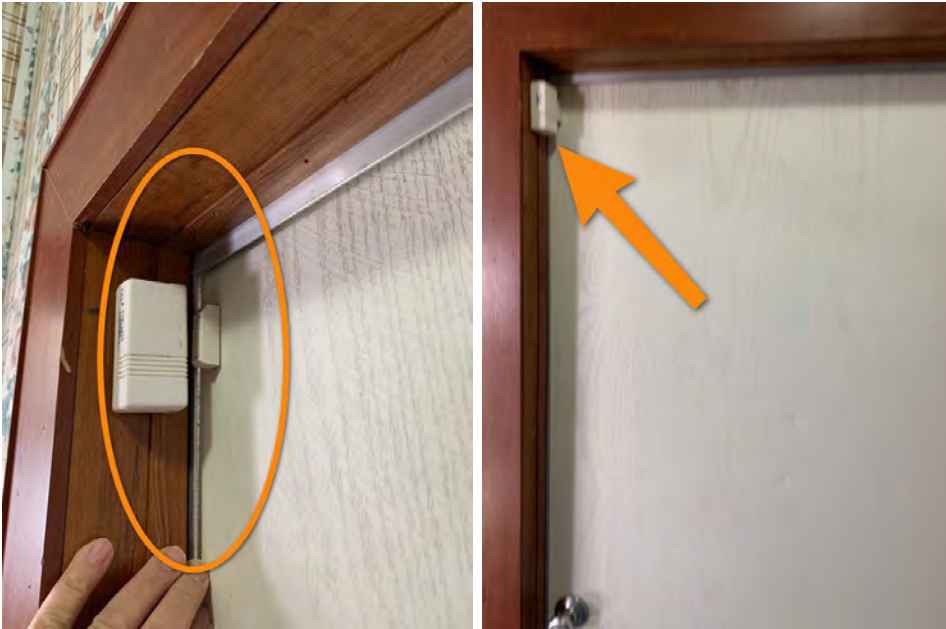
### 10.3.1 Windows and Doors

**ENTRY DOOR-WEATHERSTRIP**

The weatherstrip around one or more exterior entry doors is missing and/or deteriorated, which may cause excessive energy loss. Weatherstrip should be installed where missing and/or replaced where deteriorated by a qualified contractor.

Contact a qualified professional.

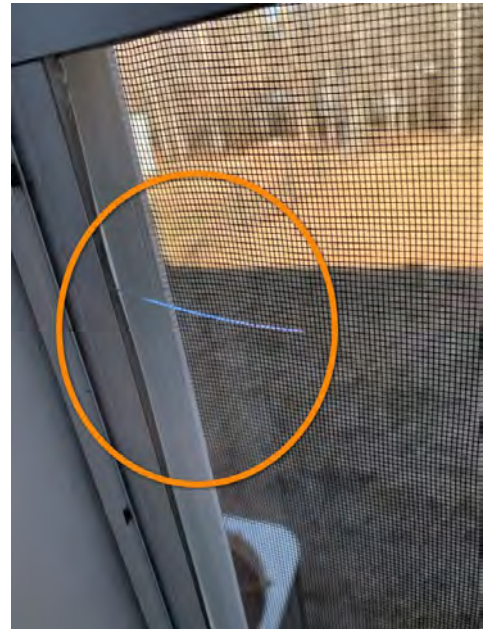
### 10.3.2 Windows and Doors

#### **WINDOW GLAZING- DAMAGE**

MULTIPLE WINDOWS HAD MINOR CRACKS

Noted glazing in one or more windows is broken/ scratched or cracked, which may require professional restoration. Recommend a qualified contractor replace/ correct glazing where necessary.

Recommend monitoring.

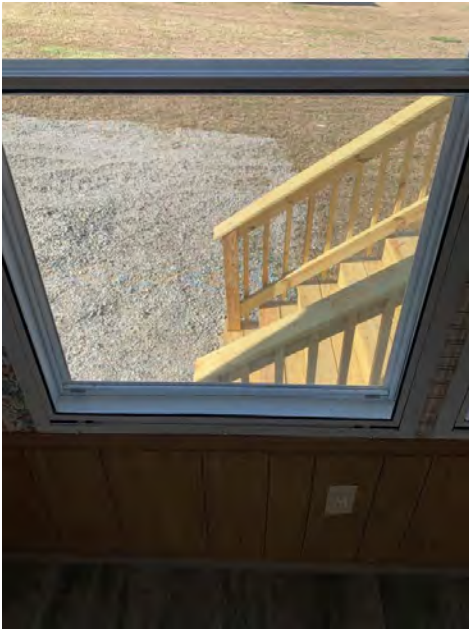
### 10.3.3 Windows and Doors

#### **WINDOW-LOCK ISSUE**

Lock mechanisms on one or more windows are missing and/or damaged so that they are difficult/inoperable, which may cause egress and security issues. Repairs should be made by a qualified contractor so that windows lock and unlock easily.

Contact a qualified professional.

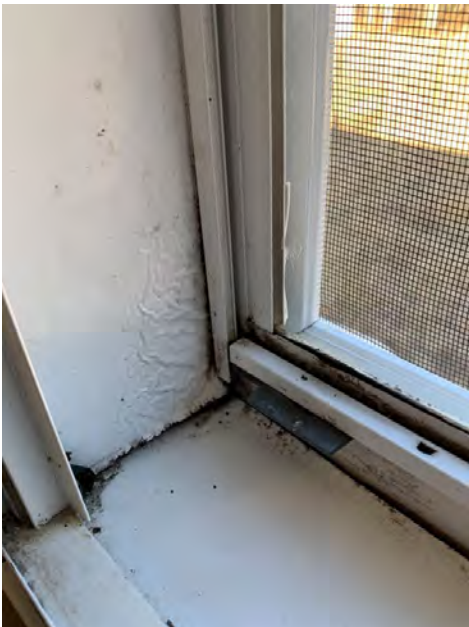
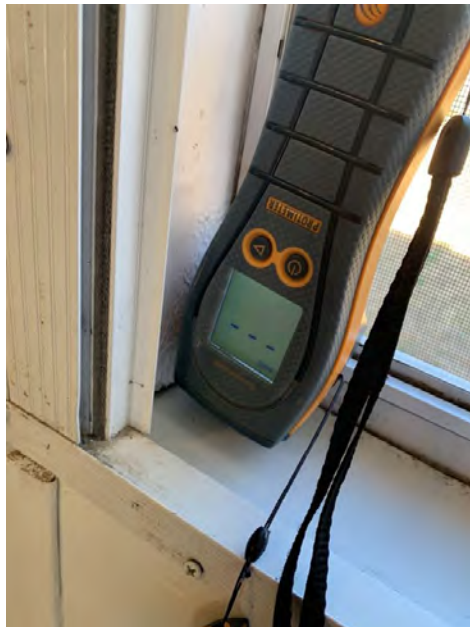
#### 10.3.4 Windows and Doors

### **WINDOW- MINOR DAMAGE**

Noted minor Damage to the window/ locks or sill was observed, which may cause improper air sealing issue or require professional restoration. Recommend qualified professional make the necessary repairs or replace.

Recommend monitoring.

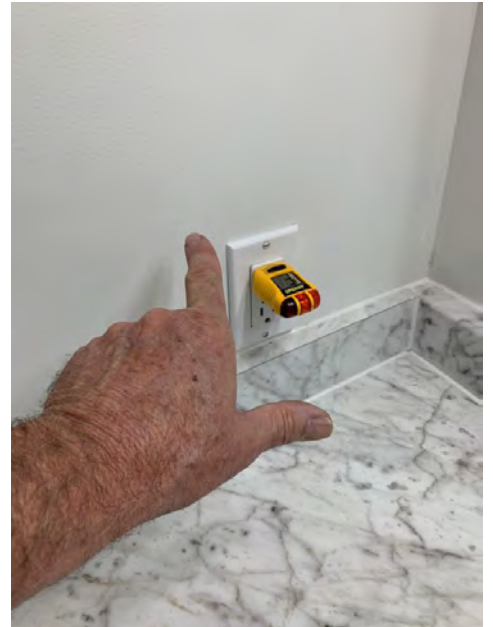
#### 10.4.1 Electrical

### **RECEPTACLE- LOOSE**

Noted one or more electric receptacles were loose, which may stress wiring connections due to excessive movement. Recommend a Licensed electrician repair as necessary.

Contact a qualified electrical contractor.

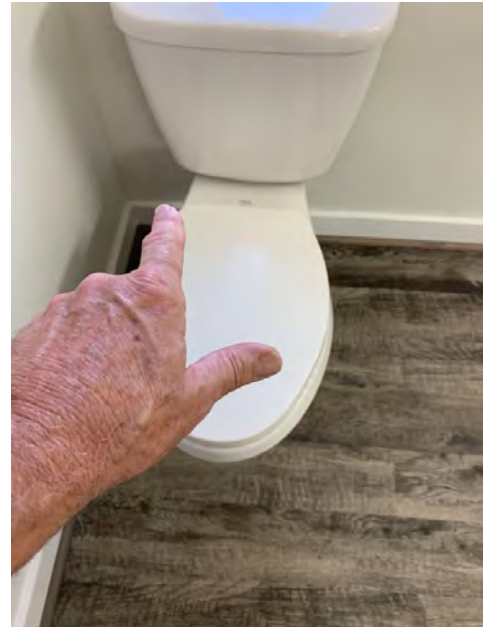
#### TOILET LOOSE

Noted One or more toilets were not securely fastened to floor, which may cause leakage due to wax seal failure. A new wax ring should be installed and toilet(s) should be securely anchored to the floor to prevent movement by a qualified contractor.

Contact a qualified plumbing contractor.

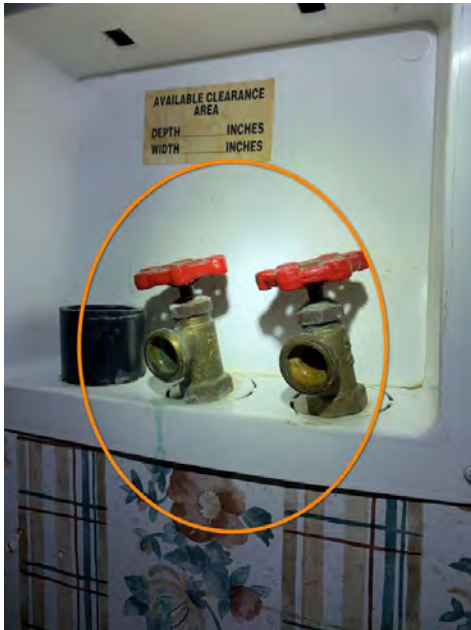
## 12.1.1 General

**WATER VALVE LEAKING**

Contact a qualified plumbing contractor.

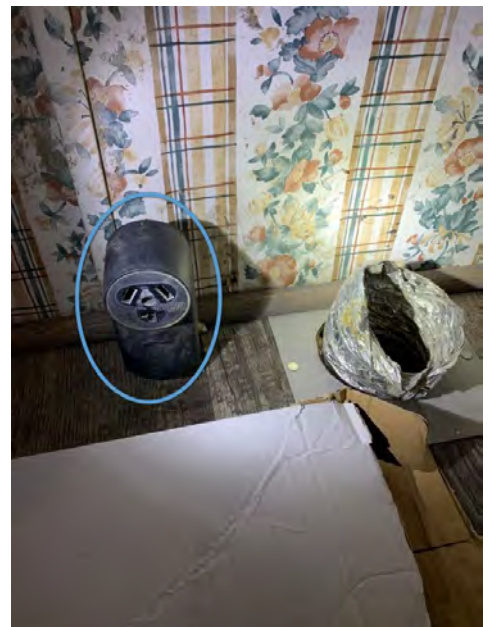
## 12.1.2 General

**OLDER STYLE 3-PRONG**

Contact a qualified professional.

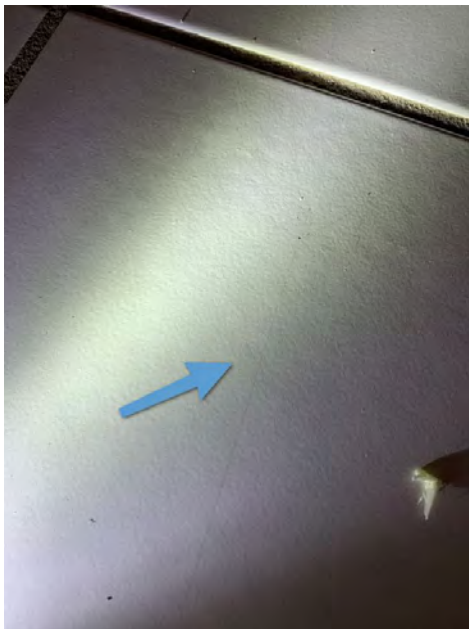
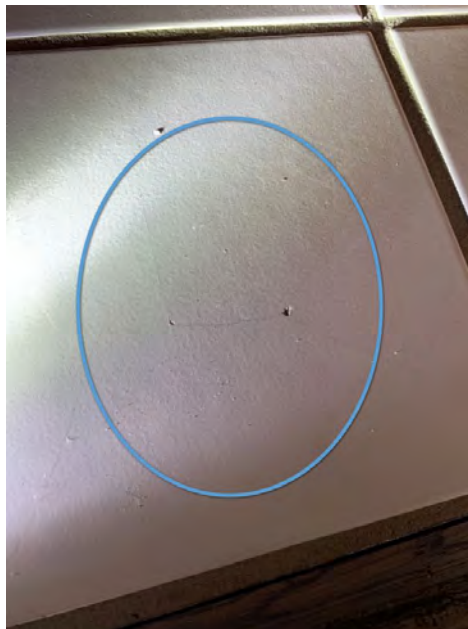
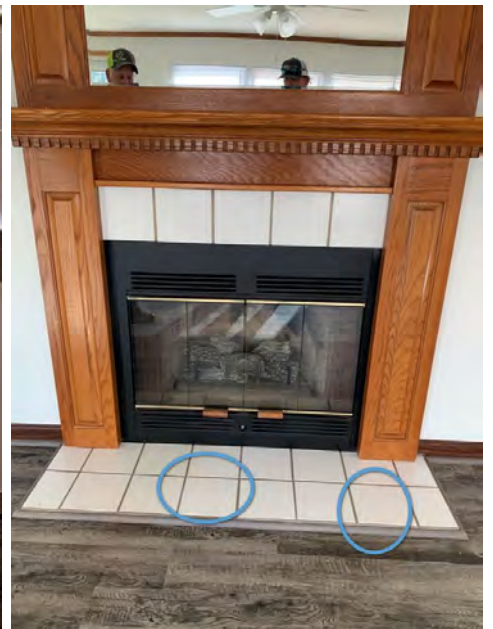
#### RECOMMEND EVALUATION

Recommend monitoring.

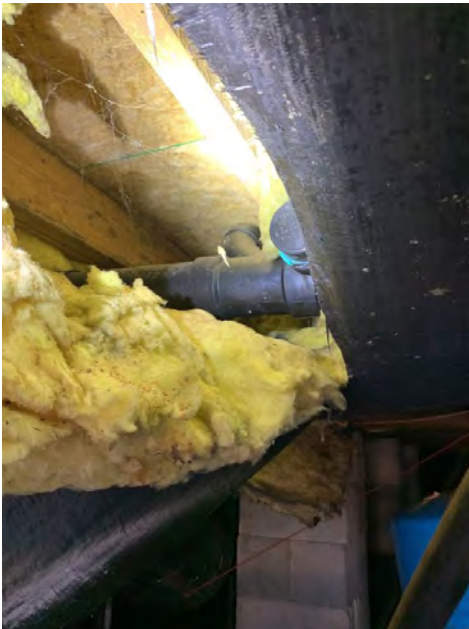
## 17.4.1 Vapor barrier

**BELLY WRAP- DAMAGED**

Contact a qualified professional.

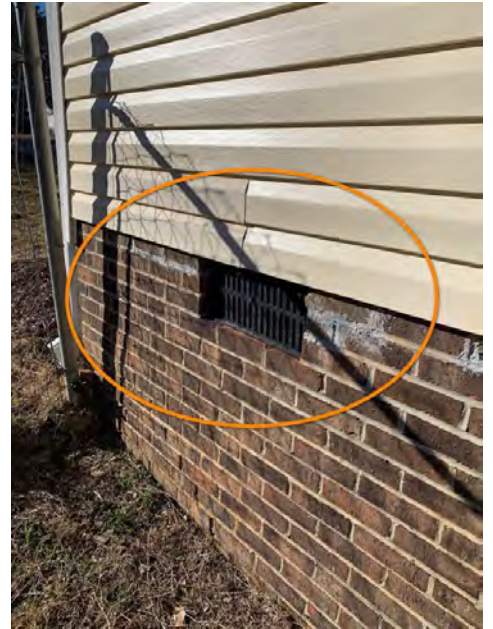
## 17.5.1 Cracks in masonry

**CRACKS IN MASONRY/  
BLOCK**

Recommend monitoring.
