**NORWOOD PLUMBING, INC**  
**Cassandra "Casey" Champion**  
**Inspector**

**On-site Wastewater Inspection**

**Property Address: 59 Pool Rock Shores Lane, Henderson, NC 27537**

**Date of Inspection: December 17, 2021**

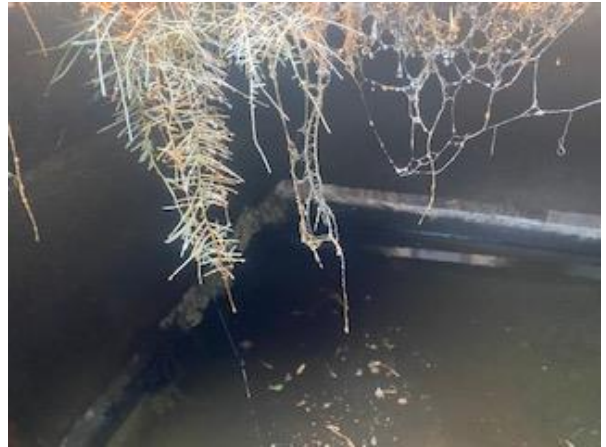
**NO** - Water level in tank is relative to tank outlet – **Water level below mid seam**

- Water level in tank is below mid seam – recommend a 24 hour leak test
- Crack in tank directly underneath inlet from root penetration
- Roots entering in at mid- seam

**Water level in tank upon opening**

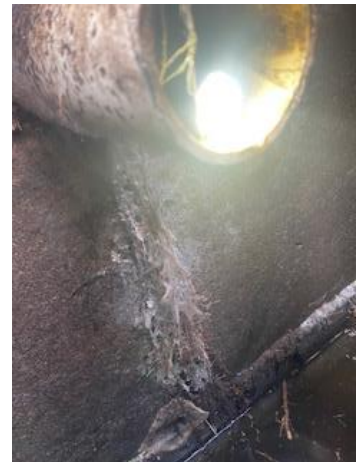
**INLET (crack)**

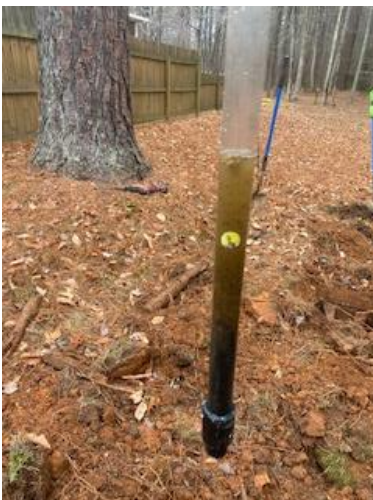
**INLET - SCUM LEVEL – 0"      SLUDGE LEVEL – 12"**

**OUTLET – SCUM LEVEL – 0"      SLUDGE LEVEL – 8"**

**SLUDGE JUDGE**

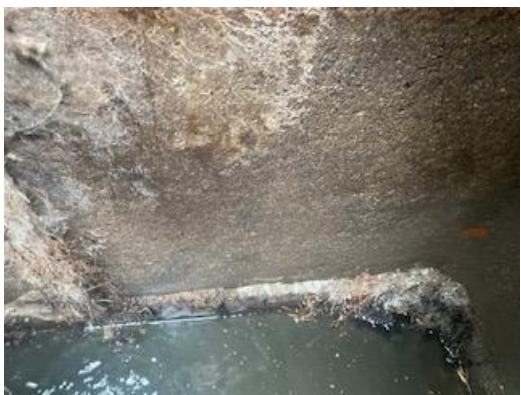
**Roots at mid seam**

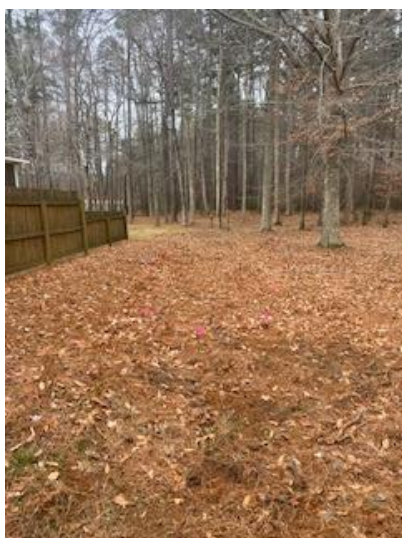
**DRAIN FIELD**

- No sign of failure in septic field at this time.
- No obvious issues noted at this time.
- We broke septic lid when trying to open tank – we replaced with a new lid.

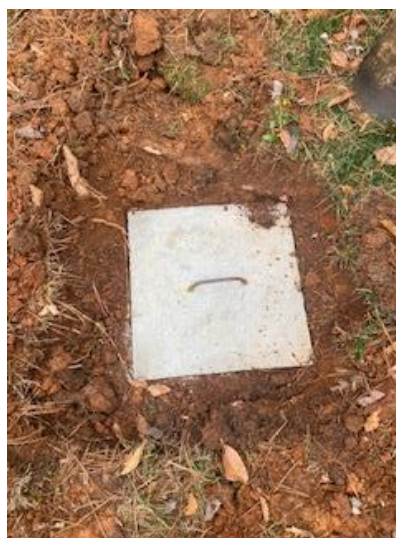
**OUTLET lid replaced**
