# Property Inspection Report

**Report Number: 123022.10**

139 Ellington Road  
Henderson, North Carolina 27537

Date of Inspection: Friday, December 30, 2022

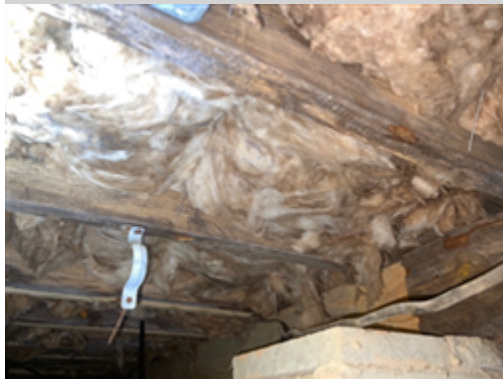
##### (A3 - 1.1 ) Main House

Further Evaluation Needed/Repairs - Floor Joist - Moisture Damage (Rot) Floor Joist & Girder / Recent Repairs - Observed severe moisture damage on the wood frame components of the floor system inside the foundation crawlspace with recent repairs (sintering floor joists). Repairs were noted on several areas of the floor joists and the main girder inside the foundation crawlspace. Some areas of damage on the floor joist were observed with out any recent repairs and fungal/mold growth was still present. Recommend professional/structural engineer provide a full evaluation of the noted damaged areas, as well as, any other areas in this floor system that is considered to be problematic due to there experience with older home floor construction repairs. At a minimum, a professional contractor specializing in structural foundation and floor system installation needs to provide an evaluation and necessary repairs in the observed area noted in the report in order to restore the structural integrity of the floor system inside the foundation. Observation/Information: Supplemental Support Systems Installed - Observed added supporting system in the crawlspace. Added/supplemental systems are not a structural component in the floor system and are provided to help support the floor system where floor noise from deflection is occurring. It is common in older homes to see added supports due to older building codes that allowed for larger spans in the floor joist construction. If any concerns are presented due to the added support structures being installed, it is suggested that a professional engineer be consulted.

Observed severe moisture damage on the wood frame components of the floor system inside the foundation crawlspace with recent repairs (sintering floor joists). Repairs were noted on several areas of the floor joists and the main girder inside the foundation crawlspace. Some areas of damage on the floor joist were observed with out any recent repairs and fungal/mold growth was still present. Recommend professional/structural engineer provide a full evaluation of the noted damaged areas, as well as, any other areas in this floor system that is considered to be problematic due to there experience with older home floor construction repairs. At a minimum, a professional contractor specializing in structural foundation and floor system installation needs to provide an evaluation and necessary repairs in the observed area noted in the report in order to restore the structural integrity of the floor system inside the foundation. Observation/Information: Supplemental Support Systems Installed - Observed added supporting system in the crawlspace. Added/supplemental systems are not a structural component in the floor system and are provided to help support the floor system where floor noise from deflection is occurring. It is common in older homes to see added supports due to older building codes that allowed for larger spans in the floor joist construction. If any concerns are presented due to the added support structures being installed, it is suggested that a professional engineer be consulted.

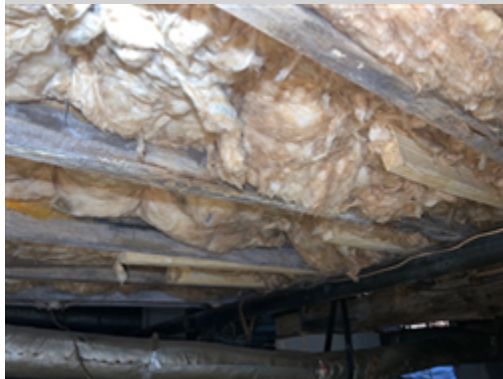
##### (A3 - 1.2 ) Main House

Additional Photograph: This is a photograph of previous comment

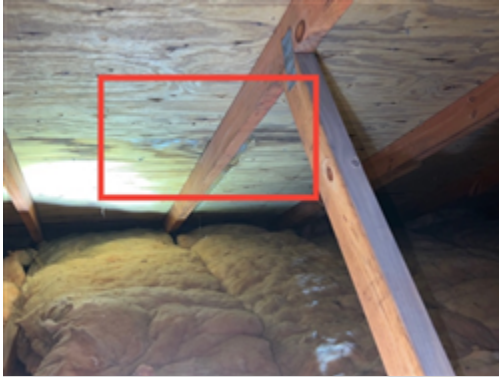
#### **(A6 - 1.1 ) Main House**

From the attic, the wood framing components are discolored and decayed. The level of decay indicates a long term leak that could involve hidden areas of damage, the flashing, and the roof covering systems. The area was also wet at the time of the inspection indicating an active leak. A licensed general contractor should be consulted for further evaluation and repair to determine the source of the leak and extent of the damage to ensure the stability of the home and prevent additional damage.

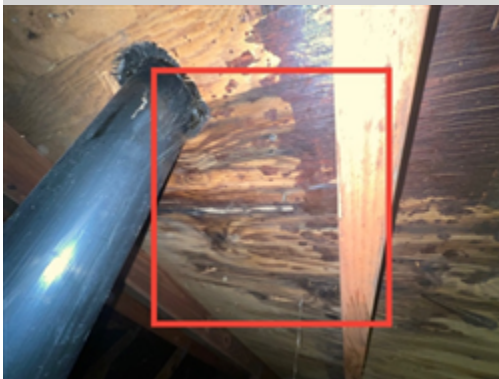
#### **(A6 - 1.2 ) Main House**

Additional Photograph: This is a photograph of active leak on the rear elevation.

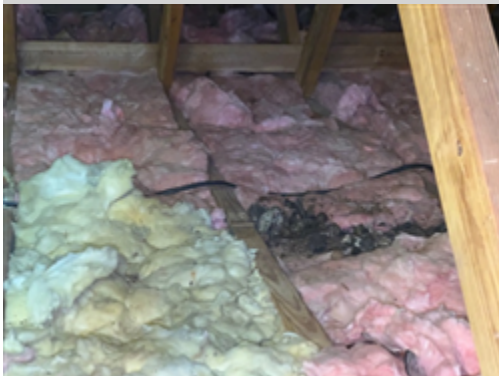
#### **(A6 - 1.3 ) Main House**

At many places in the attic, there was evidence of animal feces. This can pose an unsanitary conditions. Recommend that all access point for wildlife to enter the home be sealed up and protected. Recommend that the unsanitary conditions be reviewed and corrected as necessary by a qualified specialist.

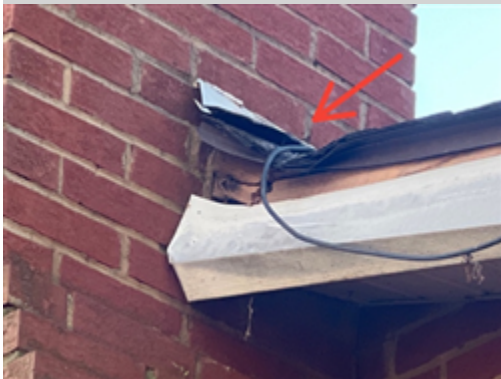
#### **(B1 - 1.5 ) Main House**

The aluminum cladding covering the wood trim was noted to be loose. The roof line was damaged. All systems listed should be evaluated and repaired as needed by a licensed general contractor to ensure that all systems are functioning as intended. The contractor should consult a specialist in each trade as needed.

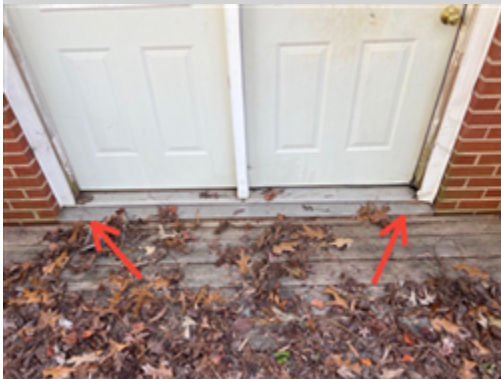
#### **(B2 - 1.1 ) All Doors**

The rear door has soft and decayed wood in the frame area. Decay in the door frames can result in leaking and water penetration and should be repaired as soon as possible. A general repair specialist or licensed general contractor should be consulted for evaluation and repair.

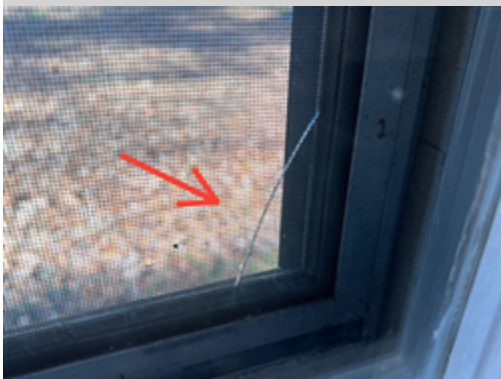
#### **(B2 - 2.1 ) All Windows**

The storm kitchen window has a broken/cracked pane. The broken glass should be repaired to prevent accidental injury and weather intrusion. A licensed general contractor should be consulted to make necessary repairs.

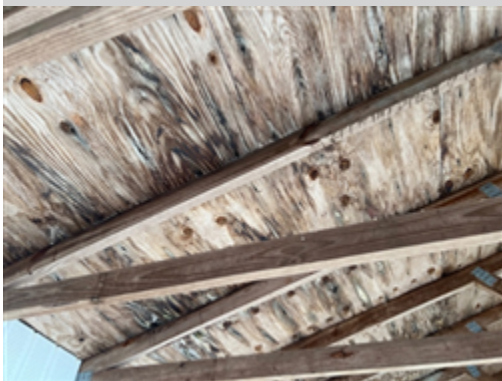
**(B4 - 1.1 ) Driveway, Carport and Front Walk**

The roof sheathing on the carport is stained and evidence suggest a history of a leak. The shingles/flashing were noted to be older and in poor condition. A licensed general contractor should be consulted to review the area of concern and repair to needed to ensure the weathertightness of the roof system.

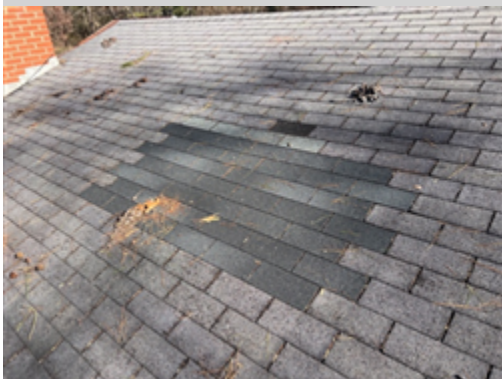
**(C1 - 1.1 ) Main House**

There are several visible repairs to the roof covering. Repairs typically indicate physical damage or history of leaks and can indicate that a roof covering is approaching the end of the service life. The owners should be asked for disclosure related to the history of repairs. A licensed roofing contractor should be consulted to evaluate the repairs and determine the life expectancy of the roof covering.

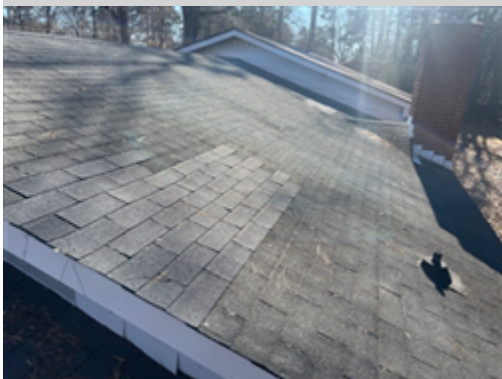
**(C1 - 1.2 ) Main House**

Additional Photograph: This is a photograph of previous comment

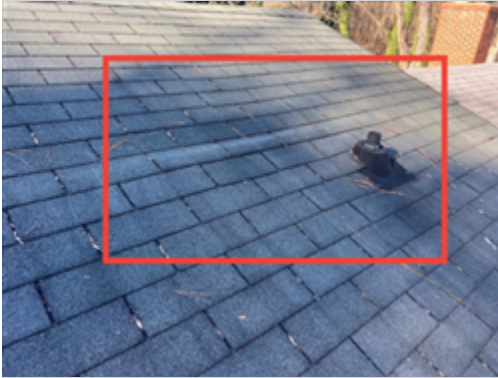
**(C1 - 1.3 ) Main House**

Additional Photograph: This is a photograph of buckled shingles

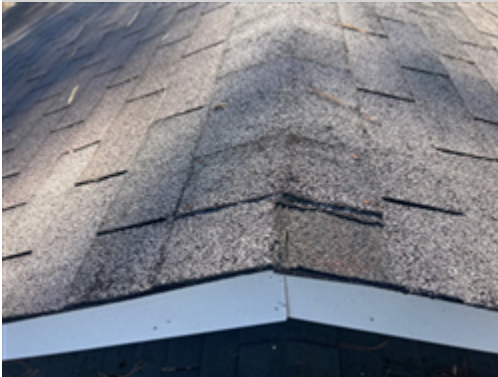
**(C1 - 1.4 ) Main House**

Additional Photograph: This is a photograph of damage shingles.

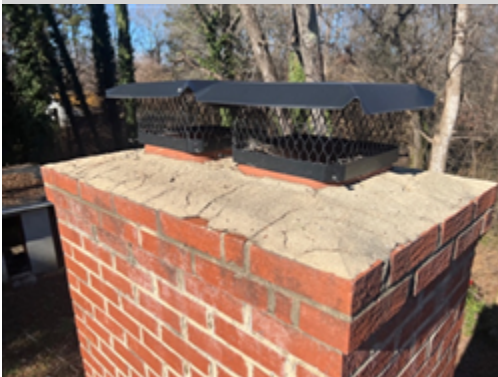
**(C4 - 1.1 ) Main House**

The mortar crown is deteriorated and cracked. When the mortar crown is damaged water can enter between the chimney body and the flue liner resulting in leaks and deterioration. A masonry contractor should be consulted for a complete evaluation of the chimney, the flue liner and the masonry crown and to make necessary repairs.

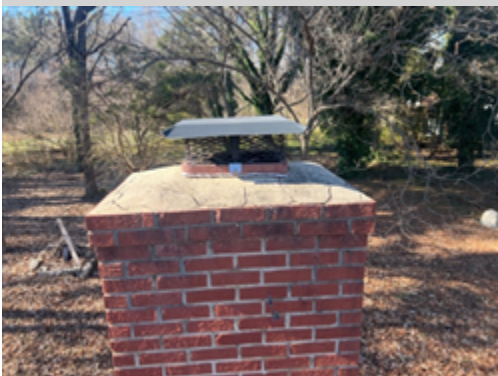
**(C4 - 1.2 ) Main House**

Additional Photograph: This is a photograph of previous comment.

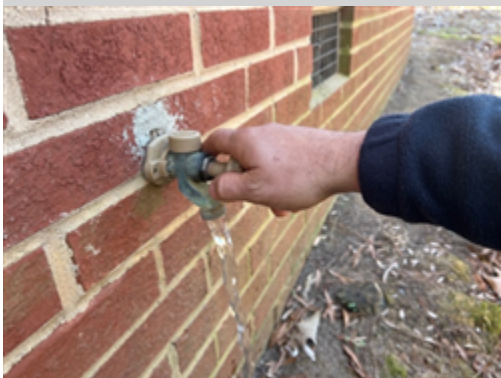
#### **(D1 - 2.1 ) All Accessible Areas**

The exterior faucet(s) is loose and not secure to the foundation wall. The faucet needs to be secured to prevent stress on the supply line that could result in plumbing supply leaks. A licensed plumbing contractor should be consulted to make necessary repairs.

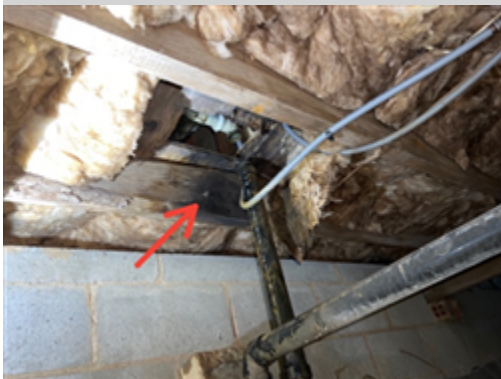
#### **(D2 - 1.1 ) All Accessible Areas**

The waste line for the tub is leaking. The leak has resulted in decay of the bathroom floor under and adjacent to the tub. The waste line needs to be repaired to ensure sanitary conditions. A licensed general contractor should be consulted for a complete evaluation of the bathroom floor system to determine the extent of the damage and to make necessary repairs. A licensed plumbing contractor should be consulted for a complete evaluation of the waste line systems to determine the general condition of the system and to make necessary repairs.

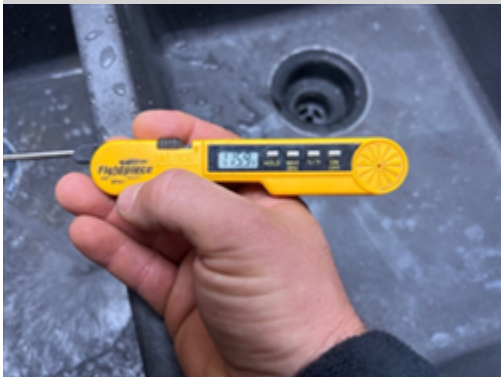
#### **(D3 - 1.1 ) Unit 1**

For Your Records this is a photograph of the hot water at the time of the inspection.

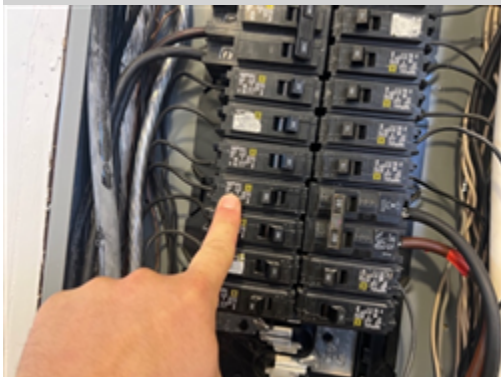
#### (E2 - 1.1 ) Main Panel

The dining room breaker was tripped. This condition presents a safety hazard that could result in serious personal injury and or property damage. A licensed electrical contractor should be consulted for repair and a complete evaluation of the electrical system.

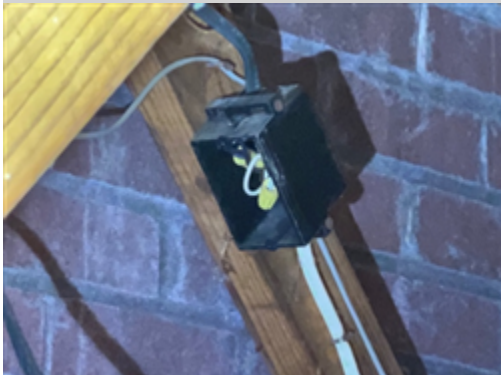
#### (E4 - 1.1 ) Crawl Space and Main Panel

Electrical connections have been made in the attic area without being properly protected in a covered junction box. The open junction leaves electrical conductors exposed and in a hazardous condition. Electrical concerns should be considered fire and safety issues and repaired as soon as possible. The electrical systems and components in the attic are in need of a complete evaluation and repair by a licensed electrical contractor.

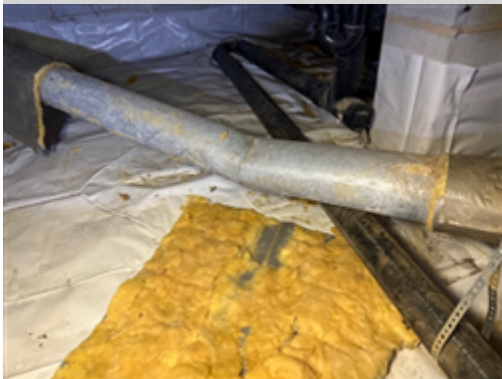
##### **(G2 - 1.1 ) Cooling Unit 1**

The insulation cover for the duct branch(s) is deteriorated. The cover protects the duct structure and holds the insulation in place. A HVAC contractor should be consulted for a complete evaluation and replacement of all damaged duct components to ensure reliable and proper operation of the HVAC system.

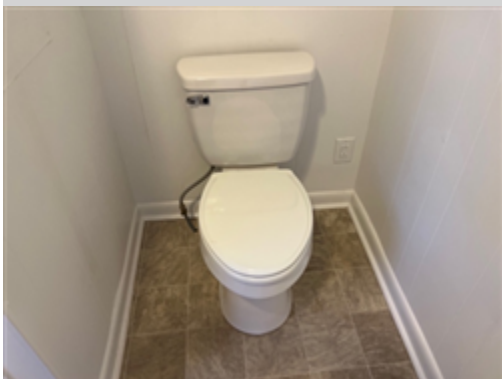
##### **(H3 - 1.1 ) Bathroom 1**

The toilet rocks and is not secure to the floor. Movement of the toilet can result in leaks and damage. A licensed plumbing and general contractor should be consulted for evaluation and repair.

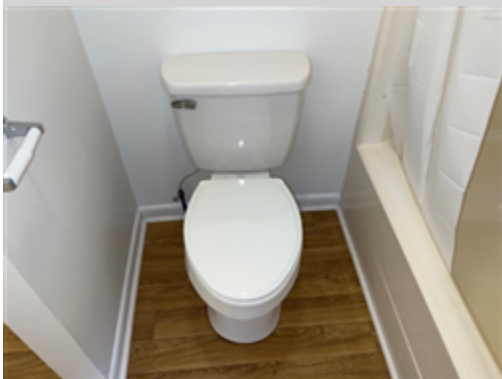
##### **(H3 - 2.2 ) Bathroom 2**

The toilet rocks and is not secure to the floor. Movement of the toilet can result in leaks and damage. A licensed plumbing and general contractor should be consulted for evaluation and repair.

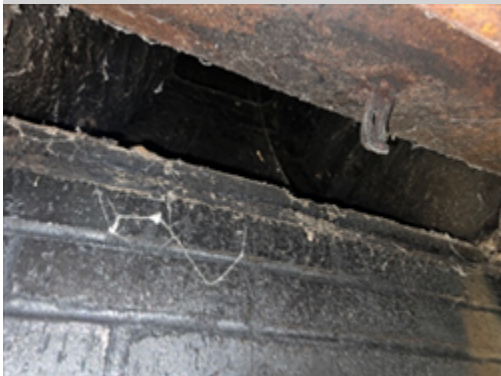
#### **(H6 - 1.1 ) Fireplace: Masonry**

The fireplace is missing the damper. This is a hazardous condition that needs correction. A licensed general contractor should be consulted for a complete evaluation and repair.

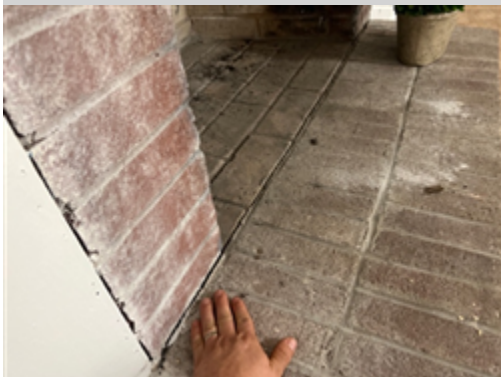
#### **(H6 - 1.3 ) Fireplace: Masonry**

The hearth is pulled away from the fireplace face. The hearth support needs further investigation. A licensed general contractor should be consulted for a complete evaluation and repair.

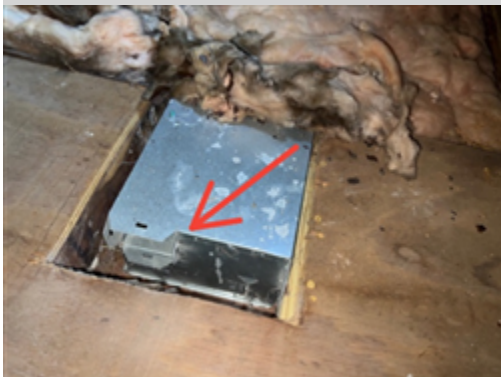
#### **(I1 - 1.1 ) Attic: All Accessible**

The bathroom ventilation fan exhaust duct does not exit to the exterior of the home. The fan exits to the attic space which will add undesirable moisture to the area. A licensed general contractor should be consulted for repair/replacement.

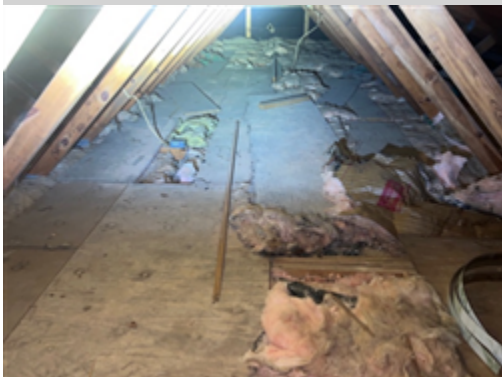
**(I1 - 1.2 ) Attic: All Accessible**

The insulation is compressed or displaced. The effectiveness of the insulation is reduced when displaced or compressed. Improper insulation installation could result in condensation, over heating of the building components, and inadequate conditioning of the living areas. A licensed general contractor should be consulted for repair/replacement.

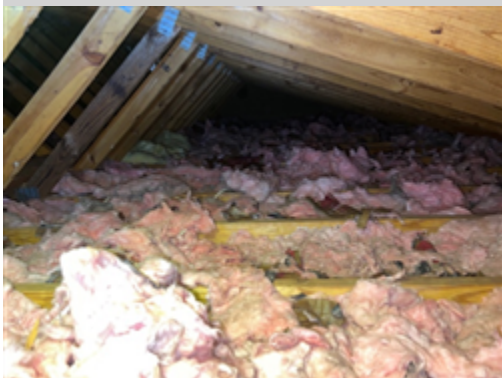
**(I1 - 1.3 ) Attic: All Accessible**

Additional Photograph: This is a photograph of compressed insulation

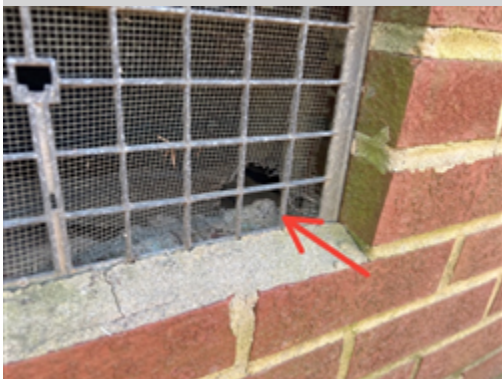
**(I1 - 2.1 ) Crawl Space: All Accessible Areas**

The screen mesh on the foundation vent(s) have missing/deteriorated. This is leaving a hole in the mesh which can provided an access point for wildlife to enter the crawlspace could allow easy access of wildlife to the crawlspace. A licensed general contractor should be consulted for a complete evaluation and to make necessary repairs.

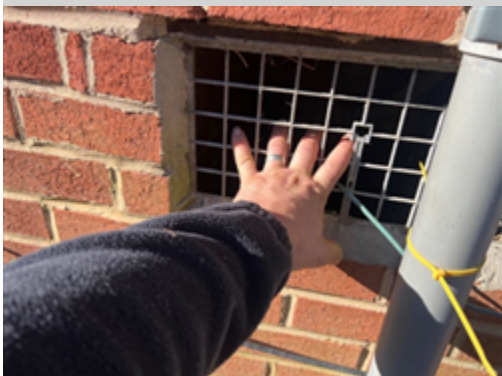
**(I1 - 2.2 ) Crawl Space: All Accessible Areas**

Additional Photograph: This is a photograph of previous comment.
