# Tim Wiggins Inspections

Name: Lou Edwards  
Address: \_\_\_\_\_  
\_\_\_\_\_  
Telephone Number: \_\_\_\_\_  
Inspection Ordered by: Client  
Property Address: 2412 Oxford Road  
Henderson, NC  
Year Built/Structure Age\*: 1954 Square Footage\*: 1296 sq ft  
Date Performed: November 12, 2024  
Reason for the Inspection: Prepurchase

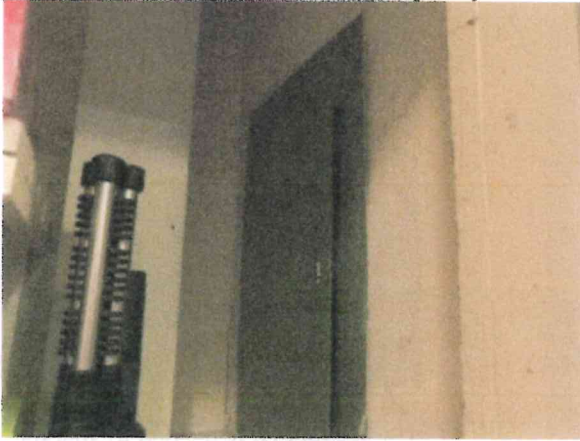
3. Adequate clearance is not available in front of the kitchen pantry electric sub panel. This is a safety hazard. At least three feet of clearance is required in front of the panel.

1. Adequate clearance is not available in front of the electric sub panel in the kitchen pantry.

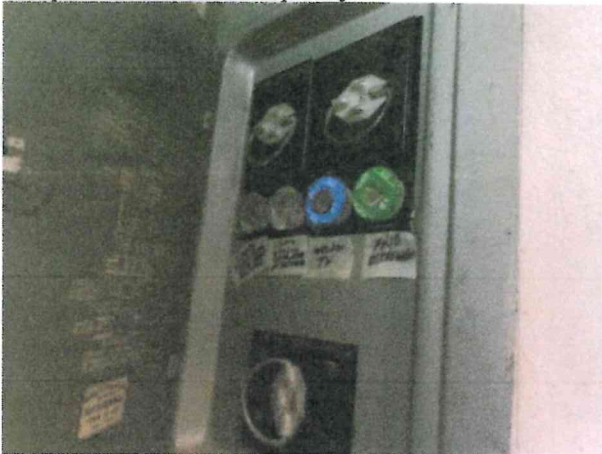
2. Two 30 amp fuses are installed in the kitchen pantry electric sub panel. The cover for the panel in the kitchen pantry could not be removed due to inadequate clearance in front of the panel. A licensed electrical contractor should evaluate the 30 amp fuse installation in the sub panel and take corrective action as needed to provide adequate overcurrent protection for the electrical circuits in the panel.

2. Two 30 amp fuses are installed in the electric sub panel in the kitchen pantry.

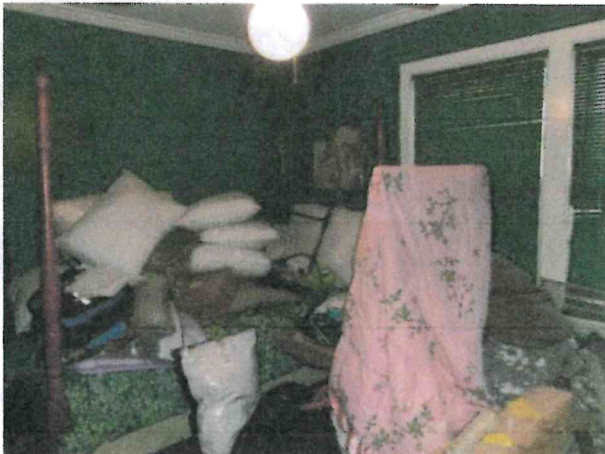
3. All areas in the front left bedroom cannot be visually inspected due to stored personal items located in the bedroom.

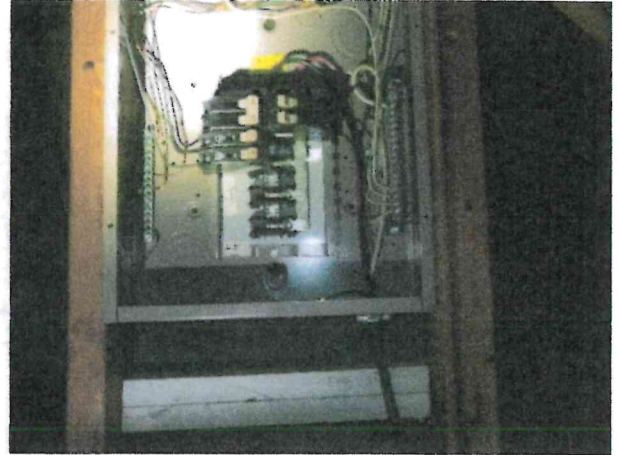
4. An electric sub panel is located in the attic.

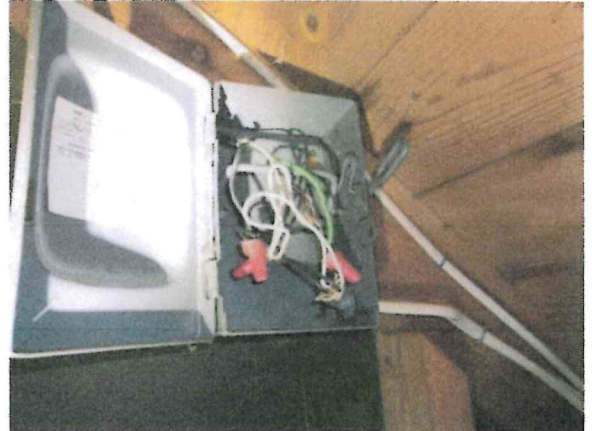
5. The disconnect panel that is located adjacent to the electric sub panel in the attic is no longer used as a disconnect panel. The panel is used as a junction box.

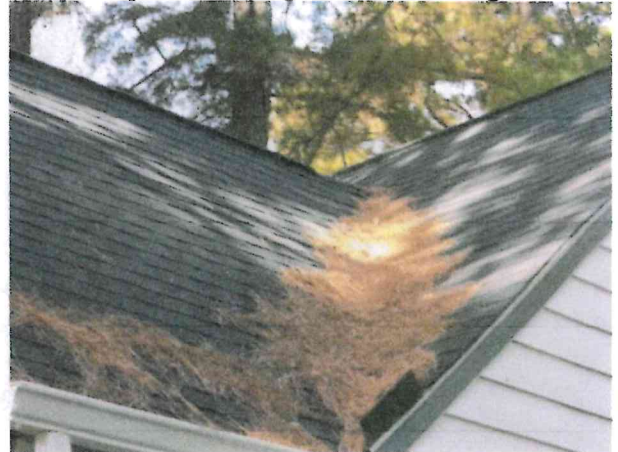
1. All debris on the roof surface should be removed to prevent damage to the roof shingles. Corrective action needed.
2. The handrail around the stairwell in the attic is not complete. A handrail should be needed at the perimeter of the stairwell for safety. Corrective action needed.

6. All debris should be removed from the roof surface to prevent damage to the roof shingles.

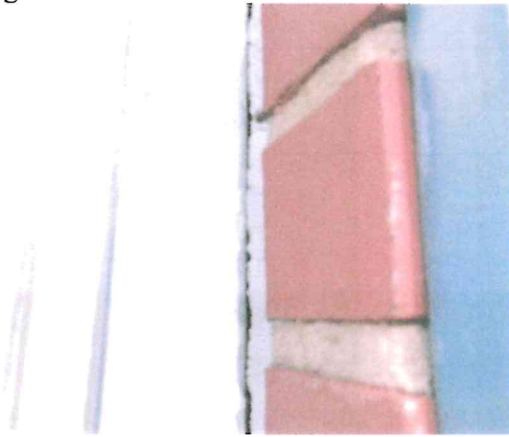
1. All joints on the aluminum siding need to be re-caulked to prevent moisture penetration and possible damage. This includes joints at the perimeter of the windows, joints on cladding on the window trim, and at joints at transitions between the brick and aluminum siding.

7. Transitions between the aluminum siding and the brick veneer siding should be properly sealed to prevent moisture penetration and possible damage.

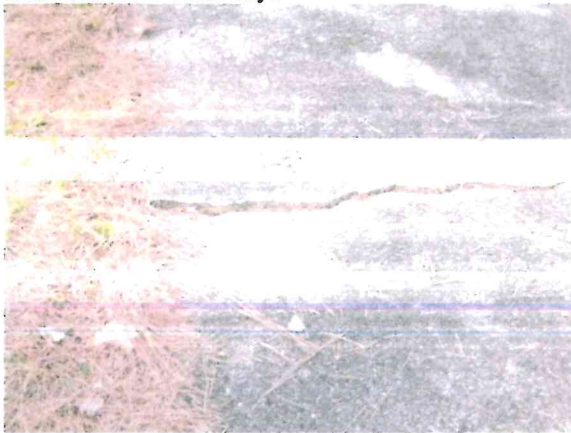
1. There is an open crack on the front concrete walkway. The walkway has an uneven surface at the open crack on the walkway. The uneven surface on the walkway creates a possible safety/tripping hazard. Corrective action needed.
2. All foundation penetrations should be sealed to prevent moisture and small animals from entering the crawl space.
3. The poly vapor barrier that is installed in the crawl space covers approximately 40% of the crawlspace area. Installation of a 6-mil poly vapor barrier over 100% of the crawl space area is recommended to help control moisture in the crawl space. Corrective action needed.
4. Floor insulation is down, missing, or damaged at multiple locations in the crawl space. Large sections of the floor system have no insulation. All down, missing, or damaged insulation should be repaired or replaced to provide adequate insulation value for the floor system.

8. There is an open crack with deflection on the front concrete walkway.

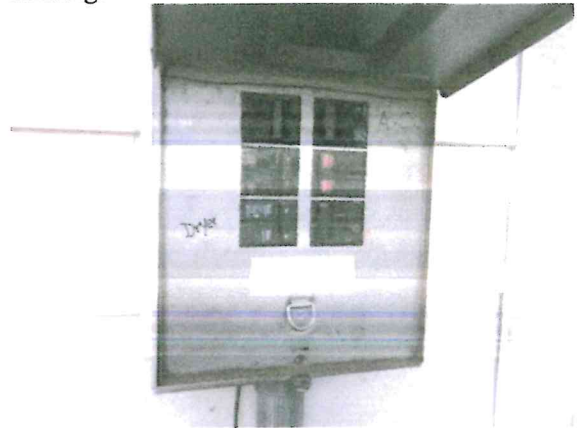
5. The screw that is needed to attach the dead front cover to the exterior electric service panel is missing. This is a safety hazard. Corrective action needed.

11. The screw that is needed to attach the dead front cover to the exterior electric service panel is missing.

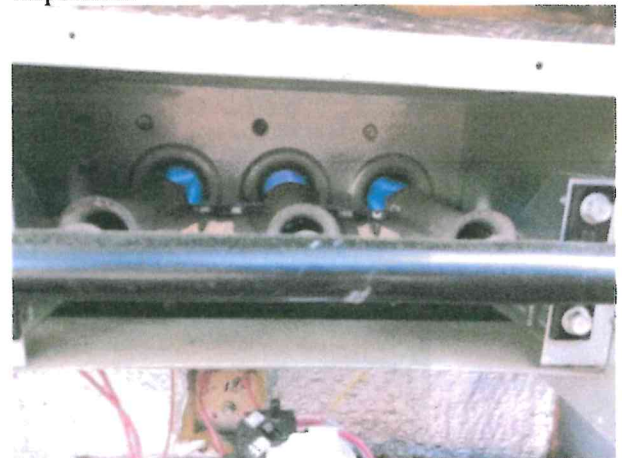
12. The gas pack unit was operating as intended when testing in the heat mode at the time of inspection.

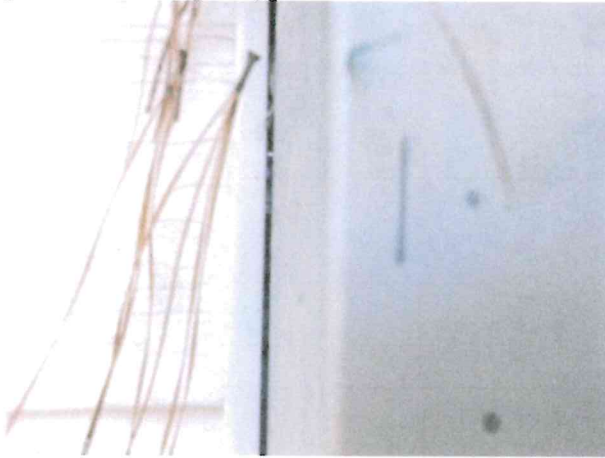
2. The siding penetration for the exterior electric service panel is not adequately sealed. Corrective action is needed to prevent moisture penetration and possible damage.

13. The siding penetration for the electric service panel is not adequately sealed.

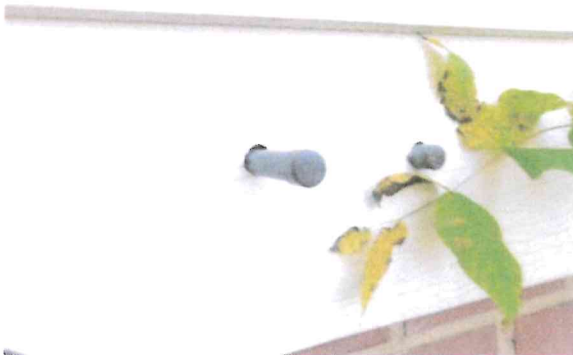
14. All penetrations on the aluminum siding should be properly sealed to prevent moisture penetration and possible damage.

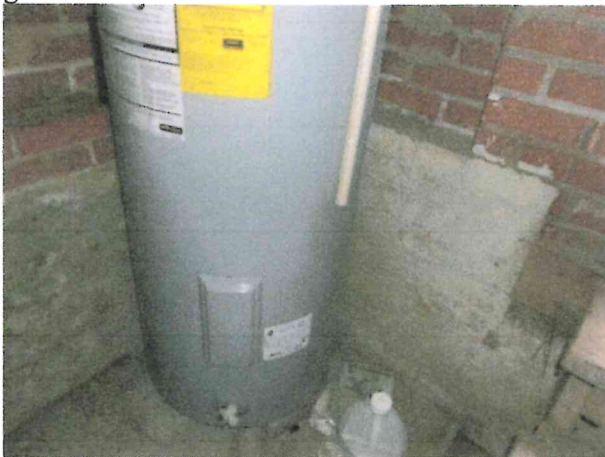
3. The water heater temperature pressure relief valve is not piped to within six inches of the ground/floor. This is a safety hazard. Repair needed.

15. The temperature pressure relief valve for the water heater is not piped within six inches of the ground.

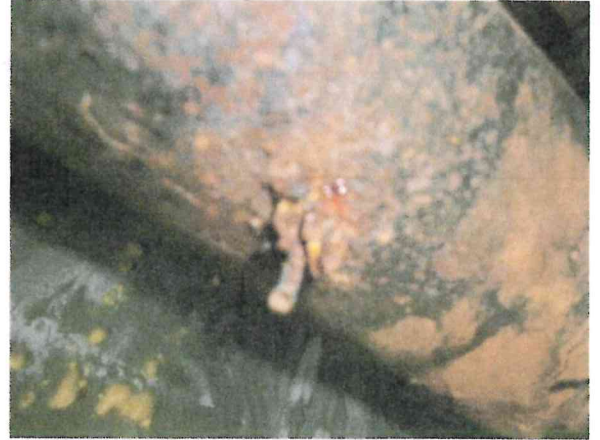
2. Leaks are present on the cast iron drain pipe in the crawl space. A licensed plumber should evaluate the cast iron drain piping and take corrective action as needed. The interior of the cast iron drain piping should be scoped to determine the severity of the damage on the cast iron piping. Note that the cast iron drain piping is near the end of its design life.

16. Visual evidence of leakage on the cast iron drain piping in the crawl space.

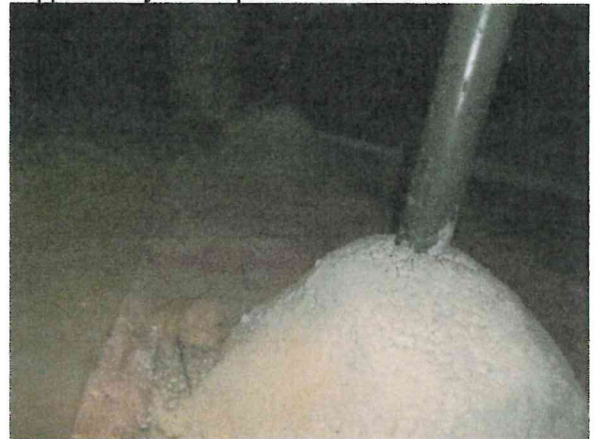
17. Multiple support girders have been added under the floor system. These support girders are supported by metal posts with concrete footers.

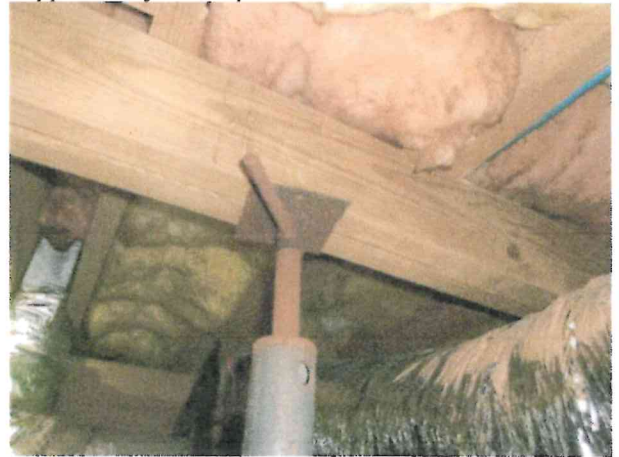
18. Multiple support girders have been added under the floor system. These support girders are supported by metal posts with concrete footers.

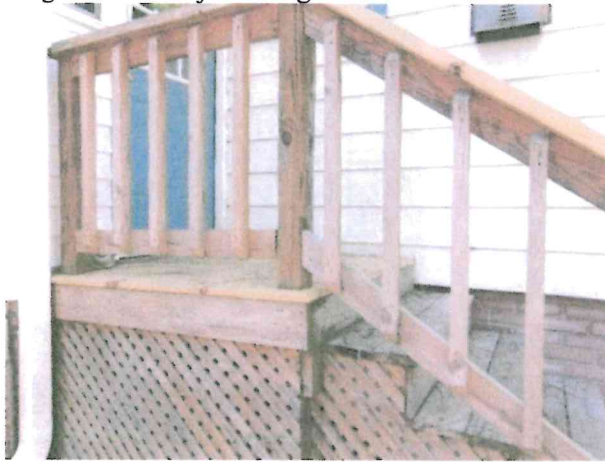
4. The floor joists for the step landing and for the right side entrance are not adequately supported by ledger boards or joist hangers. The floor joists are supported by end nails only. This is a safety hazard. Corrective action needed.

19. The floor joists for the step landing for the right side entrance are not adequately supported by ledger boards or joist hangers.
