**Prepared for Exclusive Use by:**

211 Park Ave  
Creedmoor NC 27522

11/6/2018

Floor 2 Ceiling Home Inspections, LLC dba HouseMaster

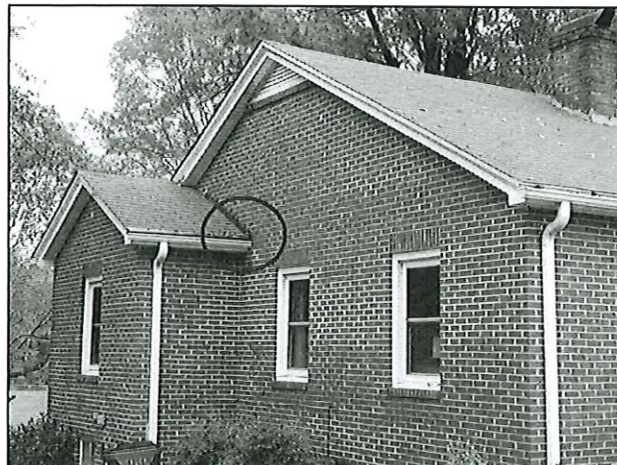
1.2 (1) Missing kickout flashing noted at the front left side of the house. This particular type of flashing is recommended where the wall continues past the lower roof-edge and gutter. Kickout flashing helps divert the water away from the siding and into the gutter. Recommend to have a qualified contractor repair as directed.

*CORRECTED  
2018-NEW ROOF  
2020*

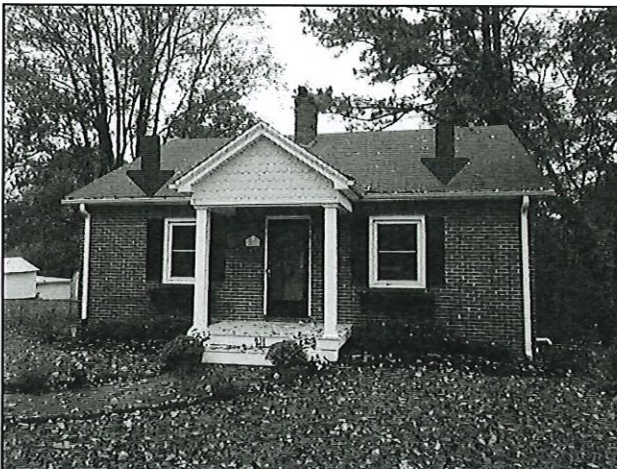
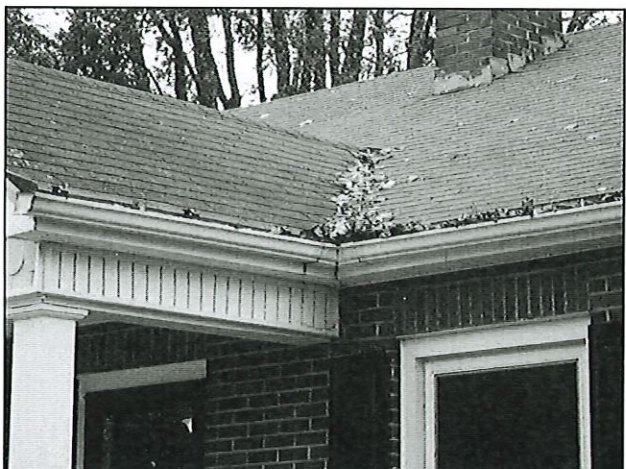
1.3 (1) There is debris noted in the gutters at the front side of the house. This is conducive to improper drainage and and water intrusion behind the gutters that will damage the adjacent elements. Recommend to remove debris where needed.

Downspouts  
Feed into  
underground  
Piping  
Corrected  
2018

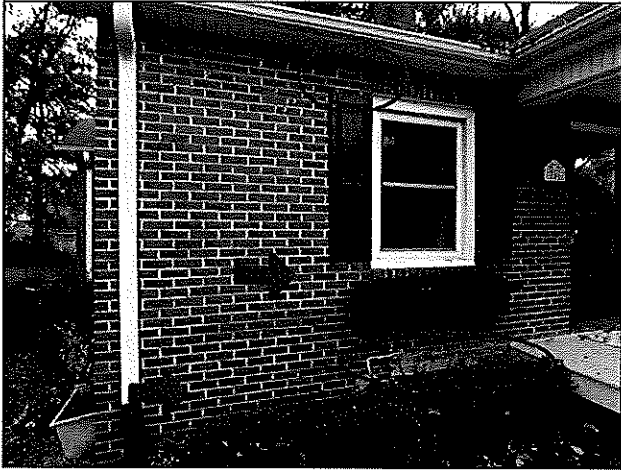
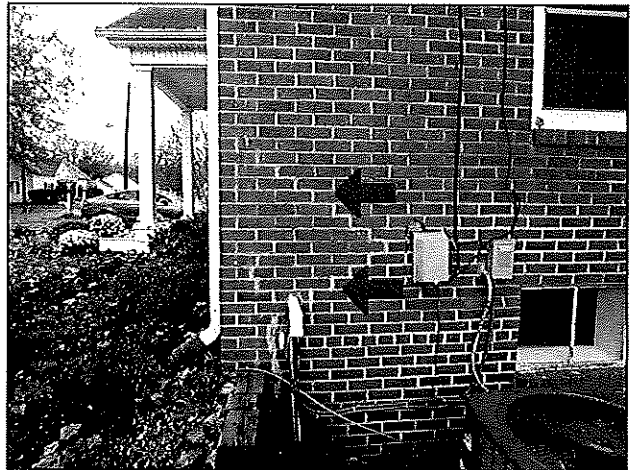
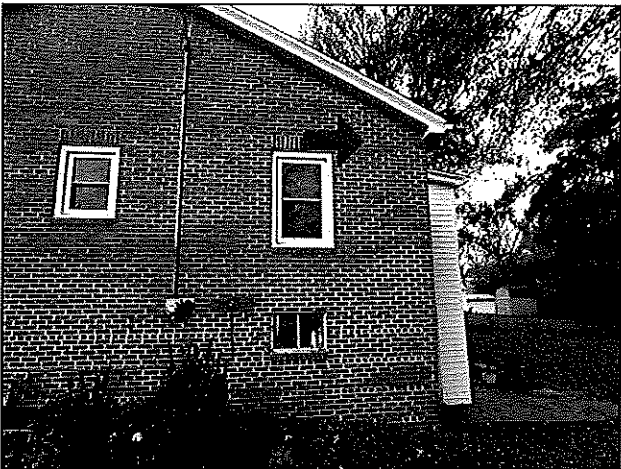
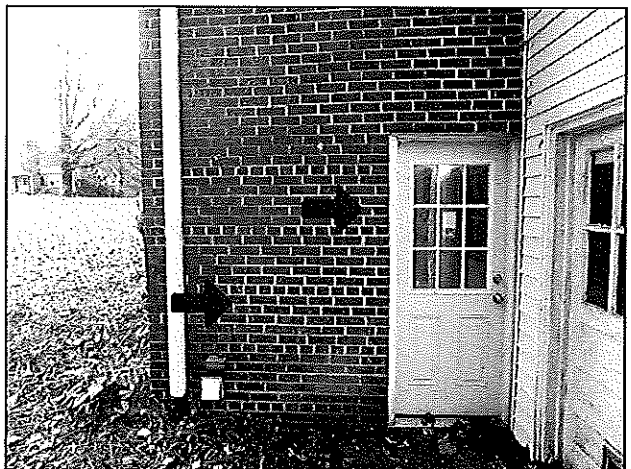
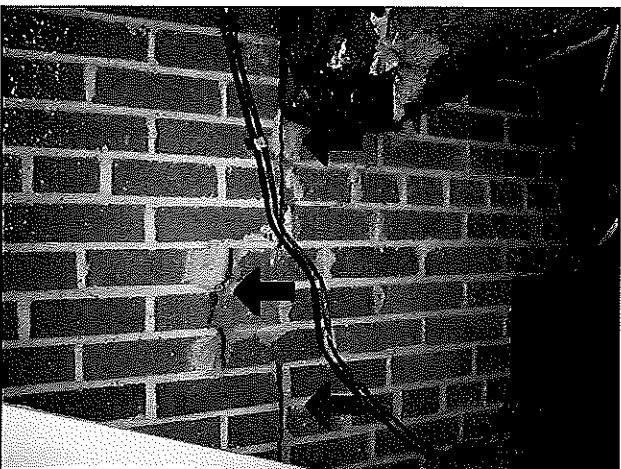
2.0 (1) Vertical/horizontal and step cracking noted on the brick siding at the front, right, and rear side of the house. Cracking was also visible at the front and rear side of the basement interior and storage room. This is conducive to possible stress/settlement and foundation concerns. Recommend to have a structural engineer evaluate and repair as directed.

CORRECTED  
EXTERIOR  
WAS POINTED UP.  
STRUCTURAL  
ENGINEER  
DETERMINED  
THEY WERE ALL  
COSMETIC.  
SEE  
REPORT  
ATTACHED  
SEPARATELY

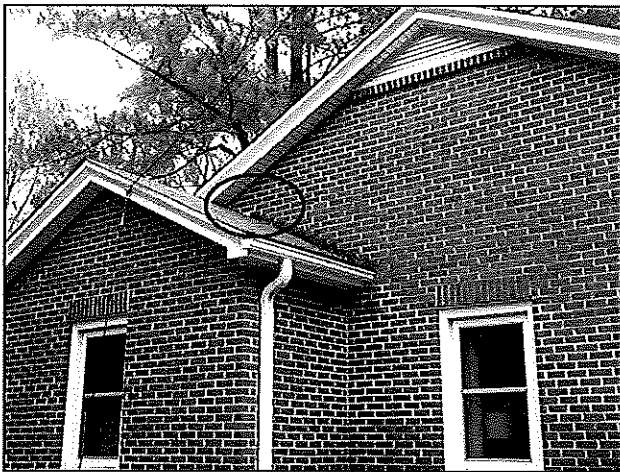
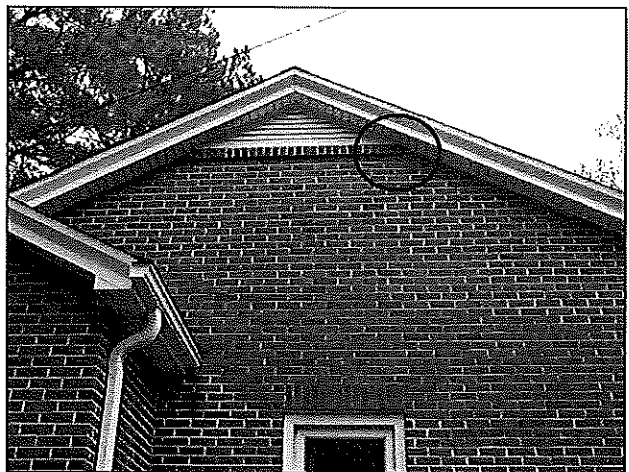
2.0 (2) Open gap/cracked mortar noted on the brick at the left side of the house. This is conducive to water/pest intrusion at the wall cavity that will damage the adjacent elements. Recommend to have a qualified contractor repair as directed.

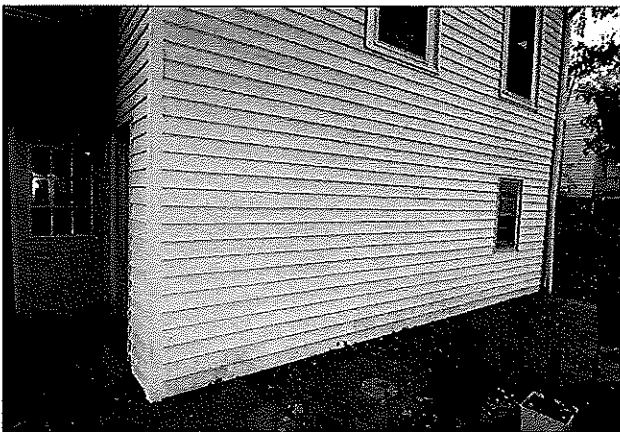
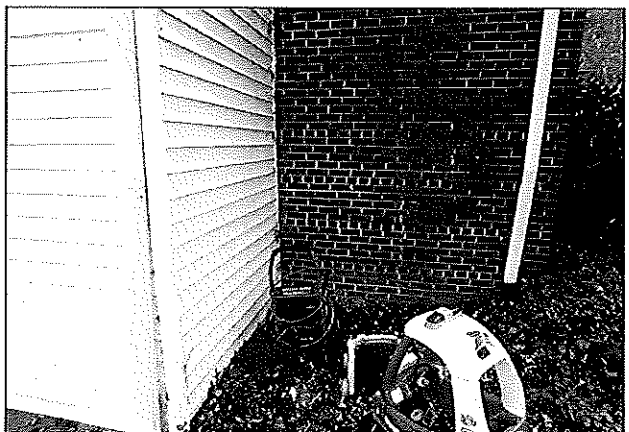
Siding is within 6 inches to the ground at the rear side. Recommend grading to prevent decay/rot/wood burrowing insects as necessary.

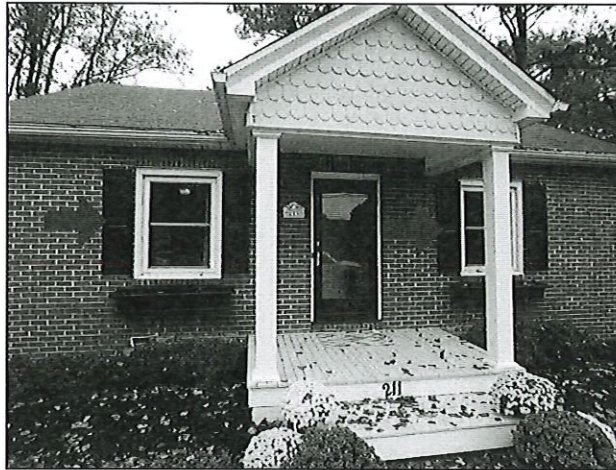
2.2 (Picture 1)

Loose window shutters. Recommend to repair/secure as directed to prevent damage from weather.

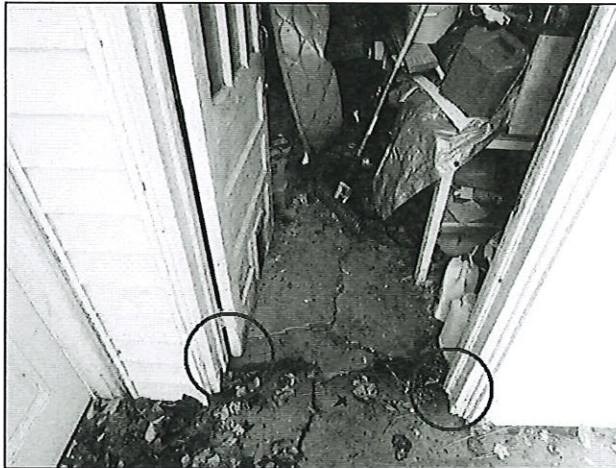
2.3 (Picture 1)

Wood rot/decay noted on the door/frame at the rear exterior door. This is conducive to water intrusion that will damage the adjacent elements. Recommend to have a qualified contractor repair/replace as directed.

*CORRECTED  
2018*

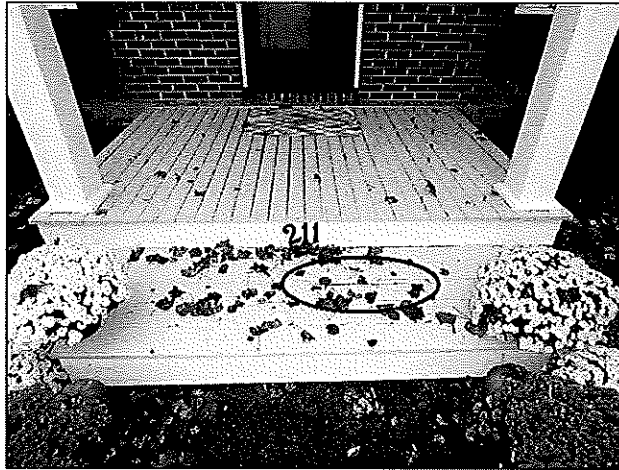
2.4 (Picture 1)

Wood rot/decay noted on the flooring at the front porch. Recommend to repair/replace as directed to prevent further damage and tripping/safety concerns.

*CORRECTED  
2018*

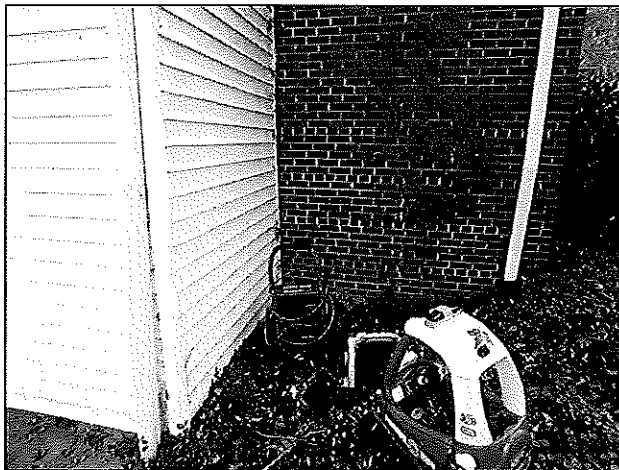
3.2 (Picture 1)

To reduce the amount of water run-off or ponding and potential for water penetration and/or structural concerns, a positive slope away from the foundation should be provided around the perimeter of the house. Maintenance of a suitable ground cover is also advised.

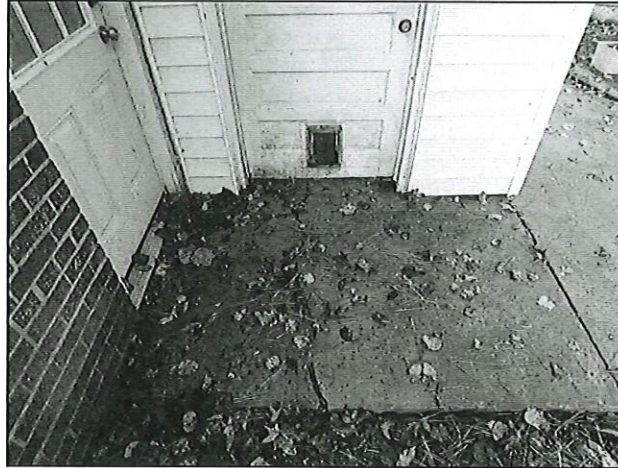
3.3 (Picture 1)

Heavy cracking noted on the patio slab extending to the storage room. This also prevents the door from opening/closing properly. Recommend further evaluation by a qualified contractor due to damage/settlement concerns and repair as directed.

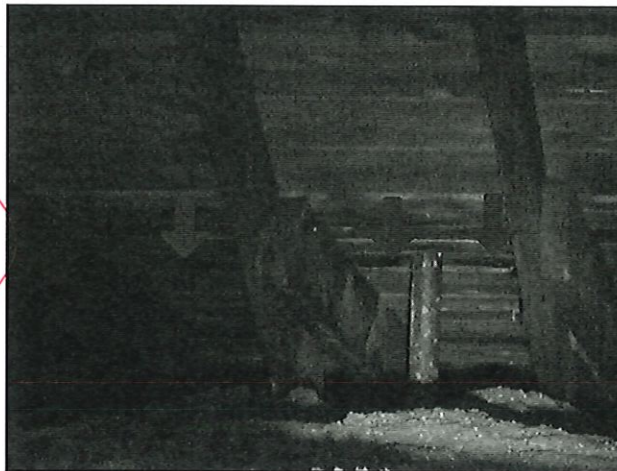
4.1 (2) Moisture stains at rear side of roof sheathing/wood members. This condition is conducive to prior/present roof leakage. Recommend to discuss prior/present condition with owner before closing and have qualified contractor evaluate to determine if the leak is active. Repair if necessary.

Roof  
replaced  
2020

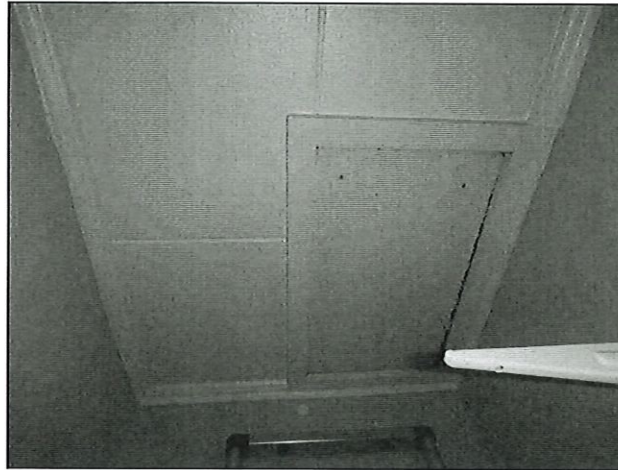
4.4 (Picture 1)

In Need of Repair: Missing insulation at Attic side of scuttle opening cover. Condition is conducive to effecting R-value/energy savings.

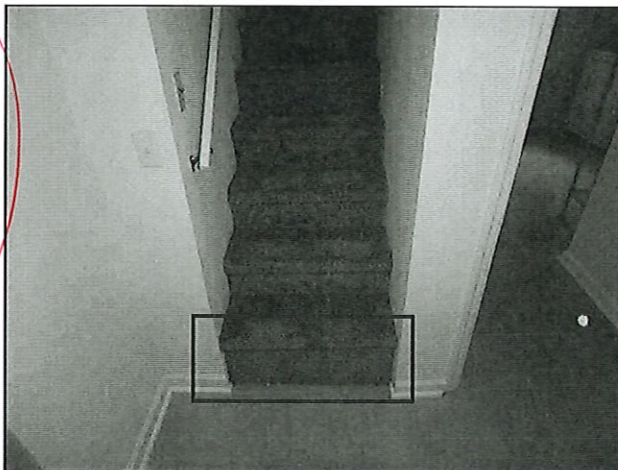
5.3 (Picture 1)

The risers are of improper height at the interior stairway. It is recommended that risers be no more than 7 3/4 inches and uniform in height due to tripping/safety concerns. Recommend to have a qualified contractor repair as directed.

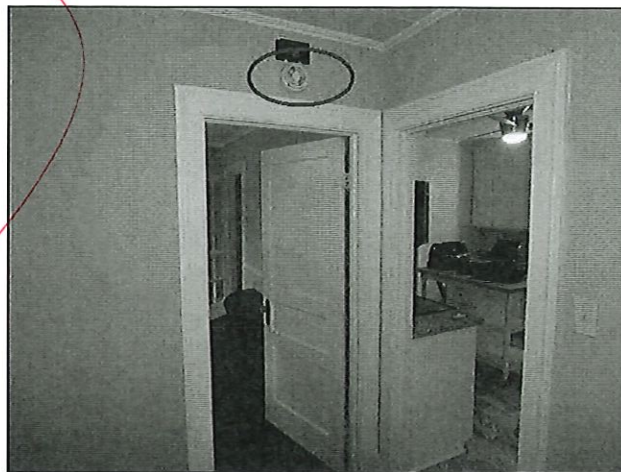
5.7 (Picture 1)

Smoke detector did not function at the main level. Recommend to replace smoke detectors and install halls and bedrooms of main level and basement. Also install carbon monoxide detectors at both levels due to safety concerns.

*Smoke  
detectors  
installed  
CO downstairs*

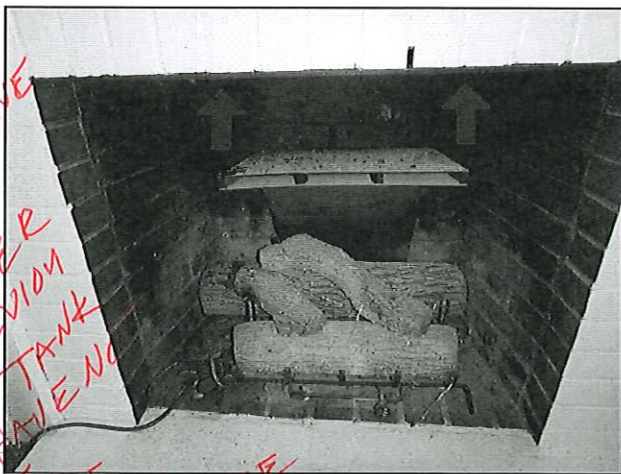
5.8 (Picture 1)

Damper damaged and missing damper clip. This is conducive to water/pest intrusion and the loss of conditioned air. Recommend to have a qualified fireplace contractor repair/replace as directed.

*CLIP REPLACED  
FIREPLACE SET  
UP FOR A PROPANE  
TANK. CURRENT  
OWNERS NEVER  
REPLACED PREVIOUS  
SELLES TANK  
AND HAVE NO  
USE THE FIREPLACE*

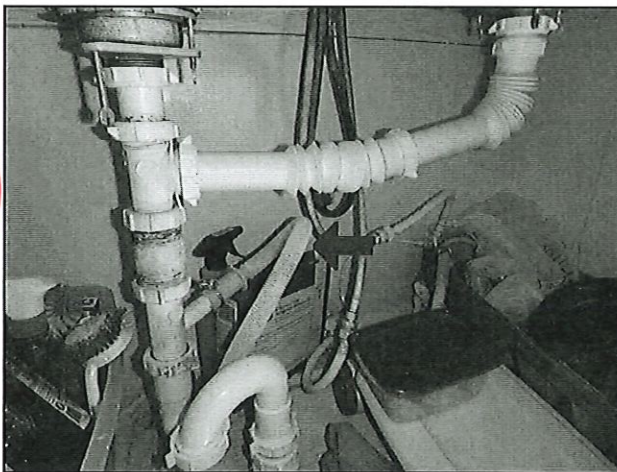
6.2 (Picture 1)

Missing drain loop for the dishwasher. This loop prevents the dirty water that is being drained from being inadvertently pulled back into the dishwasher or even siphoned back into the water system. Recommend to repair as directed.

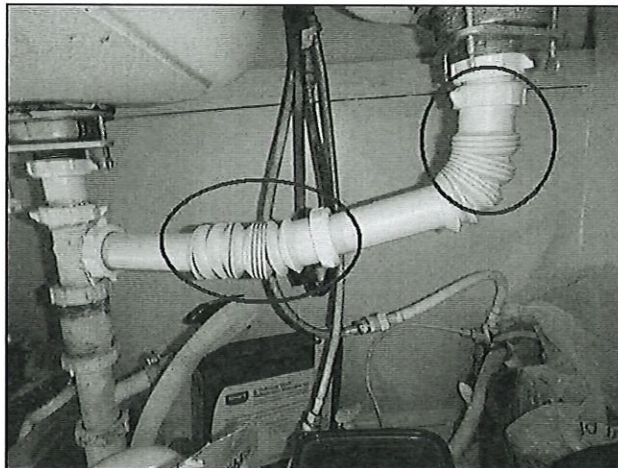
6.0 (2) Improperly installed drain line under sink at kitchen. This type of piping is not recommended due to debris/sludge build-up at interior of drain line and clogging sink drain. Evaluation/correction by licensed qualified plumbing contractor recommended.

✓  
corrected  
2018

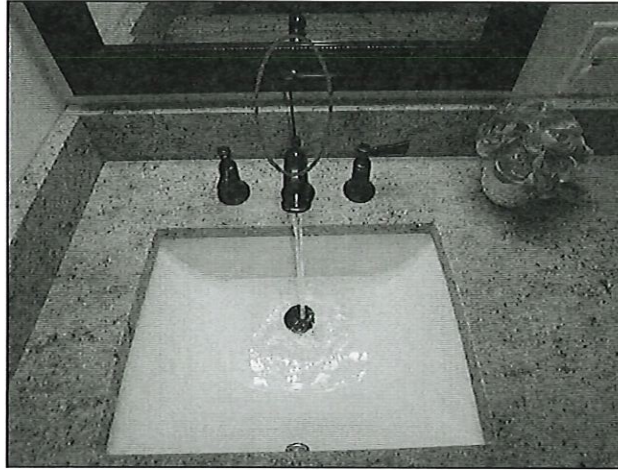
6.0 (3) Water leak noted on the drain line at the left side sink. This is conducive to water intrusion that will damage the adjacent elements and cabinetry. Recommend to have a qualified plumber repair/replace as directed.

corrected  
2018

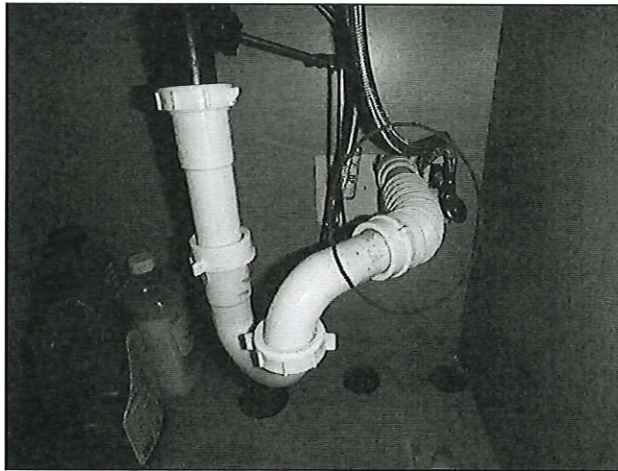
7.0 (2) Improperly installed drain line under basement sink. This type of piping is not recommended due to debris/sludge build-up at interior of drain line and clogging sink drain.

*corrected  
2018*

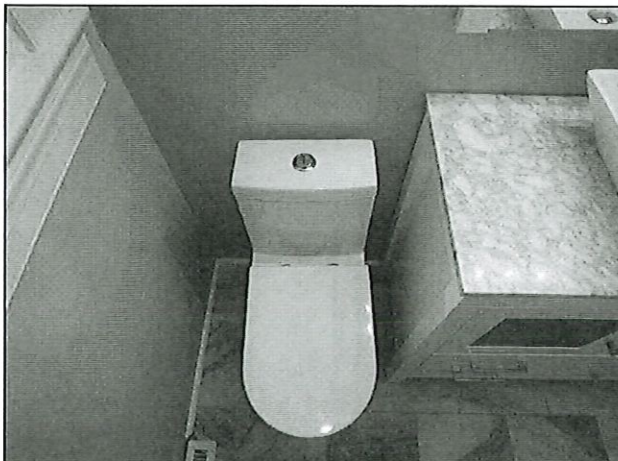
Loose toilet at the main level bathroom. This is conducive to damage to piping and water intrusion that will damage the adjacent elements and flooring. Recommend to repair/secure toilet.

*corrected  
2018*

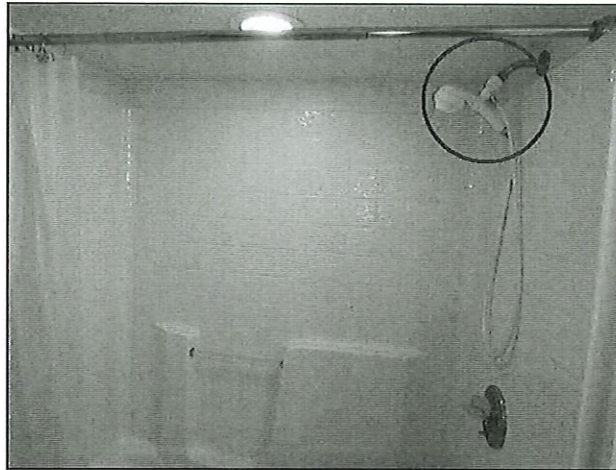
7.2 (1) In Need of Repair: Spout loose in wall and not sealed at basement bathroom. Conditions are conducive to water intrusion to inside wall cavity.

*corrected  
2018*

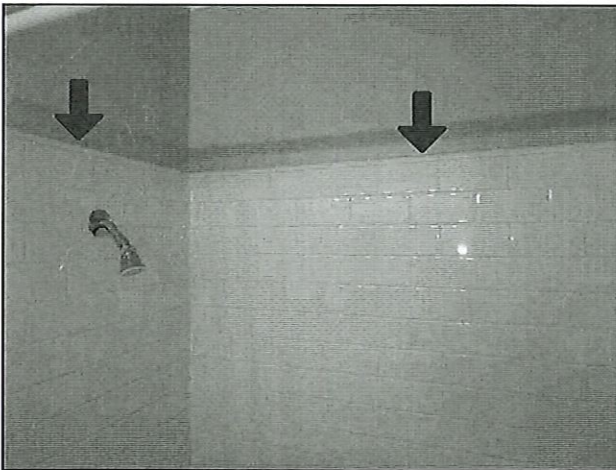
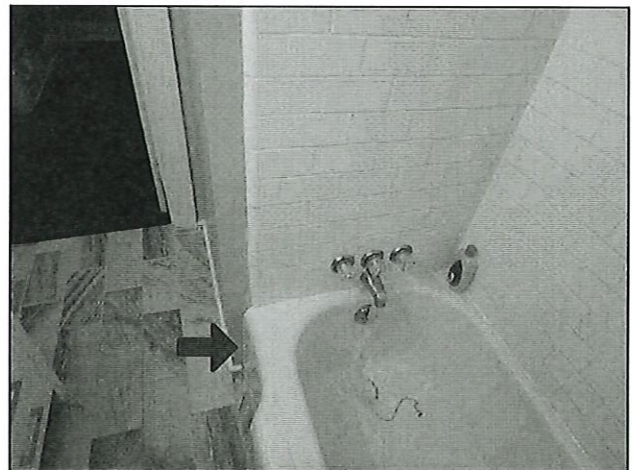
7.2 (2) In Need of Repair: Missing/open caulking at surround area in main level bathroom. Conducive condition for water intrusion.

*corrected  
2018*

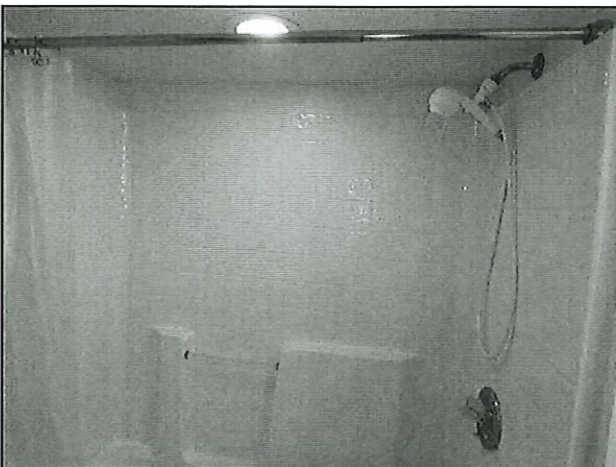
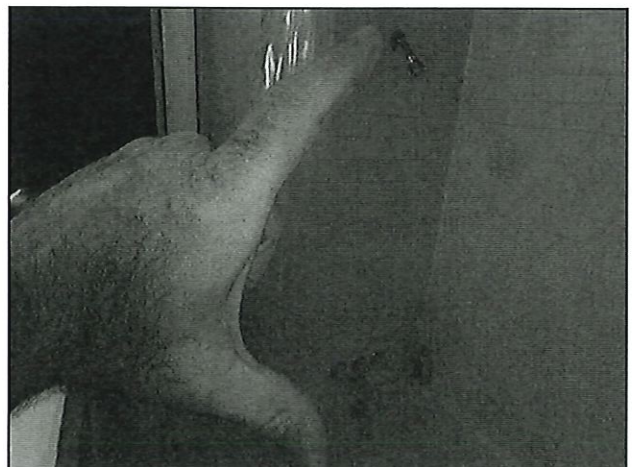
7.2 (3) Nontypical height between the shower head and floor at both bathrooms. Recommend to have a qualified plumber repair as directed to ensure proper function of the shower.

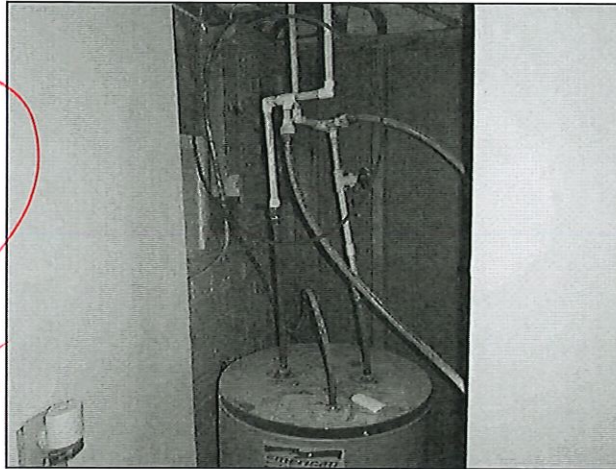
8.3 (Picture 1)

The water heater and piping is in close proximity to the service panel. It is recommended to have a 3 foot clearance in front of the service panel for servicing/safety concerns. This also limited proper inspection of the panel/breakers/wiring. Recommend to have a qualified electrician evaluate service panel including wiring/breakers/grounding and repair to ensure access. Address any concerns.

*Water heater replaced 2019*

*Electric Panel moved away from water heater*

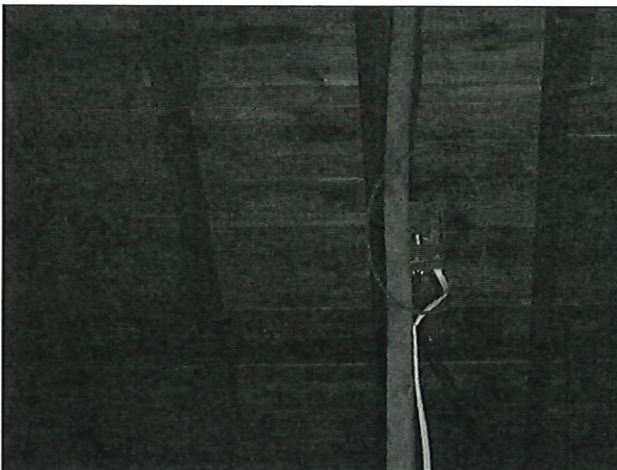
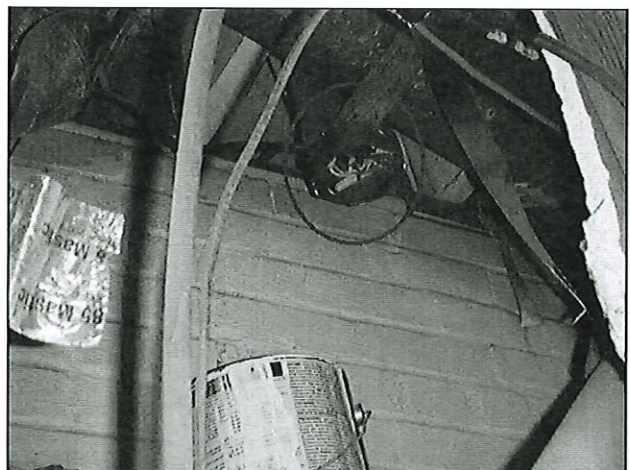
8.4 (1) Wiring is improperly terminated/open junction box at the attic, basement closet. It is recommended that all wiring terminate in a closed junction box to prevent accidental contact, safety concern. Recommend to have a qualified electrician repair as directed.

*Corrected 2018*

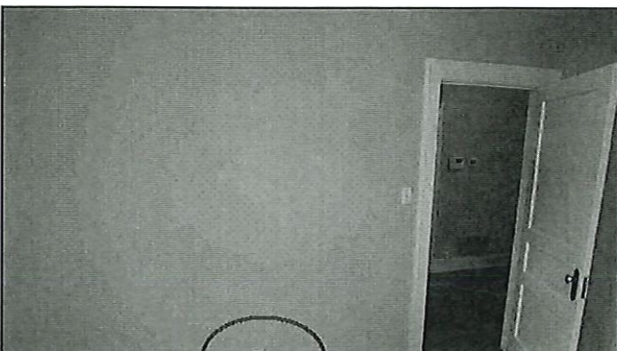
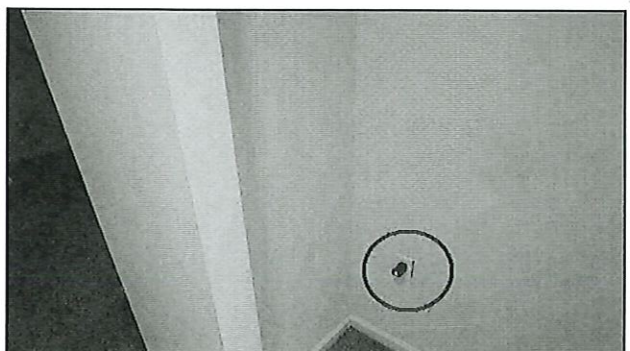
8.4 (2) In Need of Repair: Loose outlets in walls at rear right bedroom, basement. Condition is conducive to loose connections at interior of outlet box.

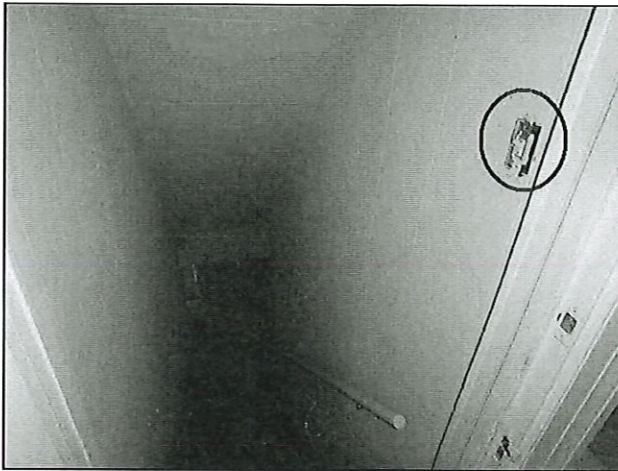
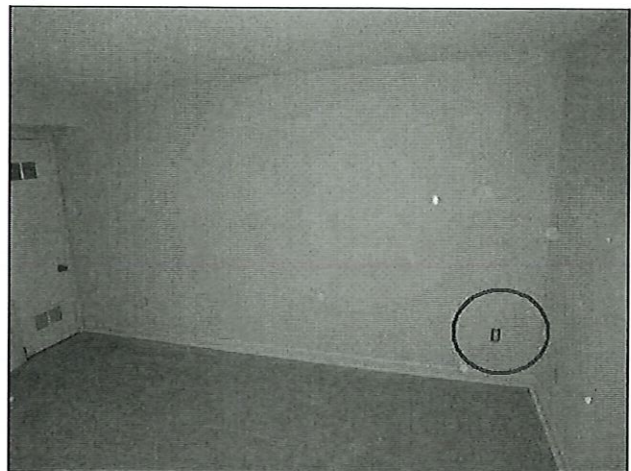
8.4 (3) Missing electrical cover noted at the stairway, basement . Recommend to install cover due to concerns of accidental contact with wiring, safety concern.

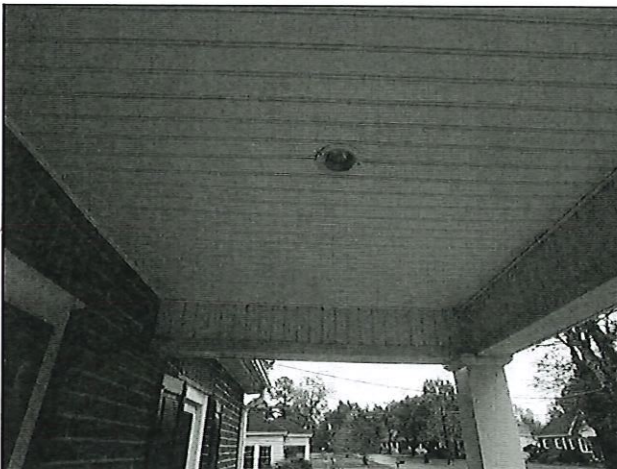
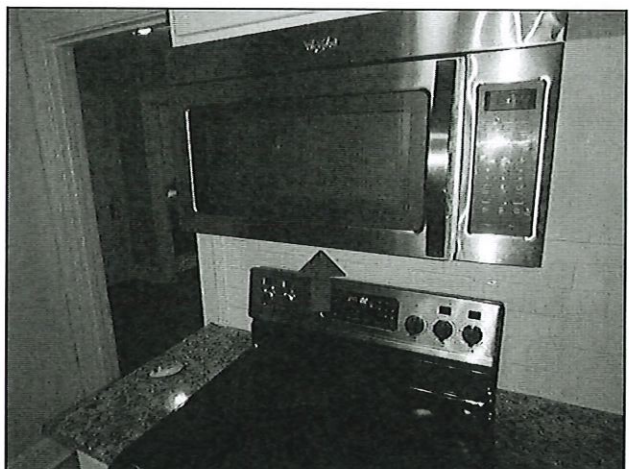
8.4 (4) Light did not function at front exterior, under microwave. Recommend bulb replacement to ensure proper function before closing. If light still does not function, recommend to have a qualified electrician evaluate fixture/wiring and repair/replace as directed.

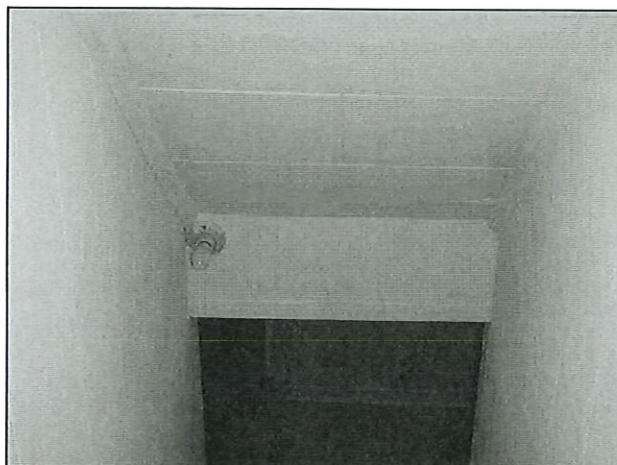
8.4 (5) The three-way switch does not function properly at the basement stairway. This particular switch controls one fixture from two or more receptacles. Recommend to have a qualified electrician repair as directed due to concerns of improper wiring.

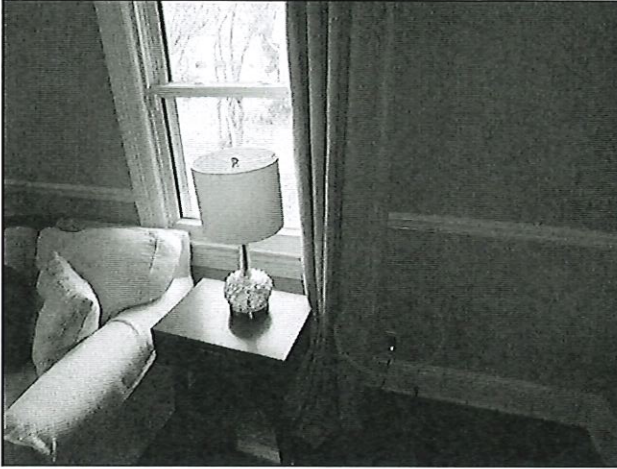
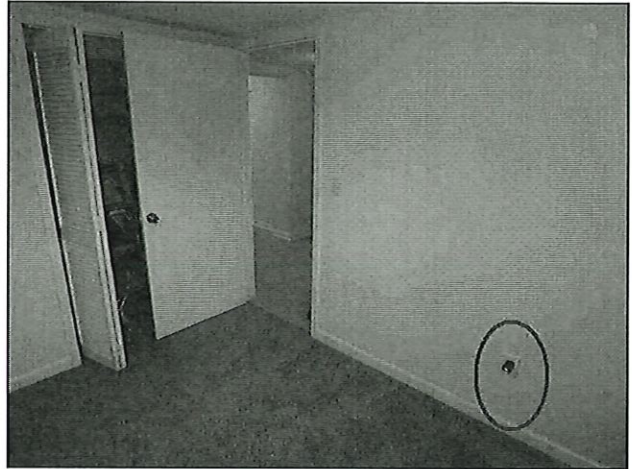
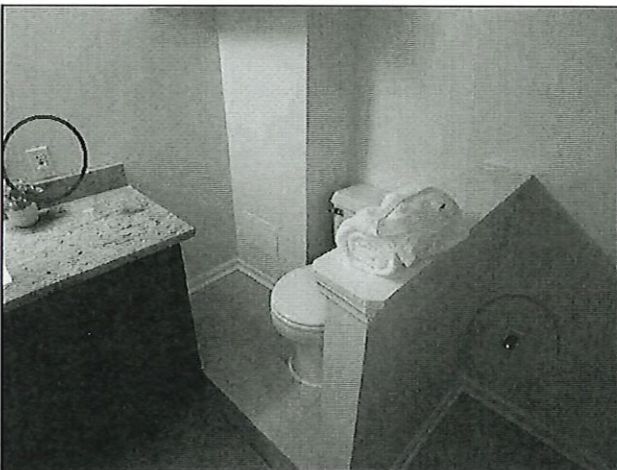
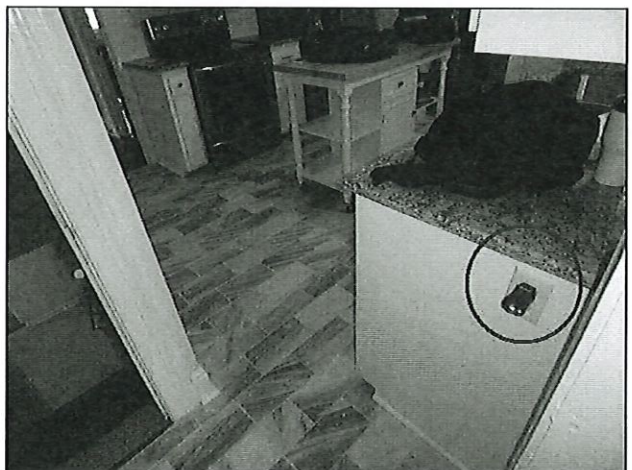
8.5 (2) The outlet tester indicated a hot/neutral reversed at the living room, basement front right room, basement bathroom, kitchen. This is conducive to improper wiring and a safety concern. Recommend to have a qualified electrician repair as directed.

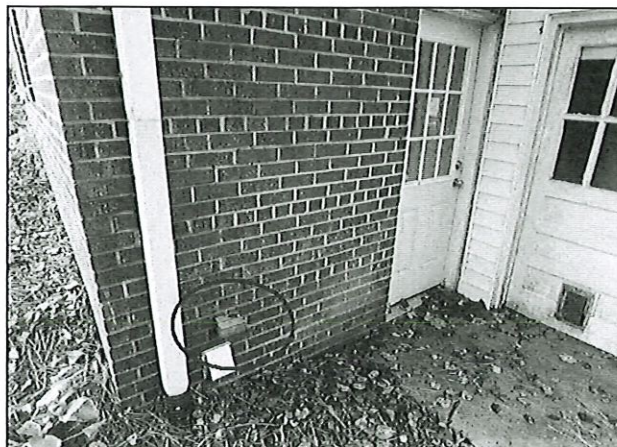
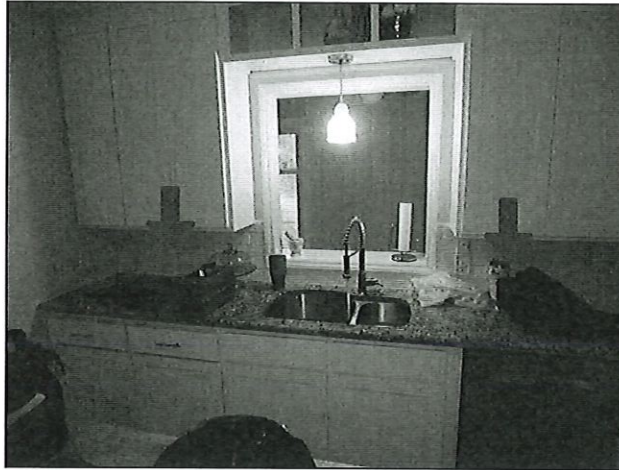
8.6 (1) GFCI outlets would not reset at the exterior rear side. This is conducive to damaged outlet and/or improper wiring. Recommend to have a qualified electrician repair/replace as directed.

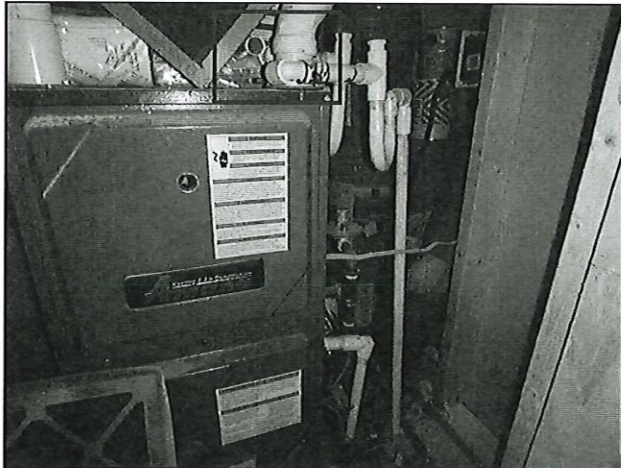
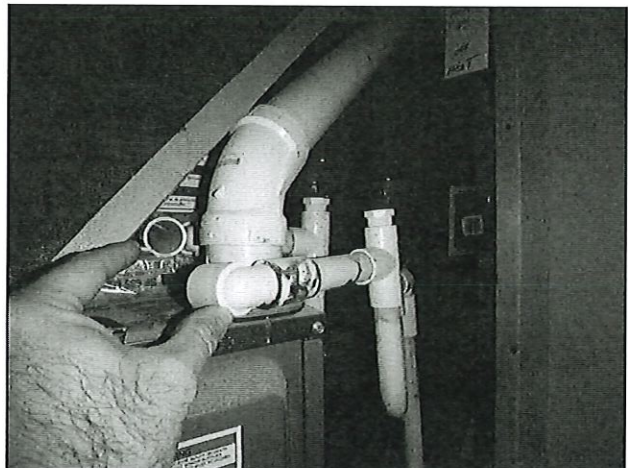
9.5 (1) Secondary condensate is not connected at the interior unit. This is conducive to water leaking/intrusion that will damage the HVAC unit and adjacent elements. Recommend to have a qualified HVAC contractor repair/replace as directed.

✓  
corrected  
2018

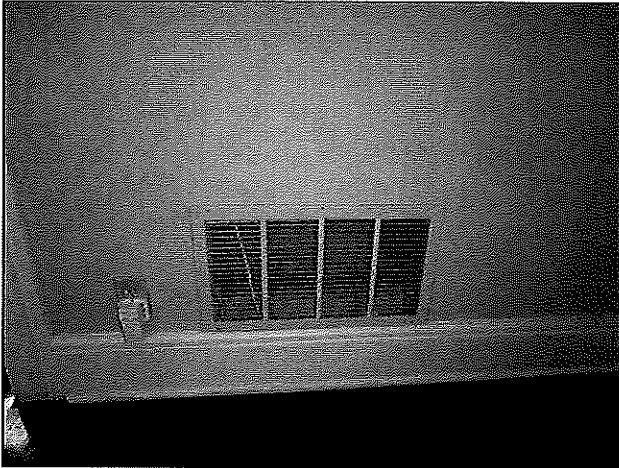
9.6 (Picture 1)

Missing filter(s) present. This condition can effect proper performance of system. Recommend changing filters monthly.

Corrected

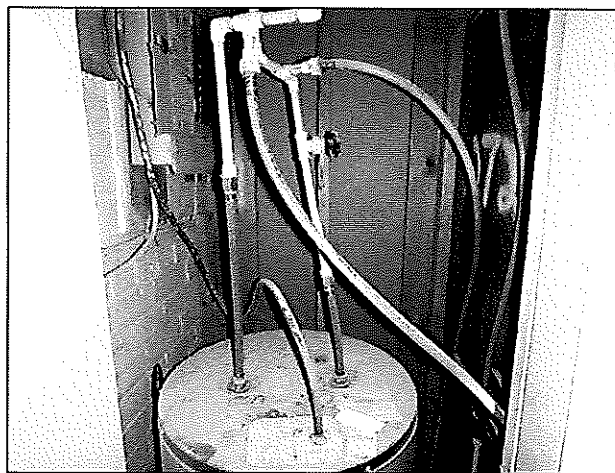
10.1 (Picture 1)

This home has a plumbing supply system that uses polybutylene plastic distribution lines and compression band fittings. Even though this plumbing system was installed in many homes from 1978 until mid-1990's, it is no longer an approved plumbing system due to a history of material failures. The failures were related to improper installation, improper handling, improper storage, and plastic deterioration due to chemical reactions with the water supply. Due to the nature of this latent defect, it was not possible to adequately assess the condition of the plumbing system during the home inspection. A licensed plumbing contractor should be consulted for a complete evaluation of the plumbing system to determine the significance of this concern.

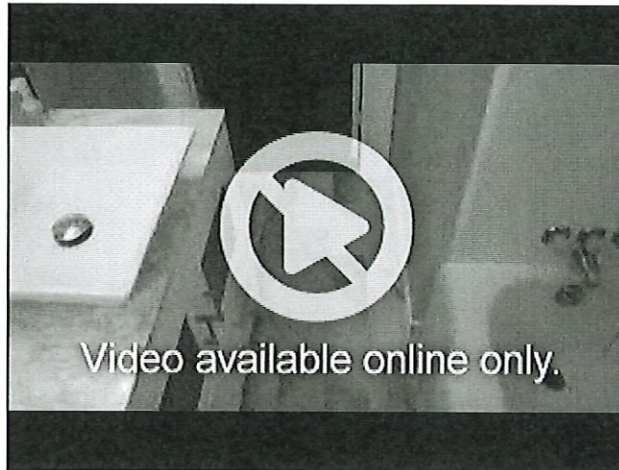
10.4 (Video 1)

Gurgling noted at adjacent fixtures while draining. This is conducive to possible obstructions in piping and/or improper venting. Recommend to have a qualified plumber evaluate and repair/replace as directed.

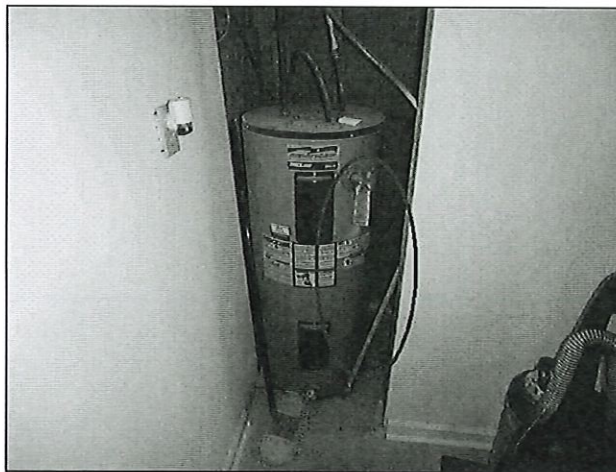
11.1 (Picture 1)

The drain tube for the TPRV Valve is missing; add 3/4 pipe to within 6 of the floor with no reducers to prevent possible scalding, safety concerns.

*Replaced  
2019*
