# General Summary

## Stephen and Son Home Inspection Services, LLC

**Customer**  
Brian Paulhus

**Address**  
3692 Summer Springs Drive  
Franklinton NC 27525

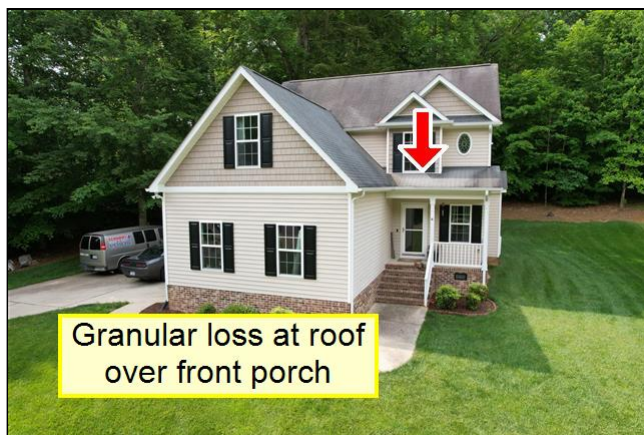
1.0 Item 1(Picture)

1,2,3,4,5,6,7,8,9. I found the following concerns with the roof shingles; granular loss on shingles( the granules protect the asphalt base), damaged roof shingles at back left roof, damaged roof shingle at left front over garage and uplifted roof shingle at left front. This can lead to water penetration and damage. The damaged shingles should be repaired. I recommend having a roofing contractor evaluate and repair as necessary. As roof shingles age, they lose their granules/ballast. The roof shingles appear to be original to the home. 3 tab asphalt/fiberglass shingles have a life expectancy of between 15 and 18 years. At the time of the repair, the roofer may be able to answer questions related to the life expectancy of the roof covering system.

Granular loss at roof over front porch

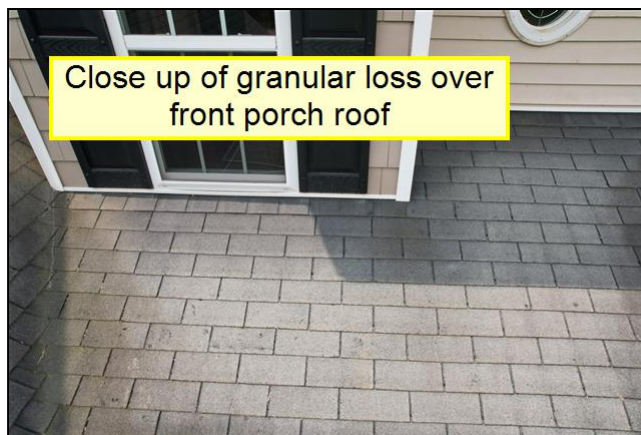
1.0 Item 2(Picture)

Close up of granular loss over front porch roof

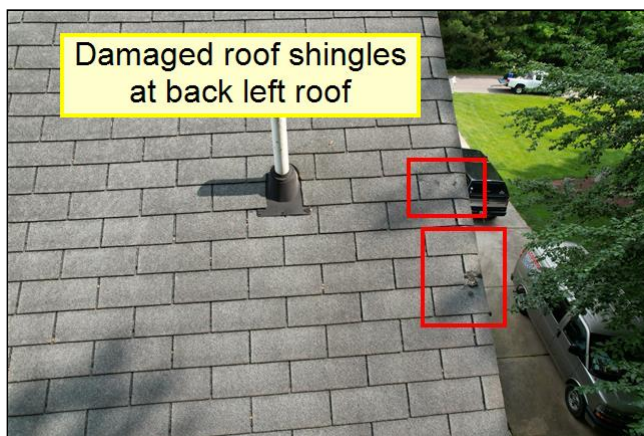
1.0 Item 3(Picture)

Damaged roof shingles at back left roof

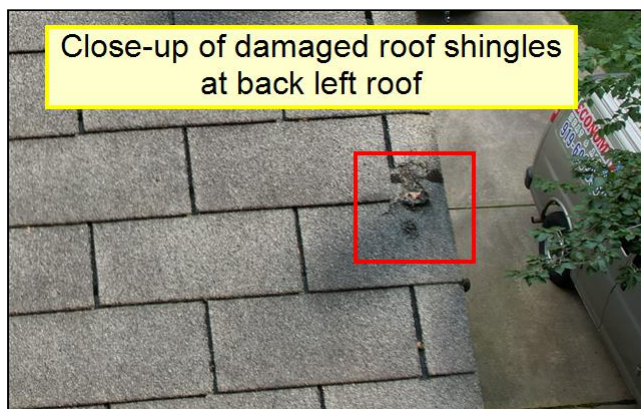
1.0 Item 4(Picture)

Close-up of damaged roof shingles at back left roof

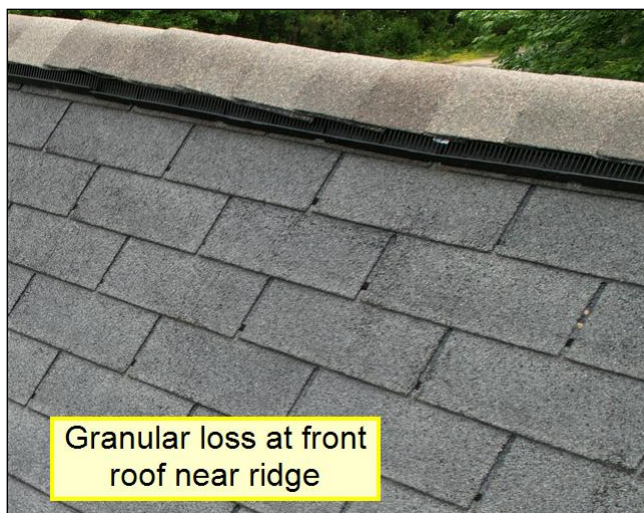
1.0 Item 5(Picture)

Granular loss at front roof near ridge

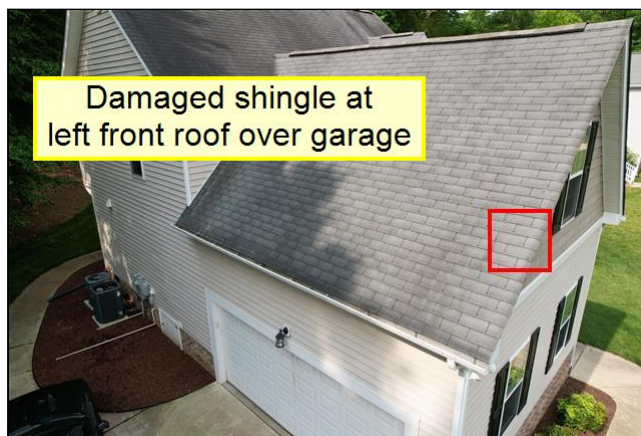
1.0 Item 6(Picture)

Damaged shingle at left front roof over garage

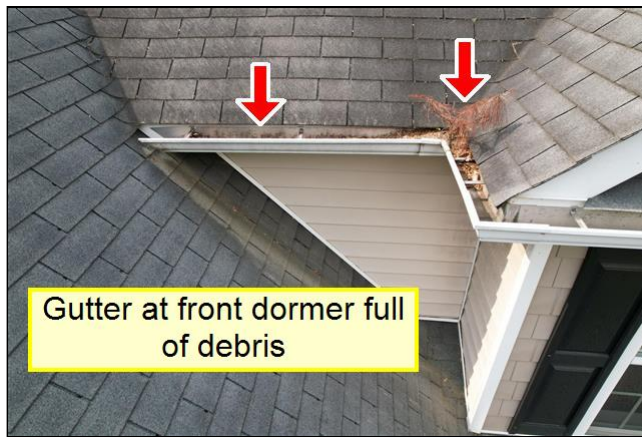
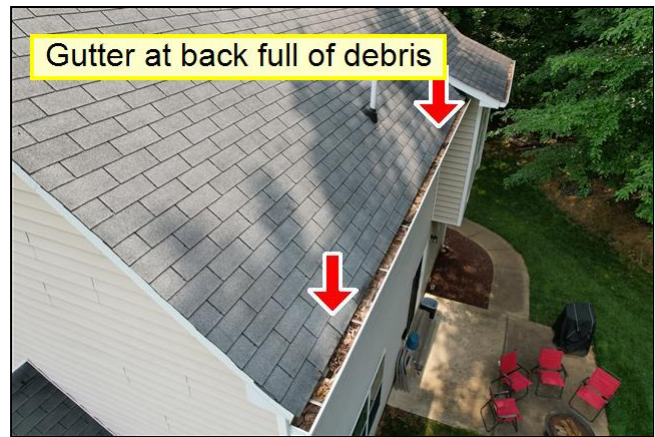
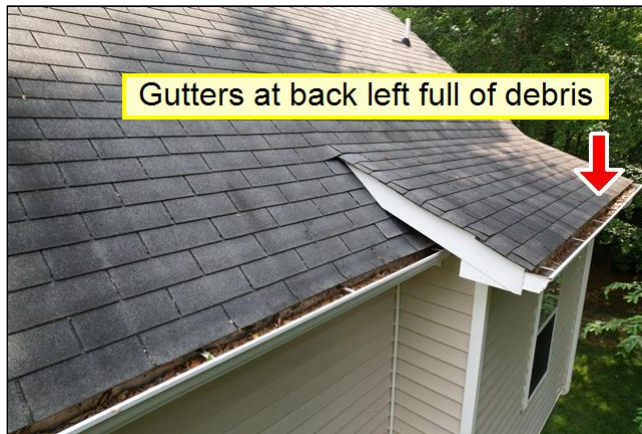
(1) 1,2,3. Many of the gutters are full of debris. This can lead to water overflowing the gutters, dumping at the foundation. This can lead to foundation deterioration. I recommend cleaning the gutters.

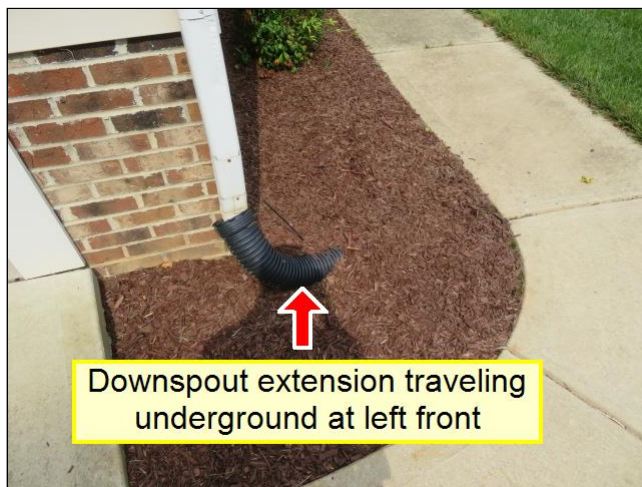
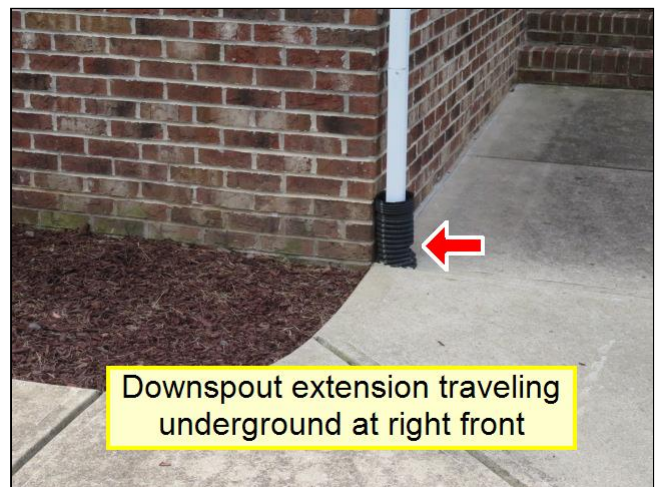
(2) 4,5. The downspout extensions on the front left and right travel underground and I was unable to locate an exit. Its important for the water to exit freely and not back up near the foundation. I recommend observing them during rainstorms, and if back ups occur, either clear the blockage or install new extensions above ground.

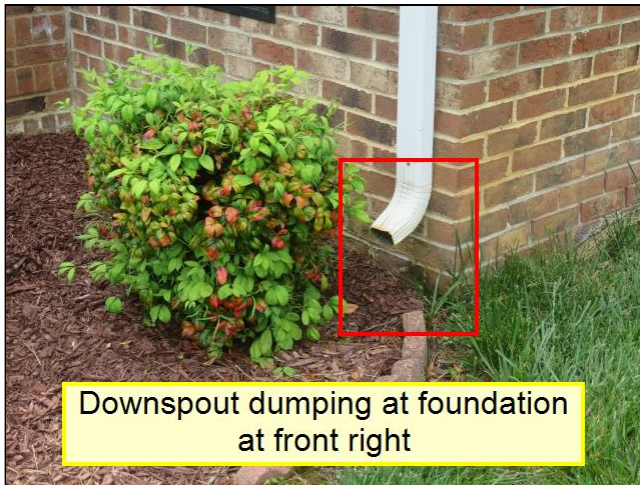
1.3 Item 6(Picture)

(3) 6. The downspout at the front right corner is terminating at the foundation or close to it. This can allow water to enter the crawl space and damage the foundation. Direct drainage from the gutter system can result in water penetration into the foundation area and foundation deterioration. I recommend adding a downspout extension to move water away from the home and foundation.

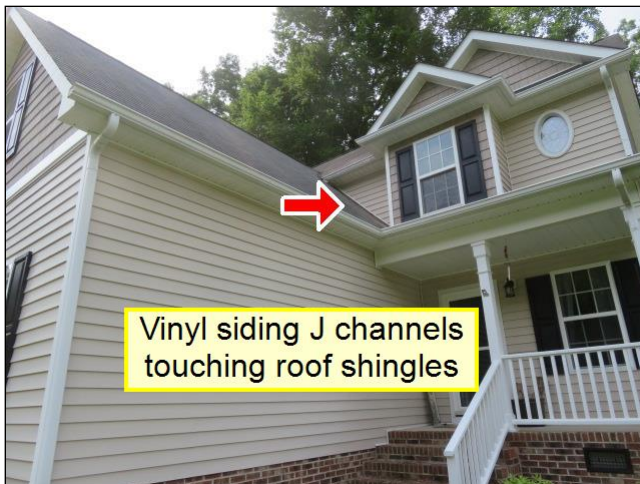
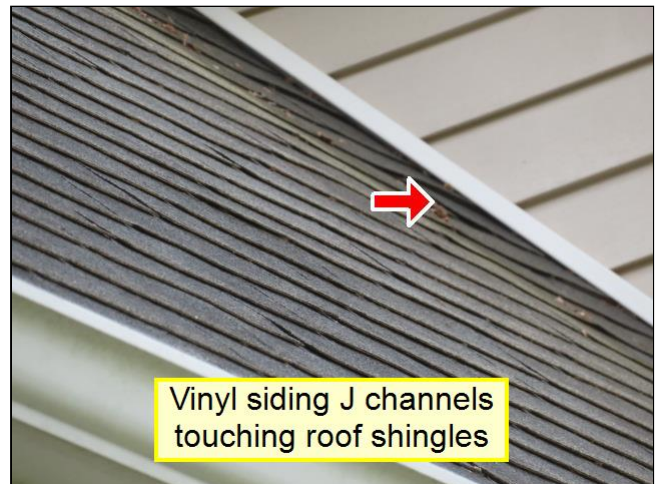
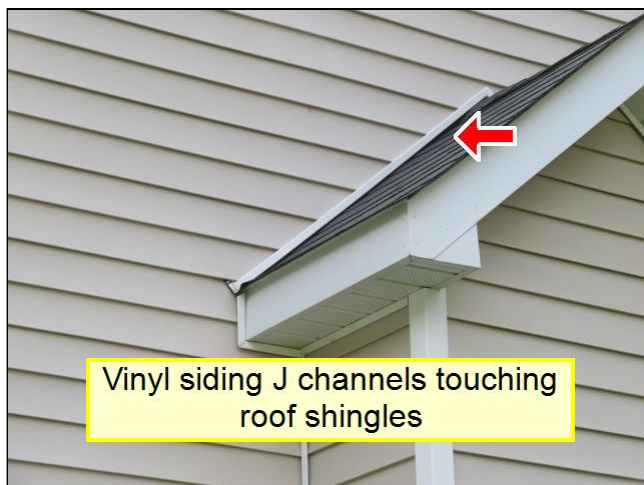
(1) 1,2,3. I found the vinyl siding J channels on the home where they intersect with the roof lines not installed according to manufactures recommendations. The J channels are installed touching the asphalt roof shingles which can lead to them warping. Vinyl siding manufacturers recommend that they be installed with at least a 1/2 inch gap between the roof shingles and vinyl to prevent damage. See page 23 and 26 of the attached vinyl siding installation instruction manual. I recommend having a qualified contractor evaluate and repair as necessary.

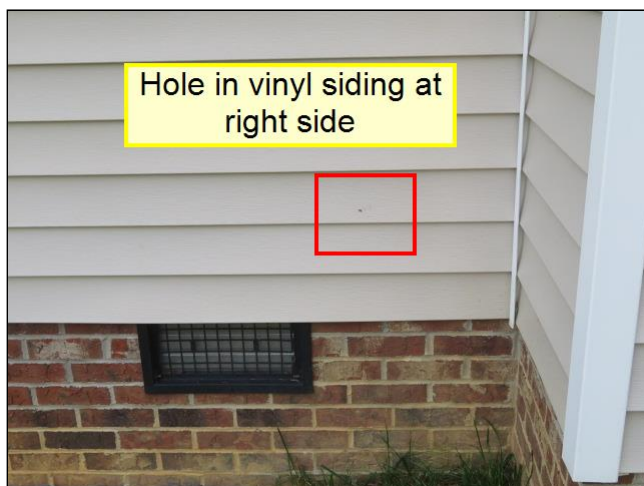
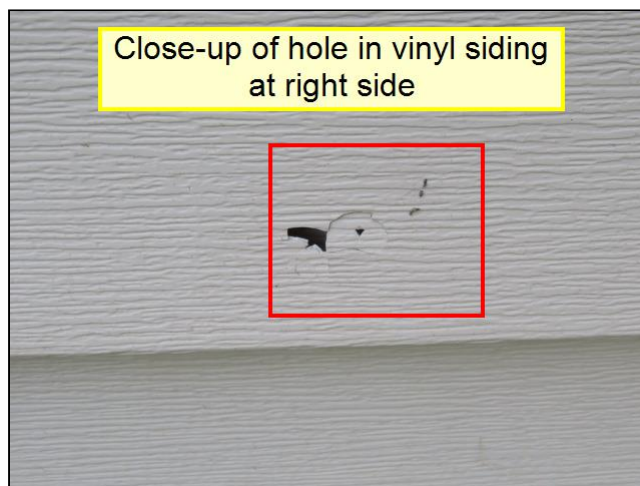
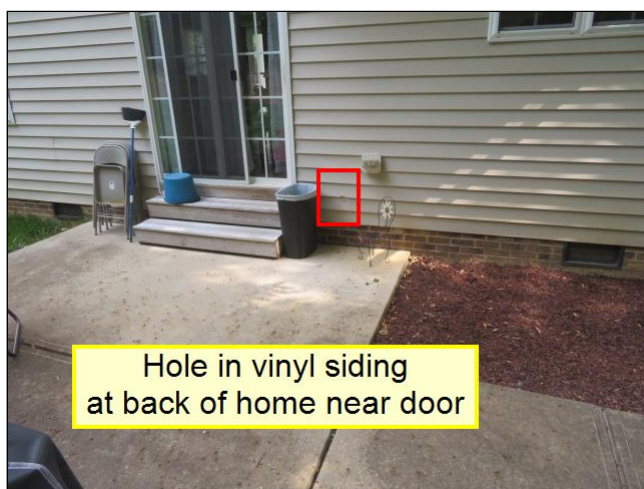
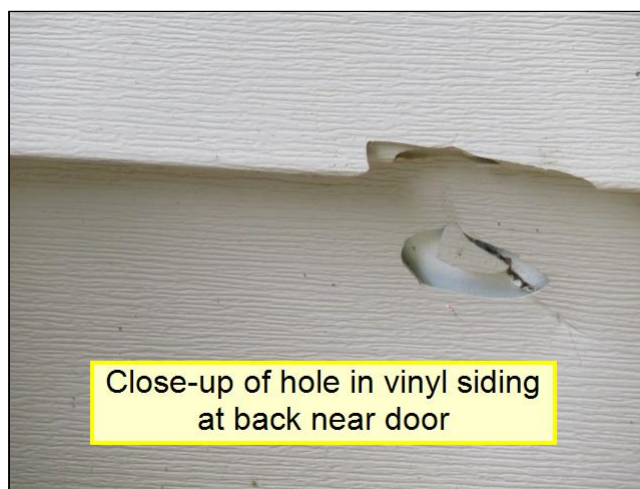
(2) 4,5,6,7.I found holes in the vinyl siding at the right side and also back near the door. This can lead to water penetration and damage. The holes should be sealed. I recommend that a qualified contractor evaluate and repair as necessary.

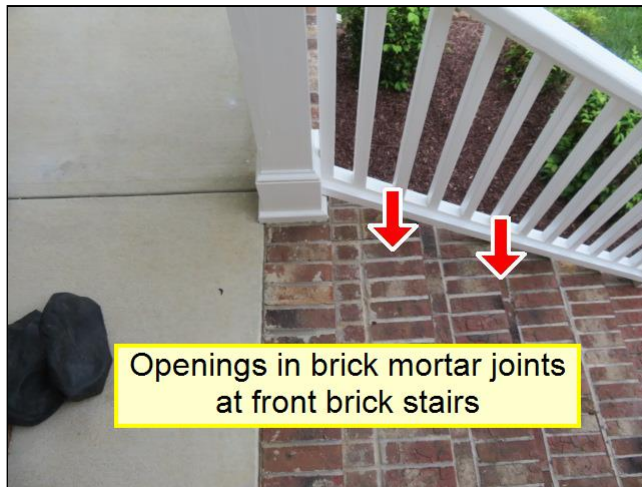
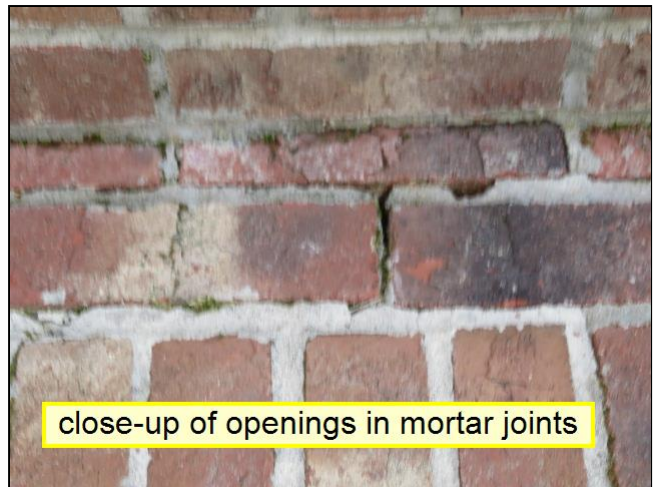
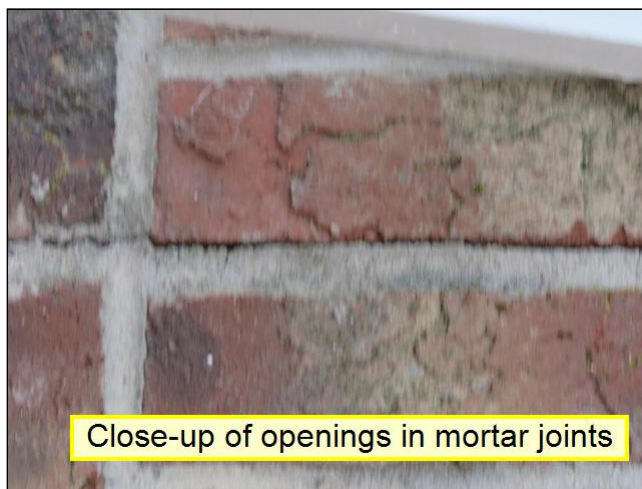
1,2,3. I found openings in the brick mortar joints at the front stairs. This can lead to water penetration and frost heave in the winter. The joints should be sealed. I recommend having a qualified contractor

evaluate and repair as necessary.

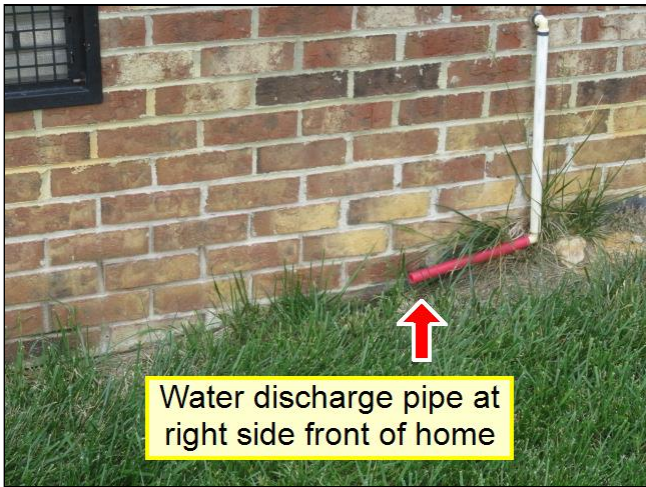
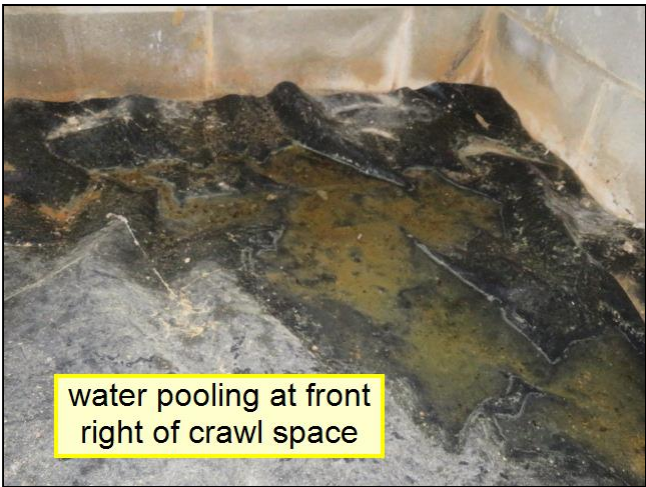
1,2. On the right side front of the house I found PEX plumbing pipes exiting the foundation and dumping water at the foundation. This may be from the water filter/softener system. In the crawl space at the right front I also found water pooling which may be from the discharge pipe dumping water near the foundation. This can lead to foundation deterioration and unhealthy conditions in the home. I recommend extending the pipe and our attaching a downspout extension to move water away from the home.

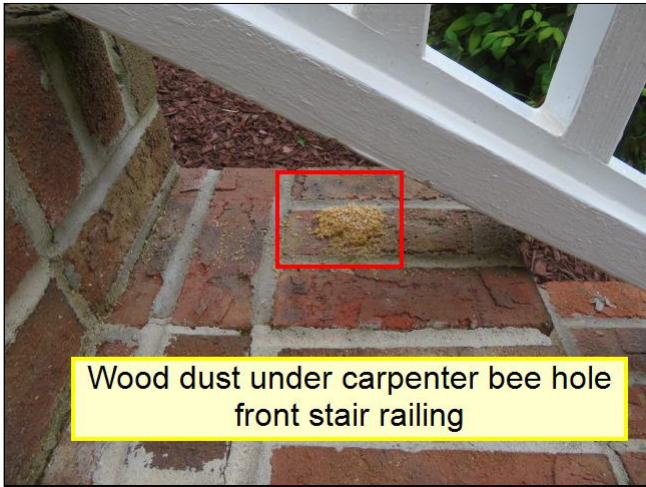
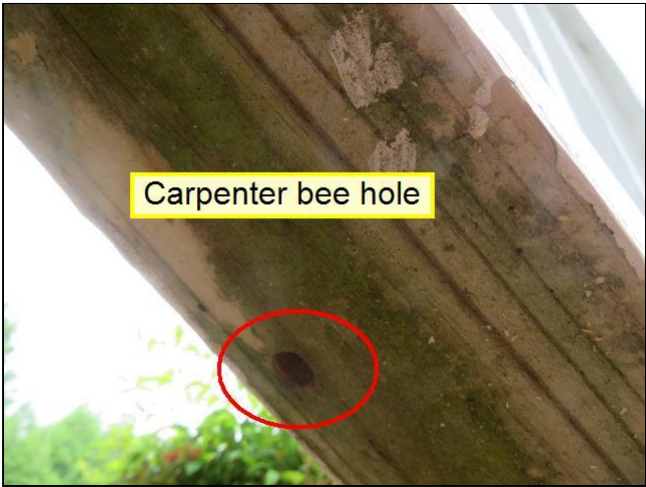
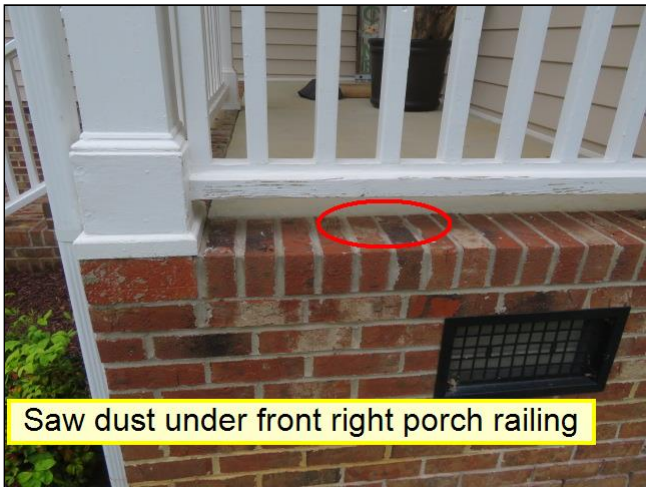
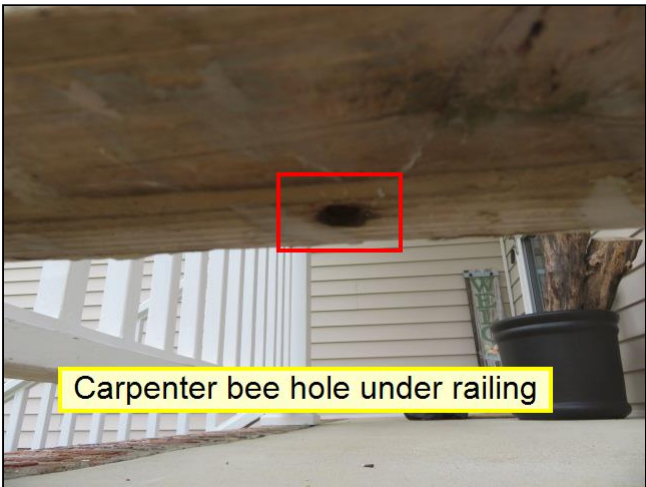
1,2,3,4. I found what appears to be evidence of active carpenter bees at the front stair railing and deck railing . Wood destroying insects can damage the home. I recommend that a pest control contractor evaluate and treat as necessary.

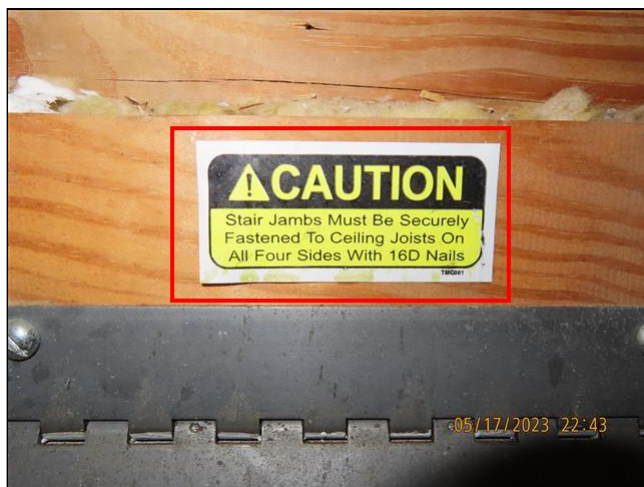
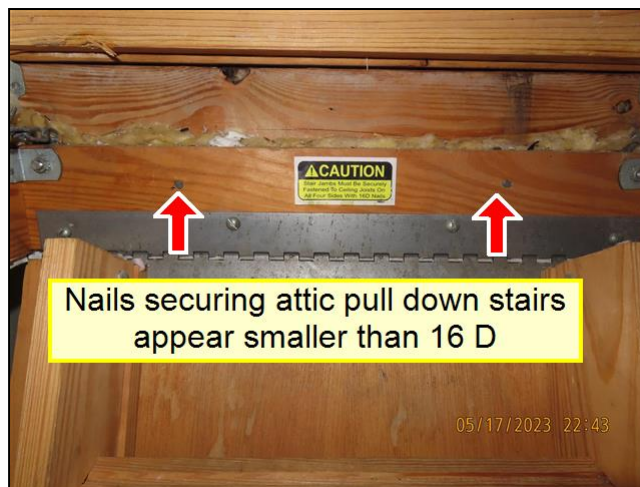
1,2. I found the frame for the attic pull down stairs attached with nails that appear smaller than 16 D. Most attic stair manufactures recommend 16 penny common nails or structural screws for installation of the stair frame. The improper installation of an attic stair way can lead to catastrophic failure and injury. I recommend having a qualified contractor evaluate and repair as necessary.

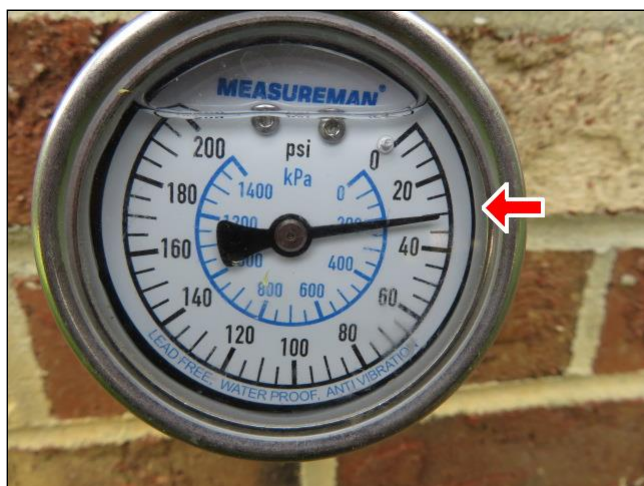
6.1 Item 1(Picture)

(1) 1. The water pressure measured 30 PSI. Typical water pressure measures between 40 and 80 PSI. I recommend consulting with a well contractor to confirm that the pressure is within acceptable limits.

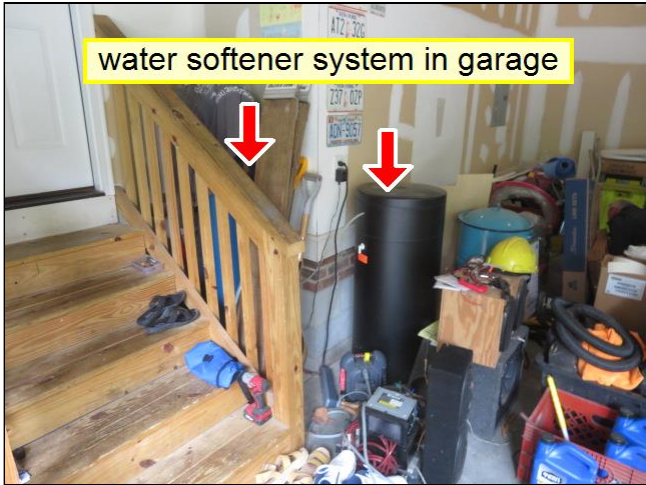
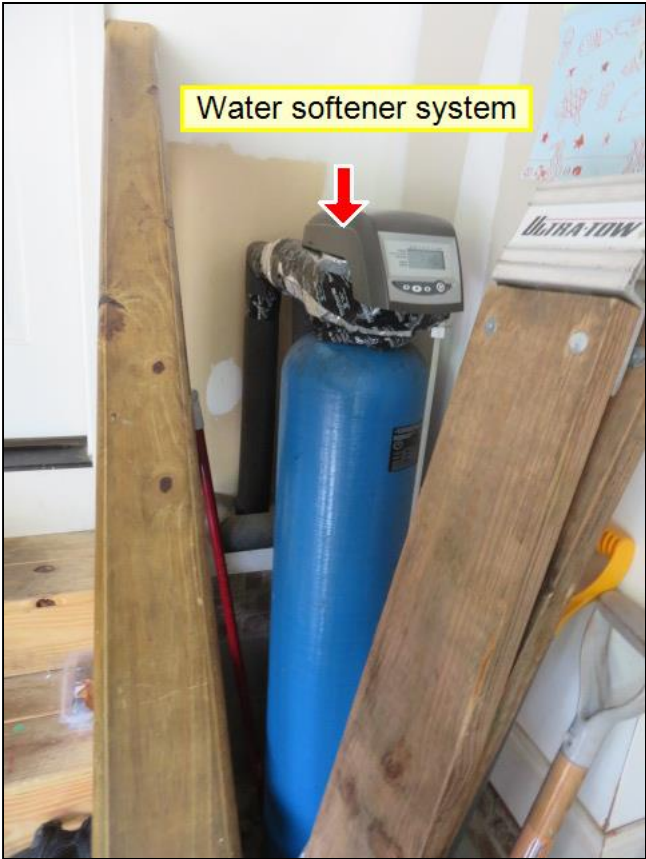
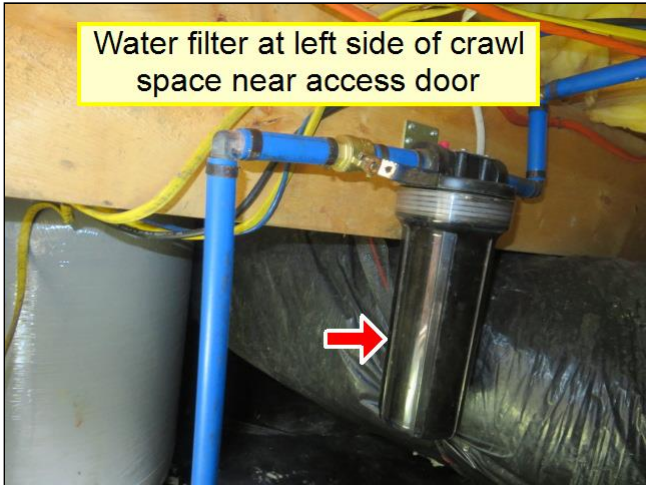
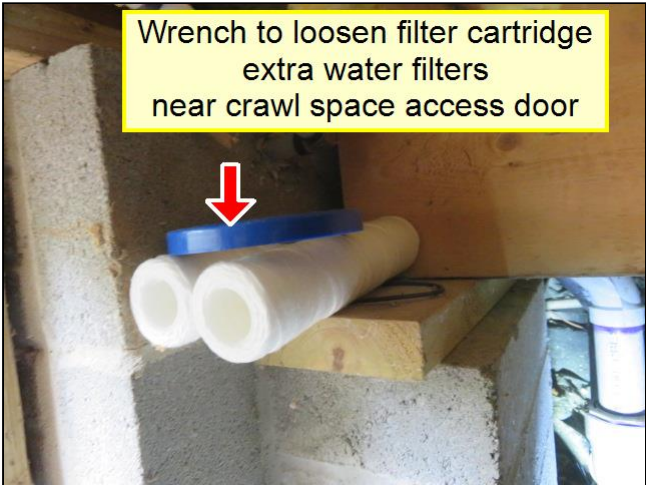
(2) 2,3,4,5. The home has a water filtration and softener system in the garage and also crawl space. Inspection of these systems is beyond the scope of a home inspection and therefore was not inspected. I recommend asking the homeowner for disclosure and or having a qualified contractor evaluate the system for proper operation.

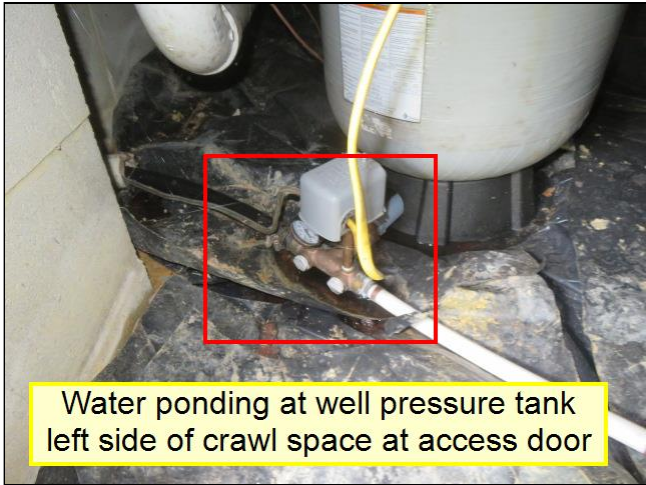
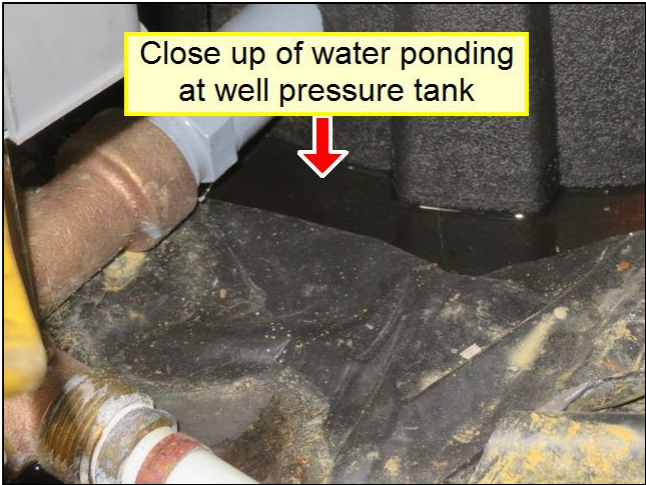
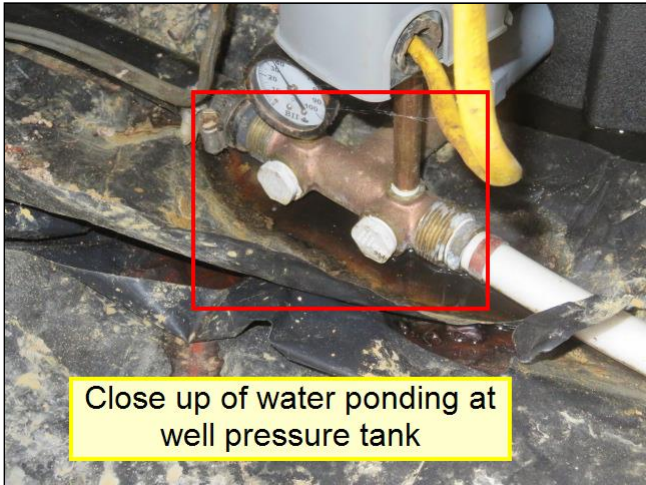
(3) 6,7,8. I found water pooling under the well pressure tank and plumbing pipes at the left side of the crawl space near the access door. It appears that there is a water leak which can lead to unhealthy conditions and property damage. I recommend having a plumber evaluate and repair as necessary.

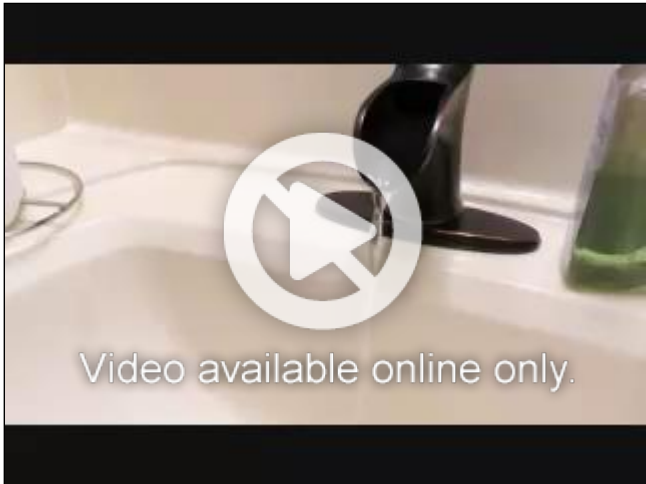
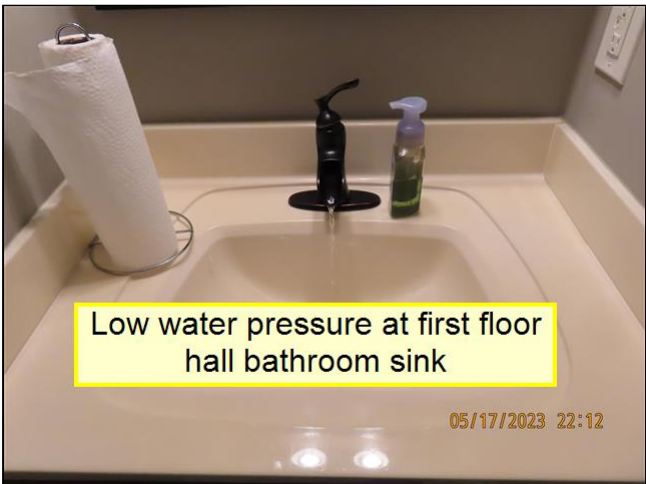
(4) 9,10.The first floor bathroom sink appears to have low water pressure. It may be a dirty aerator. I recommend having a plumber evaluate and repair as necessary.

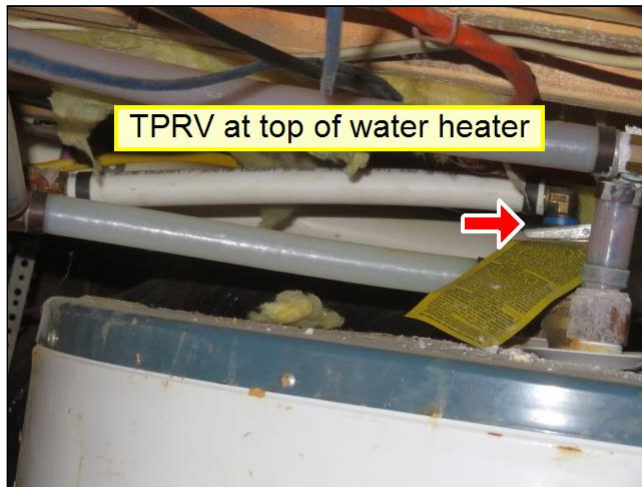
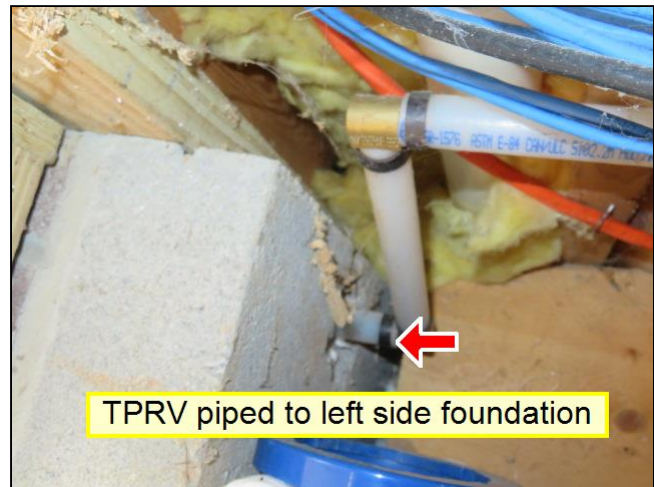
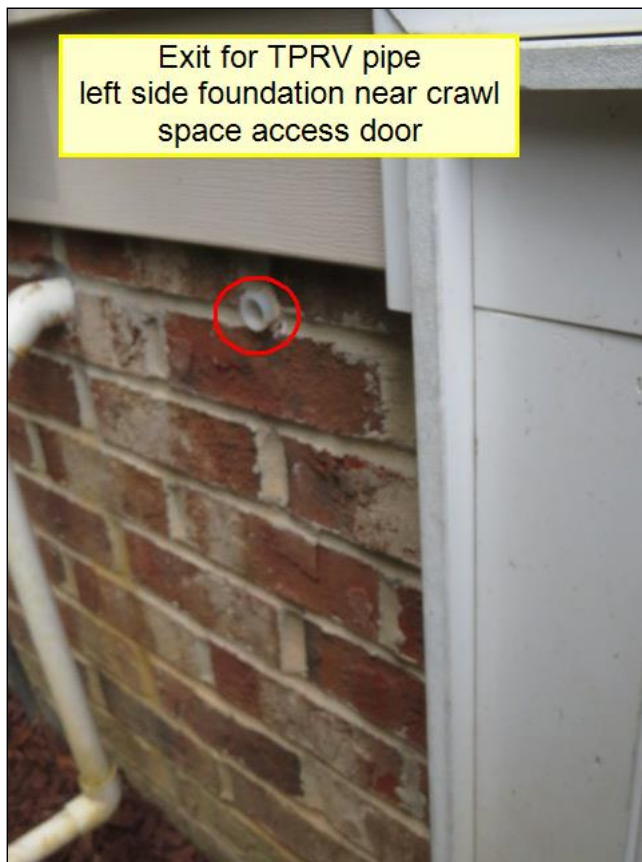
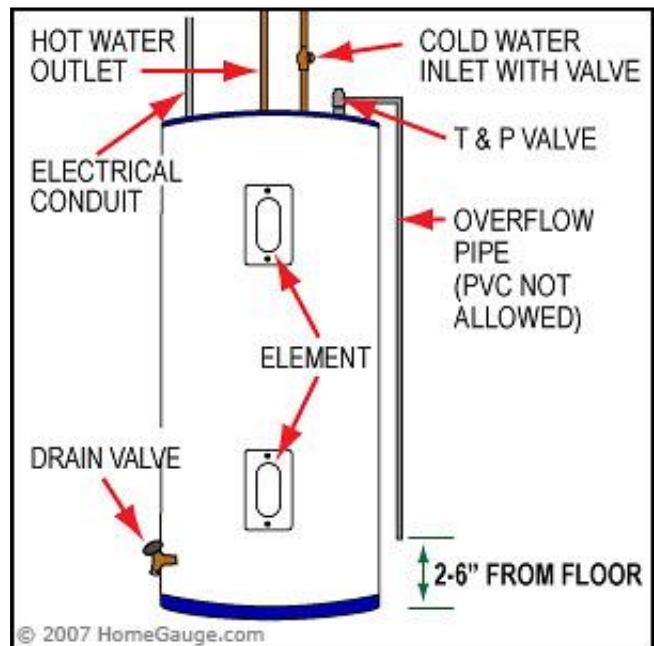
(2) 4,5,6,7. The Temperature Pressure Relief Valve (TPRV) for the water heater is a safety device to prevent the unit from exploding in case of a malfunction. The TPRV is located at the top of the hot water unit and is designed to prevent burn injury in the event of a discharge. The TPRV requires a piped

extension down to the floor area. The TPRV for this unit is piped to the left side foundation and is not directed toward and 6 inches above the ground. This is a safety issue that needs to be repaired to prevent personal injury or property damage. I recommend that a plumber evaluate and repair as necessary.

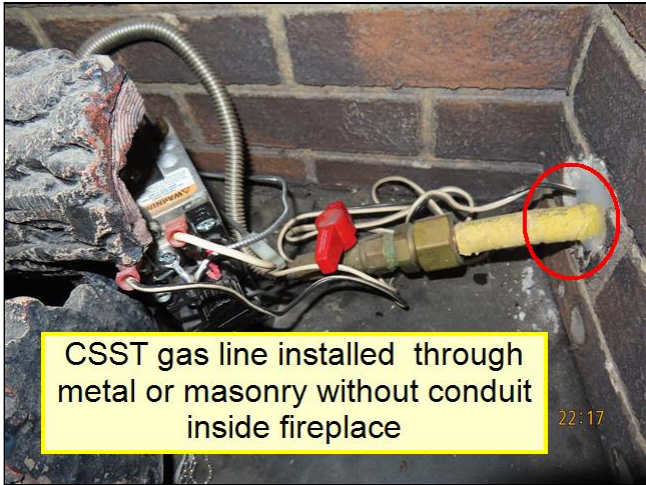
6.4 Item 1(Picture)

1,2. I found CSST gas line entering the manufactured fireplace that is either masonry/metal combination without conduit. CSST gas lines have specific requirements for safe use. Typically, when passing through masonry and or metal, conduit 1.5 times larger than the CSST pipe is installed to protect the CSST from damage. Improper installation can lead to gas leaks and injury. I recommend having an HVAC contractor evaluate and repair as necessary. See page 55 of attached installation manual in the attachment section of this report.

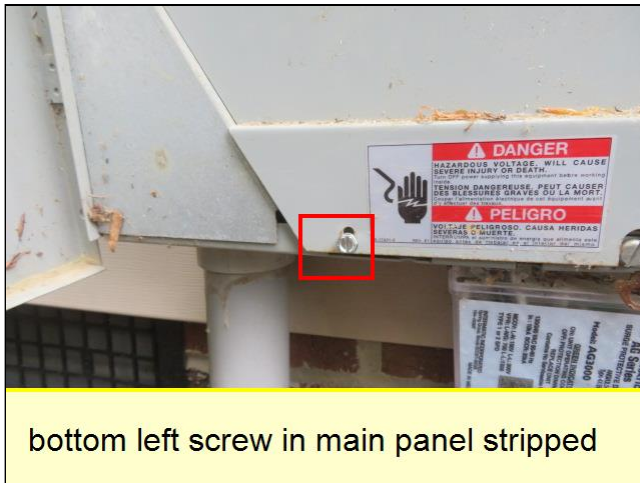
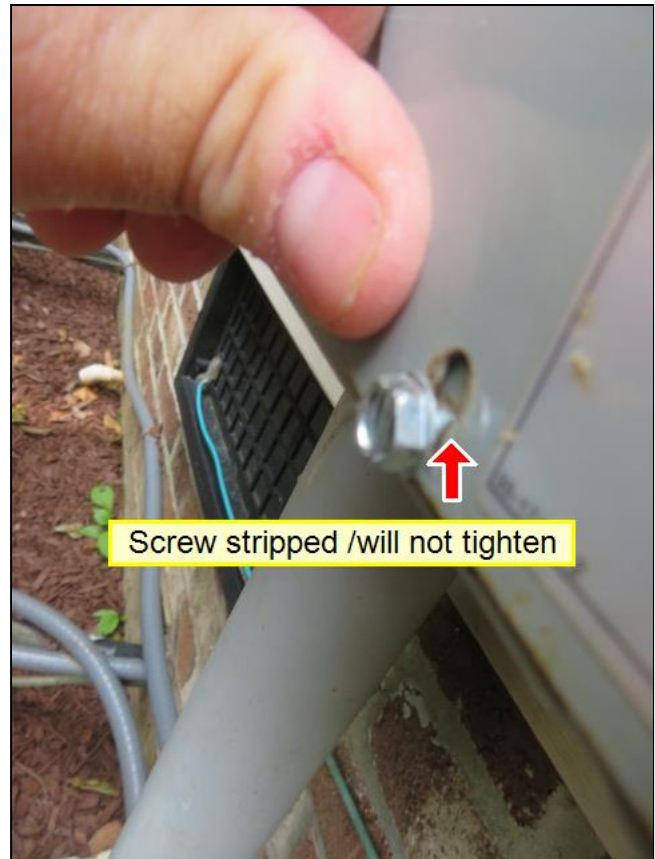
- 7.1 Service and Grounding Equipment, Main Overcurrent Device, Main and Distribution Panels
  - Repair Replace
  - (1) 1,2. The bottom left screw securing the dead front cover on the main electrical panel on the left side of the home is stripped.I recommend having an electrician install the correct size screw.

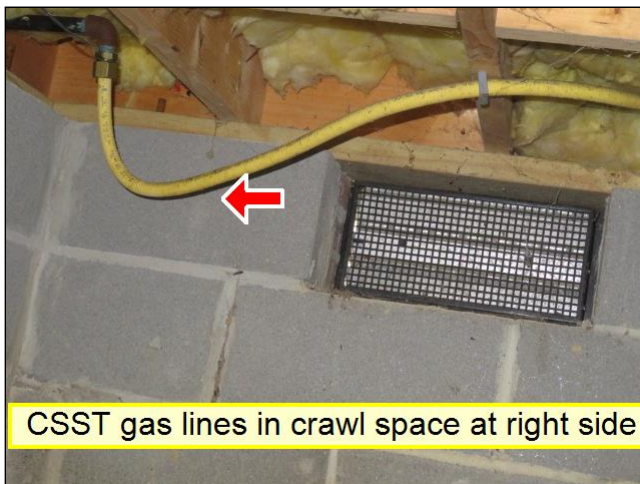
7.1 Item 3(Picture)

(2) 3. This home has corrugated stainless steel gas lines. This gas line has specific installation requirements related to required bending allowances, support, protection, and electrical bonding to ensure safe conditions. The electrical bonding is typically required to prevent damage from electrical storms in the event of a lightning strike. During the home inspection the bonding attachment could not be located. I recommend that an electrician evaluate and repair as necessary.

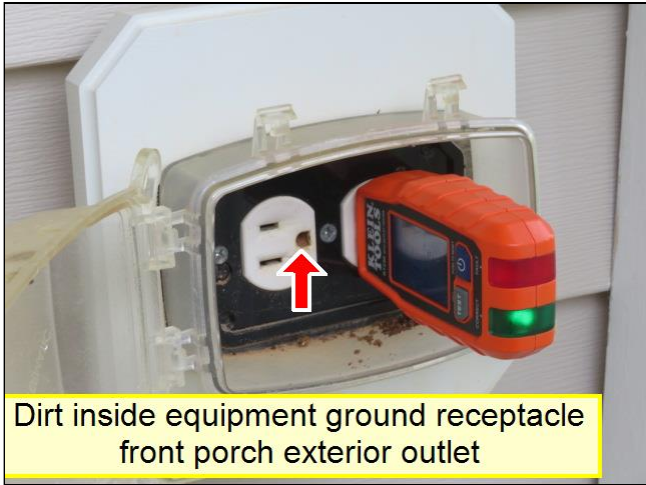
7.3 Item 1(Picture)

1. My tester would not push into the left side receptacle in the front porch exterior outlet due to dirt blocking access. I recommend having a qualified contractor evaluate and repair as necessary.

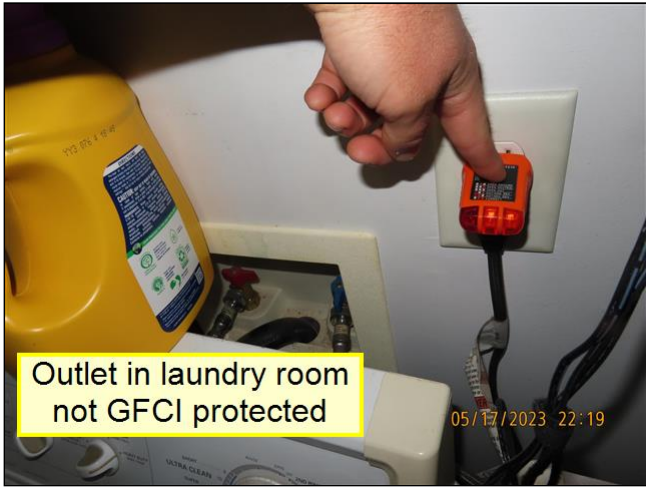
7.4 Item 1(Picture)

1,2. No ground fault circuit interrupter (GFCI) protection was provided at the time of inspection at the outlet in the laundry room. Although GFCI protection may not have been required at the time the home was built, for safety reasons, I recommend that electrical outlets located within 6 feet of a plumbing fixture and outdoors be provided with ground fault circuit interrupter (GFCI) protection in good working order to avoid potential electric shock or electrocution hazards. I recommend that a licensed electrician evaluate the outlets(s) and make any necessary repairs.

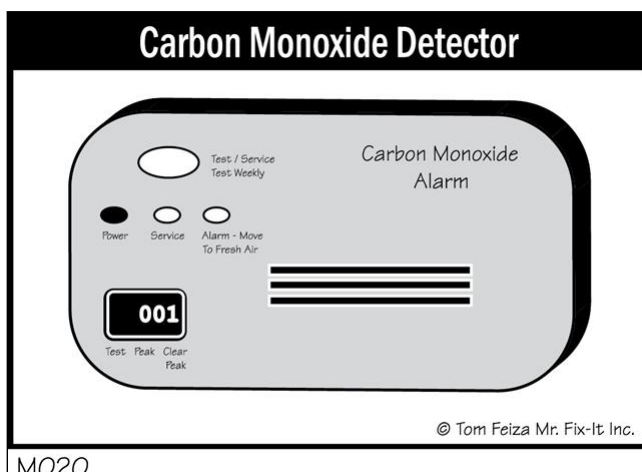
7.8 Item 1(Picture)

Note: I did not locate a carbon monoxide detector in the home. Since the home has an attached garage and gas logs, a carbon monoxide detector should be installed on each level of the home according to

manufactures instructions. I recommend installing CO detectors in the home. See attached document from the NFPA, National Fire Protection Association.

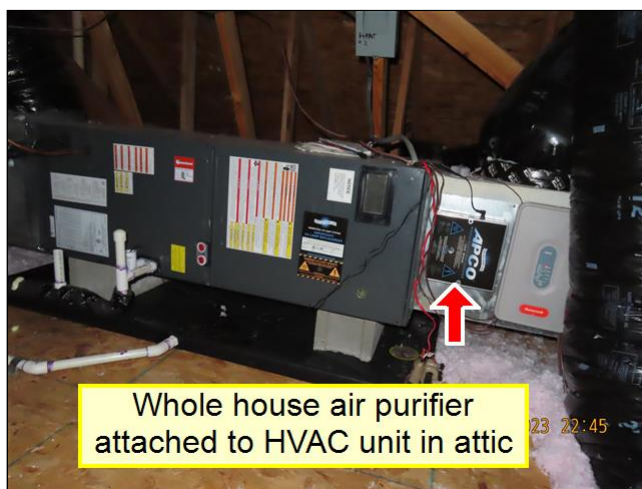
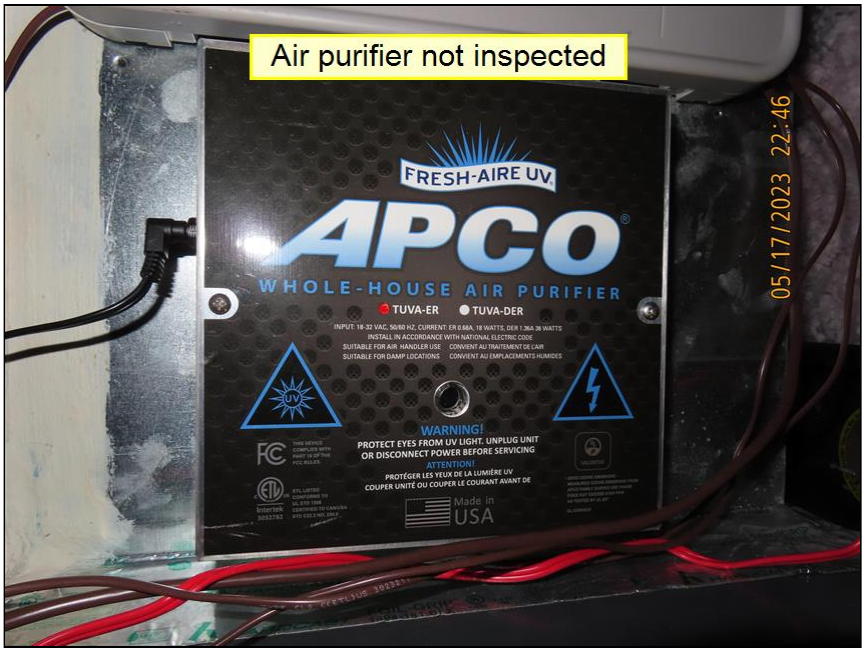
1,2. The attic HVAC unit appears to have a UV light air purifier attached. Inspection of these systems is beyond the scope of a home inspection and therefore not inspected. I recommend having an HVAC contractor inspect it for proper function.

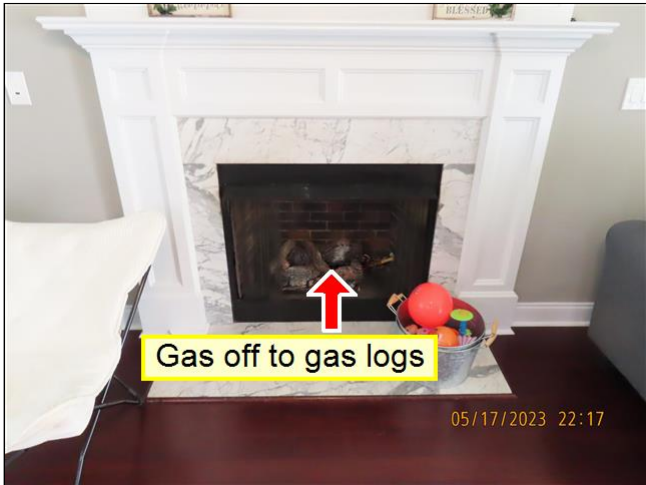
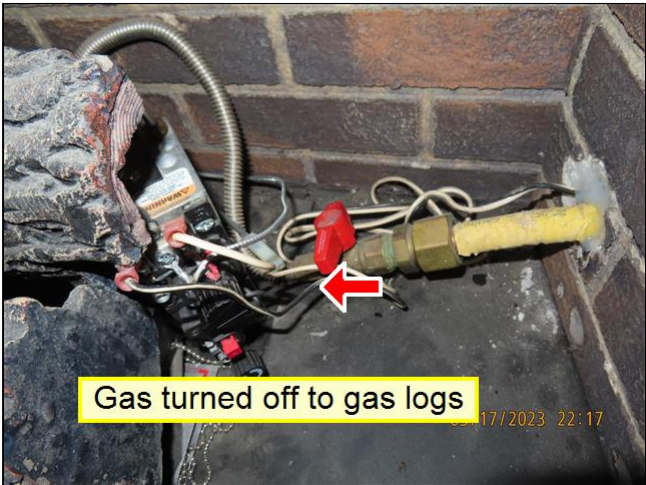
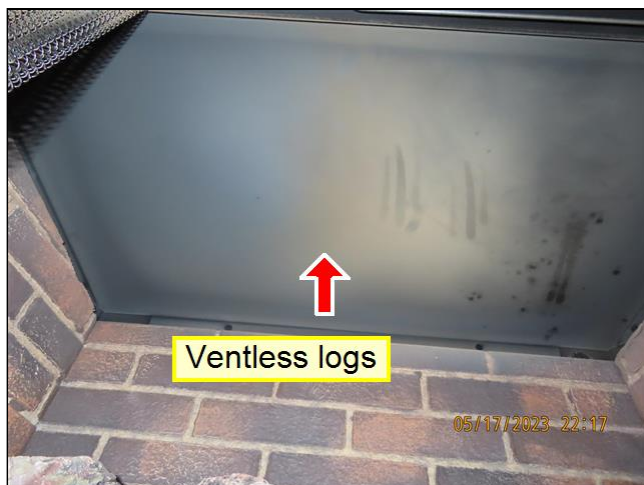
1,2,3. The gas log unit located in the livingroom fireplace was visually inspected but not operated because the gas was shut off to the appliance. Once the gas is turned on to the unit, I recommend that it be serviced and operated by a qualified contractor to ensure safe and reliable service.

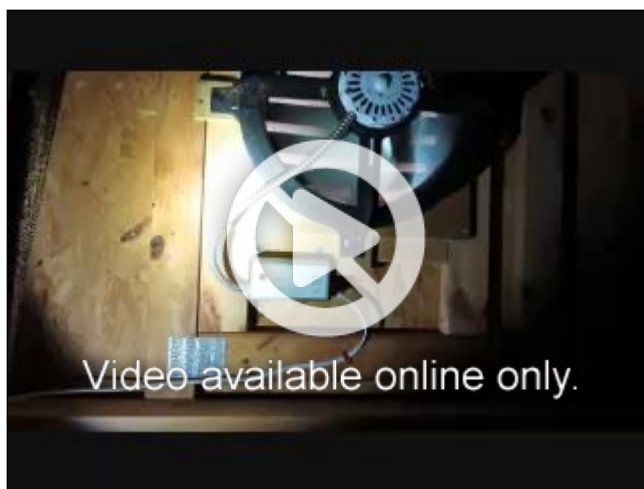
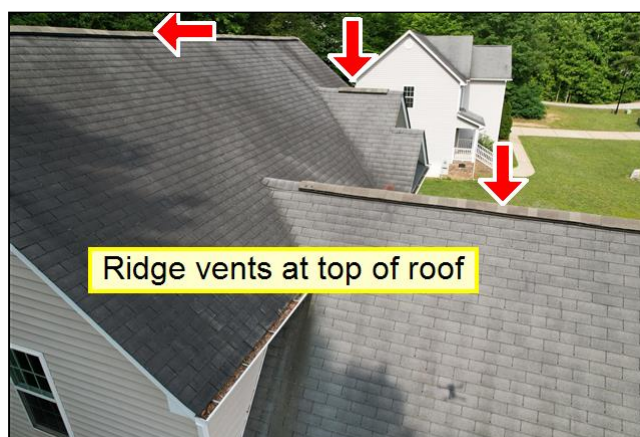
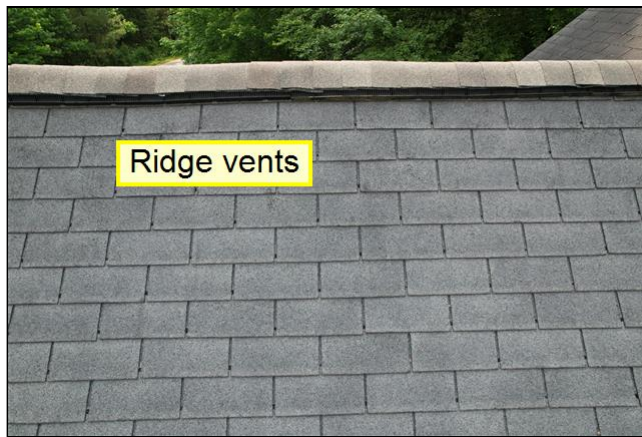
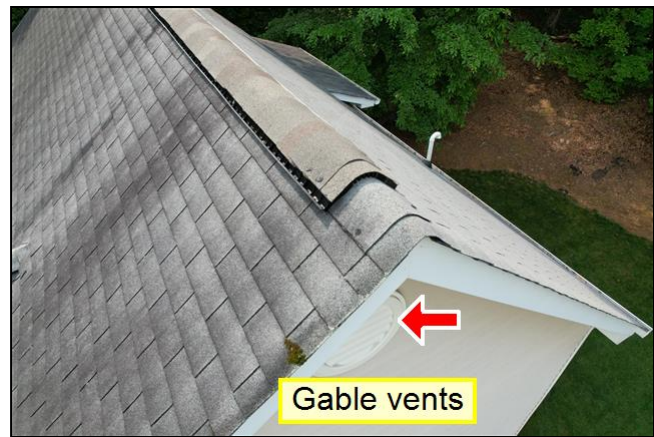
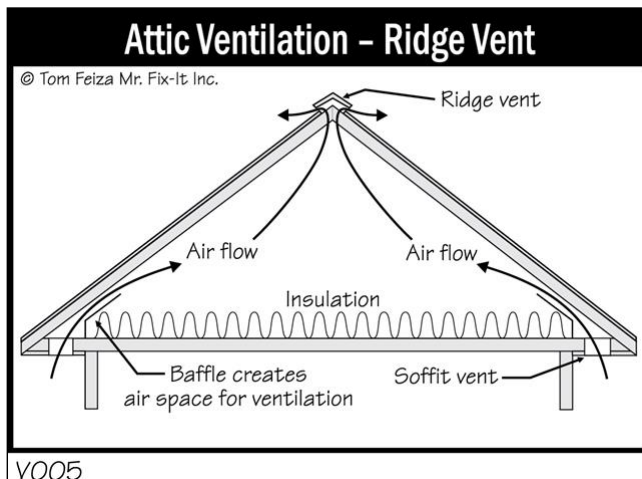
1,2,3,4,5. The home has ridge, soffit and gable vents along with a thermostatically controlled exhaust fan in the gable vent of the main attic. Typically with a ridge, soffit and gable vents, a fan is not installed because it can lead to improper ventilation. Hot air moves up through the ridge vent, but with the exhaust fan, air can be drawn in from the ridge leading to improper ventilation. I recommend turning the fan off.
