## Septic Inspection

| Transferee Name: | SIRVA | Street Address: | 4660 Hancock Rd |

On June 11, 2024, I was at the property address above to pump out the septic tank and provide a point of sale septic inspection. Prior to my arrival, I obtained the existing septic permit from *Granville County Environmental Health* that showed this 3 bedroom home as having a 1,000 gallon septic tank, a 1,000 gallon pump tank, 2x150 foot twenty-five percent reduction drain lines, and a private well for potable water consumption. Based on what I can determine, the permit was issued on 05/21/2021.

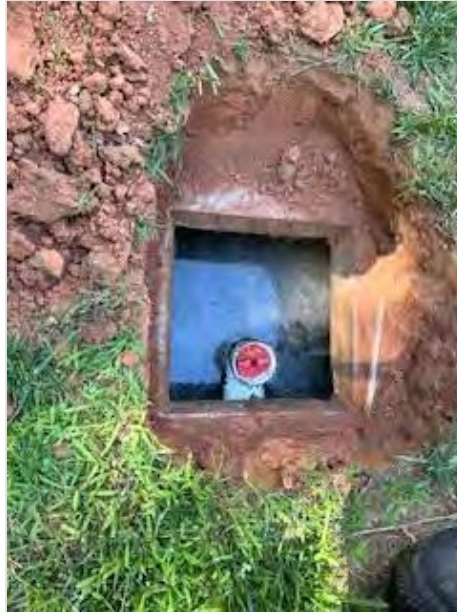
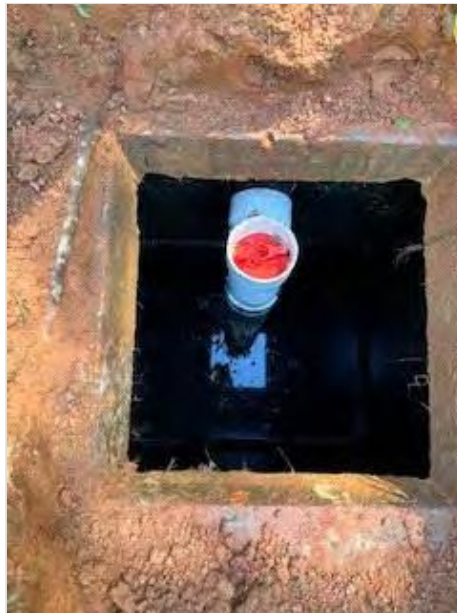
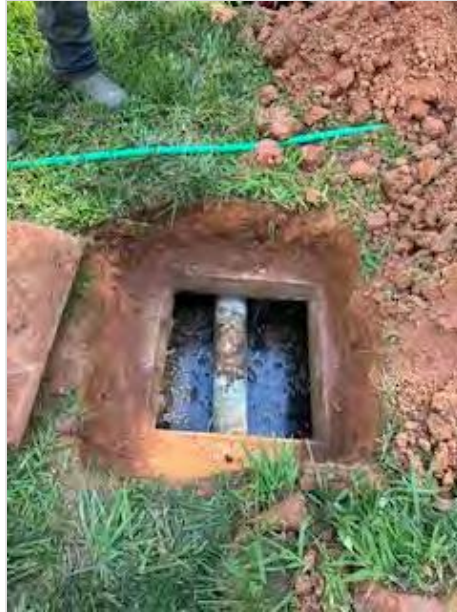
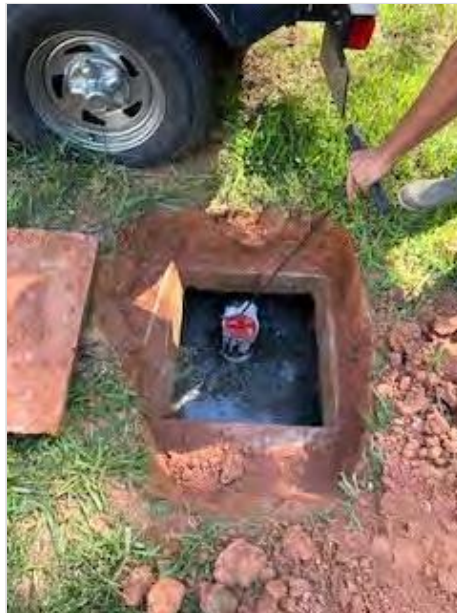
Septic Tank

On arrival, the female of the home was present. We located the septic tank at the back left corner and dug out the two access lids for pumping. The inlet access measured 8'9" off the back left foundation while the outlet compartment measured 14'7". The tank is 9.5 inches deep. NC Septic Rules require under this permit that the tank access be no deeper than 6 inches or an access riser be installed bringing access to within 6 inches of the ground surface. The tank lids were intact. The inlet plumbing pipe was stubbed into the tank well past the opening, so I cut this pipe off at a proper distance into the tank. After pumping the septic tank, I saw no problems with the tank. The effluent filter was cleaned during this service.

- Consider adding access risers to the septic tank to bring access up to ground level. The only rule at the time of this install was that access is to be within 6 inches of the ground surface. The tank is 9.5 inches deep.

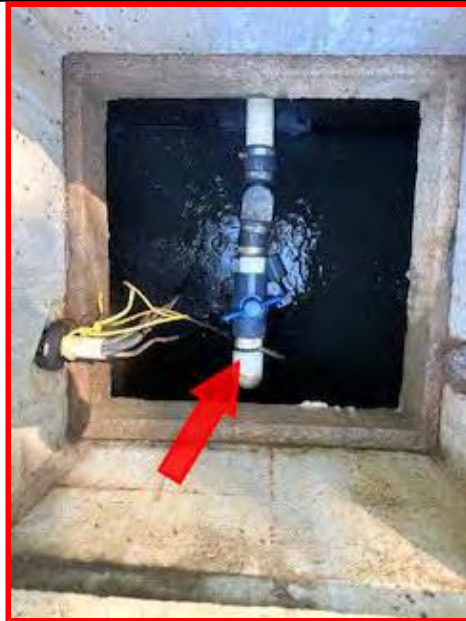
- There is leakage around both penetrations of the pump tank riser. This riser is required to be watertight.
- Consider incorporating a disconnect union in the pump discharge piping. Removal of the bands and completely disassembling the check valve is not a similar disconnect device as described in the rules.

Leak At Check Valve At Pump Tank Riser

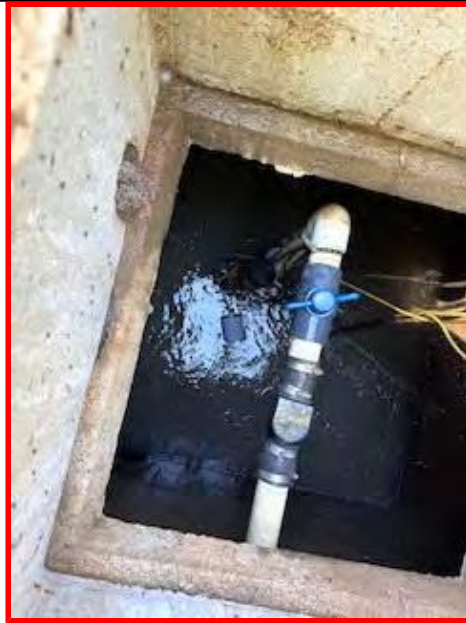
- The pump control panel was required to be 12 inches above grade at the time of inspection.
- The pump tank riser was required to be 6 inches above ground level at the time of this installation.

Pump Tank Riser At Grade

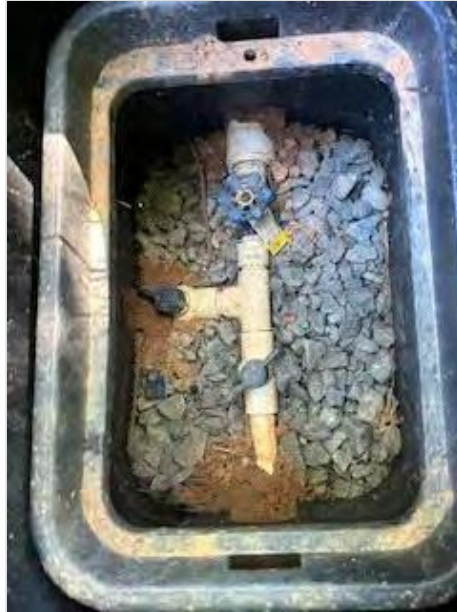
Meter Box

The meter box at the head works of the two drain lines measured 23 feet from the pump tank riser. One of the valve handles is broken, but still operable. Prior to the rectangular meter box is a round valve box for the pressure head set. The threaded cap is leaking during pumping. I walked the two drain lines and flagged them for location. I noticed settling over each drain line that can lead to hydraulic overloading if ponded water soaks into the lines.

- The 2-inch plug used for pressure head in the round valve box is leaking. This plug should have thread lock sealant on the threads and be tightened.
- The settling over the two drain lines is not causing any issues at this time. However, filling these low areas will help to sheet storm water off of the system allowing the system to work better in wet weather.

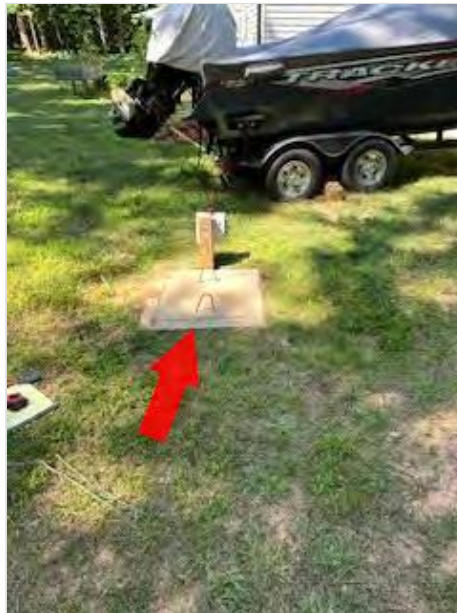
| Remarks: | The pump tank riser is required to be 6" above ground level. There are leaks around both penetrations of the pump riser and the 2 inch plug used for pressure head in the round box is leaking. | |

Riser Not 6" Above Grade

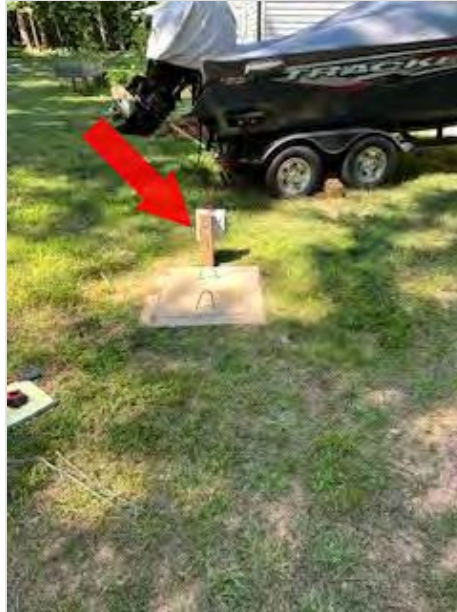
The pump tank is further away from the home and has a square concrete access riser at grade with the septic control panel adjacent. The Liberty control panel is mounted 7 inches above ground level and is required to be 12 inches above grade. The panel is in very good condition and all of the floats are properly functioning. I noticed Conseal sealant placed around the electrical conduit inside the pump tank riser and also in the original force main outlet hole through the riser that the inspector "corrected" on the permit. I injected water into the ground around these two areas with my water probed and the water poured into the tank because of a poor seal. The pump tank riser is at grade and also in a depressed area. The riser is required to be 6 inches above grade and be watertight. Inside the pump tank, the floats are mounted on the pump discharge piping and at the end of the pump cycle, the pump is not covered. I noted that the valve is mostly closed and there is not a required disconnect union. The banded rubber boots on the check valve does not equal a disconnect union (in my opinion).

Control Panel Not 12" Above Ground

Please note: Access risers were not present and the control panel was not 12 inches above grade. Recommend installing access risers and raising the control panel to 12" above grade. No visible signs of malfunction were noted and the system was functioning as intended /designed at the time of inspection. No warranty is expressed or implied as to the future condition of the septic system and related components.

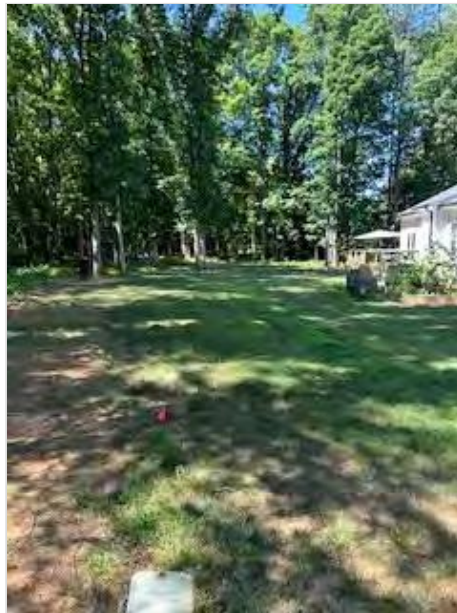
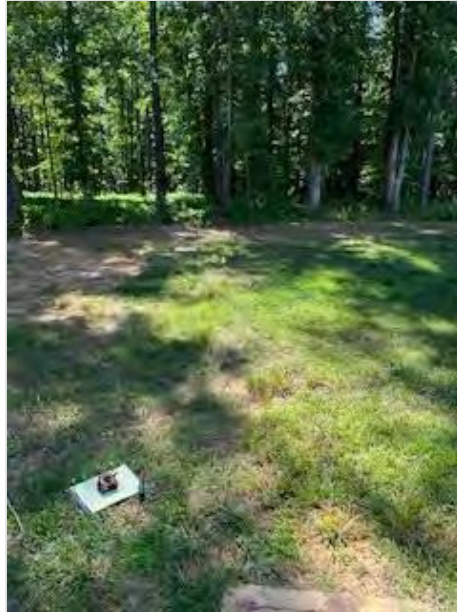
Drain Field

| Remarks: | Please note: Settling was observed over the two drain lines; however, no visible signs of malfunction were noted and the system was functioning as intended /designed at the time of inspection. Recommend adding fill in depressed areas. No warranty is expressed or implied as to the future condition of the septic system and related components. | |
