## ERC Property Assessment MCI / MCA

**Inspection Date:** 6/10/2024

**Transferee / Property Information:** SIRVA  
4660 Hancock Rd  
Oxford, NC 27565

**Inspection Type:** ERC Property Assessment  
MCI / MCA  
Customer File Number: 8648827  
ReloOlogy Number: 108027

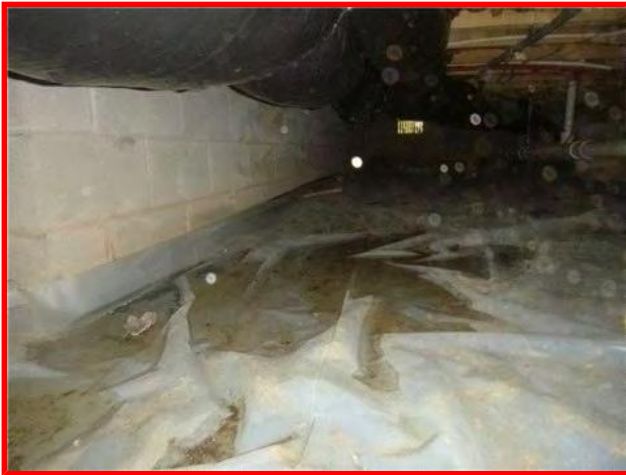
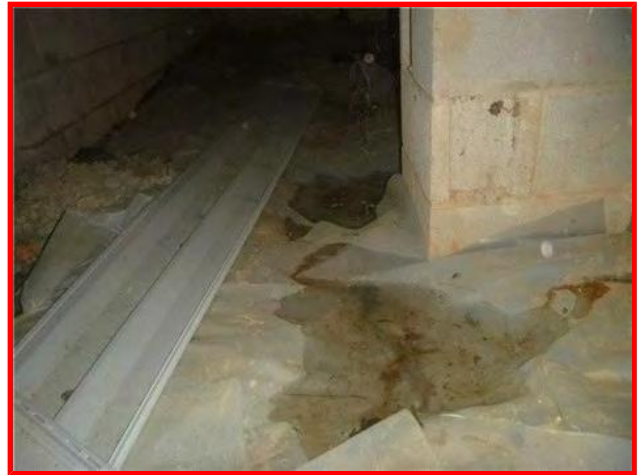
| CRAWL SPACE (CS) | | | | | |
|---|---|---|---|---|---|
| 3 | Evidence of water penetration? <input checked="" type="checkbox"/> Yes <input type="checkbox"/> No If yes, See Summary Page for Remarks. | | | | |

Pooling Water in Crawl Space

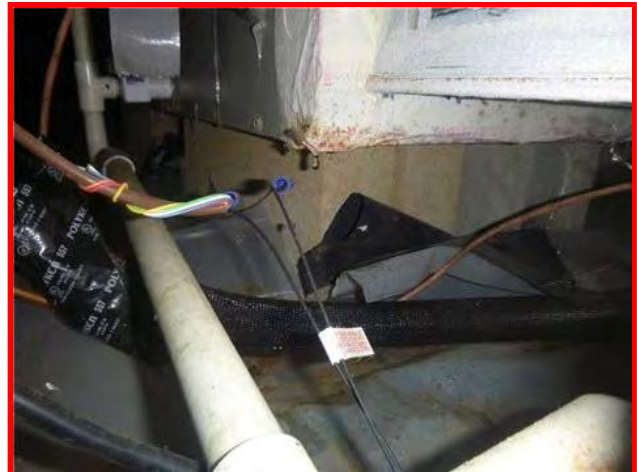
Leak at Heat Pump Condensate Line

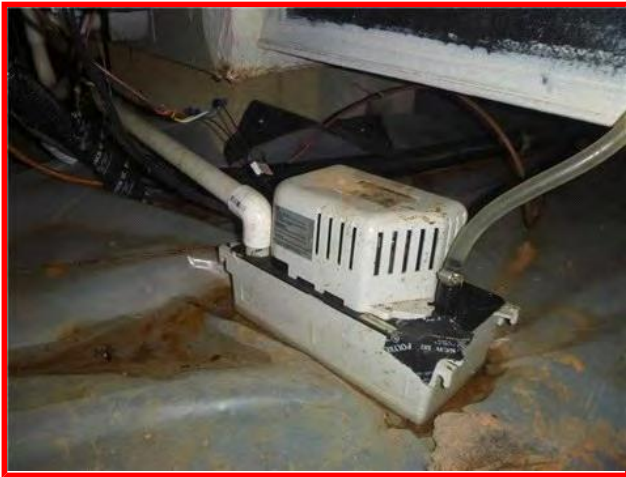
Standing Water at Condensate Pump

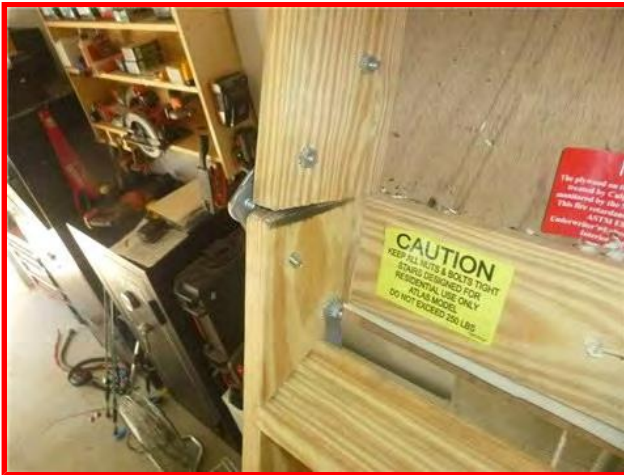
Missing Hardware at Attic Access Ladder
