**RIDER TO PURCHASE AGREEMENT ADDENDUM**

THIS IS AN ADDENDUM to Purchase Agreement and the Rider to Purchase Agreement ("Rider") dated \_\_\_\_\_, by and between BGRS Relocation Inc., "Seller," and "Buyer," for the property located at 103 Meadow Brook Ln, Oxford, NC 27565-2869 (the "Property").

## ERC Property Assessment MCI / MCA

# Worldwide ERC® Relocation Property Assessment

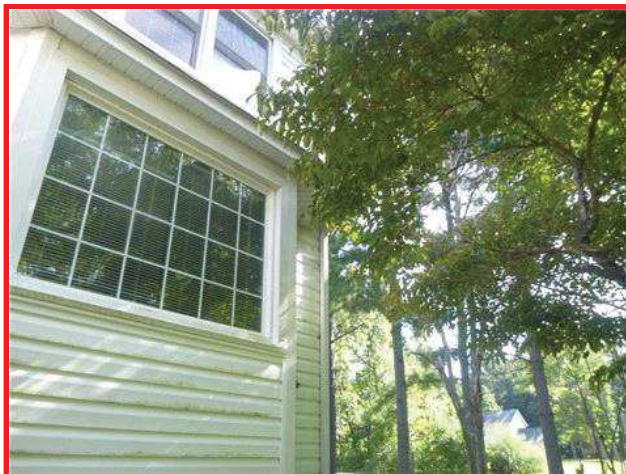
Tree in Contact with Roof

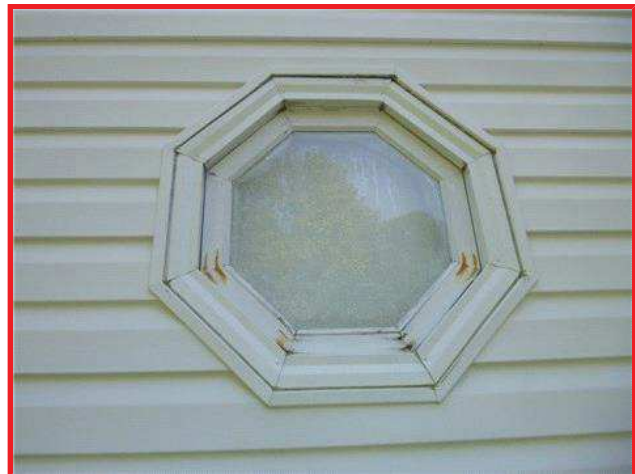
Deteriorated Trim at Octagon Window

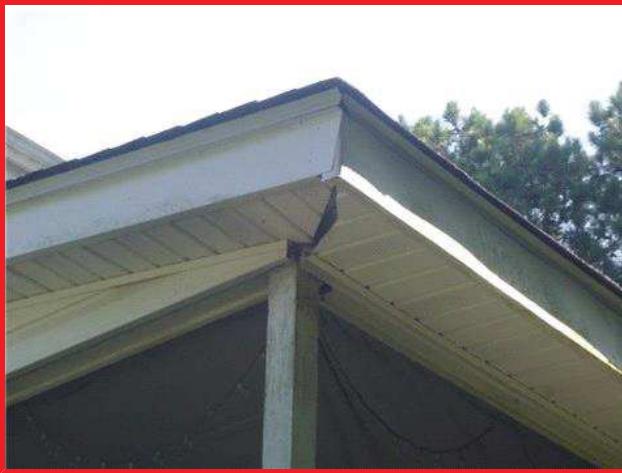
Loose Soffit at Porch

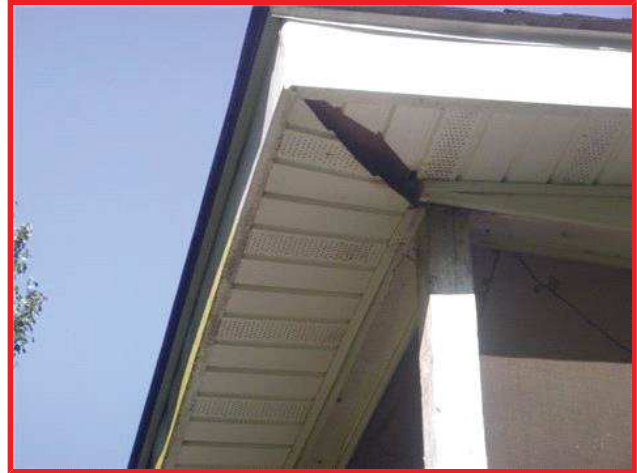
Loose Soffit at Porch

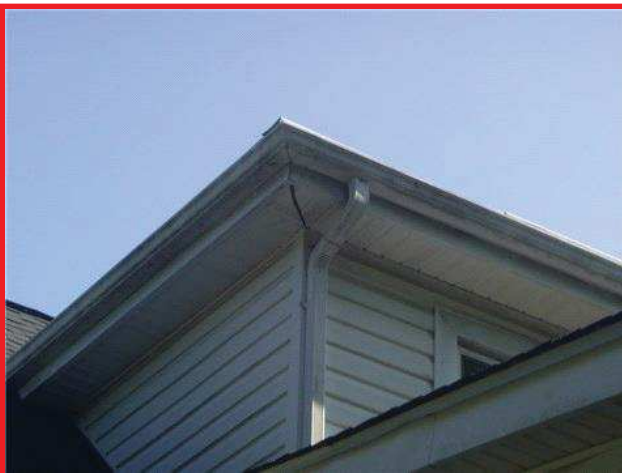
Loose Upper Soffit

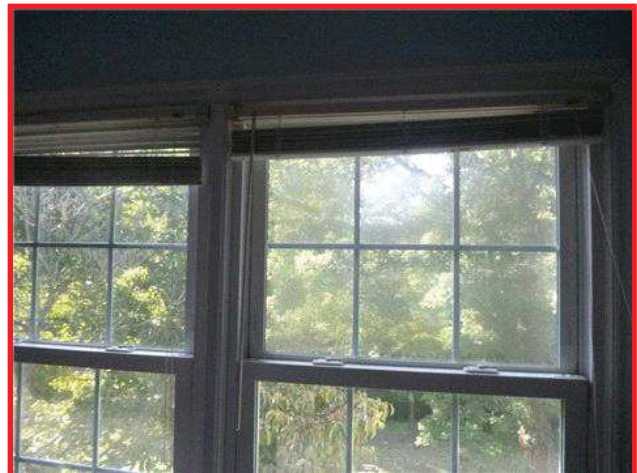
Failed Thermal Seal Window

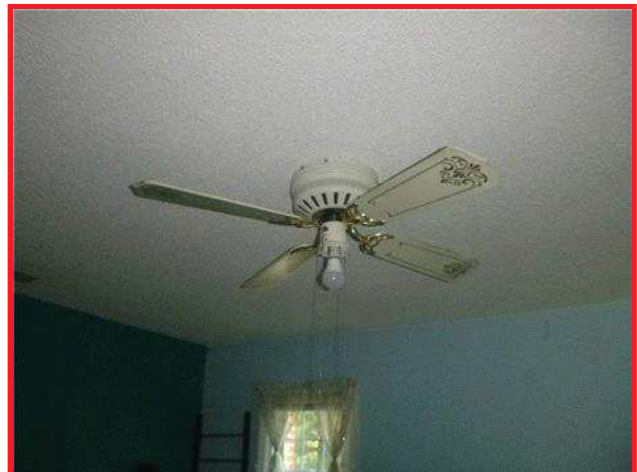
Missing Globe at Ceiling Fan Light Fixture

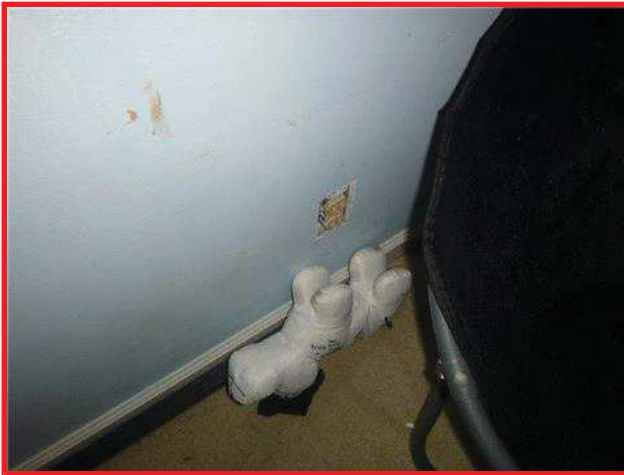
Missing Outlet Cover

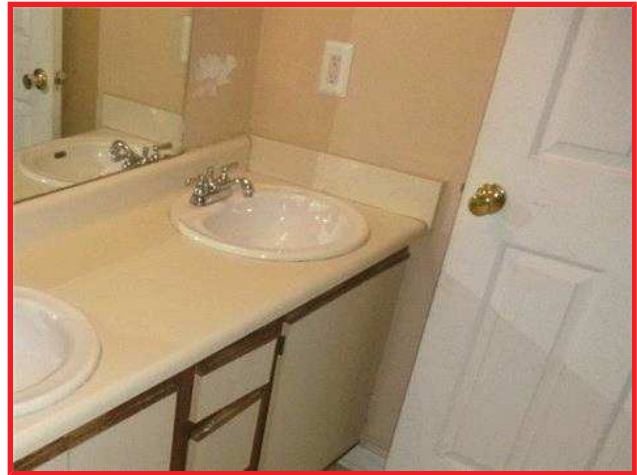
GFI Outlet Wired to Laundry Breaker

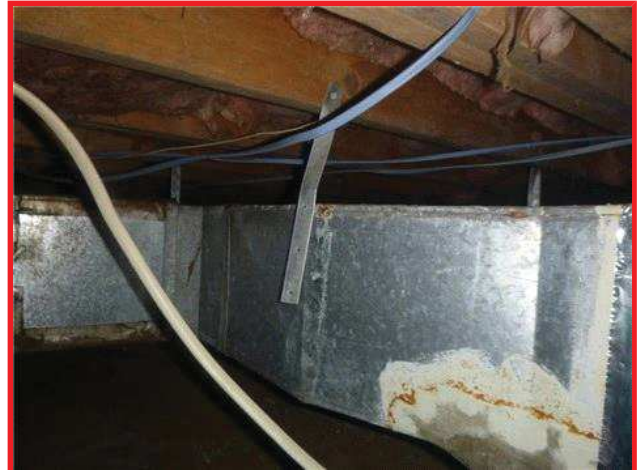
Improperly Supported Plenum

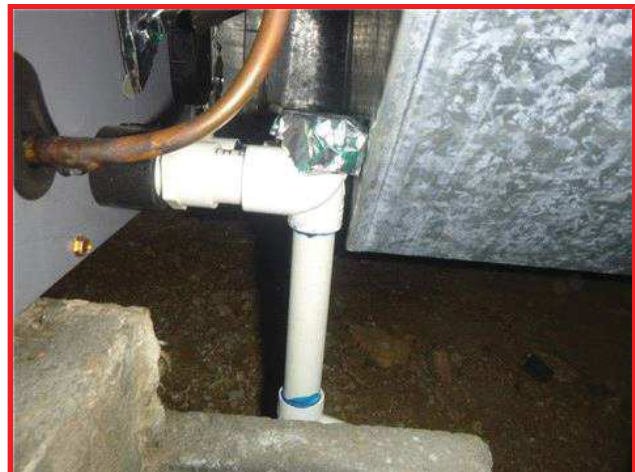
Improper / Capped Secondary Condensate Drain Line

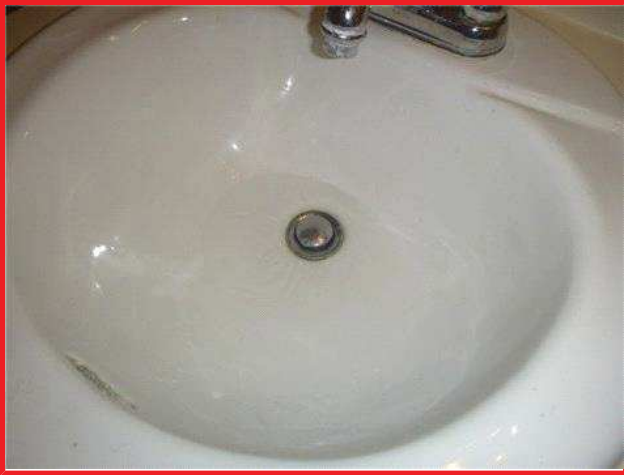
Master Bathroom Sink Drains Slowly

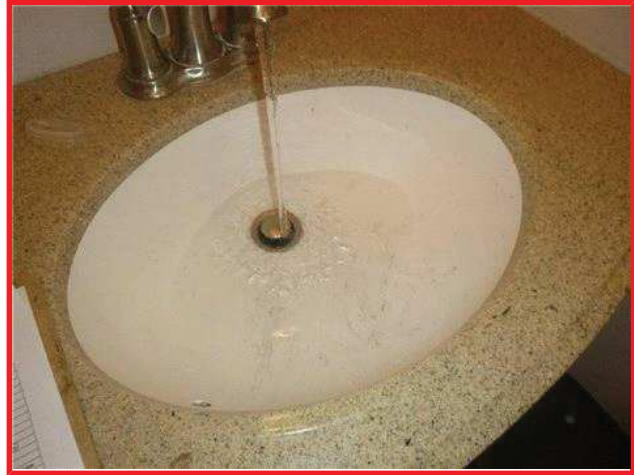
Bathroom Sink Drains Slowly

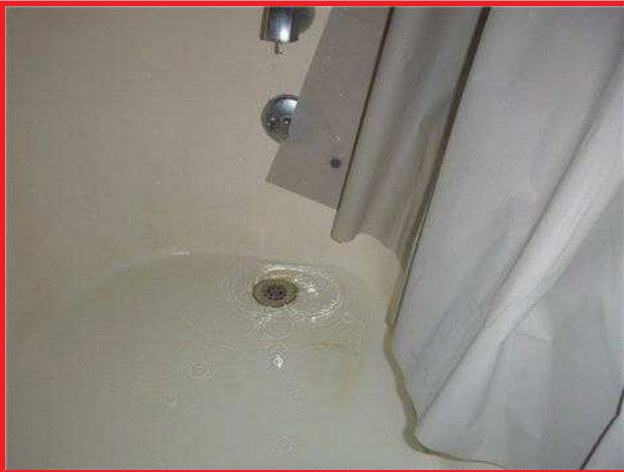
Slow Drain at Tub / Shower

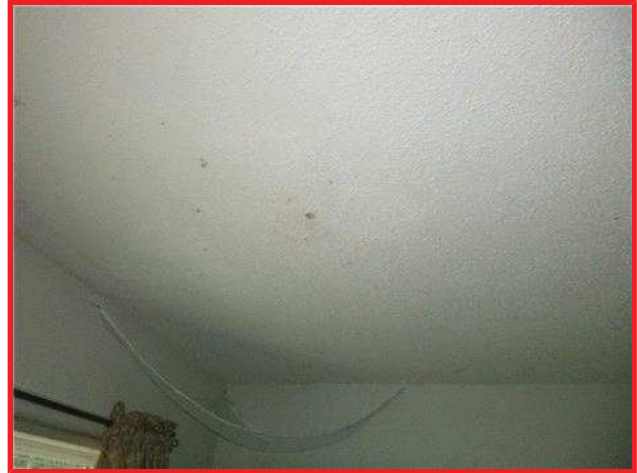
Moisture Damaged Bedroom Ceiling / Suspect Asbestos
