# Inspection Report

2557 Mint Julep Dr  
Creedmoor NC 27522

| <b>Date:</b> 5/2/2024 | <b>Time:</b> 11:30 AM | <b>Report ID:</b><br>JPmintjulep522024 |

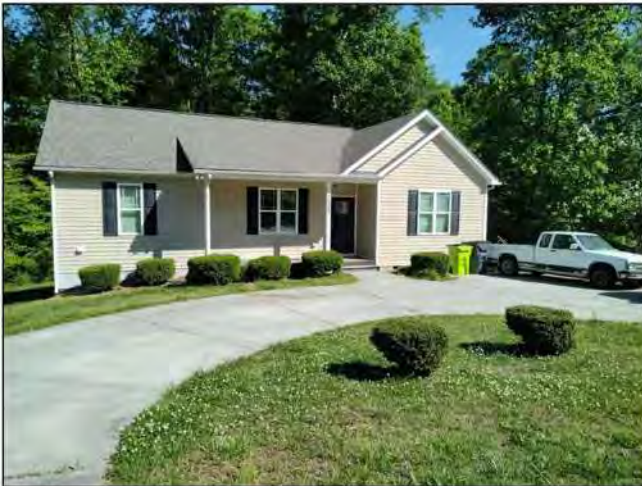
The front of the home

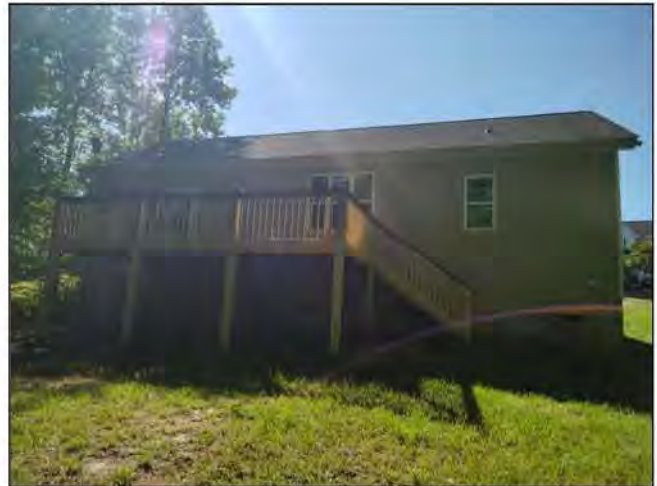
The rear of the home

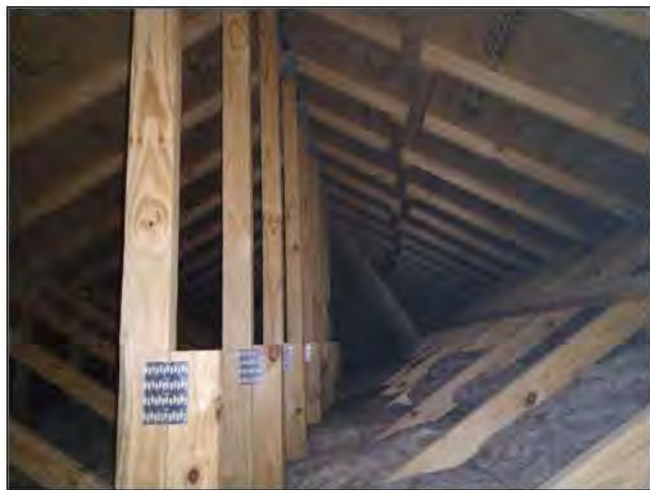
1.1 Item 1(Picture) The roof framing

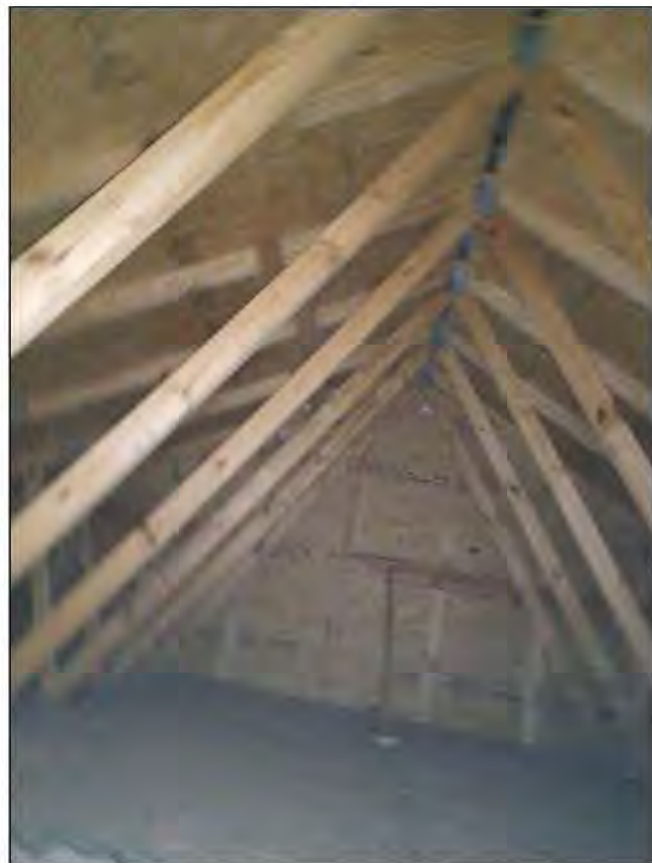
1.1 Item 2(Picture) The roof framing

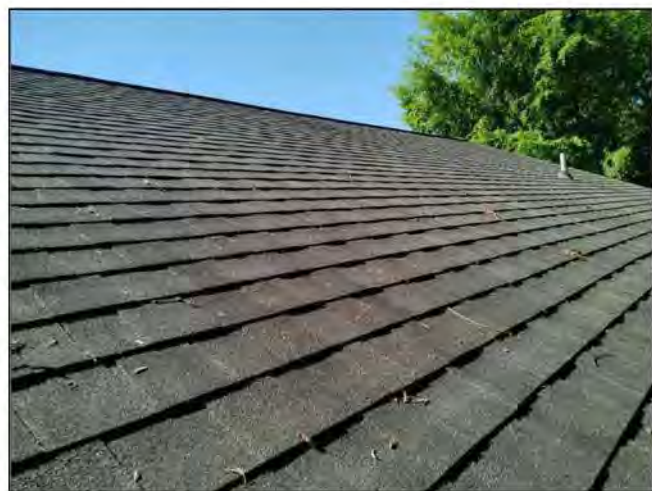
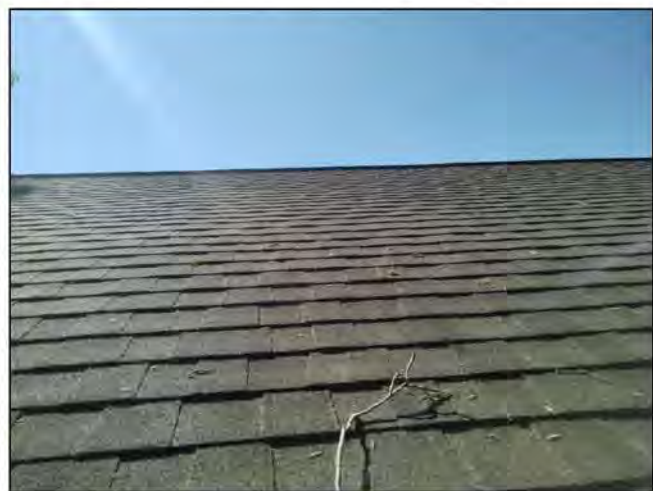
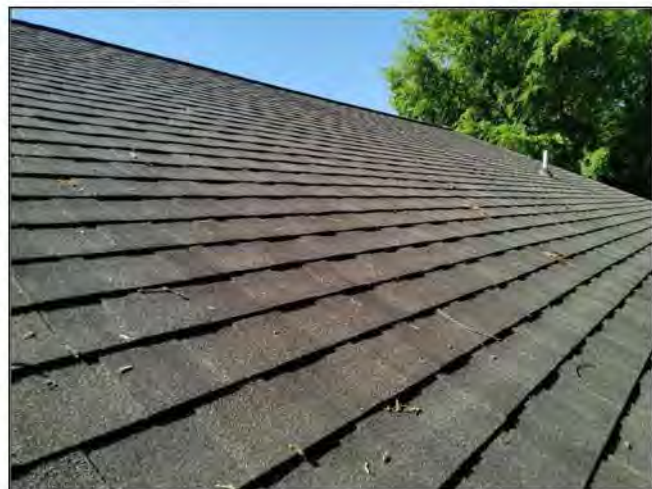
(1) Roof appears to be the original roof and would be 7 years old or the same age of the home.

2.0 Item 1(Picture) The shingles appear to be original from 2017

2.0 Item 2(Picture) Shingles appears to be original

2.0 Item 3(Picture) Shingles appears to be original

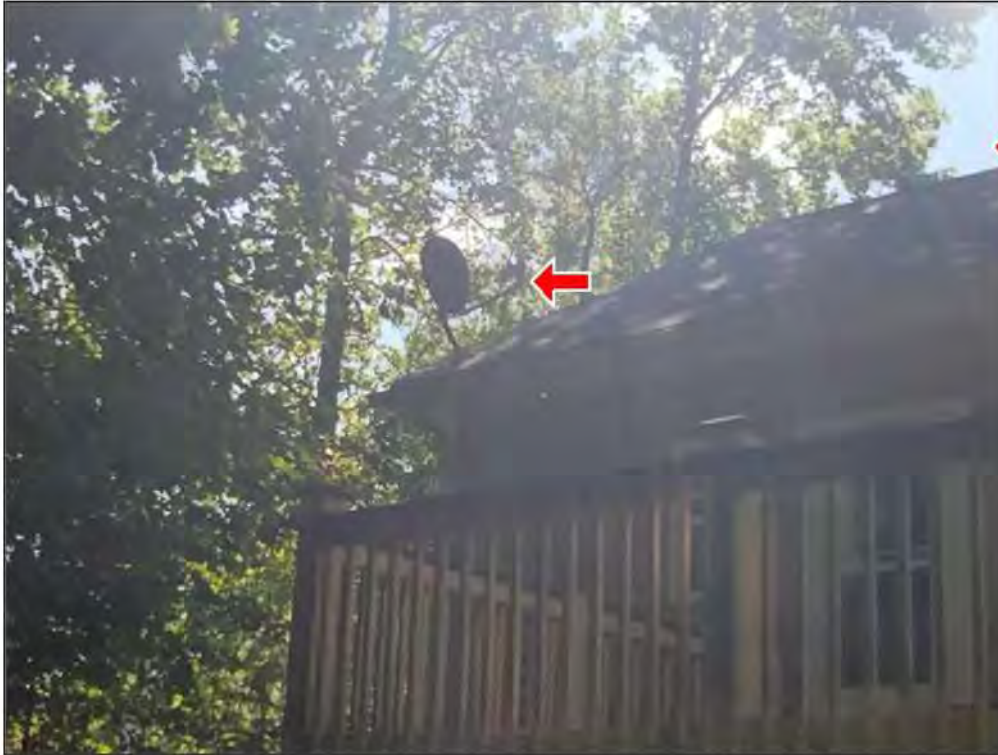
(2) A satellite frame is in place on the roof at the left rear of the home. These areas are conducive to

leaks and this frame needs to be removed, the shingles replaced in this area, and this area made functional by a qualified roofing contractor.

2.0 Item 4(Picture) Satellite frame in place on the roof coverings

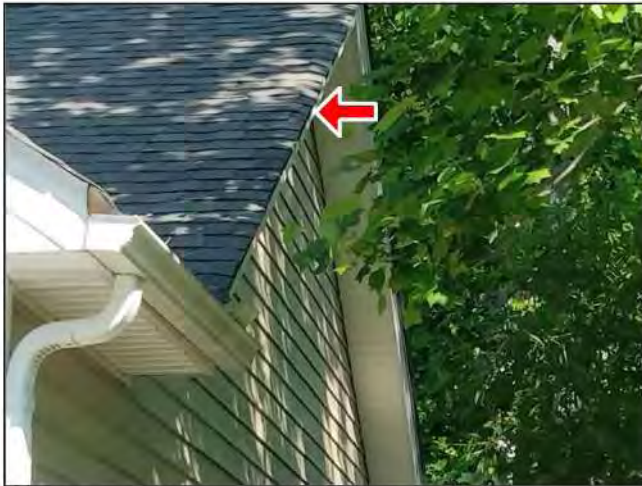
(3) The roof coverings at the right side of the home but not limited to these areas has rips, tears, and damaged areas and this roof and roof coverings needs to be evaluated by a qualified roofing contractor and all areas made functional.

2.0 Item 5(Picture) Torn shingle notes

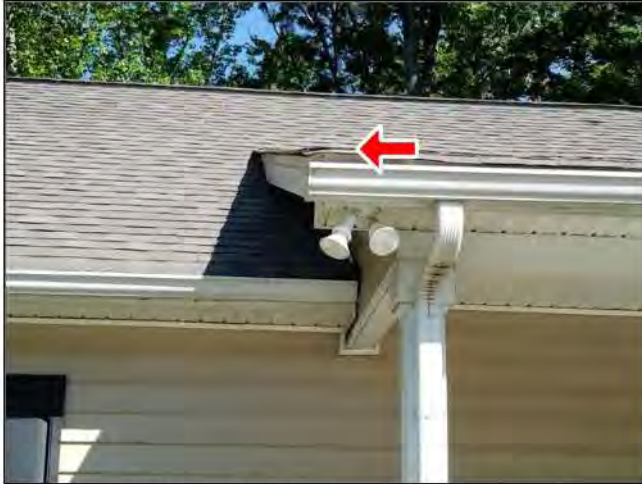
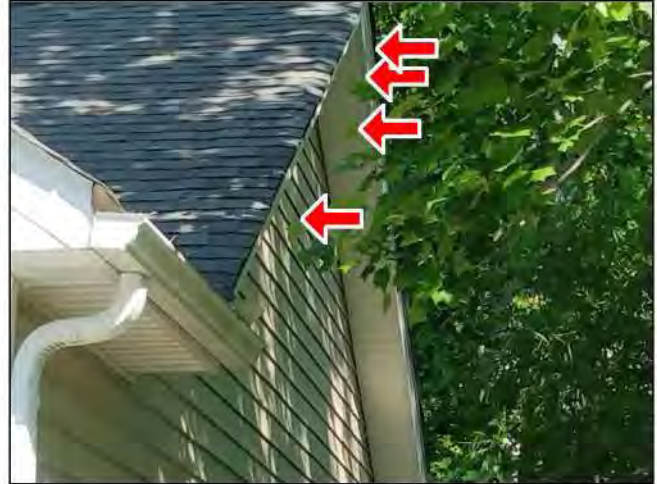
(4) The shingles at the ends over the drip edges are hanging over several inches and are bent down. This can cause the shingles to bend or break off and needs to be installed with maximum 3/8" to 3/4" inch over hang per manufacturers specifications.

2.0 Item 6(Picture) Shingles are starting to bend

2.0 Item 7(Picture) Shingles are starting to bend

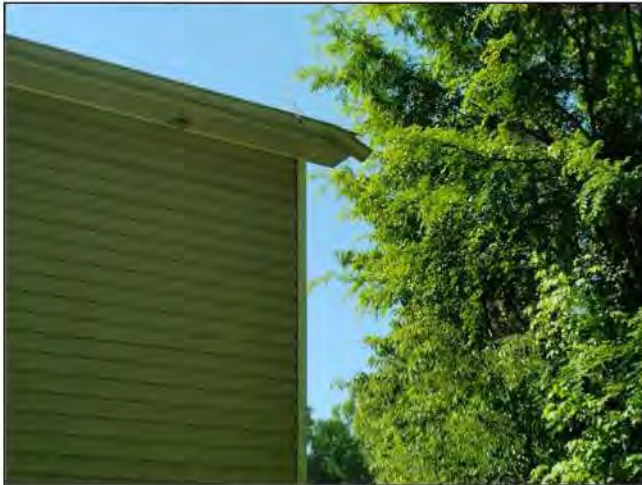
(1) The gutter across the front of the house is damaged and loose on the ends and has water improperly draining against the foundation. This can cause the fascia board to rot and or washout against the foundation. A gutter specialist should be consulted to repair or replace the gutter or fascia boards.

2.1 Item 1(Picture) Damaged gutters

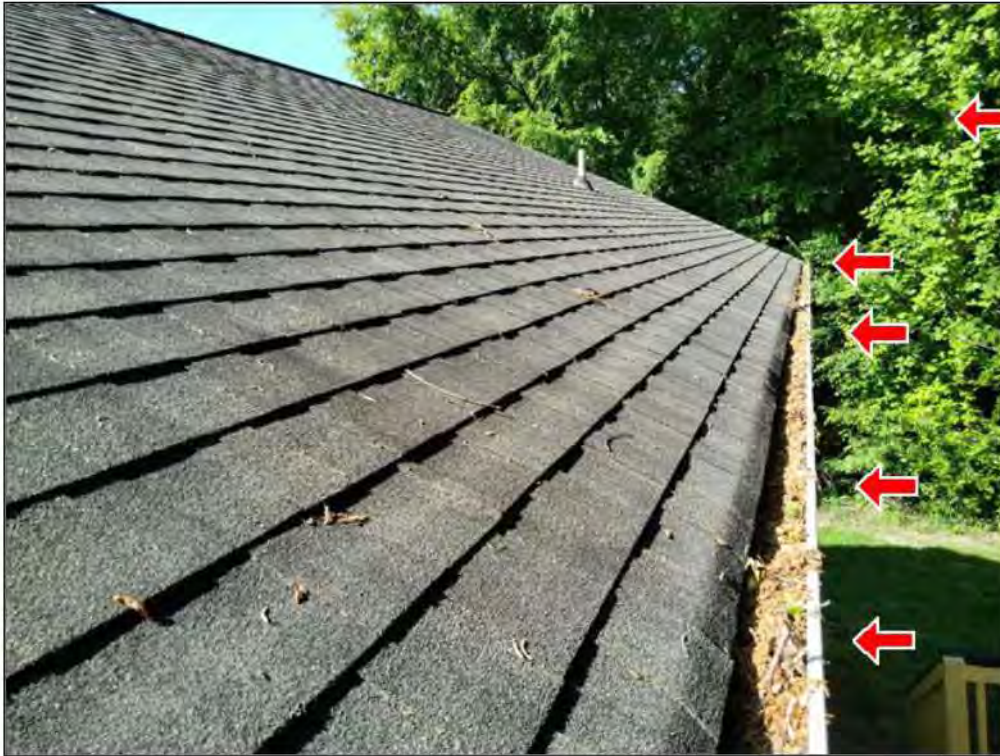
(2) The gutters are full of debris in areas and needs to be cleaned. The debris in gutters can also conceal rust, deterioration or leaks that are not visible until cleaned, and it was unable to be determined if such conditions exist.

2.1 Item 2(Picture) Gutters are full of debris

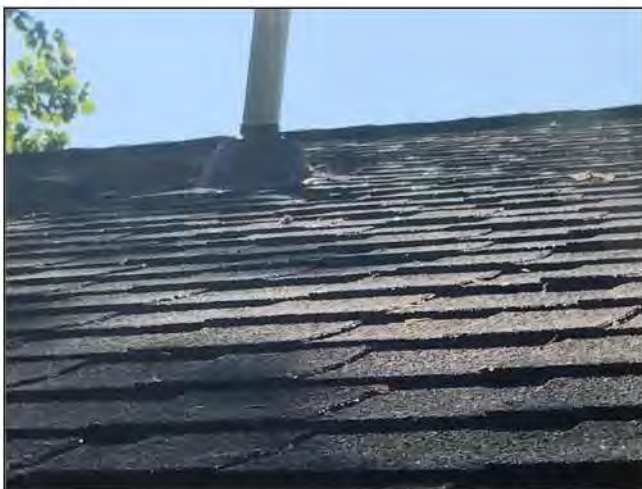
2.2 Item 1(Picture) Plumbing boots look to be functional with no signs of leaks

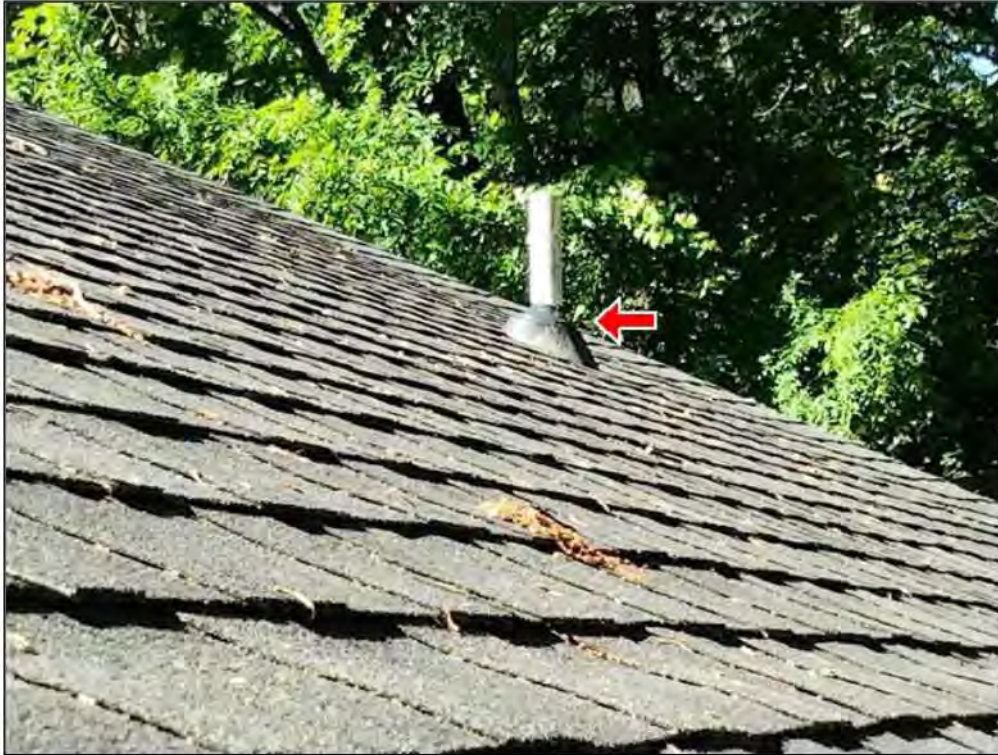
2.2 Item 2(Picture) Plumbing boots look to be functional with no signs of leaks

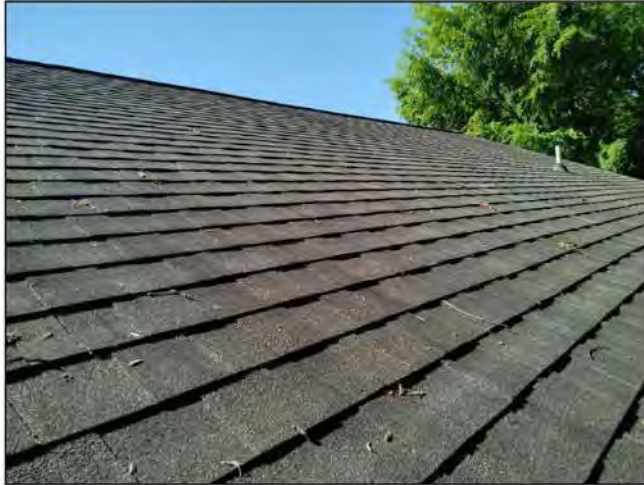
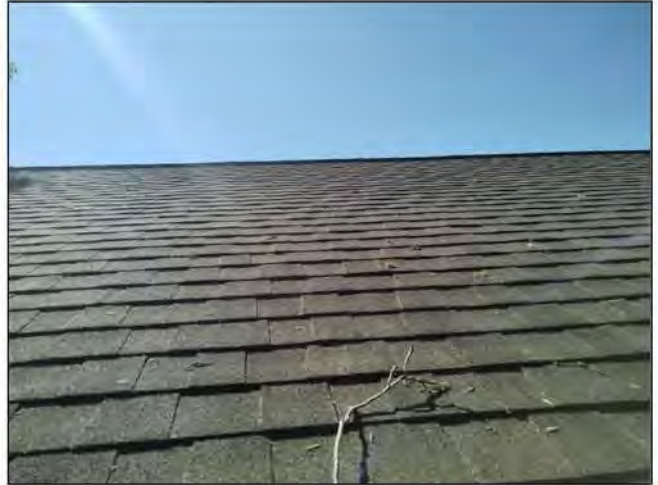
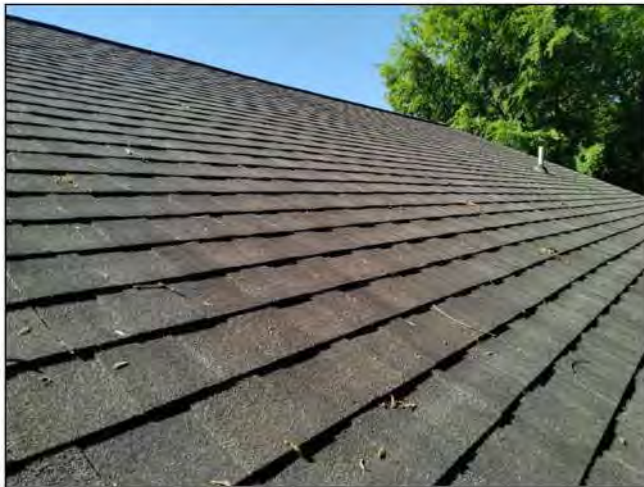
(1) Roof appears to be the original roof and would be 7 years old or the same age of the home.

2.0 Item 1(Picture) The shingles appear to be original from 2017

2.0 Item 2(Picture) Shingles appears to be original

2.0 Item 3(Picture) Shingles appears to be original

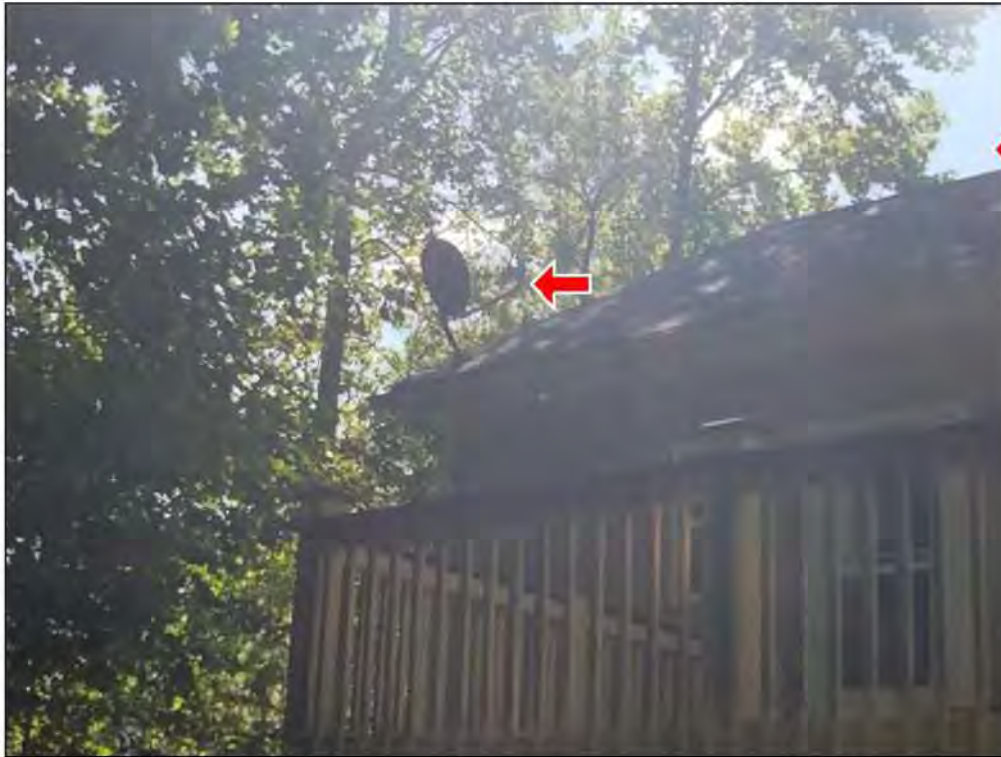
(2) A satellite frame is in place on the roof at the left rear of the home. These areas are conducive to leaks and this frame needs to be removed, the shingles replaced in this area, and this area made functional by a qualified roofing contractor.

2.0 Item 4(Picture) Satellite frame in place on the roof coverings

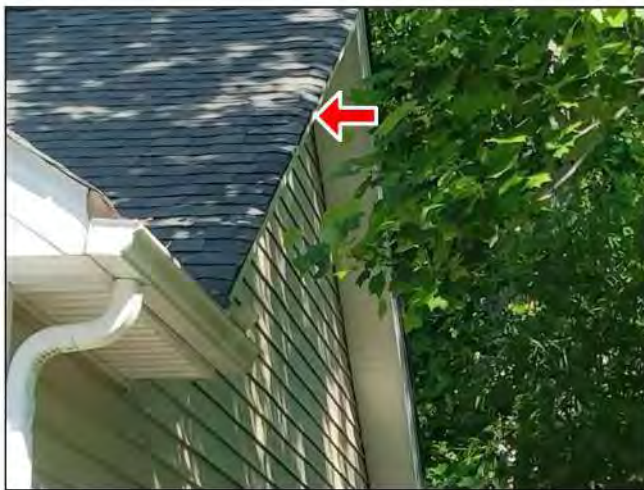
(3) The roof coverings at the right side of the home but not limited to these areas has rips, tears, and damaged areas and this roof and roof coverings needs to be evaluated by a qualified roofing contractor and all areas made functional.

2.0 Item 5(Picture) Torn shingle notes

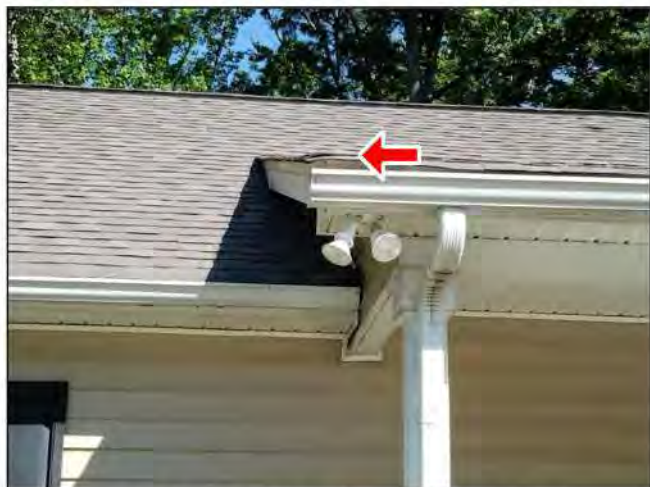
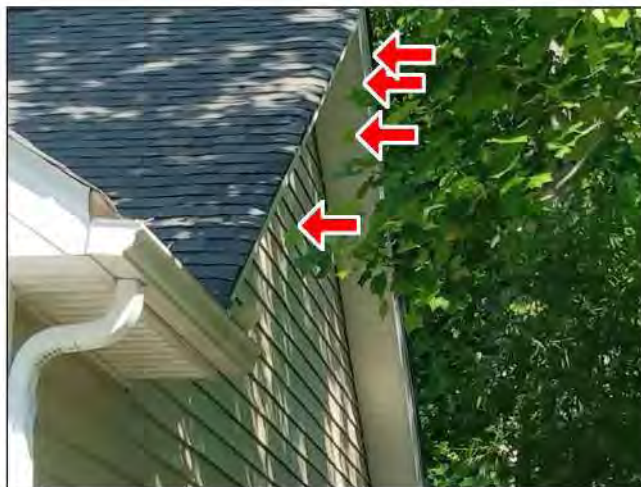
(4) The shingles at the ends over the drip edges are hanging over several inches and are bent down. This can cause the shingles to bend or break off and needs to be installed with maximum 3/8" to 3/4" inch over hang per manufacturers specifications.

2.0 Item 6(Picture) Shingles are starting to bend

2.0 Item 7(Picture) Shingles are starting to bend

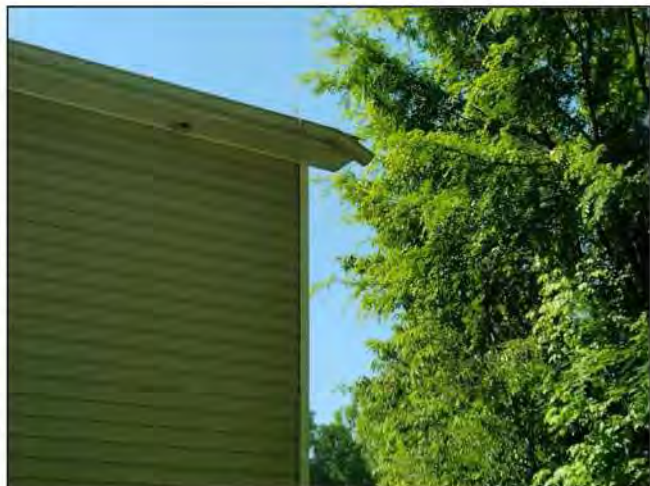
(1) The gutter across the front of the house is damaged and loose on the ends and has water improperly draining against the foundation. This can cause the fascia board to rot and or washout against the foundation. A gutter specialist should be consulted to repair or replace the gutter or fascia boards.

2.1 Item 1(Picture) Damaged gutters

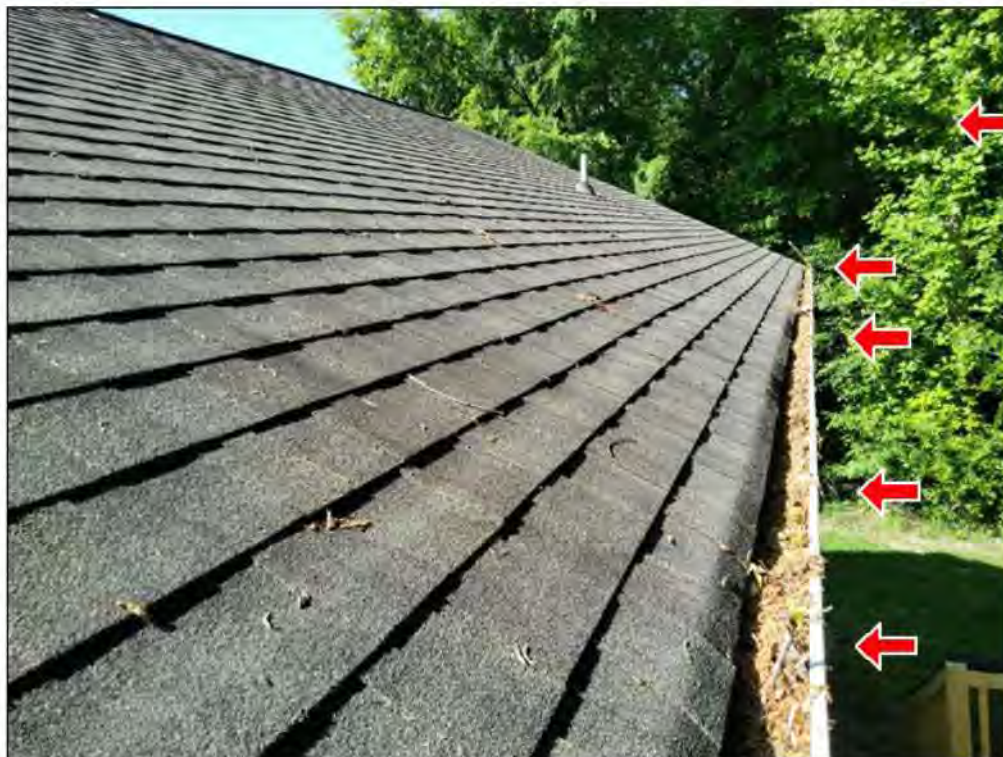
(2) The gutters are full of debris in areas and needs to be cleaned. The debris in gutters can also conceal rust, deterioration or leaks that are not visible until cleaned, and it was unable to be determined if such conditions exist.

2.1 Item 2(Picture) Gutters are full of debris
