1036 Butterfly Circle  
Wake Forest NC 27587

2/16/2022

Floor 2 Ceiling Home Inspections LLC DBA HouseMaster  
5524 Sapphire Springs Drive  
Knightdale, NC 27545  
919-803-7977

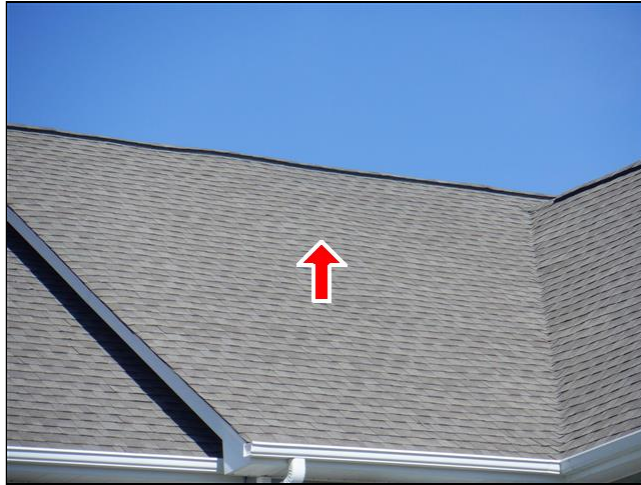
1.0 (1) Lifted shingles noted at the front side of the roof. This is conducive to damage from weather and water intrusion at the roofing elements. Recommend to have a qualified contractor repair as directed.

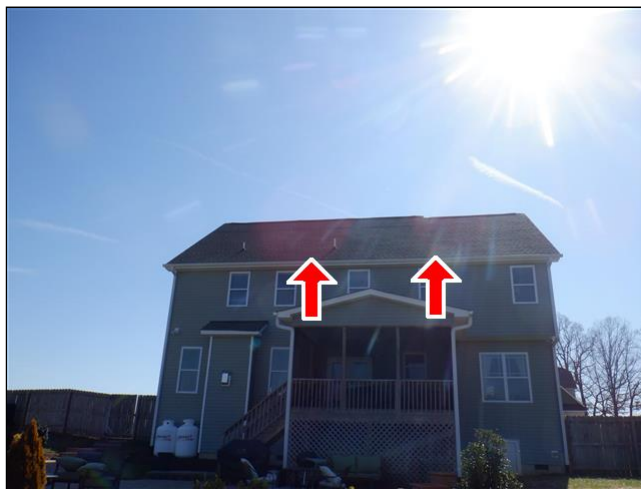
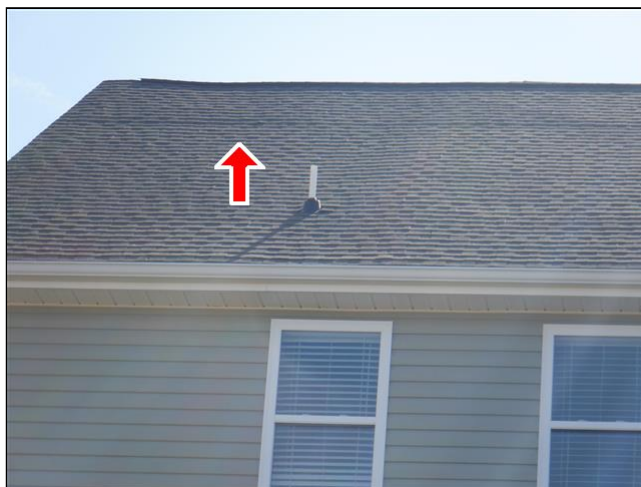
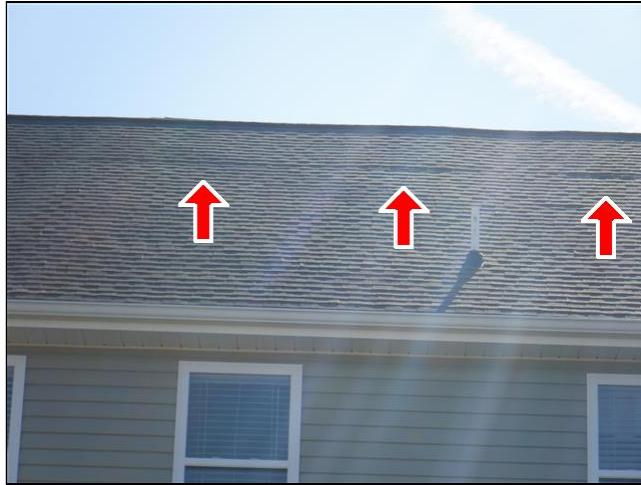
1.0 (2) Loose/missing shingles noted at the back side of the house. This is conducive to water intrusion that will damage the adjacent elements. Recommend to have a qualified contractor repair/replace as directed.

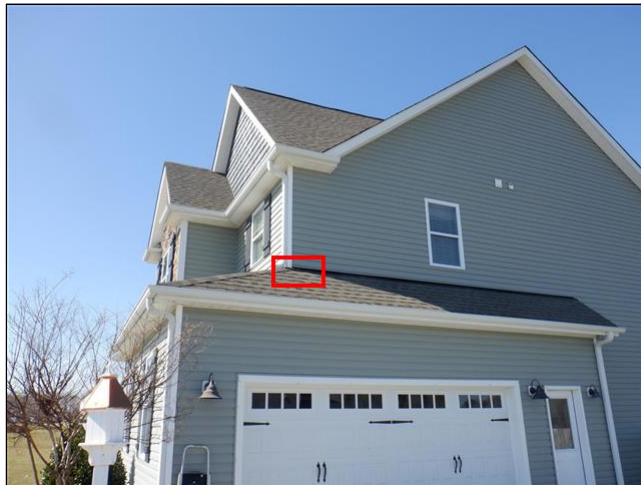
1.2 (Picture 1)

Lifted flashing/nail noted on the right and back side of the house. This is conducive to damage from weather and water intrusion at the roofing elements. Recommend to have a qualified contractor repair/replace as directed.

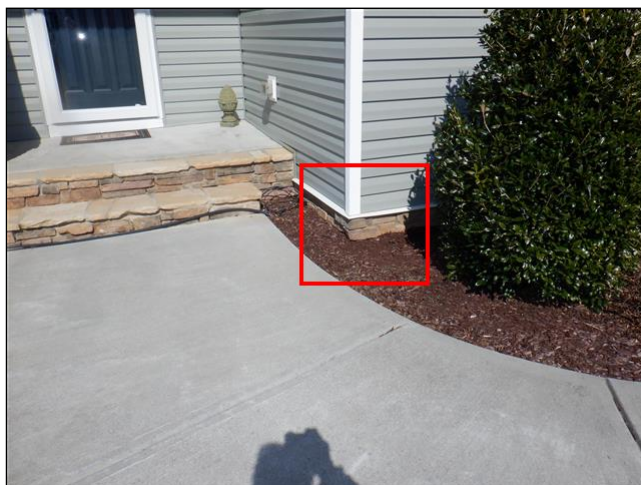
2.0 (Picture 1)

Improper clearances were not maintained between stone cladding and the ground and/or paved surfaces to prevent wicking and frost heave problems. Recommend to have a qualified contractor evaluate and repair as directed.

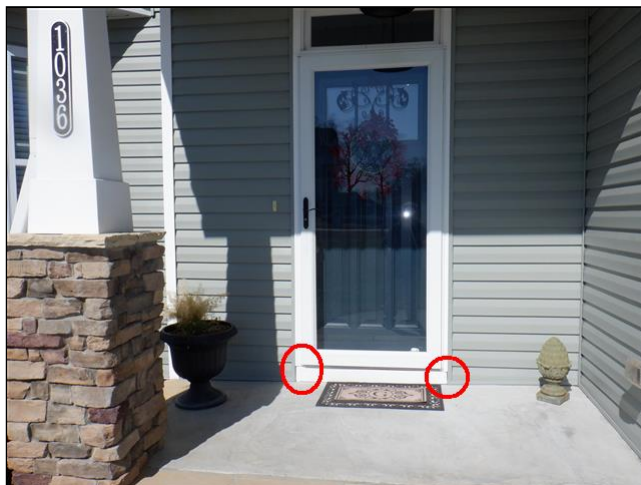
2.4 (2) In Need of Repair: Missing caulking at door trim at front side of the home. Conditions are conducive to water intrusion behind siding, which will damage adjacent elements. Recommend to seal/caulk.

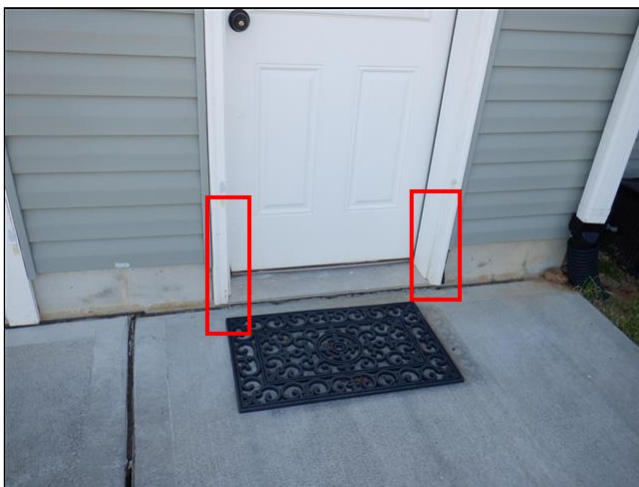
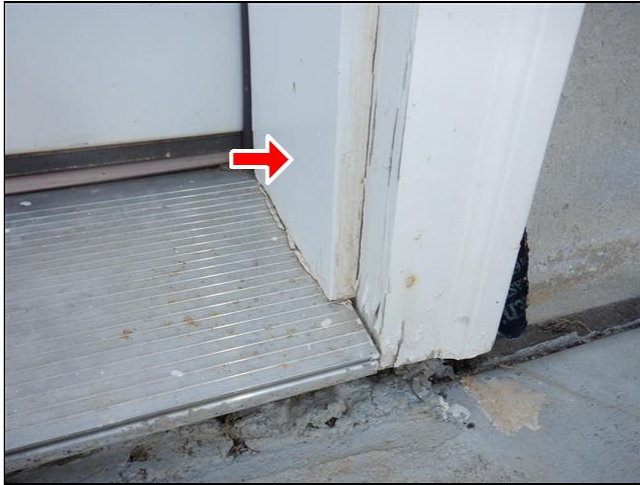
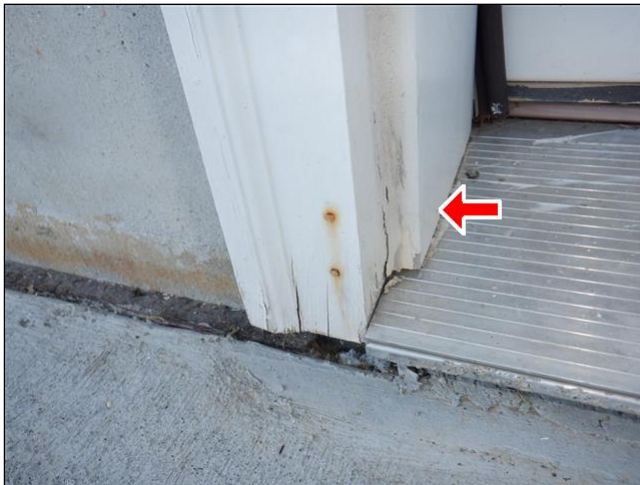
2.4 (3) Raw wood exposed at garage door at exterior. Recommend painting to protect elements and prevent water/moisture intrusion and rot/decay.

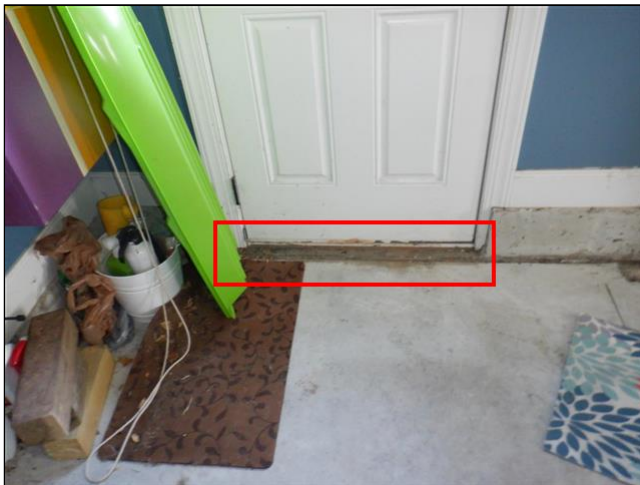
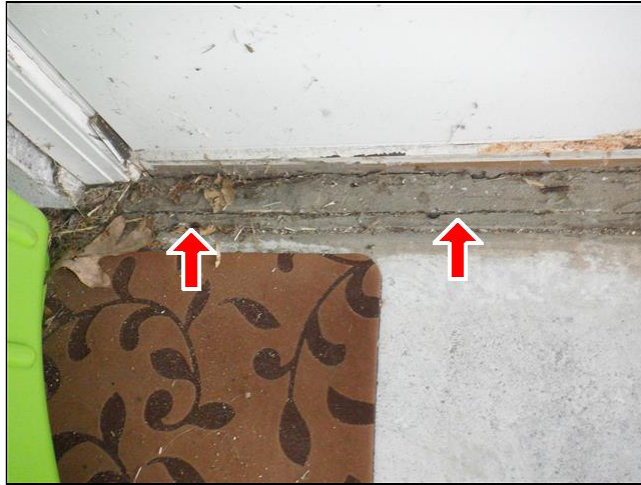
2.4 (4) Cracked mortar at garage door. Recommend caulk/seal due to water intrusion concerns.

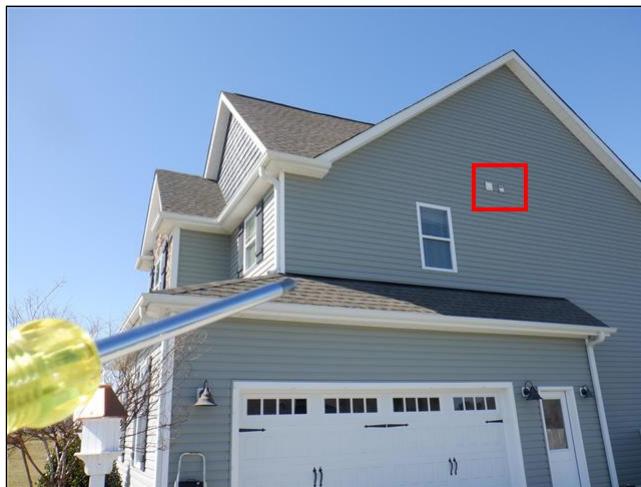
2.7 (Picture 1)

Damaged vent cover at right side of home. This is conducive to water intrusion at the wall cavity and adjacent areas. Recommend a qualified contractor repair/replace as directed.

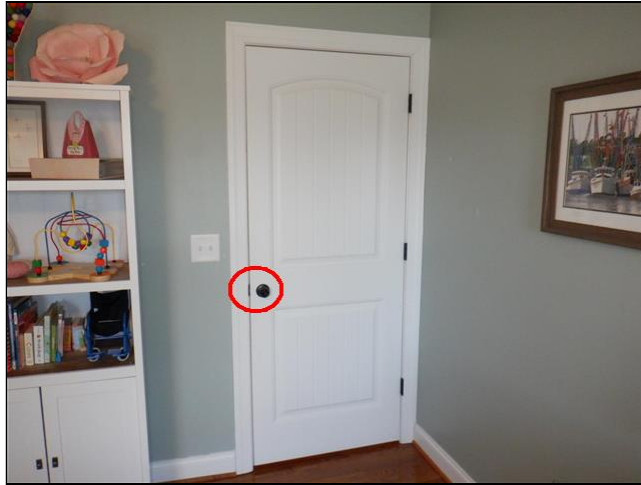
6.6 (3) Door does not engage strike plate at right rear bedroom. Recommend repair/adjustment to ensure the door closes properly.

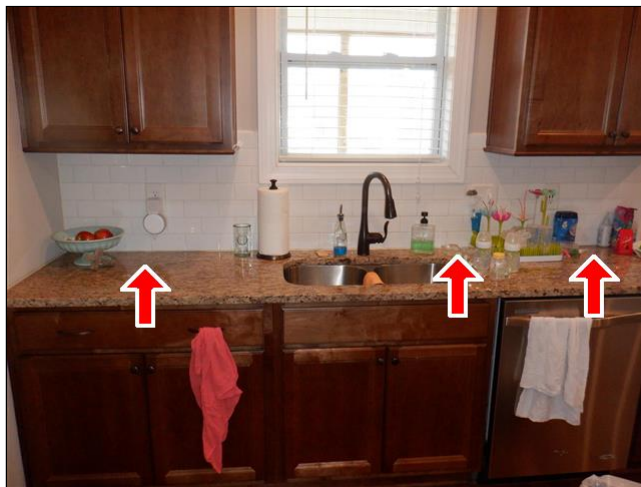
7.6 (Picture 1)

Loose/missing caulking/grout at back splash/countertop. This is conducive to water penetration at the cabinetry and the adjacent elements. Recommend to seal/caulk to prevent water damage

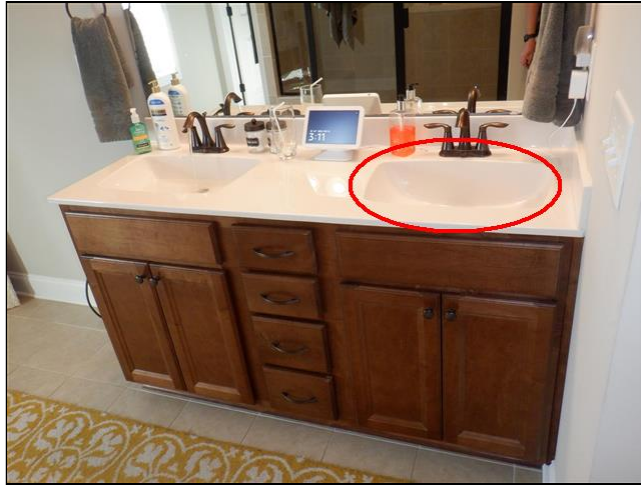
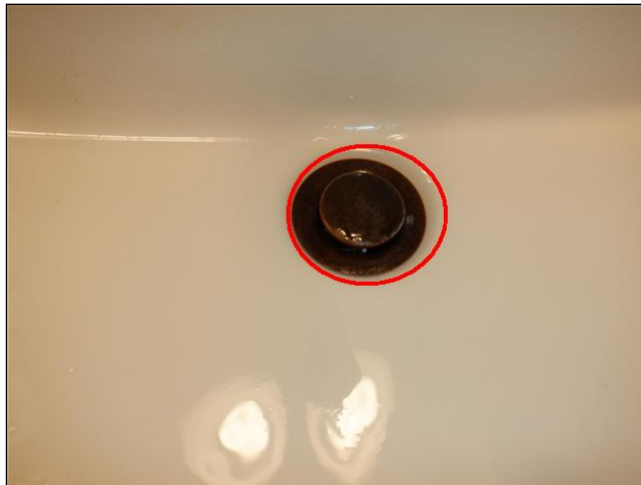
8.0 (1) Drain stoppers did not function properly at the master bathroom. Recommend to repair/replace as directed to ensure the sink basin will hold water.

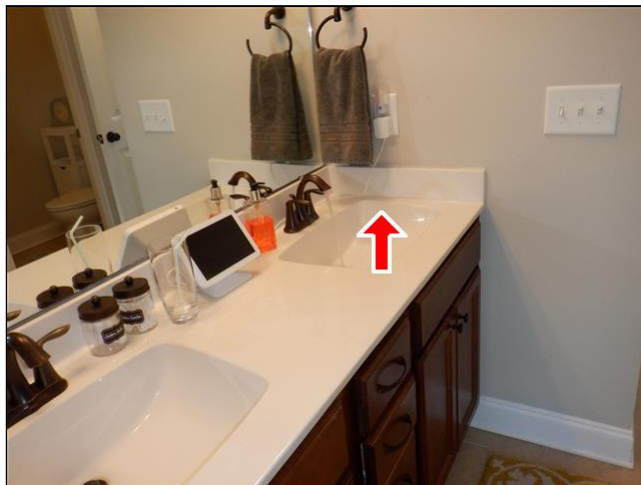
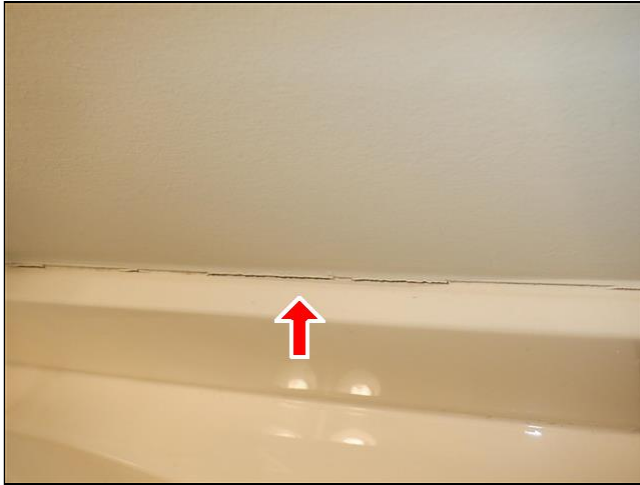
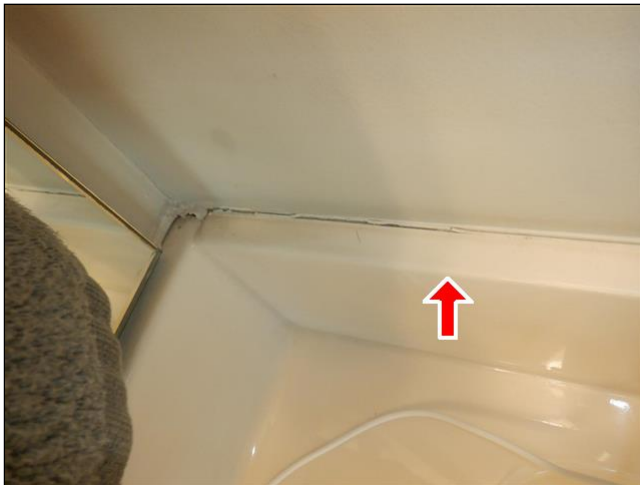
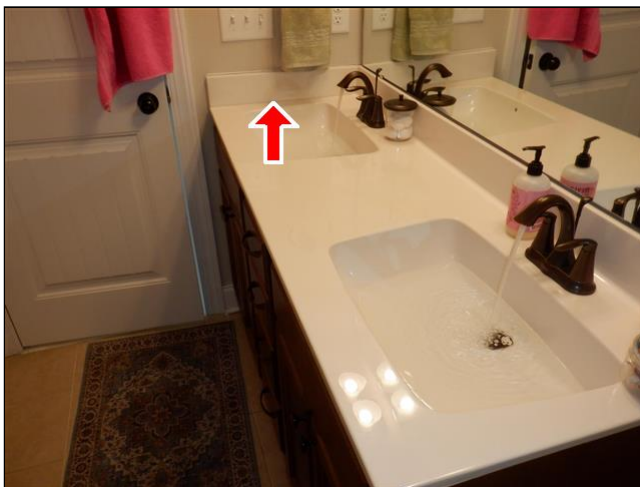
8.0 (2) Loose/missing caulking/grout at back splash/countertop at the master bathroom. This is conducive to water penetration/damage to cabinetry and adjacent elements. Recommend to seal/caulk to prevent water damage.

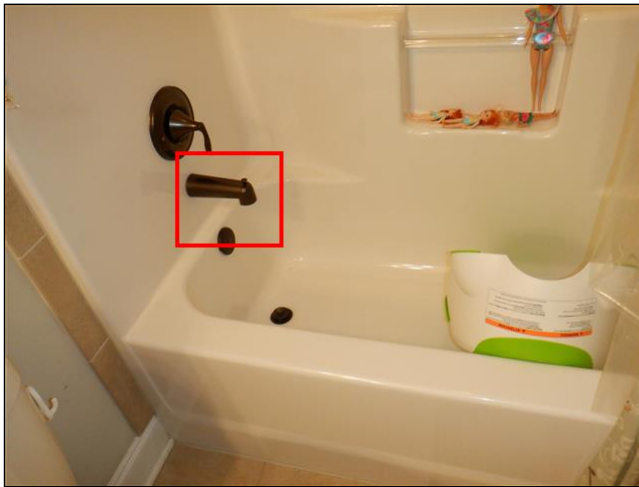
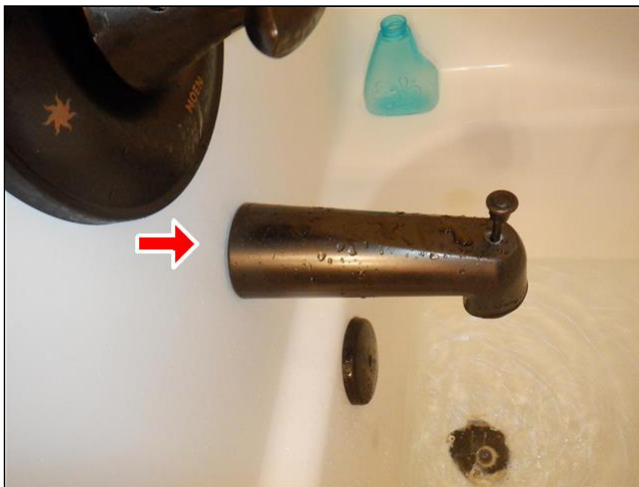
upper level hall bathtub

8.1 (1) Loose spout at wall surround at upper level hall bathtub. Condition is conducive to water intrusion into wall cavity. Recommend repair/caulking as needed.

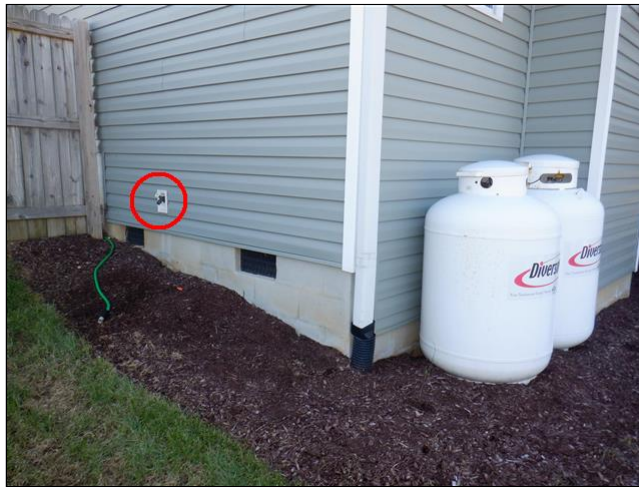
11.5 (Picture 1)

Hose bib has leakage past stem/packing at the right spigot. Full volume of water should be through spigot. Leakage may result in water penetration and/or damage and does not function as intended. Recommend repair by qualified plumber.

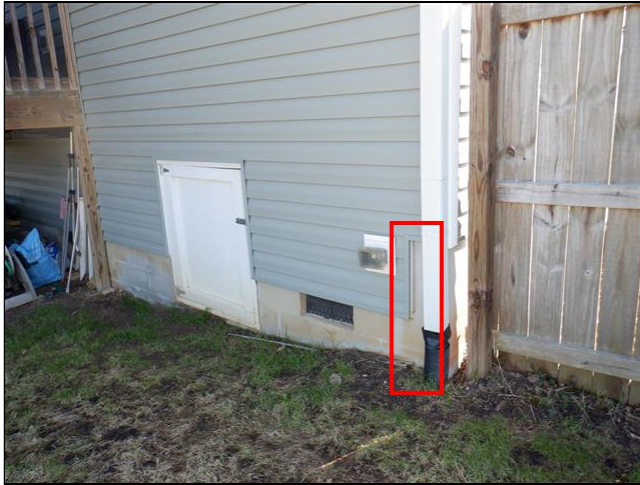
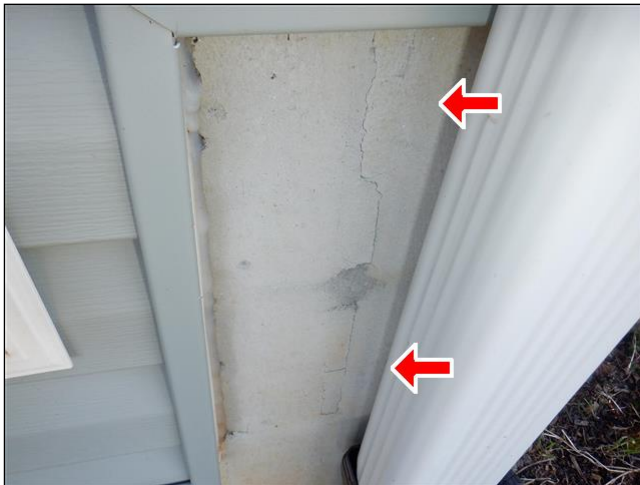
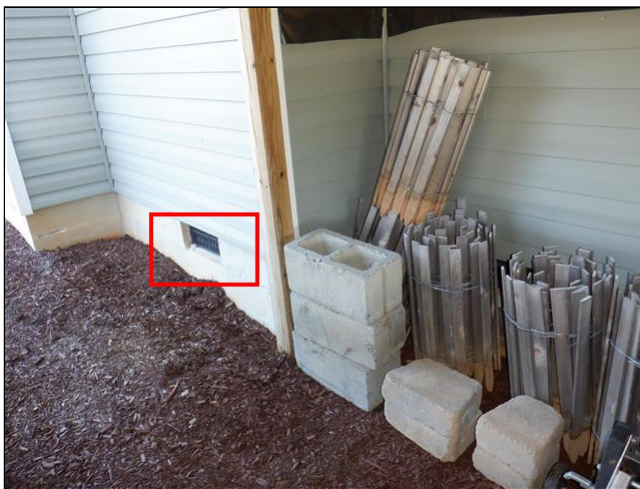
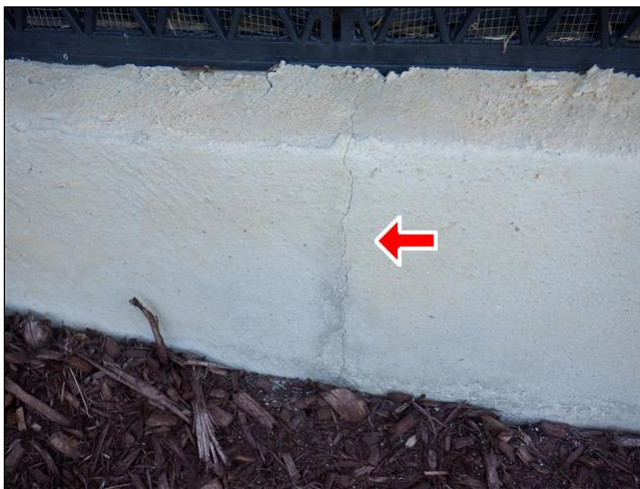
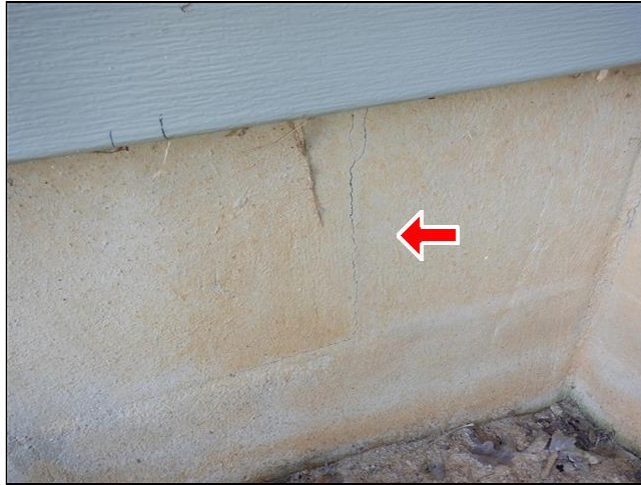
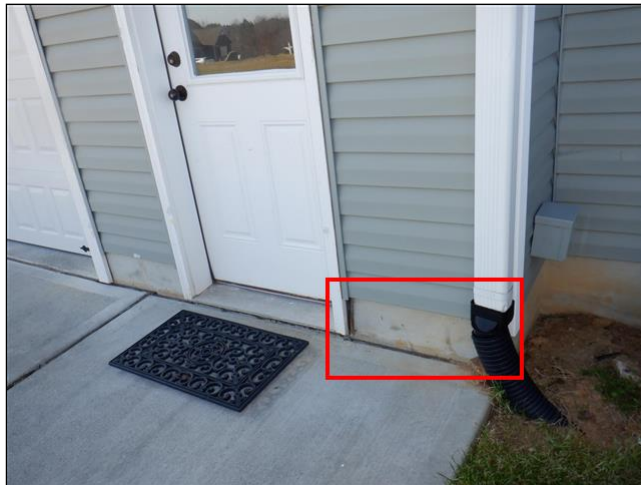
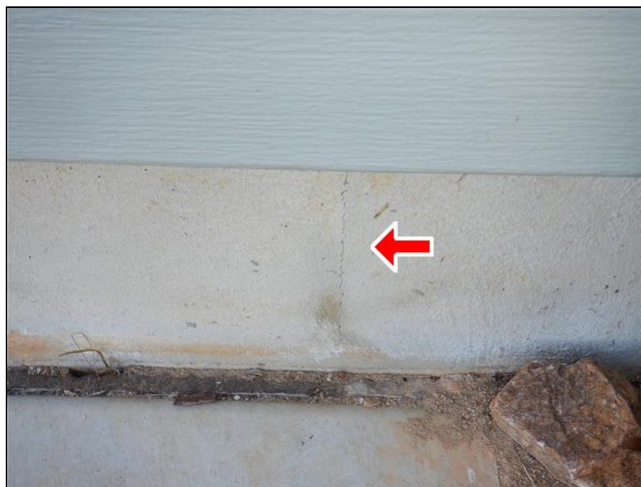
13.0 (1) Cracking noted at the left back and right side of foundation walls. Condition is conducive to possible stress/settlement and water intrusion. Recommend caulk/seal and monitor in the future.

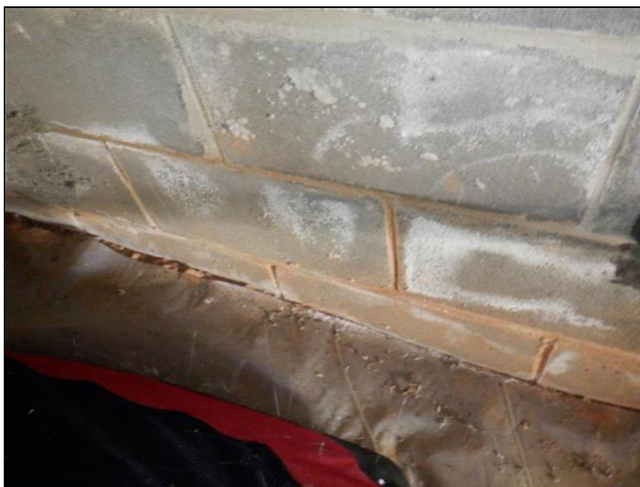
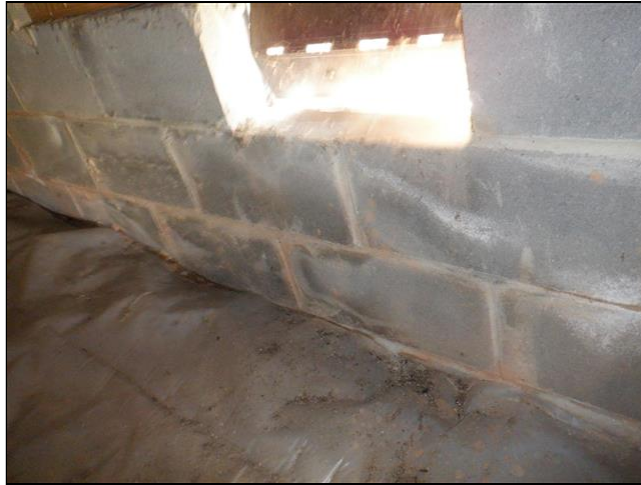
13.0 (2) White efflorescence (powder substance) on block wall indicate moisture is in contact with masonry. This does not necessarily mean that intrusion will occur. Recommend checking gutters, downspout drain lines for proper operation. Efflorescence is found on many homes without water intrusion occurring inside the home. But, it should alert you to the possibility that future steps may be needed.

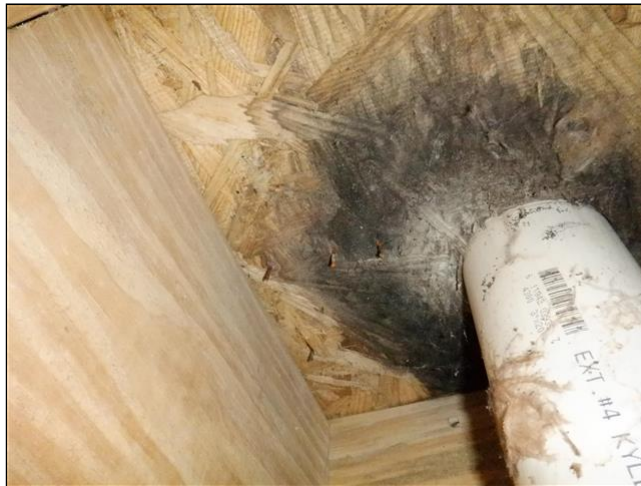
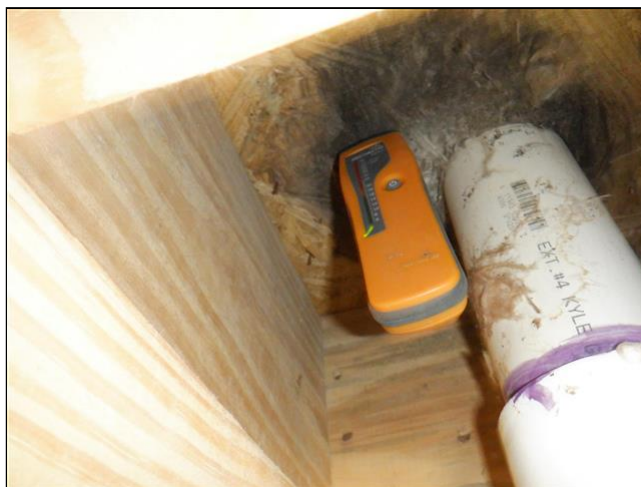
13.0 (3) Possible active leak noted under the main level hall bath area in the crawlspace. No moisture detected with moisture meter, however the insulation was wet at time of inspection. Recommend to have a qualified plumber evaluate to determine the source of the water and repair as directed.

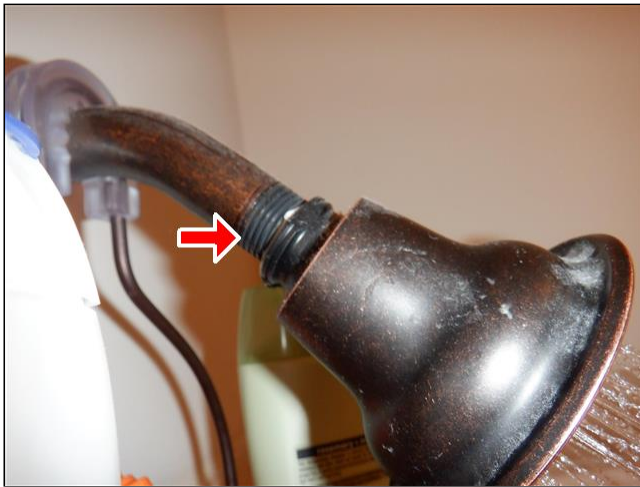
8.1(2) BATHTUB (Picture 2)

8.1 (2) Leakage observe at shower head device in upper level hall bath. Full volume of water should be through shower head. Also note that if conditions worsen, water may spray onto wall surfaces causing damage. Recommend Repair

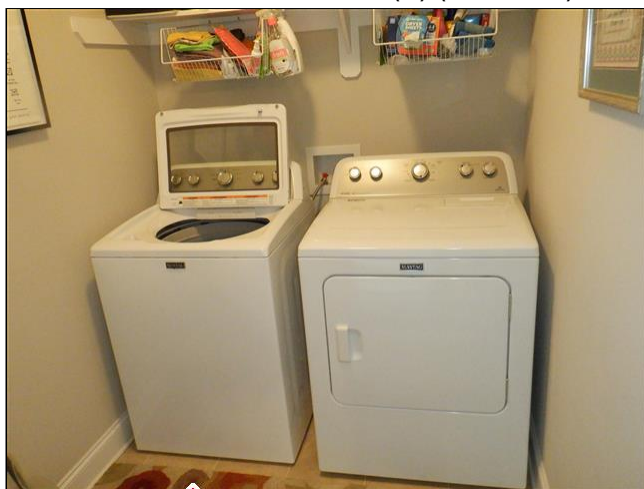
11.7 Washer / Dryer (Picture 1)

Recommend repair/replacement: Washer emergency drain pan missing at laundry area. Unit is recommended to prevent water spillage at upper level floor.

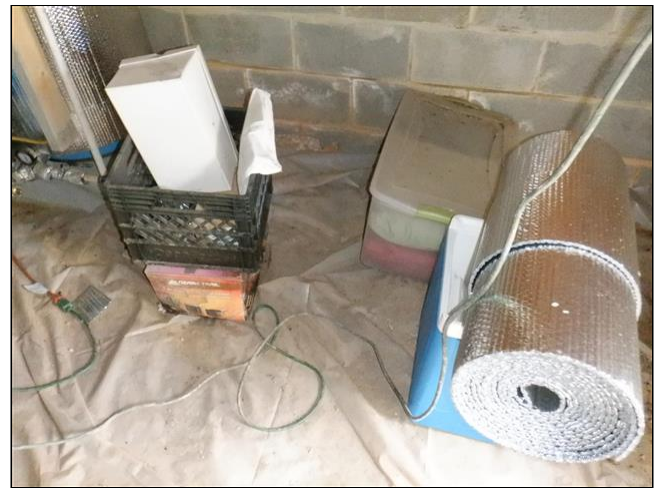
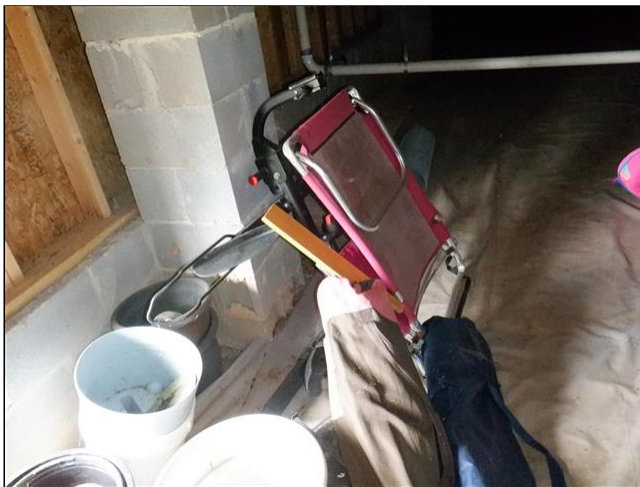
Wood/construction debris/vegetation/cellulose materials and/or storage materials are observed in subgrade areas near or on soil. This attracts undesirable insects and possible causes moisture concerns. Recommend properly removing and disposing to minimize adverse concerns prior to closing.
