**GILES FLYTHE**  
ENGINEERS

April 23, 2024

Re: Limited Structural Inspection  
1188 Turner Road  
Creedmoor, NC

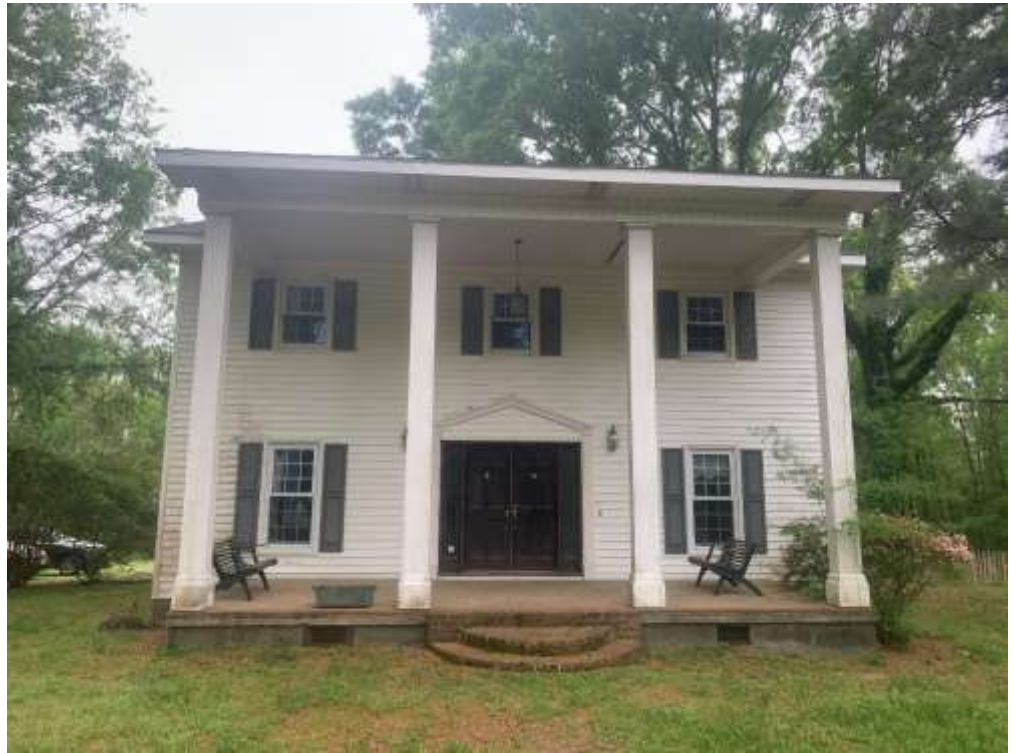
Photo No.  
1

Front elevation of  
the home.

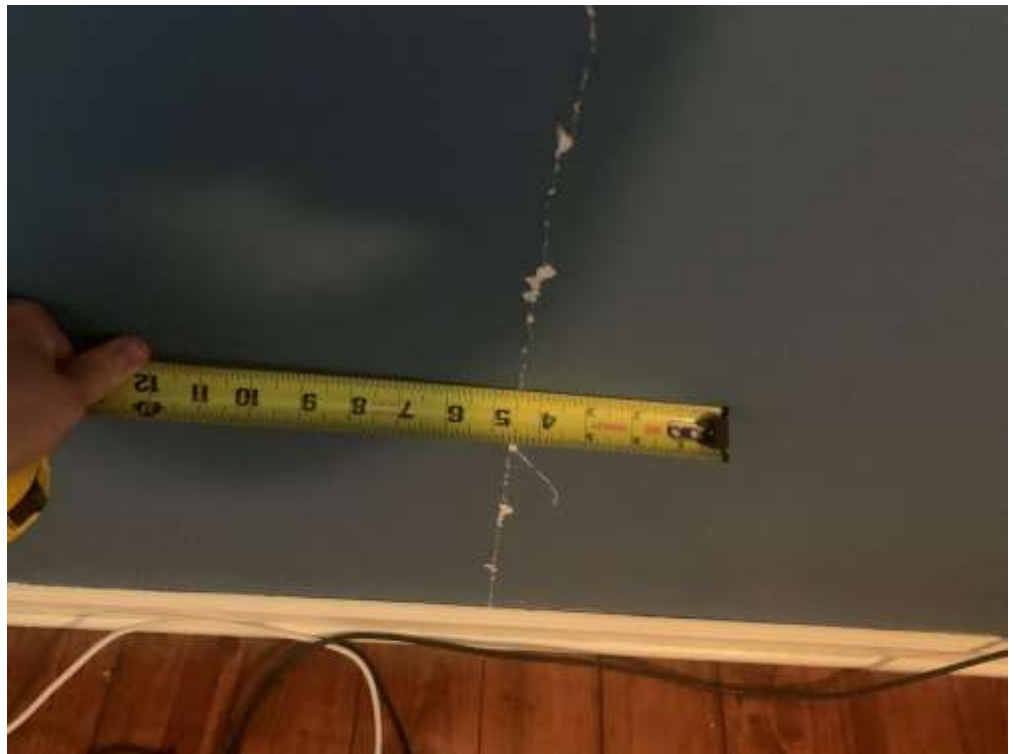
Photo No.  
2

The interior drywall cracks and interior movement noted above (Observations #1-3) are likely the result of a combination of the supporting members contracting/deflecting and differential foundation settlement discussed above. Minor drywall cracking and finish carpentry separations are typically associated with changes in weather, temperature, and humidity causing wood to shrink and swell with the seasons. When moisture is taken away from wood it has a tendency to contract thus resulting in deflection (or sagging). Any walls, windows or doors bearing on the deflected members will also move. As discussed above, we have provided a recommendation below to stabilize the foundation at isolated locations.

Typical view of a  
crack in the drywall  
finish materials.

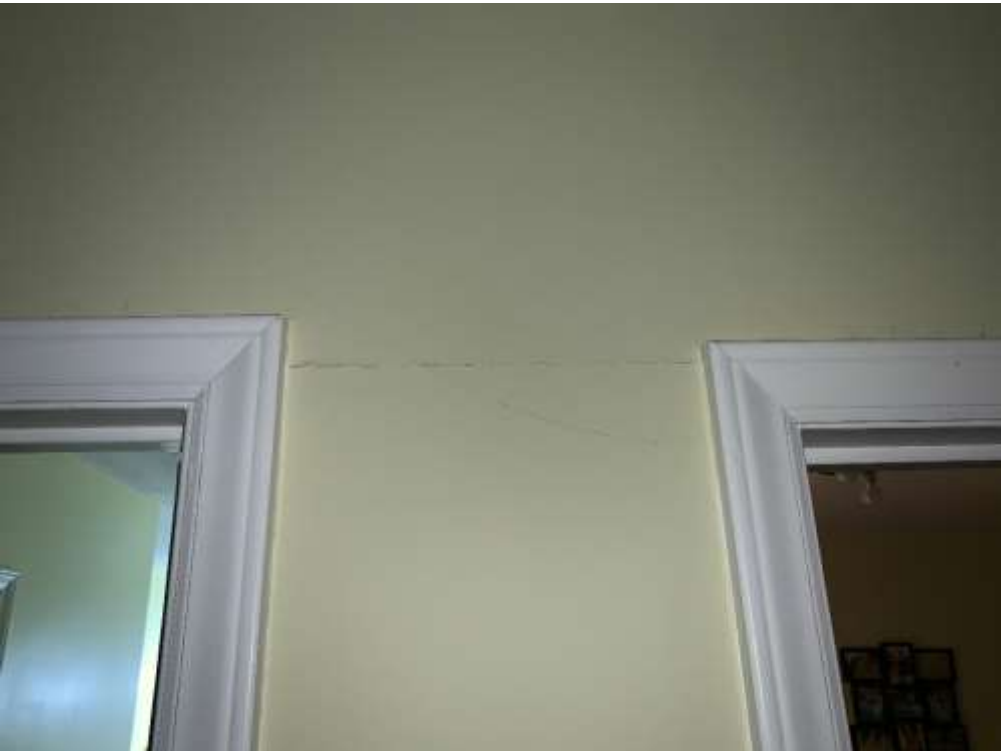
| <p><b>Photo No.</b><br/>3</p> | |

| <p><b>Description</b></p> <p>Typical view of a crack in the drywall finish materials.</p> | |

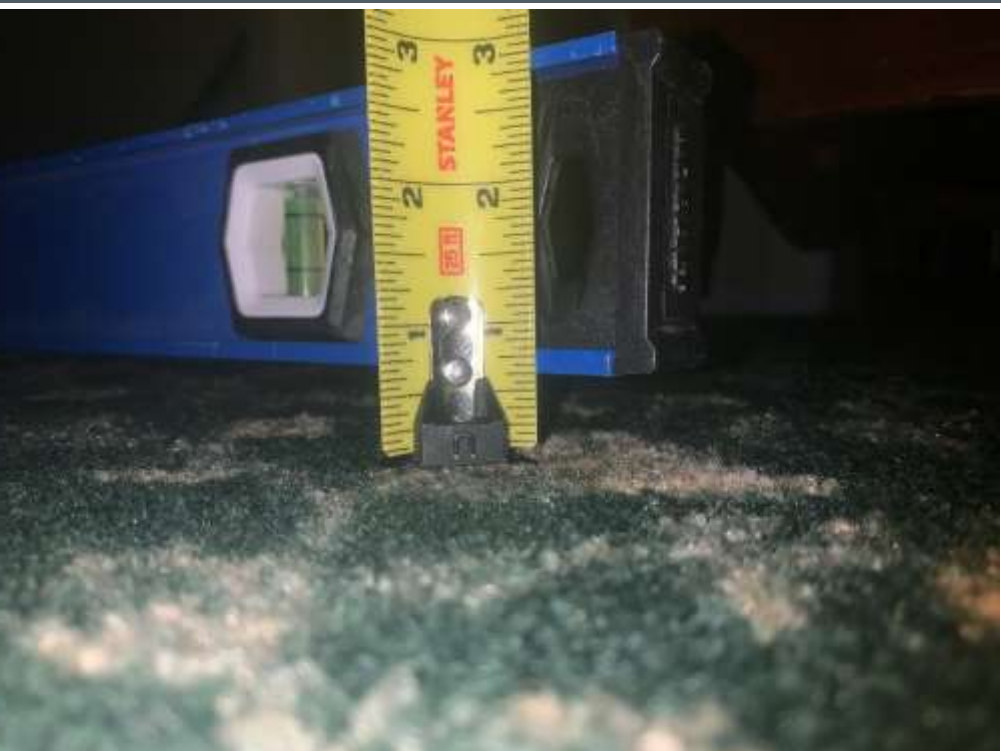
| <p><b>Photo No.</b><br/>4</p> | |

The crown in the floor and areas of sloped floors noted above (Observation #4) are likely the result of deflection in the floor framing below. Deflection of supporting members can occur with sustained loads. The floor framing supports the weight of the interior furnishings and walls. Deflection of the floor framing will be greater in areas with sustained loads than areas with movable (live) loads. Additionally, crowns in the floor can occur over girders/beams and walls below. The girders/beams and walls would provide more strength and less deflection than the adjacent floor joists, which can cause a high point in the floor. Due to finish materials installed above and below the locations of sloped floors on the second and third levels of the home, visual inspection of the floor framing was not feasible. Removal of finish materials will be required to evaluate these locations. We have, however, provided a recommendation below to address floor slope on the first level at the rear-right of the home, if desired.

| <p><b>Description</b></p> <p>Typical view of floor slope throughout the home.</p> | |

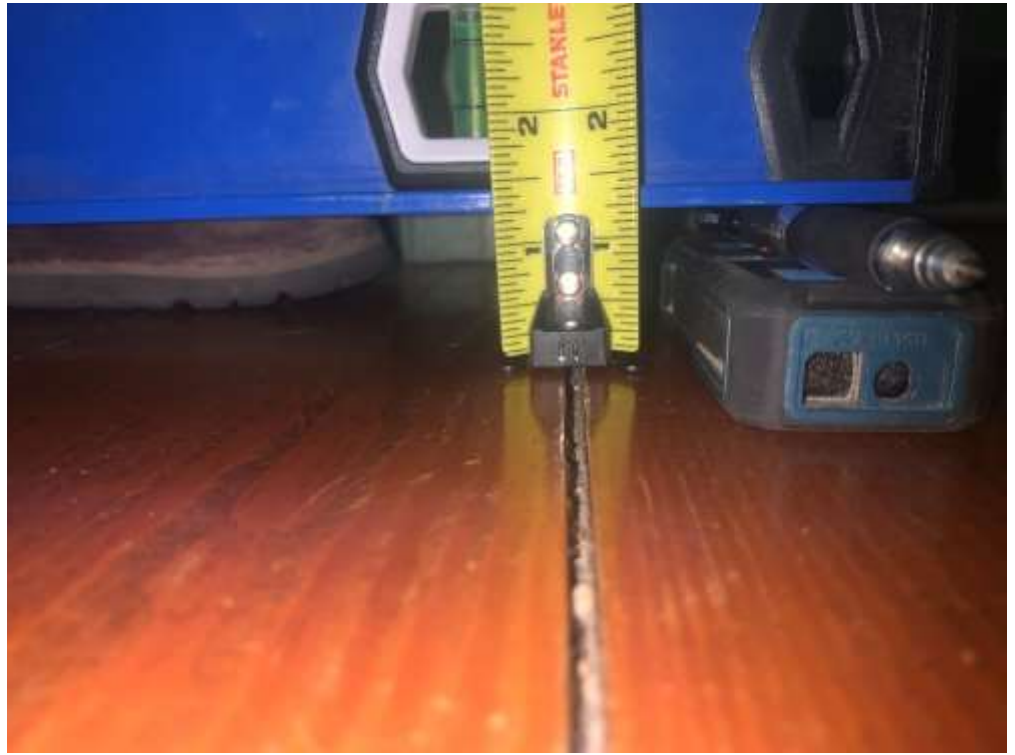
Photo No.  
5

- e. On the first level a crown in the floor was noted spanning front to rear approximately 11'-4" from the right perimeter wall. Floor slope (up to 1-1/4" vertical over 4'-0" horizontal) was measured sloping at the right of the crown approximately 12'-0" from the rear perimeter wall.

View of floor slope  
adjacent to the  
crown on the first  
level.

4. If desired, to help alleviate floor slope, we recommend installing a new 3-2x8 drop girder at the midspan of the floor joists at the rear-right of the home. The new drop girder should be supported by mortared 8"x16" CMU block piers spaced at 6'-0" O.C. (16" cantilever allowed). The piers should bear on new 20"x20"x8"-thick concrete footings. Install flat, pressure-treated wood blocking and/or metal shims to provide full-width uniform bearing of the drop girder onto the piers below.

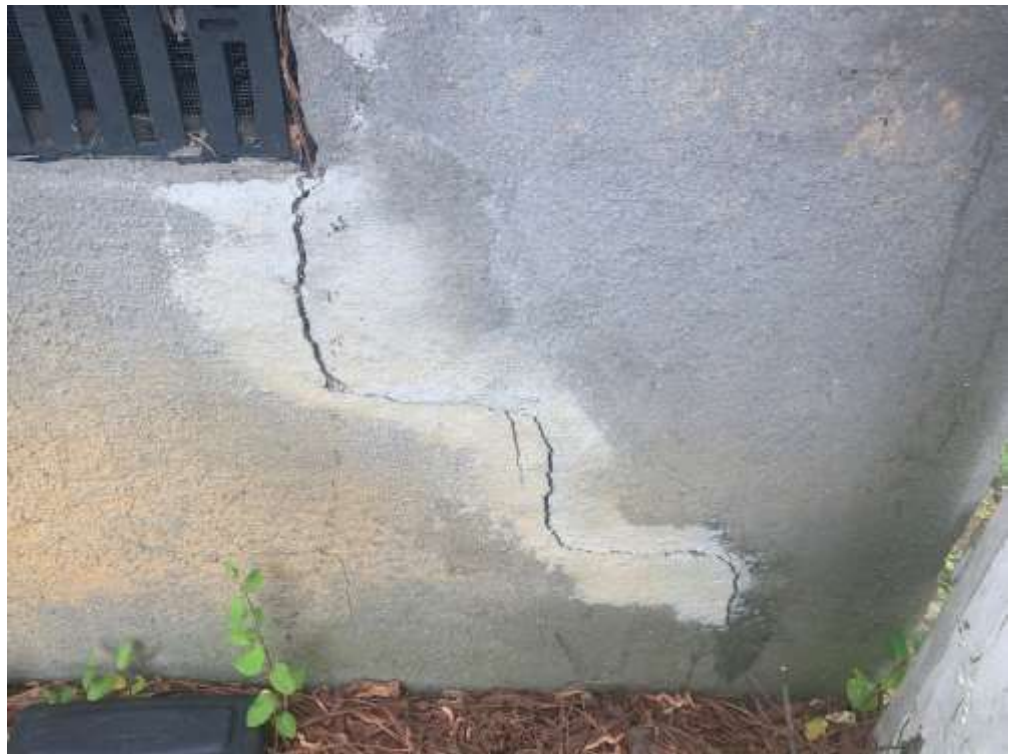
Photo No.  
6

The cracking in the parge coating in the perimeter foundation walls noted above (Observation #5) is likely the result of shrinkage and differential foundation settlement discussed above. As cement-based materials harden and dry, they typically shrink, largely due to the evaporation of excess water. This shrinkage causes a buildup of internal forces in the material, commonly resulting in minor cracking, therefore naturally alleviating the internal stresses. The parge coating is an aesthetic component installed on the foundation walls and is not a structural concern. As noted above, we have provided a recommendation below to stabilize the foundation at the immediate areas of concern.

View of a crack in  
the parge coating.

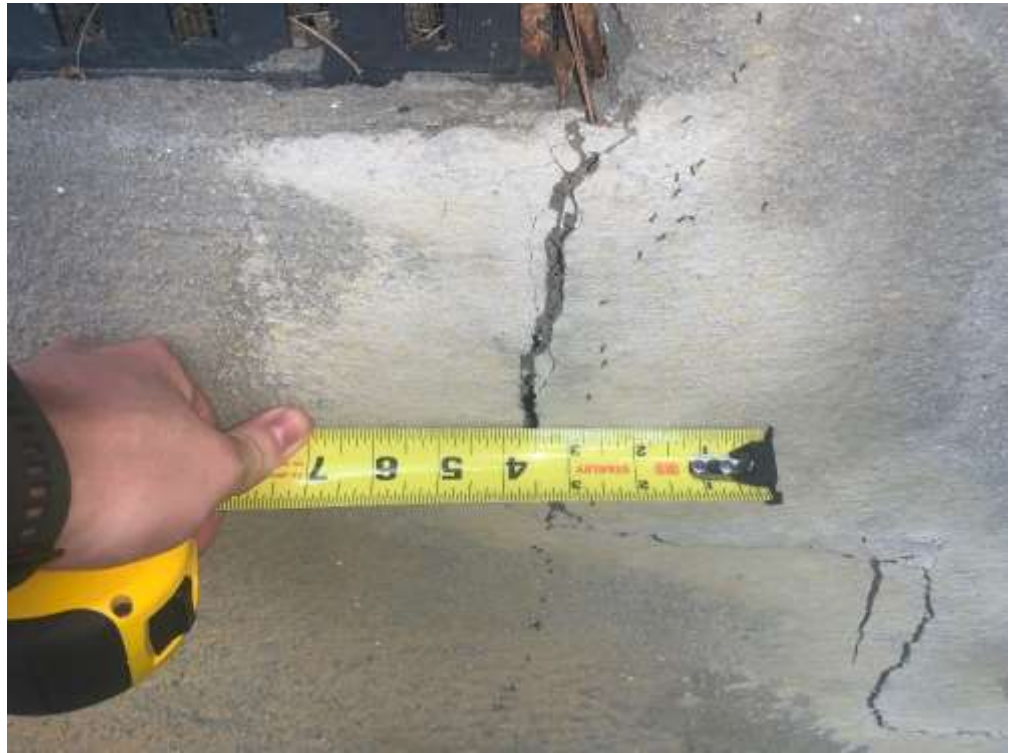
Photo No.  
7

Measured view of a crack in the parge coating.

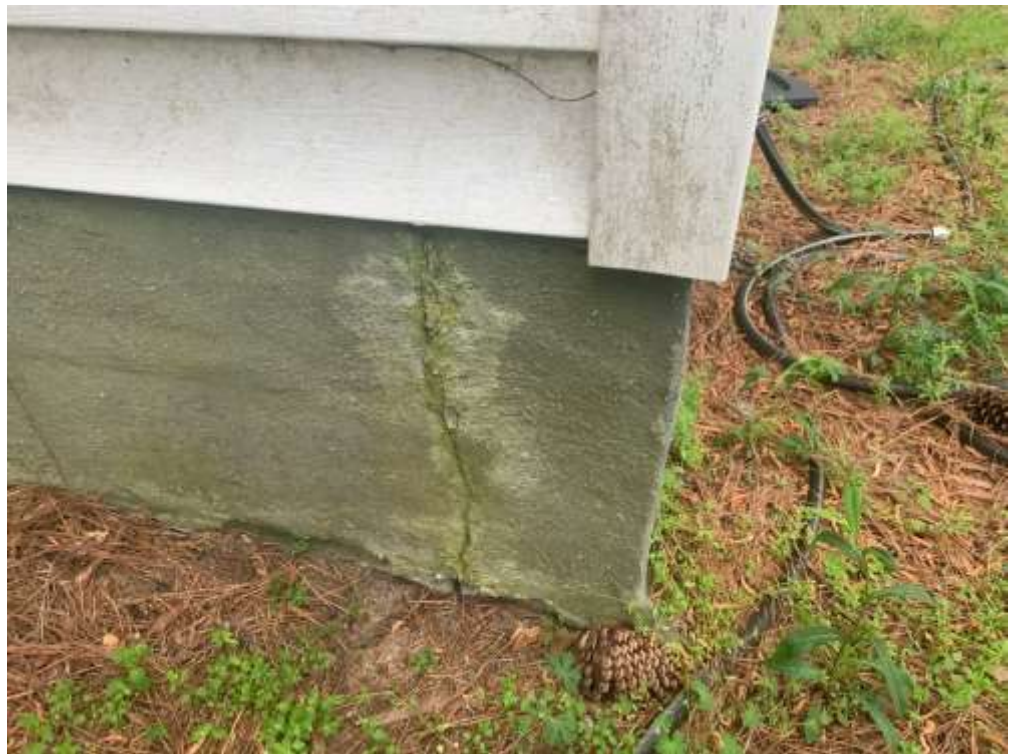
Photo No.  
8

Typical view of a minor crack in the parge coating.

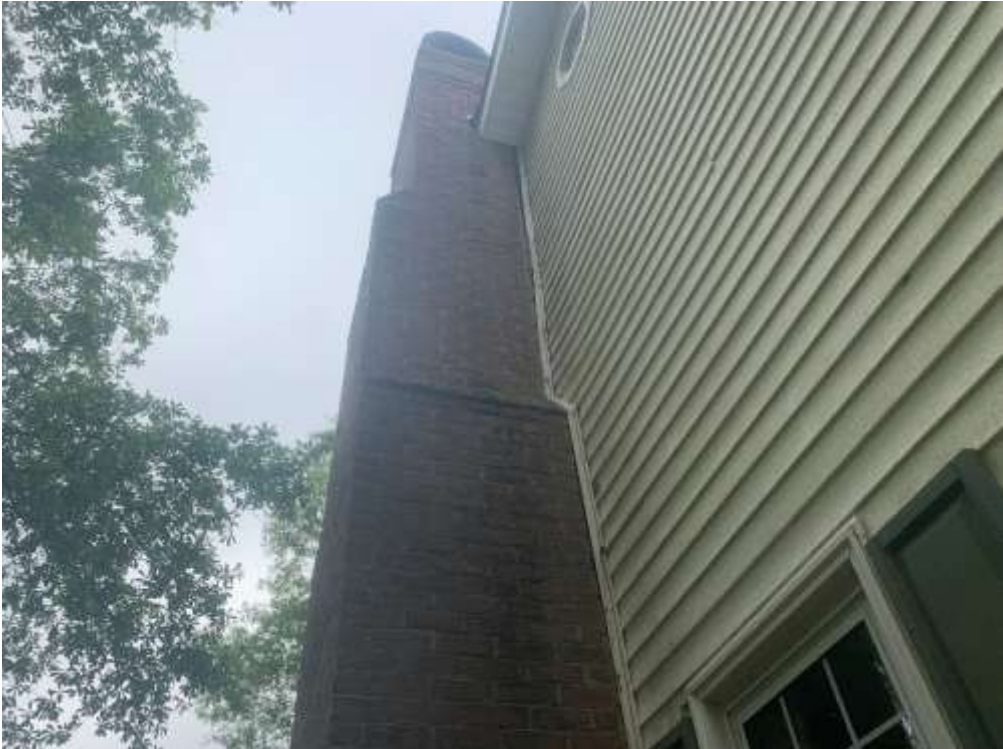
| <p><b>Photo No.</b><br/>9</p> | |

- 6. Separation (up to 7/16" wide) was noted at the rear-right re-entrant corner of the rear porch to main home transition.
- 7. The chimney along the left perimeter of the home was noted to be leaning out of plumb (up to 15/16" horizontal over 4'-0" vertical). Additionally, excessive separation of the chimney from the home was noted at the top. Per conversations with the homeowner, (2) push piers were installed beneath the chimney foundation.

The movement of the chimney noted above (Observation #7) is also likely a result of differential foundation settlement. Per measurements from the previous inspection report, the chimney has continued to move. The continuous movement of the chimney is considered to be a structural concern. We have provided a recommendation below to address this issue.

| <p><b>Description</b></p> <p>View of separation of the chimney from the home.</p> | |

2. We recommend consulting with the contractor who installed the piers under the chimney to perform necessary adjustment to ensure the piers are in full contact with the footing.

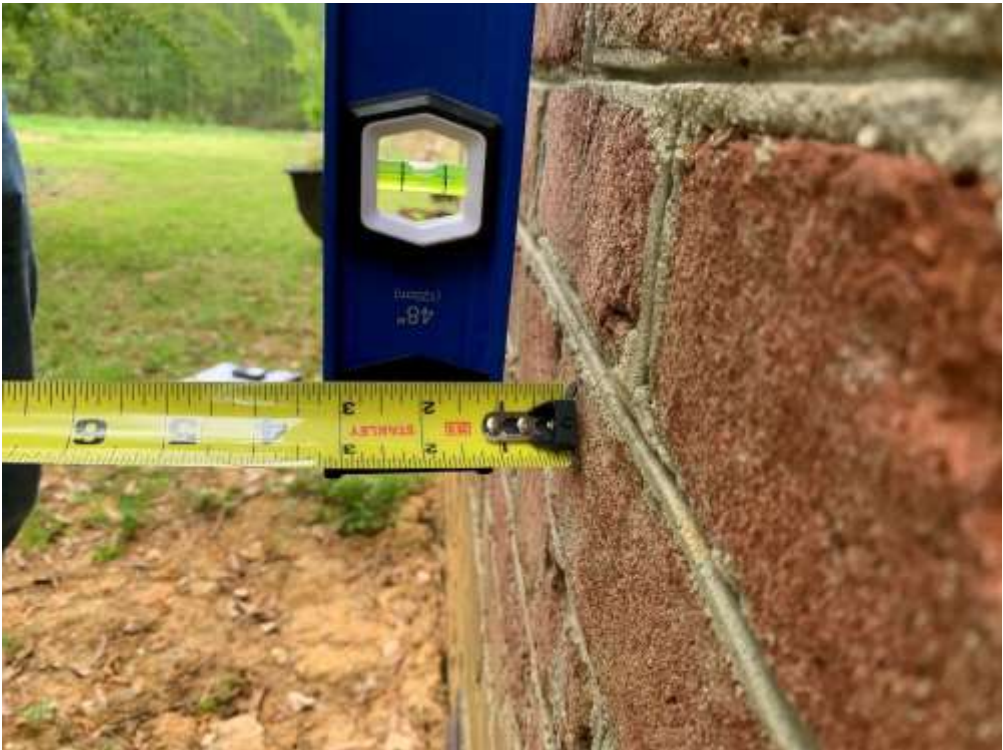
| <p><b>Photo No.</b><br/>10</p> | |

| <p><b>Description</b></p> <p>View of out of plumb chimney.</p> | |

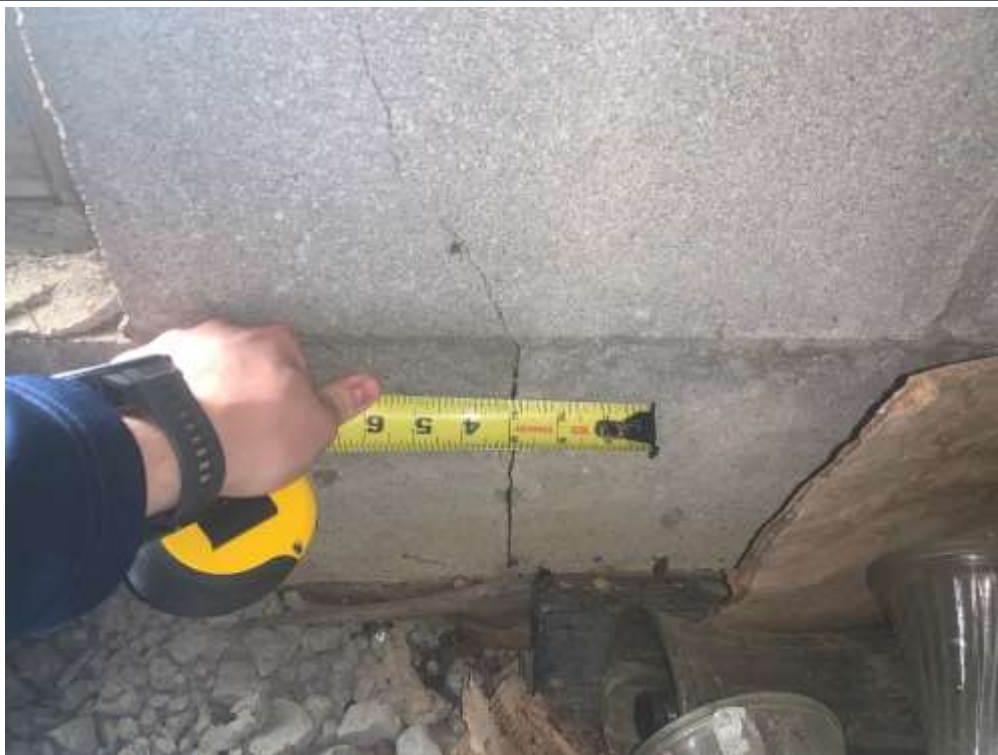
Photo No.  
11

The cracks in the foundation walls, separations, and cracked piers noted above (Observations #10-13) are likely due to differential foundation settlement. The clay soils in this area are considered "expansive" type soils and will typically expand and contract with fluctuations in the moisture content. This expansion and contraction of load-bearing soil materials can lead to soil consolidation and foundation cracking/movement. If conditions around the foundation remain relatively dry, the likelihood of future significant settlement will be reduced, but we cannot predict the extent of future settlement. The cracks, separation, and cracked piers noted above (Observations #10f-10j and #11-13) are considered to be structural concerns. Based on the globalization and magnitude of the cracks noted, it appears that the entire foundation has been affected by differential settlement. We have provided recommendations below to stabilize the foundation at isolated locations to address the immediate areas of concern; however, further stabilization of the foundation may be required in the future if the existing cracks widen or new cracks propagate. We have also provided recommendations below to address the cracked piers in the crawlspace.

Typical view of a minor crack in the foundation walls.

6. Closely monitor the cracks in the foundation walls. If the cracks widen significantly (expand by an additional 1/8") or additional significant cracks (greater than 1/4" wide) propagate, then further evaluation by a structural engineer and stabilization of other locations of the perimeter foundation walls will likely be required at that time.

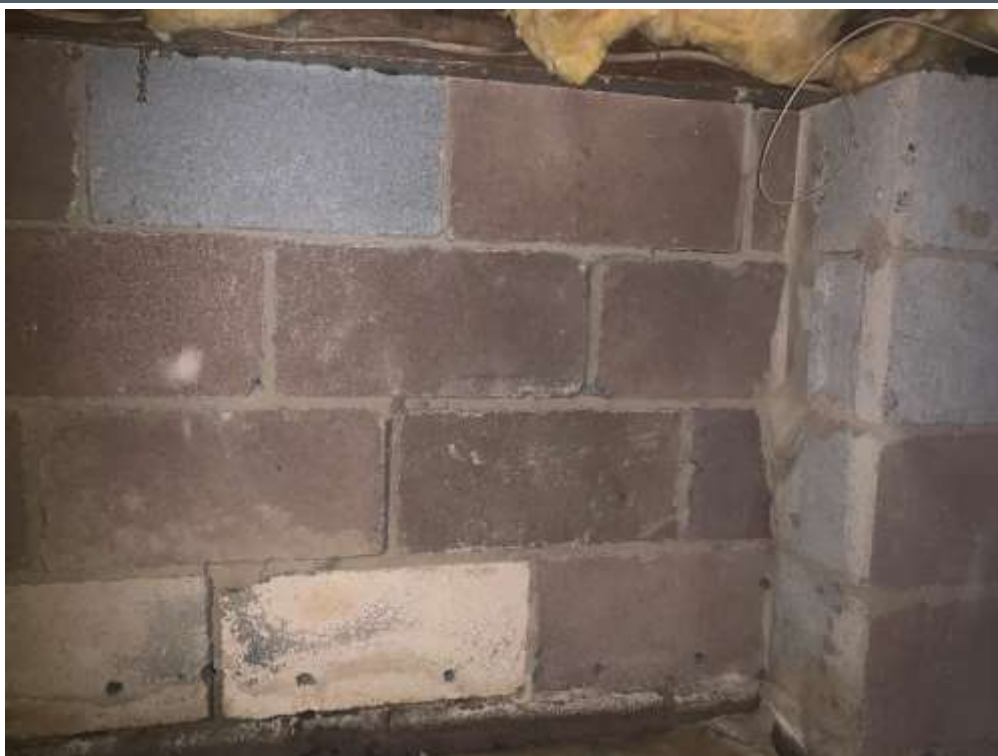
Photo No.  
12

View of a crack in the left foundation wall.

1. We recommend installing new helical piers or equivalent push piers system under the perimeter foundation walls (see attached sketch). Ten (10) helical piers should be sufficient to stabilize the immediate areas of concern noting that further stabilization may be required in the future if further movement is noted.
  - a) Helical piers are to be installed up to 6'-0" on-center and not be installed directly below doors and windows (unless otherwise noted).
  - b) Provide a minimum of 15 kips allowable bearing capacity per helical pier. Helical piers should be installed concentrically below the subject-bearing footing. This may require

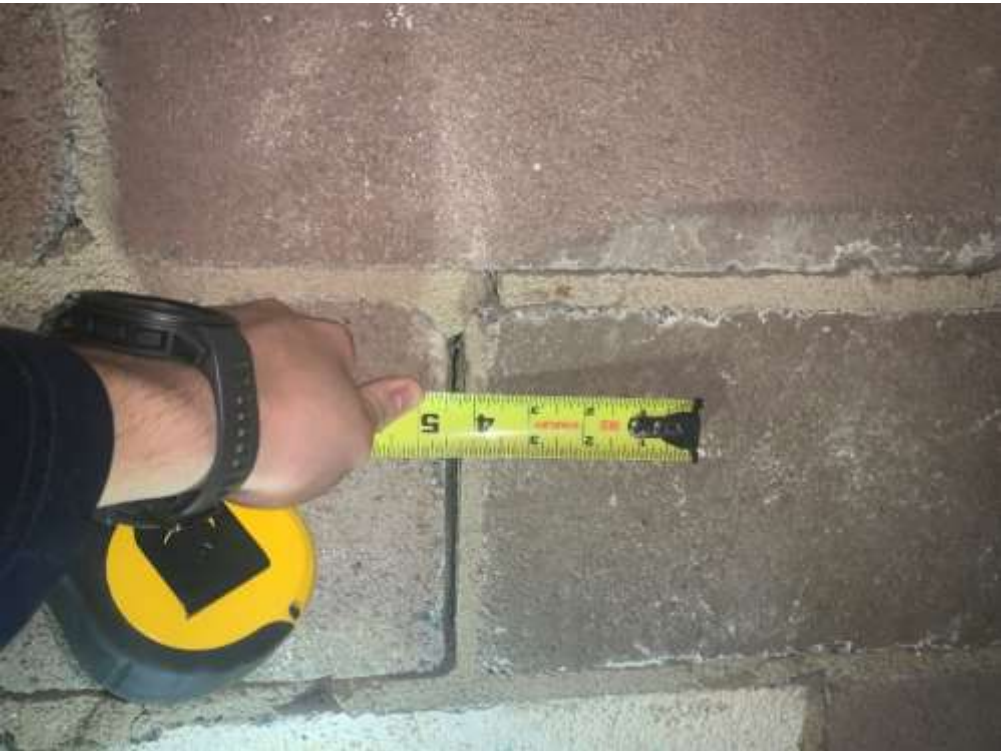
| <p><b>Photo No.</b><br/>13</p> | |

| <p><b>Description</b></p> <p>Measured view of a crack.</p> | |

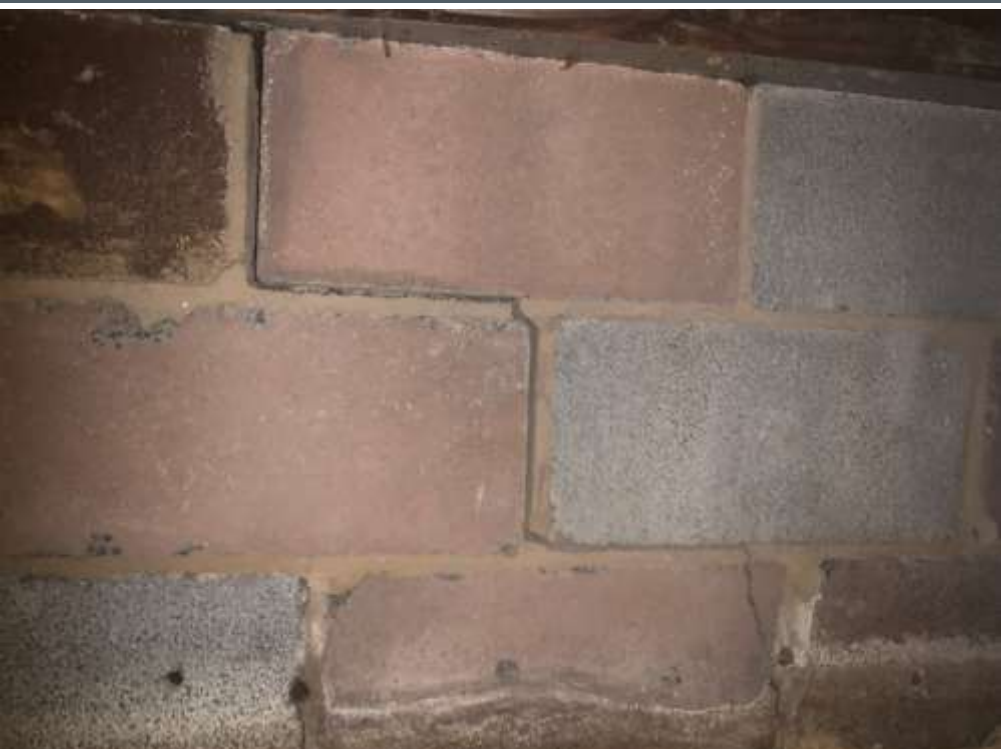
| <p><b>Photo No.</b><br/>14</p> | |

- h. A vertical/stairstep crack (up to 7/16" wide) was noted in the front foundation wall approximately 4'-0" from the left foundation wall.

| <p><b>Description</b></p> <p>View of a crack in the front foundation wall.</p> | |

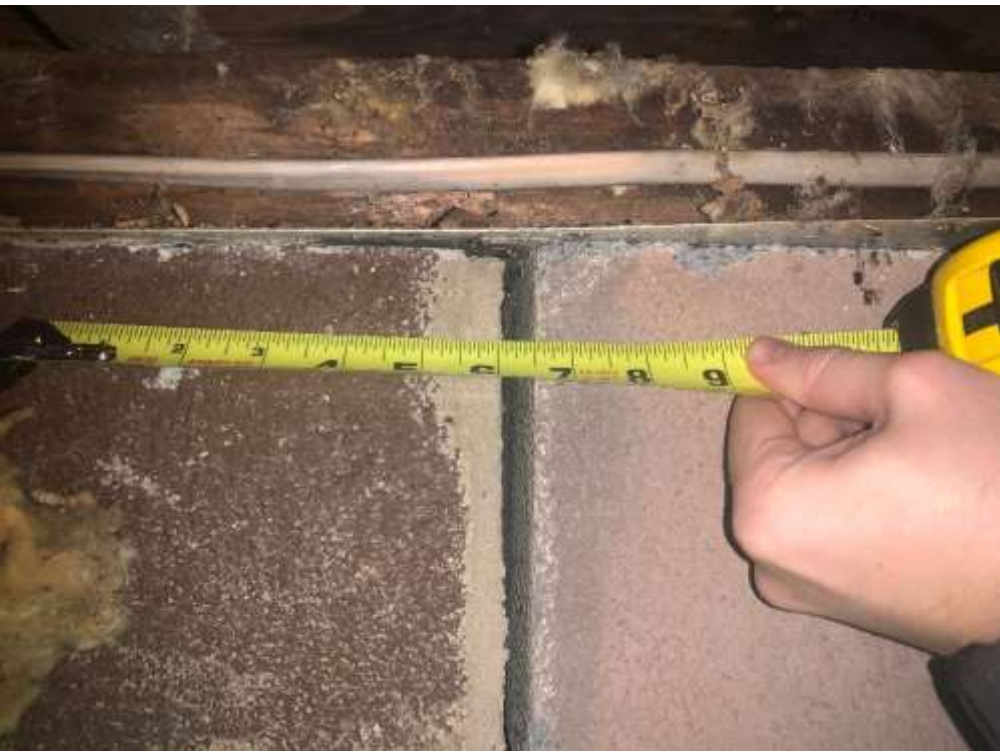
| <p><b>Photo No.</b><br/>15</p> | |

| <p><b>Description</b></p> <p>Measured view of a crack.</p> | |

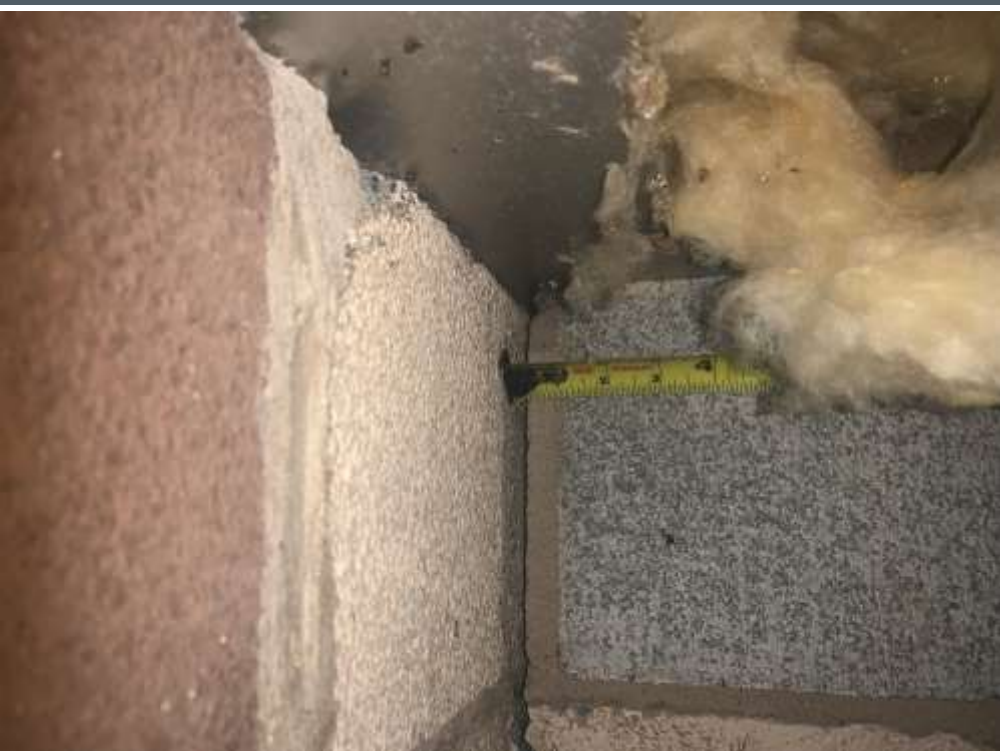
| <p><b>Photo No.</b><br/>16</p> | |

| <p><b>Description</b></p> <p>View of separation at the front to left foundation wall transition.</p> | |

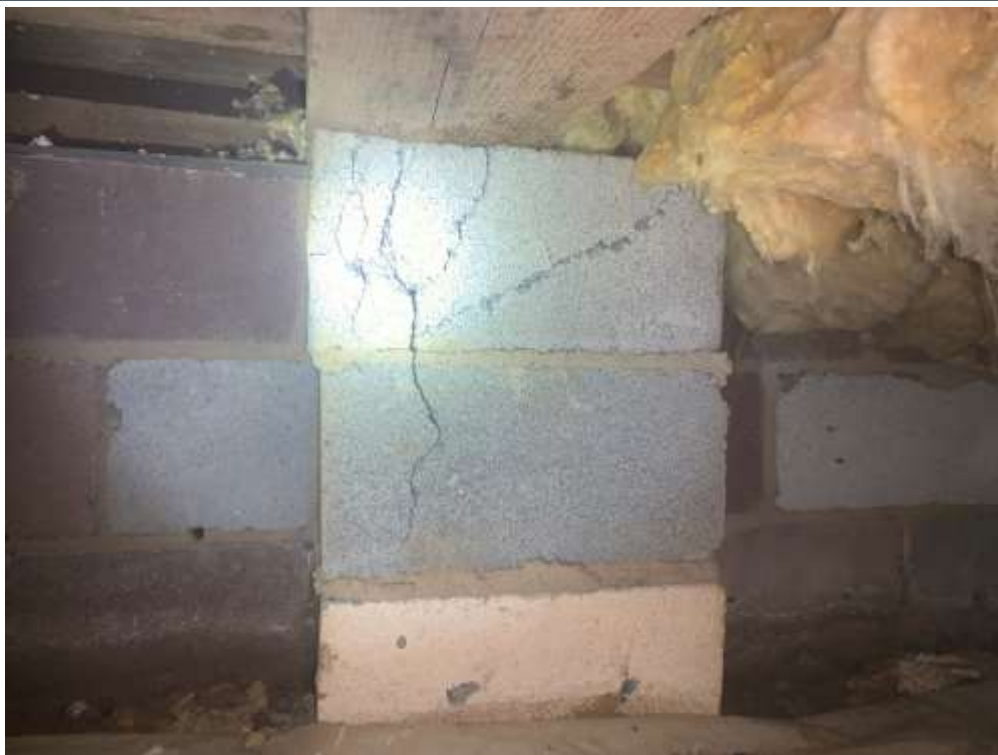
Photo No.  
17

11. A separation (up to 1/4" wide) of the right foundation wall from the front foundation wall was noted at the front-right corner of the home.
  12. A cracked/crumbling CMU pier was noted along the front foundation wall approximately 11'-3" from the left foundation wall.

View of a cracked pier.

3. In regards to the damaged piers noted above (Observations #12-13), we recommend removing and replacing the piers with new mortared 8"x16" CMU block piers. The new piers should be grouted fully solid and bear on new 24"x24"x12"-thick concrete footings. Install flat, pressure-treated wood blocking and/or metal shims to provide full-width uniform bearing of the floor girder onto the new piers below.

- a) We recommend doweling into the existing perimeter concrete footing with (3) #4 18"-long bars set 6" into the existing footing with Simpson SET-3G Epoxy (or equivalent).

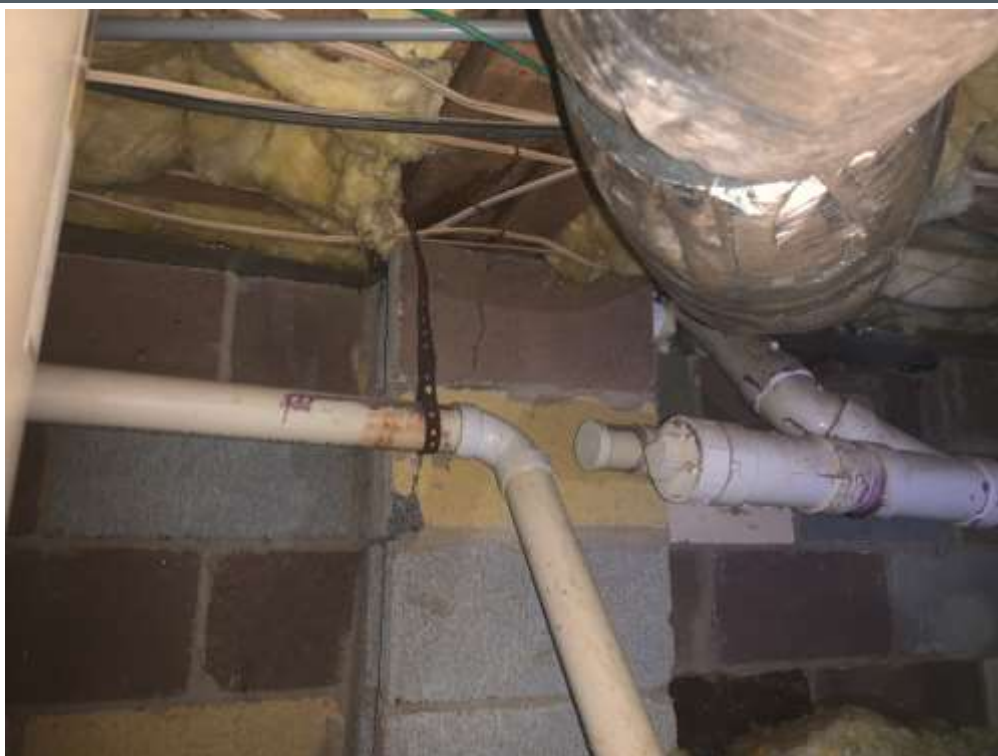
Photo No.  
18

13. A cracked/crumbling CMU pier was noted along the rear foundation wall approximately 11'-0" from the right foundation wall.
  14. Multiple steel drop girders were noted installed near the midspans of the floor joists throughout the crawlspace.

View of a cracked pier.
