# Tim Wiggins Inspections

Name: Lisa Shafer  
Address: \_\_\_\_\_  
\_\_\_\_\_  
Telephone Number: \_\_\_\_\_  
Inspection Ordered by: Agent  
Property Address: 308 Charles Street  
Henderson, NC 27536  
Year Built/Structure Age\*: 1960 Square Footage\*: 1450 sq ft  
Date Performed: March 19, 2025  
Reason for the Inspection: Prepurchase

## I. Foundation, Basement and Structure

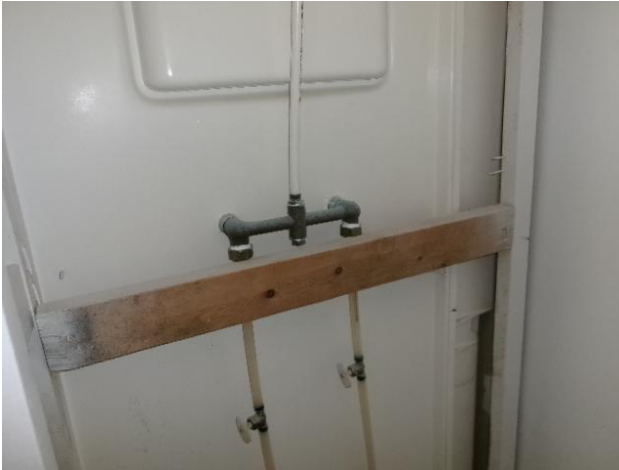
1. Water piping to the bathroom shower is exposed in the bathroom closet.

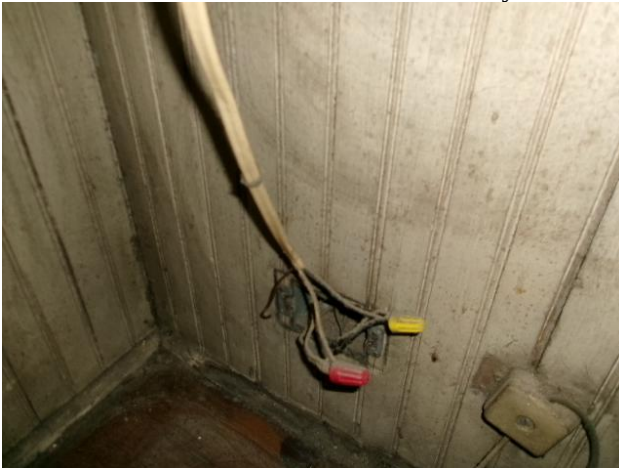
4. There is an open junction box/wire splice in the HVAC system air return chamber behind the air return filter. Hot electrical connections are exposed. This is a safety hazard. Repair needed. It should also be noted that electrical wiring should not pass through the air return chamber. Toxic fumes from the outer sheathing on the wiring can spread quickly throughout the structure during a fire event. This is a safety hazard. A licensed electrical contractor should evaluate the electrical wiring in the air return system and take corrective action as needed.

2. There is an open wire splice and open junction box in the air return chamber in the hallway.

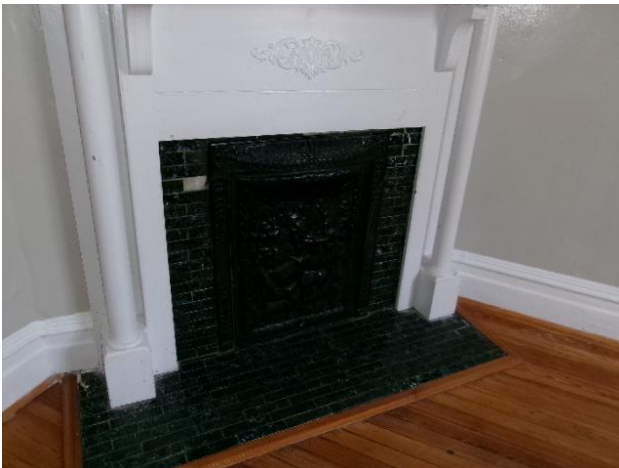
1. The coal burning fireplaces in the subject home are not functional and cannot be used for wood burning or coal burning.
2. The fireplace chimneys no longer extend above the roofline. The fireplaces are not functional.

3. The coal burning fireplaces in the subject home are not functional.

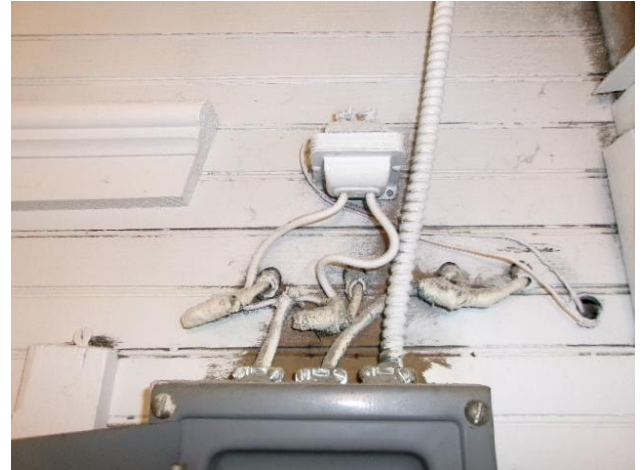
8. Multiple open wire splices are present in the back left bedroom closet above the electric sub panel. Hot electrical connections are exposed. This is a safety hazard. Repair needed.

4. Open wire splices are present in the back left bedroom closet.

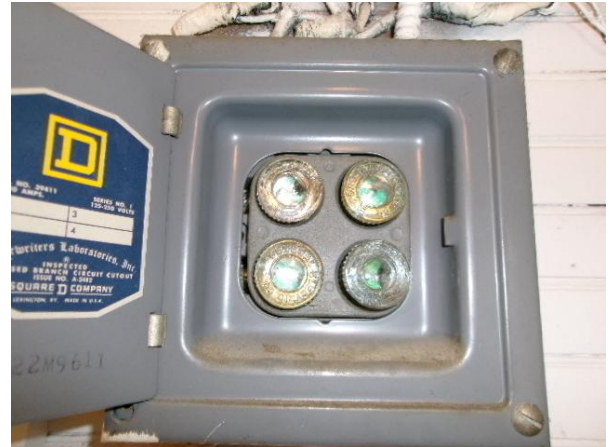
7. 30 amp fuses are installed on all electrical circuits in the electric sub panel in the back left bedroom closet. Electrical wiring for the circuits in the electric sub panel is not adequate for 30 amp overcurrent protection. This is a safety hazard. A licensed electrical contractor should evaluate the overcurrent protection on the electric sub panel circuits and take corrective action as needed.

5. 30 amp fuses are installed on all electrical circuits in the electric sub panel in the back left bedroom closet.

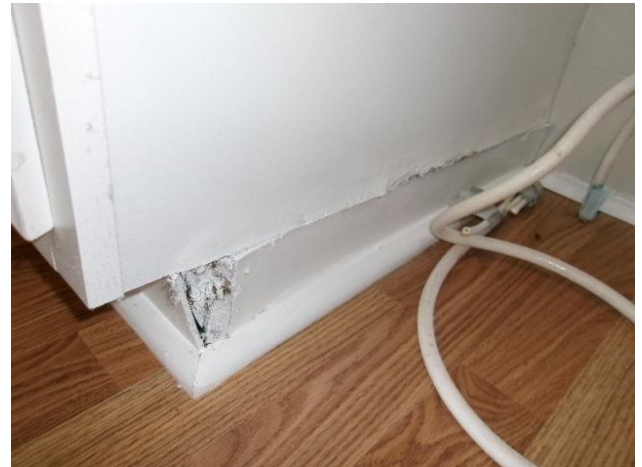
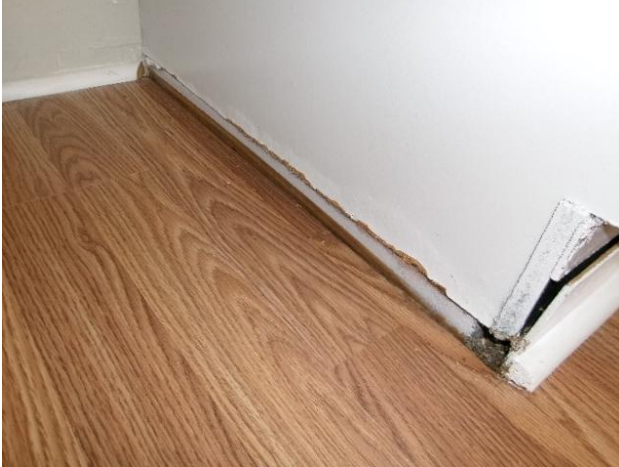
5. Moisture damage is present on multiple sections of the kitchen cabinets. A qualified contractor should evaluate the cabinets and repair as needed to provide adequate support for the granite countertops. Repair needed.

6. Moisture damage is present at multiple locations on the bottom of the kitchen cabinets.

7. Moisture damage is present at multiple locations on the bottom of the kitchen cabinets.

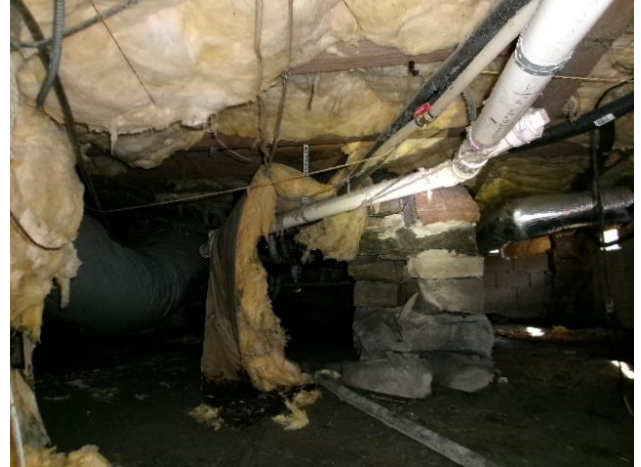
3. Floor insulation is down, missing, or damaged at multiple locations in the crawlspace. All down, missing, or damaged insulation should be repaired or replaced.

10. Floor insulation is down, missing, or damaged at multiple locations in the crawl space.

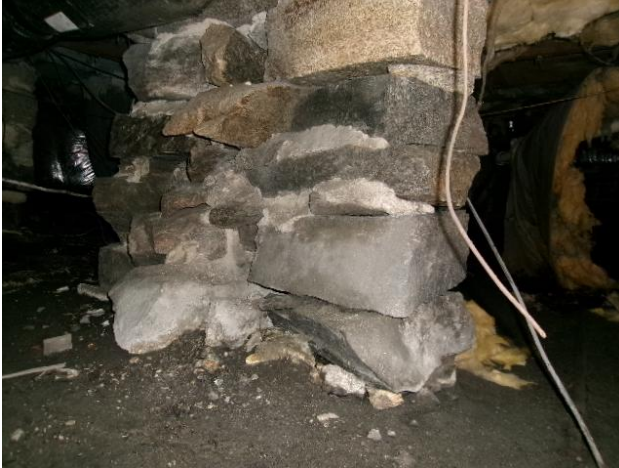
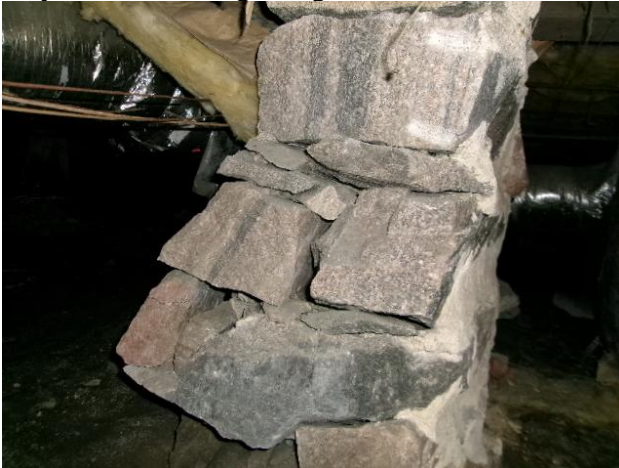
2. The subject home was originally built on stone pilasters. The crawlspace was enclosed at a later date with the addition of concrete block curtain walls between the pilasters. The original stone pilasters are beginning to deteriorate. The dry stacked stone pilasters have shifting stones and some of the stones have fallen away from the pilasters. A licensed contractor should evaluate the original stone pilasters and take corrective action as needed to stabilize the pilasters to prevent further damage to the pilasters.

8. The original stone support pilasters for the subject home are beginning to deteriorate.

9. The original stone support pilasters for the subject home are beginning to deteriorate.

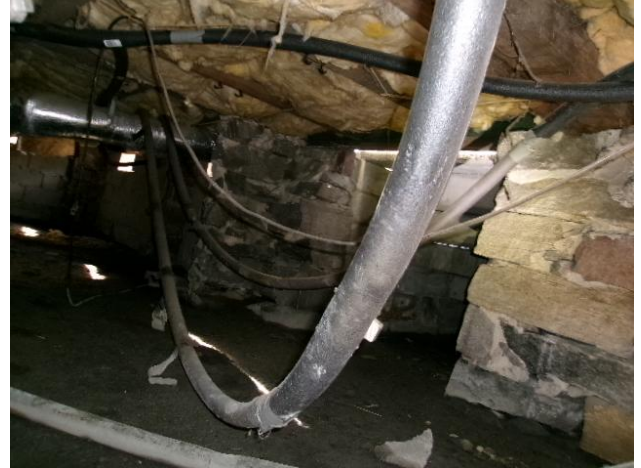
2. The water heater is not installed in a level position. The water heater should be leveled to prevent damage to the water heater.
3. Plumbing pipes are not adequately supported in the crawlspace. A licensed plumber should evaluate the situation and take corrective action as needed to prevent damage to the plumbing pipes.

11. Plumbing pipes are not adequately supported in the crawl space.

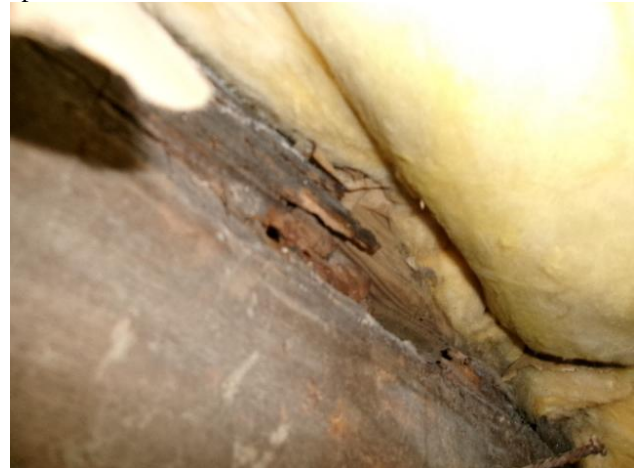
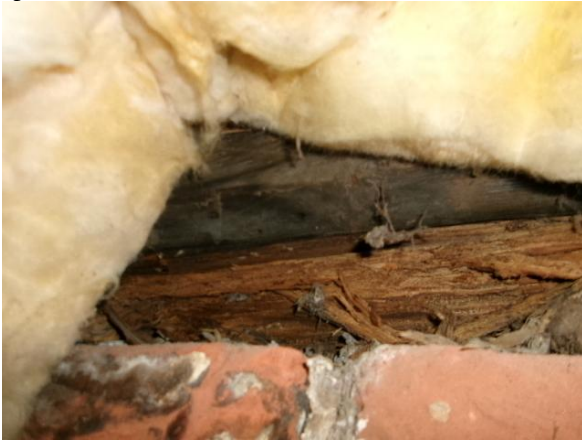
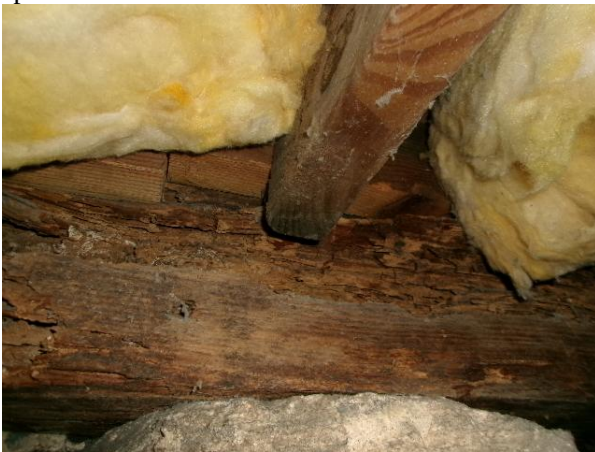
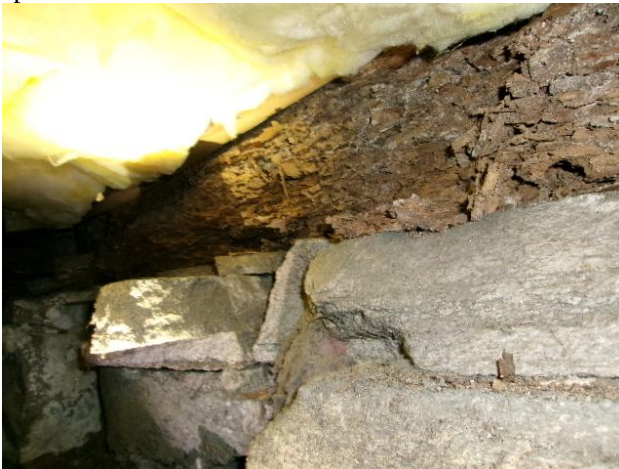
4. Support girders have moisture and/or insect damage at multiple locations throughout the structure. Some of the damaged areas on the support girders are identified with orange ribbons. A licensed contractor should evaluate all wooden structural components on the floor system and repair/replace as needed to provide adequate support for the structure.

12. Moisture and/or insect damage is present on the support girders at multiple locations in the crawl space.

13. Moisture and/or insect damage is present on the support girders at multiple locations in the crawl space.

14. Moisture and/or insect damage is present on the support girders at multiple locations in the crawl space.

15. Moisture and/or insect damage is present on the support girders at multiple locations in the crawl space.

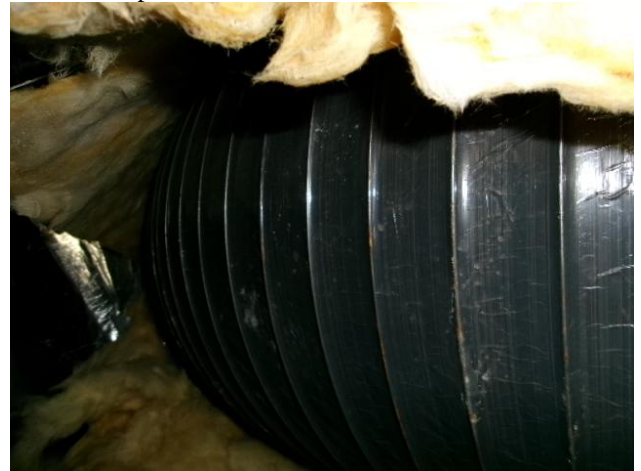
3. The air supply and air return duct work is damaged in the crawl space. A licensed mechanical contractor should evaluate all duct work in the crawl space and repair/replace as needed to allow efficient use of the HVAC system.

16. Air return and air supply ducts are damaged in the crawl space.

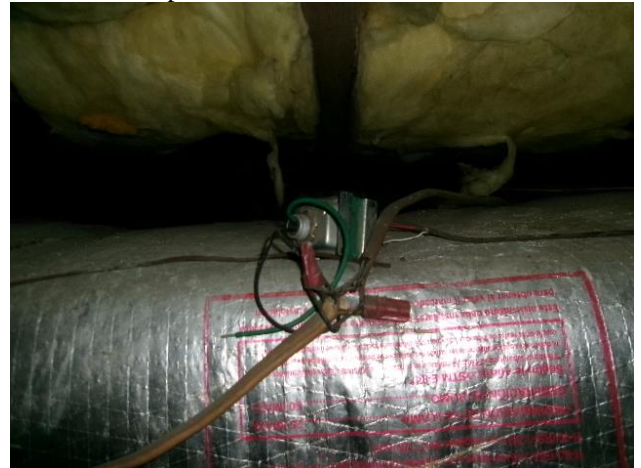
12. Multiple open wire splices, open wire terminations, and open junction boxes are present in the crawl space. Hot electrical connections are exposed. This is a safety hazard. A licensed electrical contractor should evaluate all electrical connections in the crawl space and take corrective action as needed.

17. Multiple open wire splices open wire terminations and open junction boxes are present in the crawl space.

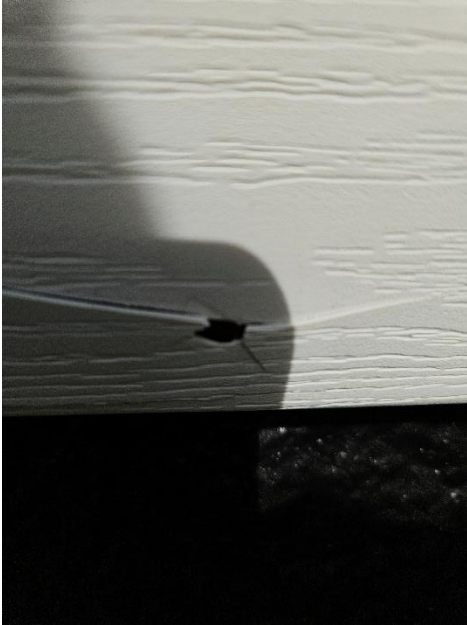
4. There is a damaged area on the front right vinyl siding corner trim. Repair needed to prevent moisture penetration and possible damage.
5. There is a damaged area on the bottom siding panel on the back side of the structure. The damaged siding should be repaired or replaced to prevent moisture penetration and possible damage.

18. The bottom siding panel on the back side of the structure is damaged.

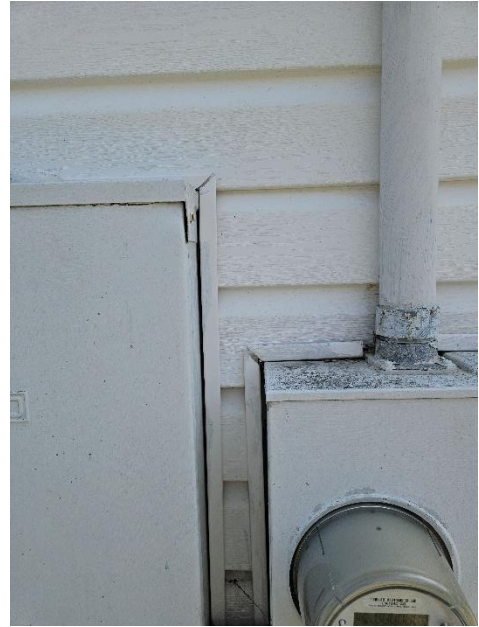
3. The siding penetration for the electric meter base and the electric service panel are not adequately sealed. Corrective action is needed to prevent moisture penetration and possible damage.

20. The siding penetrations for the electric meter base and the electric service panel are not adequately sealed

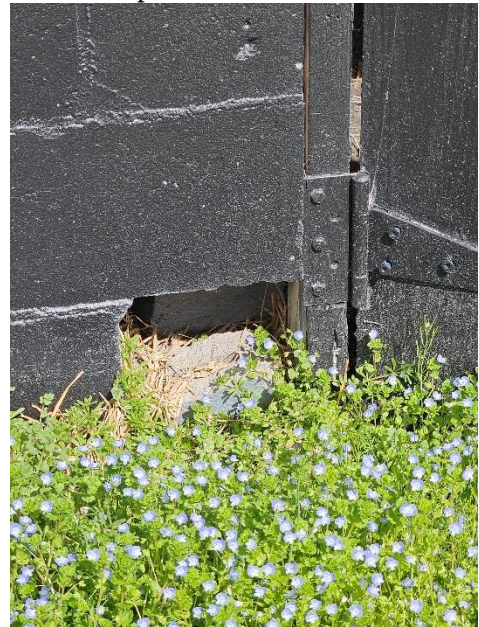
1. There is a gap on the foundation wall at the bottom corner of the crawlspace access door. Small animals can enter the crawlspace at this location. Corrective action needed.

21. There is a gap on the foundation wall adjacent to the crawl space access door.

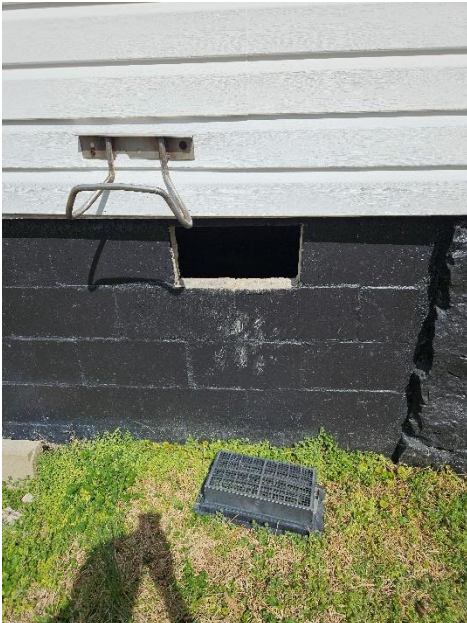
8. One of the foundation vents on the back foundation wall has fallen out of the foundation. Repair to the foundation vent is needed to prevent small animals from entering the crawl space.

23. One of the foundation vents on the back foundation wall has fallen out of the foundation.

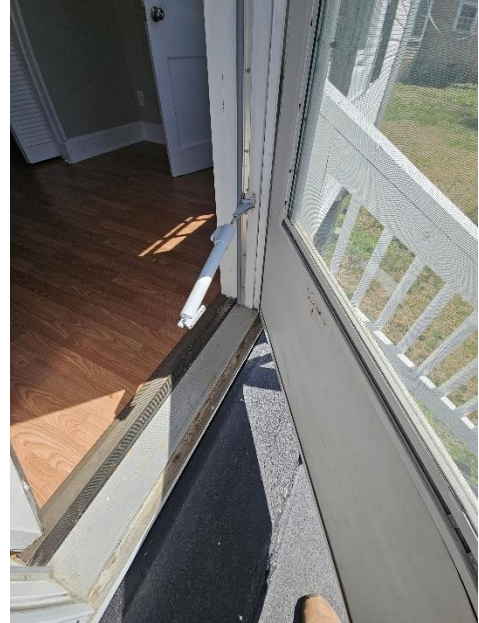
1. The top step on the back entrance steps is damaged. Damaged area on the step tread creates possible safety/tripping hazard. Repair needed.
2. The back storm door is damaged. The door closer is detached from the door. Replacement of the back storm door will be needed.

24. The back storm door is damaged. Replacement needed.

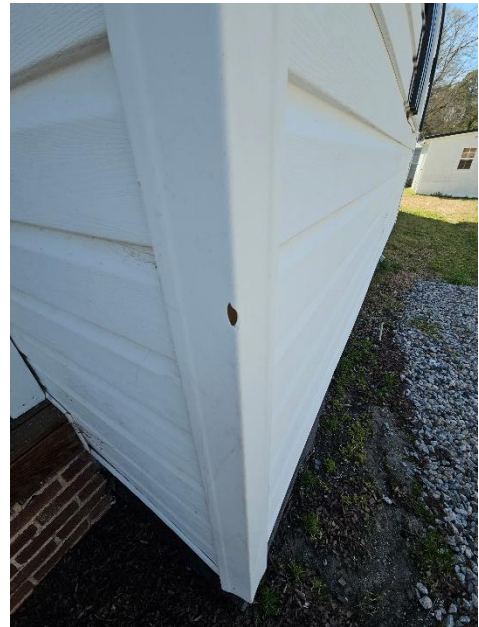
25. There is a damaged area on the vinyl siding corner trim at the front right corner of the structure.

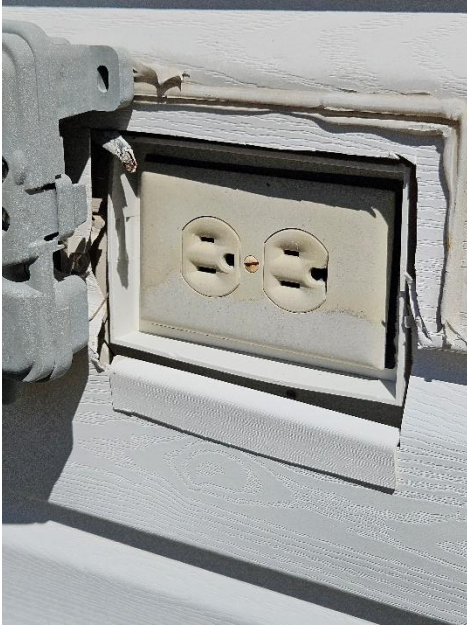
1. The weatherproof cover for the back exterior receptacle is missing. This is a safety hazard. Repair needed.

26. The weatherproof cover is missing on the back exterior receptacle.

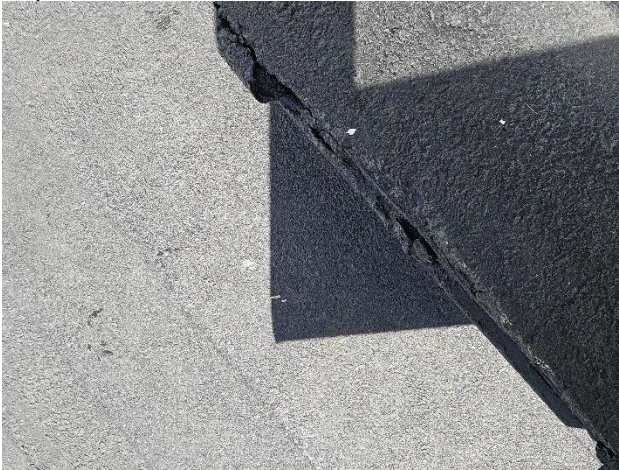
27. The top step tread is damaged on the back door steps.
