**NORWOOD PLUMBING, INC**

**On-site Wastewater Inspection**

**Property Address: 900 Roxboro Road, Oxford, NC 27565**

**Date of Inspection: April 12, 2022**

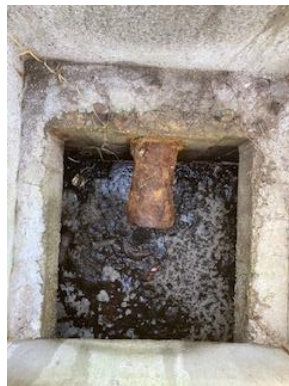
**INLET LID With RISER**

**YES** - Access riser(s) – **INLET SIDE ONLY - CEMENT**

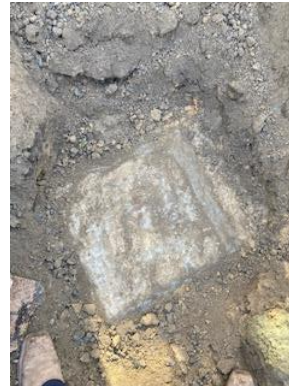
**OUTLET**

**YES** – Interior Tank lids intact – **OUTLET LID CRACKED**

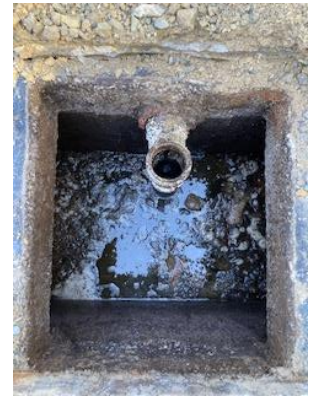
**OUTLET TEE**

**YES**- Outlet T is present

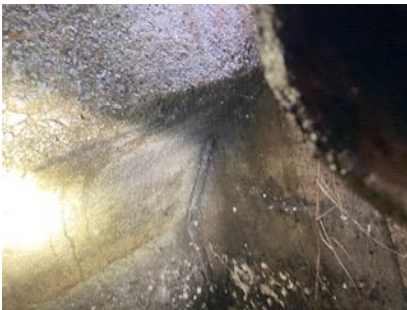
**TANK INTERIOR**

**NO**- Water level in tank is relative to tank outlet – **SLIGHTLY LOW**

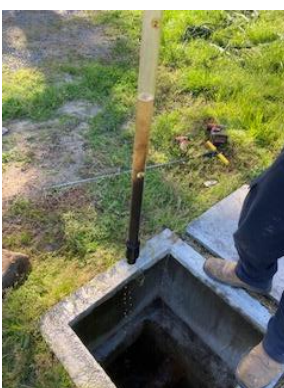
**INLET SLUDGE**

**INLET - SCUM LEVEL -0"**

**SLUDGE LEVEL –12"**

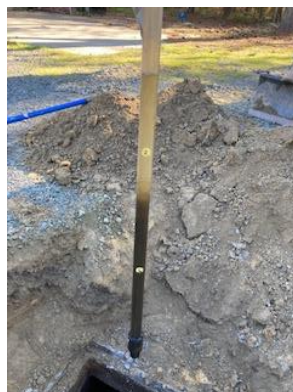
**OUTLET SLUDGE**

**OUTLET – SCUM LEVEL – 0"**

**SLUDGE LEVEL –18"**

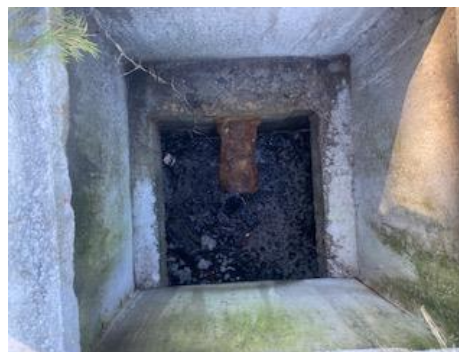
**TANK INLET**

**YES** - Inflow to tank is noted as sufficient

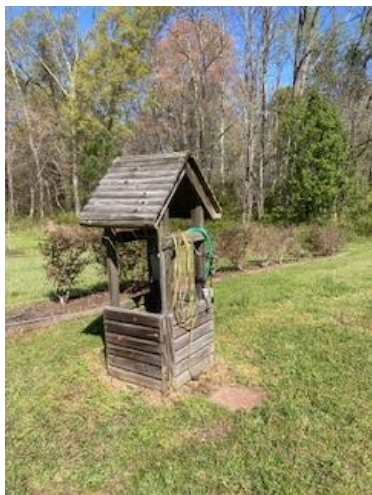
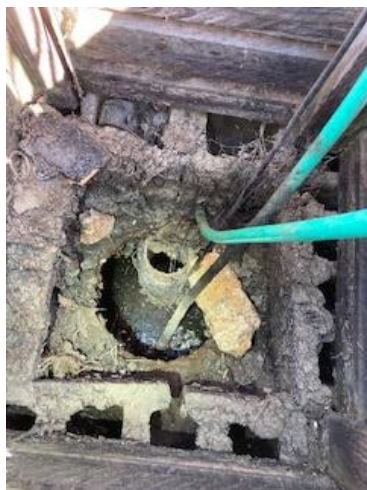
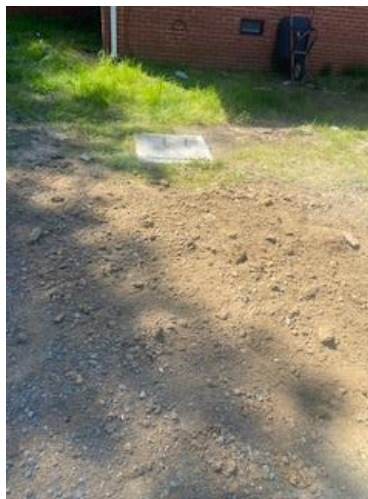
- UTILIZED EXCAVATOR TO DIG UP TANK DUE TO PART OF TANK IN DRIVEWAY
- DECORATIVE WELL HOUSE IS OPENING FOR A MAKESHIFT TANK THAT RECIEVES SINK AND WASHING MACHINE WATER ... SUMP PUMP LOCATED IN IT THAT SENDS WATER TO NEIGHBORING YARD (KILLING BUSHES) . NEEDS TO BE CORRECTED.

**AREA THAT RECIEVES GRAY WATER – TANK (BARREL)**
