**Advantage  
Inspection**

## **WELL COMPONENT EVALUATION**

**Date:** March 21, 2025  
**Report for:** Thomas & Traci Hathaway  
**Inspection address:** 8437 Charlie Stovall Road, Oxford, NC 27565  
**Realtor:** Jacquelyn Harvey  
**System Design:** 2007

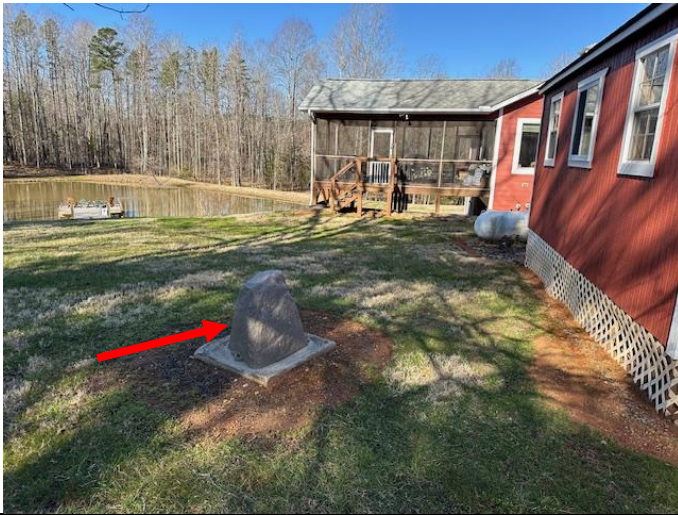
Location of well head shown

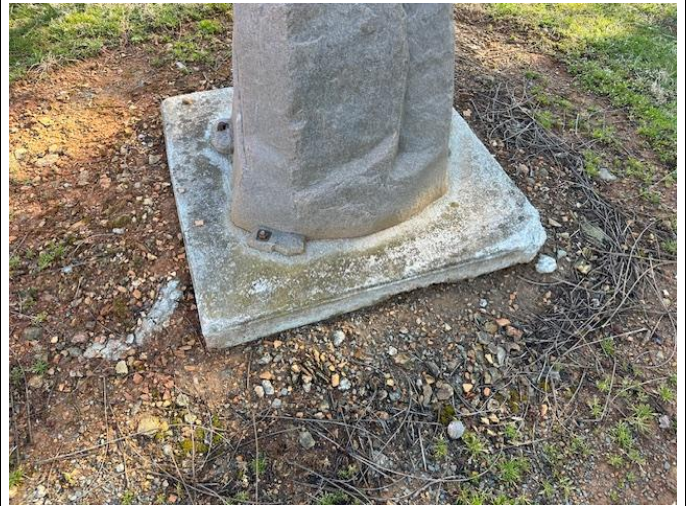
Well head shown slab shown

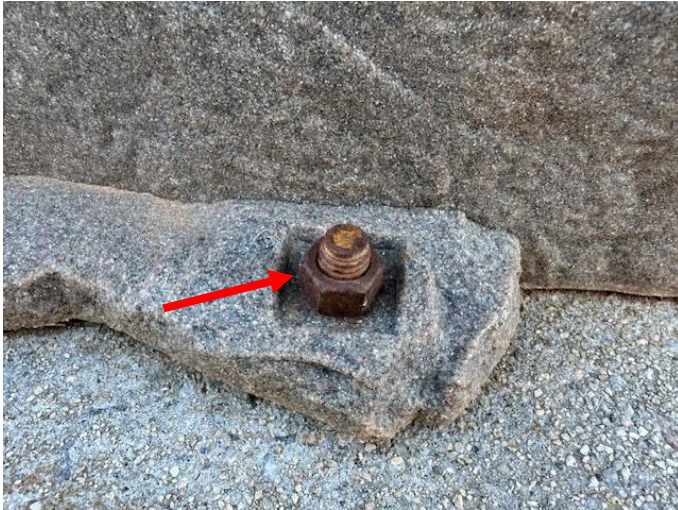
Bolts and nuts noted as corroded not removed

- ☐ The well head insulated cover bolts and nuts were noted as being corroded and unable to be removed as both the bolts and nuts spun. The sections where the bolts were fastened has to be damaged in order to gain access to the well head. It is recommended that a qualified contractor further evaluate and make all necessary repairs.
- ☐ The contact relay cover was noted as not being fully sealed (see photo). It is recommended that a qualified contractor further evaluate and make all necessary repairs.
- ☐ The sediment filter was noted as having signs of leaking (staining and a bucket under filled with water). It is recommended that a qualified contractor further evaluate and make all necessary repairs.

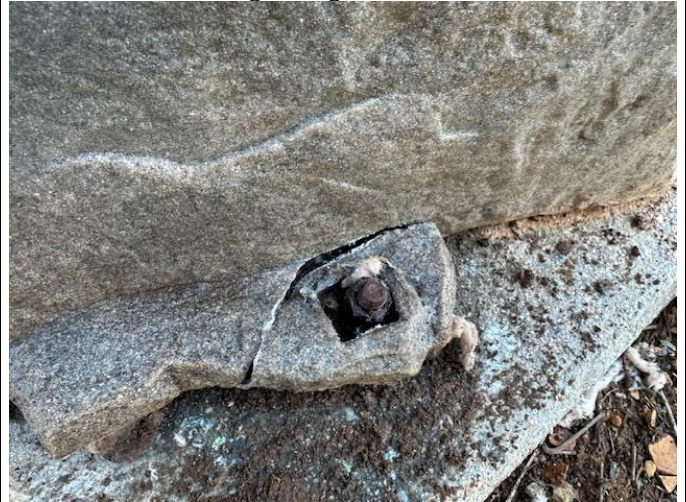
Insulated rock damaged to gain access to well head

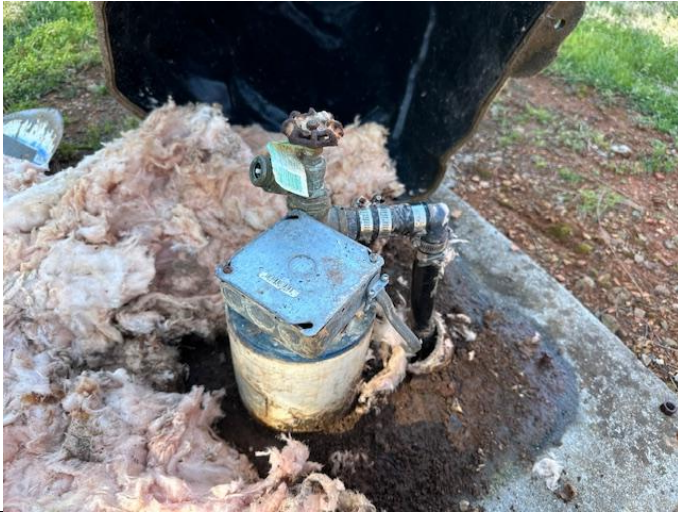
Well head shown

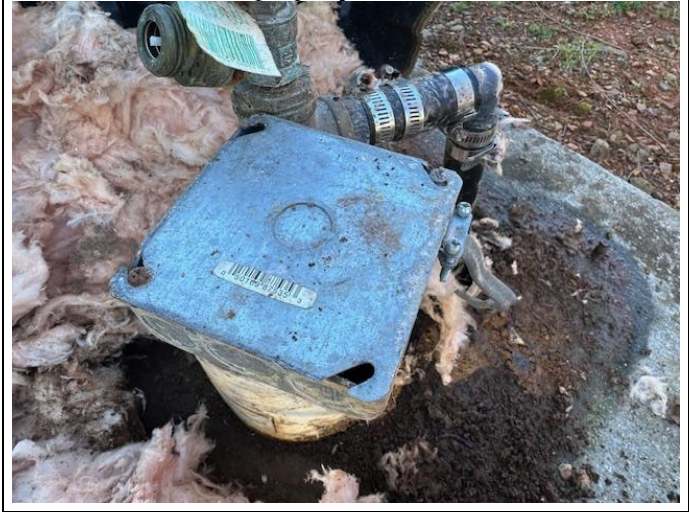
Junction box shown properly sealed

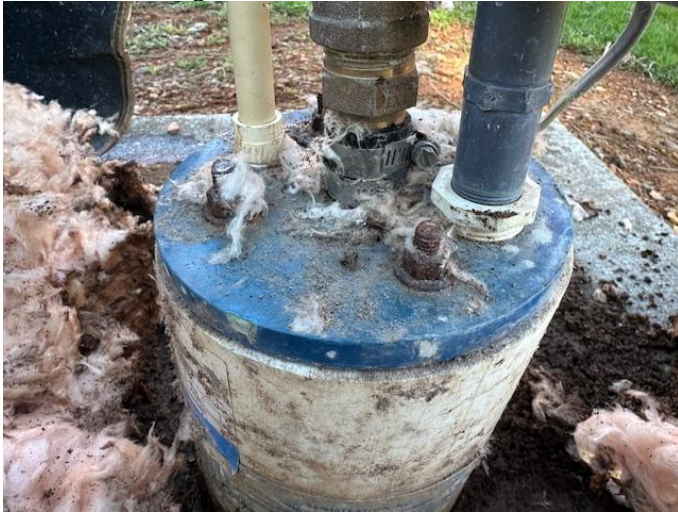
Well head casing seal shown

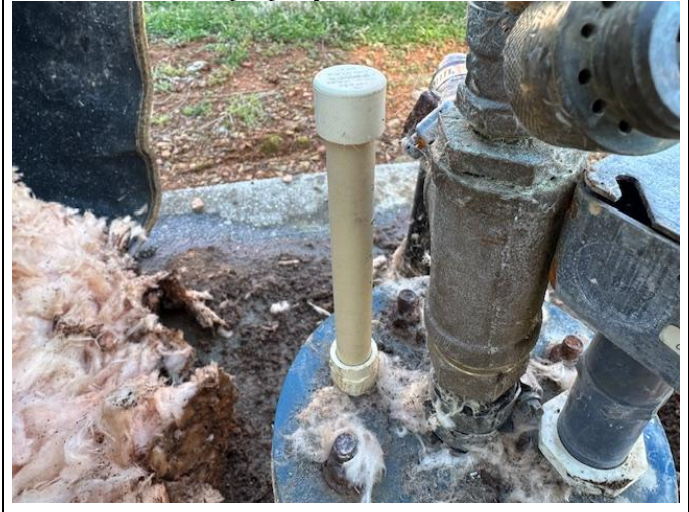
Vent stack shown properly installed

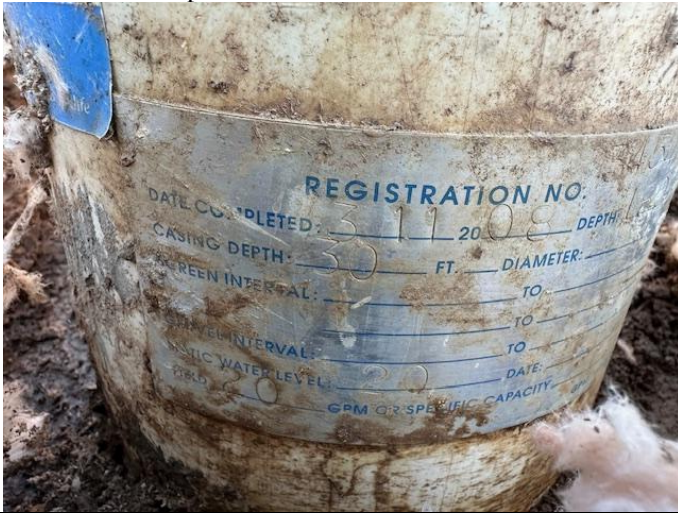
Well head data plate shown

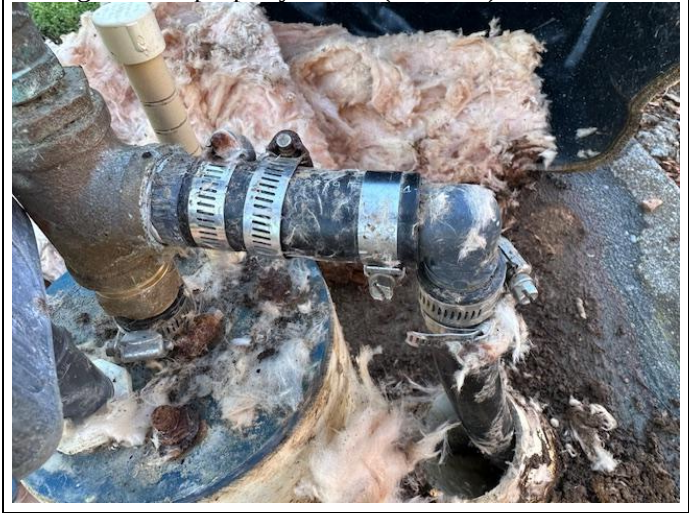
Fittings shown properly sealed (no leaks)

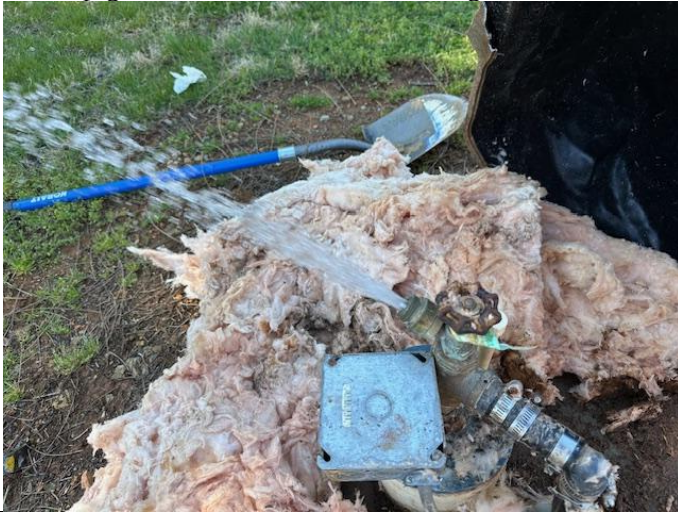
Hose spigot at well head shown working

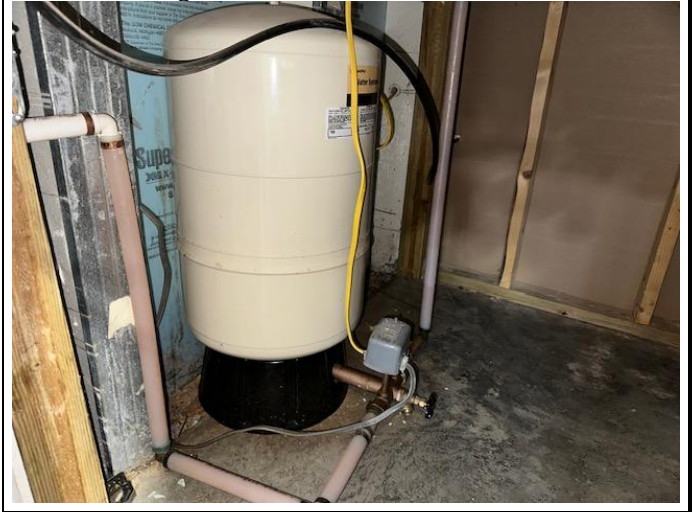
Pressure storage tank shown located in basement

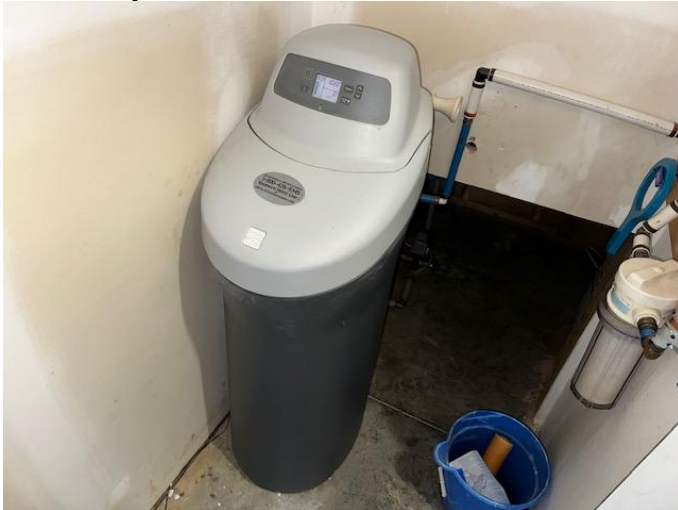
Filtration system shown installed

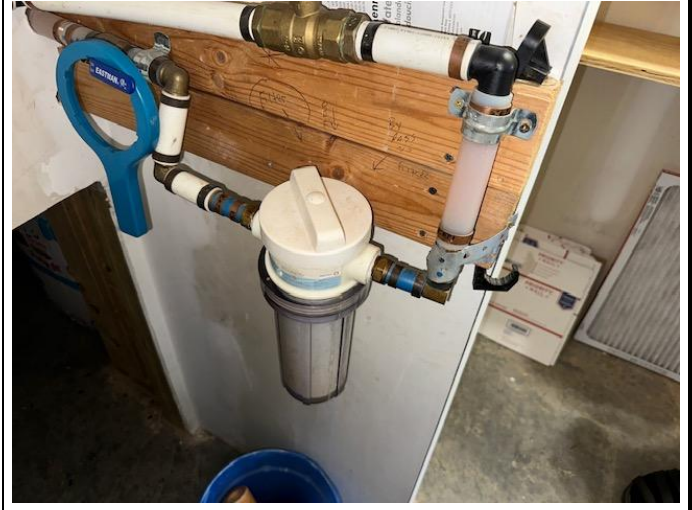
Sediment filter shown installed

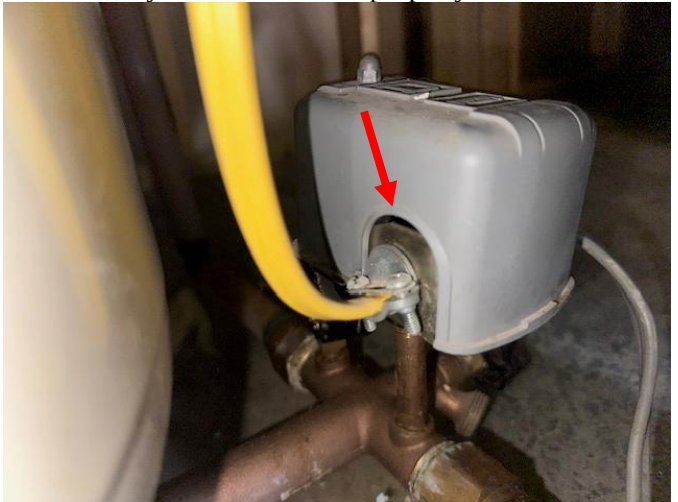
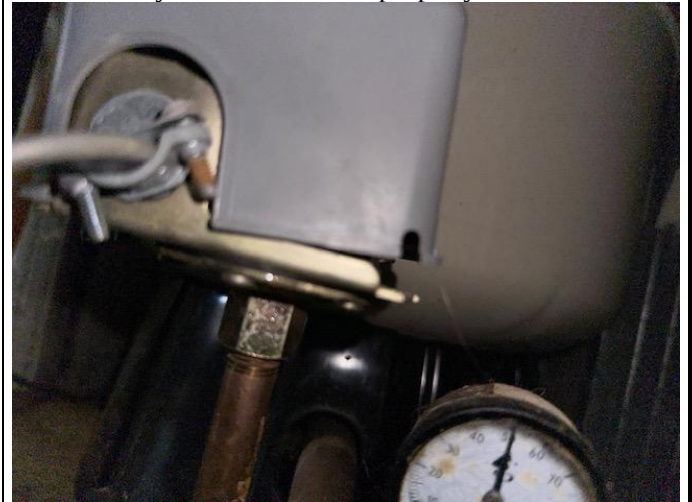
Contact relay cover shown not properly sealed

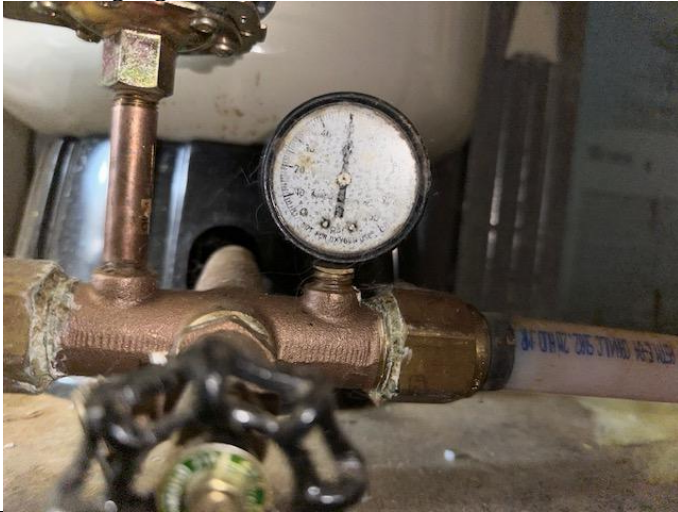
Pressure gauge shown

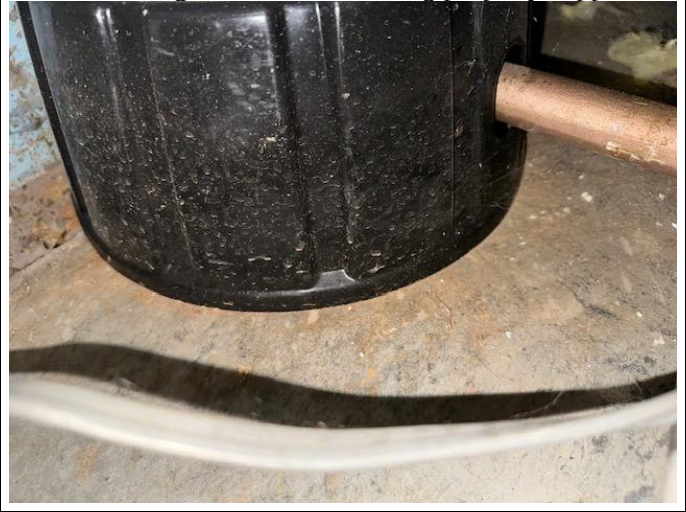
Pressure storage tank noted as being properly supported

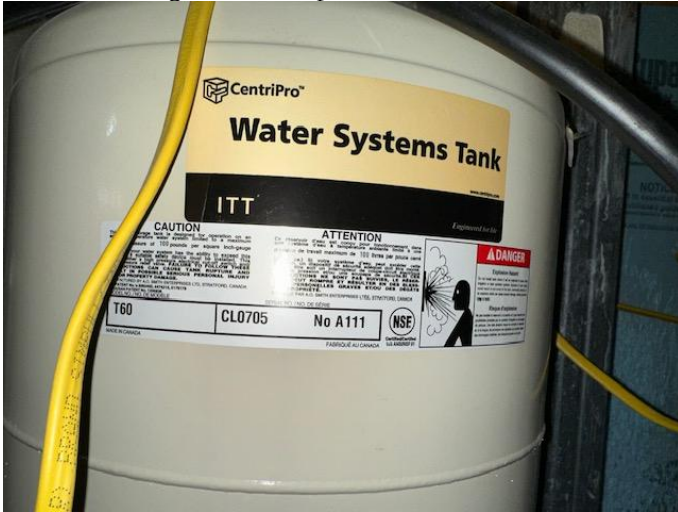
Pressure storage tank data plate shown

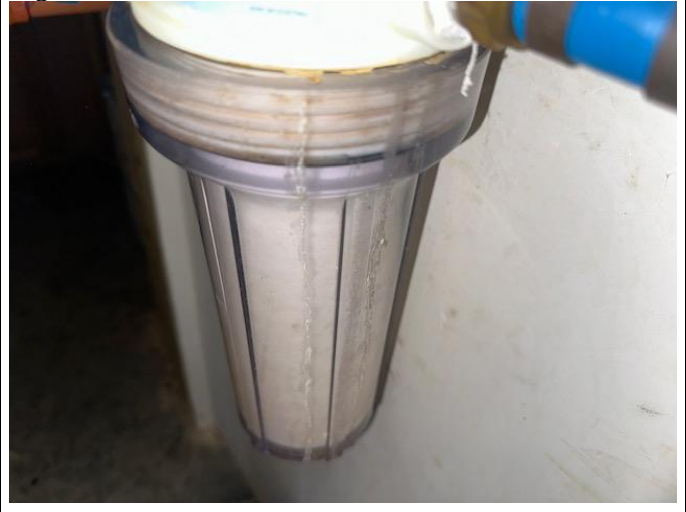
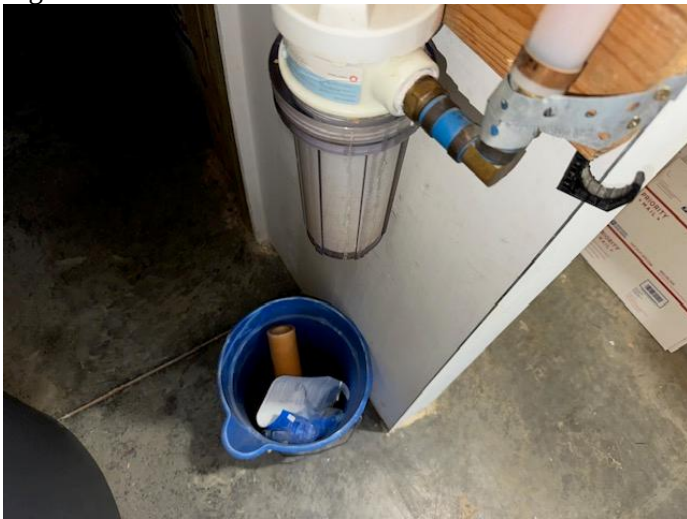
Signs of leaks at the sediment filter

- ☐ Due to the well system having a filtration system installed it is suggested that the homeowner be consulted to determine what maintenance schedule is in place related to the sediment filter to ensure that the system is working as intended.
- ☐ The EPA recommends sanitization of the well annually. This procedure can be found online at the EPA's homeowner's information on private well systems.
- ☐ Minor deterioration at the bolt connections at the well head (See Photo) No evidence of leaking was observed at the time of the inspection, but the corrosion does verify the start of deterioration at this connection. Recommend all connection be monitored semi- annually for an increase in corrosion and/or loose connection/leak.
