# Inspection Report

8437 Charlie Stovall Road  
Oxford, NC 27565

Your Inspector  
Jim Delaney  
Lic# 5789

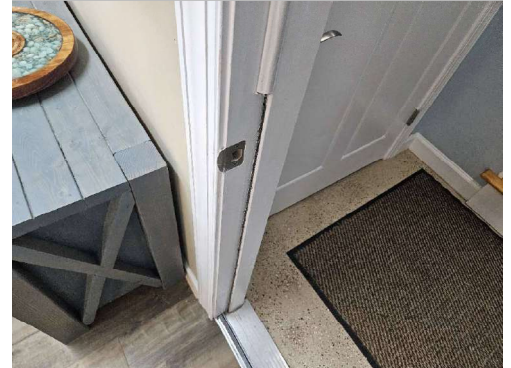
#### 1. Needs Repair: Side Door - Damaged Weather Strip Insulation -

The garage/side entrance door is not making a good seal on the weather strip insulation at the lower striker side of the door jamb where the insulation strip is deteriorated, most likely from the dog pawing at the lower jamb of the door. Have a professional contractor replace the damaged insulation strip on this door so that a complete seal is provided at this door.

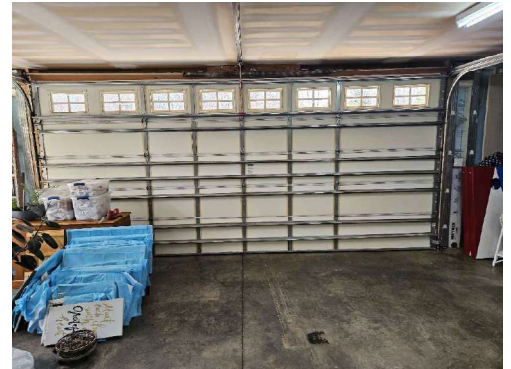
#### 2. Needs Repair: Garage - Garage Door Opener Down Force Adjustment Needed -

The garage door did not reverse motion when a small amount of resistance (three fingers alone used to stop downward motion) were applied to the door while closing. Improperly set door openers can result in damage to the door/personal property, or personal injury. Have a professional garage door installation contractor adjust the downforce on the automatic garage door opener auto-reverse function so that less resistance is required in order to reverse downward door motion.

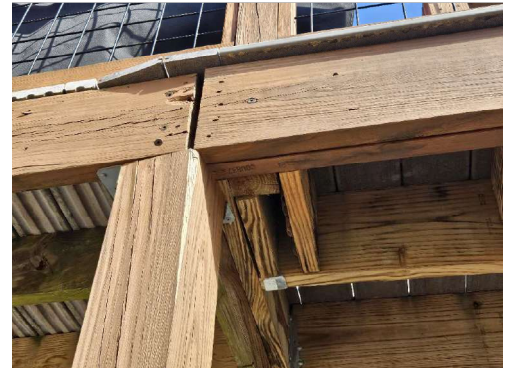
#### 3. Needs Further Evaluation/Repair: Deck – Improper Repairs/Structural Support –

There is an area on the deck that may not be properly supported. It appears that an addition to the deck was performed. The junction of the new portion of the deck and the previously existing portion of the deck has a questionable connection. The support girder is cut/compromised in the center of the span and is not centered on the support post it rests on. A variation in the height of the deck boards can be felt at this location and there is some bounce when walking on the deck. Recommend having a qualified general contractor who specializes in deck construction evaluate the deck for proper support and construction and make the appropriate repairs, if necessary.

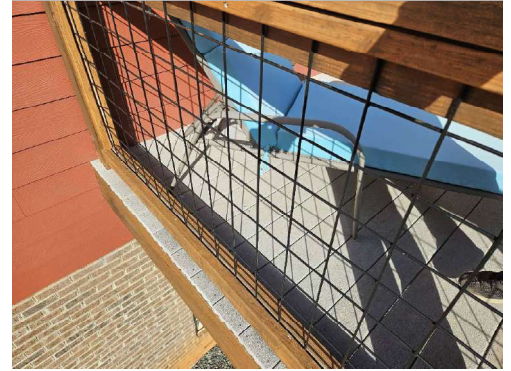
### 4. Needs Repair: Deck Rails - Loose Rails -

The deck rails are loose and need to be properly secured on the right side of the deck. Rails provide a sense of security/protection from falling when present. Loose rails, currently present, may give out if enough pressure is applied to them. Have a professional contractor evaluate the deck stairs and make any necessary repairs so that proper support is provided if leaned on.

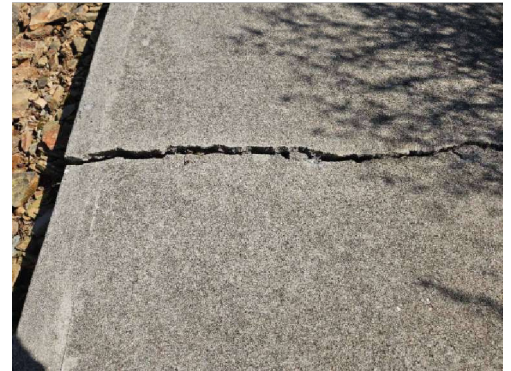
### 5. Needs Repair: Walkway - Displaced Walkway -

Uneven walkway with a displaced cement section could be a tripping hazard at the front exterior of the home. Displacement of the cement is about 1/2" and could be considered a safety hazard. Have a professional contractor make the necessary repairs due to concerns for personal safety and liability.

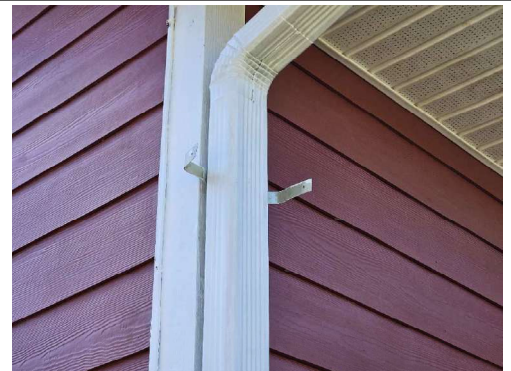
### 6. Needs Repair: Gutter System - Downspouts Not Secure -

Some of the gutter downspouts around the home are not secured to the home properly. (See Photo) Loose downspouts may allow water to discharge directly at the foundation. Have a professional contractor secure all downspouts so that water is properly directed away from the foundation.

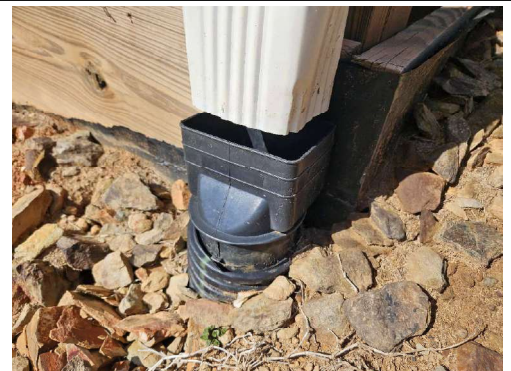
### 7. Needs Repair: Downspout Not Connected At Plastic Pipe Extensions -

Some of the gutter downspouts are not properly connected to the buried plastic pipe transition couplings around the home. (See Photo) Water is not being fully captured by the drain system at these locations. Have a professional landscape contractor make a proper connection at all of the downspouts so that all water shedding off the roof system is properly being directed away from the foundation.

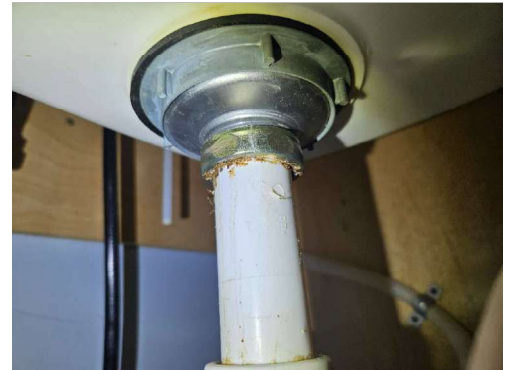
### 8. A. Needs Repair: Kitchen Sink - Waste Plumbing Leak -

Observed a leak from inside the base cabinet under the kitchen sink at the sink waste line. The exact source of the leak was not determined during the inspection, but dripping was occurring at this location. Recommend that a professional plumbing contractor evaluate the area and make the necessary repairs to prevent further leaking.

### B. Needs Repair: Water Supply Plumbing - Deteriorated Fittings -

Observed deteriorated water supply plumbing valves under the kitchen sink. Fitting deterioration can result in leaking. Recommend that a professional plumbing contractor evaluate the entire water supply system and make any necessary repairs to ensure long term serviceability and prevent possible leaking.

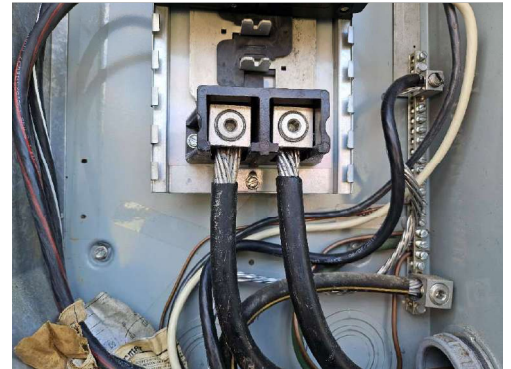
### 9. Needs Repair: Electrical Service Entrance Wire – Unprotected Main Service Lugs/Insulation Stripped Too Far –

The main service lugs are not protected with a rubber or plastic barrier inside the main electric panel on the left elevation. Also, the insulation on the electrical service entrance wires is stripped back too far. Unprotected, excessive exposed cable without its protective sheath could cause a short circuit or electrical shock. Have a qualified electrician evaluate the service entry cables and make the necessary repairs.

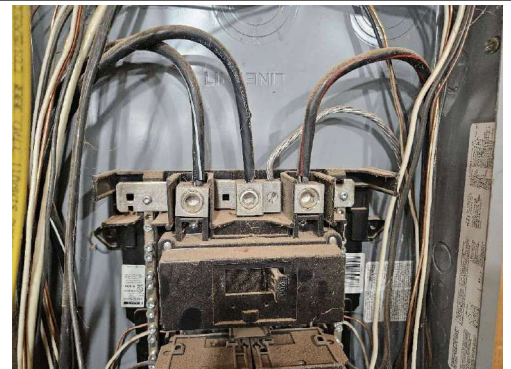
### 10. A. Needs Repair: Large Outbuilding Main Electrical Panel – Incorrectly Sized Breaker/Service Wires –

The main breaker at the service wire entry of the main electrical panel is incorrectly sized. The wires are 2-gauge aluminum, which is only rated at 100 amps. The breaker is a 200-amp breaker. This presents an electrical safety risk/fire hazard. Excessive current could be allowed to flow into the panel; more than the service wires are rated to handle. Have a qualified electrician evaluate and make the appropriate repairs.

### B. Needs Repair: Large Outbuilding Main Electrical Panel - Loose Wires -

Observed some electrical wires in the main electrical panel that are not properly installed or secured. They are run outside of the panel, preventing the cover from being properly secured. The loose, unsecured wires can become an electrical hazard if contact is made with a live portion of the panel components. Have a professional electrical contractor properly install the loose wires in the main electrical panel.

### C. Needs Repair: Electrical Wiring - Large Outbuilding Wire Splices Not Covered -

Observed wires spliced together and outlets installed in the large outbuilding without proper junction boxes and/or covers installed. All wire splices must be safely contained inside a covered junction box to prevent an electrical hazard. All outlets must have appropriate covers installed. Have a professional electrical contractor add the necessary junction boxes/covers at any uncovered connections throughout the building.

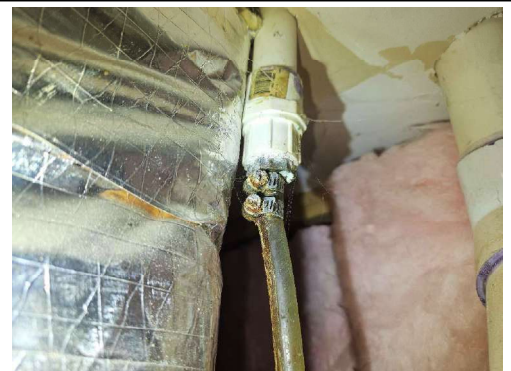
### 11. Needs Repair: Heating – Condensate Discharge – Rust/Deterioration –

There is some deterioration on the fitting between the flexible condensate discharge line and the main PVC discharge line at the furnace in the basement closet. Some rust stains are present and leaking is imminent. Recommend a qualified HVAC contractor evaluate and make the appropriate repairs to prevent any leaking.

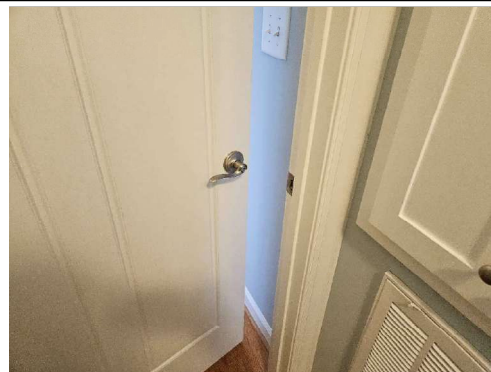
### 12. Needs Repair: Interior Doors - Door Not Latching -

The left front bedroom door will not latch properly when closed. Doors that do not latch properly cannot be properly secured. Have a professional interior trim contractor evaluate all of the doors throughout the home and make any necessary repairs to allow for proper operation.

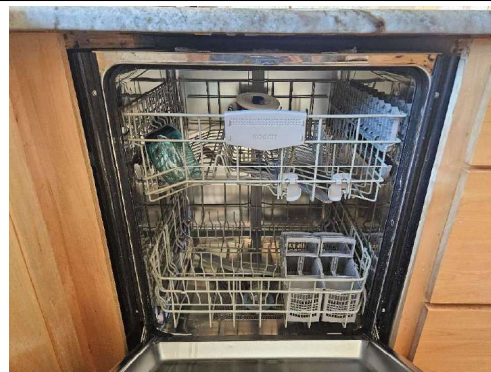
### 13. Needs Repair: Dishwasher - Dishwasher Not Secured Properly -

The dishwasher needs to be properly secured to the underside of the countertop and/or sides of the cabinet. (See Photo) The loose appliance can result in damage/personal injury. Recommend a professional contractor to properly secure the dishwasher.

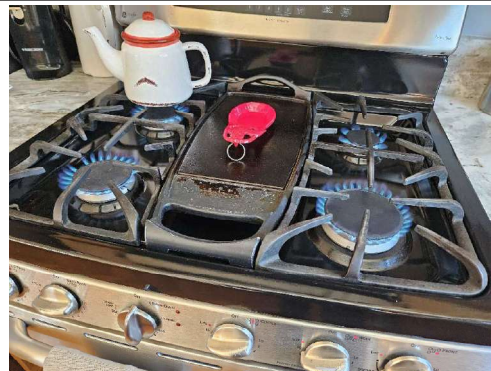
### 14. Needs Repair: Range - Missing Anti-Tip Bracket -

The anti-tip bracket required for safety on all freestanding ranges, was not installed at the time of the inspection. The anti-tip device can prevent personal injury/damage caused by the appliance tipping over due to weight added to the open door. Recommend a professional appliance installation contractor install this anti-tip device as required to prevent damage and personal injury.

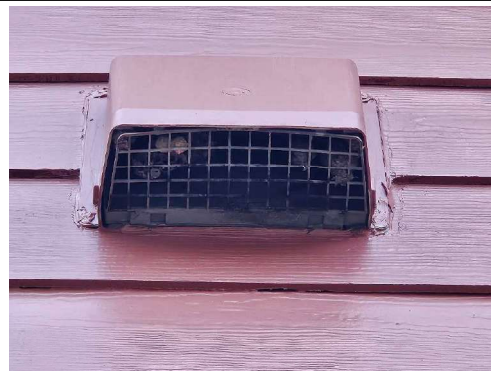
### 15. Needs Repair: Range Hood Vent - Insect Nests Inside Vent -

The range hood vent exhaust end cap has some insect nests present where it vents through to the exterior of the home. (See Photo) The baffle that closes when the vent fan is not operating is partially open at all times. Being open all the time allows air exchange between the exterior and interior of the house, as well as the possibility of vermin getting in the exhaust duct. Have a professional contractor make repairs/remove the insect nests so that the baffle closes fully when not being used.

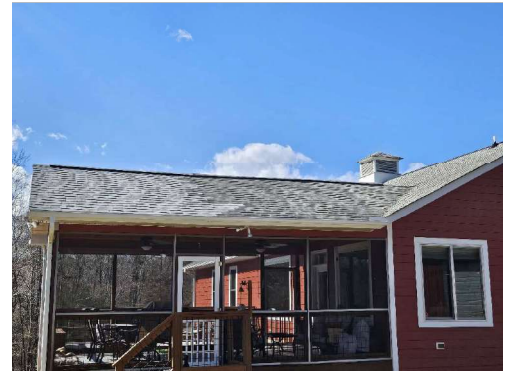
**16. Information/Observation: Roof Covering – Remodeling/Retrofit Roof Installation –**  
There is an area of the roof covering that appears to have been installed more recently than the original installation. Newer roofing shingles are tied into the existing back patio area. Evidence of extension on the deck also confirms that the rear enclosed patio of the home is a newer addition. No adverse signs were noted.

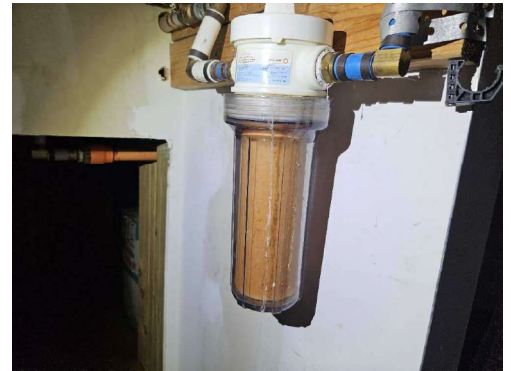
**17. Information: Whole House Sediment Filter System -** The main water supply line for this house is equipped with a whole house water filter that helps filter out high levels of sediment/contaminants from the water being delivered from the water supply. When low water pressure/volume levels are present in the house, the filter cartridge in this filter needs to be replaced.

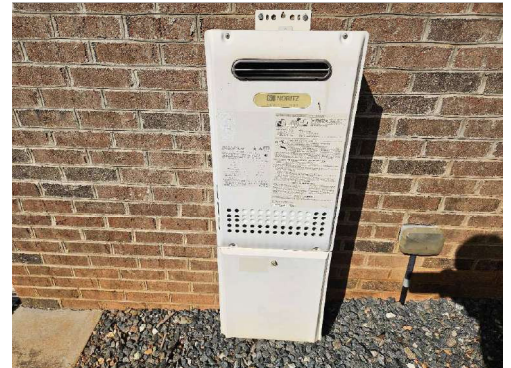
**18. Information/Recommendation: Water Heater – Water Heater Advanced Age –**  
The water heater in the home is original to the home's construction and is 18 years old. It is reaching the end of its lifespan. Recommend budgeting for replacement soon. Have a qualified plumber evaluate the water heater and perform the necessary repairs/replacement.

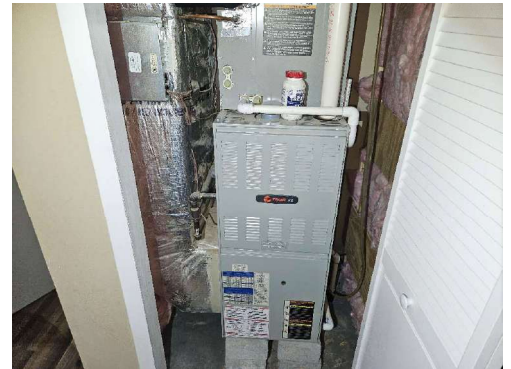
**19. Further Evaluation is Suggested: Older Furnace -**  
The average life expectancy of an HVAC system is about 13 years. Observed this HVAC system's furnace age to be near or to have surpassed 17 years. Even though the systems operated as intended at the time of inspection, it is suggested that a more thorough/invasive evaluation of the systems be provided by a professional HVAC contractor.

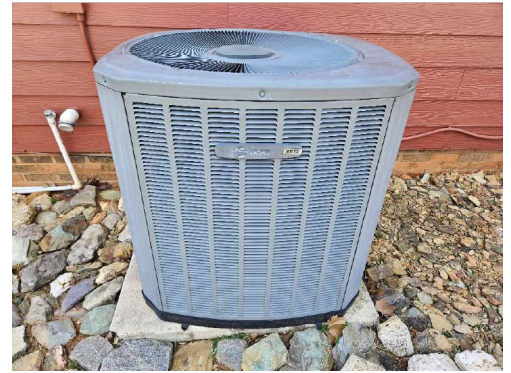
**20. Further Evaluation is Suggested: Older HVAC AC System -**

The average life expectancy of an HVAC system is about 13 years. Observed this HVAC system's AC age to be near or to have surpassed 17 years. Even though the systems operated as intended at the time of inspection, it is suggested that a more thorough/invasive evaluation of the systems be provided by a professional HVAC contractor.

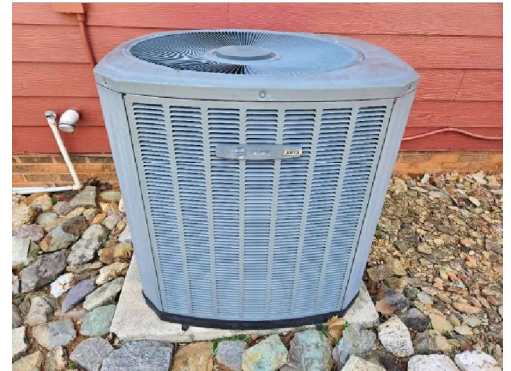
**21. Limited Evaluation: A/C Equipment -** The A/C systems were visually inspected only. Cooling function was not tested due to manufacturers recommendations not to operate when the outdoor temperature is less than 60 degrees.
