# Tim Wiggins Inspections

Name: Nikolay Wolff and Rebecca Hicks  
Address: \_\_\_\_\_  
\_\_\_\_\_  
Telephone Number: \_\_\_\_\_  
Inspection Ordered by: Agent  
Property Address: 358 Pool Rock Shores Lane  
Henderson, NC 27537  
Year Built/Structure Age \* : \_\_\_\_\_ Square Footage \* : 1950 sq ft  
Date Performed: March 26, 2024  
Reason for the Inspection: Prepurchase

## I. Foundation, Basement and Structure

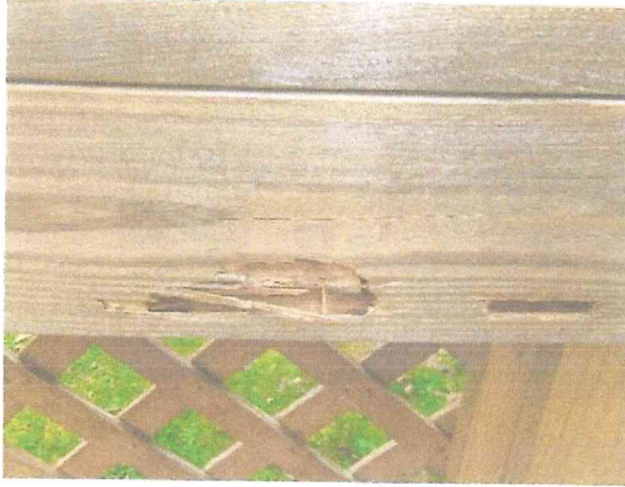
10. The back handrail on the back left deck has insect damage on the upper railing. This is a safety hazard. A licensed contractor should evaluate the damage to the deck handrail and repair as needed.

1. Insect damage is present on the back deck railing on the left side deck.

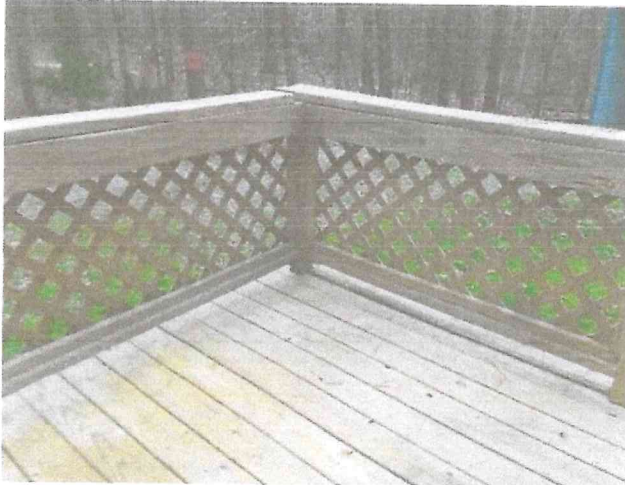
9. The lattice handrailing on the exterior decks are a possible safety hazard. A licensed contractor should evaluate the deck handrail and take corrective action as needed.

2. The lattice handrail on the exterior decks is a possible safety hazard.

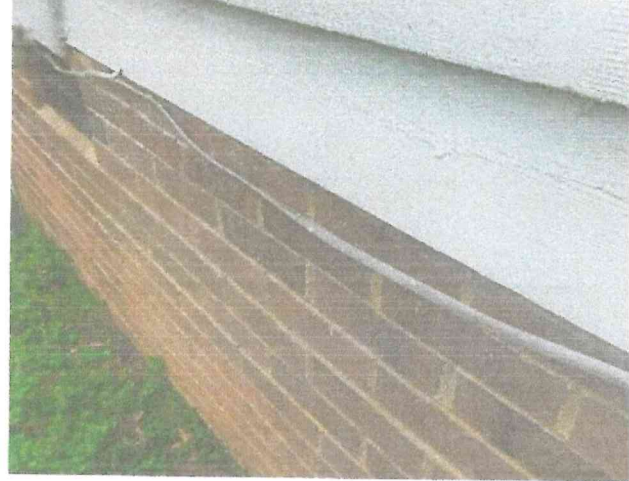
8. Electrical wiring is exposed on the exterior of the structure on the left side of the home at the bottom of the wood siding. The exposed wiring is susceptible to damage. This is a safety hazard. Repair needed.

3. Electrical wiring is exposed on the left side of the structure at the bottom of the wood siding.

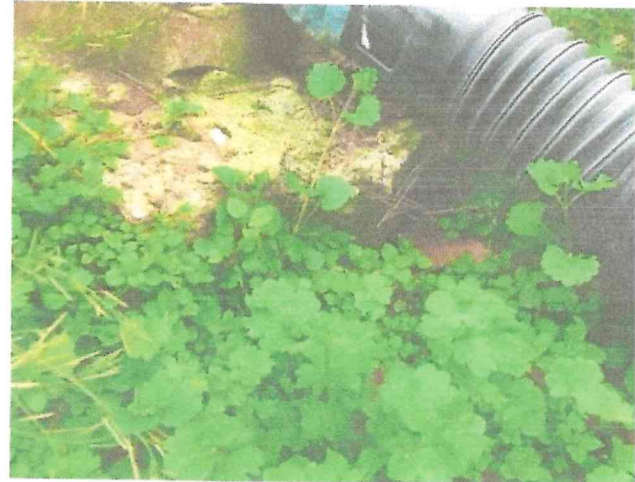
4. The concrete footer for the foundation for the right side addition has been undermined by erosion at the back right corner of the foundation. An extension has been installed on the gutter downspout in this area to help move water away from the structure. The soil grade in this area should be corrected to help move water away from the foundation.

4. Erosion is undermining the concrete footer for the brick foundation at the back right corner of the structure.

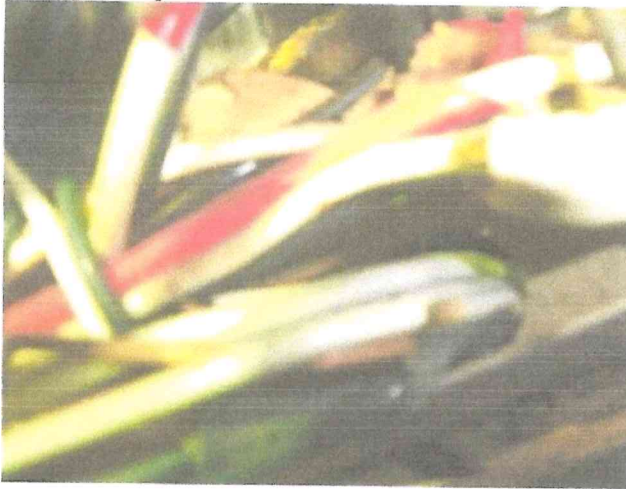
5. Electrical wires enter the bottom of the electric service panel through an open knockout. The wires are not adequately protected at the open knockout. This is a safety hazard. Repair needed.

5. Electrical wiring enters the electric service panel through an open knockout.

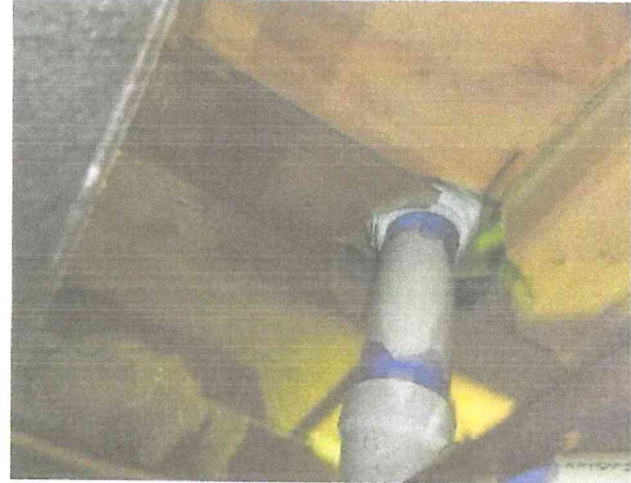
7. Adequate rodent proofing material is not installed at the subfloor penetrations for the plumbing drainpipes.

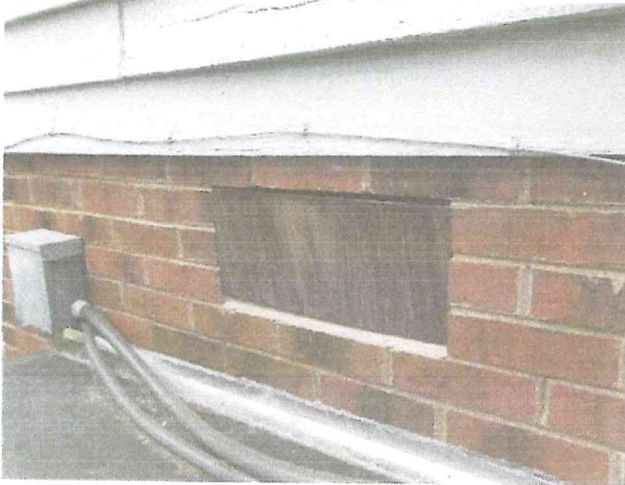
5. One of the foundation vents on the back side of the structure has been sealed with a piece of plywood. The foundation vent cannot perform its intended function. Corrective action needed.

6. One of the foundation vents at the back side of the structure is covered by plywood.

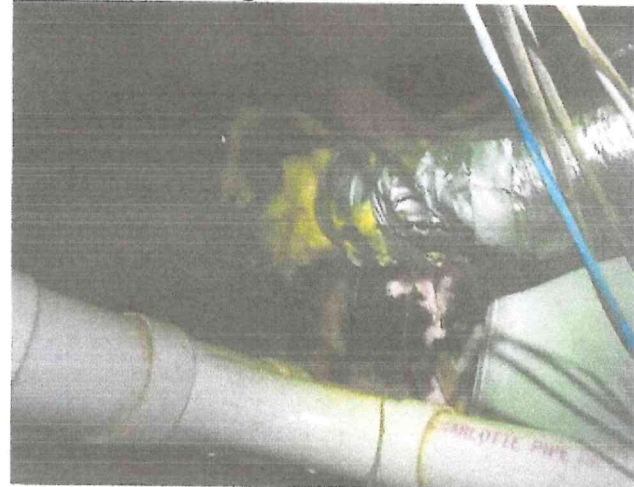
1. Air supply ducts in the crawlspace are damaged in the original section of the crawlspace. At least one section of the duct work will need replacement. A licensed contractor should evaluate all duct work in the crawlspace and repair/replace as needed.

8. Duct work in the original section of the crawlspace is damaged.

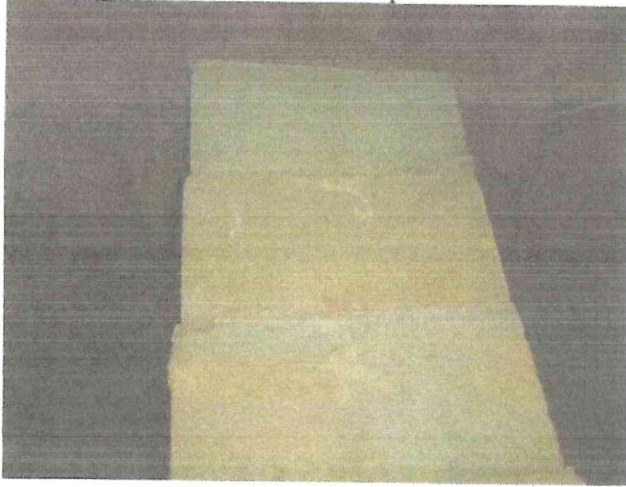
9. Some of the foundation support pilasters in the original section of the crawlspace as constructed with dry stacked concrete block pilasters.

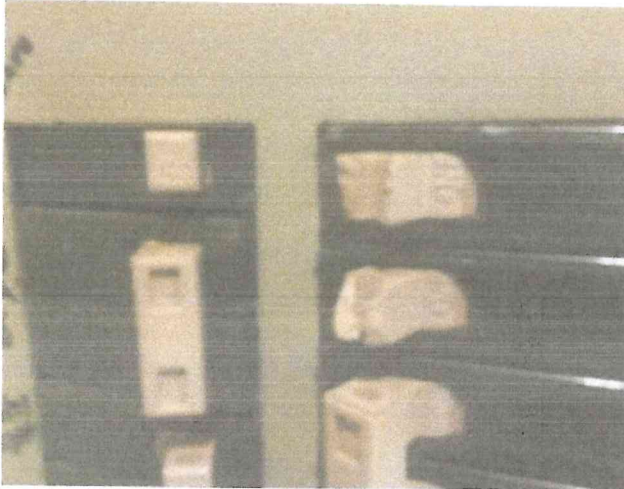
6. Two of the breaker handles are damaged at the top right corner of the electric subpanel. Replacement of the damaged breakers will be needed.
7. Two receptacles in the family room bath that are identified with blue stickers have open grounds. This is a safety hazard. A licensed electrical contractor should evaluate the open ground condition on the subject receptacles and take corrective action as needed.

10. Two of the breakers in the electric subpanel are damaged.

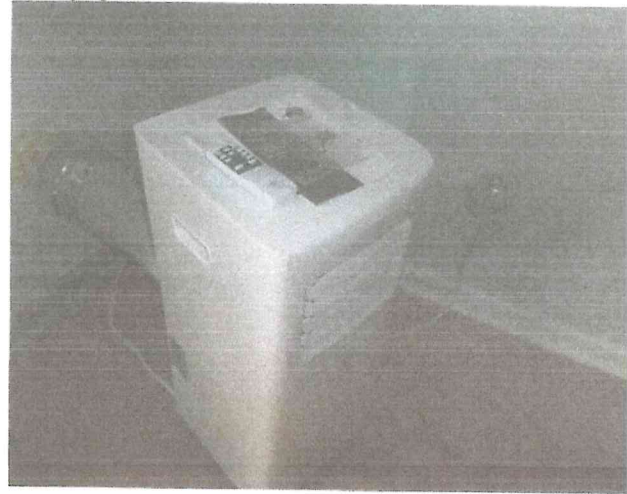
11. A portable AC unit is present in the upper level living space.

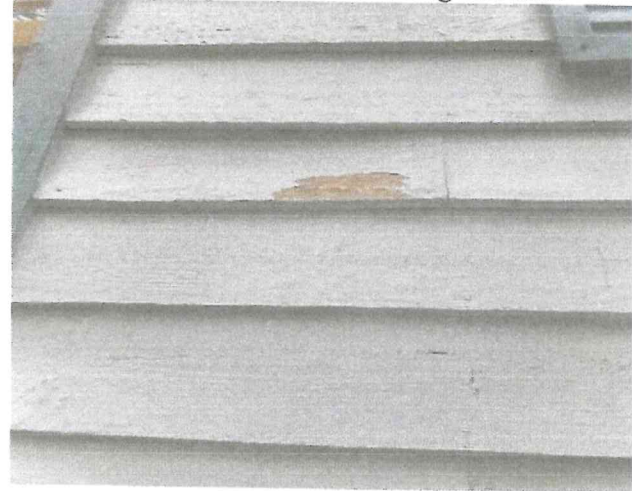
8. The paint on the exterior of the structure is peeling. After repairs have been made to the exterior siding and trim, the exterior siding and trim will need to be cleaned, caulked, and painted to prevent moisture penetration and possible damage.

12. Paint is peeling on the exterior siding and trim.

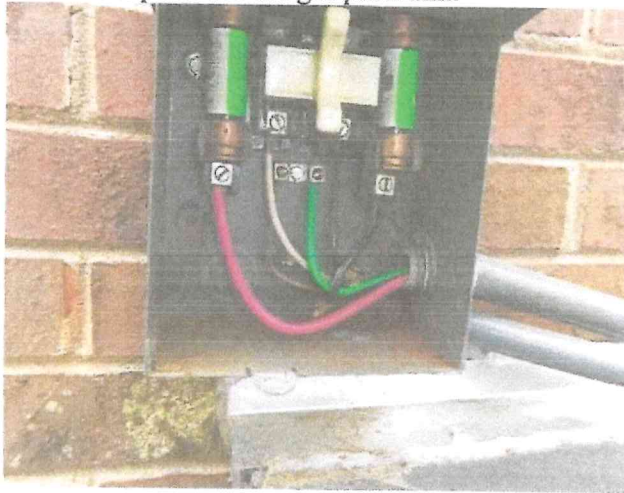
10. No dead front cover is installed on the gas pack disconnect panel. Hot electrical connections are exposed. This is a safety hazard. Repair needed.

13. No dead front cover is installed on the disconnect panel for the gas pack unit.

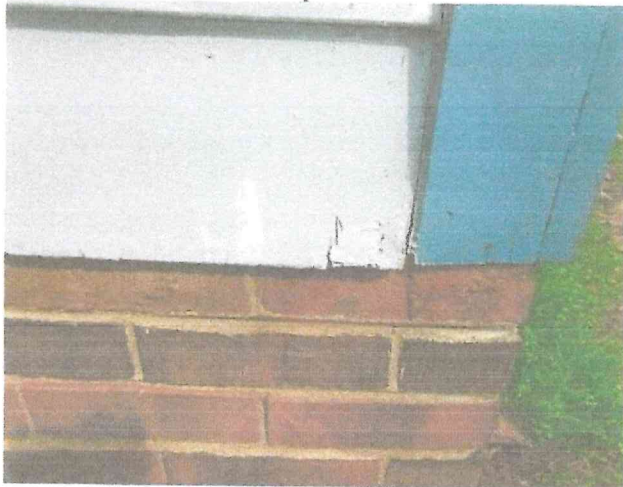
6. The hardboard siding is damaged at the right end of the front porch and above the back deck area. All damaged hard board siding should be repaired or replaced to prevent moisture penetration and possible damage.

14. The hardboard siding has moisture damage near the right end of the front porch.

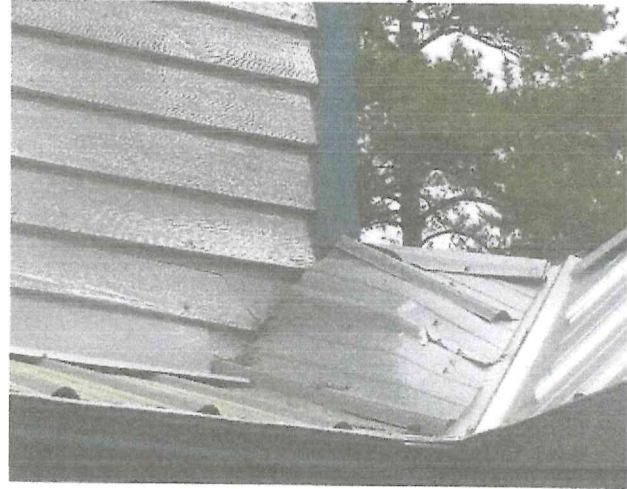
1. Roof flashing is improperly installed where the gazebo roof blends into the front porch roof. A qualified roofing contractor should evaluate the roof flashing in this area and take corrective action as needed to prevent leakage and possible damage.

15. Roof flashing is improperly installed at the gazebo roof intersection with the porch roof.

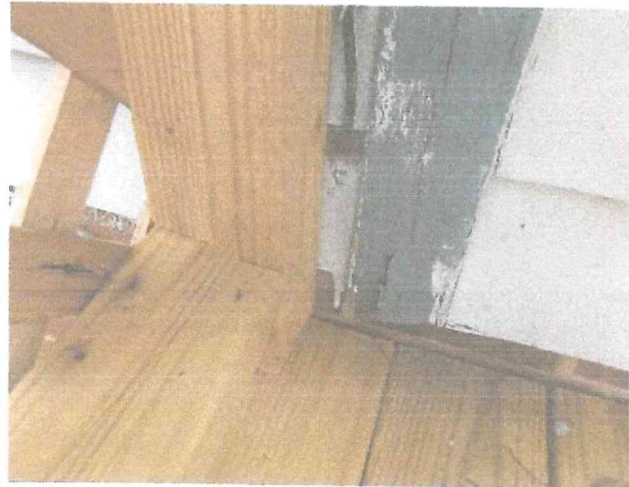
7. Water damage is present on the vertical trim board above the left side deck near the back side of the exterior door. All damaged trim should be repaired or replaced to prevent moisture penetration and possible damage.

16. Moisture damage is present on the vertical trim board at the back right corner of the left side deck.

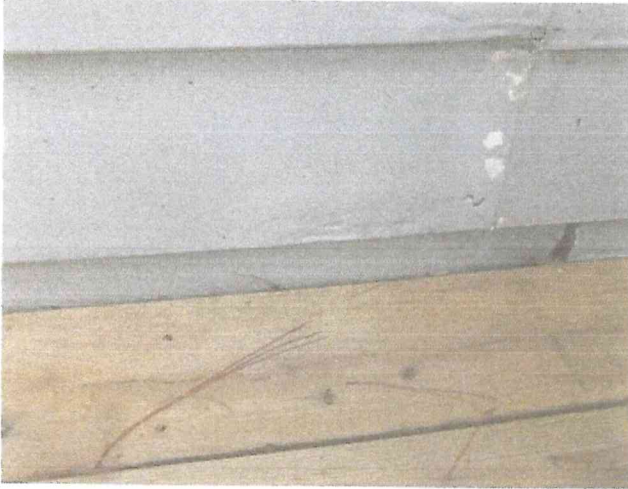
17. Moisture damage is present on the hard board siding above the back right deck floor surface.

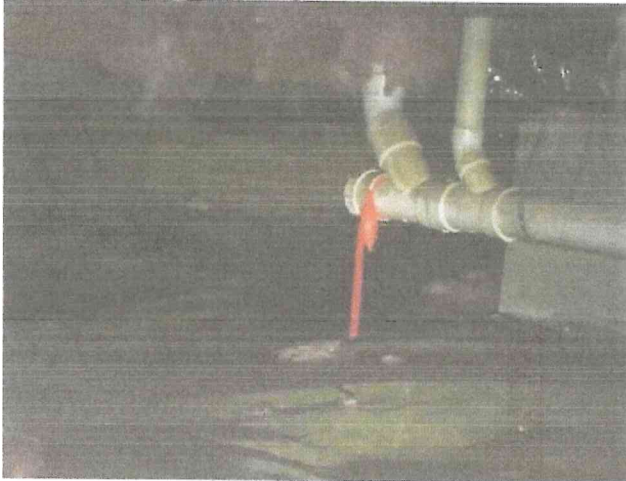
6. There is a leak on the main drainpipe in the right side addition crawlspace. The leak in the crawlspace is identified with an orange ribbon. Repair needed.

18. There is a drain leak on the main drain pipe in the right addition crawlspace.
