**On-site Wastewater Inspection**

**Property Address: 107 Edgewood Drive, Oxford, NC 27565**

**Date of Inspection: April 30, 2025**

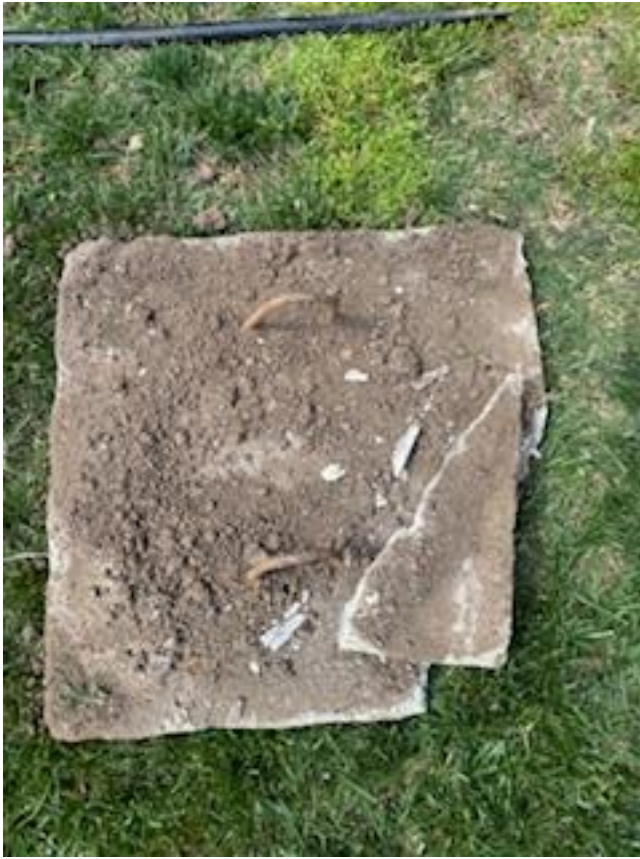
YES – Damage to system components – **Tank lid was broken on inlet side – we replaced with new**

- Septic tank is original to property
- SEPTIC INLET RISER LID HAD A CRACK IN IT AND WHEN WE PULLED IT THE LID BROKE - WE REPLACED WITH NEW
- SEPTIC TANK INLET INTERIOR LID HAD NO HANDLES – WE REPLACED WITH NEW

BROKEN RISER LID

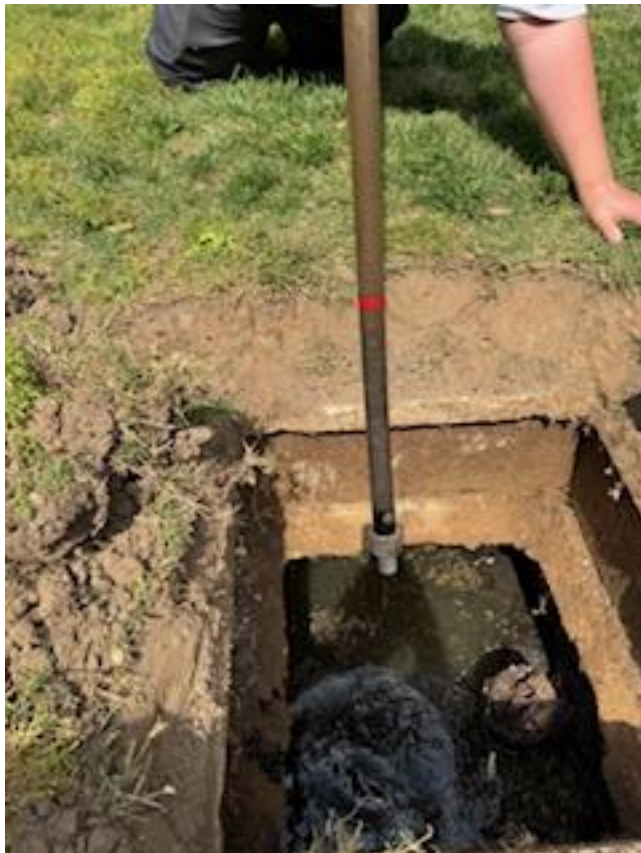
SLUDGE LEVEL - 12"

**YES- TANK NEEDS TO BE PUMPED DUE TO SOLIDS GREATER THEN 10% OF TANK**

SLUDGE MEASUREMENT

- TANK WAS NOT PUMPED AT INSPECTION - recommend pumping
- Currently there are NO signs of failure or malfunction in the drain field- Recommend septic system under normal operation of at least 2 weeks to determine full functionality.

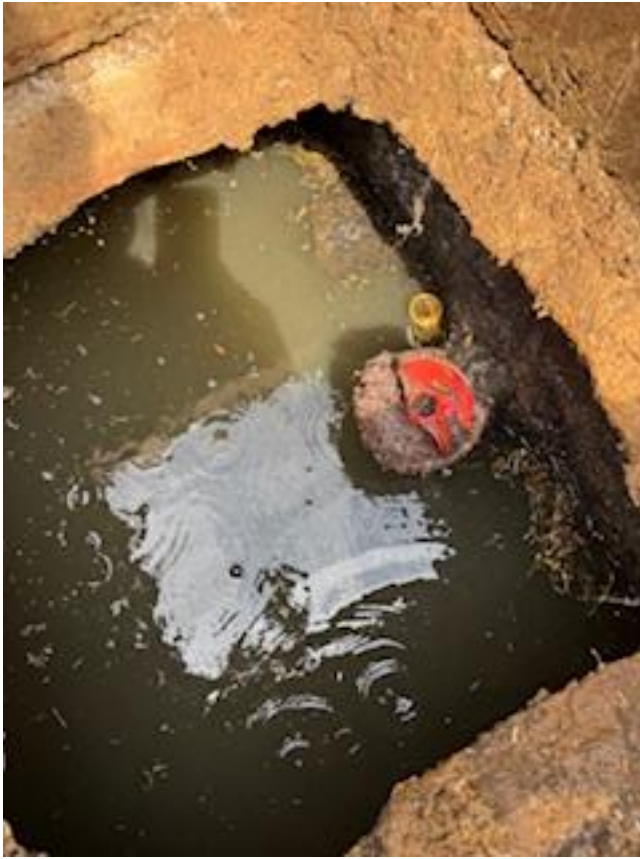
YES - Outlet T is present - PVC

YES - Outlet has filter

TANK OUTLET TEE AND FILTER

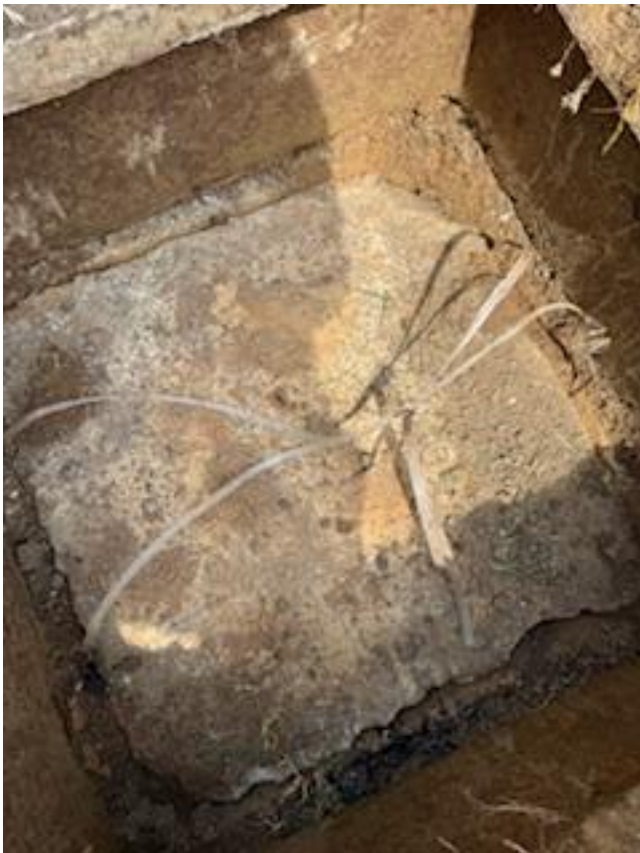
INTERIOR LID – NO HANDLES

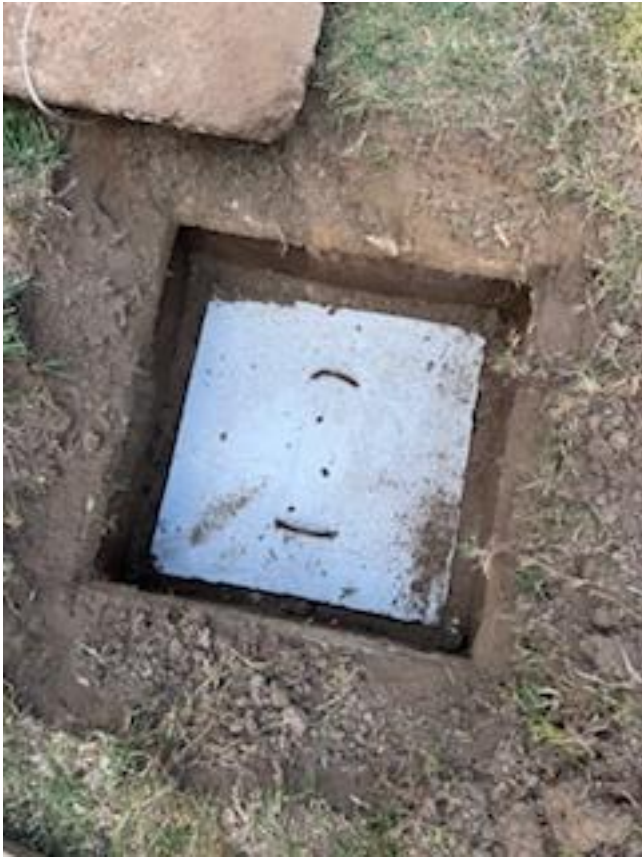
NEW INTERIOR LID

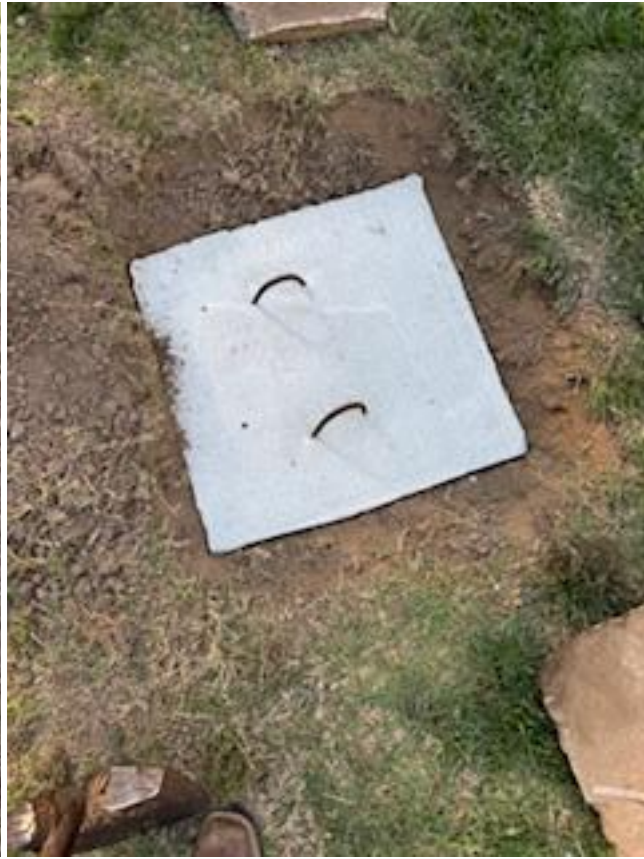
NEW RISER LID
