# Inspection Report

06.18.25

1984 Sadler Avenue  
Creedmoor, NC 27522

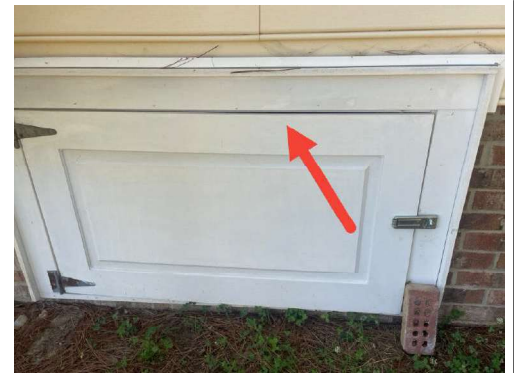
1. Needs Repair: Crawlspace Door- Not Properly Sealing- Observed the crawlspace door, not properly sealing at the top when closed. Currently in this condition, vermin and pest can enter inside of the crawlspace. Recommend a contractor make repairs to provide a proper seal around the crawlspace door when closed.

Note from owners: Door was not properly closed the last time that it was accessed, added weatherstripping as a precaution

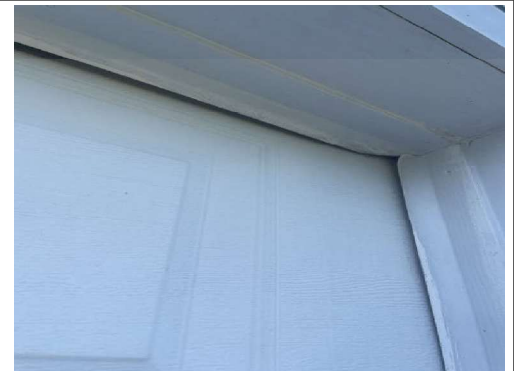
2. A) Needs Repair: Garage - Damaged Weather Stripping - Observed damaged weather stripping at the top, right side and bottom left corner of the garage door. Gaps in the weather stripping can allow pests into the area/home. Recommend that a professional contractor evaluate the garage door and replace/repair weather stripping as necessary.

B) Needs Repair: Garage - Garage Door Not Sealing at the Slab - The garage door is not sealing across the length of the lower door panel at the cement slab. The opening currently present can allow access of water and vermin into the garage. Have a professional contractor make the necessary repairs to allow the door to seal when closed.

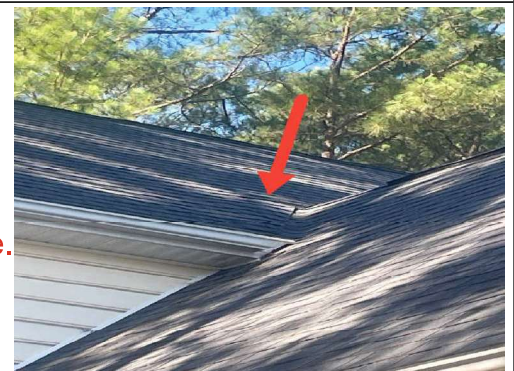
3. Needs Repair: Roof Covering - Raised Shingles - Observed a few raised shingles on the front roof. Raised shingles can allow moisture to penetrate under the roof covering that can result in damage, as well as exposing the shingle to further damage during high wind conditions. Have a professional roofing contractor evaluate the entire roof and make the necessary repairs for proper installation and long term serviceability.  
NOTE: This is a double layered roof.

Note from owners: Roof is not a double layer, only at the ridge. We had Steve at ProCraft Restoration come out June 17th, 2025 and he did not find any issues with the roof. He can be reached at 919-710-2005 if there are questions.

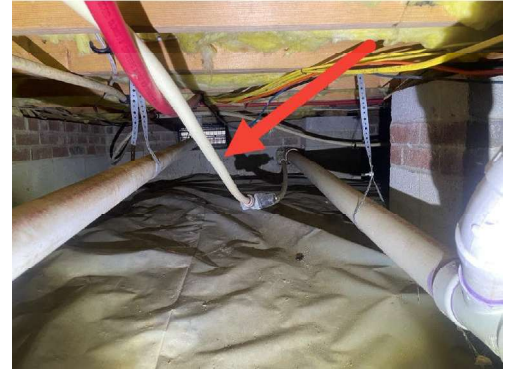
4. Needs Repair: Water Supply Plumbing Support - Unsupported Main Water Line - The water supply plumbing main water line is not properly supported inside the crawlspace. Unsupported water lines can result in damage to the plumbing. Have a professional plumbing contractor evaluate the water supply lines serving the home and make any necessary repairs to properly support all of the water supply plumbing.

**Note from owners: This has been repaired**

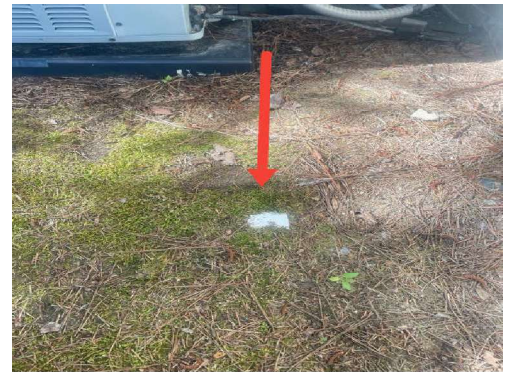
5. Needs Repair: Waste Plumbing - Exposed Waste Pipe Outside the Foundation - The main waste drain line drain just outside the foundation wall is exposed at the surface dirt grade. Installation requirements of plumbing waste lines call for no drainage piping (other than a cleanout) to be installed outside of or under a building in an exposed, open or unheated area. Measures should be taken such that the waste drain pipe is installed so that none of the pipe is exposed to possible damage.

**Note from owners: This has been covered so it is no longer exposed**

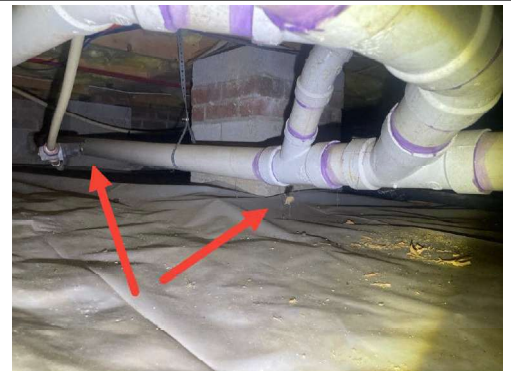
6. Needs Repair: Waste Plumbing Support/Slope - Waste Water Lines - The main waste water line is not properly sloping inside the crawlspace. Not properly sloping waste pipes can result in damage to the plumbing and leaking. Have a professional plumbing contractor evaluate the plumbing waste pipes serving the home and make any necessary repairs to provide proper installation to all of the water supply/waste plumbing.

**Note from owners: House was constructed in this manner. We have not had any issues with the plumbing in the home.**

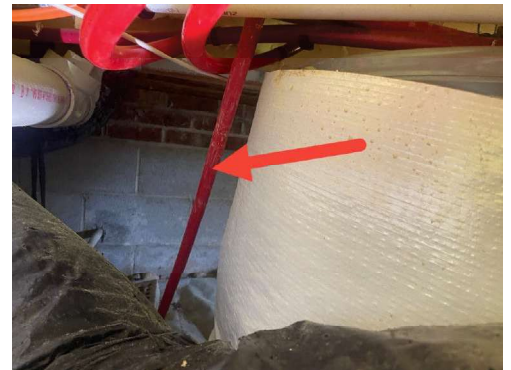
7. A) Needs Repair: Water Heater Safety - Pressure Relief Drain Line Not Properly Installed - Observed the PRV (pressure relief valve) discharge pipe is not installed properly on the relief valve servicing the water heater. Professional plumbing contractors that replace equipment with new, must upgrade systems to comply with current code requirements. Current plumbing standards require that the discharge pipe on the high pressure relief valve extend to the exterior of the foundation within 6" of grade. Have a professional plumbing contractor properly install discharge pipe per current plumbing standards due to the presence of a newly installed appliance. At a minimum, this discharge pipe should be installed so that it vents to within 6" of the grade surface at the base of the appliance.

B) Needs Repair: Water Heater Safety - Thermal Expansion Tank Not Pressurized - The thermal expansion tank (TET) on the water supply plumbing system was observed to not be pressurized. This tank compensates for increased water pressure resulting from the stored heated water in the water heater. Tank not being pressurized will not help protect the water supply pipes. Have a professional plumbing contractor service this device and make any repairs necessary in order to provide proper installation.

>>> Note: The tank pressure should be verified as being pressurized so that it matches the pressure setting of the PRV (pressure regulating valve) - whole house water pressure.

**Note from owners for 7A: We spoke with Brandon at Lester's Plumbing service about this and he stated this is a common occurrence and not concerning.**

**7B: The thermal expansion tank is being replaced June 23rd, 2025.**

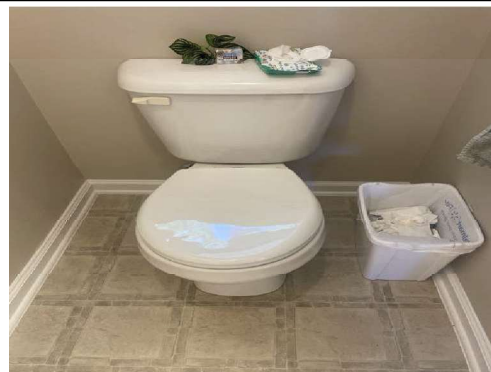
8. Needs Repair: Bathroom Toilet Loosely Installed at Floor -  
The primary bathroom toilet is loosely connected to the floor. This can result in damage/leaking. Recommend that a professional plumbing contractor fully evaluate the toilet and make the necessary repairs for proper installation and long term serviceability.

**Note from owners: Toilet is being repaired June 23rd, 2025.**

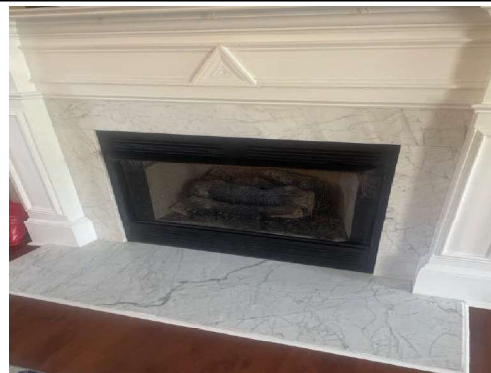
9. Needs Repair: Fireplace Gas Log Set - Not Operational - No Gas Supply-  
The fireplace gas log set was not operational at time of inspection. No gas supplied to logs. Have a professional contractor evaluate the log set and make the necessary repairs after gas is available.

**Note from owners: We no longer rent the propane tank for this fireplace. At the time we purchased the house, it was functioning. We have never used the fireplace.**

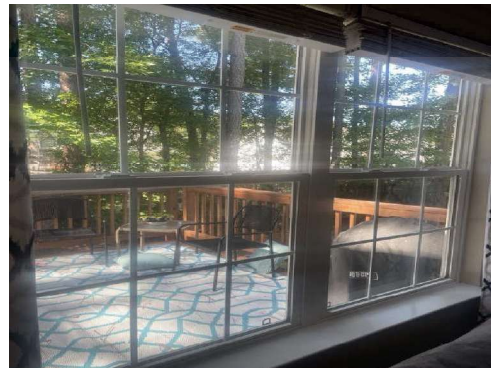
10. A) Needs Repair: Windows - Vinyl Windows Hard to Open -  
Observed a few of the vinyl windows in the home to be difficult to open. Windows that are difficult to open can slow or prevent egress during an emergency situation, and can result in damage to the sash support components of the windows. Recommend that the window frame tracks be cleaned, lubricated, and serviced if necessary, at this time for proper operation to be possible.

B) Needs Repair: Windows - Windows Not Holding Position -  
Observed the window near the front porch to not hold position once the windows were raised/unlocked. Windows that will not stay in position can prevent use/result in damage to the windows. Recommend that a professional window installation/service contractor evaluate all of the windows throughout the home and make any necessary repairs to allow for proper operation.

C) Needs Repair: Windows - Broken Window -  
Observed a broken window in the primary bathroom above the toilet. The broken window will not properly insulate the area, and broken glass can be a hazard. Recommend that a professional window repair/installation contractor replace the damaged glass unit.

D) Needs Repair: Windows - Window Glass Unit Seal Failure -  
Glass unit insulation seal was observed to be compromised in the primary bedroom window. Compromised glass seals may not necessarily be limited to just the glass units noted. Signs of compromised glass seals can be masked by weather conditions, lighting, and cleanliness of glass at the time of the inspection. Have a professional window pane replacement company evaluate all of the glass units in the home and make the necessary repairs/replacement to restore the insulation integrity of any units determined to have bad seals.

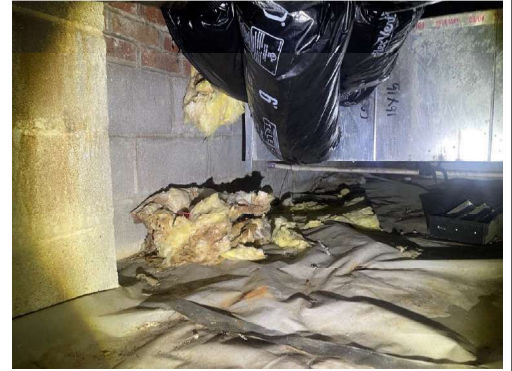
**11. Needs Repair: Crawlspace Insulation - Fallen/Missing Insulation -**  
Some crawlspace insulation is falling down or missing at the right side of the HVAC unit. This will reduce the "R" value across the floor. Have a professional contractor evaluate all of the insulation in the crawlspace area and repair/replace insulation at any location where insulation is not properly installed or deteriorated.

**Note from owner: Insulation in crawl space is being replaced and secured in this area.**

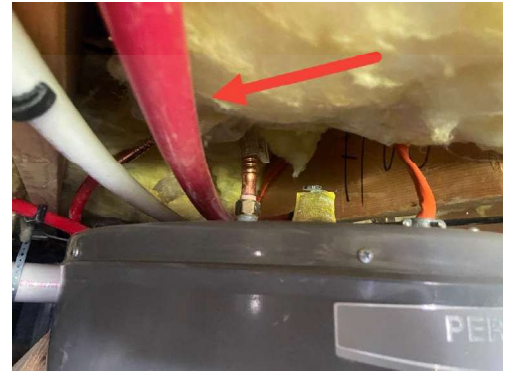
12. Suggestion: Water Pipe Insulation - Hot water lines should be insulated to help water heater be more energy efficient. The location of the water heater being in an unconditioned space allows uncontrolled air to cool water in the lines.

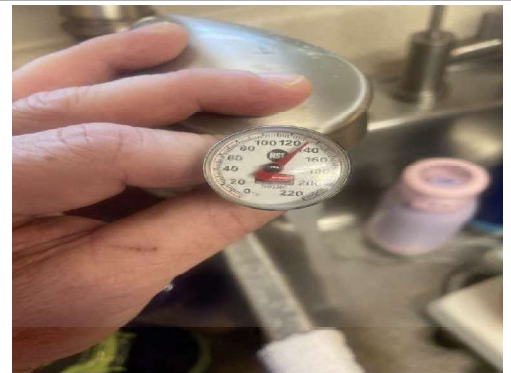
13. Information/Recommendation: Water Heater Temperature Adjustment Suggested - The water heater was inspected and operated as intended at the time of the inspection. The water temperature was measured at 135 and noted as being higher than what safe/economical levels would recommend - in excess of 110 degrees. The U.S. Consumer Product Safety Commission (CPSC) urges all users to lower their water heaters to 110 degrees Fahrenheit. In addition to preventing accidents, this decrease in temperature will conserve energy and save money.

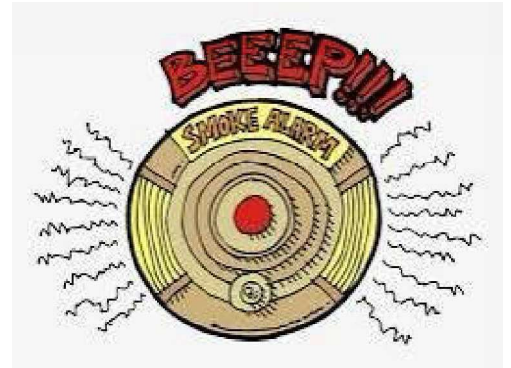
14. Information: Smoke Detectors - Smoke detection device installation appears to be typical for the time period of the home's construction. Change out batteries (if provided with a backup power source) on all smoke detectors annually in order to provide a continued backup power source for detectors during periods of interrupted power outages.

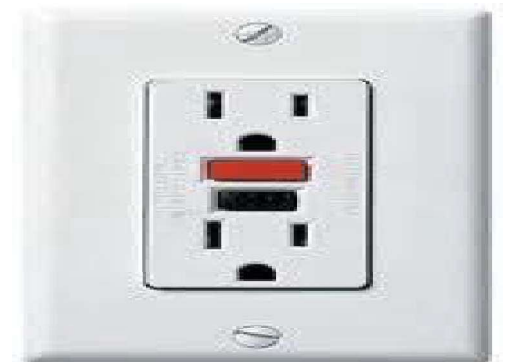
15. Information: GFCI Outlets- Bathroom Outlets-

The first floor half bathroom, second floor hall bathroom and primary bedroom bathroom GFCI outlets were tested. All outlets tripped and reset. The second floor bathroom and primary bathroom outlets will not reset on there own. You have to reset the first floor half bathroom outlet first. The first floor half bathroom outlet controls all the bathrooms outlets.

**Note from owner: This is a common occurance for GFCI outlets to be linked together.**

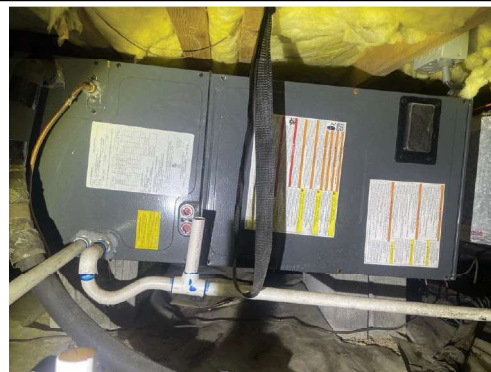
**16. Limited Evaluation: Heat Pump - Outdoor Temperature Above 60 Degrees** - When outdoor temperatures exceed 60 degrees, the heating function of a heat pump will not be tested due to manufacturers' recommendations not to operate above that outdoor temperature limit. The heating function of a heat pump should be considered operating properly if the cooling (AC) operated properly. Recommend having a professional HVAC contractor further evaluate the HVAC system prior to closing.

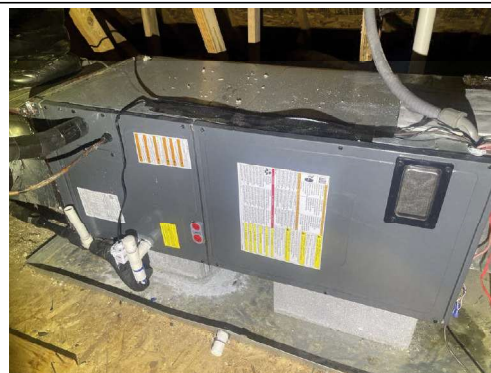
**17. Limited Evaluation: Heat Pump - Outdoor Temperature Above 60 Degrees** - When outdoor temperatures exceed 60 degrees, the heating function of a heat pump will not be tested due to manufacturers' recommendations not to operate above that outdoor temperature limit. The heating function of a heat pump should be considered operating properly if the cooling (AC) operated properly. Recommend having a professional HVAC contractor further evaluate the HVAC system prior to closing.

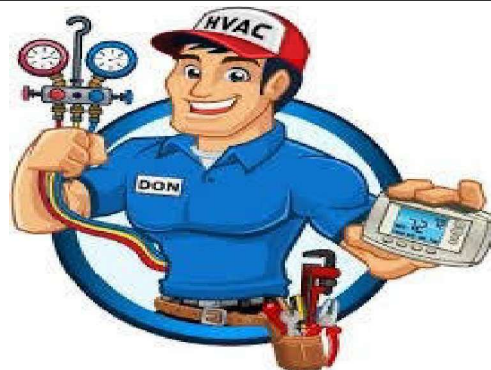
**18. Information/Recommendation: General HVAC Maintenance** - Manufacturer recommended maintenance service cleaning to be provided annually on all HVAC systems. It is known that an A/C system can lose up to as much as 10% operating efficiency a year if not being properly maintained. At a minimum, maintenance service should be provided no less than every three years in order to maintain operating efficiency above seventy percent. If preventative maintenance records cannot be provided demonstrating that the system has been serviced in the past 3 years, it is strongly suggested that a HVAC contractor provide further evaluation of this system including cleaning the evaporator and condensing coils, checking refrigerant levels/pressures and a visual inspection of the heat exchanger (gas furnaces only) as part of a scheduled maintenance service. If more than 1/2 pound of refrigerant was required to refill the system, leak checking should be performed in order to ensure that a leaking condition is not present in the system. If records are provided, it is recommended to review the service receipt in order to determine what services were provided.

**Note from owner: HVAC serviced June 17th, 2025**

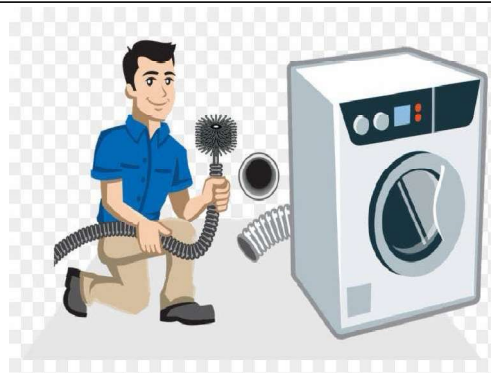
**19. Information: Dryer Vent System** - This exhaust duct system should be checked periodically for lint build up which can be a safety hazard. If dryer drying time is observed to be taking longer than usual, clean the duct lines and or roof end vent cap that may have become clogged with build up of lint. Testing of air flow and/or visible inspection of the exhaust duct end cap was not completed. If service records cannot be provided by the current owner demonstrating that this duct run has been cleaned in the recent past, it is suggested that this service be provided due to known lint build up that occurs over time of use.
