**On-site Wastewater Inspection**

**Property Address: 2253 Highway 96, Franklinton, NC , 27525**

**Date of Inspection: June 20, 2025**

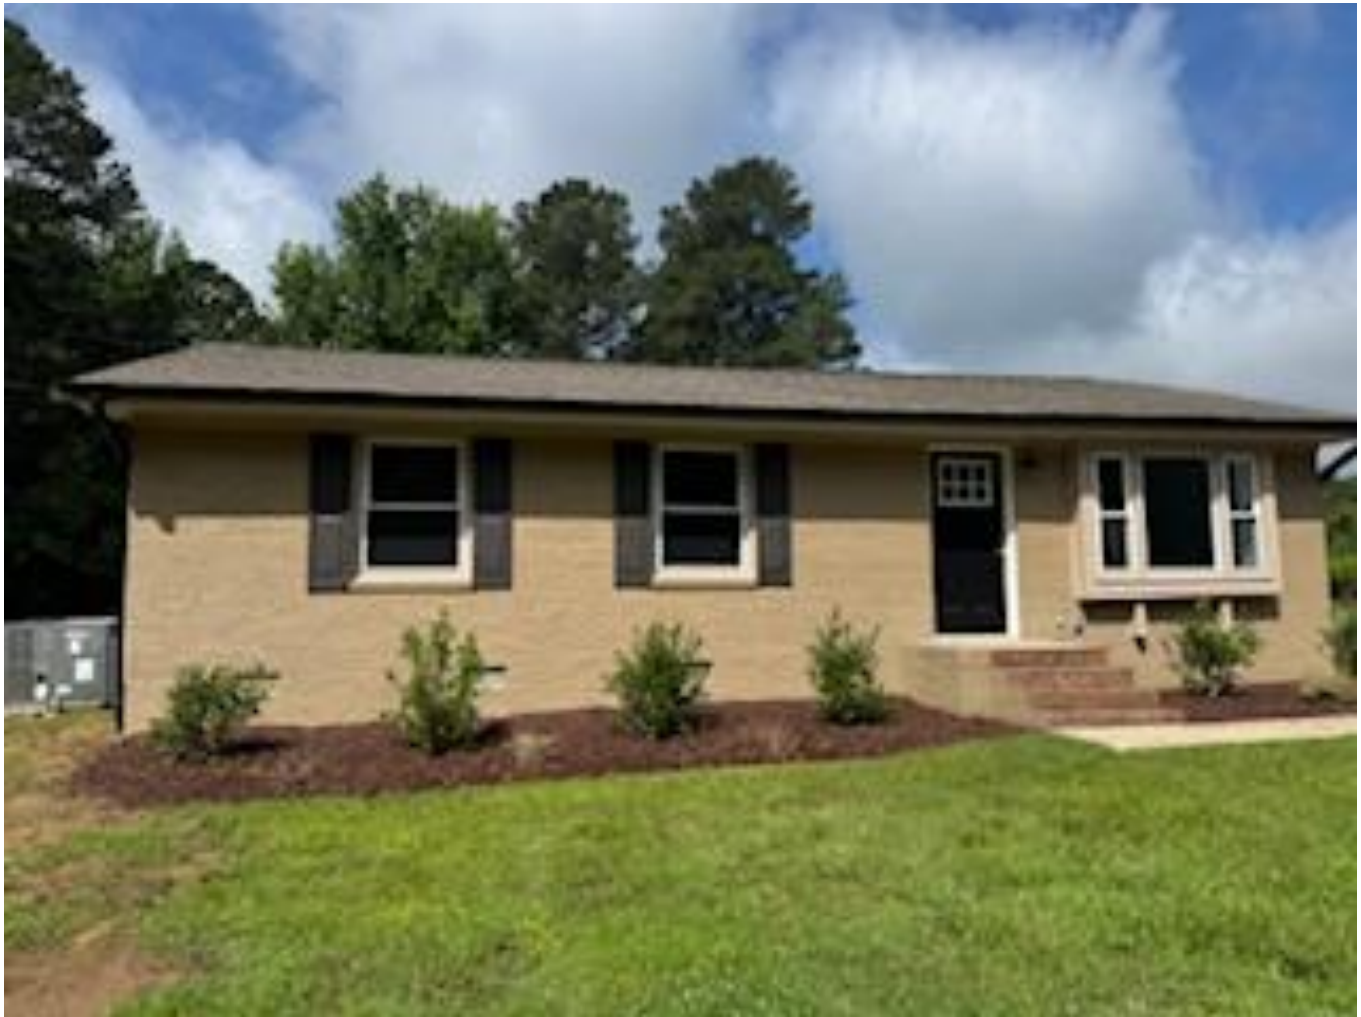
**HOUSE** – HOUSE UNOCCUPIED

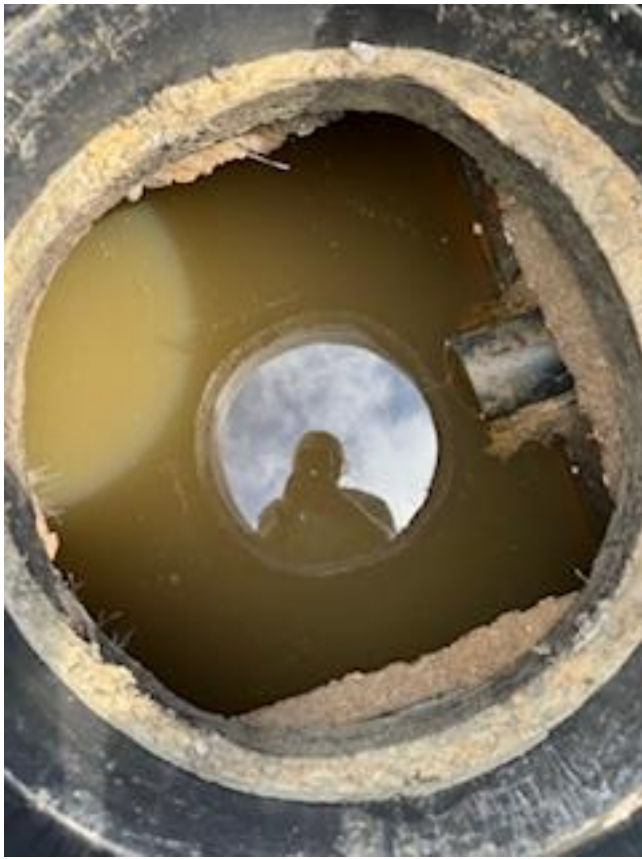
INLET OF TANK

INLET - SCUM LEVEL – 0"

SLUDGE LEVEL - 18"

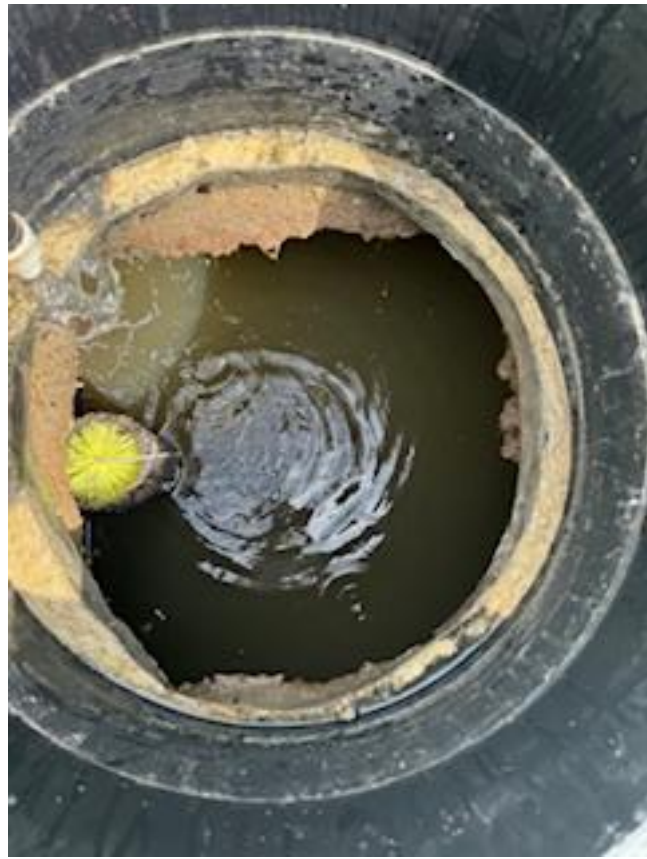
OUTLET OF TANK

OUTLET – SCUM LEVEL– 0"

SLUDGE LEVEL - 24"

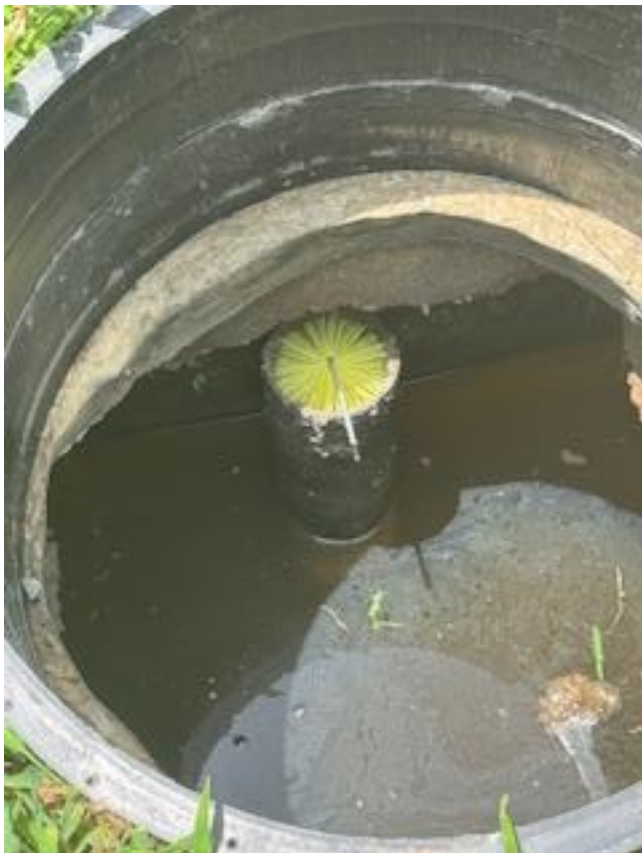
TANK TEE and FILTER – OUTLET

YES - Outlet T is present -PVC

YES - Outlet has filter

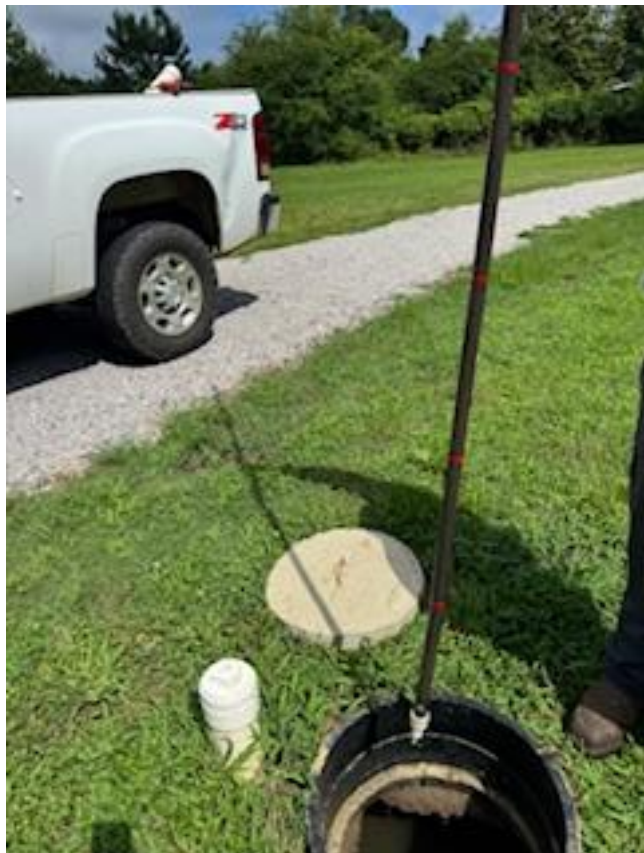
OUTLET SLUDGE MEASURE and CLEANOUT

**YES - TANK NEEDS TO BE PUMPED DUE TO SOLIDS GREATER THEN 10% OF TANK**

- TANK WAS NOT PUMPED AT INSPECTION - Recommend Pumping
- Currently there are NO signs of failure or malfunction in the drain field
- Septic tank is original to property

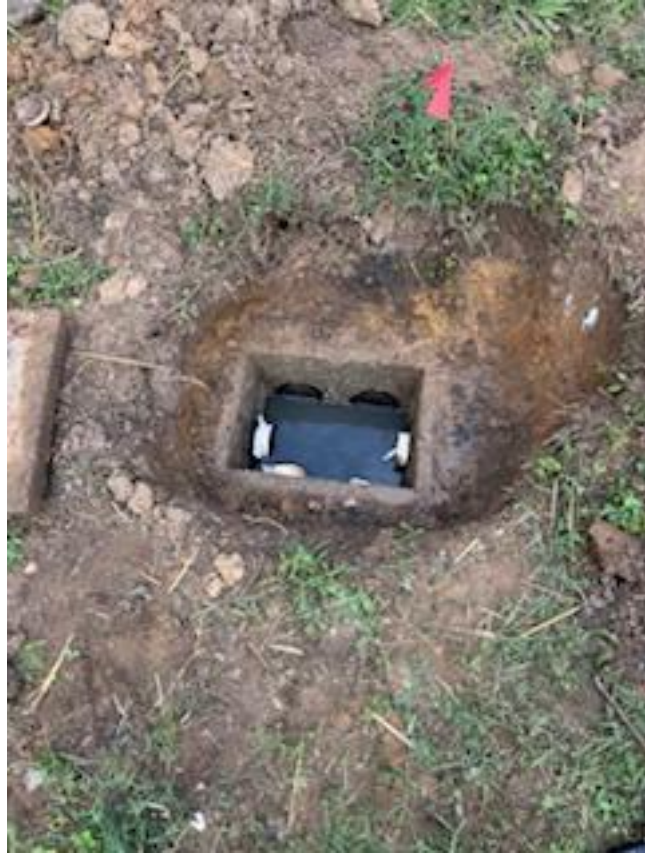
DISTRIBUTION BOX

Dispersal field: Type of system: **Gravity to Distribution Box to EEZZ-FLOW**

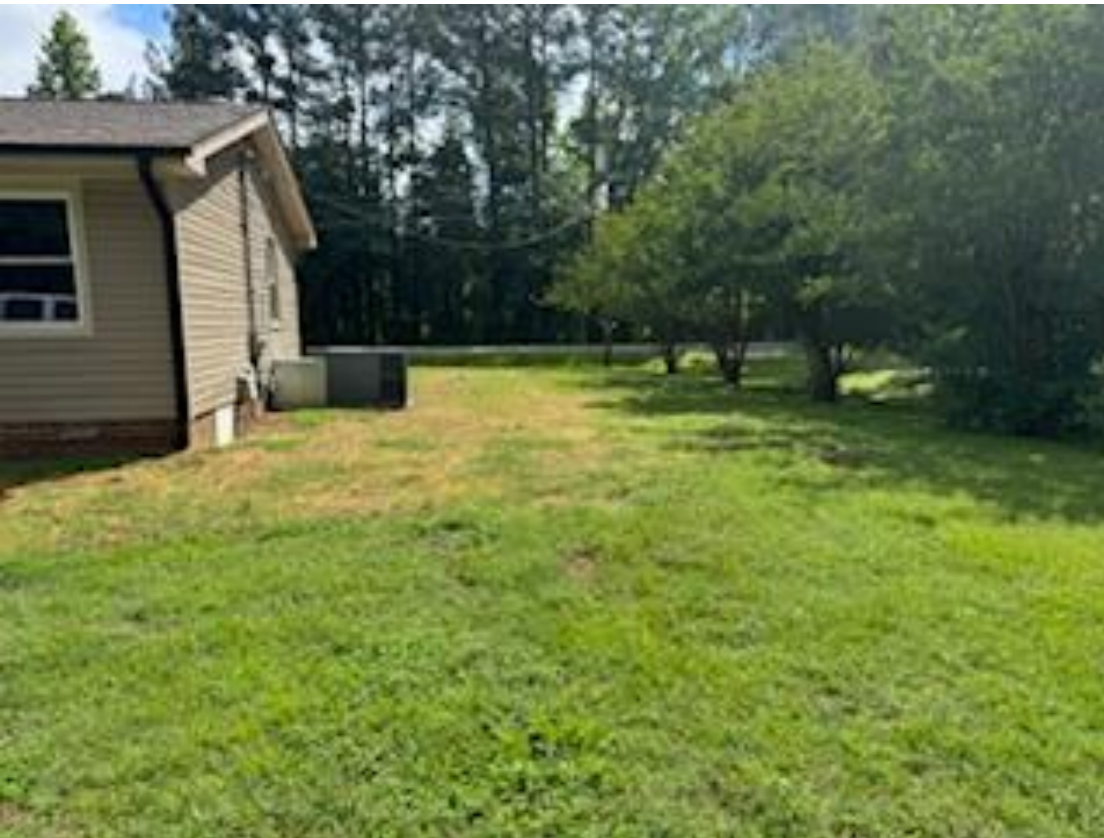
DRAIN FIELD

- **DEPTH OF LINES: 12-24"**
- **WIDTH OF DRAINLINES: 36"**
- **LENGTH OF DRAIN LINES: 2 at 95 ft each , 1 at 80 ft**
- **DISTRIBUTION – TOTAL LENGTH: 270 ft**

**NO** - Evidence of past or current surfacing at time of inspection

**YES** - Vegetation, grading and drainage noted that may affect the condition of the system or system components

**YES** - Effluent is reaching the dispersal field

- Do not drive over septic tank or drain field
