# HouseMaster®

## ON-SITE WASTEWATER INSPECTION

6641 Woodlawn Dr, Oxford, NC 27565

06-24-2025

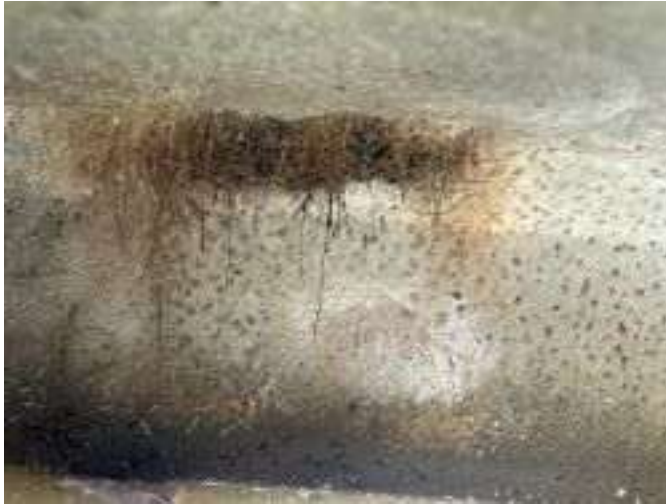
Are roots present in the tank? ☒ Yes ☐ No, Describe: Root intrusion noted at the baffle wall

Baffle wall with root intrusion.

Any adverse conditions present that require repair or subsequent observation or warrants further evaluation by a septic contractor or the local health department? ☒ Yes ☐ No  
If yes, describe the conditions: Root intrusion noted at the baffle wall, Pressure pipe inside the pump tank is leaking. Recommend qualified septic tank contractor repair.

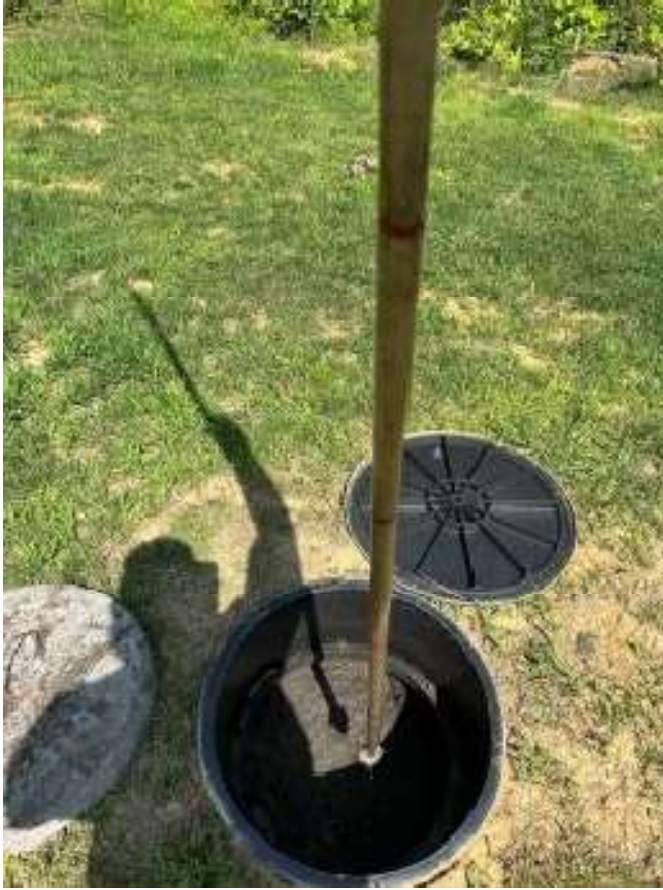
Inlet: scum level 2 inches sludge level 2 inches

Outlet: scum level 1 inches sludge level 1 inches

Comments: Scum and sludge levels indicate tank does not need to be pumped at this time.

Scum and sludge levels.

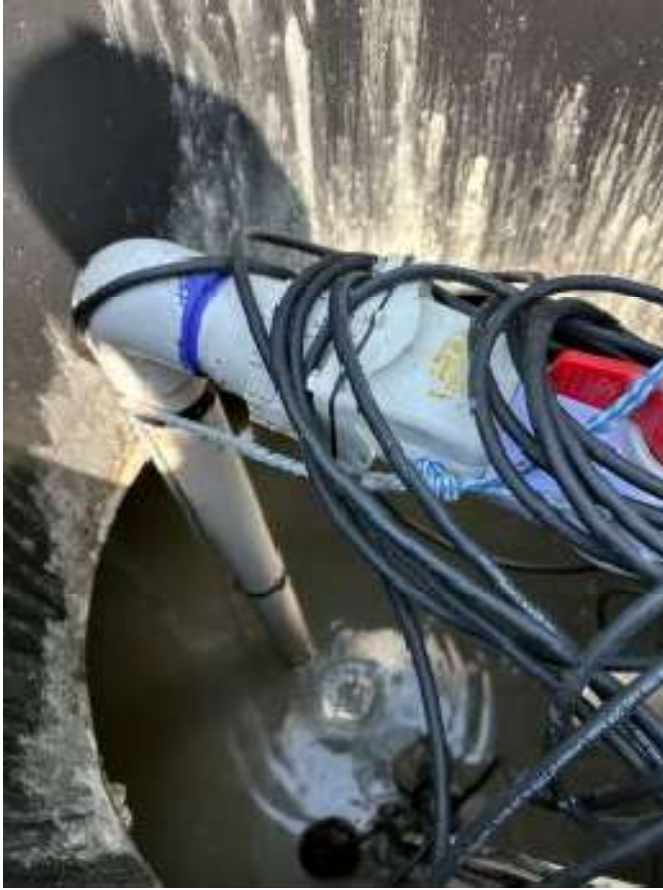
pipe

Leak noted at the pressure
