**Address of Property:**

6641 Woodlawn Dr  
Oxford NC 27565

6/24/2025

Jeremy Howard  
Home Inspector #5517 Septic Inspector #9364I

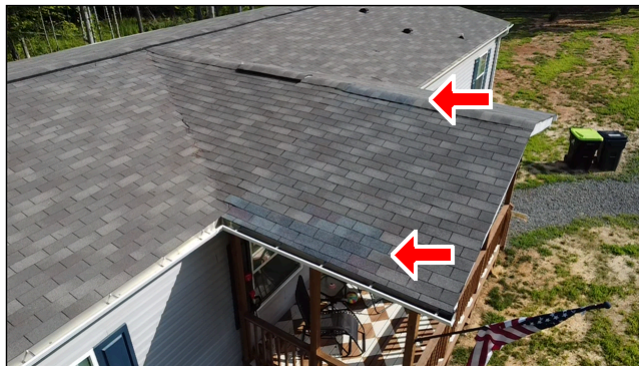
1.0 (Picture 1)

Evidence of repairs made to the roof at the front side. Recommend to discuss with owner about history/repairs made and monitor for any signs of water intrusion in the future.

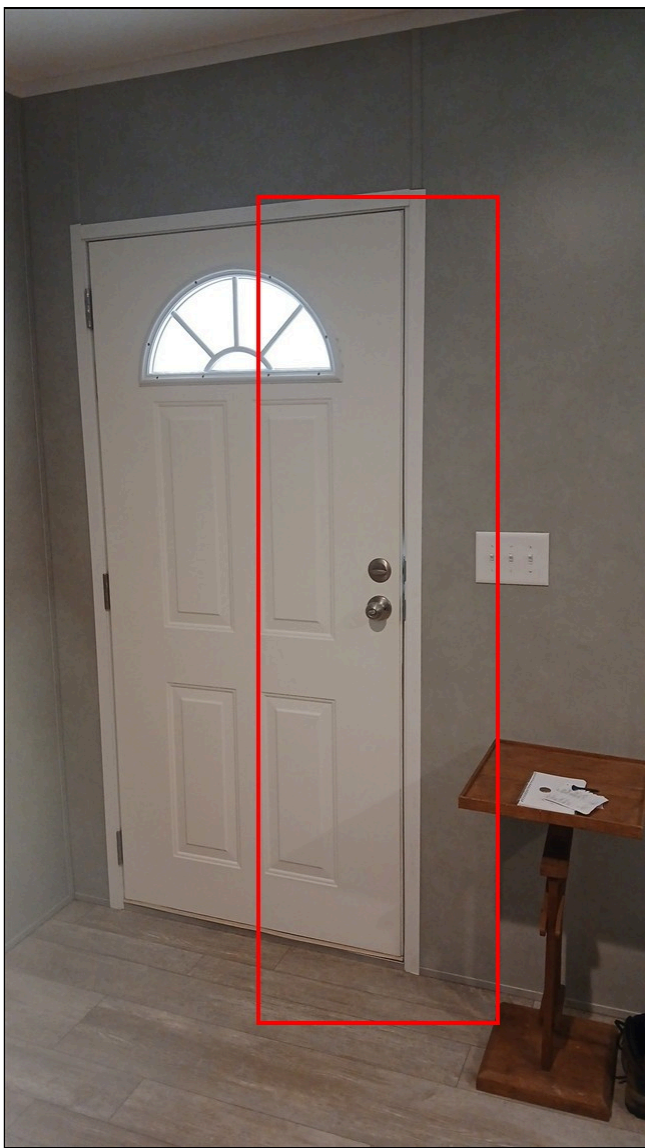
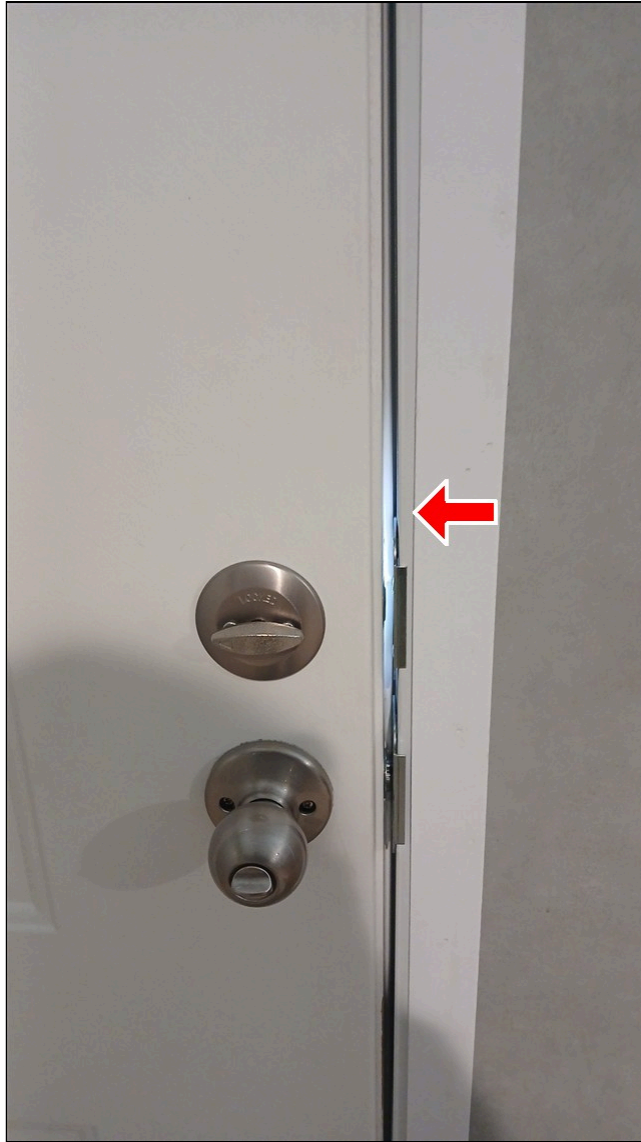
2.2 (1) In Need of Repair: Weather stripping at front exterior door has light that was observed which allows for escape of conditioned air due to door not sealing when closed and possible water intrusion at the adjacent elements.

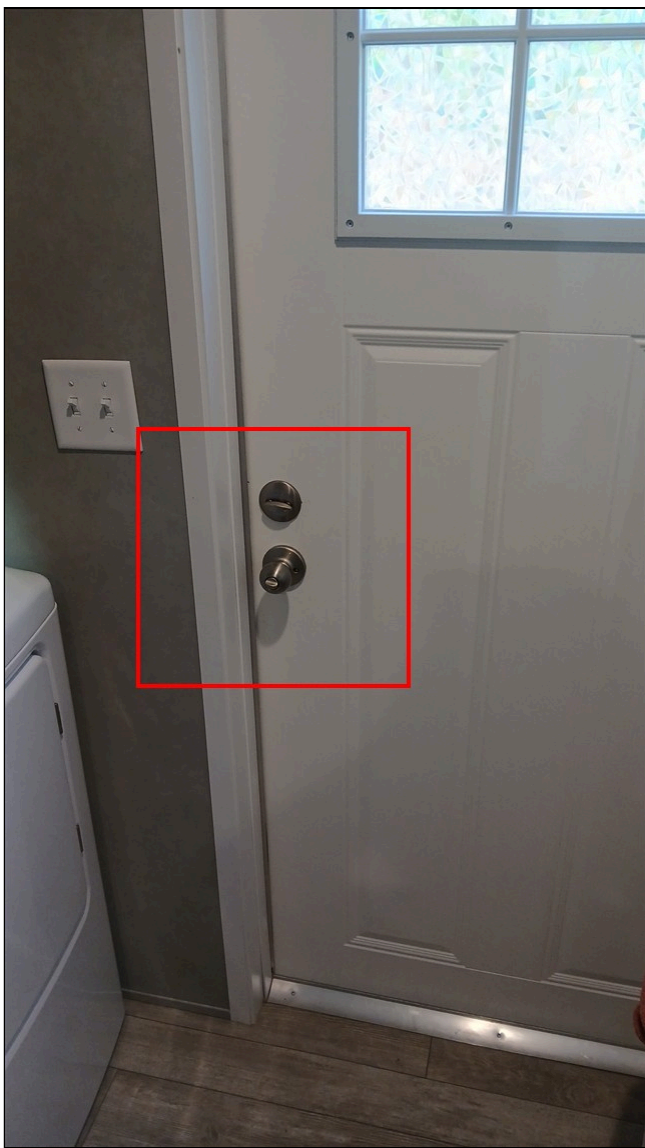
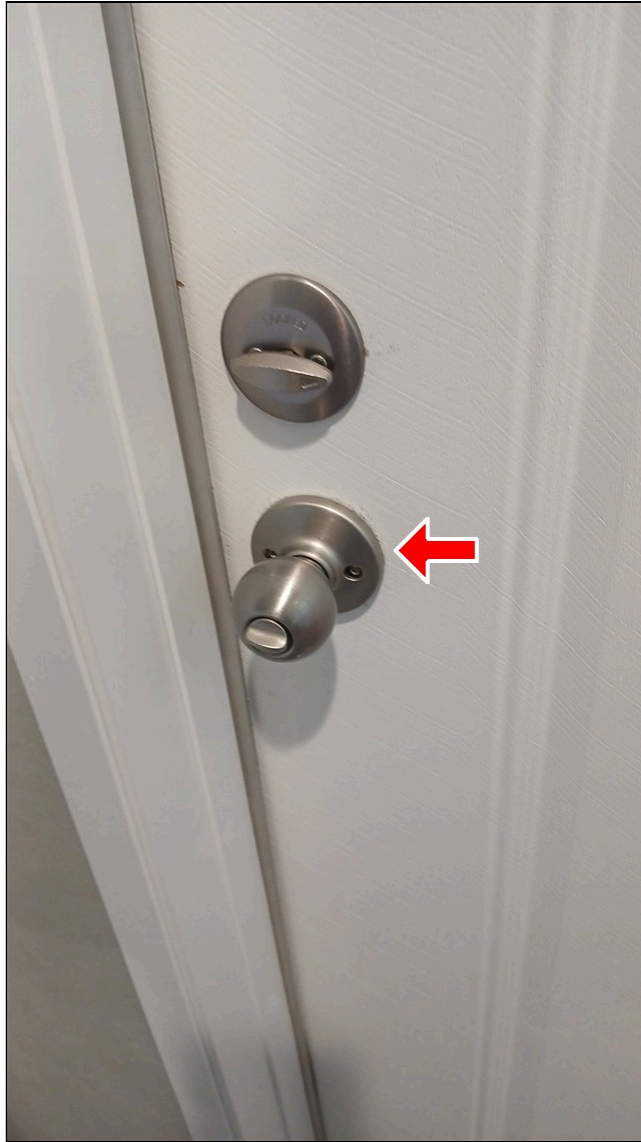
2.2 (2) Rear exterior door knob is loose. Due to security concerns recommend to secure.

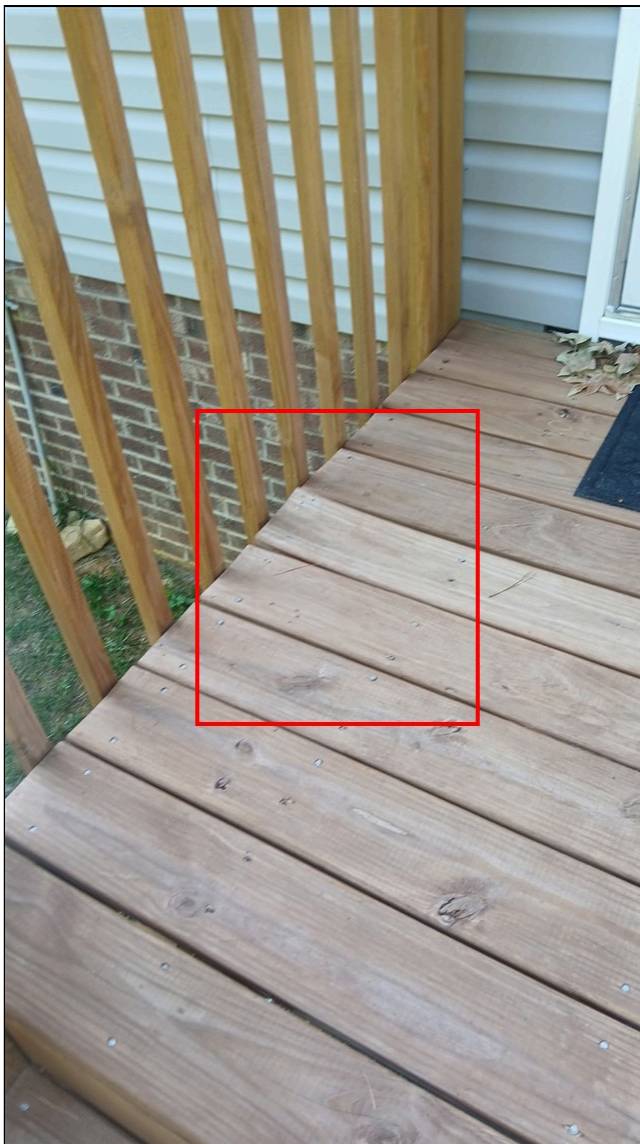
2.3 (Picture 1)

In Need of Repair: Loose boards noted at the rear steps. Due to safety concerns of tripping/falling, recommend to have a contractor evaluate/repair.

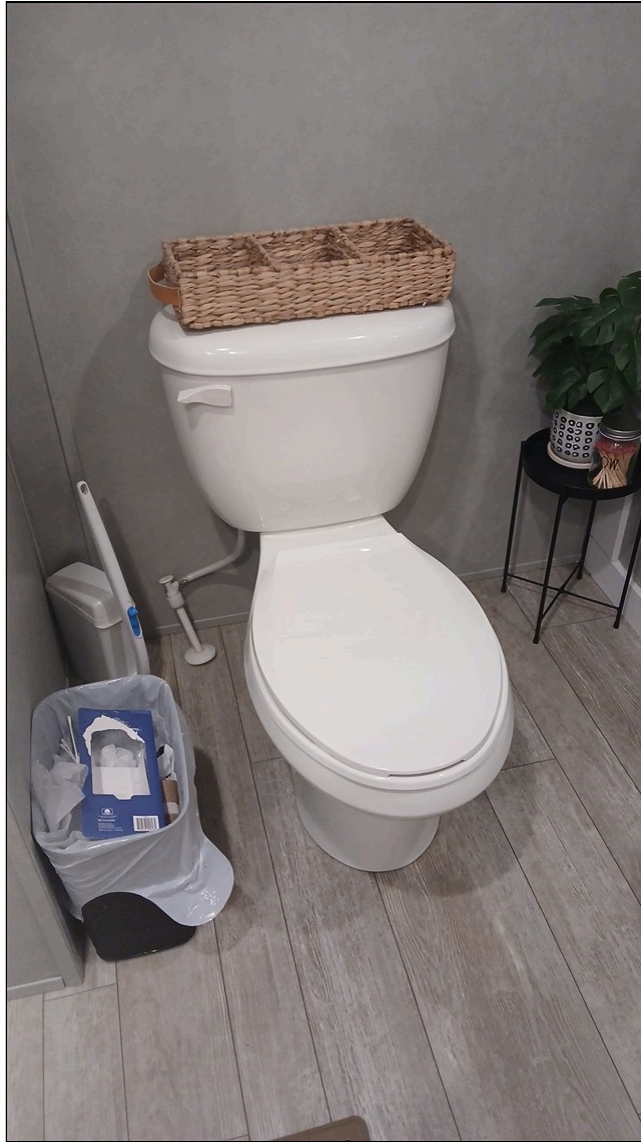
6.1 (Picture 1)

Toilet loose at floor in master bathroom, If seal is broken due to loose toilet, it can damage sub flooring under toilet. Recommend to have a plumber evaluate/repair.

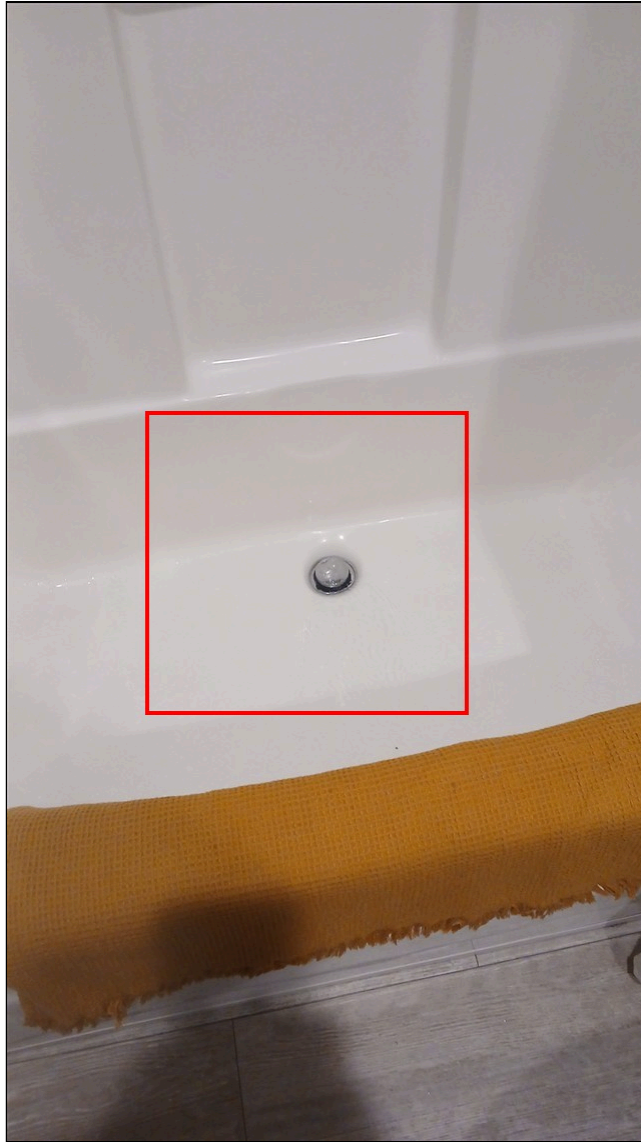
6.2 (Picture 1)

Drain stopper did not function properly at the hall bathtub. Recommend to repair/adjust to ensure tub holds water.

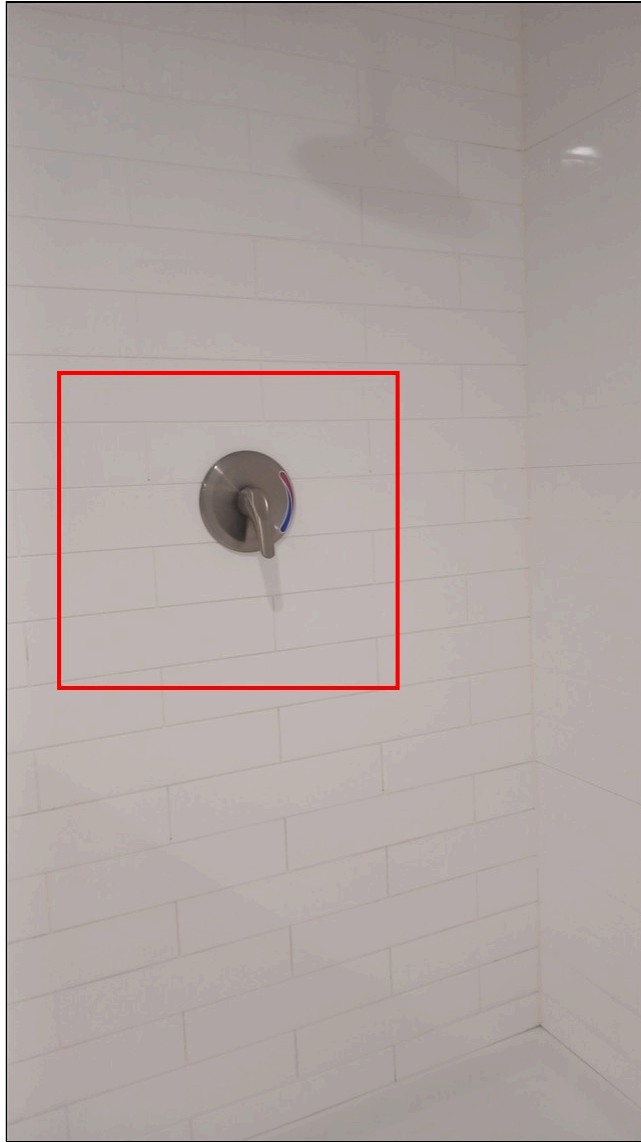
6.3 (Picture 1)

In Need of Repair: Missing/open caulking at spout/surround area at master stall shower. Conducive condition for water intrusion at the wall cavity and adjacent elements. Recommend to seal/caulk to prevent water damage.

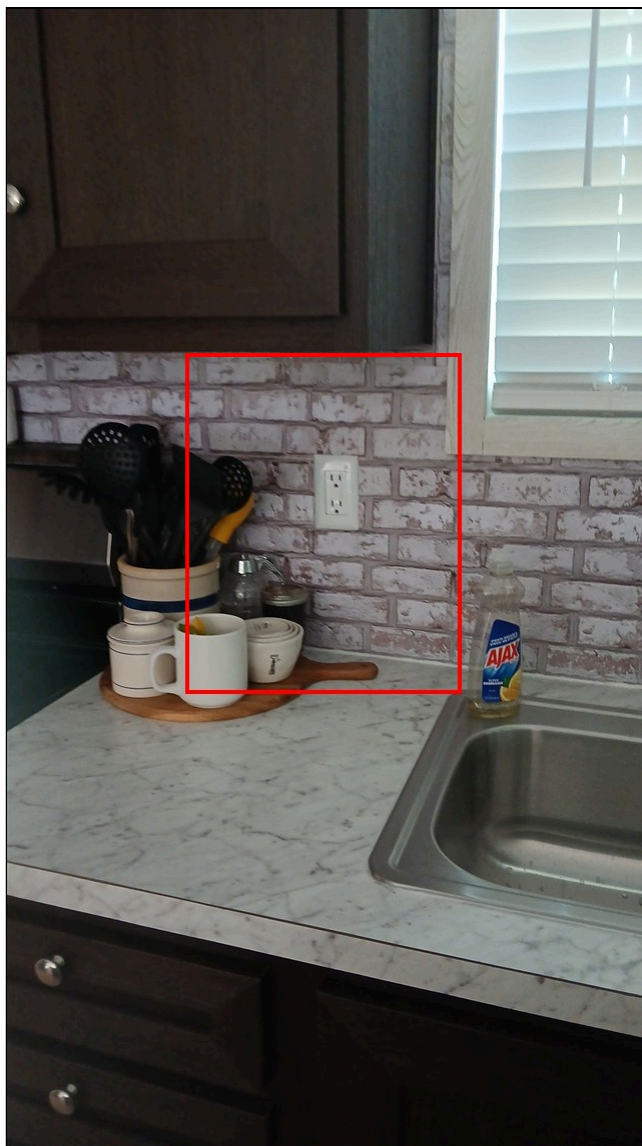
7.2 (Picture 1)

In Need of Repair: Damaged/cracked receptacle at the kitchen. Recommend a qualified electrician evaluate/repair due to safety concerns.

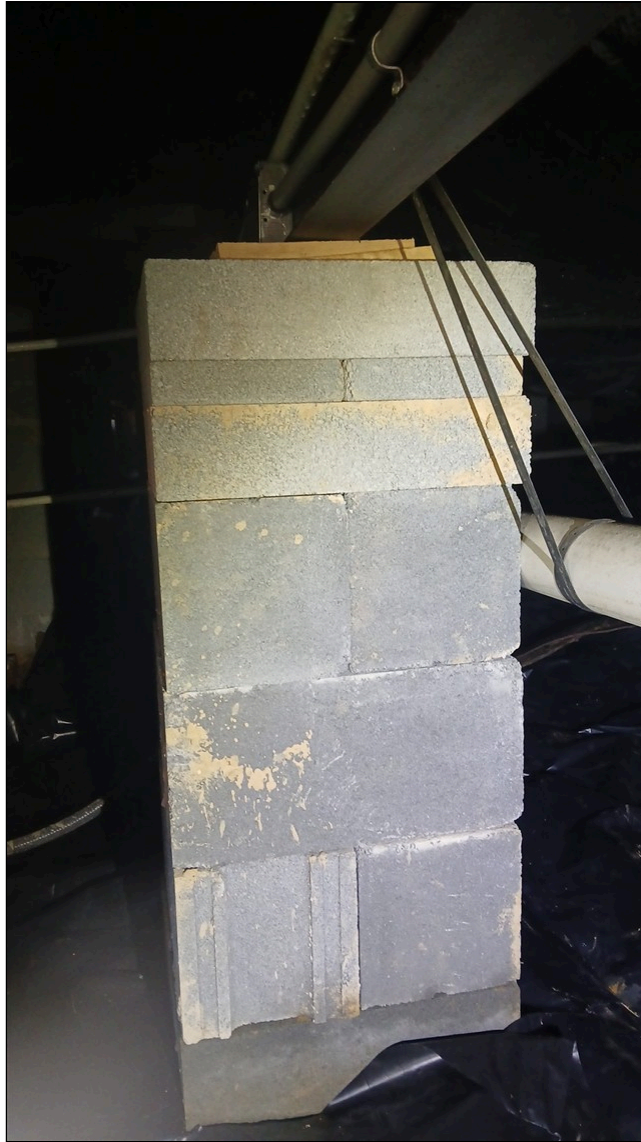
11.0 (Picture 1)

Dry stack CMU blocks noted at the foundation. Condition is conducive to movement. Recommend a qualified contractor evaluate/repair.

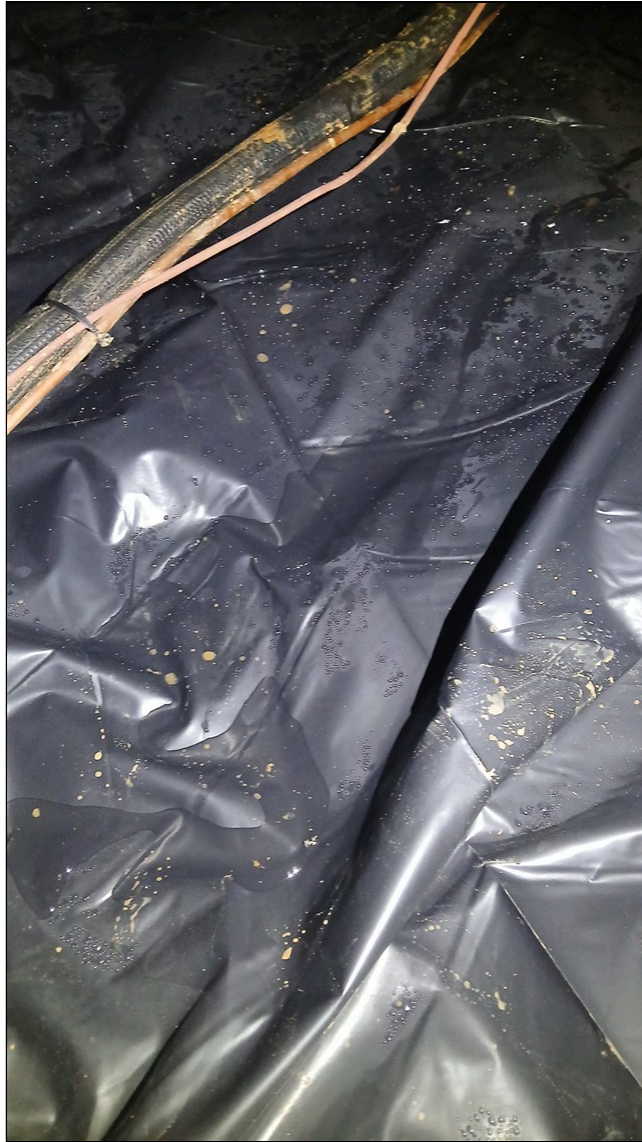
12.1 (Picture 1)

Evidence of water pooling on the moisture barrier at the rear and front side of the crawlspace. This is conducive to elevated moisture levels in the substructure. Recommend to have a qualified crawlspace contractor evaluate to determine the source of the water and repair as directed.

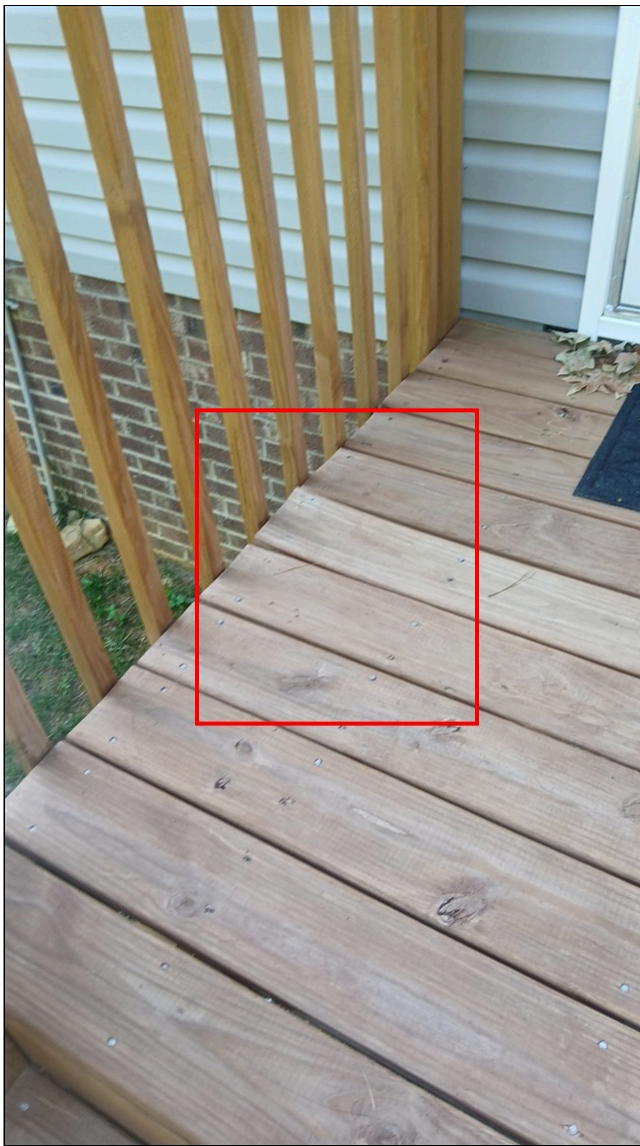
2.3 STAIRS / STOOPS / RAILINGS (Picture 1)

| | | ● | | | <b>2.3 STAIRS / STOOPS / RAILINGS</b><br>In Need of Repair: Loose boards noted at the rear steps. Due to safety concerns of tripping/falling, recommend to have a contractor evaluate/repair. |
