# Property Inspection Report

2776 Jordan Ct  
Creedmoor NC 27522

**Steve Smallman Property Inspections**

| <b>Date:</b> 7/9/2025 | <b>Time:</b> 09:00:00 AM | <b>Report ID:</b> 070925GS4 |

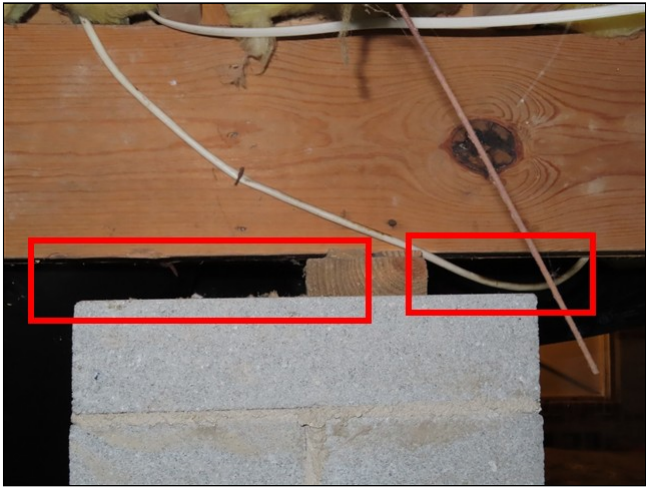
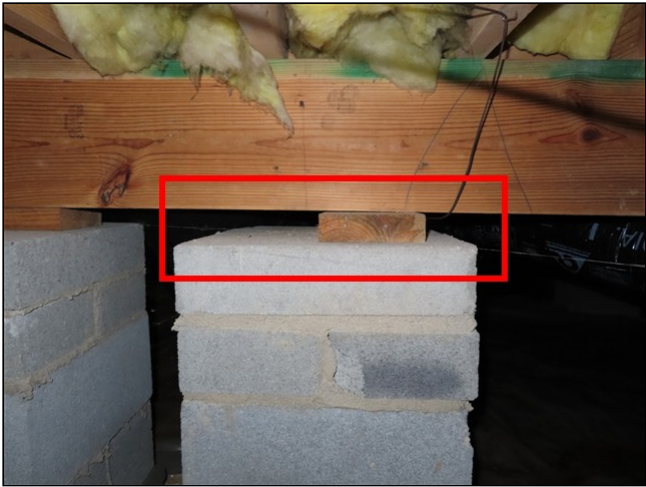
**1 Repair Item** Some of the girders do not rest on the full width of the piers in the crawl space. The shims installed between the piers and the girders are smaller than the piers. In some cases, this can result in over spanning of the girders resulting in sagging of the floor framing. In most cases, the girder should be supported the full width of the pier to assure proper bearing of the girder. We recommend that the girders be fully shimmed over the piers or have these evaluated by a PE (registered professional engineer) to determine if the current method of bearing of the girders on the piers is adequate.

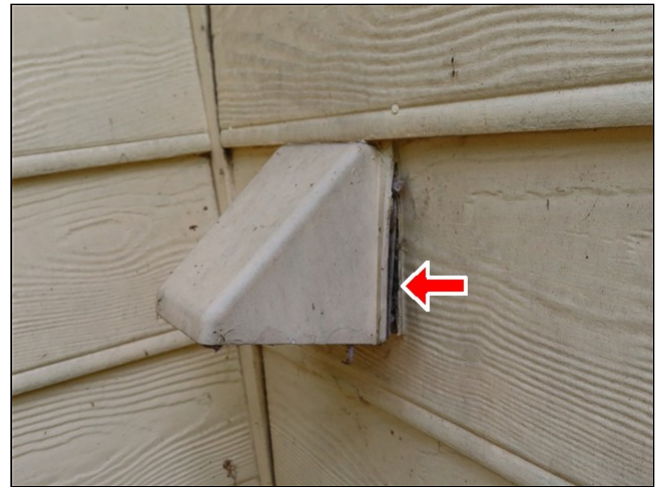
**4 Repair Item** The dryer vent damper (at the vent termination on the exterior wall) is missing. The damper must open fully to avoid restricting dryer venting, and must close fully to keep birds and insects out. In this case, a screen has been installed but this screen can and is clog with lint. It was also noted that the vent termination cap is not flush and sealed to the siding which can allow water to enter. The vent termination cap should be replaced for safe venting of the dryer.

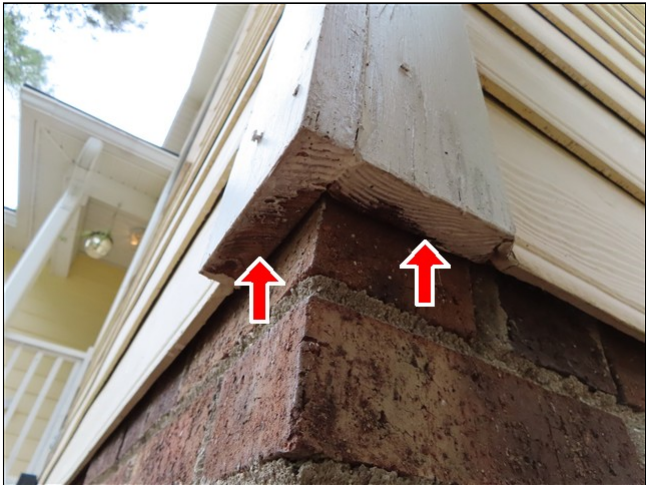
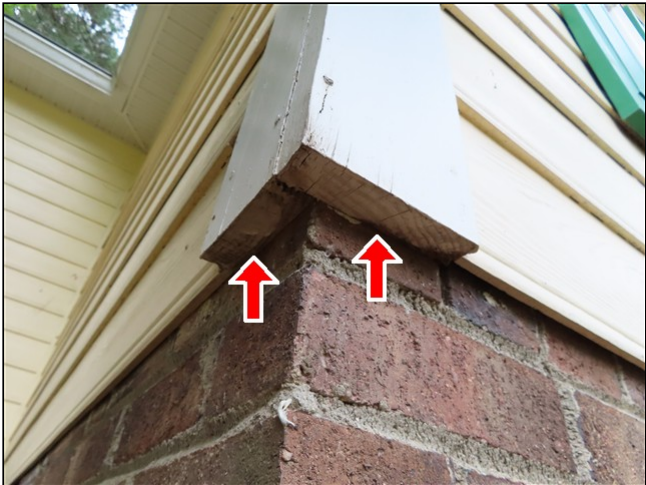
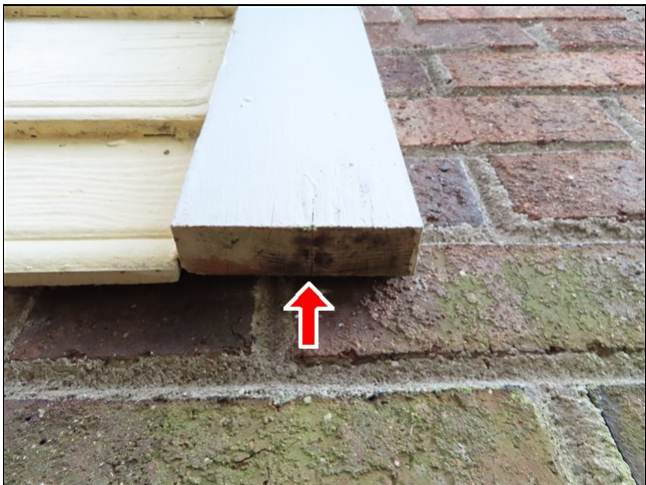
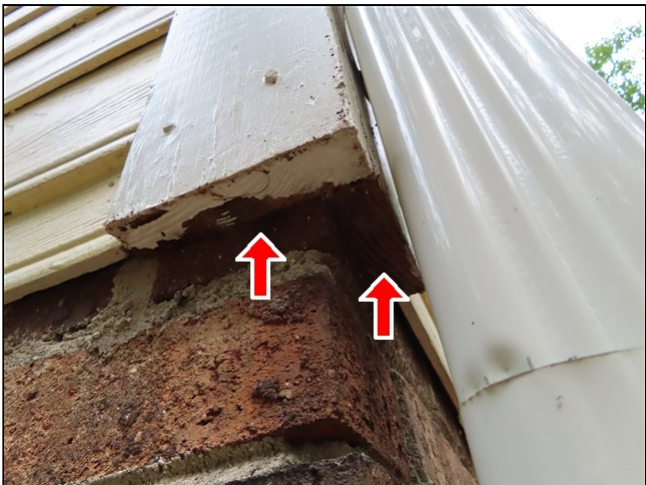
**Repair Item** The bottom edges of some of the corner trim boards are not painted. As water runs down the trim boards, the un-painted lower edge can wick up the water resulting in damage. Paint as required.

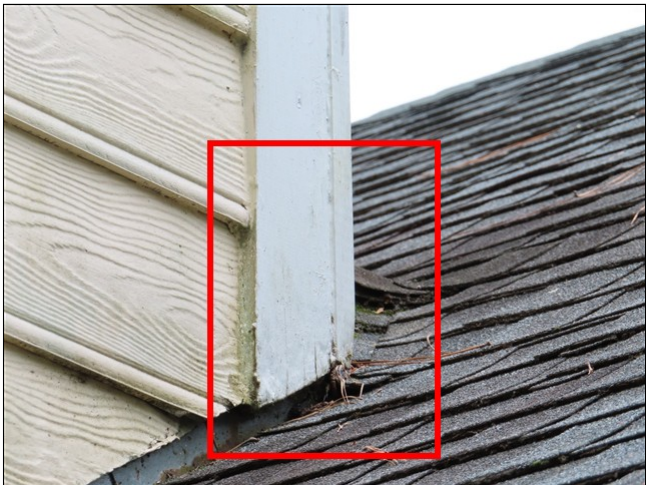
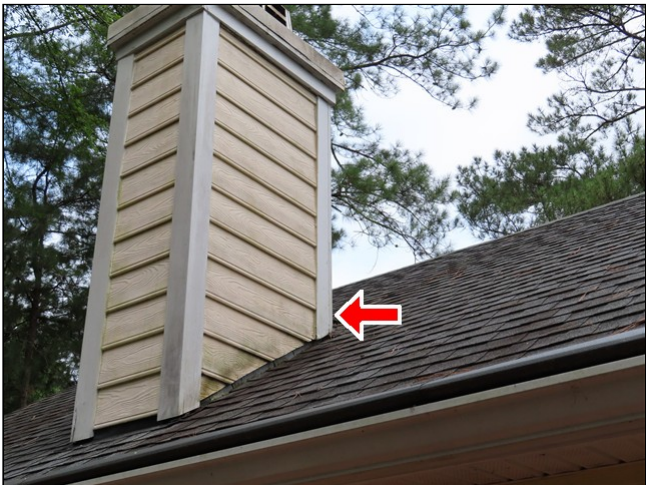
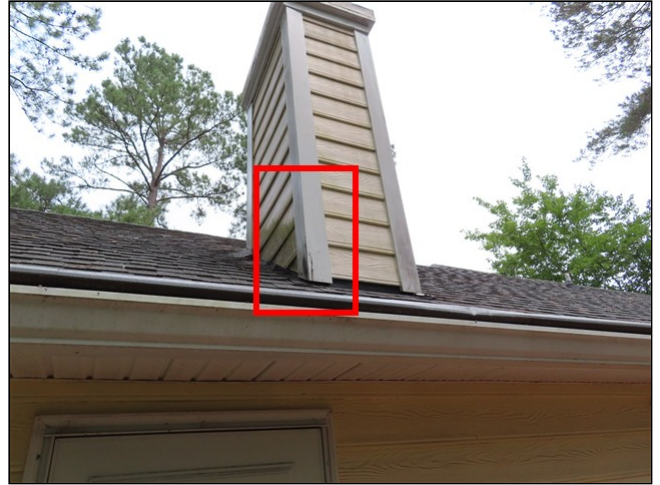
**8 Repair Item** One or more pieces of siding and/or trim are damaged or deteriorated to the degree that repair or replacement is needed. Damaged cladding materials should be corrected to prevent further damage and possible water penetration to the wall assembly behind the cladding. Location(s): Base of some of the trim boards at the chimney where the trim boards abut the roof.

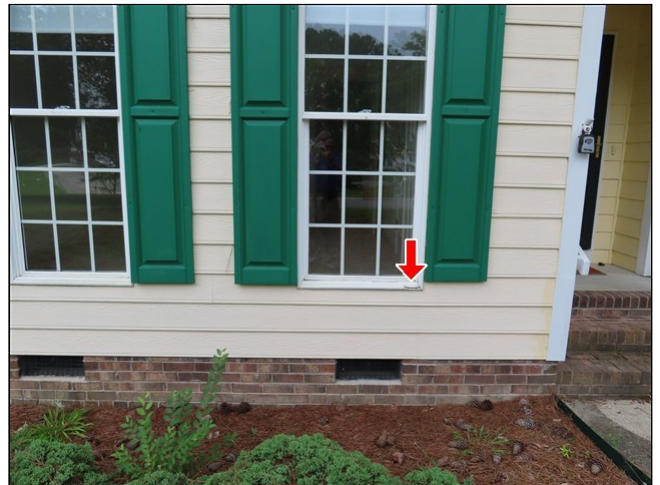
**10 Repair Item** There is a hole through the vinyl at the right front window at the front right bedroom. This may allow water to enter resulting in damage. The window should be repaired or replaced by a qualified contractor.

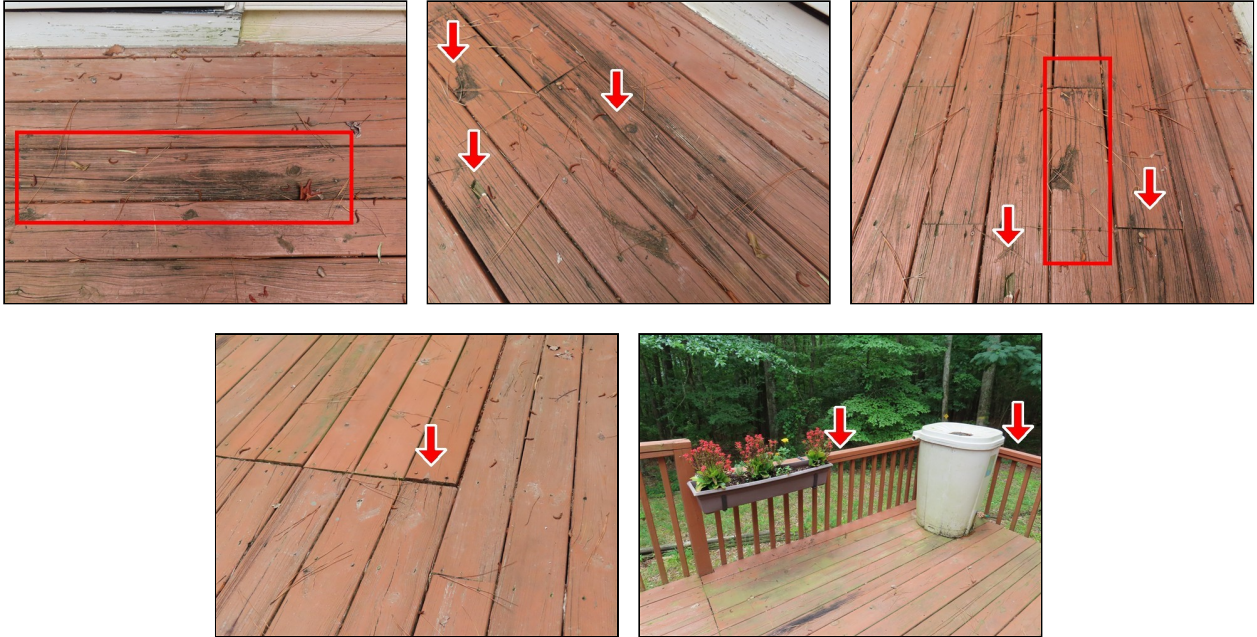
**11 Repair item** Exterior wood deck: while most of the deck floor and framing are intact there are several decayed wood components that need replacement. Several of the deck planks are decayed to the extent that replacement is needed. Some deck planks are bowed up away from the framing. Some of the guard rails do not meet safety standards in that they are too low. A qualified contractor should check the deck and repair as needed using these items as examples.

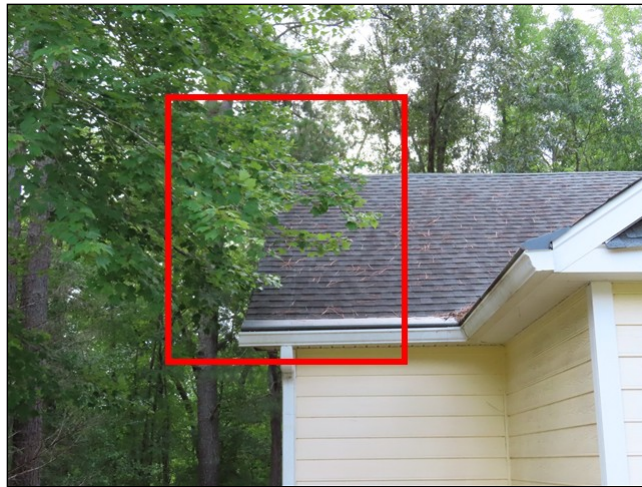
**12 Repair Item** Tree branches are in contact with or too close to the roof. This can damage the roofing materials. Trim back branches, and inspect for any damage that may have been done.

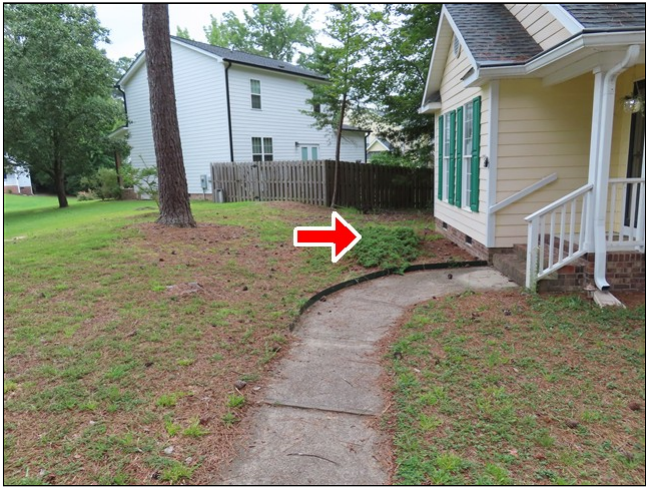
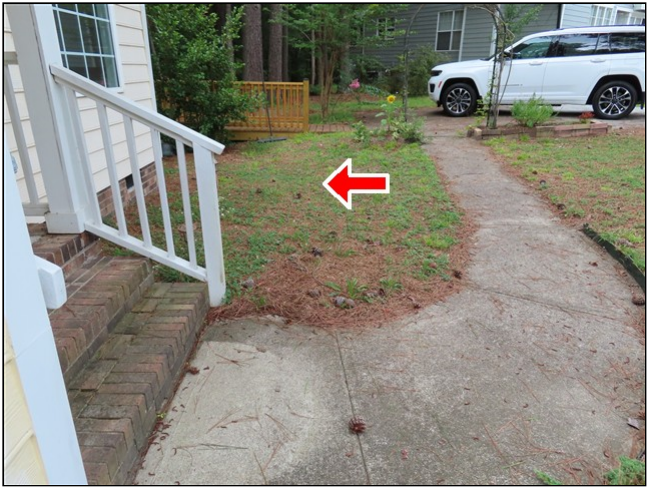
**13 Repair Item** The exterior grading at the front side of the house slopes towards the house and does not provide for positive drainage away from the foundation walls. A landscaping contractor should be contacted for repair to provide positive drainage away from the foundation and crawl space.

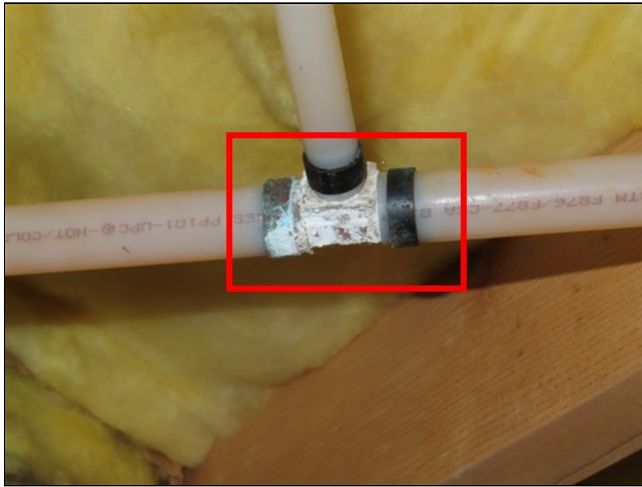
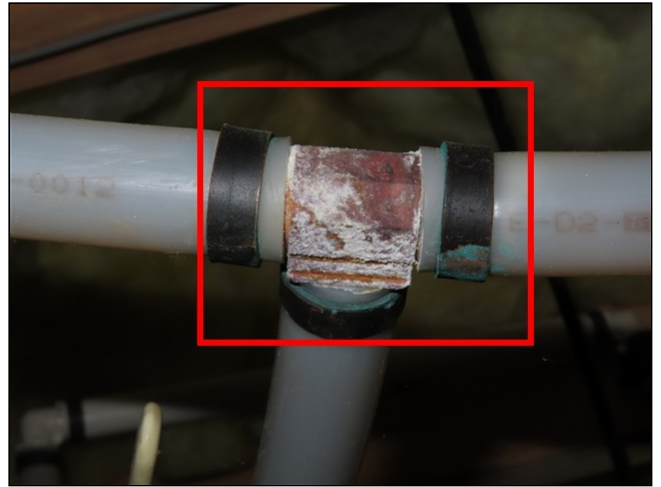
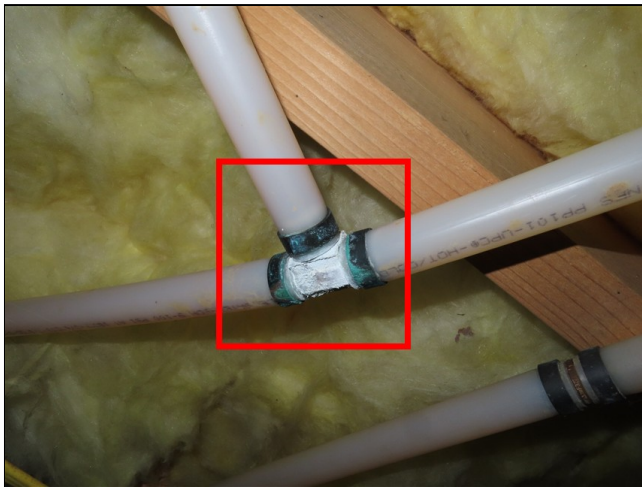
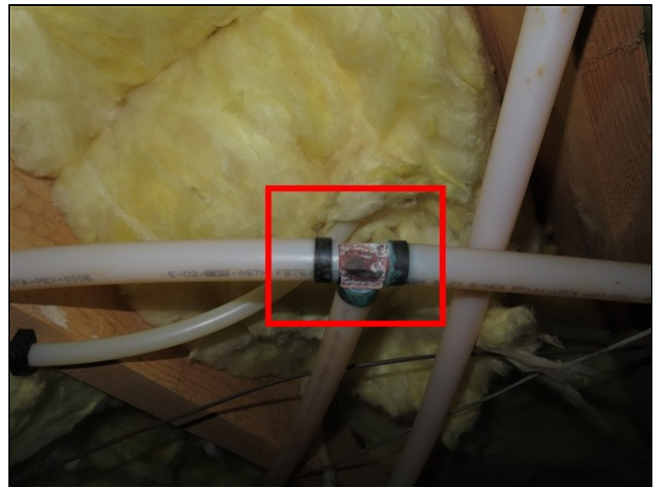
**15 Investigate Further** Water supply piping in this house is PEX, with brass alloy fittings. Some brands of this type of fitting have experienced a higher incidence of corrosion, occlusion, and leakage than others. I observed corrosion on several of these fittings, which is evidence of a problem, but no active leakage. Some fittings are concealed and not readily accessible for inspection. I recommend that you have a licensed plumbing contractor investigate to determine if repairs are needed and if a claim can be filed under class action settlement. For more information visit the website <http://failures.wikispaces.com/PEX+plumbing+Failures.com>

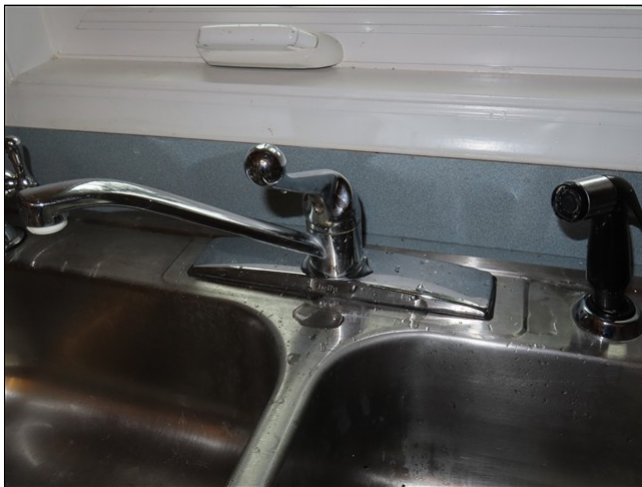
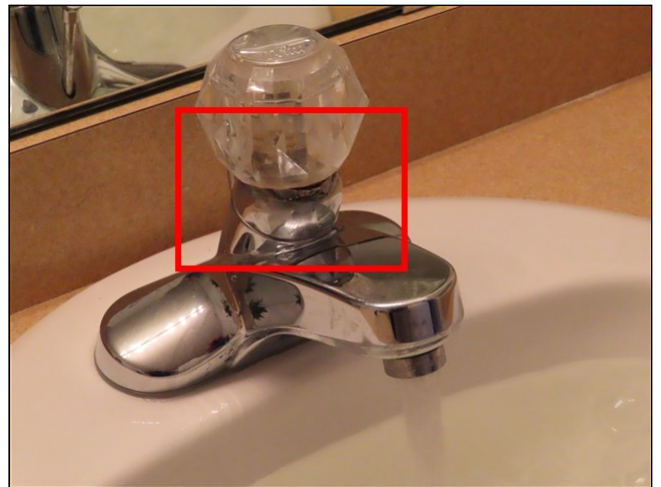
**16 Repair Item** Repair is needed to the plumbing valve that leaks through its handle when the water is on. Location(s): kitchen sink faucet and faucet at the right sink in the hall bathroom. Contact a plumber for repair.

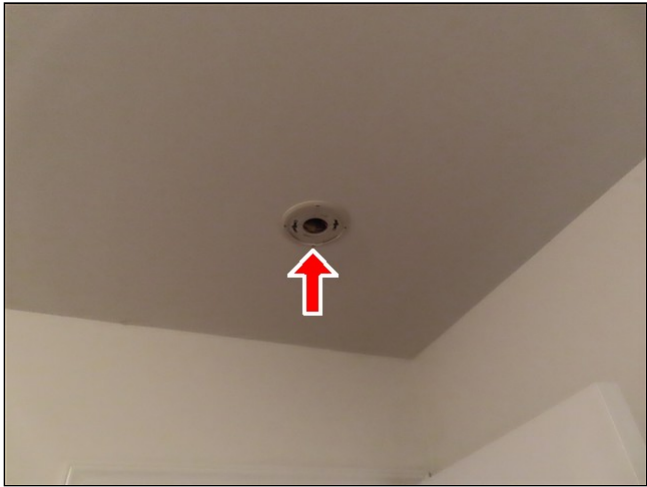
**23 Repair item** The smoke detector in the left end bedroom has been removed. It should be replaced for a first line of notification in the event of a fire.

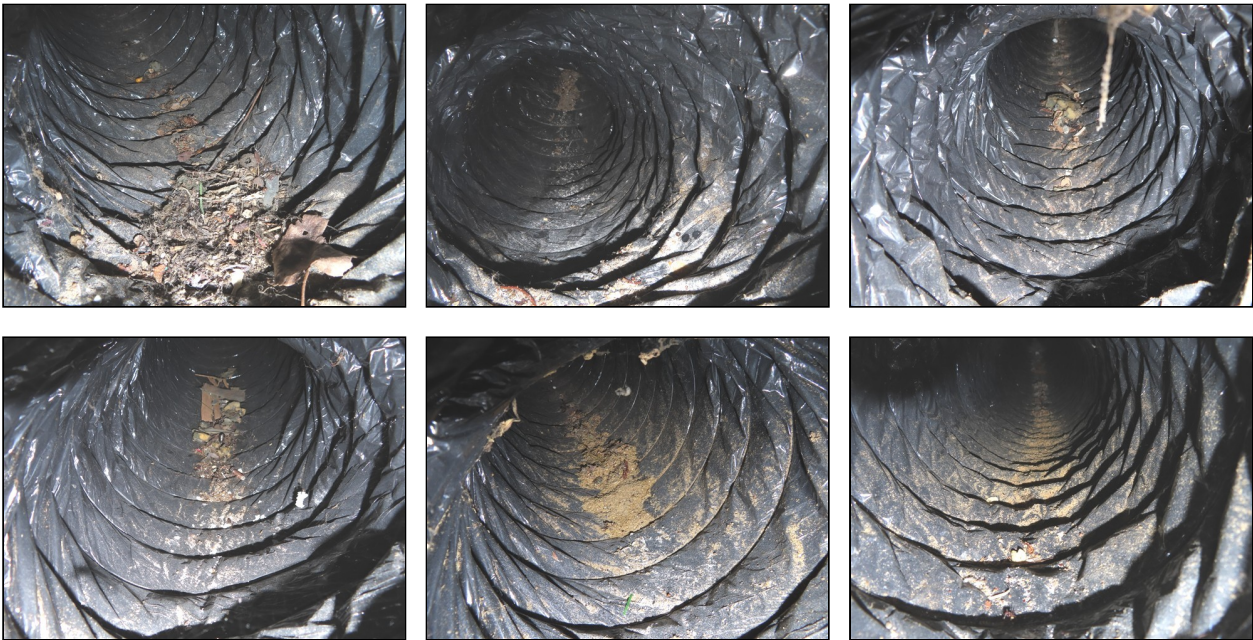
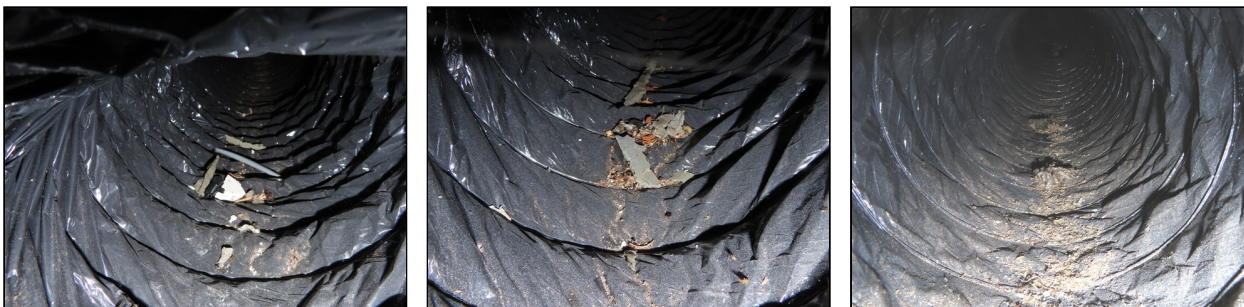
**25 Repair Item** Dirt and other debris was noted in most of the heating/cooling ducts. This may result in poor air quality in the home. The ducts should be professionally cleaned by a qualified contractor to remove the debris and any other contaminants that may exist.

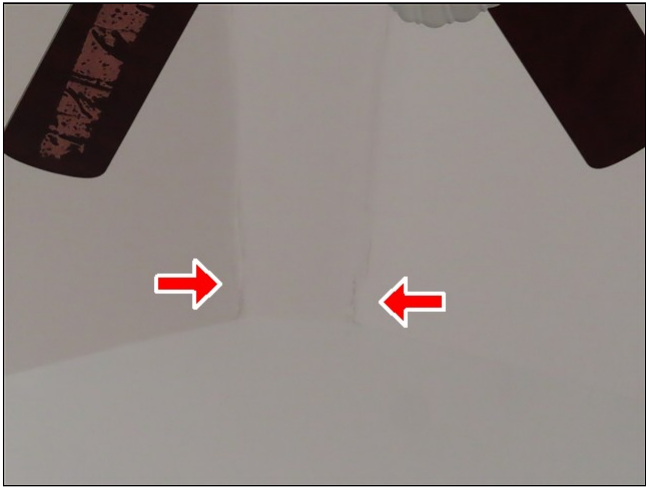
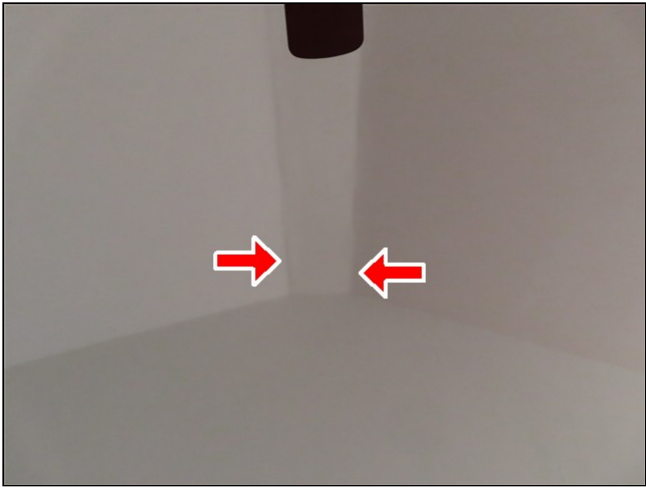
**28 Repair Item** The drywall tape joint is loose at the following locations: peak of the ceiling in the living room. A drywall mechanic should be contacted to complete the needed repairs.

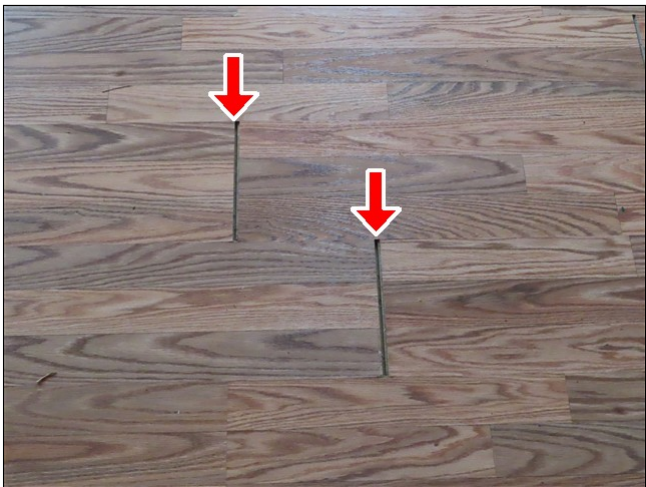
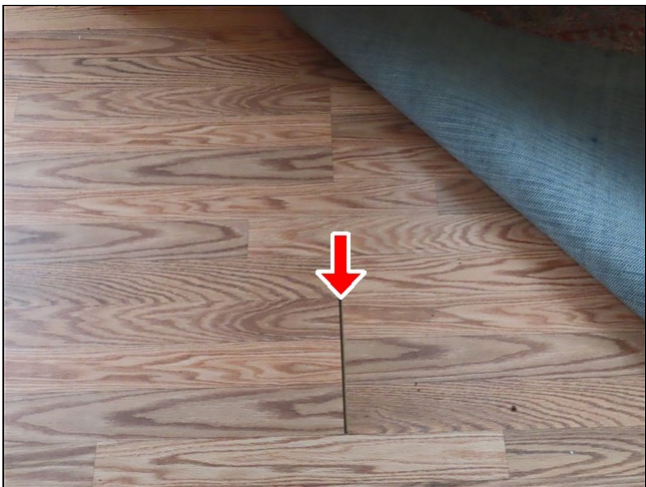
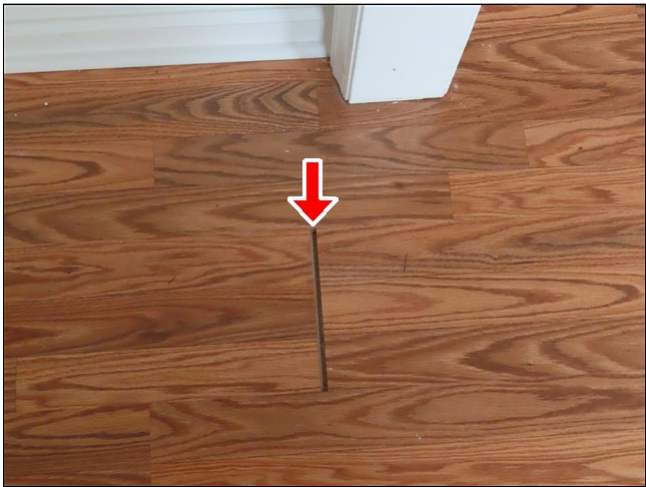
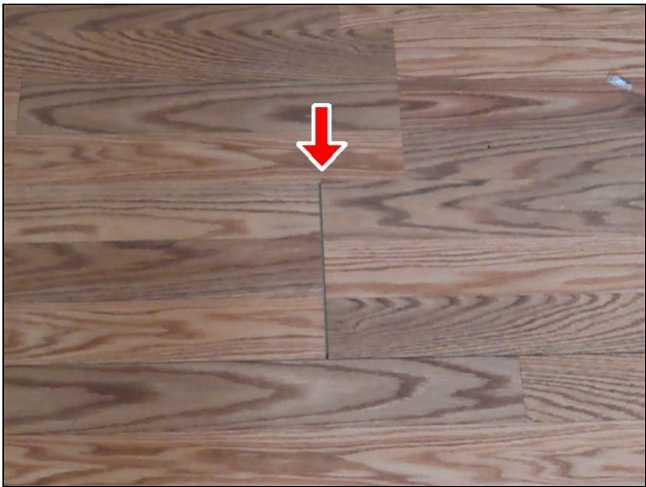
**29 Repair Item** There are gaps between the butt ends of some of the vinyl floor planks in the living room and hallway. This will allow debris to enter between sections of floor covering and make cleaning difficult. Most of manufactures of this type of floor cover have interlocking taps to keep the floor covering tight. We recommend that a floor covering installation contractor be contacted for repairs.

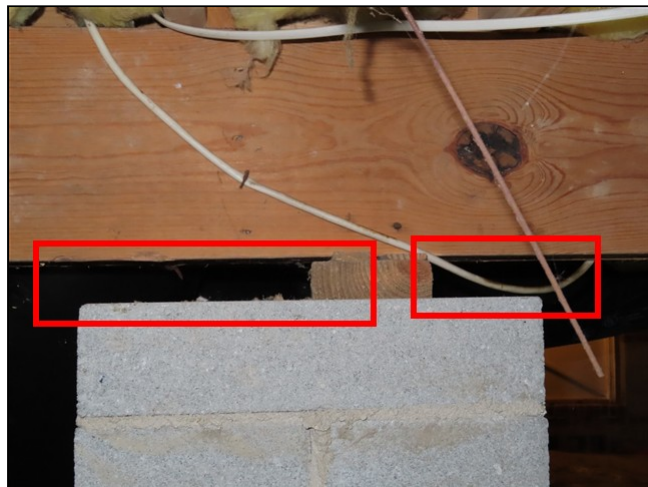
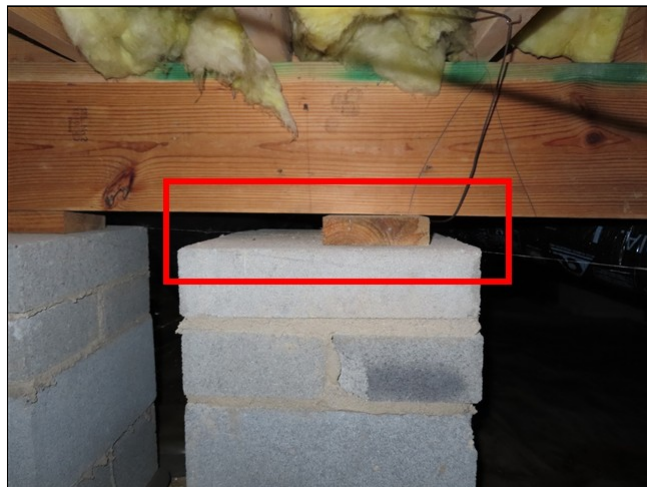
**Repair Item** Some of the girders do not rest on the full width of the piers in the crawl space. The shims installed between the piers and the girders are smaller than the piers. In some cases, this can result in over spanning of the girders resulting in sagging of the floor framing. In most cases, the girder should be supported the full width of the pier to assure proper bearing of the girder. We recommend that the girders be fully shimmed over the piers or have these evaluated by a PE (registered professional engineer) to determine if the current method of bearing of the girders on the piers is adequate.

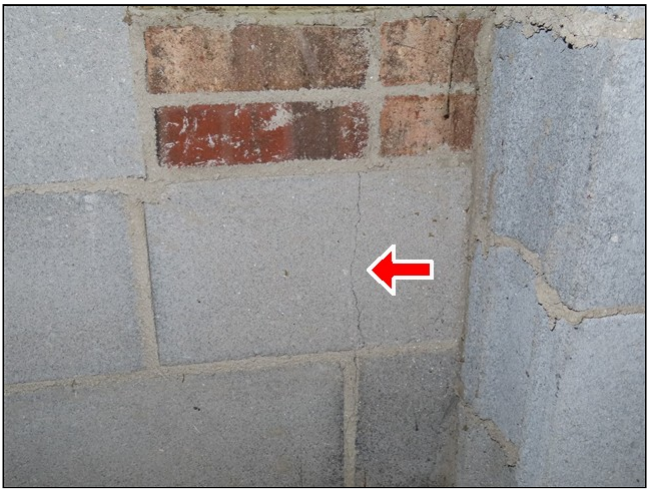
**Comment** Hairline cracks were observed in some of the concrete block foundation walls. Locations: left side of the house under a foundation vent near the crawl space access door. These cracks do not appear to require repair for practical purposes. In most cases cracks such as these are stable and do not significantly change once a house has reached this age. In all cases we cannot predict nor guarantee against future changes that might require repair.

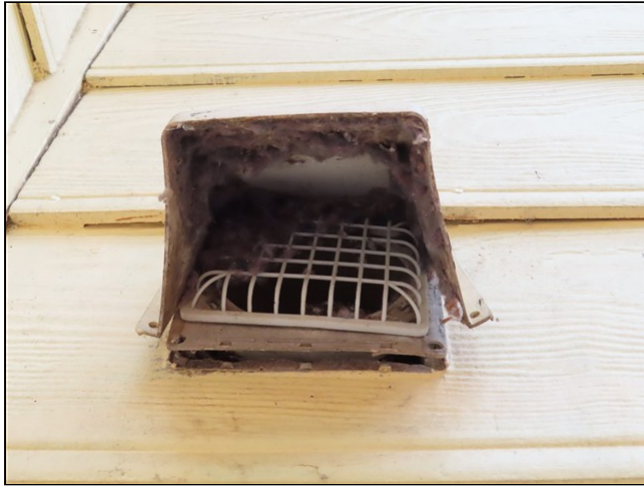
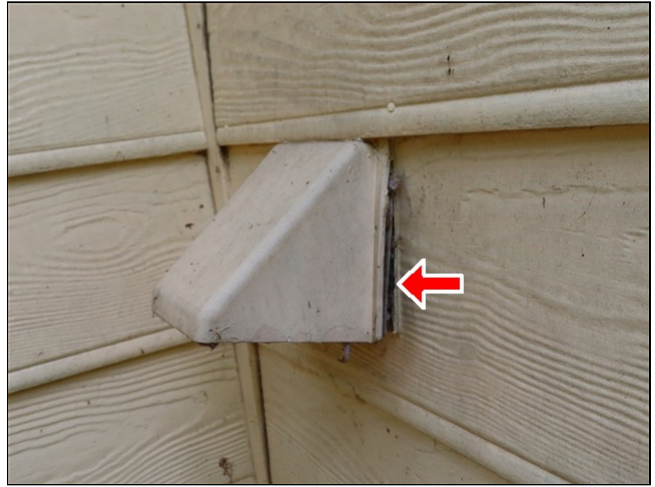
**Repair Item** The dryer vent damper (at the vent termination on the exterior wall) is missing. The damper must open fully to avoid restricting dryer venting, and must close fully to keep birds and insects out. In this case, a screen has been installed but this screen can and is clog with lint. It was also noted that the vent termination cap is not flush and sealed to the siding which can allow water to enter. The vent termination cap should be replaced for safe venting of the dryer.

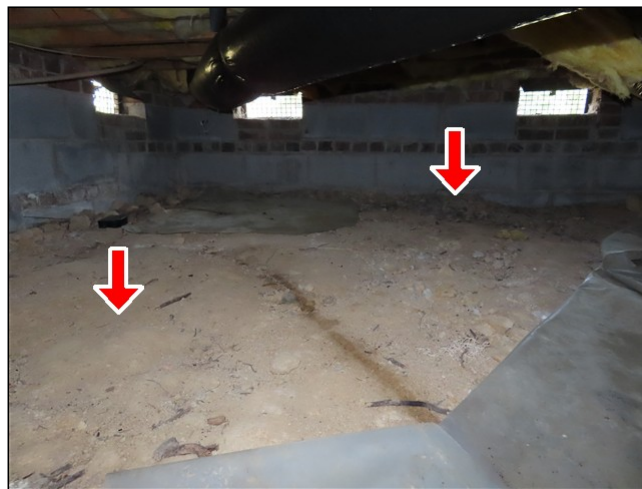
**Repair item** There are several areas where the crawl space vapor barrier is missing, damaged, moved aside, leaving the earth floor of the crawl space exposed. The vapor barrier is intended to help control moisture in the crawl space, and these conditions reduce its ability to do so. We recommend that the vapor barrier be repaired by a qualified contractor to cover all exposed earth.

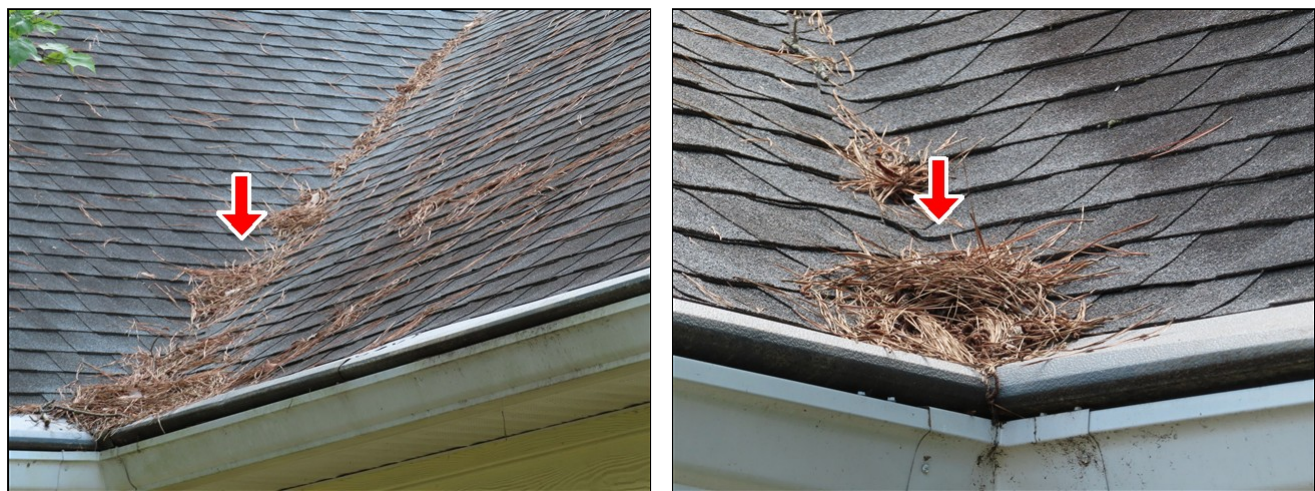
**Maintenance** It is important that leaves be kept from accumulating on the roof surfaces. Accumulated leaves can cause leakage and will accelerate the wear of the roof coverings by trapping moisture. Cleaning is needed at this time.

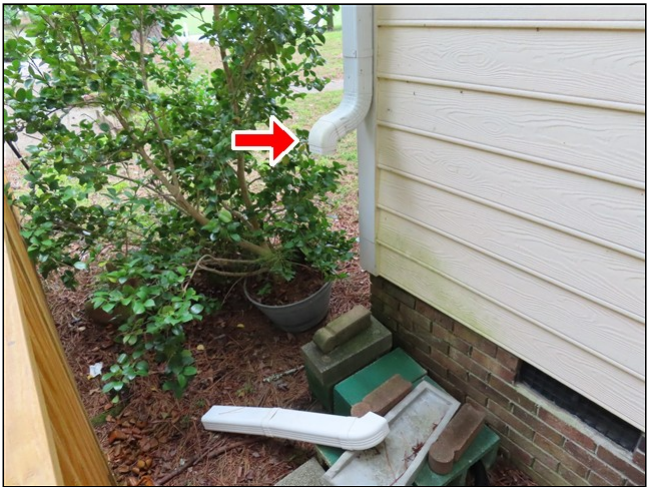
**Repair Item** The gutter downspout at the front right corner of the house does not terminate at grade level. The downspout should be extended and a elbow installed to divert water away from the foundation and crawl space.

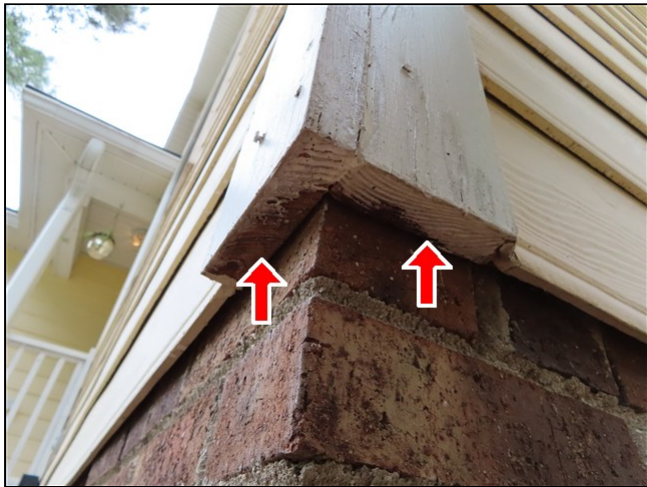
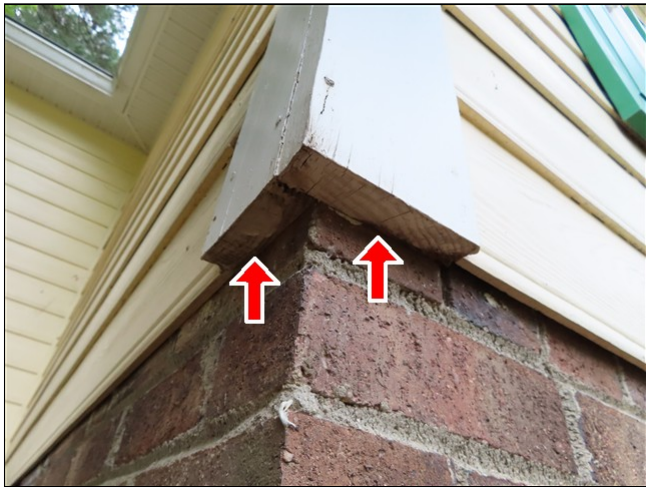
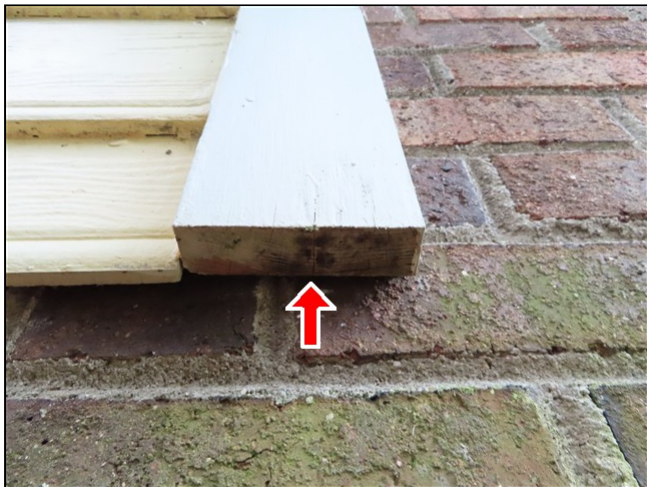
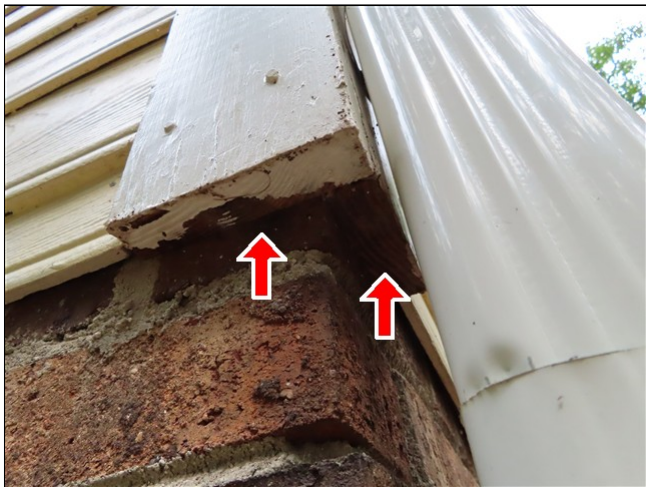
**Repair Item** The bottom edges of some of the corner trim boards are not painted. As water runs down the trim boards, the un-painted lower edge can wick up the water resulting in damage. Paint as required.

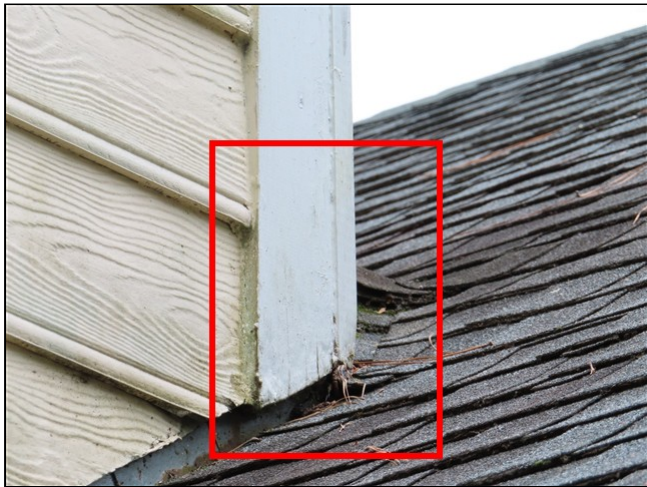
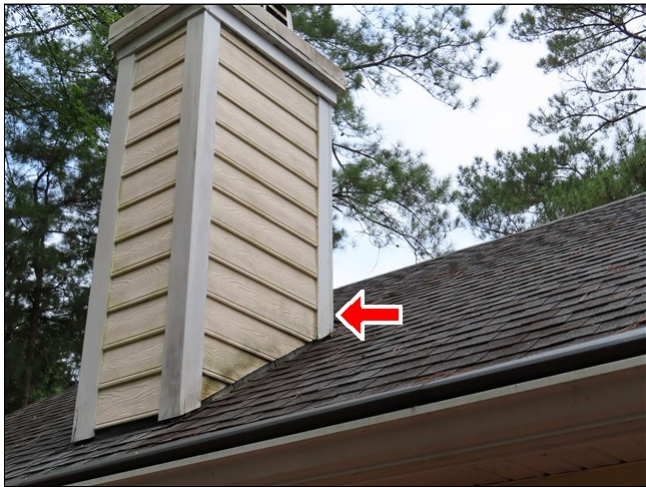
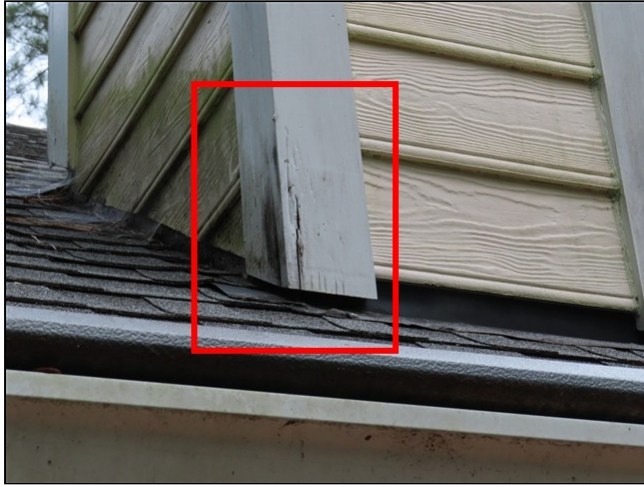
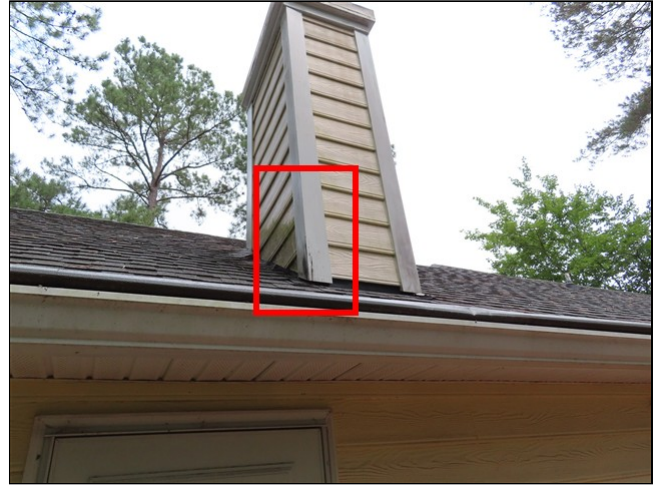
**Repair Item** One or more pieces of siding and/or trim are damaged or deteriorated to the degree that repair or replacement is needed. Damaged cladding materials should be corrected to prevent further damage and possible water penetration to the wall assembly behind the cladding. Location(s): Base of some of the trim boards at the chimney where the trim boards abut the roof.

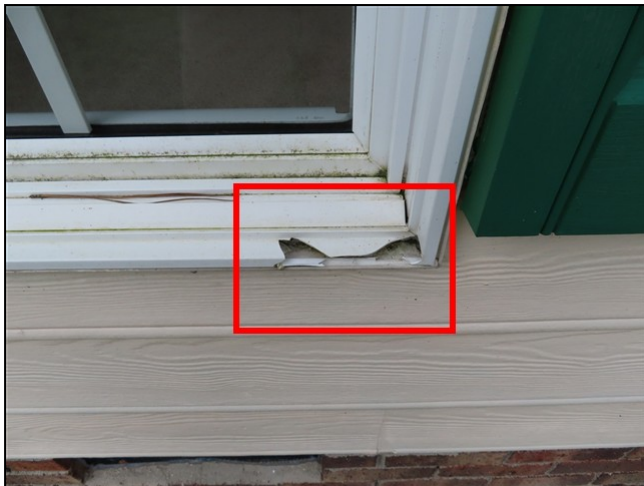
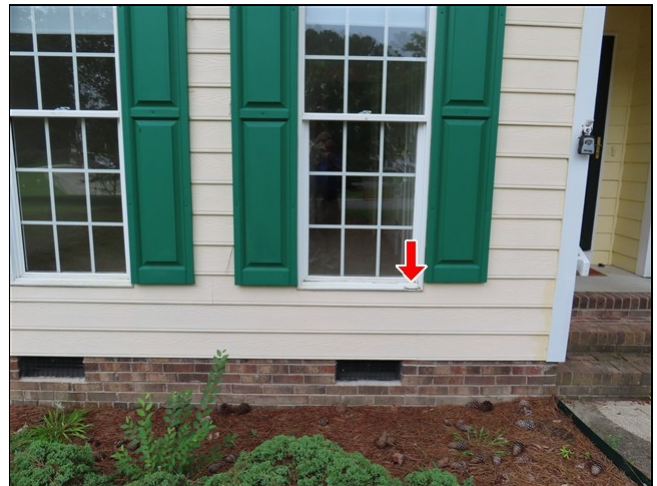
**Repair Item** There is a hole through the vinyl at the right front window at the front right bedroom. This may allow water to enter resulting in damage. The window should be repaired or replaced by a qualified contractor.

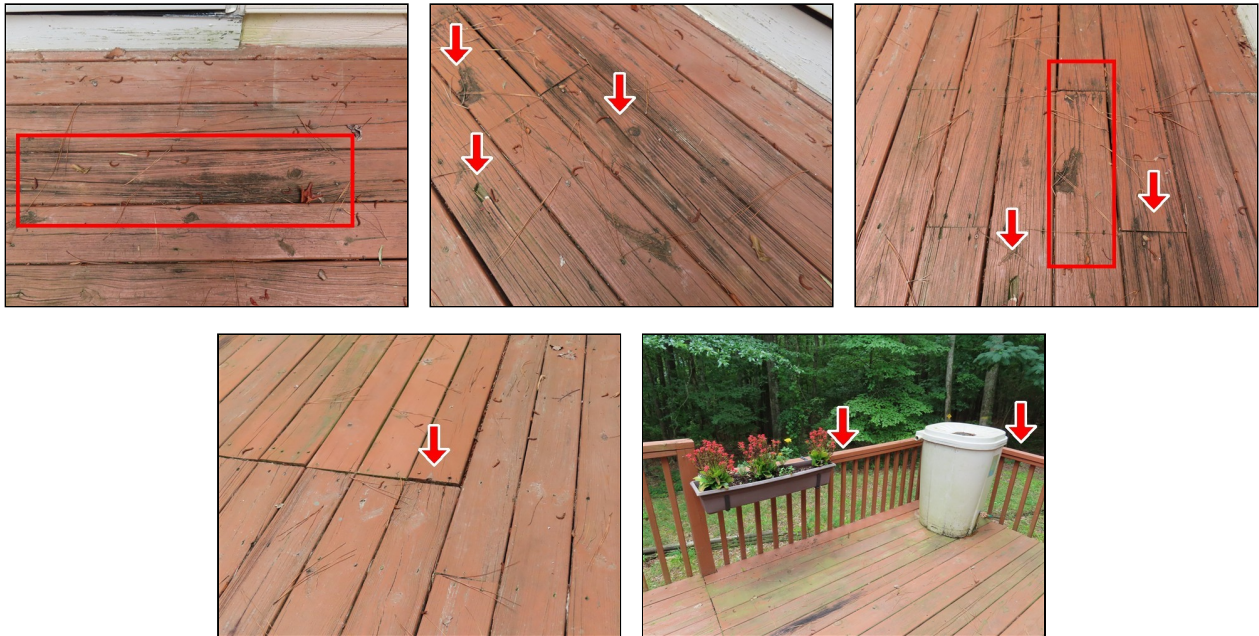
**Repair item** Exterior wood deck: while most of the deck floor and framing are intact there are several decayed wood components that need replacement. Several of the deck planks are decayed to the extent that replacement is needed. Some deck planks are bowed up away from the framing. Some of the guard rails do not meet safety standards in that they are too low. A qualified contractor should check the deck and repair as needed using these items as examples.

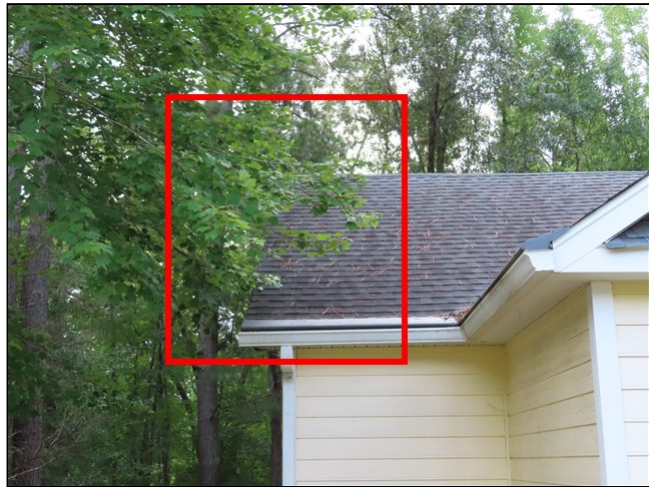
**Repair Item** Tree branches are in contact with or too close to the roof. This can damage the roofing materials. Trim back branches, and inspect for any damage that may have been done.

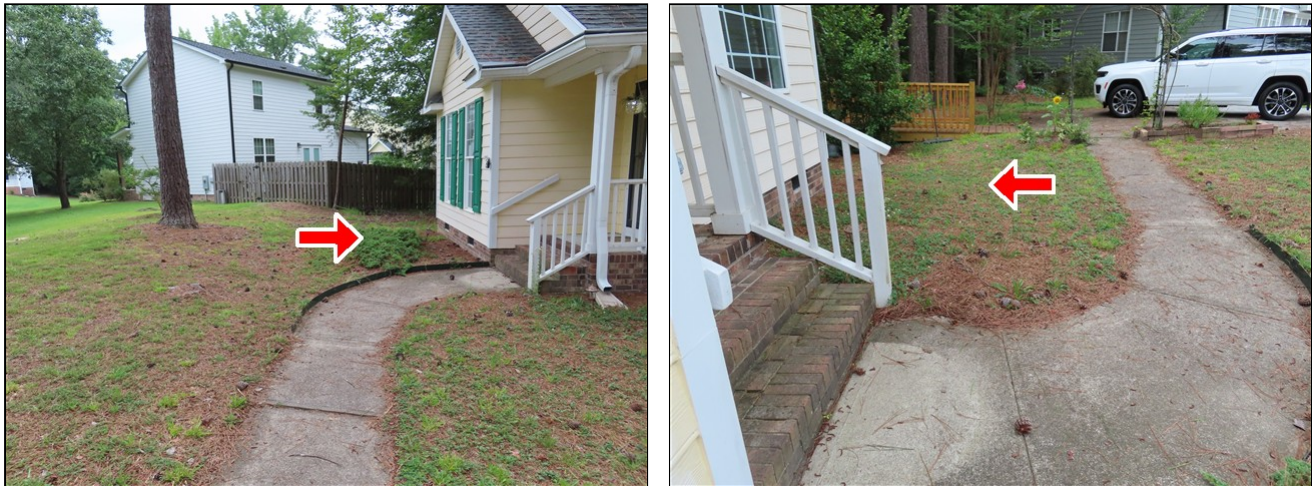
**Repair Item** The exterior grading at the front side of the house slopes towards the house and does not provide for positive drainage away from the foundation walls. A landscaping contractor should be contacted for repair to provide positive drainage away from the foundation and crawl space.

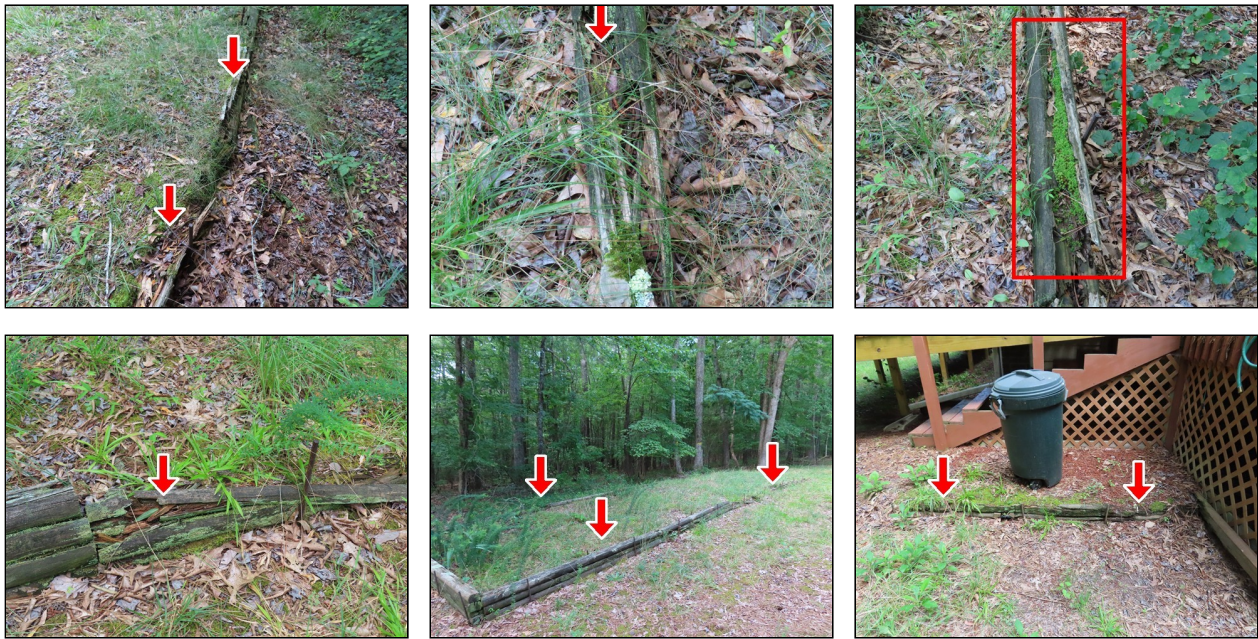
**Repair Item** Most of the landscaping timbers at the planter near the middle of the rear yard and around the trash bins are deteriorated to the degree that replacement is needed. Contact a qualified landscaping contractor for repairs.
