# Property Inspection Report

2776 Jordan Ct  
Creedmoor NC 27522

**Steve Smallman Property Inspections**

| <b>Date:</b> 7/9/2025 | <b>Time:</b> 09:00:00 AM | <b>Report ID:</b> 070925GS4 |

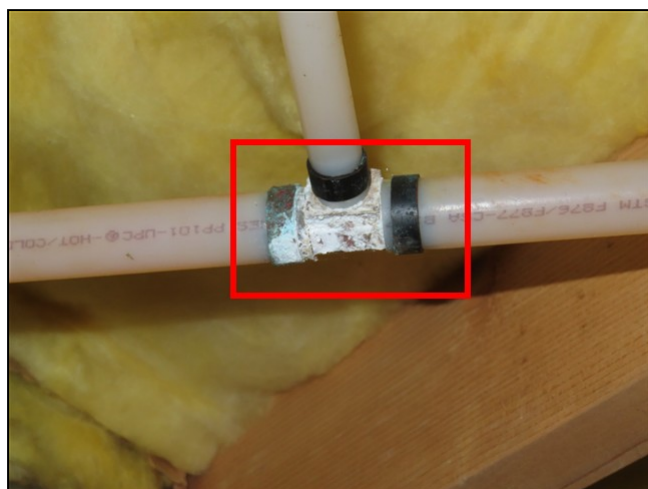
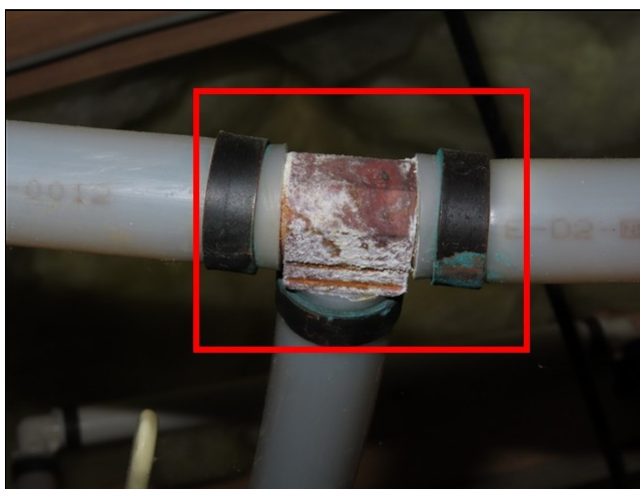
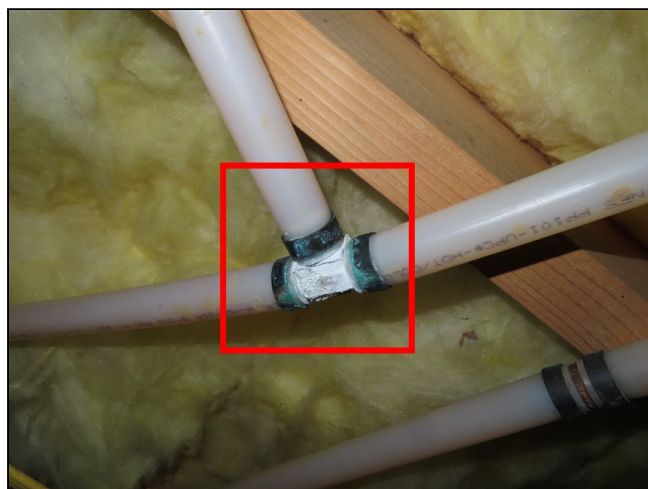
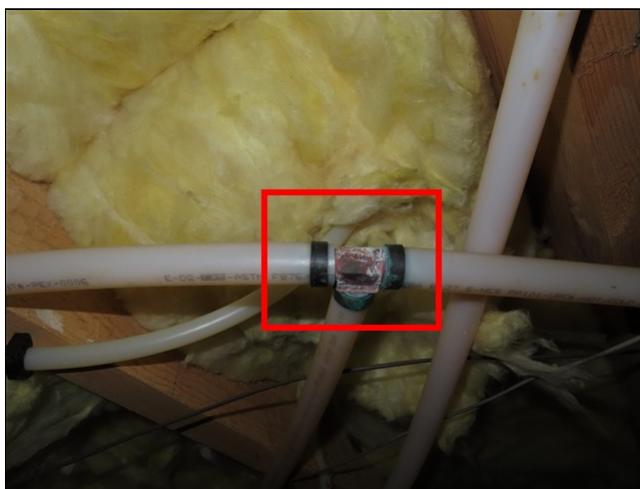
**Investigate Further** Water supply piping in this house is PEX, with brass alloy fittings. Some brands of this type of fitting have experienced a higher incidence of corrosion, occlusion, and leakage than others. I observed corrosion on several of these fittings, which is evidence of a problem, but no active leakage. Some fittings are concealed and not readily accessible for inspection. I recommend that you have a licensed plumbing contractor investigate to determine if repairs are needed and if a claim can be filed under class action settlement. For more information visit the website <http://failures.wikispaces.com/PEX+plumbing+Failures.com>

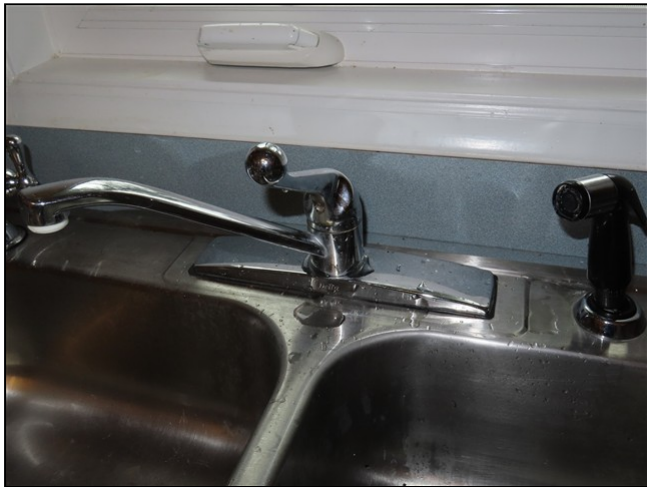
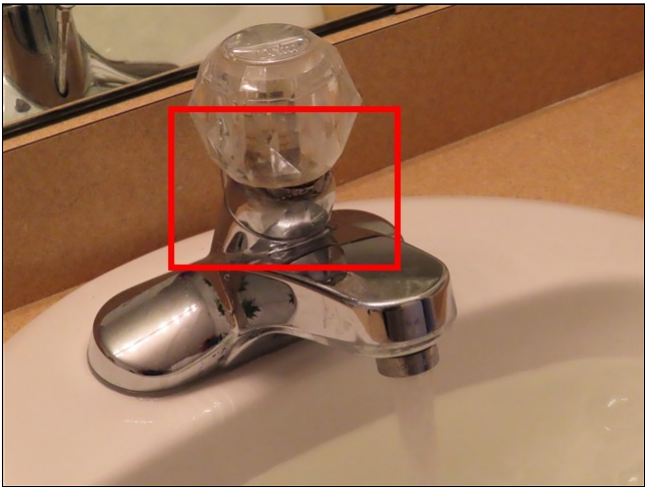
**Repair Item** Repair is needed to the plumbing valve that leaks through its handle when the water is on.  
Location(s): kitchen sink faucet and faucet at the right sink in the hall bathroom. Contact a plumber for repair.

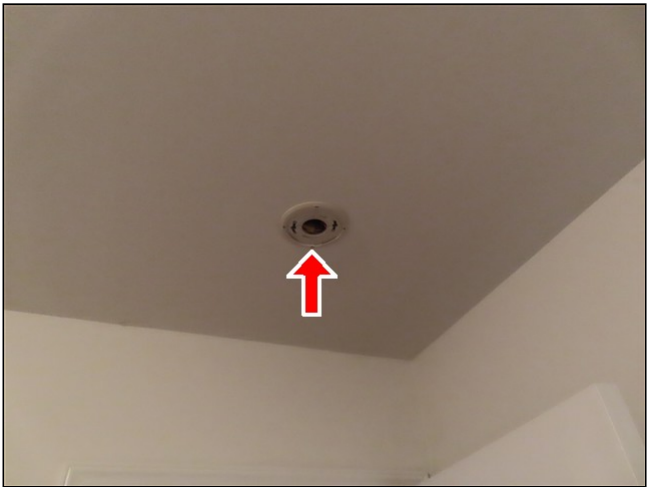
**Repair item** The smoke detector in the left end bedroom has been removed. It should be replaced for a first line of notification in the event of a fire.

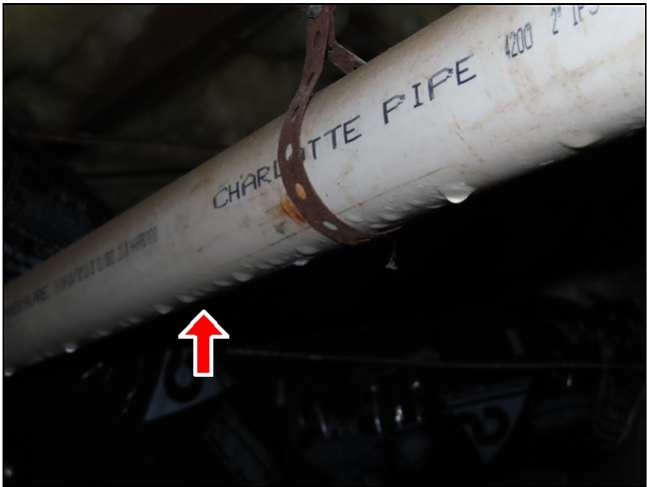
**Comment** Several of the plumbing pipes in the crawl space were wet due to condensation. This makes checking for leaks difficult due to the pipes being wet.

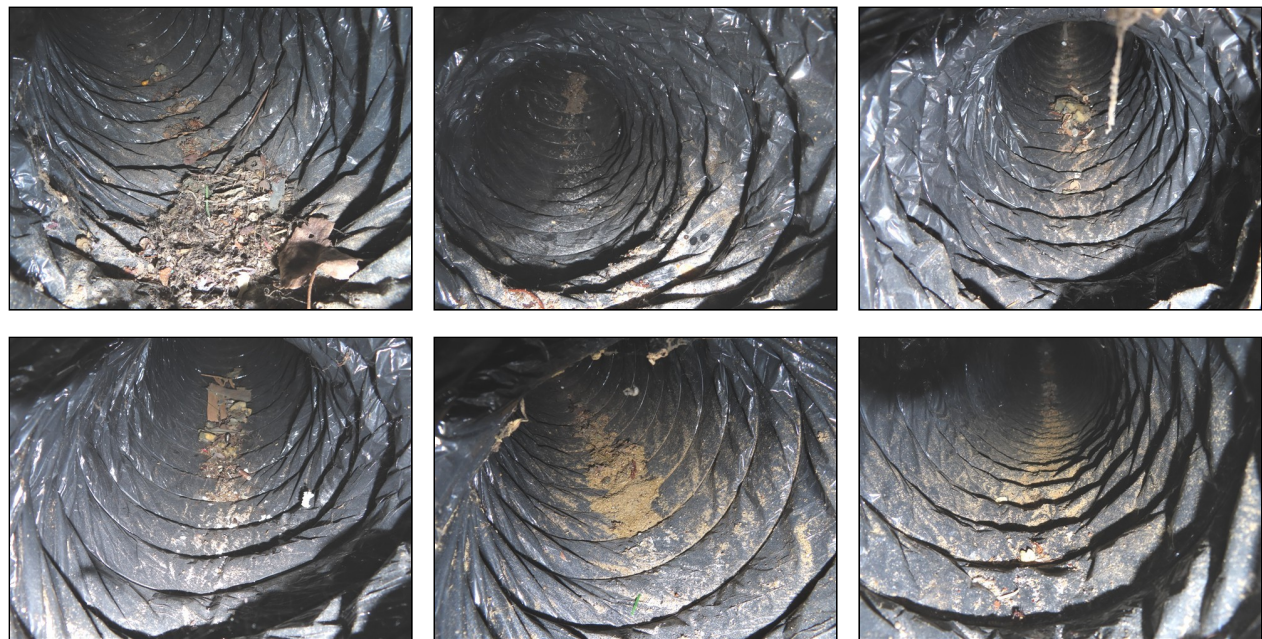
**Repair Item** Dirt and other debris was noted in most of the heating/cooling ducts. This may result in poor air quality in the home. The ducts should be professionally cleaned by a qualified contractor to remove the debris and any other contaminants that may exist.

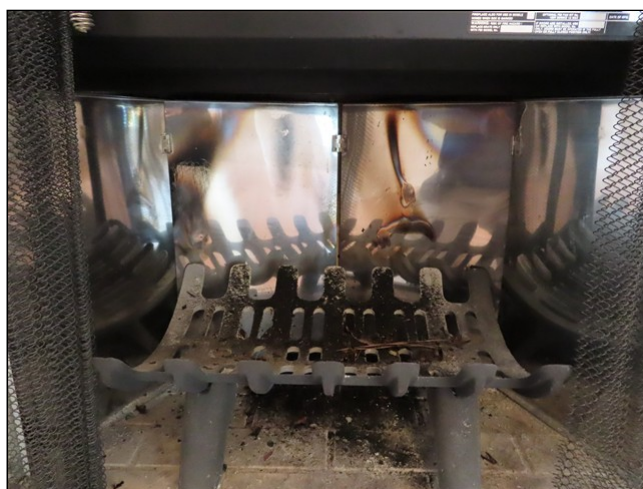
**Investigate Further** Reflective panels have been installed inside the fireplace. This blocks are view of the liners inside the firebox. We recommend that the reflective panels be removed and the liners inspected prior to using the fireplace.

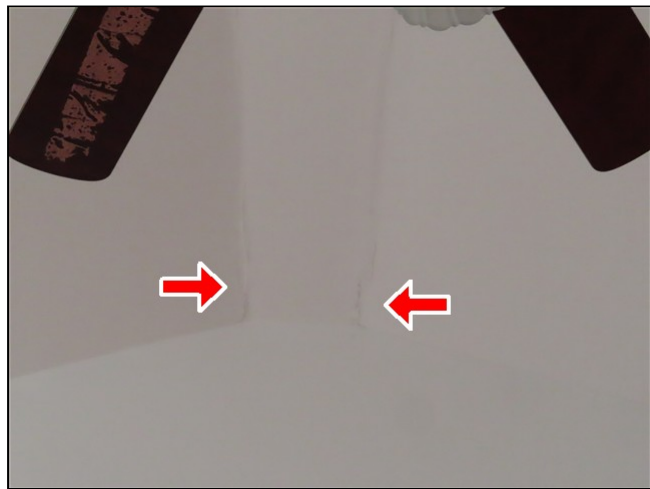
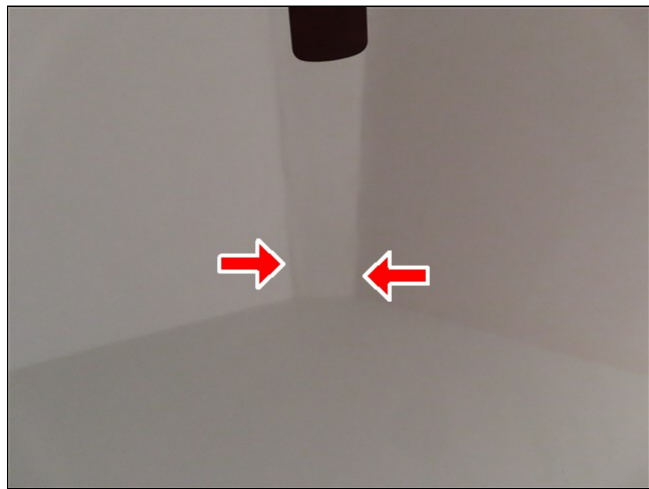
**Repair Item** The drywall tape joint is loose at the following locations: peak of the ceiling in the living room. A drywall mechanic should be contacted to complete the needed repairs.

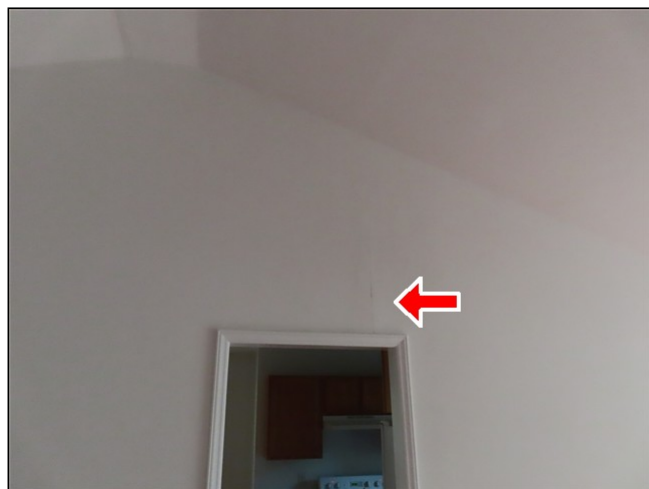
**Comment** There are some cracks in the drywall over doors. This type of crack is not uncommon and is usually a result of normal settling. Example locations include but not limited to: over door between the living room and kitchen, over opening between the living room and hallway, and over door at the primary bedroom. Repair may be desired for aesthetic appeal.

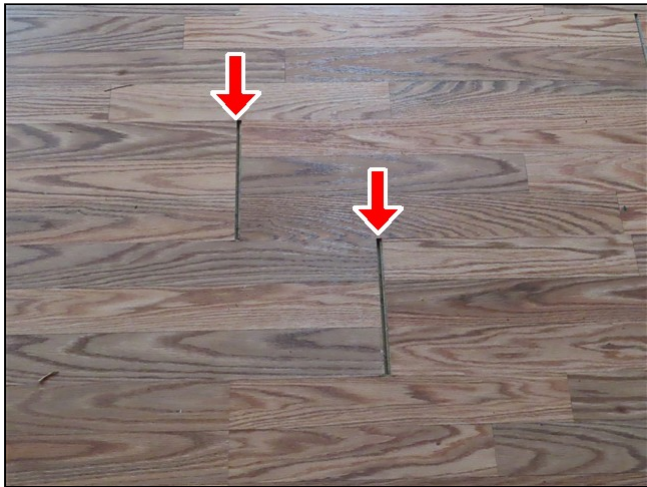
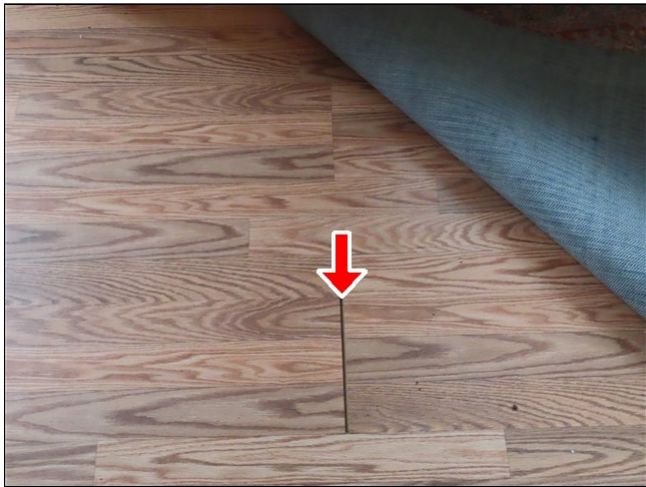
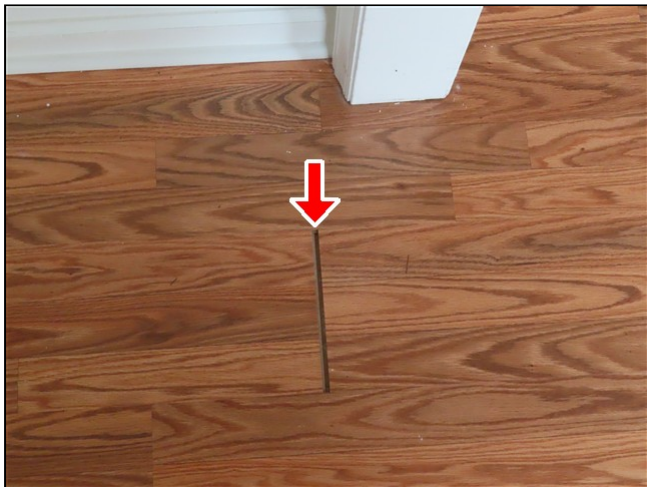
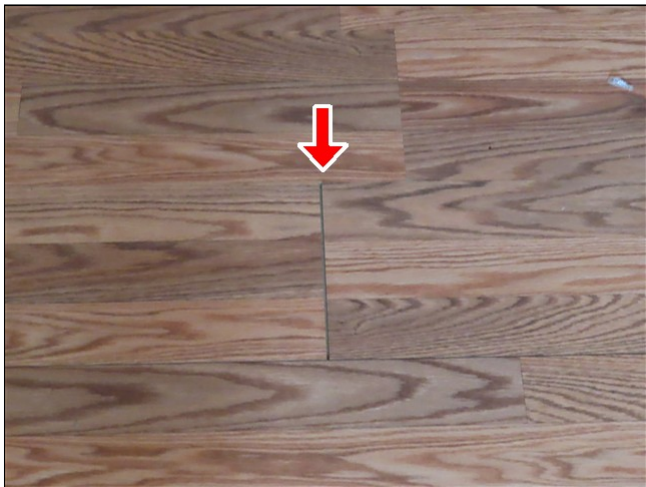
**Repair Item** There are gaps between the butt ends of some of the vinyl floor planks in the living room and hallway. This will allow debris to enter between sections of floor covering and make cleaning difficult. Most of manufactures of this type of floor cover have interlocking taps to keep the floor covering tight. We recommend that a floor covering installation contractor be contacted for repairs.

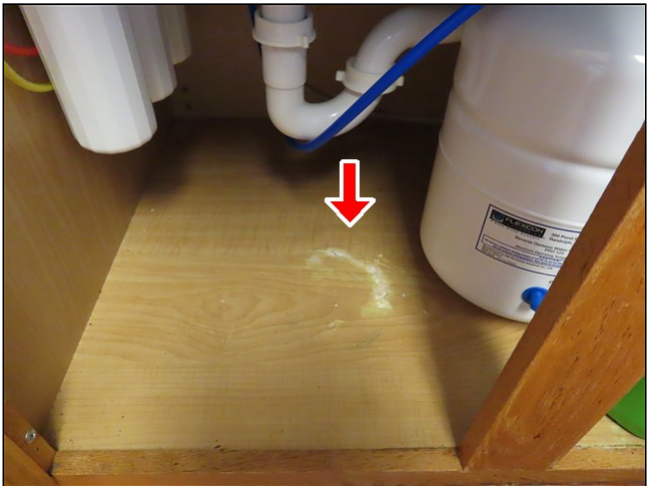
**Repair Item** Deterioration was observed at the bottom panel inside the kitchen sink base cabinet. A qualified carpenter or cabinet repair specialist should be contacted to complete the needed repairs.
