Inspection Report For Matthew Louis

Date of inspection: 06/09/25

Address: 801 Williamsboro Street, Oxford NC 27565

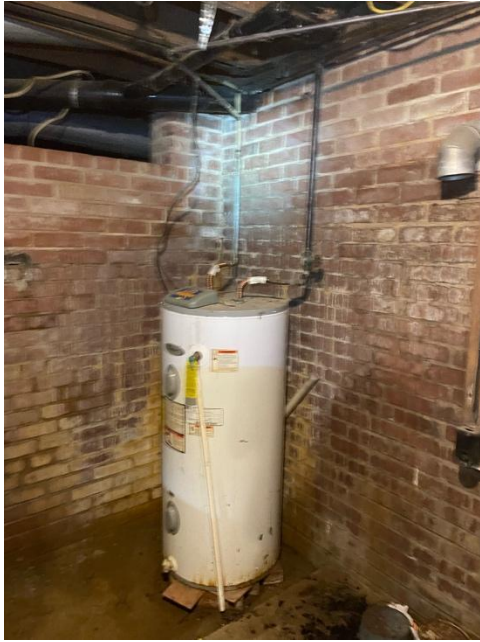
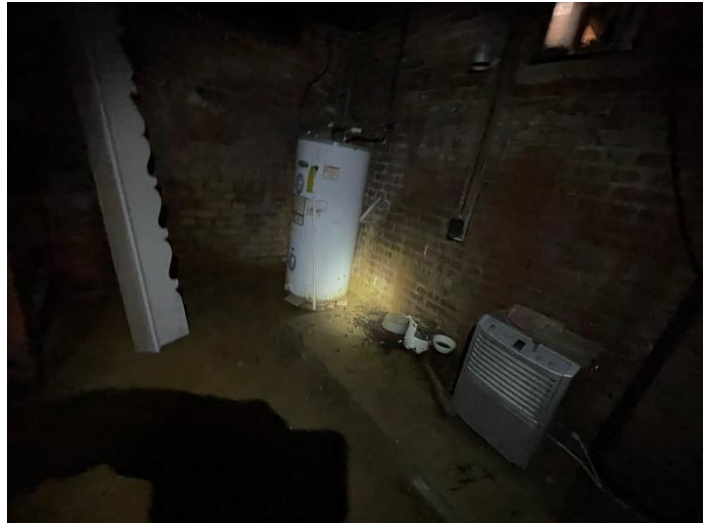
Inspection confirmed that there was water intrusion in the basement coming from the cold joint at the bottom of the basement wall and where the concrete floor meet.

Basement floor was wet in several areas where it made contact with the perimeter walls. In addition the basement wall was wet to the touch in several spots.

To address the water seepage coming in through the cold joint is is recommended that a basement gutter system and sump pump be installed to manage water before it reaches the basement floor. The gutter system will be installed in the basement floor and covered with 1" of concrete so as not to be visible on the surface except clean out ports located along the foundation wall.
