Reference: Engineering Services  
9590 Amis Chapel Rd.  
Oxford, NC 27565  
TE&D Project No.: 2501-020149

- 1) Assessment of the crawl framing and foundation in response to observed moisture damage.

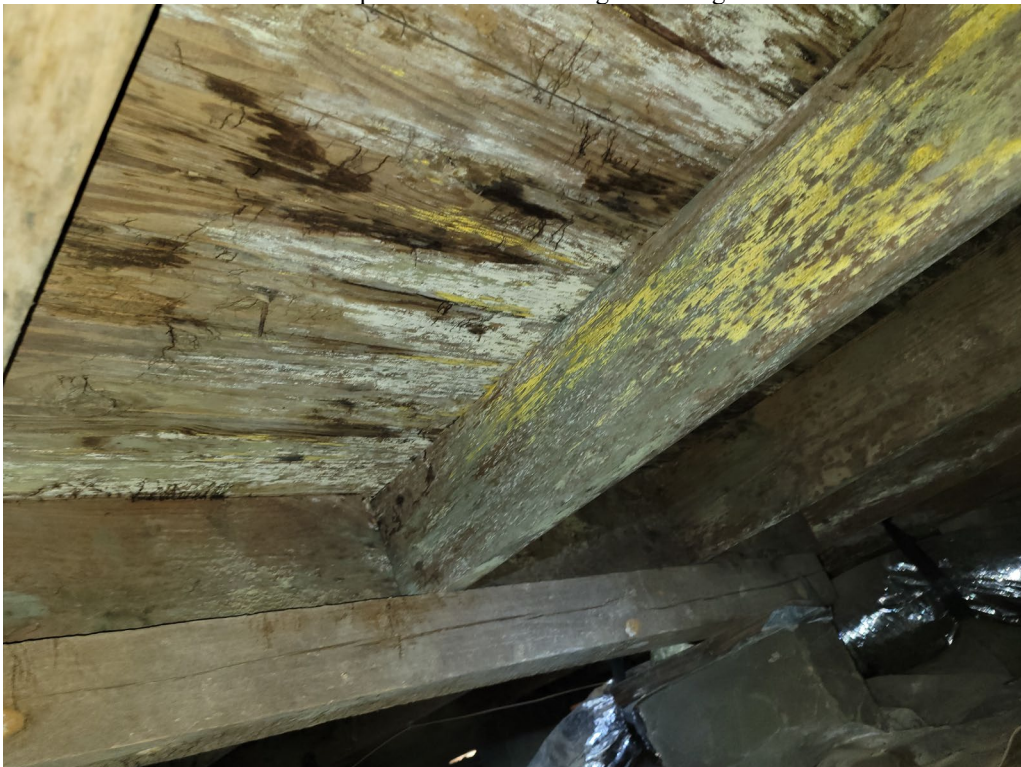
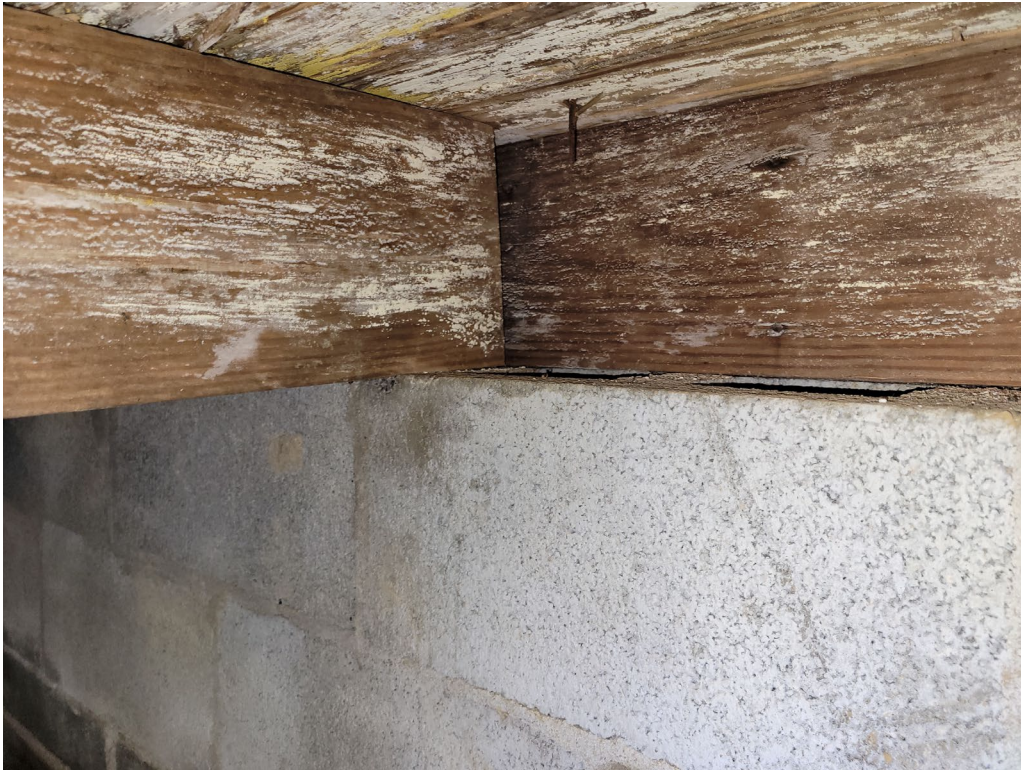
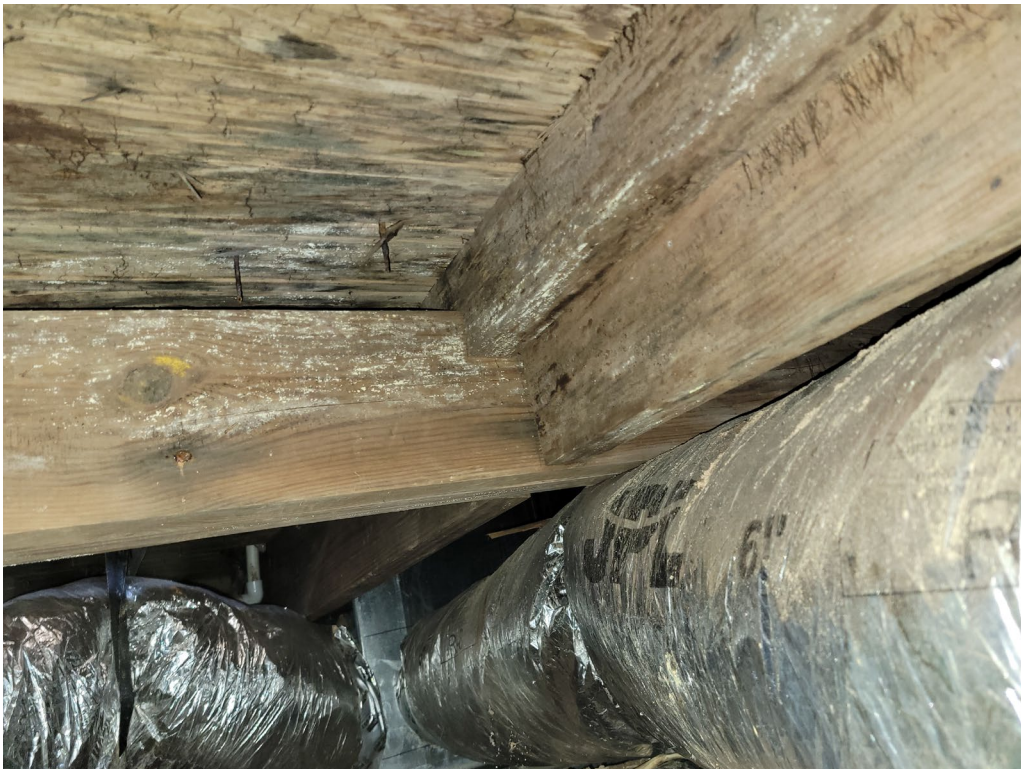
- A) The majority of the floor framing below the kitchen, the bedroom directly to the left of the kitchen, and the living room were observed to have significant moisture damage. TE&D recommends removing the existing damaged 2 x 8 floor joists and associated exterior bands and replacing with new, treated 2 x 8 floor joists and bands. New joists are to be installed at 16" o.c.

Examples of moisture damaged framing:

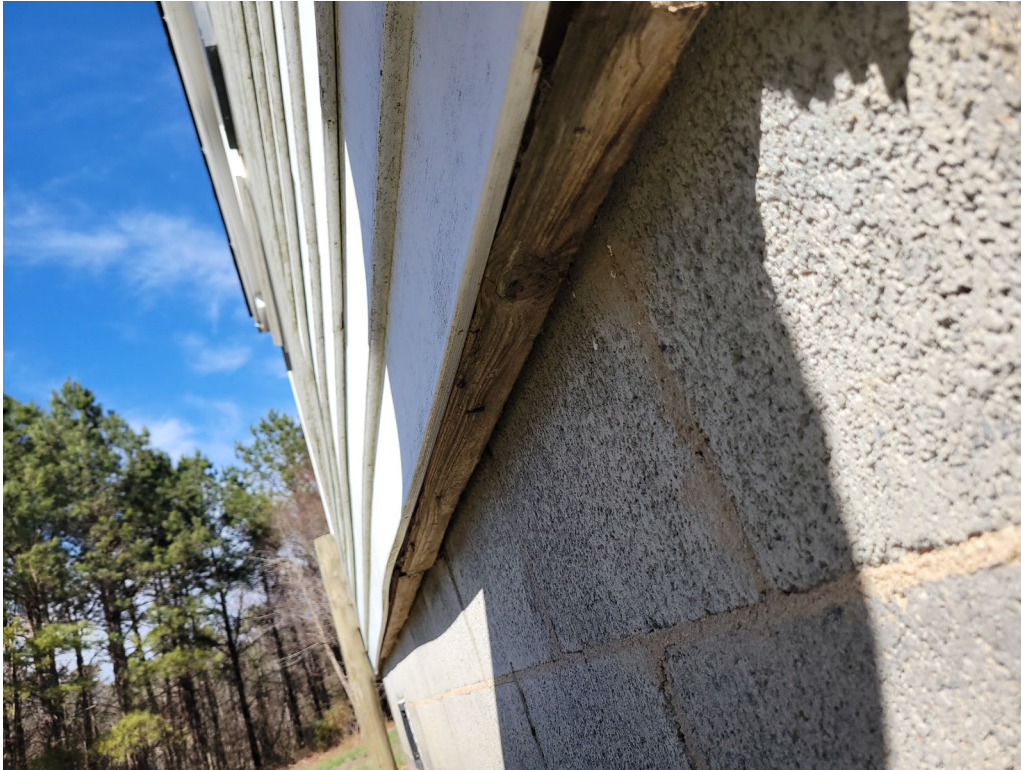
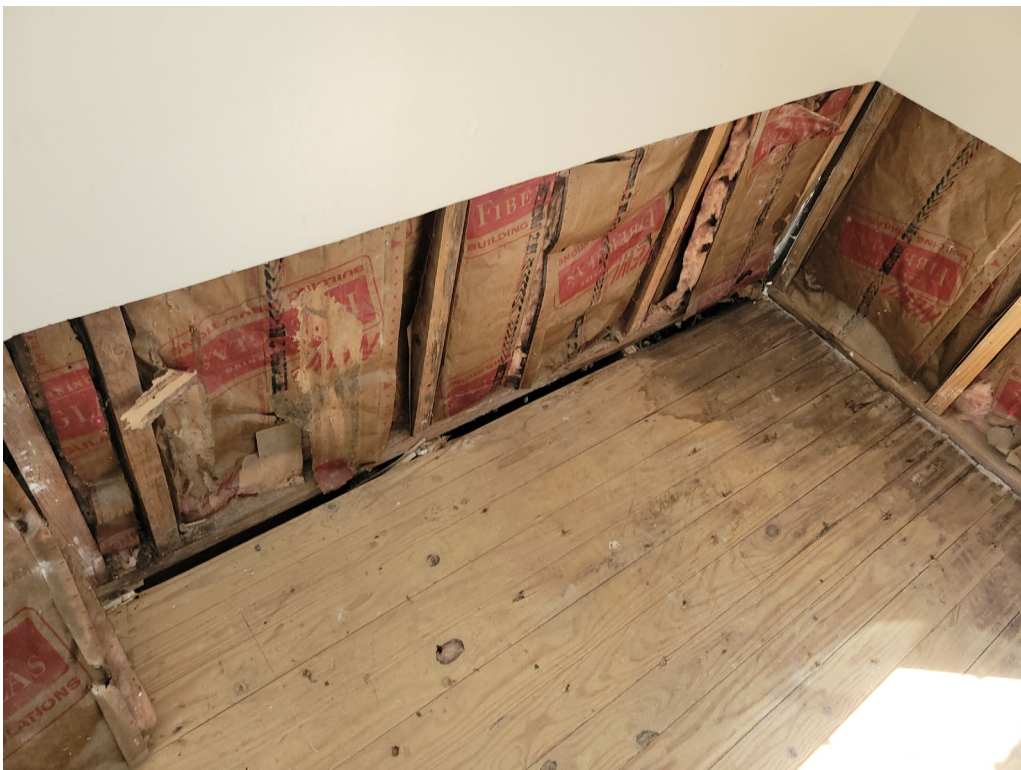
- 0' to 6' from the left foundation wall
    - 0' to 18' from the right foundation wall
  - C) Due to the expansion of the wood framing from moisture exposure, the front exterior band was observed to be pulling away from the floor framing. As a result, the front exterior walls were observed to be skewed and are no longer fully supported by the crawl framing and foundation. The front exterior band is to be removed and replaced with a new, treated, equivalent member. Additionally, a new treated sill plate is to be installed between the floor framing and the foundation wall. The new sill plate is to be anchored to the foundation per the 2018 NC Residential Building Code. Upon installation of the new band and sill plate, the wall above may be shifted back vertical and attached to the repaired floor framing.

Front band shifted off foundation wall:

Note: Floor joists may be notched for installation of new sill plate.

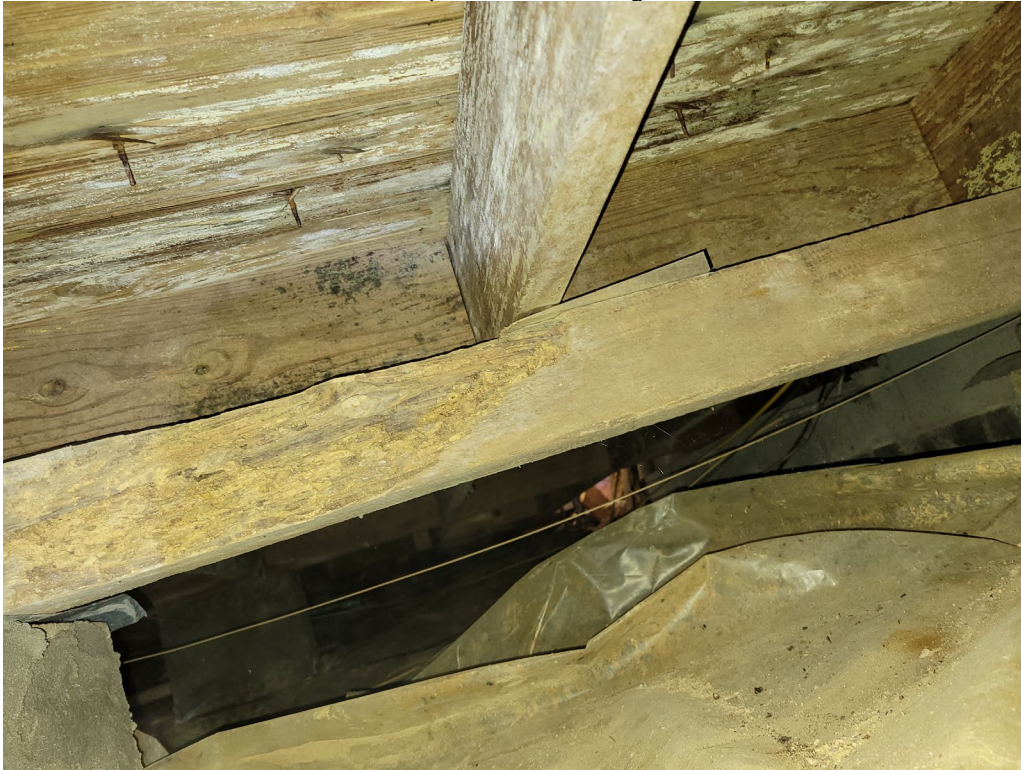
- D) We observed multiple instances of insect damage in existing 4 x 4 reinforcement girders below the living room. All damaged 4 x 4 reinforcement girders are to be removed. No additional reinforcement is required as the new 2 x 8 joists installed in item 1.A. are adequate to support the anticipated loading conditions.

Example of Insect Damage:

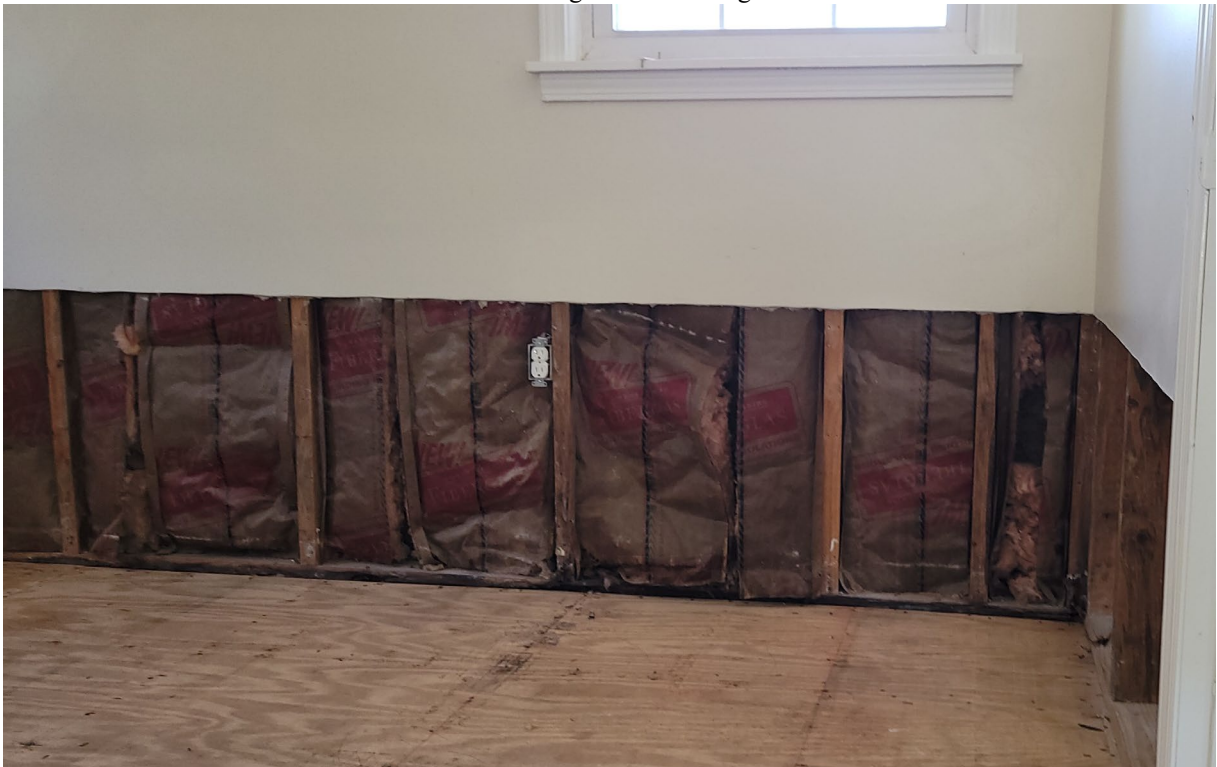
- F) Moisture damage was observed at the rear exterior wall in the back-left bedroom. The bottom plate and a 2 x 4 stud approximately 8'-0" from the left exterior wall are to be removed and replaced with new, treated, equivalent members.

Moisture damaged wall framing

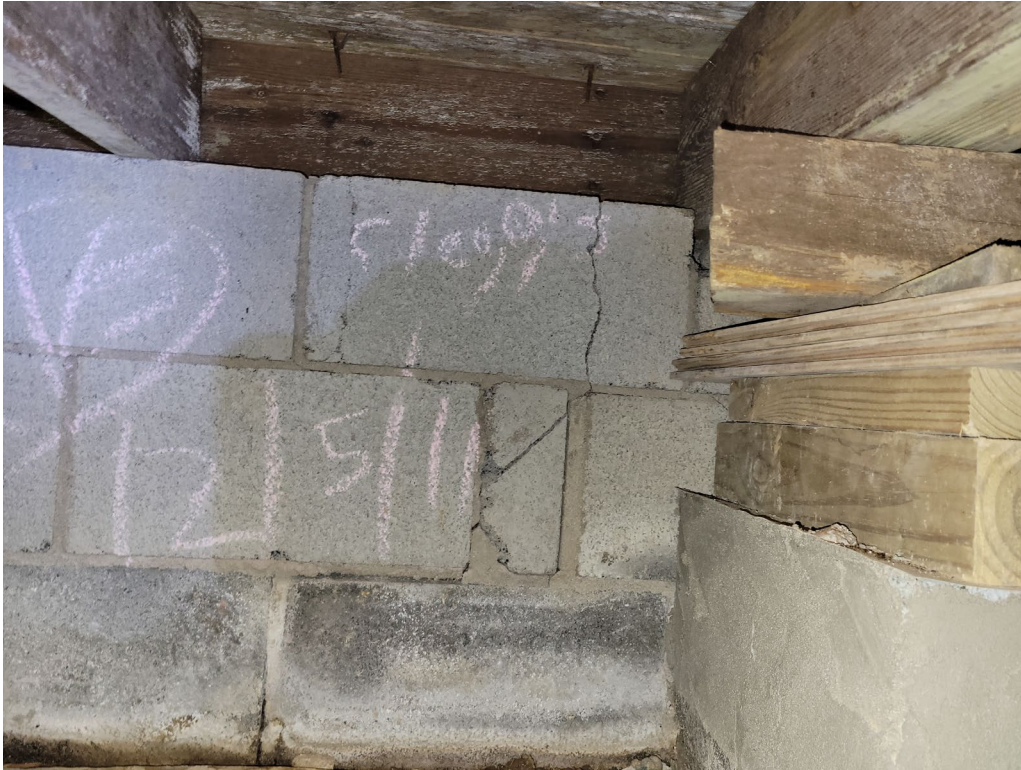
- G) We observed an approximately 1/16" wide, vertically trending crack in the front foundation wall approximately 15'-0" from the left foundation wall. The soils around the foundation were qualitatively probed and subjected to Static Cone Penetrometer (SCP) testing at depths up to 2'-0" below existing grade and were found to be adequate to support the anticipated loading conditions of 2000psf.

Based on our observations and analysis, the existing cracks in the foundation are indicative of the type of cracking typically associated with differential settlement of the underlying soils and shrinkage of the concrete materials. It is TE&D's opinion that the existing cracks do not indicate excessive differential settlement (i.e. more than 1/2" total) and are not a structural concern at this time. Therefore, the existing damage may be regarded as cosmetic and should not affect the overall structural integrity of the dwelling. The foundation cracks may be sealed or pointed up with epoxy and/or mortar. We also recommend that all drains (roof, foundation, HVAC, etc.) be directed away from the foundation with positive drain to daylight.

Foundation Crack:
