March 6, 2024

Re: Limited Structural Inspection  
270 Wiggins Road  
Louisburg, NC

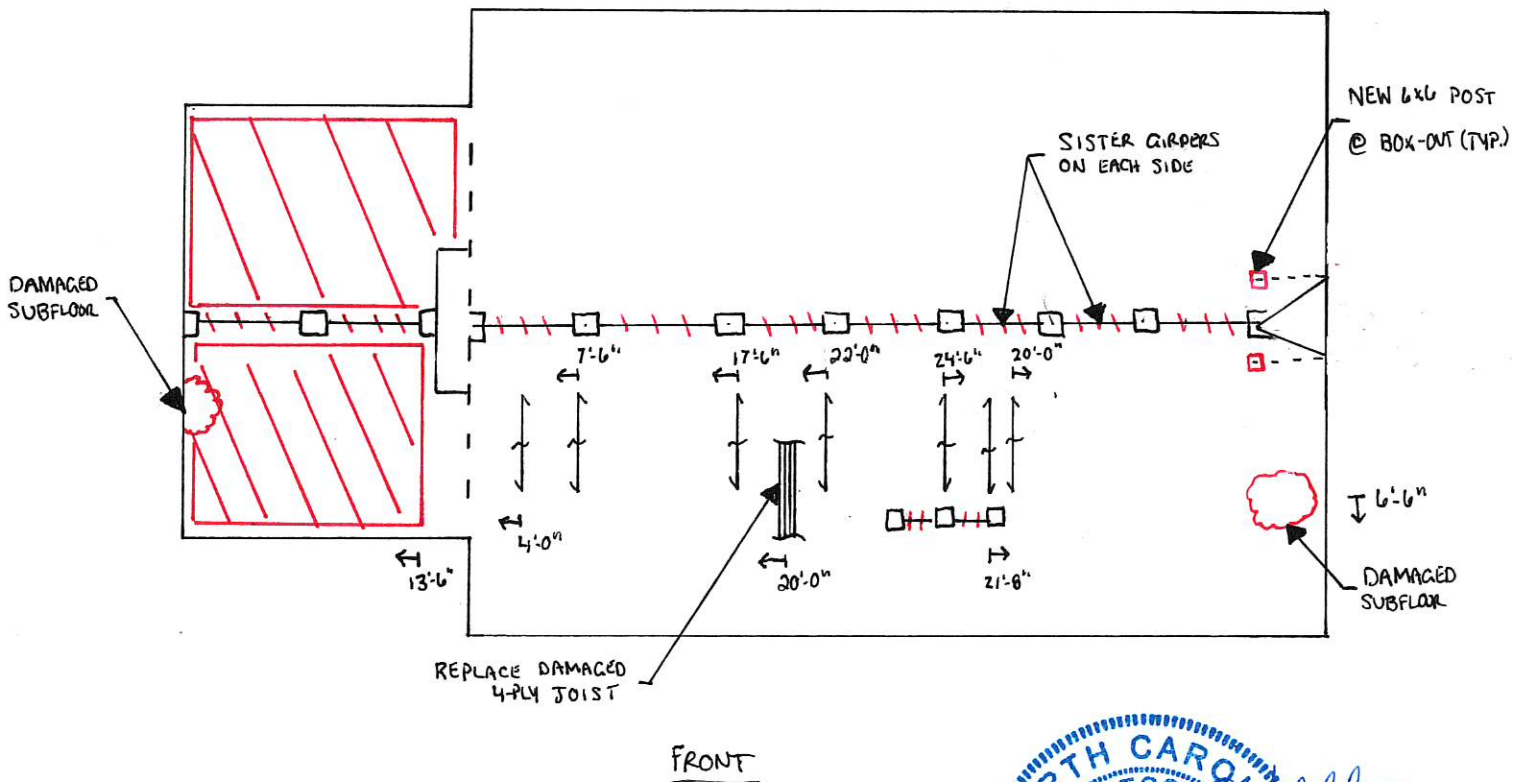
LOCATION SKETCH  
(NOT TO SCALE)

- H: DAMAGED GIRDER
- ▣: SECTION OF DAMAGED FLOOR JOISTS
- ↑: DAMAGED FLOOR JOIST

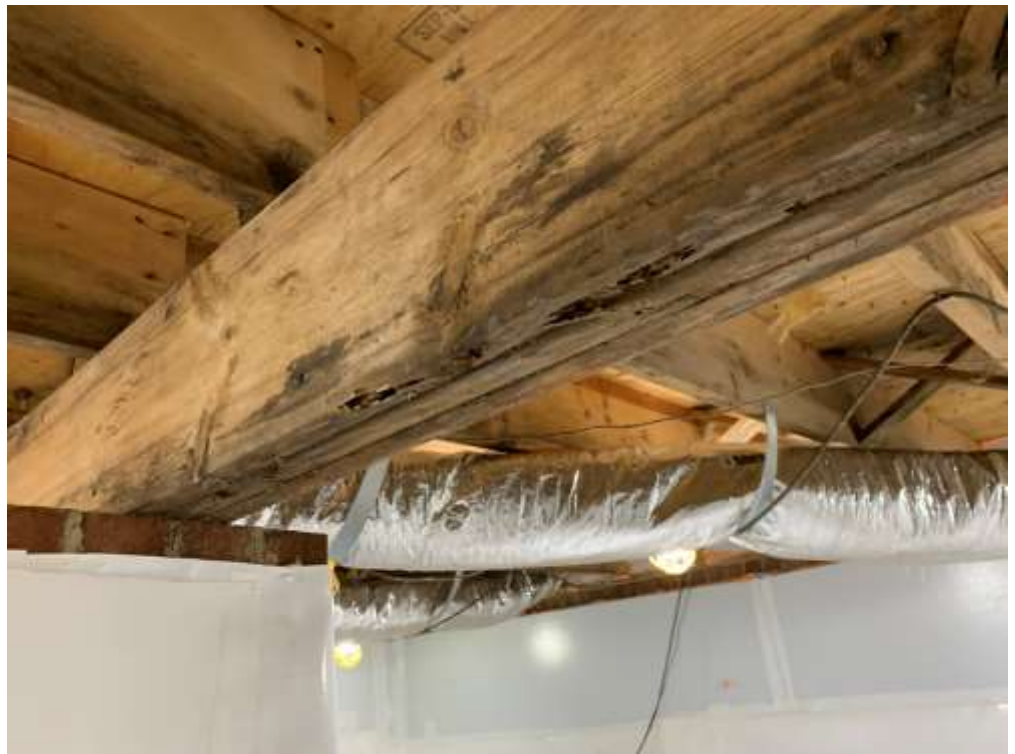
Photo No.  
2

- b. Damage was noted to nearly all floor joists spanning front to rear at the rear of the crawlspace.
  - c. Damage was noted to a section of floor joists spanning front to rear at the front of the crawlspace. The damage was noted to start at the left foundation wall and extend towards the right approximately 13'-6".

The damaged floor framing noted above (Observations #2-3) is likely the result of moisture intrusion into the building envelope in combination with prolonged elevated moisture levels in the crawlspace and wood-damaging insect infestation. Excess water intrusion in the building envelope over time can deteriorate the integrity of the wood framing members and cause rot. The damaged floor framing is considered to be a structural concern. We have provided recommendations below to address these issues.

Typical view of a  
damaged floor joist.

- a) Additionally, we recommend positively re-attaching the subfloor from above with 8d nails spaced up to 12" O.C.
5. We recommend fully sistering the damaged, split, and cut floor joists noted above (Observations #2b-2c, 3c-3i, and #4-5) for the full length (bearing point to bearing point). All double joists should be sistered on each side. The sistered member should match the size of the existing and be attached with (3) 10d nails at 16" O.C.

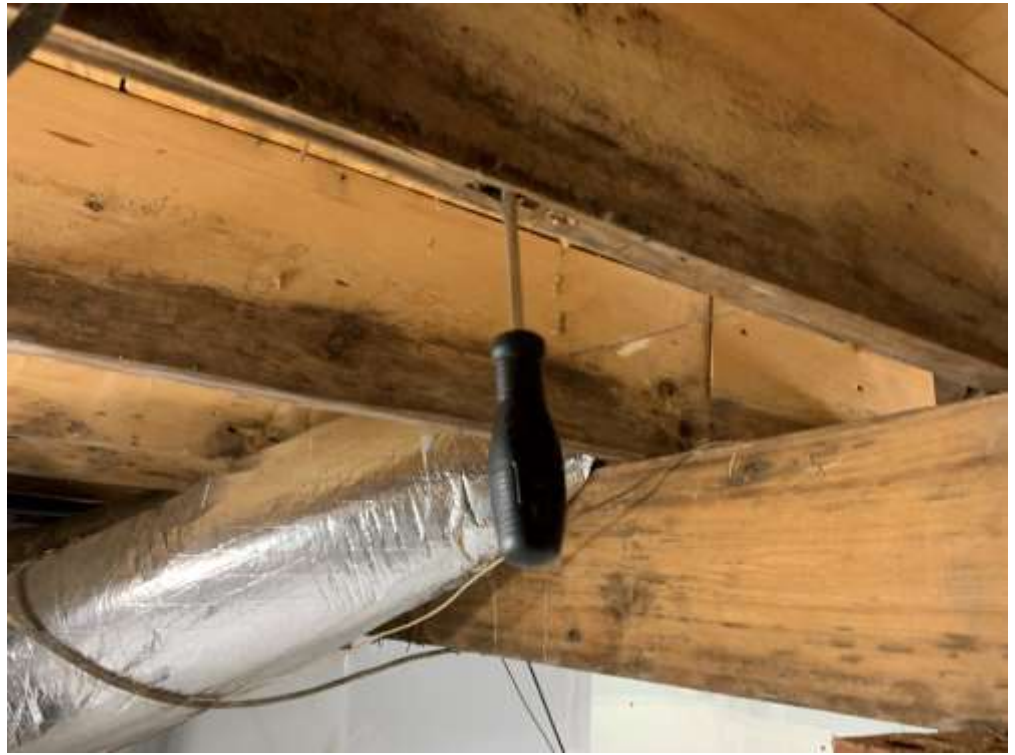
Photo No.  
3

4. Cracked/split floor joists were noted in the main crawlspace at the following locations:
  - a. A cracked/split floor joist was noted at the front of the crawlspace approximately 11'-6" from the left intermediate foundation wall.

- b. A cracked/split floor joist was noted at the front of the crawlspace approximately 14'-0" from the left intermediate foundation wall.
  - c. A cracked/split bearing end of a floor joist was noted at the front of the crawlspace 14'-2" from the left intermediate foundation wall.

The cracked/split floor joists noted above (Observation #4) are likely due to natural defects in the lumber causing the members to split. The condition of the floor joists is considered to be structural concerns. We have provided a recommendation below to address this issue.

Typical view of  
cracked/split floor  
joists.

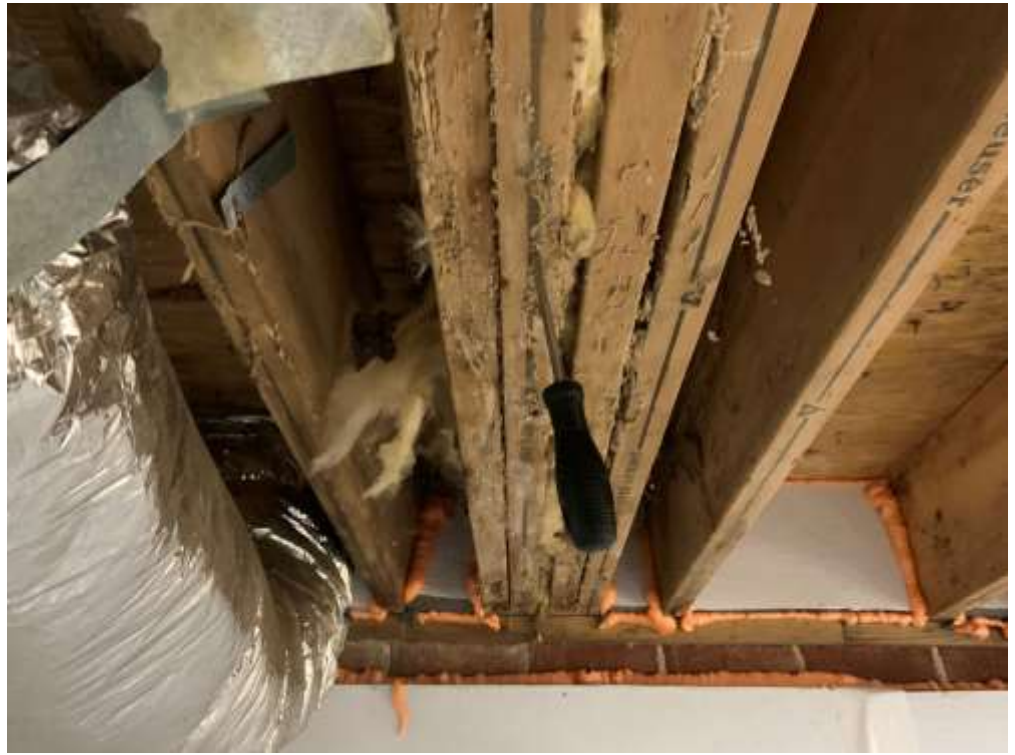
Photo No.  
5

The inadequately supported box-out framing is likely due to construction methods at the time of original construction of the home. If left in this condition, vertical displacement and finish material damages are likely. We have provided a recommendation below to address this issue.

Typical view of  
inadequately  
supported box-out  
header.

7. In regards to the inadequately supported framing ends noted above (Observations #6-7), we recommend installing new pressure-treated 6x6 posts at the left ends of the box-out header to the front and rear of the chimney. The new posts should bear on minimum 12"x12"x8"-thick

concrete footings. Positively attach the post to the footing with a Simpson Post Base (or equivalent).
