**Advantage  
Inspection**

## **SEPTIC SYSTEM INSPECTION**

**Date:** September 9, 2025  
**Report for:**  
**Inspection address:** 270 Wiggins Rd, Louisburg, NC 27549  
**Realtor:**  
**System Design:**

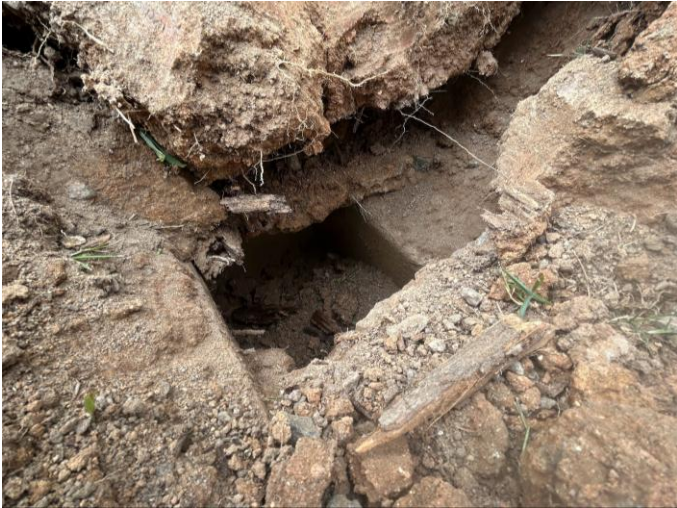
Inlet riser shown damaged.

- **Roots were noted as being present around the inlet inspection port.**
- **The inlet riser lid was noted as being damaged.**
- **The inlet chamber riser was noted as being at dirt grade. When installed risers are to be no less than 3" above surrounding dirt grade. It is suggested that the riser be extended to meet current state installation standards.**

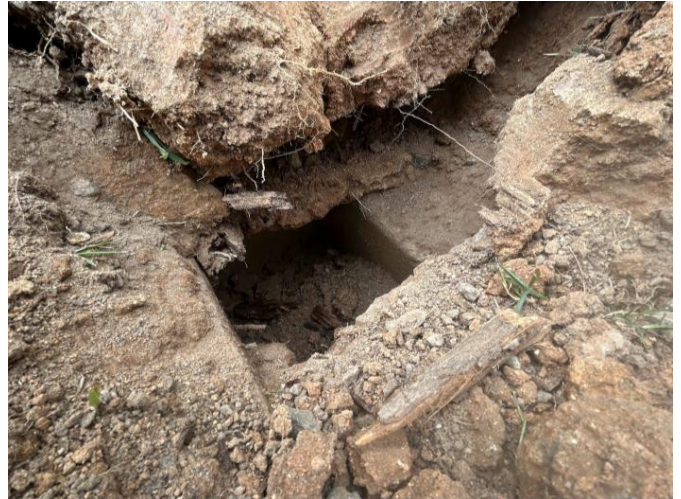
Inlet riser shown less than 3" above grade.

- The inlet chamber riser was noted as being at dirt grade. When installed risers are to be no less than 3" above surrounding dirt grade. It is suggested that the riser be extended to meet current state installation standards.

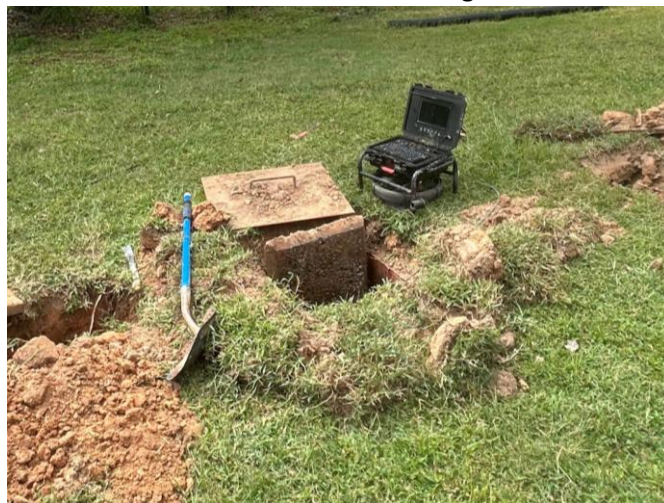
Outlet riser shown less than 3" above grade.

- The outlet chamber riser was noted as being at dirt grade. When installed risers are to be no less than 3" above surrounding dirt grade. It is suggested that the riser be extended to meet current state installation standards.

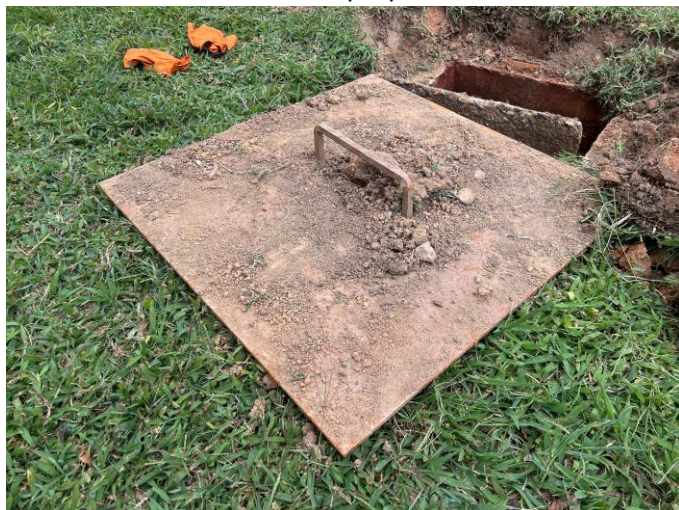
Outlet riser fitted with an improper lid.

- **The outlet riser was noted as being fitted with an improper riser lid (custom made metal lid).**
- **The outlet lid was noted as missing a handle.**

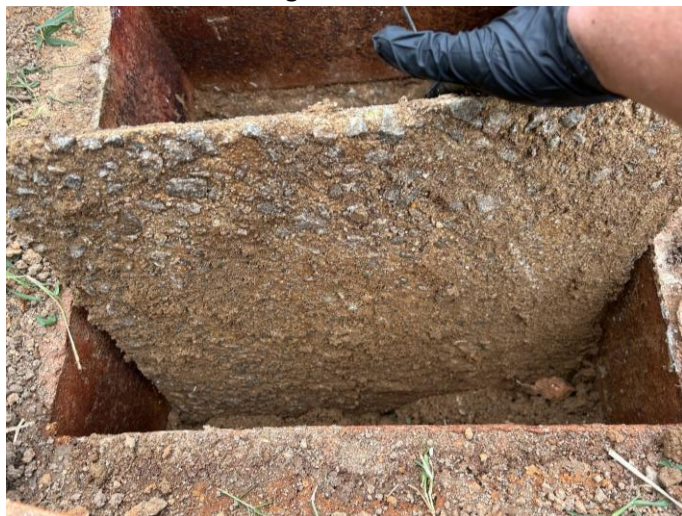
Outlet lid shown missing a handle

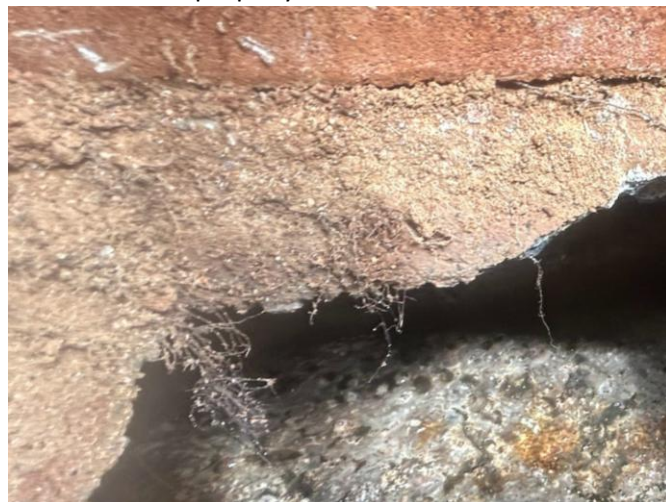
Root intrusion shown around outlet inspection port - outlet riser not properly sealed to tank.

- **Roots were noted as being present around the outlet inspection port due to the outlet riser not being properly sealed to the tank.**
- **The outlet riser was noted as being fitted with an improper riser lid (custom made metal lid).**
- **The outlet lid was noted as missing a handle.**
- **The outlet pipe penetration was noted as not being properly sealed.**
- **Deterioration was noted as being present around the outlet inspection port.**
- **The outgoing drainline from the septic tank to the distribution box was scoped and inspected. The outgoing drain line was noted as having a blockage and root intrusion at the beginning of the line.**

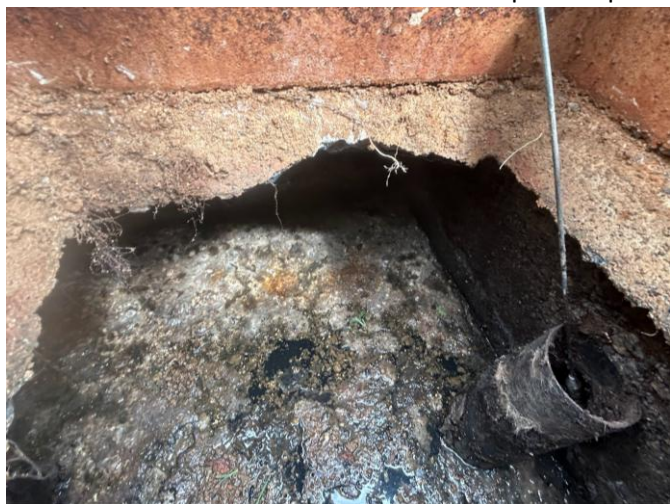
Deterioration shown around the outlet inspection port.

- **The outlet pipe penetration was noted as not being properly sealed.**
- **Deterioration was noted as being present around the outlet inspection port opening.**

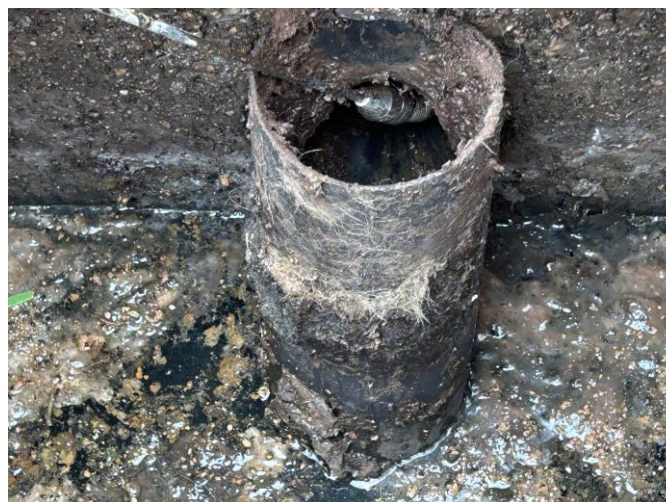
Effluent level shown at least 5" below a normal effluent level.

**3)** Water levels under normal conditions inside the septic tank would place the wastewater effluent level at the invert of the outlet drain (the bottom edge of the outgoing drain pipe) and typically, the outgoing drain pipe is installed at a lower elevation inside the septic tank than that of the incoming drain pipe. The effluent level inside the septic tank was observed to be as much as 5" inch total inside. The house is known to have been inactive for an unknown period of time, and inactivity can be considered as a reason for some reduction in effluent level as the effluent can evaporate through the whole house waste pipe system at a rate of up to 1" a month (equates to approximately 20 gallons of water loss) in some cases. The home would have had to have been vacant for close to 5 months for the current effluent level to be considered attributed to naturally occurring evaporation alone. If this system is not verified as having been inactive for a very long period of time, leaking in the septic tank itself should be considered as the reason for the lower effluent level. Leak checking should be performed in order to verify the structural integrity of the septic tank. Leak checking requires that the effluent level inside the tank needs to be filled back to a normal level and then checked after a 24- hour time period. Only a 1/2" reduction in water level is allowed to be present within this time period. If more than 1/2" in reduced lower effluent levels are present, the tank structural integrity is considered to be compromised and repair/replacement are considered to be required. **Due to the lower effluent level currently inside the septic tank, have a qualified septic tank installation contractor provide further evaluation in order to determine if the structural integrity of the septic tank is compromised (leaking) and provide a repairs/replacement if considered necessary.**

- **Due to the lower effluent level currently inside the septic tank, have a qualified septic tank installation contractor provide further evaluation in order to determine**

if the structural integrity of the septic tank is compromised (leaking) and provide a repairs/replacement if considered necessary.

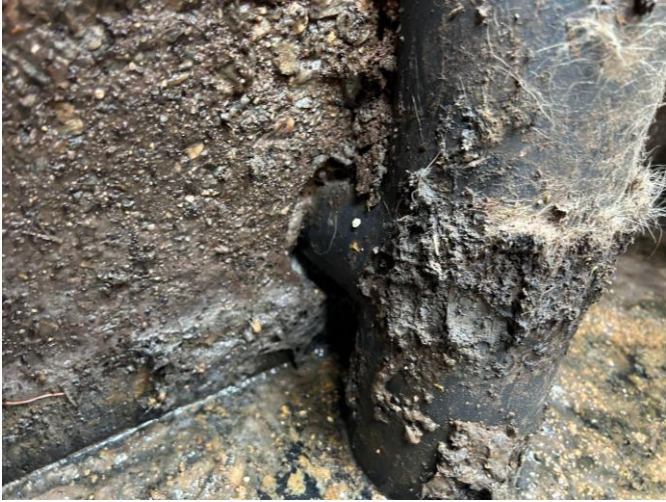
Outlet pipe penetration shown not properly sealed.

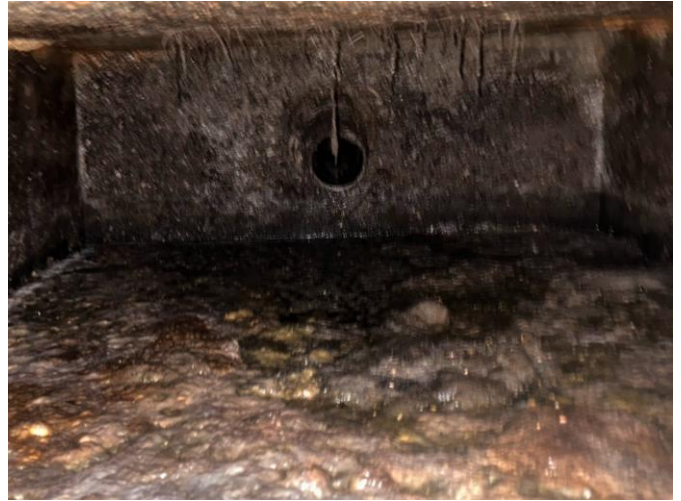
Inlet side shown from the outlet inspection port - root intrusion shown around the inlet inspection port.

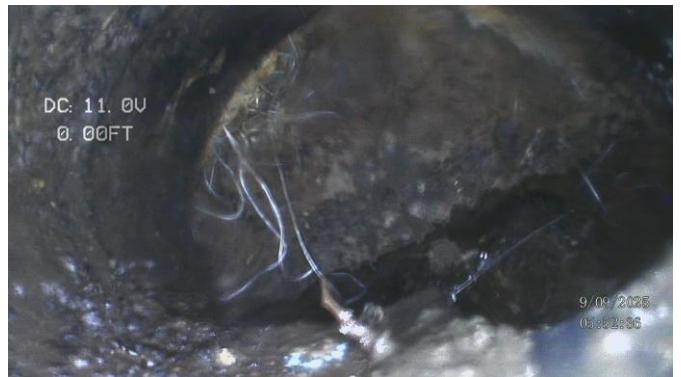
Outlet line shown scoped with an obstruction and root intrusion.

- **The outgoing supply line from the septic tank to the distribution box was scoped and inspected. The outgoing drain line was noted as having a blockage and root intrusion at the beginning of the line.**

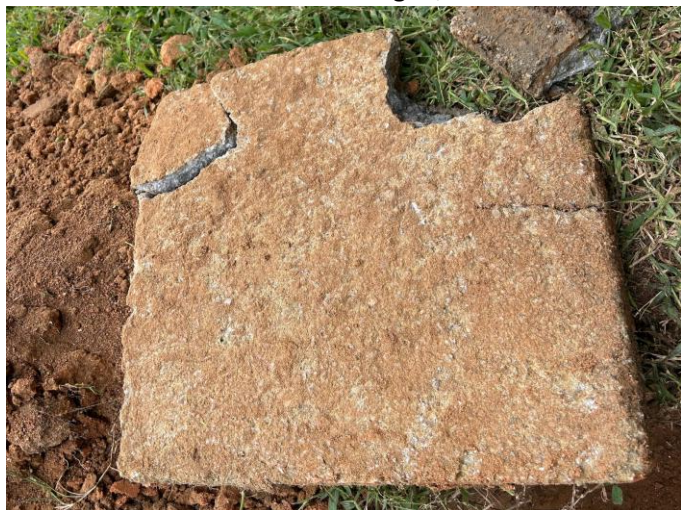
Distribution box lid shown damaged/deteriorated.

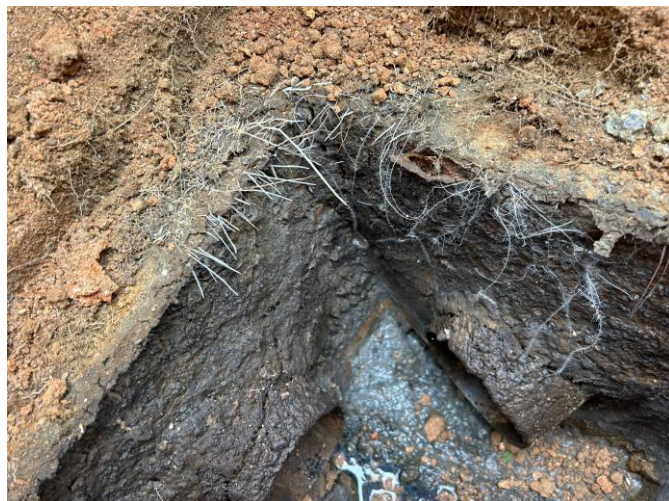
Root intrusion shown in the distribution box.

- **The distribution box was noted as having roots present inside (see photo).**
- **The distribution box was noted as having solids collected in the bottom. Solids can collect inside of the distribution box and deteriorate the interior sidewalls of the distribution box. Solids collected inside of the distribution box can also flow into the drain lines resulting in restriction of flow.**
- **The distribution box lid was noted as being damaged/deteriorated.**
- **The drain lines were scoped and inspected. Drain line 1 was noted as having accumulated solids and root intrusion throughout.**
- **The drain lines were scoped and inspected. Drain line 2 was noted as having accumulated solids and root intrusion throughout.**
- **The drain lines were scoped and inspected. Drain line 3 was noted as having accumulated solids throughout.**

- It is suggested that a preventative maintenance treatment of a root killer be added in the septic system to kill off any root mass intruding into the drain lines. Any products (specified for septic system use) that consist mostly of copper sulfate will kill off existing roots and prevent further root growth from growing in and around the drain lines.

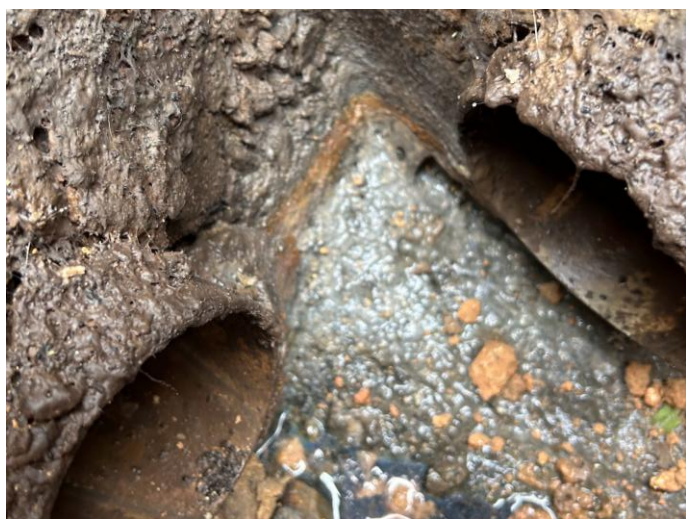
Solids shown in the distribution box.

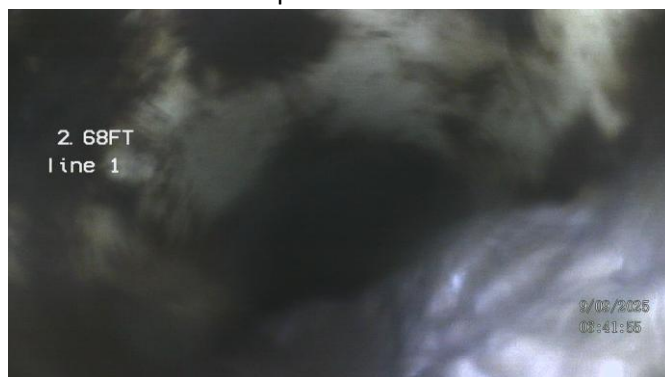
Drain line 1 shown scoped with accumulated solids.

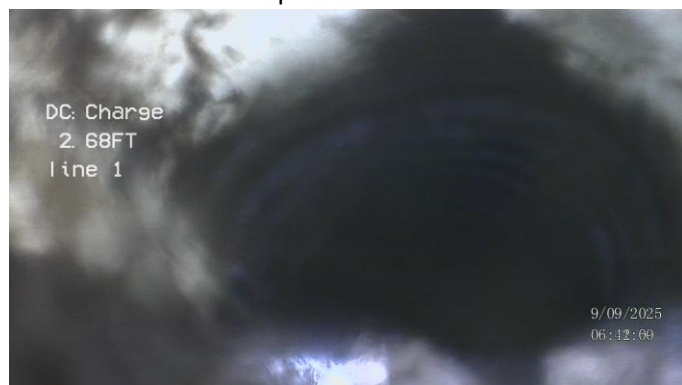
Drain line 1 shown scoped with accumulated solids.

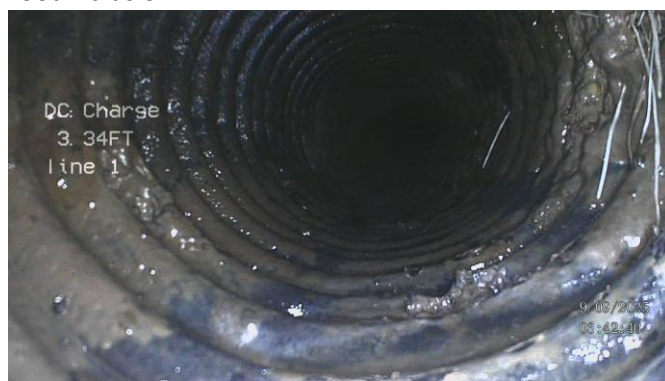
Drain line 1 shown scoped with accumulated solids and root intrusion.

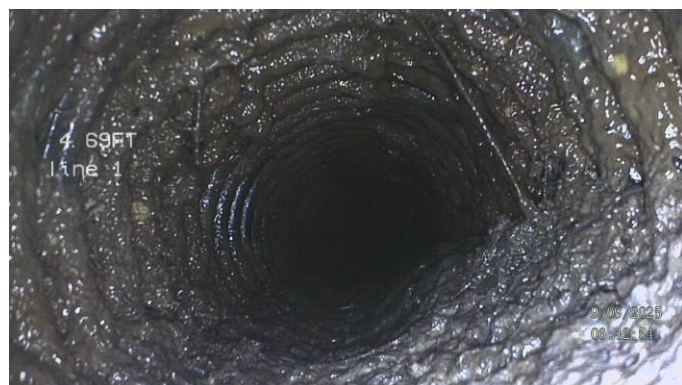
Drain line 1 shown scoped with accumulated solids and root intrusion.

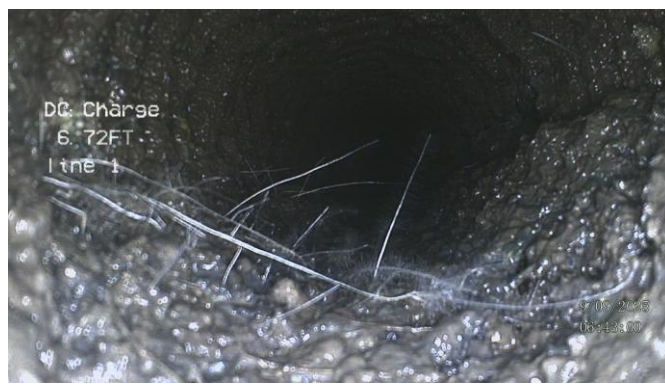
Drain line 1 shown scoped with accumulated solids and root intrusion.

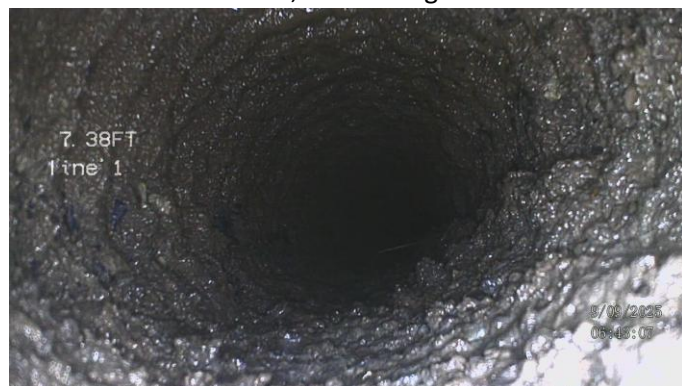
Drain line 1 shown scoped with accumulated solids and root intrusion at 7.38FT, could not go further.

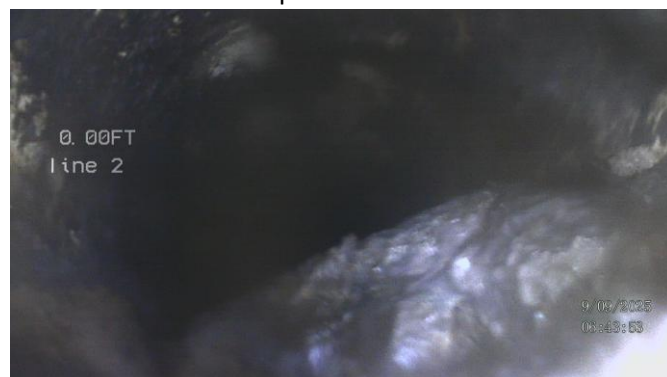
Drain line 2 shown scoped with accumulated solids.

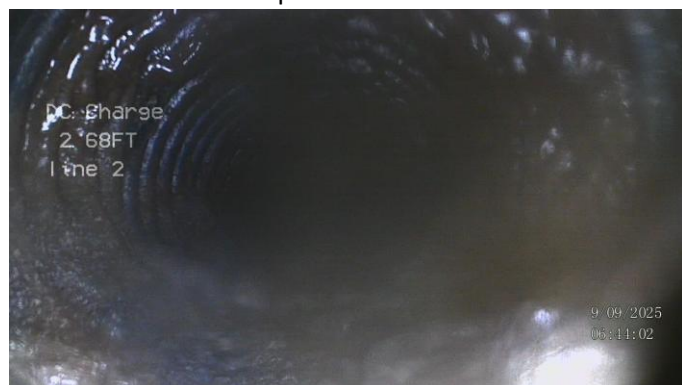
Drain line 2 shown scoped with accumulated solids.

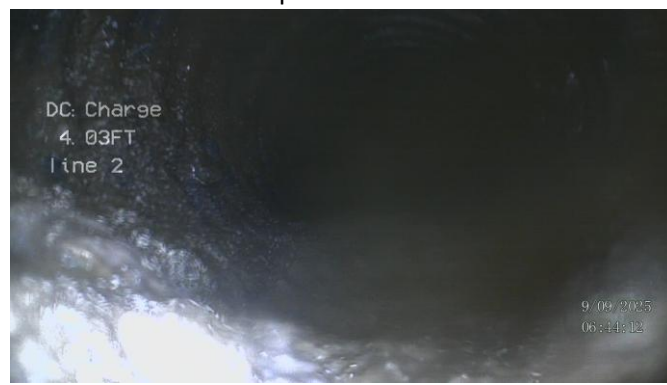
Drain line 2 shown scoped with accumulated solids.

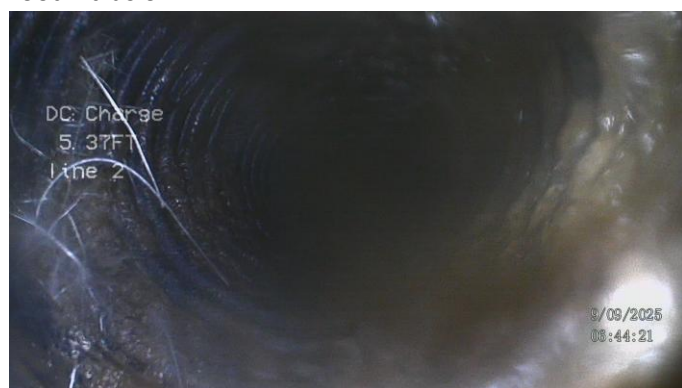
Drain line 2 shown scoped with accumulated solids and root intrusion.

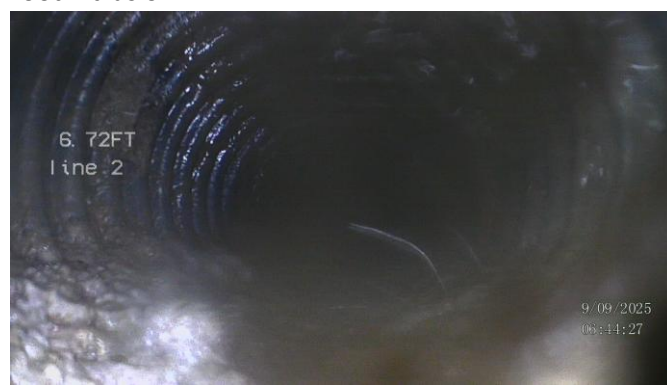
Drain line 2 shown scoped with accumulated solids and root intrusion.

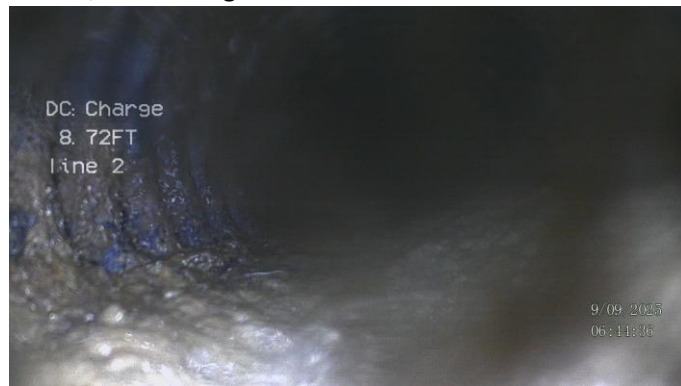
Drain line 2 shown scoped with accumulated solids at 8.72FT, could not go further.

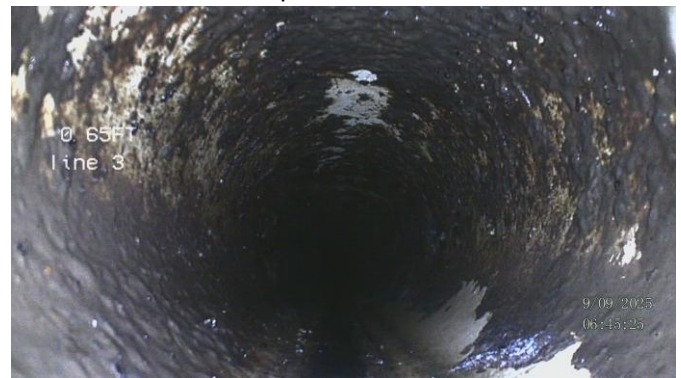
Drain line 3 shown scoped with accumulated solids.

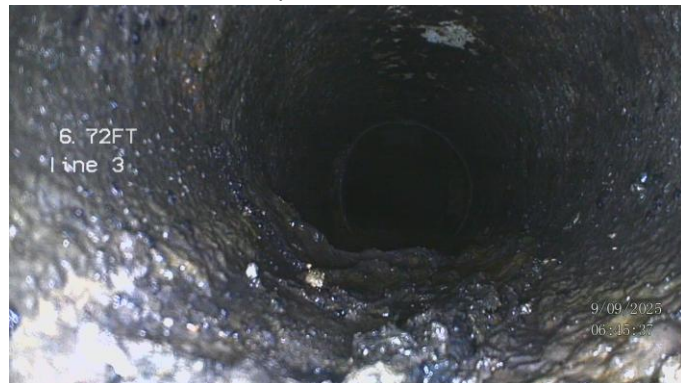
Drain line 3 shown scoped with accumulated solids.

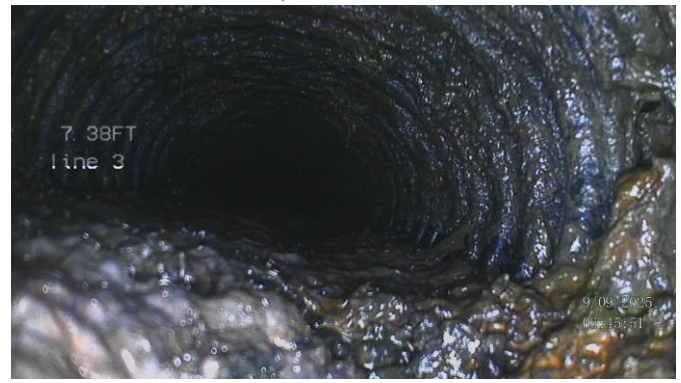
Drain line 3 shown scoped with accumulated solids.
