**Advantage  
Inspection**

## **WELL COMPONENT EVALUATION**

**Date:** September 9, 2025

**Inspection address:** 270 Wiggins Rd, Louisburg, NC 27549

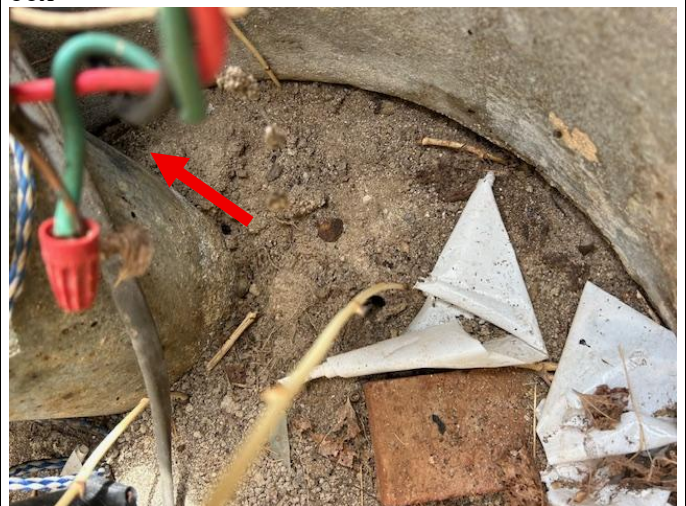
Electrical wires shown not properly sealed in junction box

| Description. | Good | Comments | Fair | Poor |
|---|---|---|---|---|
| Electrical | - | | - | X |

- ☐ The electrical wires at the well head were noted as not being confined inside of a junction box (see photo). Failing to enclose wellhead electrical wires in a junction box is a electrical and safety hazard. It is recommended that a qualified contractor further evaluate and make all necessary repairs.
- ☐ The electrical wire penetration at the well head was noted as not being properly sealed (see photo). It is recommended that a qualified contractor further evaluate and make all necessary repairs.
- ☐ The well head concrete protective cover was noted as damaged with cracks (see photo). It is recommended that a qualified contractor further evaluate and make all necessary repairs.
- ☐ A leak was noted/observed at the well head (see photo). Water was observed leaking at the fitting. It is recommended that a qualified contractor further evaluate and make all necessary repairs.

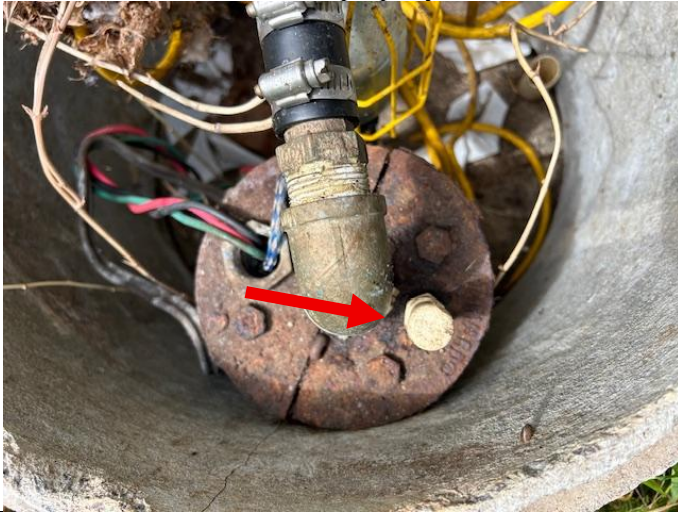
Well head vent stack shown properly installed

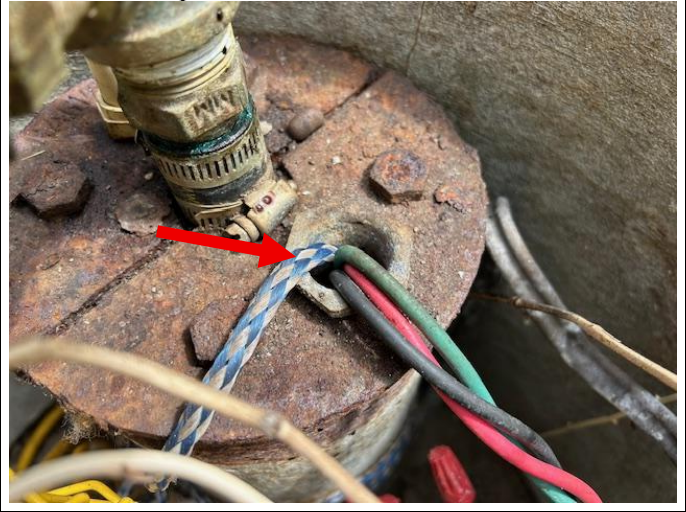
Electical wire penetration shown not sealed

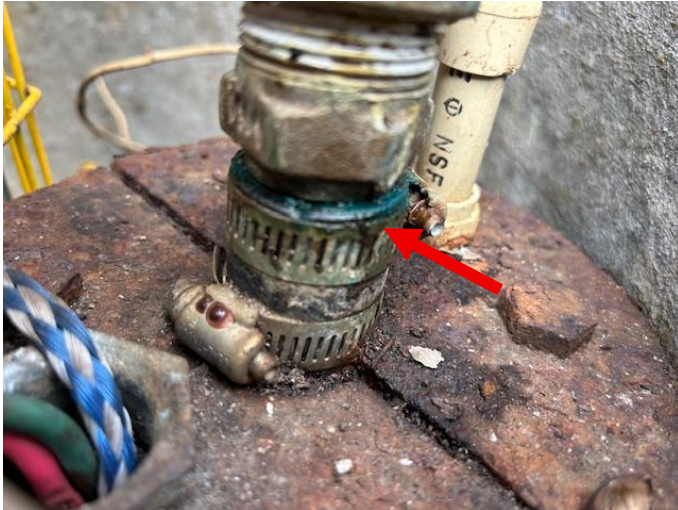
Leak noted at well head

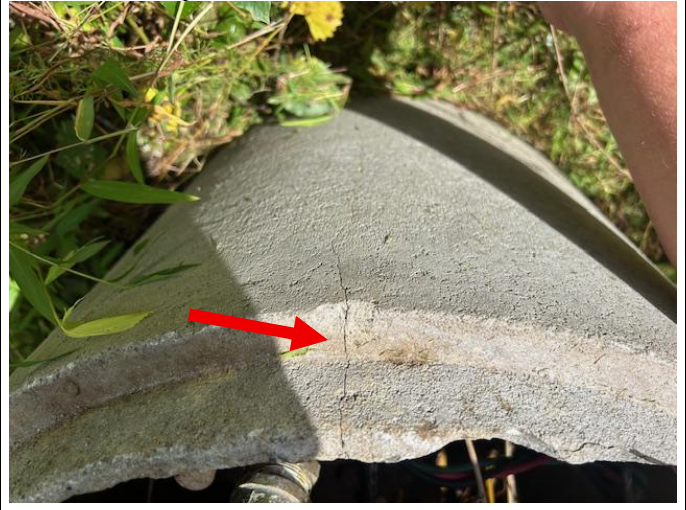
Crack on well protective cover

| Description. | Good | Comments | Fair | Poor |
|---|---|---|---|---|
| Containment/Housing | - | | X | - |

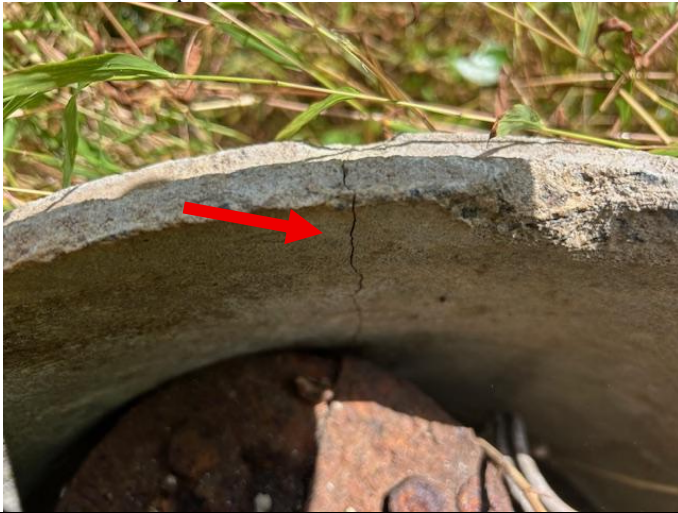
Crack on well protective cover

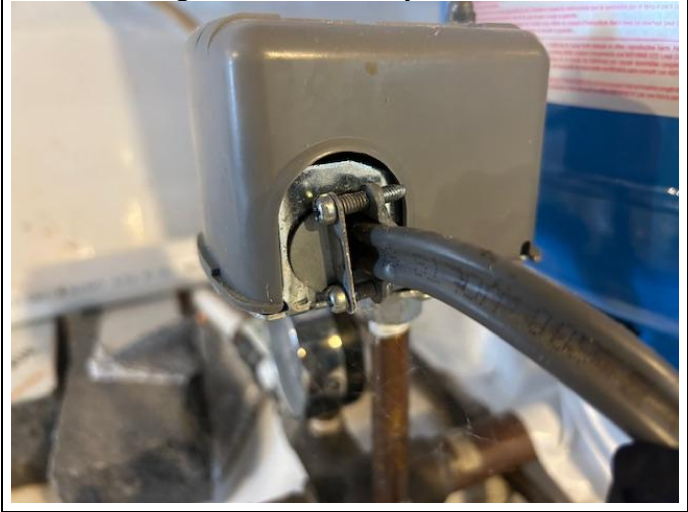
Pressure storage tank contact relay shown sealed

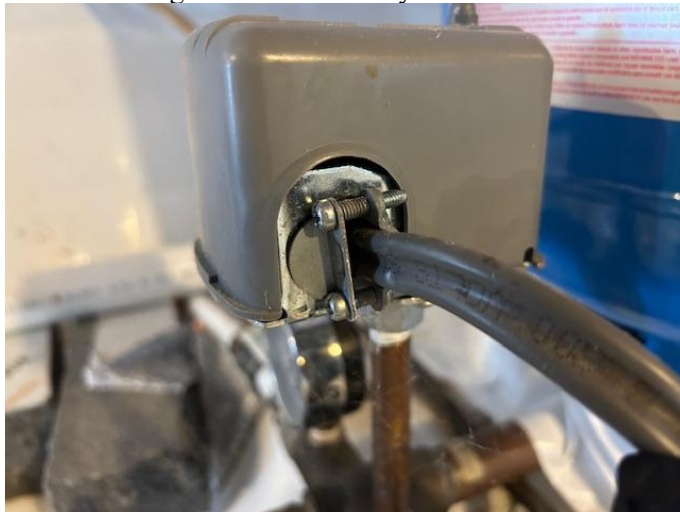
Pressure storage tank contact relay shown sealed
