# NCSI

**INSPECTION REPORT:**

**PROPERTY ADDRESS:** 109 Old Watkins Road  
Henderson, NC 27537

**DATE OF INSPECTION:** November 09, 2022

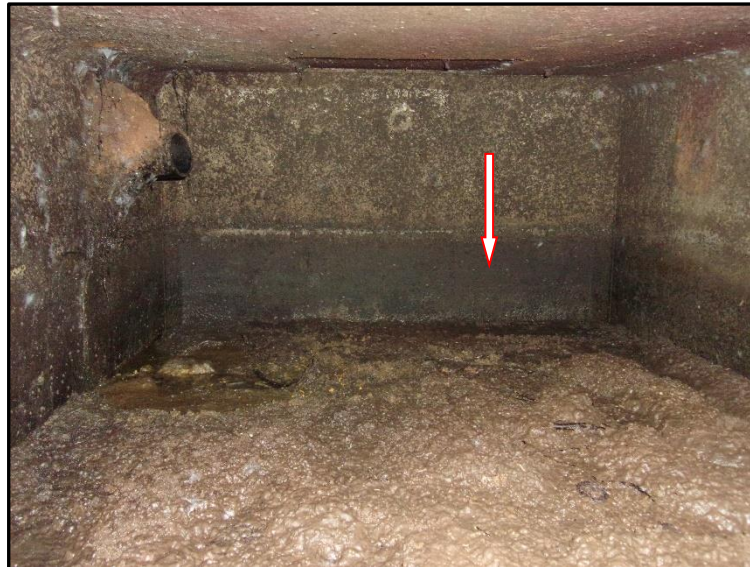
- 1). Considering the current depth of mixed solids, sludge, and the thickness of surface scum, in addition to **non-biodegradable materials**, it is recommended that septic tank be pumped and cleaned of roots. FYI: Systems of this age may require pumping more frequently than newer systems. Subject tank should be pumped on a 3-to-5-year rotation, or sooner if necessary (see page 8 for additional information and pictures).

- 1). Because of the depth of surface scum, mixed solids, and bottom sludge, in addition to **non-biodegradable materials**, it is recommended that tank be pumped and cleaned. Septic tank should be pumped on a 3 to 5 year rotation, or sooner if necessary. FYI: Systems of this age may require pumping maintenance more frequent. For your maintenance records, it is recommended that seller provide the date of the last scheduled pumping and the service provider that performed the service.

**Scum and Non-Biodegradable Materials:**

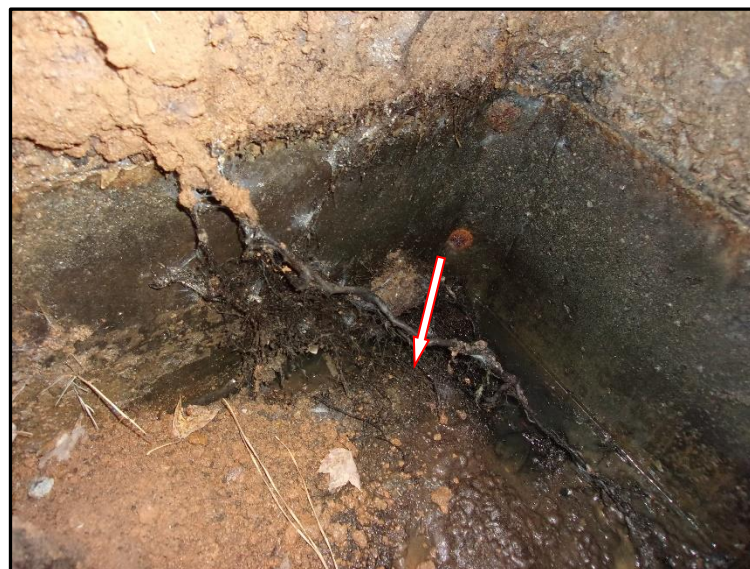
**Extensive Root Infiltration:**

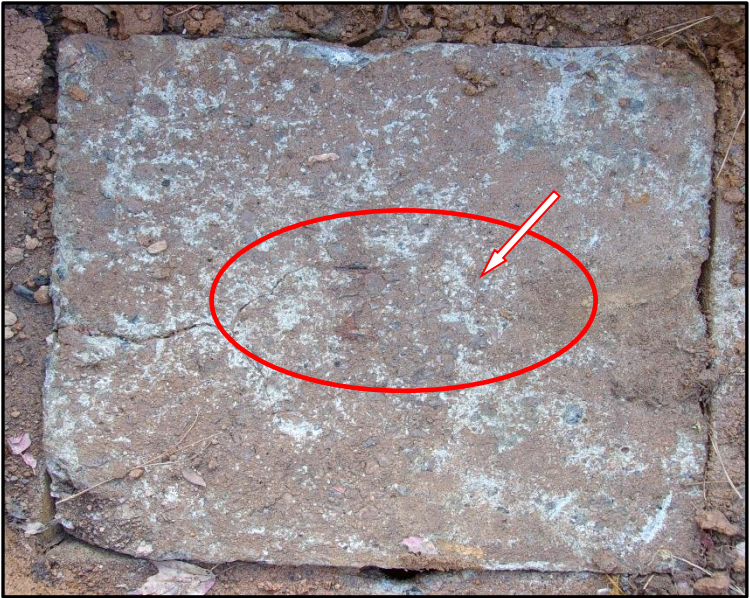
- 2). The outlet access lid has a broken wire handle. Concrete lids without handles are very difficult to remove for the purpose of general maintenance. It is recommended that lid be replaced if an adequate and acceptable repair cannot be made (see page 9 for additional information and pictures).

- 2). The outlet access lid has a broken wire handle, in addition to stress cracks. FYI: Concrete lids without handles are very difficult to remove for the purpose of general maintenance. It is recommended that lid be replaced if and adequate an acceptable repair cannot be made.

**Broken Wire Handle:**

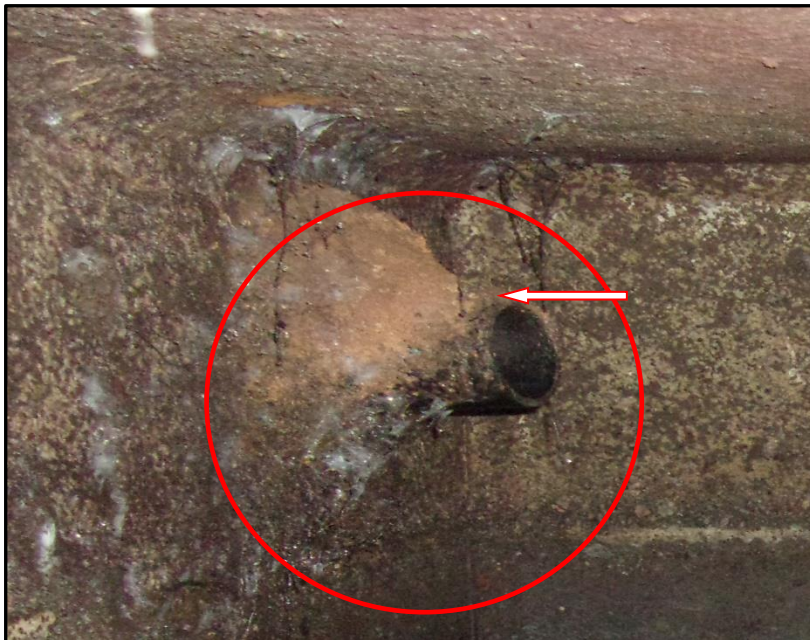
- 3). Root growth was present around both the inlet and outlet wastewater supply pipes. It is recommended that Service Provider re-seal these areas with non-expansion grout or with the appropriate hydro-cement sealant (see page 10 for additional information and pictures).

**Existing Inlet Wastewater Supply Pipe:**

- 3). To prevent the infiltration of roots, ground water, and possible leakage of effluent. It is recommended that Service Provider re-seal around the inlet and outlet wastewater supply pipes with non-expansion grout or with the appropriate hydro-cement sealant.

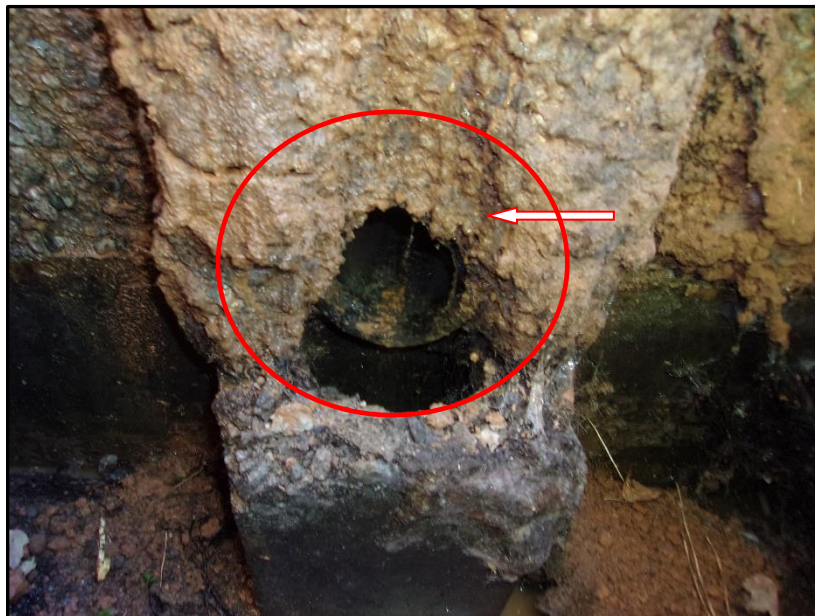
**Outlet Wastewater Supply Pipe (Root Infiltration):**

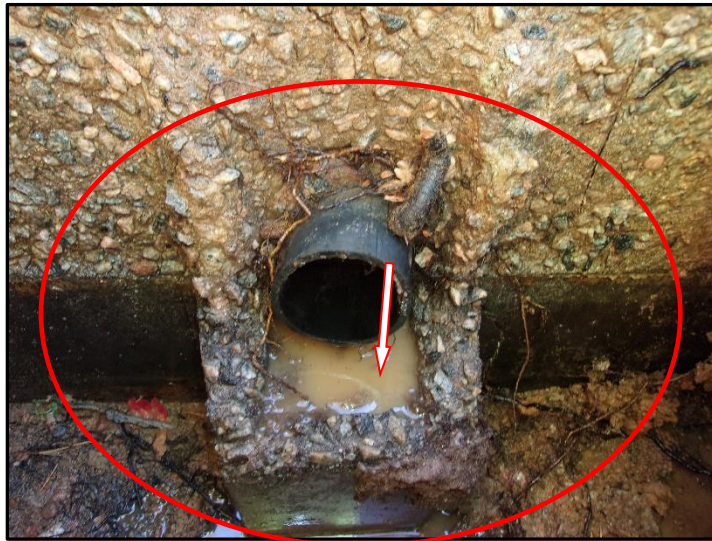
- 4). Extensive corrosion and deterioration was present around outlet baffle tee. Because of the extensive corrosion and deterioration, pre-cast concrete outlet baffle should be replaced with a PVC Sanitary tee. Effluent strainer is an option, however, strainer is recommended (see page 11 for additional information and pictures).

- 4). Extensive corrosion and deterioration were present on outlet baffle tee. Outlet baffle tee is not performing the function it was intended to do. For your information baffle tees are designed to restrict the movement of mixed solids, sludge, and surface scum from tank area to nitrification field. Baffle tee has disintegrated and is no longer restricting the movement of solids. **Because of the corrosion and deterioration, outlet baffle should be replaced with a PVC Sanitary tee with an effluent strainer.**

### Existing Pre-Cast Outlet Baffle Tee (Extensive Corrosion):

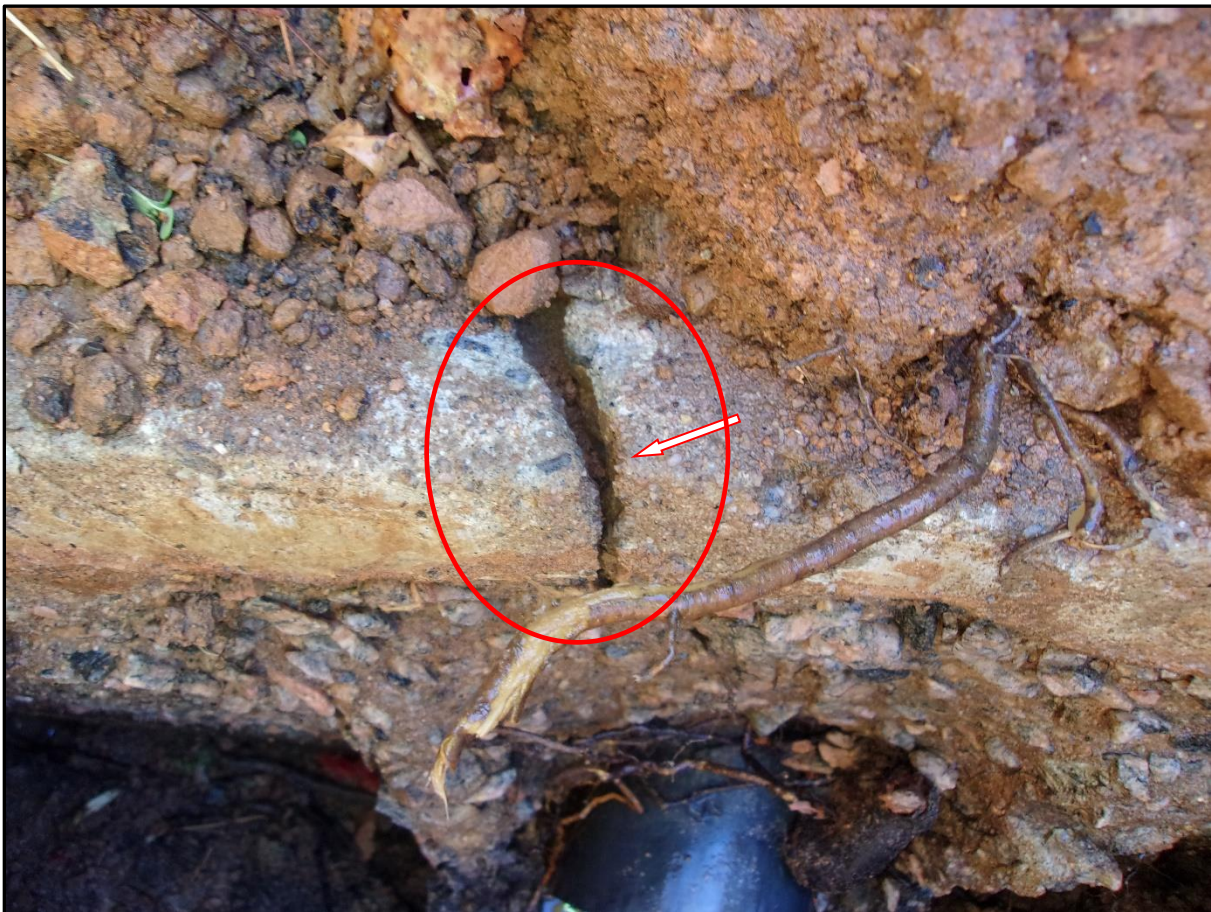
- 5). Age related stress cracks were present around outlet access opening. It is recommended that Service Provider, seal the cracks with hydro-cement or the appropriated cement sealant to prevent the infiltration of surface water. FYI: To determine if cracks extend or advance past the openings, additional soil over the top of tank would have to be removed (see page 12 for additional information and pictures).

- 5). Stress cracks were present around outlet secondary chamber access openings. To prevent infiltration of surface water, it is recommended at time of pumping that Service Provider seal the cracks with hydro-cement or the appropriate sealant to prevent the infiltration of surface water. FYI: Cracks extending outside of the perimeter of the opens should also be checked and sealed if necessary. **FYI: To determine if cracks extend past the openings, addition soil over the top of tank would have to be removed.**

**Secondary Chamber Stress Cracks:**

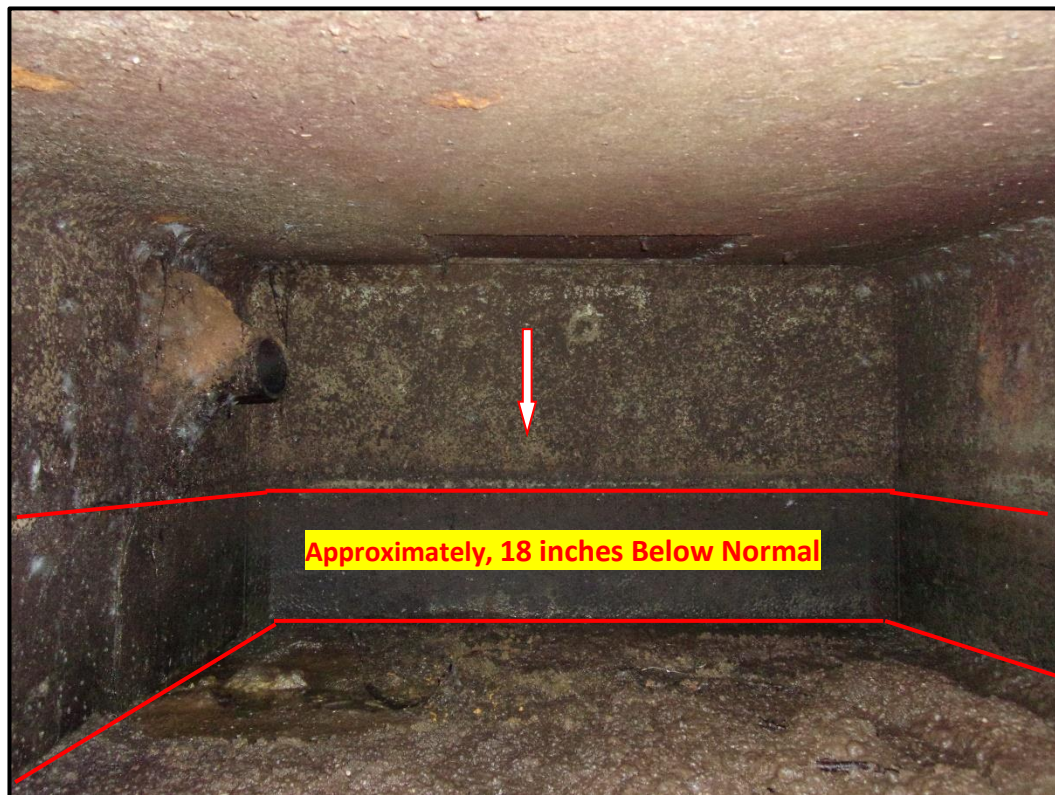
### Interior of Subject Septic Tank:

6). At time of inspection, effluent level in tank was approximately 12 inches below invert of outlet. For your information, it is not unusual for liquid levels to be low when tanks have been dormant or not in use for extended periods of time. However, the visual inspection discovered root infiltration. Tank could possibly be leaking around the mid-seam and areas of root infiltration. It is recommended that the Pumping Service Provider re-evaluate the tank to determine if there is a breach in the sidewalls. A leak down test maybe necessary to determine if tank is leaking (see page 13 for additional information and pictures).

- 6). At time of inspection, effluent level in tank was approximately 18 inches below invert of outlet. For your information, it is not unusual for liquid levels to be low when a tank has been dormant or not in use for an extended period of time, however, it is unusual for effluent level to be as low as in subject tank. Pumping Service Provider should re-evaluate the tank to determine if there is a breach in the sidewalls. A leak down test maybe necessary to determine if tank is leaking. A leak down test consists of filling the tank to the invert of the outlet. System would remain unused for a minimum of 24 to 36 hours. A re-evaluation would then be necessary to confirm if effluent level remained the same or had lowered. If the effluent level in tank lowers by more than  $\frac{3}{4}$  of an inch in a 24 hour period or more than  $1\frac{1}{2}$  inches in 36 hours a leak or breach in the sidewalls of tank is probable. To further confirm, tank should be refilled to the invert of outlet and be observed for an additional hour. If effluent lowers  $\frac{1}{2}$  inch or more, a repair or replacement would be necessary. FYI: If it is determined that tank is leaking, a replacement will be necessary if an adequate repair cannot be made.

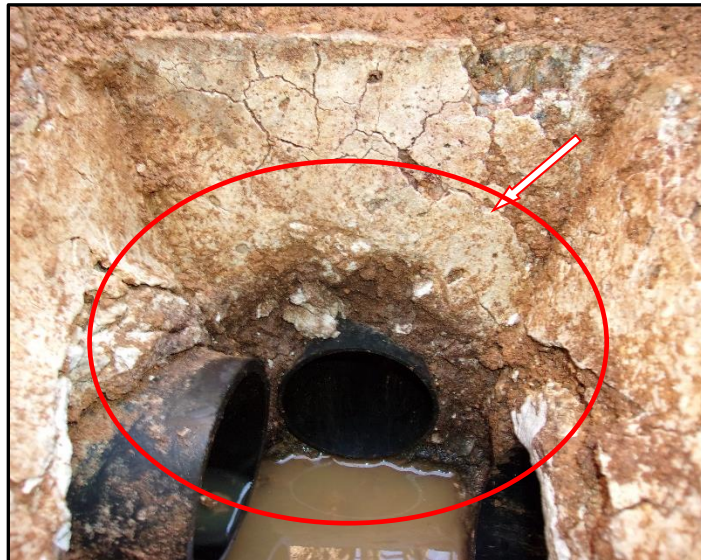
7). The inspection of the distribution box discovered corrosion and deterioration, in addition to accumulated sand, sludge, and mixed solids. Lid to distribution box also has corrosion and age-related deterioration. At time of inspection, distribution box was partially cleaned, however, not all the debris could be removed. Because of the present condition, it is recommended that Septic Tank Service Provider replace the distribution box and its lid (see page 14 for additional information and pictures).

- 7). The inspection of the distribution box discovered excessive accumulation of sludge, sand, mixed solids, and root infiltration, in addition the sidewalls have extensive corrosion and deterioration. Distribution box could possibly be leaking around the static water line. At time of inspection, distribution box was partially cleaned, however, not all the sludge, sand, and mixed solids could be removed. It is recommended that a NC Licensed Septic Contractor replace the existing distribution box and its lid. FYI: Speed levelers should be installed to assure that effluent is being equally distributed to each individual nitrification line.

**Distribution Box (Corrosion and Deterioration):**

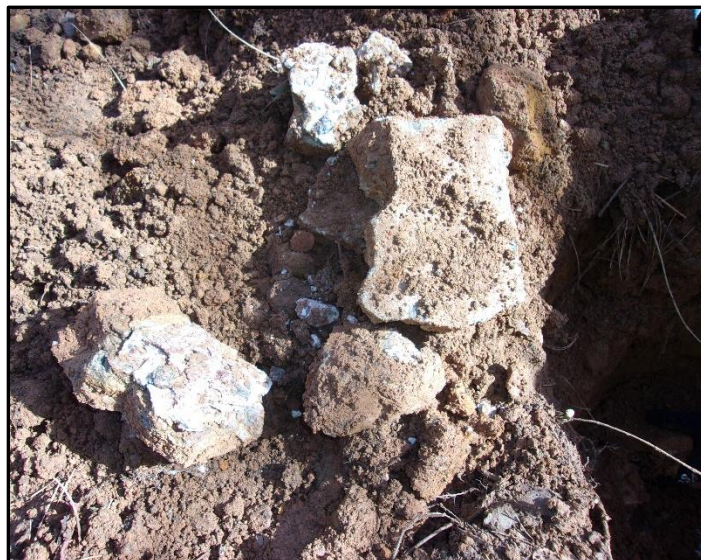
**Broken and Deteriorated Lid:**

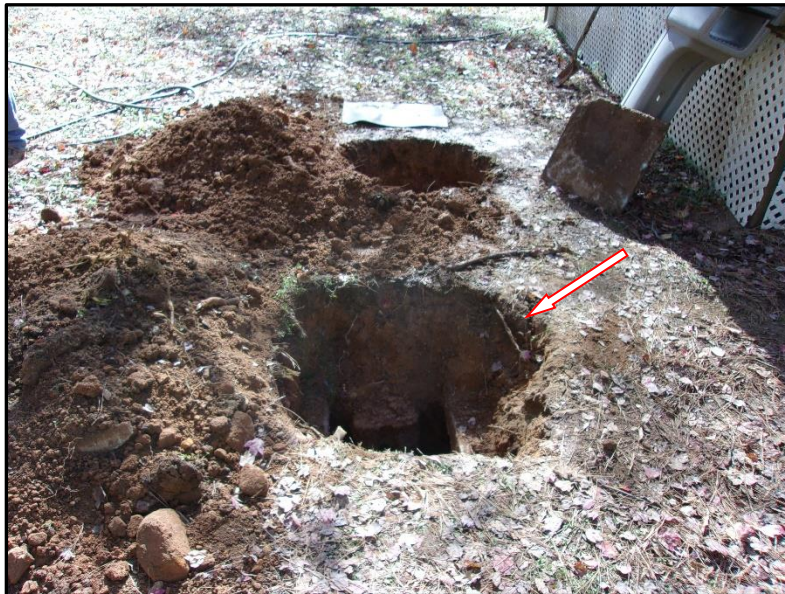
### Existing Access Openings:

8). Because of the depth that tank is buried beneath the soil surface and the amount of time and difficulty in uncovering the inlet or outlet access lids to pump and clean the tank, it is recommended installing risers over one or both these access openings. FYI: Installing a riser over the outlet access opening would make it easier to remove and clean the effluent strainer, when soiled, if one is added with the addition of an outlet PVC Sanitary Tee (see page 15 for additional information and pictures).

- 8). Because of the depth that tank is buried beneath the soil surface and the amount of time and difficulty in uncovering the inlet or outlet access lids to pump and clean the tank, it is recommended installing risers over one or both these access openings. FYI: Installing a riser over the outlet access opening would make it easier to remove and clean the effluent strainer, when soiled, if one is added with the addition of an outlet PVC Sanitary Tee.
