# Tim Wiggins Inspections

Name: Sam Etheridge  
Address: \_\_\_\_\_  
\_\_\_\_\_  
Telephone Number: \_\_\_\_\_  
Inspection Ordered by: Agent  
Property Address: 1214 Anne Street  
Henderson, NC 27536  
Year Built/Structure Age\*: 1975 Square Footage\*: 1614 sq ft  
Date Performed: September 2, 2022  
Reason for the Inspection: Prepurchase

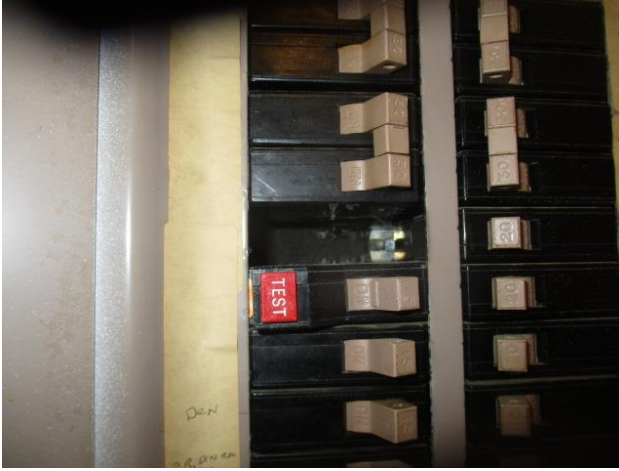
1. There is an open knockout on the dead front cover for the electric service panel. Hot electrical connections are exposed. This is a safety hazard. Repair needed.

1. There is an open knockout on the dead front cover for the electric service panel.

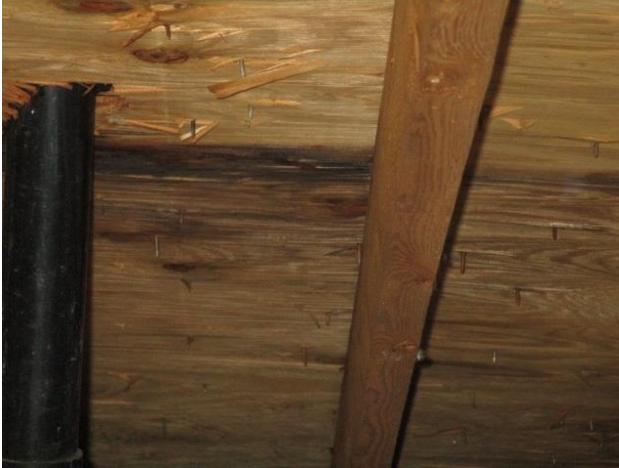
2. Visual evidence of a history of leakage at the roof penetrations for the plumbing vent pipes.

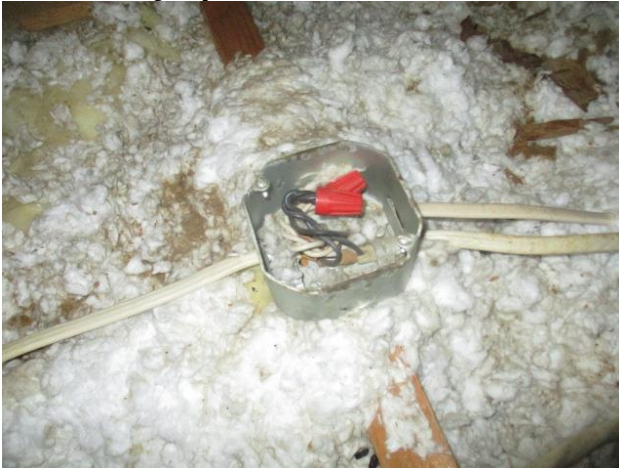
2. There is an open junction box in the attic. Hot electrical connections are exposed. This is a safety hazard. Repair needed. The open junction box is identified with an orange ribbon.

3. There is an open junction box in the attic.

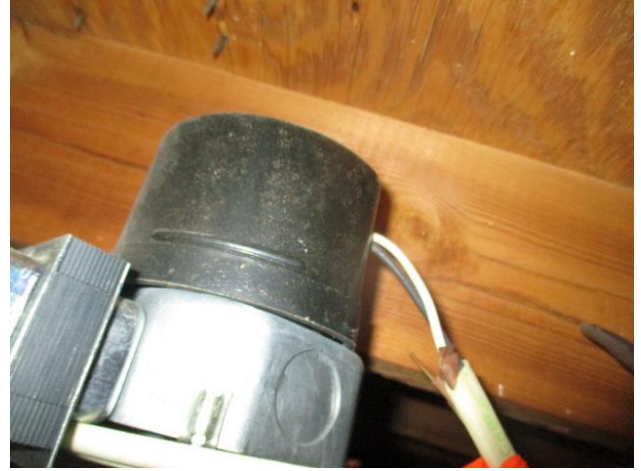
4. Wiring that enters the attic light fixture junction box is not adequately protected. The outer sheathing has been removed from wiring that enters the subject junction box. This is a safety hazard. Repair needed. The subject wiring is identified in the attic with an orange ribbon.

4. Wiring that enters the junction box for the attic light fixture is not adequately protected.

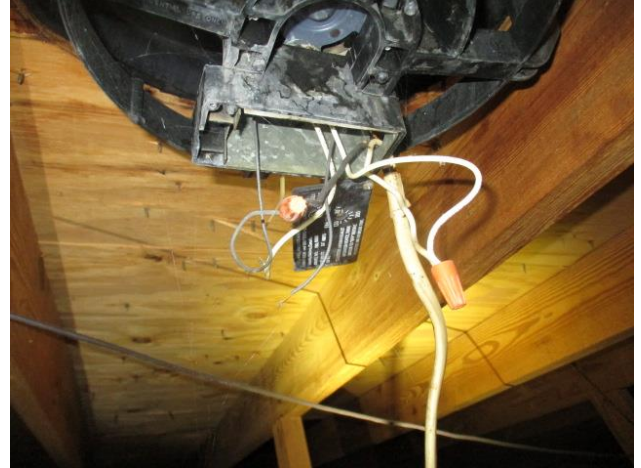
3. The electrical connection for the attic ventilation fan is exposed in the attic. Hot electrical connections are exposed. This is a safety hazard. Repair needed. The open electrical connection at the attic ventilation fan is identified in the attic with an orange ribbon.

5. Exposed electrical connection at the attic ventilation fan.

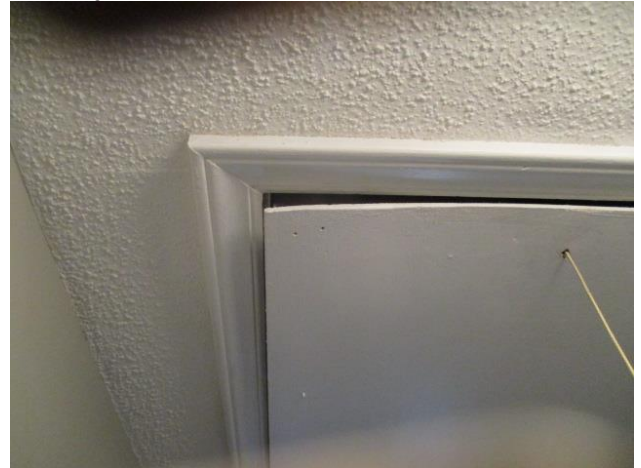
3. No insulation or weather stripping are present on the pulldown stairway. Excessive air infiltration is possible at this location. Repair needed.
4. The pulldown stairway does not adequately seal the ceiling penetration for the stairway when the stairway is closed. Excessive air infiltration is possible at this location. Corrective action needed.

6. The pulldown stairway does not adequately seal the ceiling penetration for the stairway when the stairway door is closed.

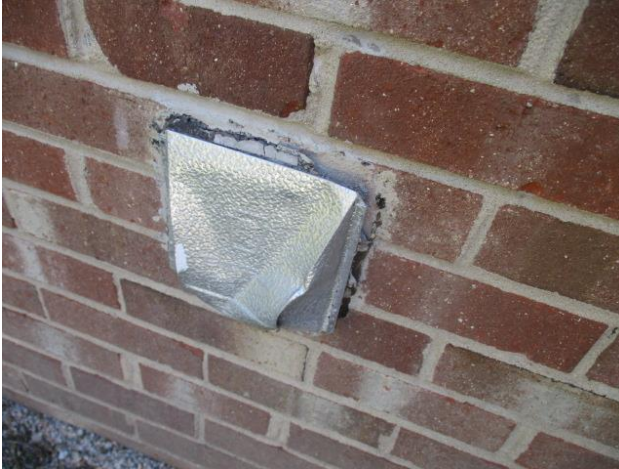
1. The clothes dryer vent pipe exterior louver is damaged. The louver will need replacement to allow adequate airflow through the louver. Corrective action needed.

7. The clothes dryer vent pipe exterior louver is damaged.

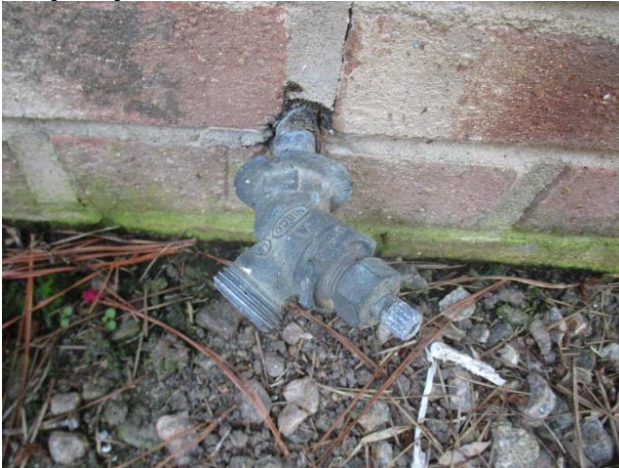
2. The back exterior faucet is not adequately attached to the structure. The faucet handle is missing. Repair/ replacement of the faucet is needed to allow proper function of the faucet.

8. The control valve handle on the back exterior faucet is missing. The subject faucet is not adequately attached to the structure.

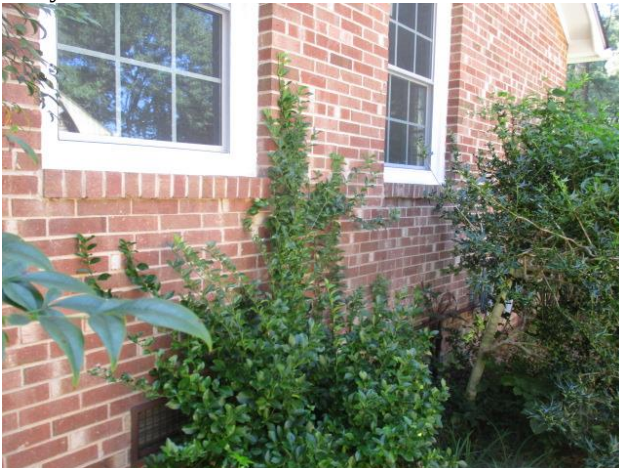
10. All trees and bushes should be cut back away from the structure. Overgrown trees and bushes may cause excessive moisture accumulation on the exterior siding and trim. The excessive vegetation growth also reduces ventilation to help dry exterior siding and trim to prevent moisture damage. All tree limbs and bushes that have contact with the roof surface should be cut back to prevent possible damage to the roof shingles. Corrective action needed.

9. All trees, vines, and bushes should be cut back away from the structure.

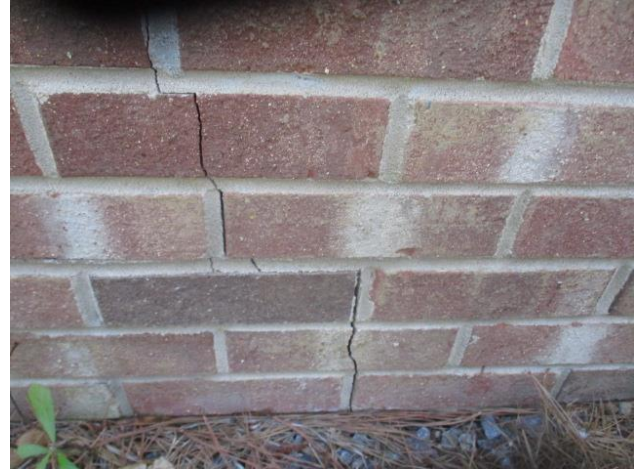
10. Open cracks under the front left bedroom window.

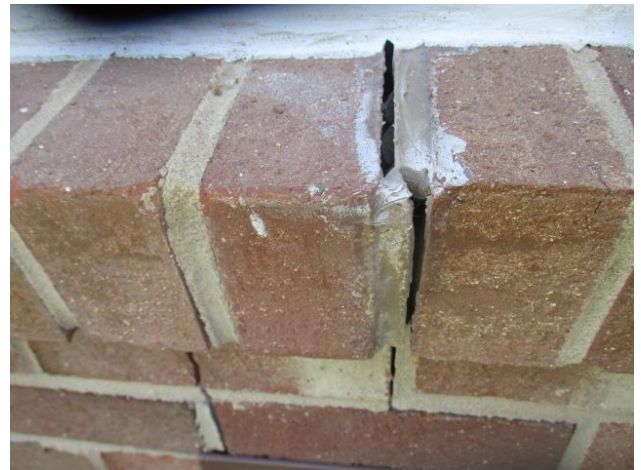
11. Open cracks under the front left bedroom window.

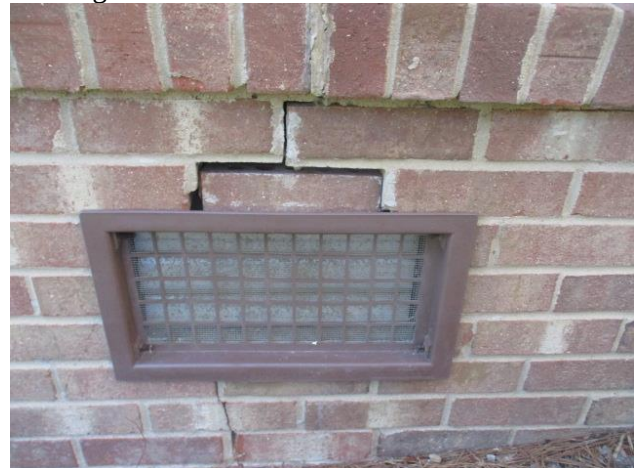
12. Open cracks on the brick veneer siding under the front right bedroom window.

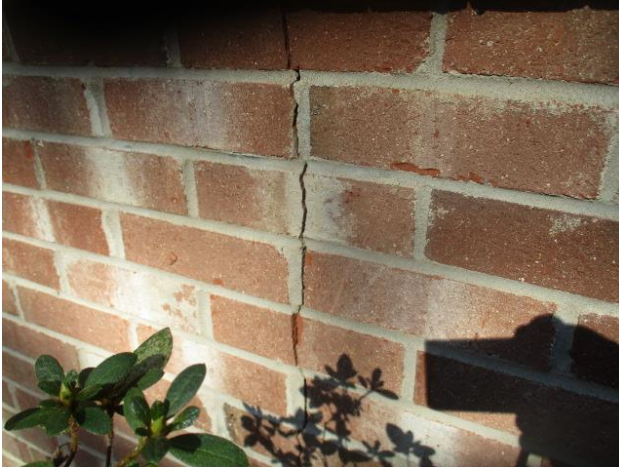
3. Multiple cracks are present on the brick veneer siding. Cracks are present under both of the front bedroom windows, under the front right window, under the right side back window, above the right side back window, and under the back bedroom back window. The crack above the back right side window is the most significant crack. A structural engineer should evaluate the cracks on the brick veneer siding and recommend corrective action as needed. If no other corrective action is needed, all open cracks on the brick veneer siding should be sealed to prevent water infiltration and possible damage.

13. Open cracks on the brick veneer siding.

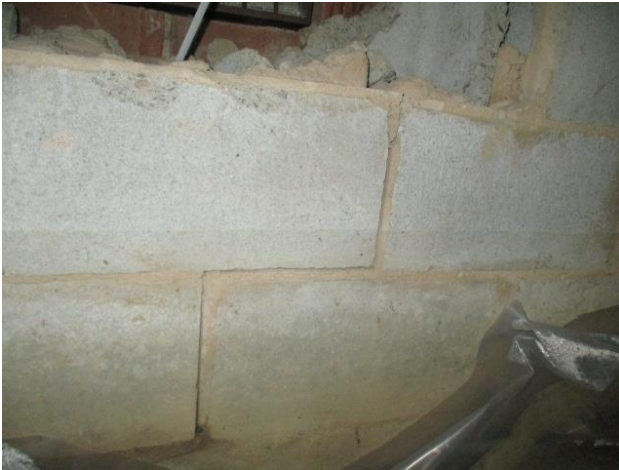
16. There is a step crack on the front concrete block foundation wall near the front left corner of the structure. A structural engineer should evaluate the crack on the foundation wall and recommend corrective action as needed.

14. There is a step crack on the concrete block foundation wall near the front left corner of the foundation.

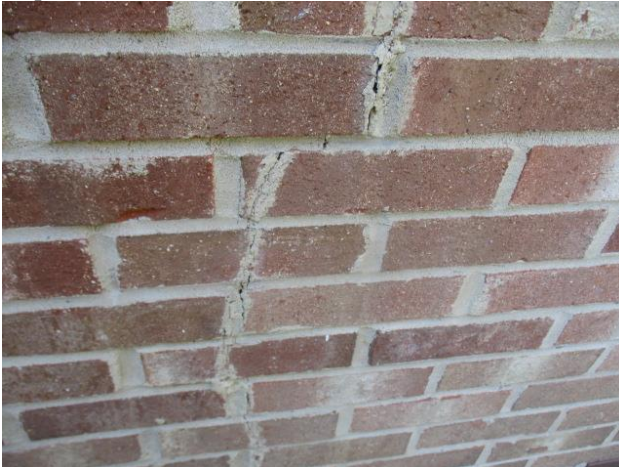
15. Repaired crack under one of the front windows.

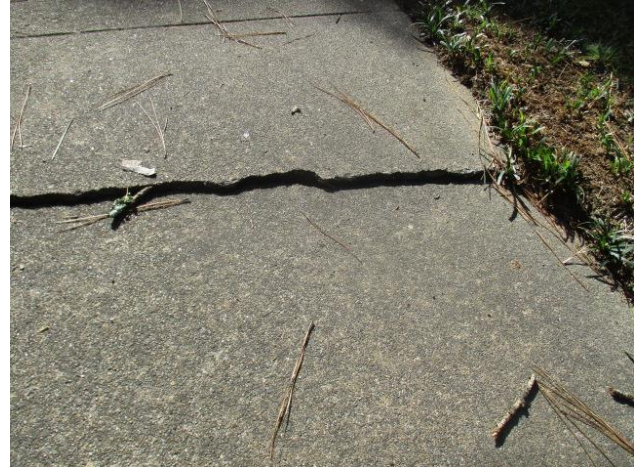
1. Open cracks and an uneven surface are present on the front concrete walkway. Repair to the walkway is needed to prevent water infiltration and further damage to the concrete. Repair to the walkway is needed to prevent a possible safety/ tripping hazard.

16. The front concrete walkway has an uneven surface due to damaged areas on the walkway.

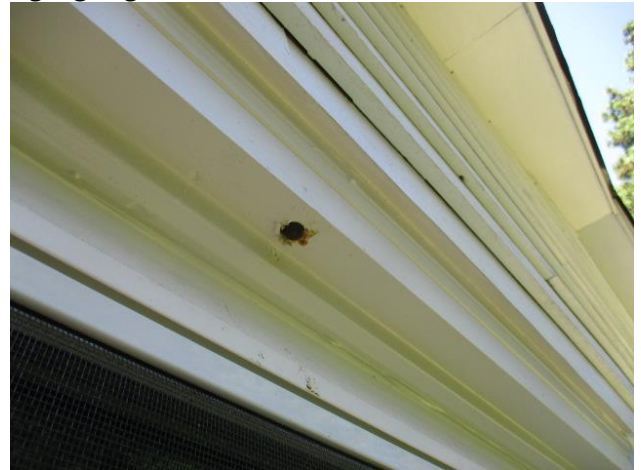
9. Carpenter bee damage is present on the back right garage window trim. The carpenter bees should be eliminated. The damaged area on the window trim should be repaired and sealed to prevent moisture penetration and further damage.

17. Carpenter bee damage is present on the back right garage window.

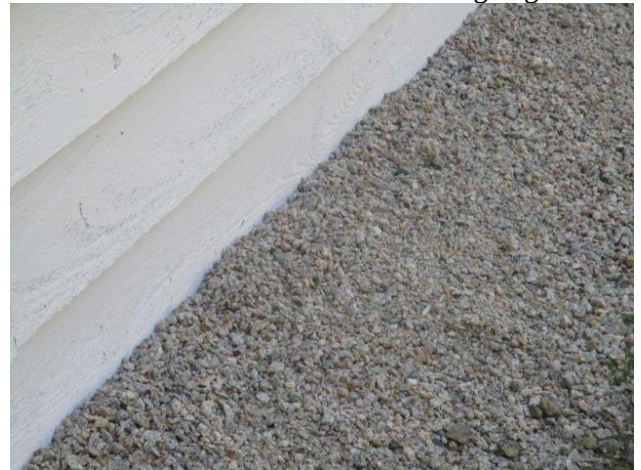
18. The wood siding on the garage has ground contact at the left and back sides of the garage.

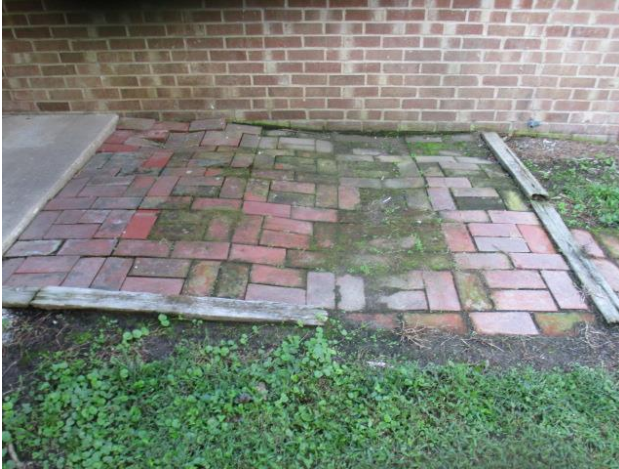
3. The brick paver walkway outside of the left side entrance area has an uneven surface. The uneven surface on the walkway creates a possible safety/ tripping hazard. Repair needed.

19. The brick paver walkway at the left side entrance area has an uneven surface.

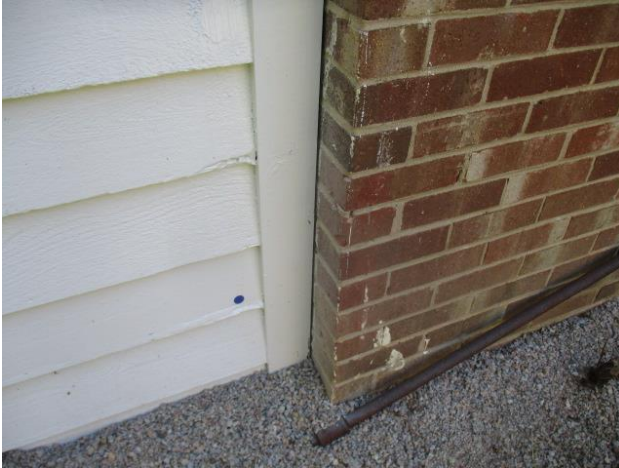
2. Water damage is present on the wood siding at the left side of the garage at the area that is identified with a blue sticker. All damaged siding should be repaired or replaced to prevent moisture penetration and further damage.

20. A blue sticker is used to identify damaged wood siding at the front left corner of the garage area.

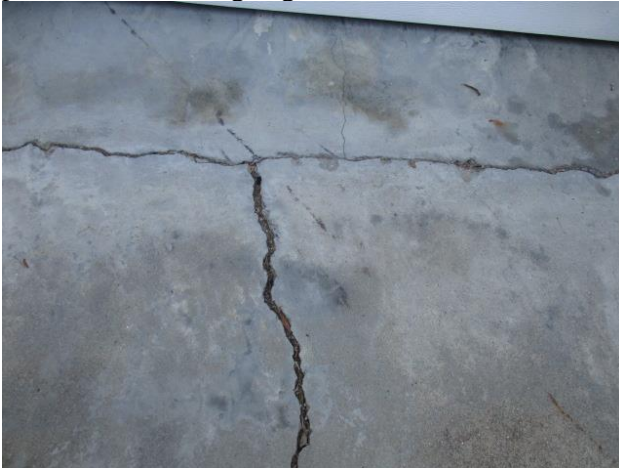
21. Open cracks are present on the concrete parking pads outside of the garage doors.

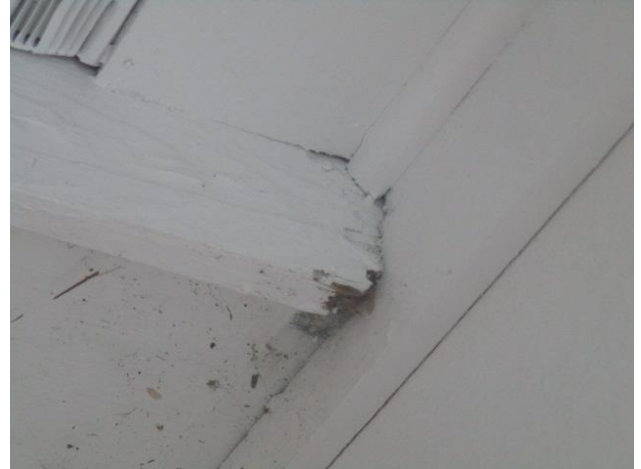
7. There is a small area of moisture damage on the fascia at the front right corner of the garage area roof. All damaged fascia should be repaired or replaced to prevent moisture penetration and further damage.

22. There is a small area of damage on the fascia board at the front right corner of the garage roof.

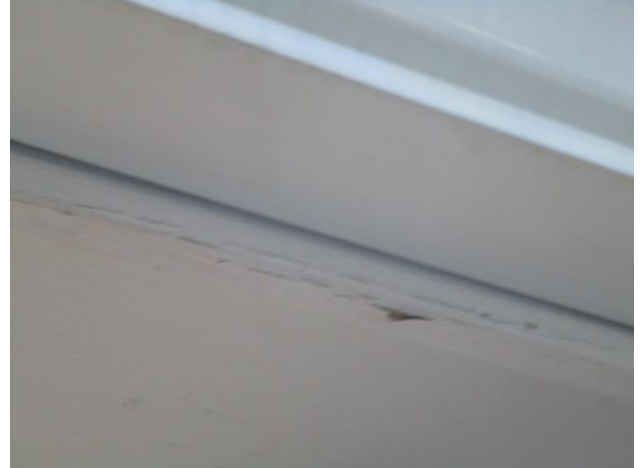
11. Paint is peeling on exposed sections of the exterior wood trim, all exposed exterior wood siding and trim should be cleaned, caulked and painted to prevent moisture penetration and further damage.

23. Paint is peeling on exposed sections of the exterior wood trim.

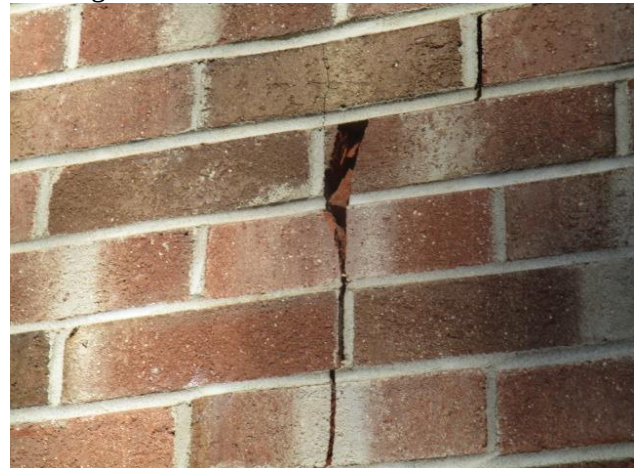
24. There is a significant crack on the brick veneer siding on the right side of the structure above the back right side window.

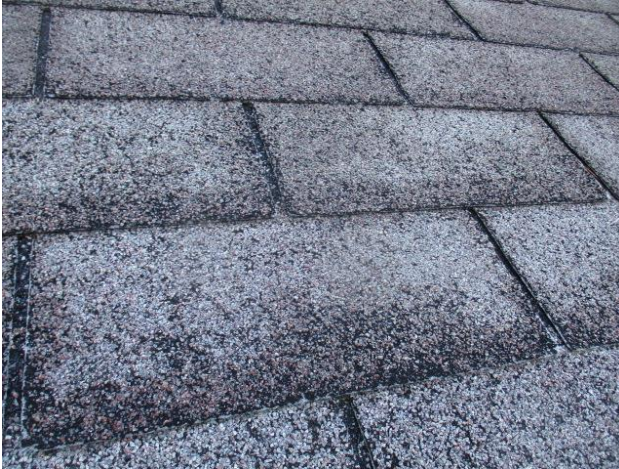
1. The roof shingles have experienced a loss of granules. The roof shingles are at or near the end of their design life. Budget for replacement. No roof leaks were detected at the time of inspection.

25. The roof shingles have experienced a loss of granules.

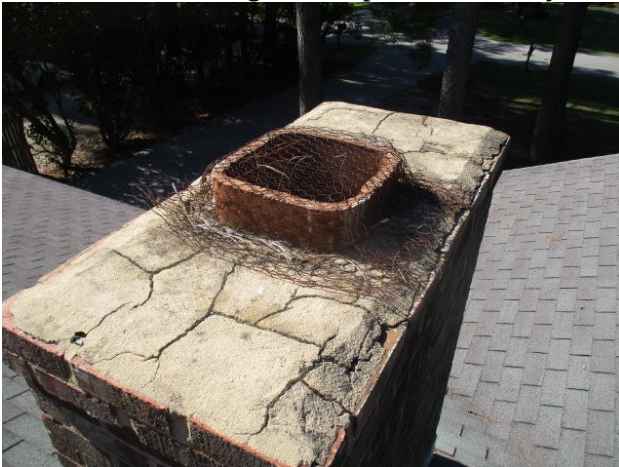
5. No chimney cap is installed on the masonry fireplace chimney. A chimney cap should be installed to prevent moisture and small animals from entering at the top of the chimney.

6. The mortar cap on top of the masonry chimney has open cracks on the mortar. The top of the mortar cap on the masonry chimney should be sealed to prevent moisture penetration into and through the chimney.

26. Open cracks on the mortar cap on the top of the masonry chimney should be sealed to prevent moisture penetration into and through the chimney. A chimney cap is needed on the chimney flue liner to prevent moisture and small animals from entering at the top of the chimney.

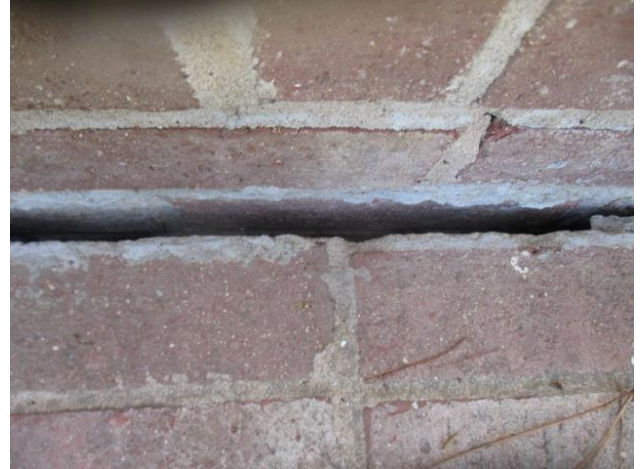
4. The front steps are separated at the step attachment to the front porch. The gap between the steps and the porch should be sealed to prevent water infiltration and further damage to the steps.

27. The front steps are separated from the front porch.

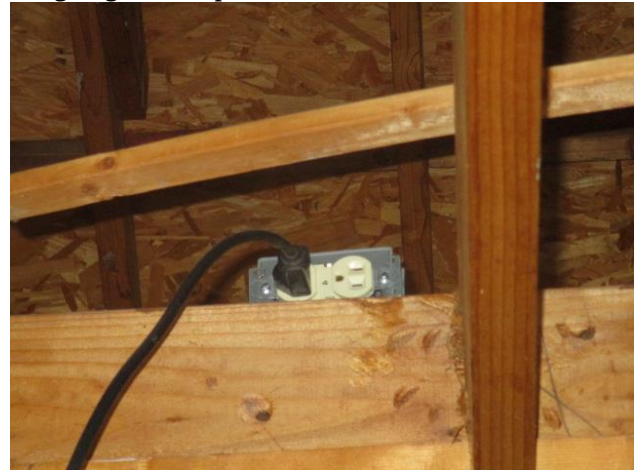
5. The cover plates are missing on the garage door opener receptacles in the garage. Hot electrical connections are exposed. This is a safety hazard. Repair needed.

28. Cover plates are missing on the receptacles for the garage door openers.

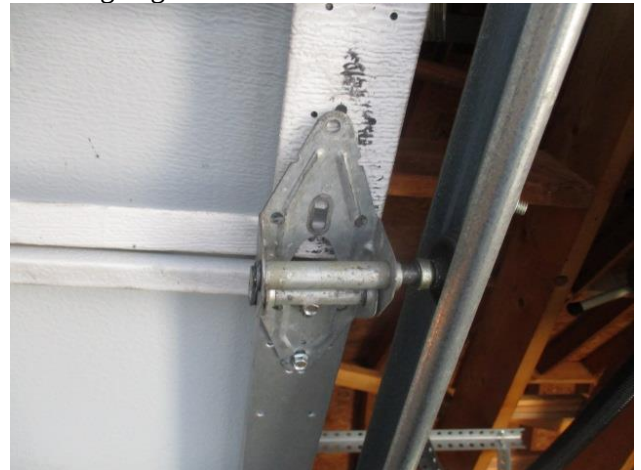
29. Hinge bolts are missing on one of the hinges for the left garage door.

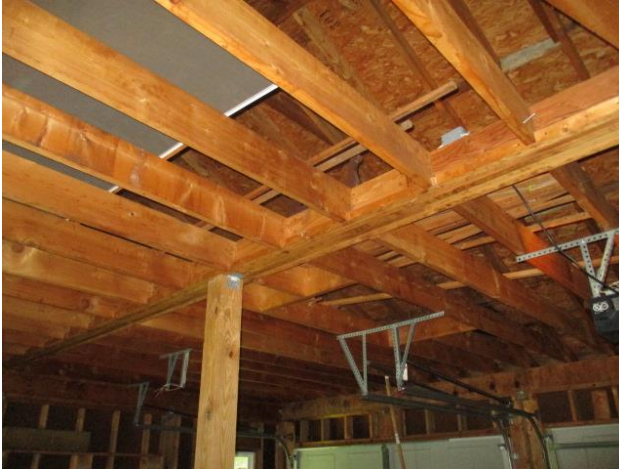
30. The garage ceiling is not adequately sealed for fire safety.

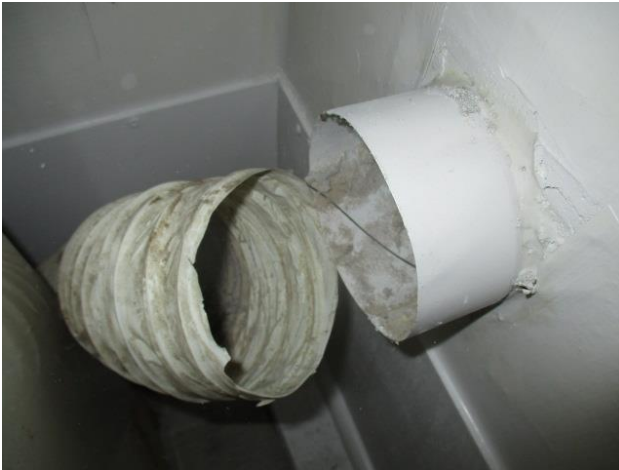
1. The clothes dryer is not connected to the clothes dryer vent pipe. Repair needed.
2. The clothes washer was not connected to the electrical system or the water supply system at the time of inspection. Operation of the clothes washer could not be tested.

31. The clothes dryer vent pipe is not connected to the exterior louver.

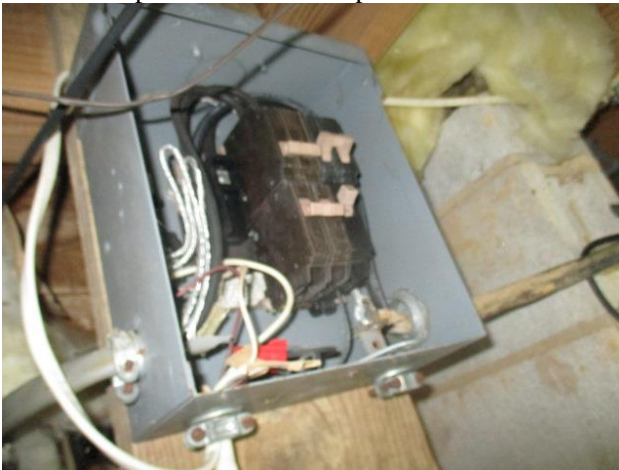
32. The dead front cover is missing on the electrical disconnect panel in the crawlspace.

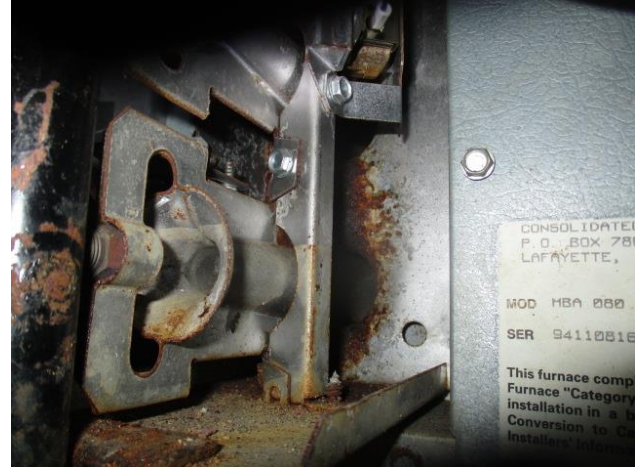
3. Excessive rust is present on the burner apparatus and heat exchanger for the gas furnace heating unit. Excessive rust on the heat exchanger creates a possible safety hazard. A licensed mechanical contractor should evaluate the gas furnace unit and heat exchanger and take corrective action as needed.
4. Installation of a carbon monoxide detector is recommended.

33. Excessive rust is present on the gas furnace heat exchanger and burner apparatus.

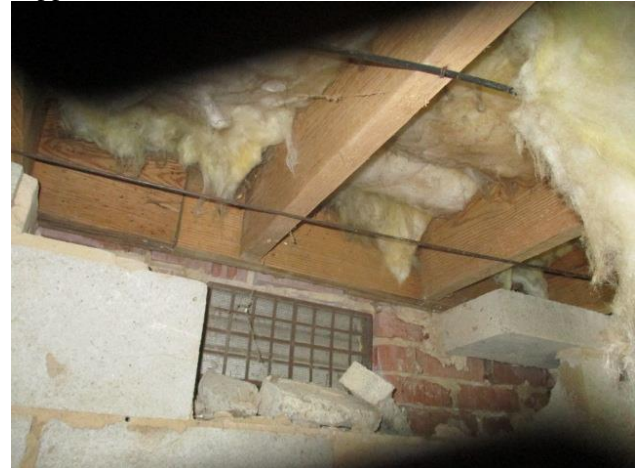
4. Floor joists that terminate above foundation vents are not adequately supported. Joist hangers should be installed to support the floor joists that terminate at the foundation vents. Corrective action needed.

34. Floor joists that terminate above foundation vents in the crawlspace are not adequately supported.

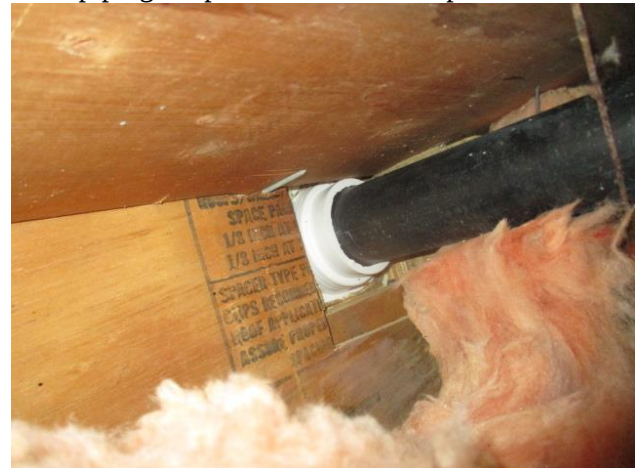
35. Multiple glue type joints between ABS and PVC drain piping are present in the crawlspace.

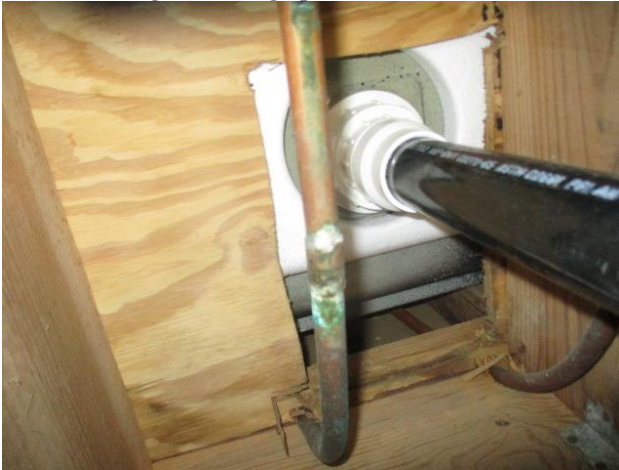
6. Adequate rodent proofing material is not installed at the subfloor penetrations for plumbing drainpipes. Corrective action is needed to prevent small animals from entering the living space.
7. A small section of the floor insulation in the crawlspace is installed upside down with the insulation vapor barrier on the bottom side of the insulation. Installation of the insulation in this manner may allow moisture to become trapped between the insulation vapor barrier and the bottom of the floor system. Corrective action needed.
8. There is a step crack on the front concrete block foundation wall near the front left corner of the structure. A structural engineer should evaluate the crack on the foundation wall and recommend corrective action as needed.

36. Floor penetrations for plumbing drainpipes are not adequately sealed to prevent small animals from entering the living space.

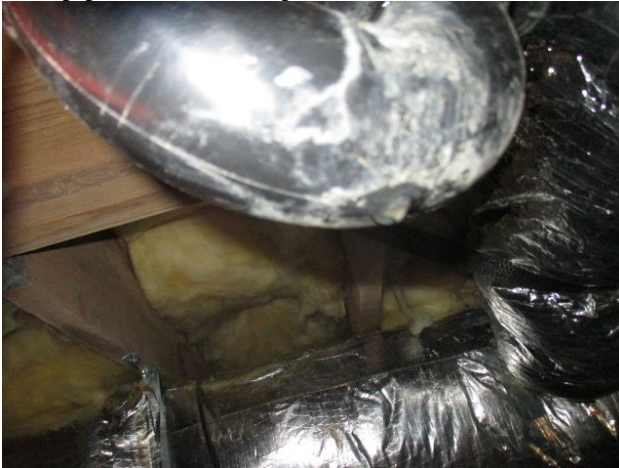
6. There is a drain leak on the ABS drain piping in the crawlspace. The leak on the drainpipe is identified in the crawlspace with an orange ribbon. Repair needed.

37. There is a drain leak on one of the ABS drainpipes in the crawlspace.

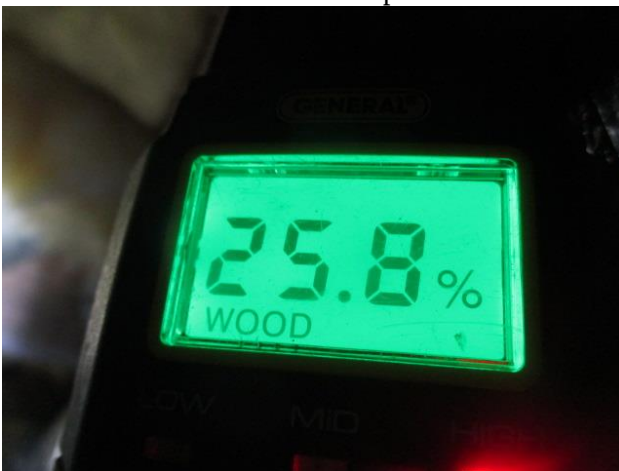
5. The moisture level on the bottom of the floor system was 25.8% or greater when tested with a moisture meter at the time of inspection. Mold growth is possible when a moisture level of 18% or greater is present. Wood damage is possible when a moisture level of 20% or greater is present. A licensed

contractor with experience in crawlspace moisture elimination should evaluate the situation and take corrective action as needed to prevent poor environmental conditions in the crawlspace and possible damage to the floor system.

38. The moisture level on the bottom of the floor system was 25.8% or greater when tested with a moisture meter at the time of inspection.

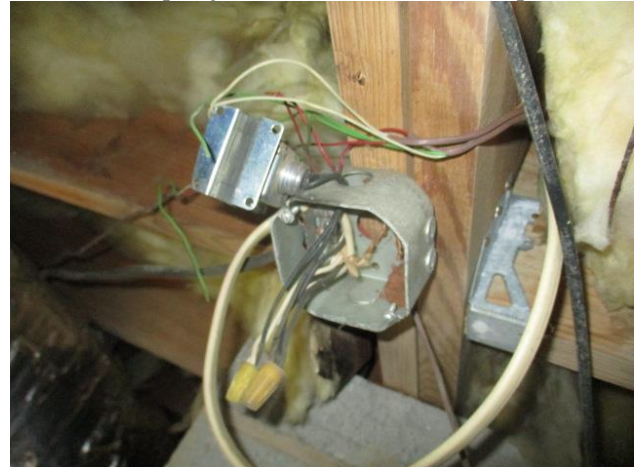
39. There is an open junction box in the crawlspace.
