## A Building Inspection Report

**22 Greta Ln.  
Henderson, NC 27537**

Inspection Date: March 22, 2022

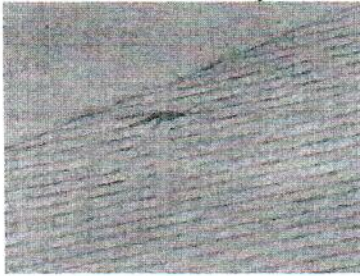
1. Shingle tabs at the left end of the main roof have separated and detached from the roof sheathing. This may lead to a roof leak and should be corrected by qualified professional.

| Main Roof Material | <input checked="" type="checkbox"/> Asphalt/ Fiberglass <input type="checkbox"/> Built up <input type="checkbox"/> Slate <input type="checkbox"/> Wood<br><input type="checkbox"/> Rubberized <input type="checkbox"/> Metal <input type="checkbox"/> Other<br>Estimated number of Layers: One    Estimated Age: 17 years<br><br><b>* Shingle tabs at the left end of the main roof have separated and detached from the roof sheathing. This may lead to a roof leak and should be corrected by qualified professional.</b> | <b>D</b> |

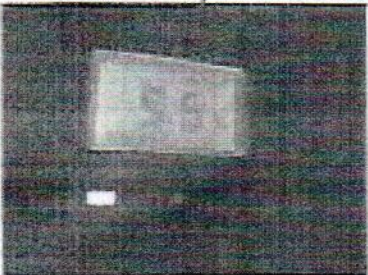
| SECTION II STRUCTURAL, VENTILATION AND INSULATION | | FINDINGS |
|---|---|---|
| Moisture Level in Floor Framing / Sub Floor | 5.5% Wood Members/sub floor (Note: Above 19% wood begins to decay)<br>*This is the highest level of moisture recorded at the time of the inspection. | A |

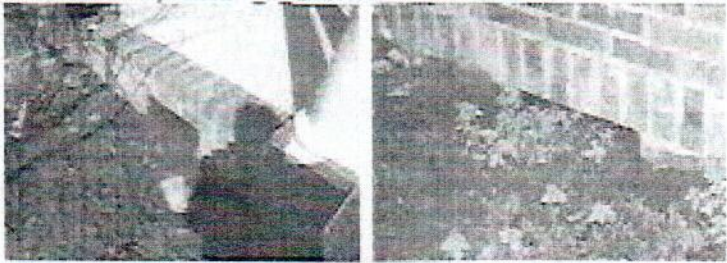
1. Foundation vents are at, or below finished grade on both sides of the front porch and the right end wall. This allows water intrusion through the vent openings and into the crawl space area increasing moisture. Installation of "area wells", (half round metal barriers) is recommended in front of vents which are at or below grade to serve as a barrier against water intrusion into the crawl space.

| SECTION II STRUCTURAL, VENTILATION AND INSULATION | | FINDINGS |
|---|---|---|
| Crawl Space | <input checked="" type="checkbox"/> Vented Not Vented <input type="checkbox"/> Sealed<br>Method of Inspection: <input checked="" type="checkbox"/> Entered <input type="checkbox"/> Viewed From the Access Opening<br><br>Foundation vents are at, or below finished grade on both sides of the front porch and the right end wall. This allows water intrusion through the vent openings and into the crawl space area increasing moisture. Installation of "area wells", (half round metal barriers) is recommended in front of vents which are at or below grade to serve as a barrier against water intrusion into the crawl space.<br><br>On a vented crawl space it is important that foundation vents be kept open for adequate air circulation and the evaporation of excess moisture. | SR |

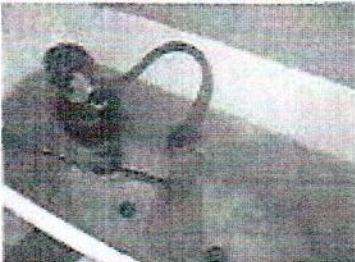
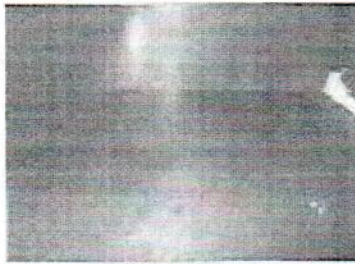
1. The water level in the half bath toilet rises to above the overflow tube which may cause the toilet to run continuously and waste precious or costly water. Adjustment to lower the water level in the tank is needed.

2. Water drips from beneath the left side master bath sink and is believed to be from a crack in the sink finish. Repair by a qualified professional is recommended.

| | Bathroom Sinks / Commodes / Showers and Tubs<br> <p>* The water level in the half bath toilet rises to above the overflow tube which may cause the toilet to run continuously and waste precious or costly water. Adjustment to lower the water level in the tank is needed.</p> <p>* Water drips from beneath the left side master bath sink and is believed to be from a crack in the sink finish. Repair by a qualified professional is recommended.</p> <p><b>Note:</b> Leaks in showers and tubs are often difficult to detect and may not be evident until days or weeks later or only when someone is actually in the tub or shower. Standing in the tub or shower is not performed as part of the inspection. PNP Residential can make no guarantee as to the absence of leaks in tubs or showers.</p> | SR |

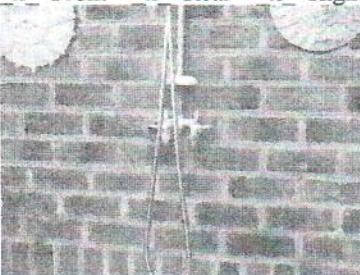
| Exterior Faucet Locations | <input checked="" type="checkbox"/> Front <input checked="" type="checkbox"/> Rear <input checked="" type="checkbox"/> Right Side <input type="checkbox"/> Left Side <input type="checkbox"/> Yard<br><br><b>* The rear outdoor shower was turned off for winterization at the time of the inspection and was not tested.</b> | A/SR |

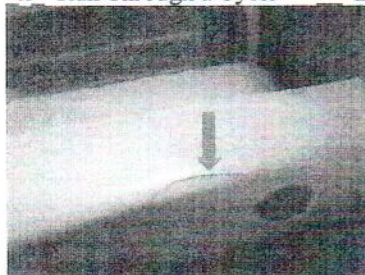
5. A small crack is present in the corner of the dishwasher door. Repair as needed.
6. A food disposal is installed beneath the kitchen sink. Disposals are not recommended to be used in conjunction with private septic systems as they may introduce the wrong type of matter into the natural biodegradable septic system causing problems. Caution should be taken when using the disposal.

| Dishwasher | <input checked="" type="checkbox"/> Run Through a Cycle <input type="checkbox"/> Leaks <input type="checkbox"/> Not Secured to Counter Top<br><br><b>* A small crack is present in the corner of the dishwasher door. Repair as needed.</b> | SR |

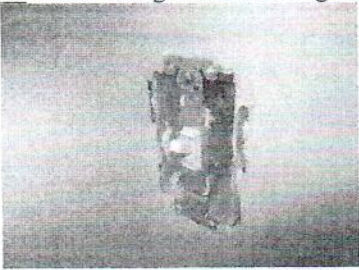
1. The cover plate is missing from the left side master bedroom closet light switch posing a potential shock hazard. All damaged or missing outlet/switch covers should be replaced for electrical safety.
2. The recessed ceiling light at the right rear corner of the kitchen does not function by any control switches tested (possibly a burnt bulb). Replace the existing bulb and test.
3. The doors to the master bath and guest bath do not latch when closed. Since these are "privacy" doors, adjustment to the strike plates is needed for proper closure, latch and/or lock.
4. Many areas of the dwelling were cluttered with stored personal items pending an estate sale and could not be readily accessed for inspection. It is important to understand that condition.

| Wall Receptacles/<br>Switches/Junction Boxes | All Tested Outlets Grounded: <input checked="" type="checkbox"/> Yes <input type="checkbox"/> No<br>Three Prong Outlets on Ungrounded Circuit(s)<br><br><b>* The cover plate is missing from the left side master bedroom closet light switch posing a potential shock hazard. All damaged or missing outlet/switch covers should be replaced for electrical safety.</b> | SR |

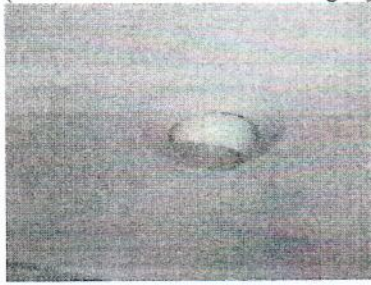
| Electrical Fixtures | Paddle Fans / Ceiling Lights/ Wall Lights<br>(Timers / sensors and low voltage systems are not tested).<br><br><b>* The recessed ceiling light at the right rear corner of the kitchen does not function by any control switches tested (possibly a burnt bulb). Replace the existing bulb and test.</b> | SR |

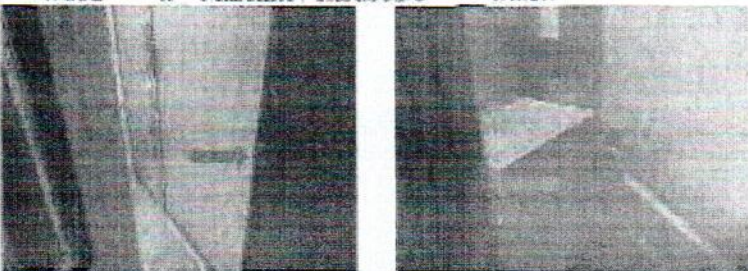
| Interior Doors | <input type="checkbox"/> Wood <input checked="" type="checkbox"/> Masonite / Hardboard    Other:<br> <p>The doors to the master bath and guest bath do not latch when closed. Since these are "privacy" doors, adjustment to the strike plates is needed for proper closure, latch and/or lock.</p> | D |

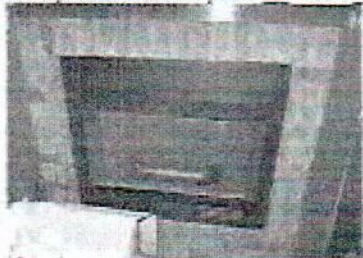
1. The gas log fireplace was not lit or fueled at the time of the inspection and was not tested. Lighting shut down gas devices is not performed as part of the inspection process for safety reasons. Prior to starting the gas logs or other gas appliances, subsequent evaluation by a qualified gas professional should be made to insure all such items are in good and safe working order. Consult with your future gas provider for recommendations.

| Alternative Heating | <input type="checkbox"/> Fireplace <input type="checkbox"/> Woodstove/Insert <input checked="" type="checkbox"/> Gas Logs    Gas/Electric Heater(s)<br>Damper Blocked Open?    Yes    No <input type="checkbox"/> Direct/Vented <input checked="" type="checkbox"/> Non Vented<br> <p>The gas log fireplace was not lit or fueled at the time of the inspection and was not tested. Lighting shut down gas devices is not performed as part of the inspection process for safety reasons. Prior to starting the gas logs or other gas appliances, subsequent evaluation by a qualified gas professional should be made to insure all such items are in good and safe working order. Consult with your future gas provided for recommendations.</p> | Not Tested/ SR |

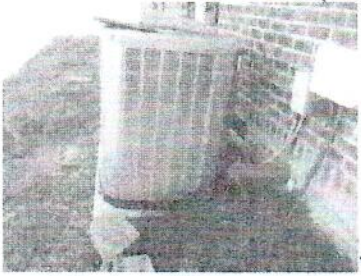
- X
2. **The condenser unit is not level.** This may result in the refrigerant in the condenser to flow unevenly causing the system to perform improperly. Repair to properly level the unit in place is recommended.
  3. Given the age of the heating and cooling equipment (17 years), routine service by a licensed HVAC contractor is recommended to enhance the continued performance of the system.
  4. The rear sunroom is conditioned by a PTAC, or through wall heat pump which was found to be functional at the time of the inspection.

| Type of System | <input checked="" type="checkbox"/> Heat Pump <input type="checkbox"/> Hydro/Apollo <input type="checkbox"/> Forced Hot Air <input type="checkbox"/> Zoned System<br><input checked="" type="checkbox"/> Electric Central Air Conditioning <input checked="" type="checkbox"/> Dual/Multiple Systems<br>Note: Shut-off and gate valves are not tested on Hydro-Systems (Apollo type)<br>Brand Name: Trane Model #(AC) 2TWR3042A1000AA 3.5 ton split system<br> * The condenser unit is not level. This may result in the refrigerant in the condenser to flow unevenly causing the system to perform improperly. Repair to properly level the unit in place is recommended. | SR |
