**NORWOOD PLUMBING, INC****Cassandra "Casey" Champion, Inspector, 4676 I, REHS- 1874, NCWC 4102 C****Matt Norwood, Installer 7223, Plumbing 29979 P1****P.O. Box 699, Oxford, NC 27565****336-598-2054****[cjchampion323@gmail.com](mailto:cjchampion323@gmail.com)****On-site Wastewater Inspection**  X   Pre-Inspection Contract, signed by Client is attached to Inspection**Property Address:** 108 Lakeview Dr, Youngsville, NC 27596

**Client Name:** DreAAM Properties**Current owner of Record:** SAME**Lot # 21****Date of Inspection:** November 06, 2024**BUILT IN 1996**

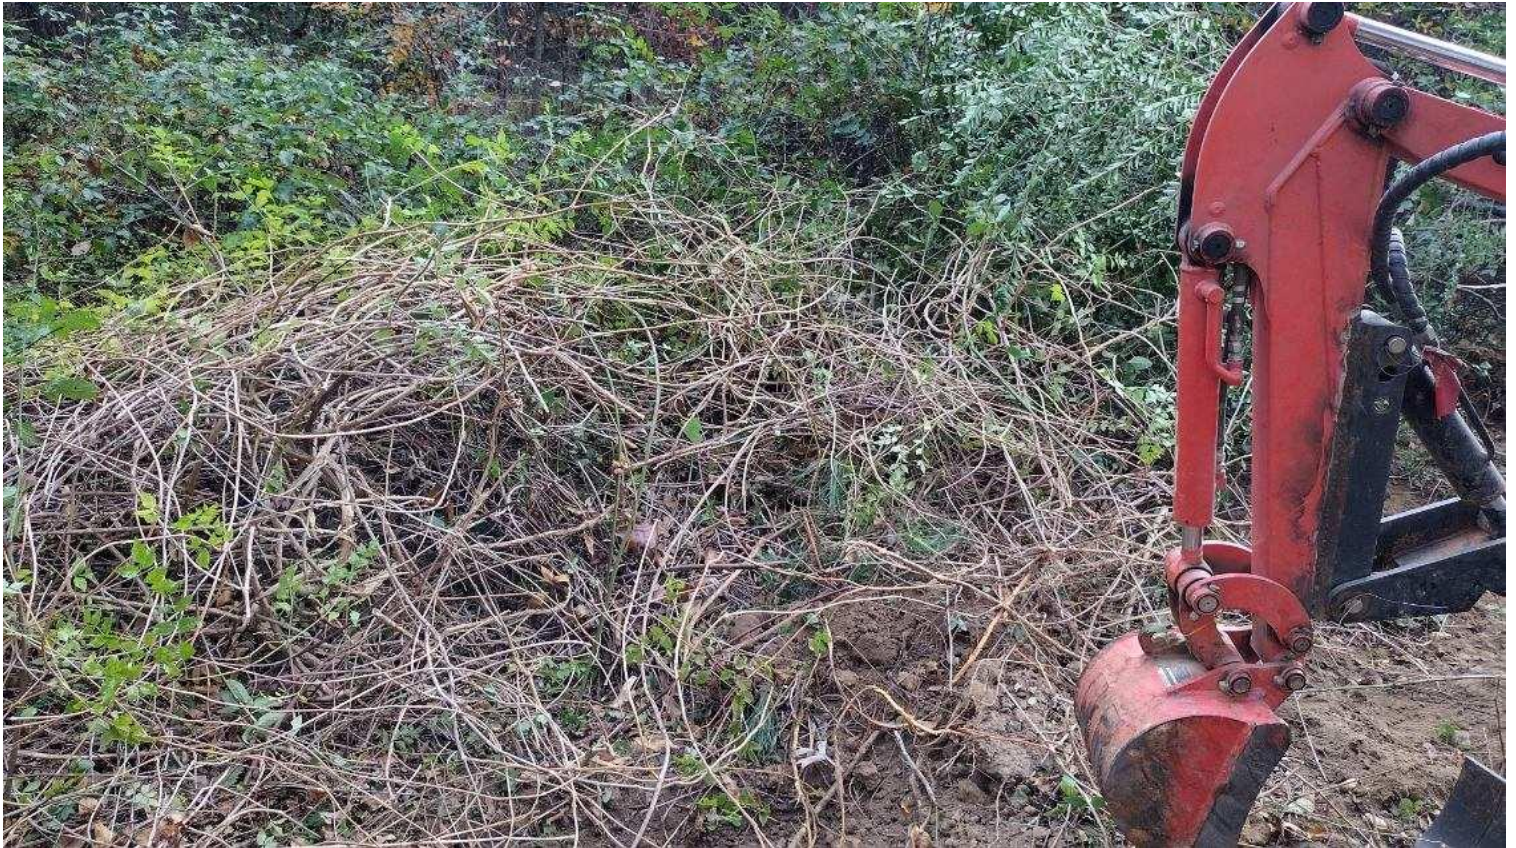
VINES COVERING TANK

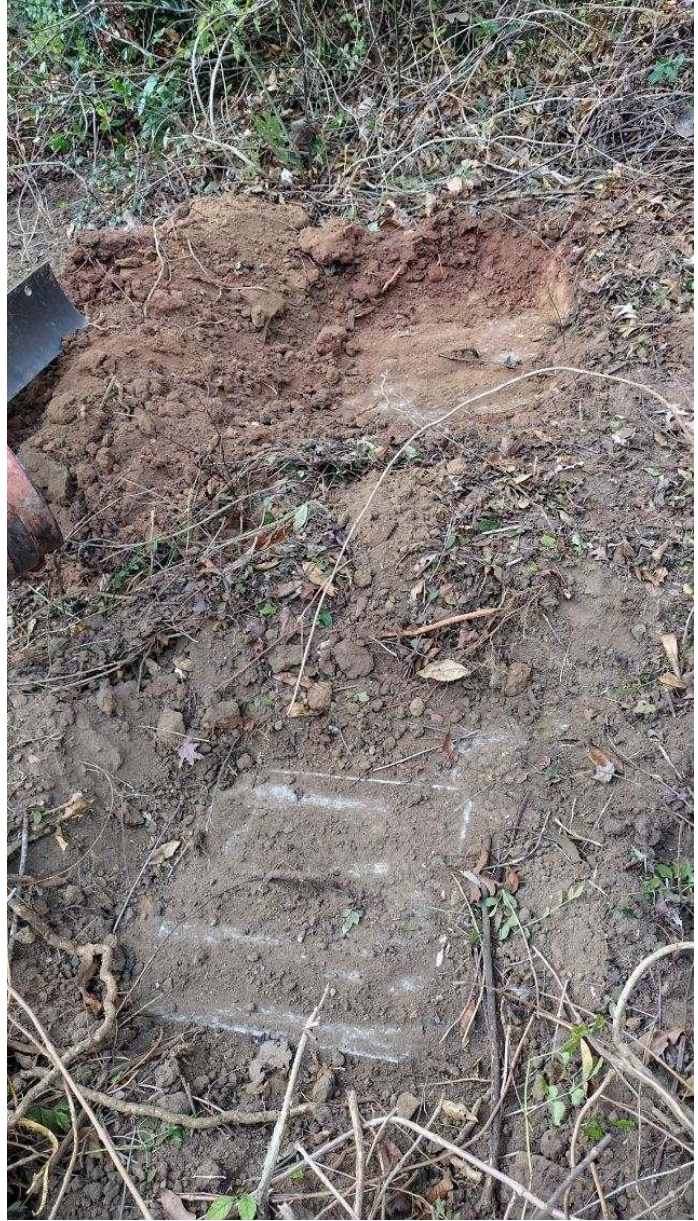
**INLET**

**INLET - SCUM LEVEL – 6”**

**SLUDGE LEVEL -22”**

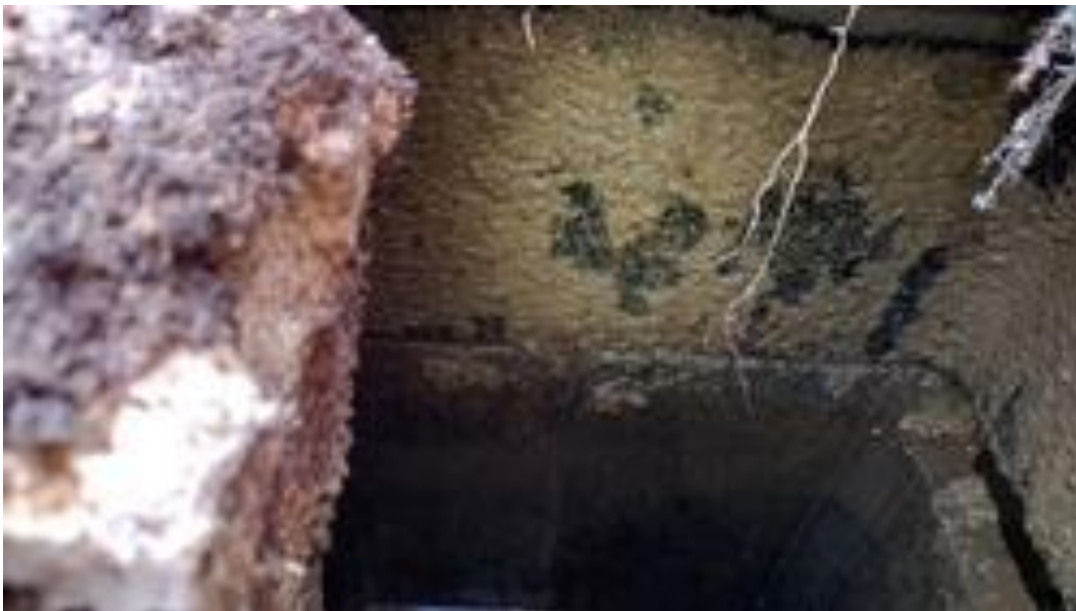
**TANK – OUTLET**

**OUTLET – SCUM LEVEL– 4”**

**SLUDGE LEVEL – 18”**

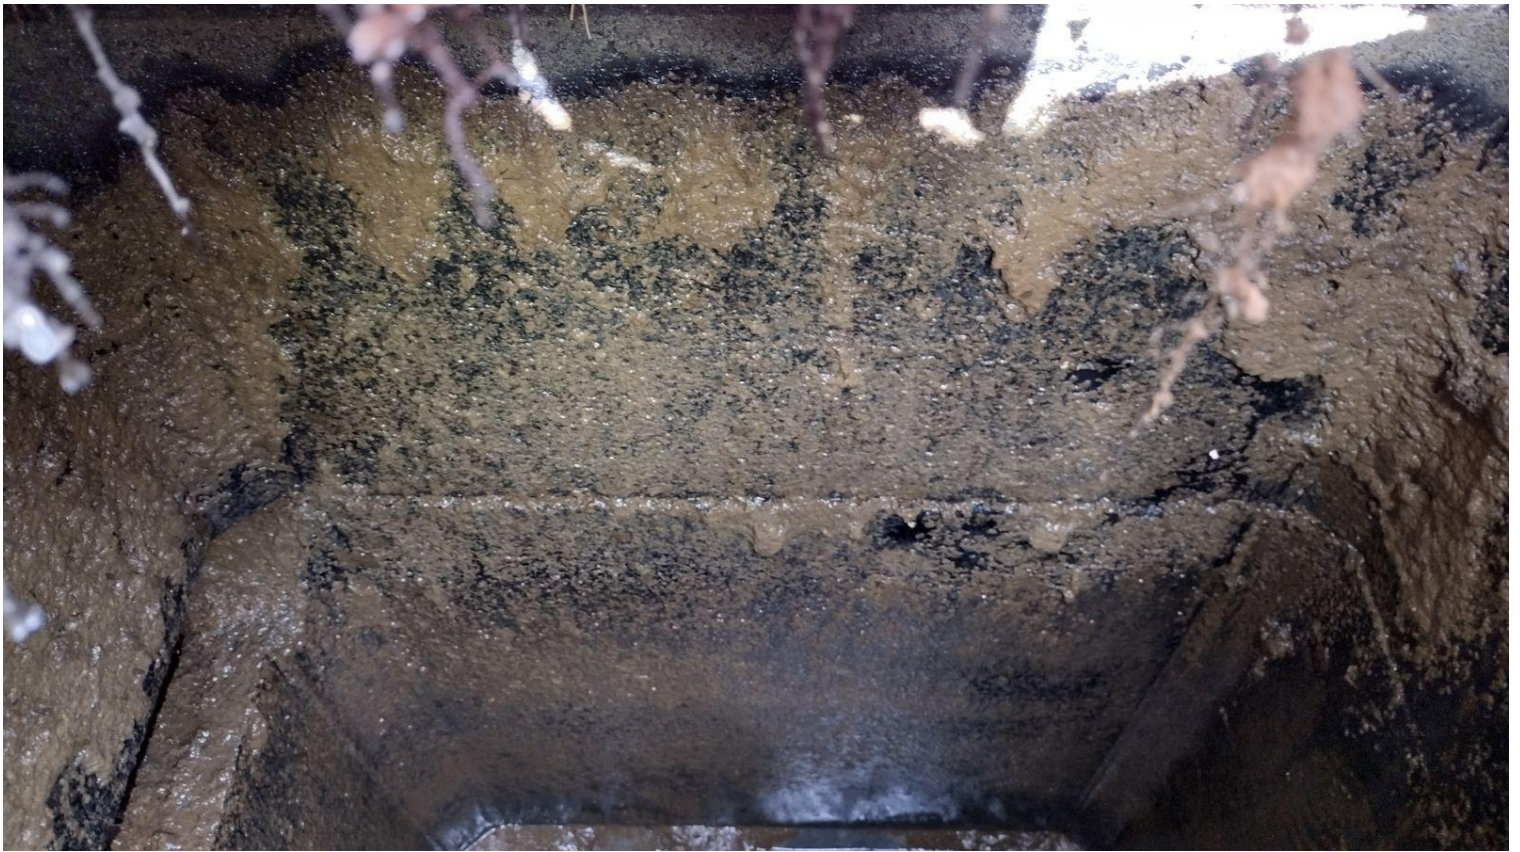
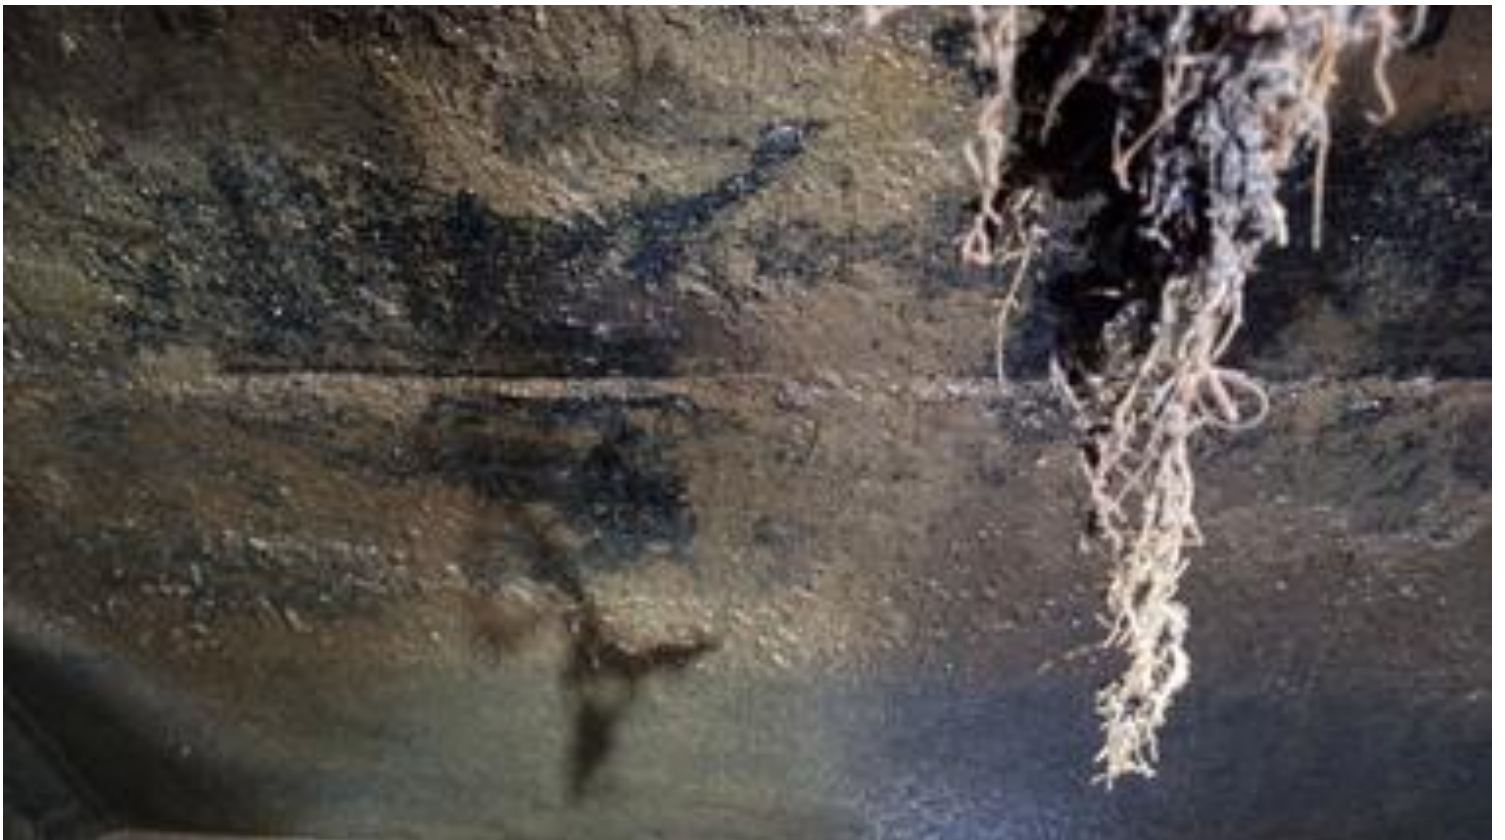
**TANK INTERIOR**

**YES** - Roots present in tank

- TANK WAS PUMPED AT INSPECTION
- Currently there are NO signs of failure or malfunction in the drain field
- Septic tank is original to property
- TREAT ROOTS with copper sulfate into tank every 3 months

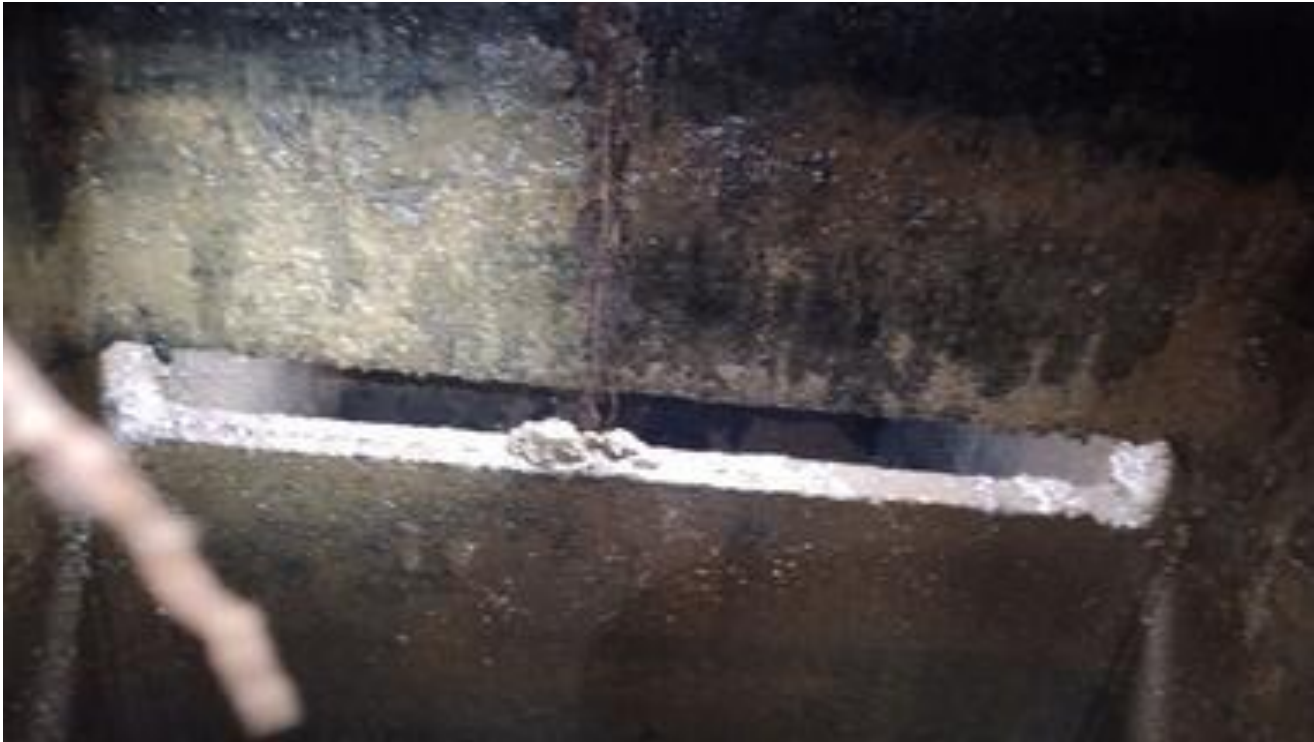
**BAFFLE WALL**

**YES** - Tank has baffle wall

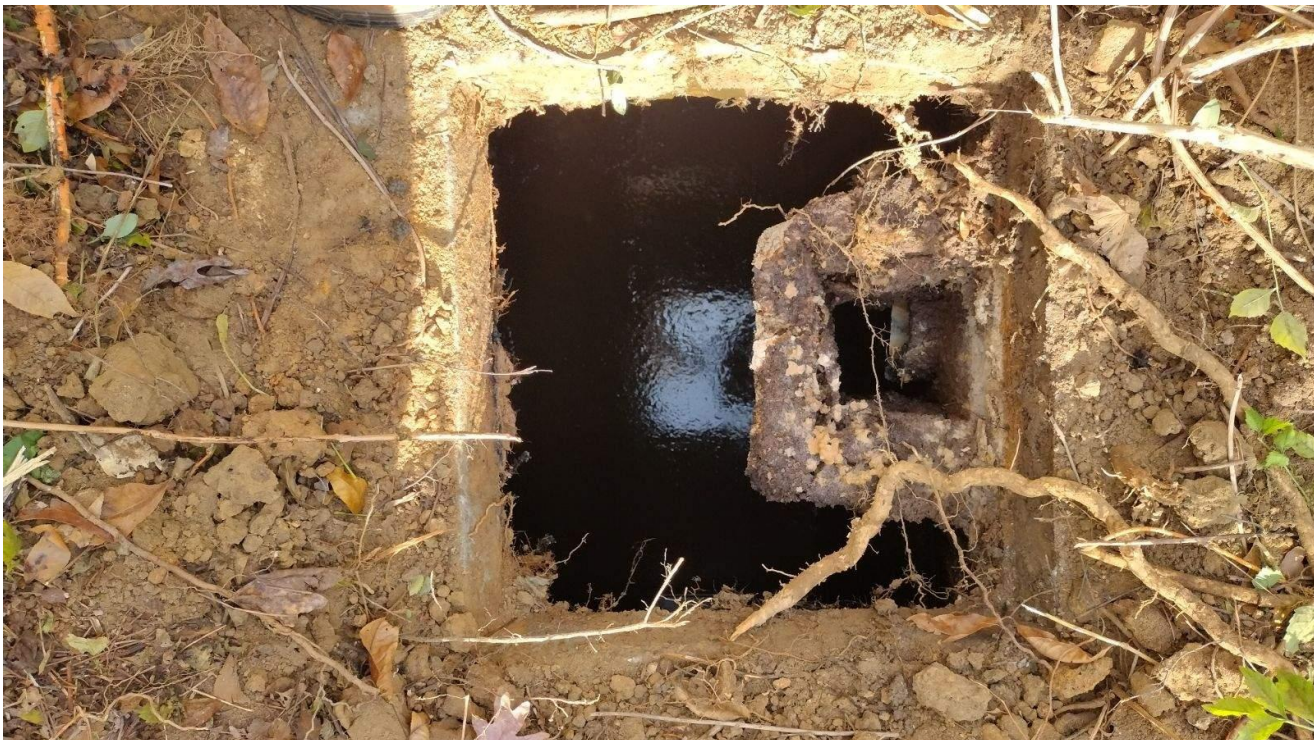
**TANK TEE**

**YES** - Outlet T is present - **CEMENT**

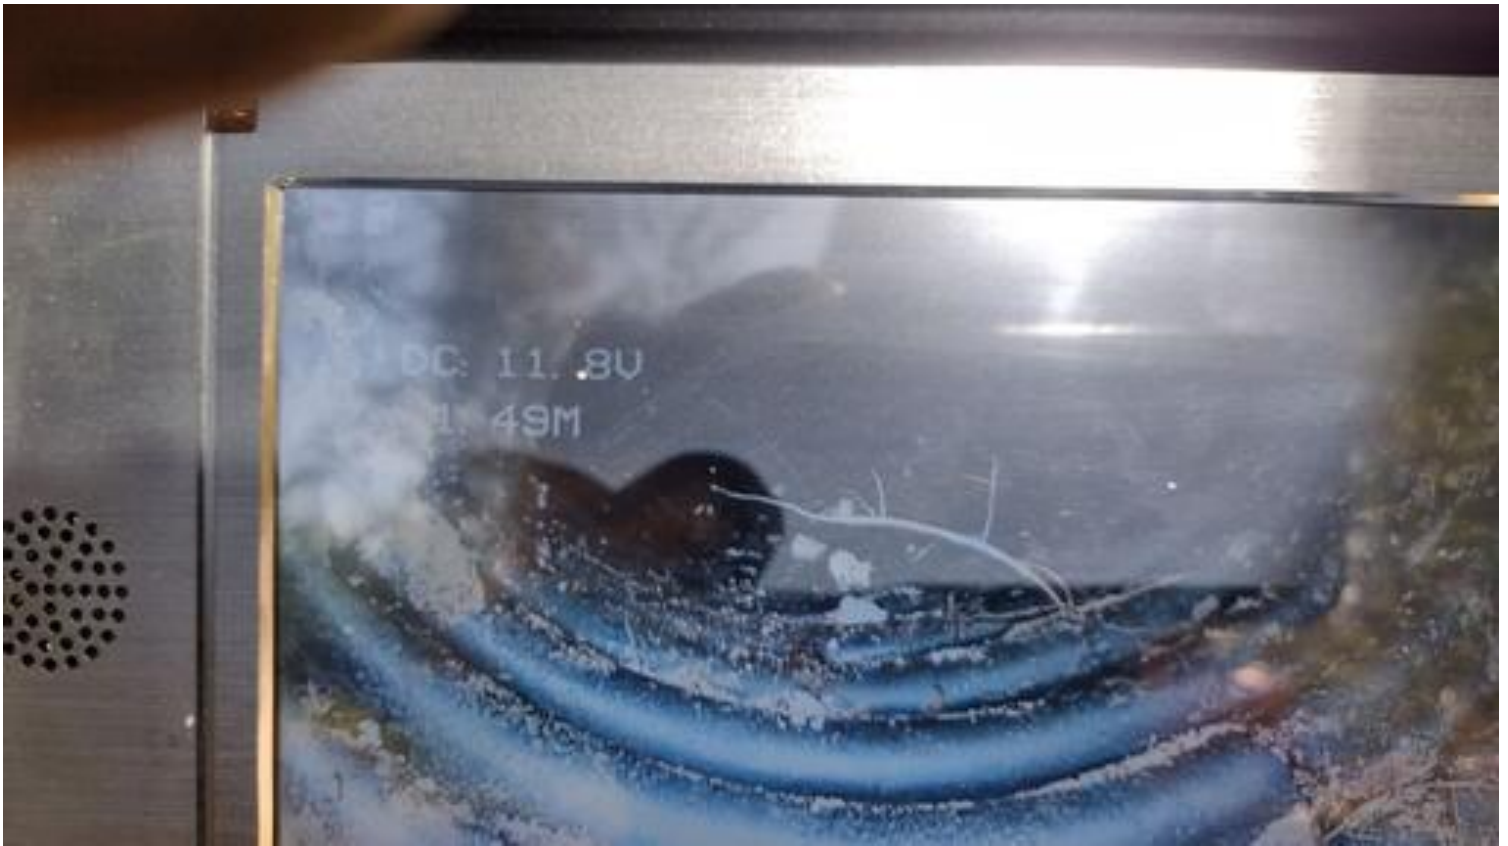
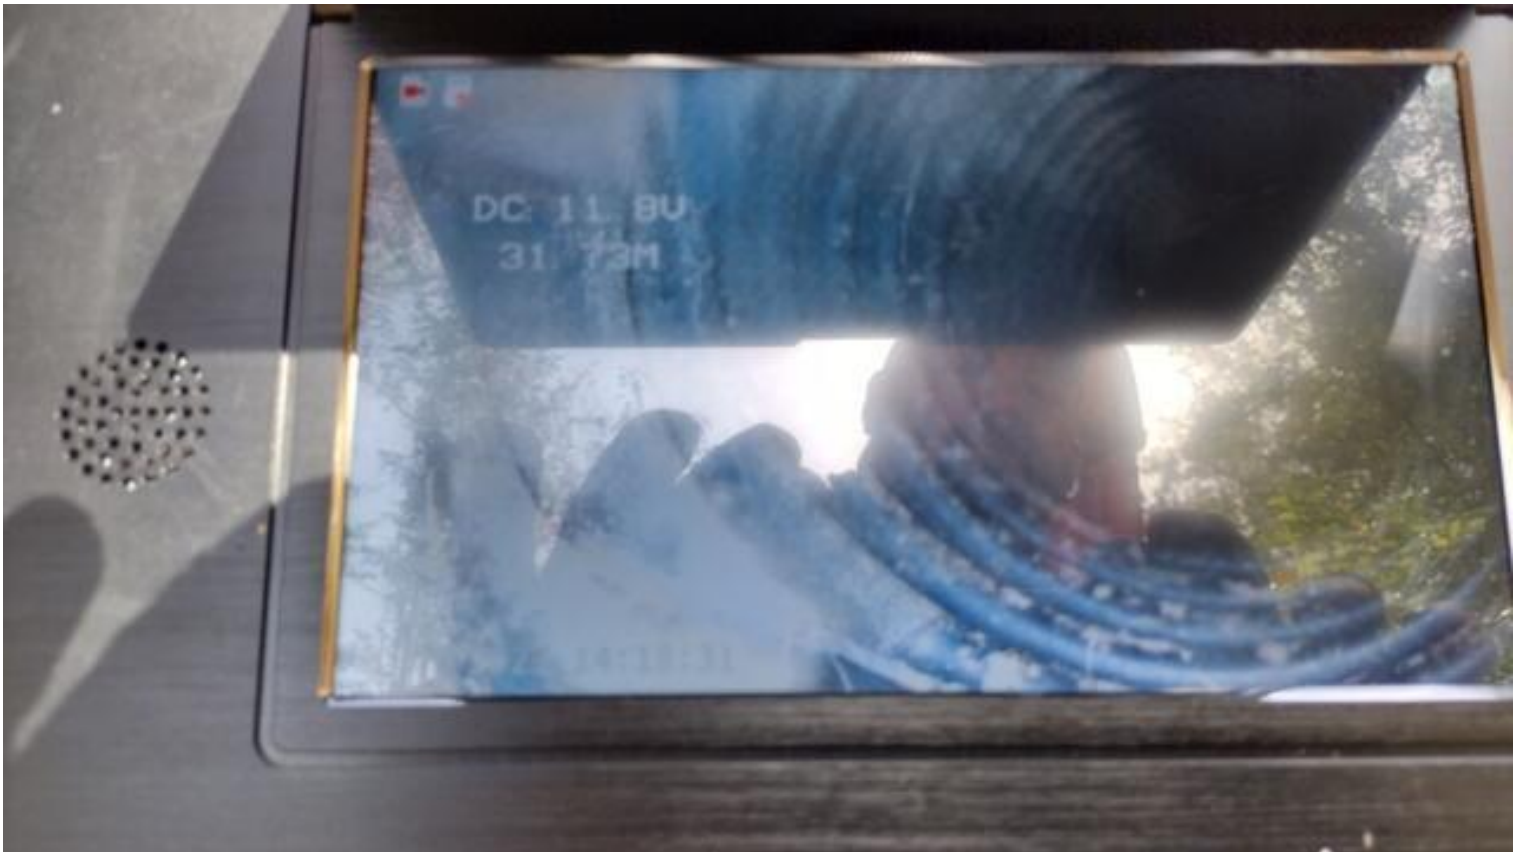
TANK DRAIN LINES – SOME ROOTS
