# **Full Inspection Report**

**Inspection Date 2/7/2025**

**Property Address: 160 Remington Ct, Youngsville, NC 27596**

**VIP Inspection Services Inc. Rich Koeblin #4297 Septic #6362I 919-468-3114**

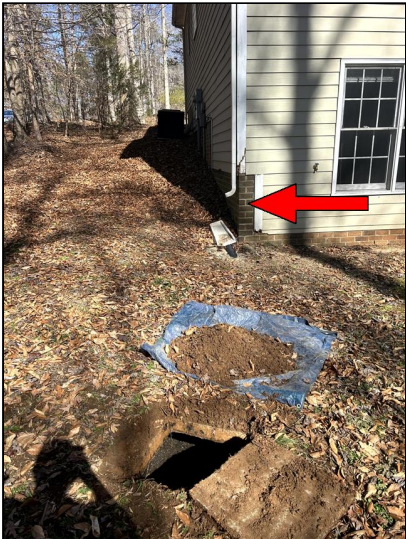
3.1 Other Summary Items

The gutter at the back corner of the house should be re-directed away from the tank. Excess ground water can enter the tank, taking up extra room. Ground water can also cause soft and muddy soil conditions, which can cause shifts or damage to the tank and components. Along with this, there are some slightly low areas around the tank, which can pool ground water. A qualified professional should repair or replace as necessary.

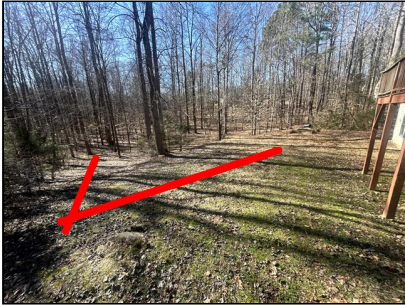
I did not note any issues with the dispersal field or it's visual components today. This is for your information. The drainfield appears to be the raised and lower cleared areas of the back yard.

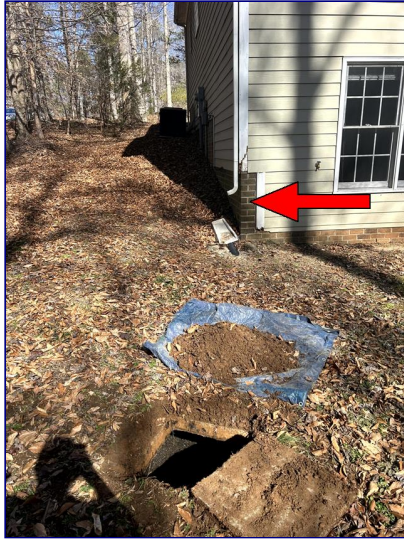
### **3.1 Other Summary Items**

The gutter at the back corner of the house should be re-directed away from the tank. Excess ground water can enter the tank, taking up extra room. Ground water can also cause soft and muddy soil conditions, which can cause shifts or damage to the tank and components. Along with this, there are some slightly low areas around the tank, which can pool ground water. A qualified professional should repair or replace as necessary.
