# Property Inspection Report

**Report Number: 040925-1**

5138 NC-56  
Franklinton, North Carolina 27525

Date of Inspection: Wednesday, April 9, 2025

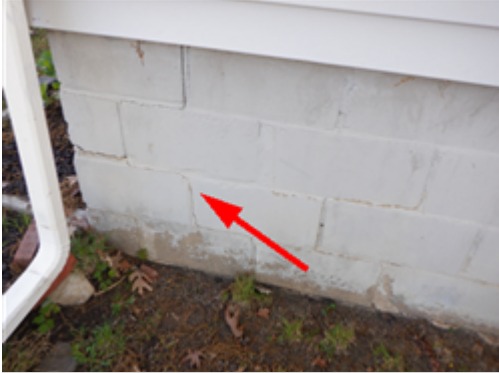
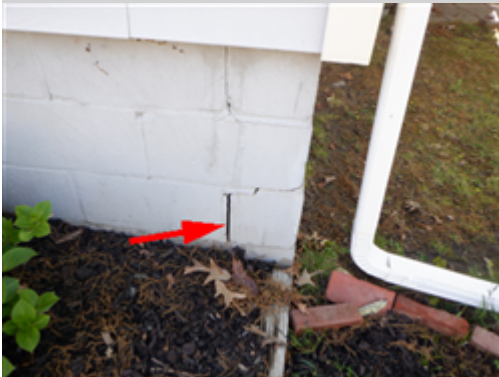
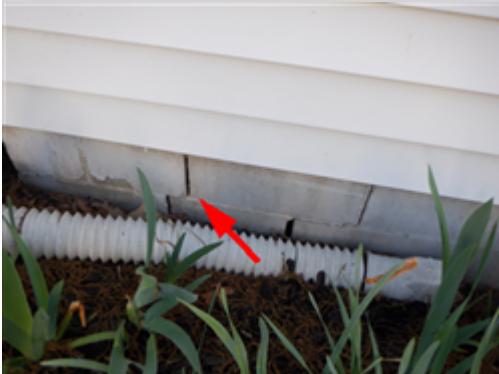
### **(A1 - 1.1) Main House**

Cracks/ rotated blocks were noted in the foundation of the home. Cracks in the foundation indicate a deficiency in the foundation, footing, or supporting soil that can change and worsen if it progresses over the life of the home. An engineer should be consulted to determine the significance/cause of the cracks and outline any necessary repairs.

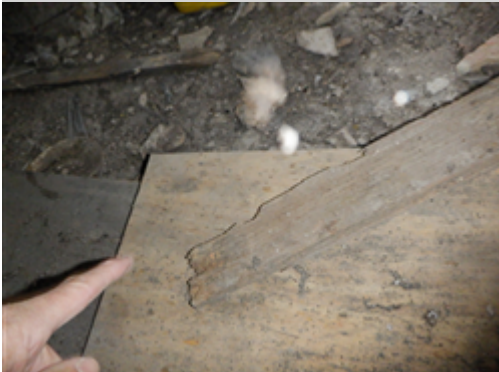
### **(A1 - 1.4) Main House**

Wood debris was left in the crawl space. The wood encourage insects. A licensed general contractor should be consulted for a complete evaluation and to make necessary repairs.

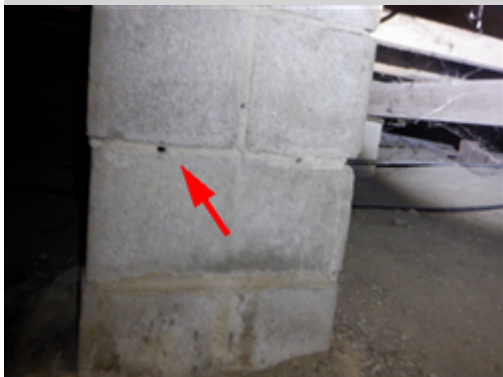
#### (A1 - 1.5 ) Main House

Evidence of termite treatment was noted in the crawl space. Termite damage is often hidden and requires invasive inspection to determine the extent of the damage. Owner disclosure and/ or a licensed termite inspector be consulted for further evaluation.

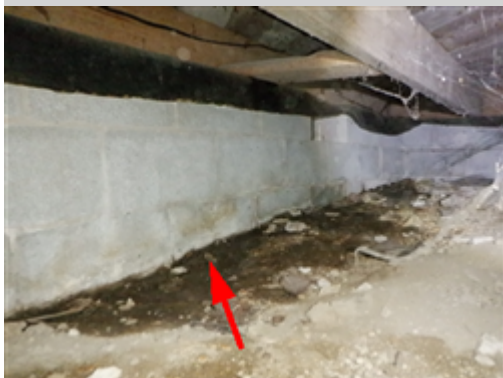
#### (A1 - 1.6 ) Main House

In the crawl space, the front right foundation walls were wet and the soil adjacent to the foundation was muddy from direct water penetration in the area. Direct water penetration damages the foundation, the wood structure, and creates an undesirable environment in the crawl space areas that encourages insects and or fungal growths such as mold/mildew. Repairs are needed to prevent water penetration. A licensed general contractor should be consulted for further evaluation to determine the source of the moisture and to make necessary repairs.

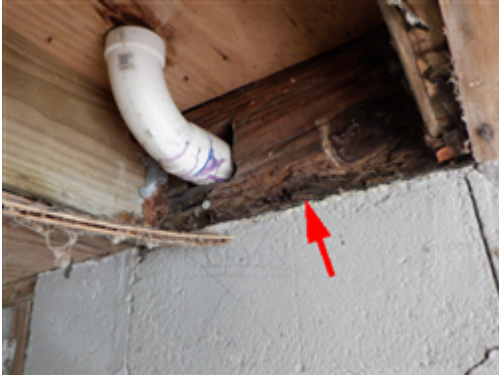
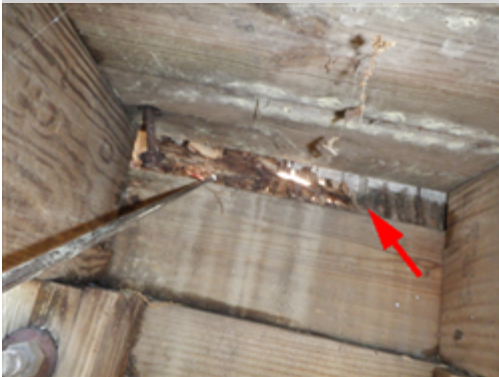
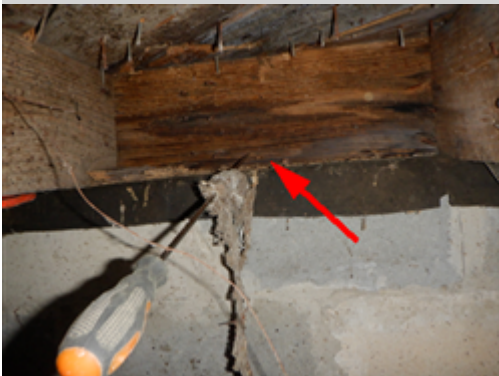
**(A3 - 1.1) All Accessible Areas**

The wood framing for floor system has been subjected to moisture damage. Damage to the floor framing components was located at band rear left and rear porch. A complete invasive evaluation by a licensed contractor to determine the extent of the damage and necessary repairs to ensure the stability of the home.

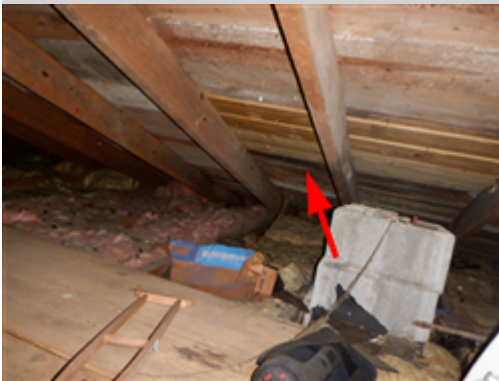
### (A6 - 1.1) Main House

From the attic, the wood framing components are discolored. This indicates a history of a long term leak that could involve hidden areas of damage, the flashing, and the roof covering systems. The area was dry at the time of inspection. A licensed general contractor should be consulted for further evaluation and repair to determine the source of the leak and extent of the damage to ensure the stability of the home and prevent additional damage.

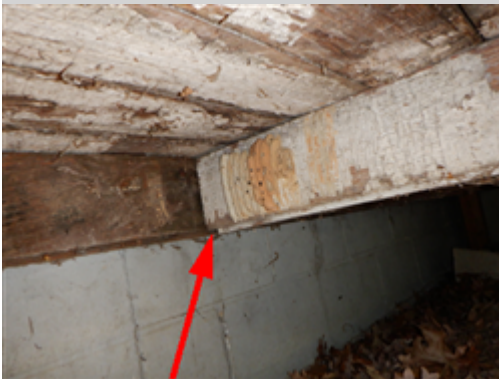
#### (B3 - 1.1) Porch

The floor joists for the porch are supported or attached by nail connections only. Nails can corrode and fail leaving the floor system unsupported. A licensed general contractor should be consulted for a complete evaluation of the deck and to make necessary repairs to ensure the stability and durability of the porch.

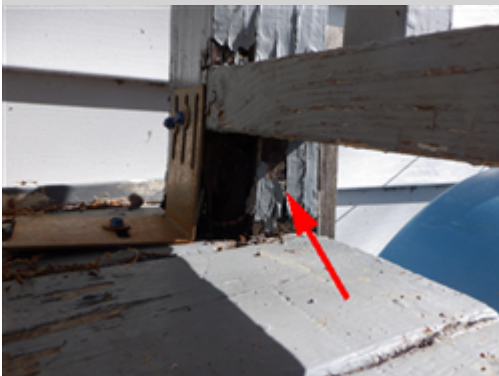
#### (B3 - 2.1) Deck

The post for the hand railings on the deck are decayed and in need of repair or replacement to ensure safe and functional use of the deck. A licensed general contractor should be consulted for a complete evaluation and to make necessary repairs.

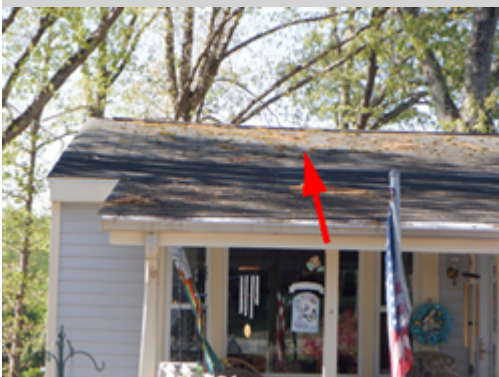
#### **(C1 - 1.1) Main House**

The shingles have heavy moss growth presence. The moss growth damages the shingle asphalt base and could result in accelerated aging and usually advances at the end of the shingles life. A licensed roofing contractor should be consulted for a complete evaluation of the roof covering and to make necessary repairs to ensure the weathertightness of the roof covering system. At the time of the repair, the roofer may be able to answer questions related to the life expectancy of the roof covering system.

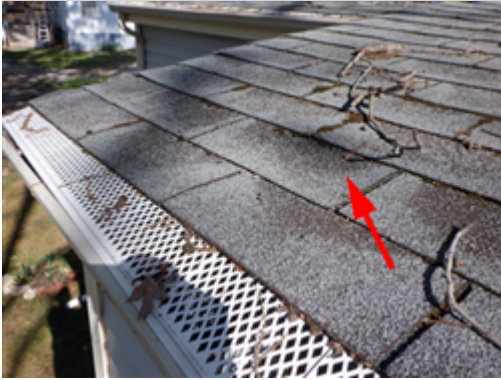
### (C1 - 1.2 ) Main House

The shingles have visible signs of deterioration such as low ballast, and exposed base matt that indicate that they are approaching the end of their service life. A licensed roofing contractor should be consulted for a complete evaluation of the roof covering and flashings system to make necessary repairs to ensure the weathertightness of the roof covering system. At the time of the repair, the roofer may be able to answer questions related to the life expectancy of the roof covering system.

The shingles have visible signs of deterioration such as low ballast, and exposed base mat that indicate that they are approaching the end of their service life. A licensed roofing contractor should be consulted for a complete evaluation of the roof covering and flashings system to make necessary repairs to ensure the weathertightness of the roof covering system. At the time of the repair, the roofer may be able to answer questions related to the life expectancy of the roof covering system.

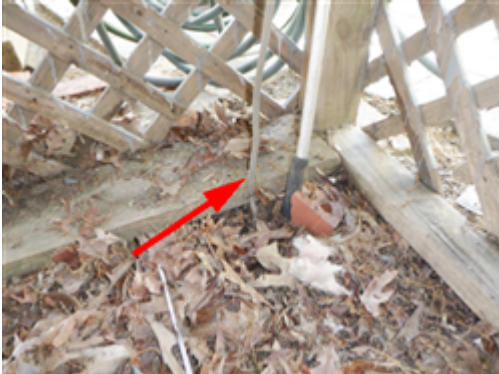
### **(E4- 1.2 ) All Accessible**

Exposed electrical wires were noted at under deck. Electrical wires are required to be protected. Electrical concerns should be considered safety issues and repaired as soon as possible. The electrical systems and components are in need of a complete evaluation and repair by a licensed electrical contractor.

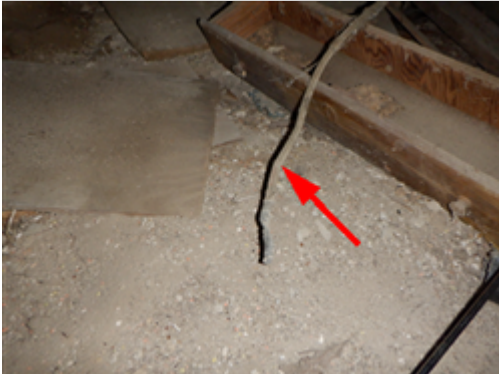
### **(E4- 1.3 ) All Accessible**

Disconnected wires were noted in the crawl space. Disconnected wires should be removed or properly terminated. The disconnected wires leave electrical conductors exposed and in a hazardous condition. Electrical concerns should be considered fire and safety issues and repaired as soon as possible. The electrical systems and components are in need of a complete evaluation and repair by a licensed electrical contractor.

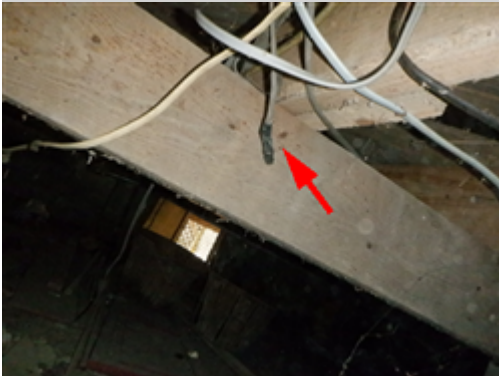
### **(E4- 1.4 ) All Accessible**

Electrical connections have been made in the crawl space without being properly protected in a covered junction box. The damage leaves electrical conductors exposed and in a hazardous condition. Electrical concerns should be considered fire and safety issues and repaired as soon as possible. The electrical systems and components are in need of a complete evaluation and repair by a licensed electrical contractor.

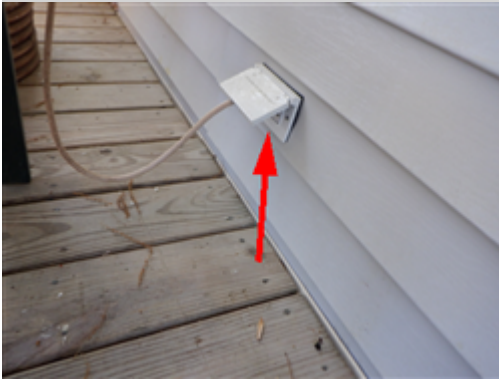
#### **(E5 - 1.1 ) Exterior**

The porch receptacle tested as open ground. An equipment ground provides an extra safety feature to prevent electrical shock hazards and property damage. A licensed electrical contractor should be consulted for a complete evaluation to determine the significance of this concern and make necessary repairs to correct defects and prevent safety hazards.

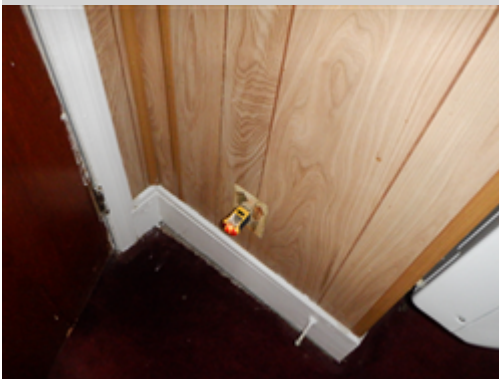
#### **(E5 - 2.1 ) Interior**

The 3 prong type receptacle(s) tested as open equipment ground. This home was built in an era where receptacles were 2 prong type without an equipment ground. An equipment ground provides an extra safety feature to prevent electrical shock hazards and property damage. Receptacles typically should not be updated to the 3 prong type without the installation of an equipment ground or GFCI protection and proper labeling. At least one GFCI receptacle was noticed in the living space, however, no labels were present and protection could not be confirmed. A licensed electrical contractor should be consulted for a complete evaluation to determine the significance of this concern and make necessary repairs to correct defects and prevent safety hazards.

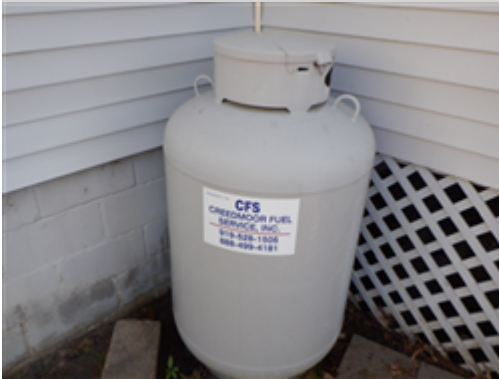
### (F3 - 1.1) Exterior

The home has an above ground fuel storage tank; storage tanks are either leased from the fuel supplier or owned by the homeowner. The buyer should request more information concerning the storage tank, service requirements and ownership.

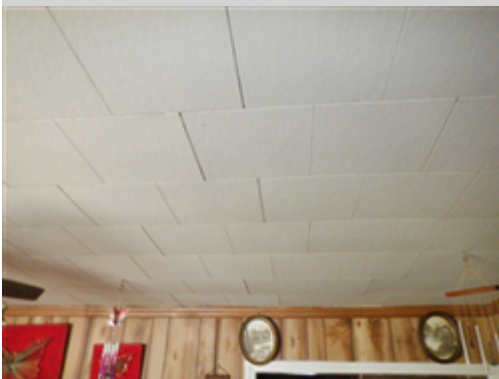
#### (H1 - 1.1) All Rooms

Ceiling tiles installed before 1990 could contain asbestos. Asbestos was banned in ceiling treatments by the Clean Air Act of 1978 in the United States. However, in order to minimize economic hardship to existing inventories of asbestos ceiling materials were exempt from the ban, so it is possible to find asbestos in ceilings that were installed through the 1980s. The tiles in this home may have been installed before the ban on asbestos; its removal/repair should only be done by a licensed professional or after testing of a sample by a qualified laboratory has ruled out asbestos contamination. For more information consult <http://www.epa.gov/asbestos/protect-your-family.html>.

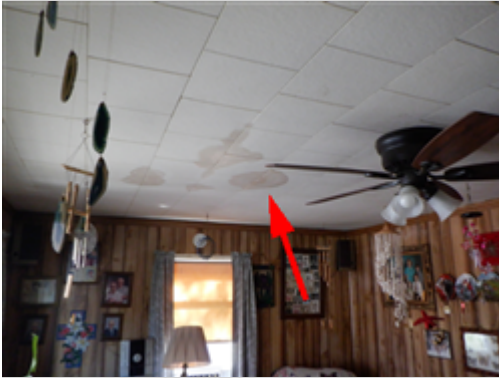
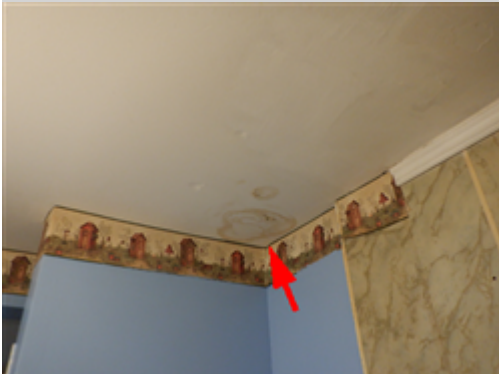
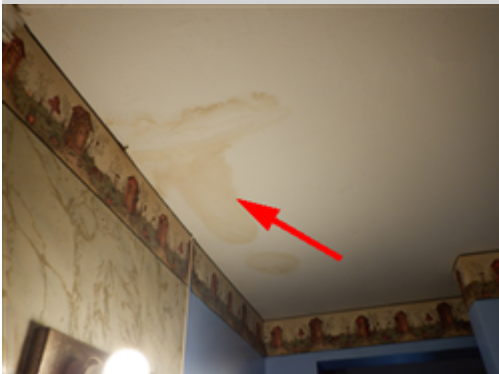
**(H1 - 1.2 ) All Rooms**

Stains on the living room and bathroom ceilings indicate a history of a leak. At the time of the inspection it was not possible to determine if the condition was due to an active or past occurrence. Further investigation by a repair specialist and owner disclosure is recommended.

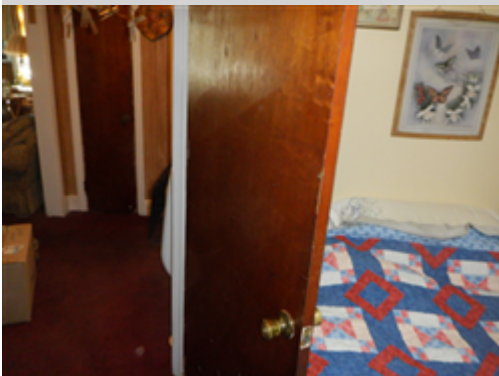
**(H1 - 1.5 ) All Rooms**

The doors located in the bedrooms and hallway closet need repairs to ensure proper operation and privacy. The doors did not properly latch, close. A general repair specialist should be consulted.

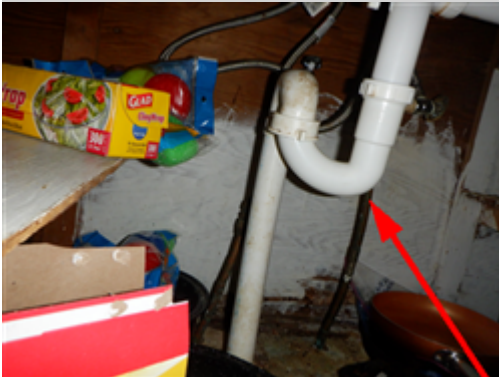
### (H2 - 1.1) Kitchen

The plumbing trap for the sink is an "S" type trap. This trap has a tendency to siphon and become dry allowing sewer gases to enter the home. The trap plumbing needs to be corrected or replaced to prevent sewer gases from entering the home and to ensure sanitary conditions. A licensed plumbing contractor should be consulted for evaluation and repair.

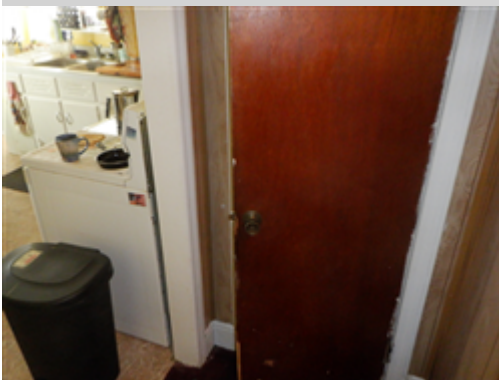
### (H3 - 1.1) Bathroom #1

The door for the bathroom needs repair to ensure proper operation and privacy. The door did not properly latch. A general repair specialist should be consulted.

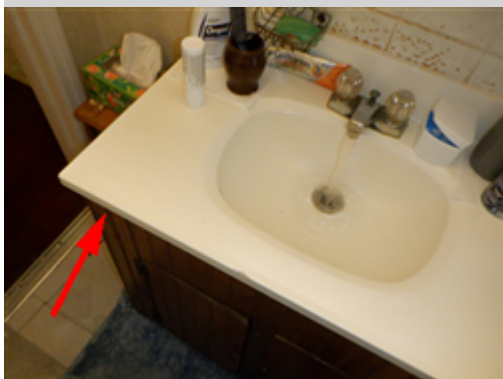
**(H3 - 1.2 ) Bathroom #1**

The counter top is not secured to the cabinet. A general contractor should be consulted for evaluation and repair to ensure the stability and durability of the counter top

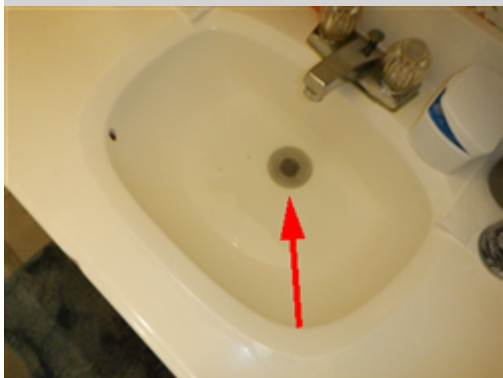
**(H3 - 1.3 ) Bathroom #1**

The sink drain was noted to be slow. A slow drain could indicate a clogged line or an underlying problem with the drain/waste/vent system. A licensed plumbing contractor should be consulted for evaluation and repair to ensure proper service.

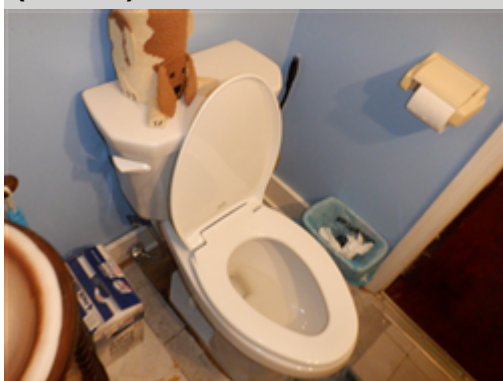
**(H3 - 1.4 ) Bathroom #1**

The toilet rocks and is not secure to the floor. Movement of the toilet can result in leaks and damage. A licensed plumbing and general contractor should be consulted for evaluation and repair.

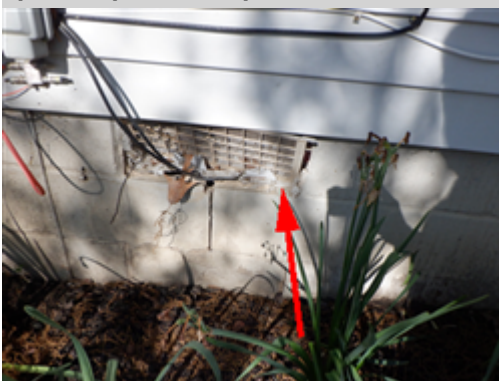
#### **(I1 - 2.1 ) Crawl Space: All Accessible Areas**

The front left foundation vent is damaged/ loose. A licensed general contractor should be consulted for a complete evaluation of the crawl space to determine the significance of the concern and make necessary repairs.

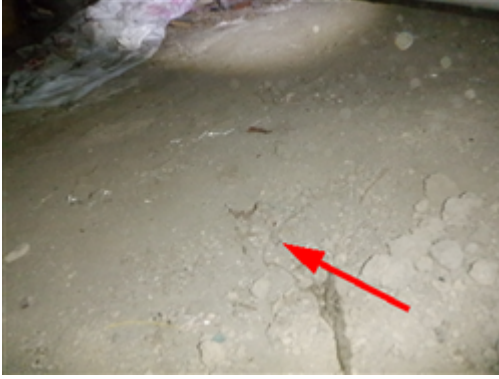
**(I1 - 2.2 ) Crawl Space: All Accessible Areas**

The crawl space floor is missing a vapor barrier. An absent vapor barrier can result in excessive moisture levels and growths such as mold. A general contractor should be consulted for further evaluation of moisture concerns and make necessary repairs.
