# TARHEEL<sup>TM</sup>

## BASEMENT SYSTEMS

| Date<br>April 7, 2025 | Client Name<br>Ryan Speer | Client No<br>253095 |
| Site Address<br>108 Horseman Dr<br>Louisburg, NC 27549 | Inspector<br>Clint Weirich CF <i>[Signature]</i> | |

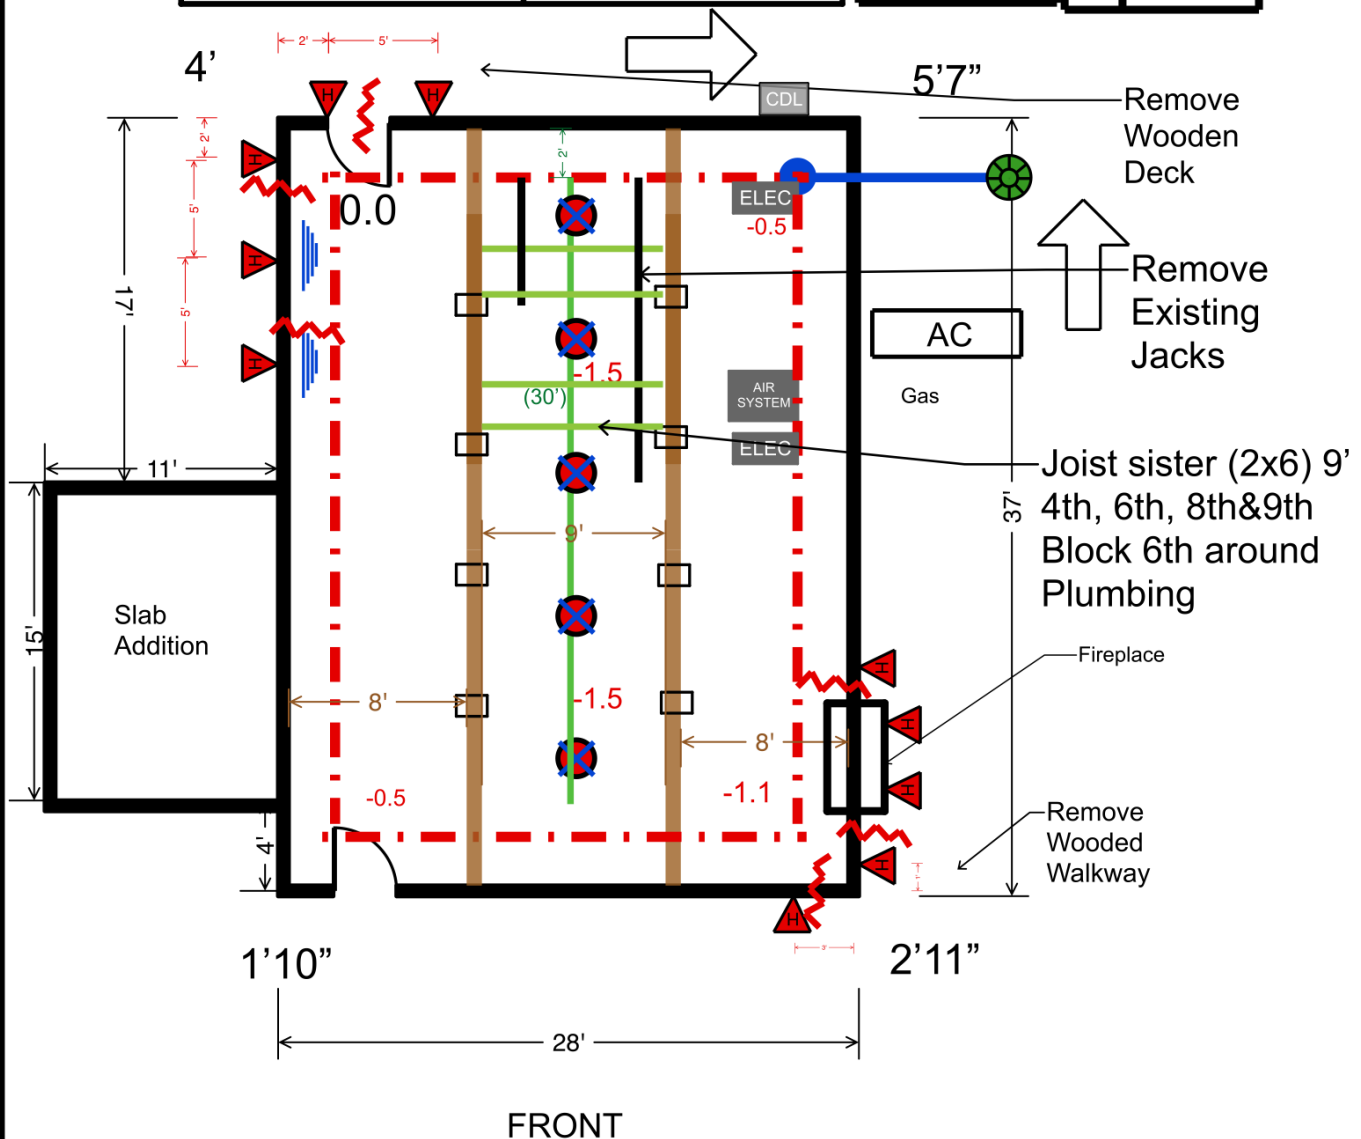
\* Sitting ground water seepage in rear left corner and along left wall and significant evidence of ground water throughout: mud lines, channels of flow. RECOMMENDATION: drainage on interior wall leading to a sump pump in the rear right corner, drainage matting on ground (under AquaStop crawlseal).. Note: 1 GFCI would be required for the sump pump prior to project day--I can recommend an electrician if you require one)

\* High humidity throughout crawlspace (15% joist moisture, 77-82% humidity). This usually occurs from vapor rising up from the ground, in through the porous block walls and through the vents. RECOMMENDATION: 20mm AquaStop CrawlSeal on ground and wrapping CMU piers and on walls, sealing the vents to seal off the crawlspace, humidity controlled by an AprilAire E100 air system/dehumidifier. Note: 1 GFCI dedicated outlet is required for the dehumidifier.. This supports the annual maintenance of the sump pump and dehumidifier and checks on all our work.

\* Falling insulation and non-existing in spots (This usually occurs due to the high humidity and pests making nests in insulation). RECOMMENDATION: remove the R19 and install AquaStop Xtremebloc foam board (transferable lifetime warranty) insulation on perimeter walls up to 4" from sill plate to allow for termite inspection and stuffing RimJoist insulation above the sill plate.

\*Settling floor framing in the middle of the home. -0.3" up to -1.5" (See CAD for detailed placement). This usually occurs from washed out ground under perimeter footing, over spanning or rotting of organic wood. The first two points have appeared to cause the settling floor and cracks in the perimeter. RECOMMENDATION: remove existing temporary wood supplemental beams and jacks and install 30' of galvanized steel down the center of the home, supporting the over span of the 2x6 joists that should be spanning no more than 8', stabilized (or lifted if you wish) by five SettleStop Intellijacks.. There are 4 joists in the rear/middle of the home that require sistering (1 due to a cut joist around a bathtub drain pipe, 2 due to failing to stand straight and 1 due to lacking support as evidenced on the existing supplemental beam). This is the 4th, 6th, 8th and 9th joists from the rear wall

\* cracks on the perimeter foundation on the front right corner and rear left corner. This is usually caused by the ground being washed out from the footing from the earlier mentioned

ground water seepage. RECOMMENDATION: SettleStop Helical Piers on wrapping the two corners spaced 5'-6', 5 on each corner. Stabilization guaranteed, lift if you wish to attempt. Note: the deck on the rear and the wooden walk-through on the front would need to be removed for the work to be done and the walkway on the right side of home may be affected by our excavator equipment
