**THE FOLLOWING ITEMS SHOULD BE CHECKED FOR EXTENT OF DAMAGE AND/OR REPAIRED BY QUALIFIED REPAIR PERSON**

## Needs Repair / Needs Further Evaluation

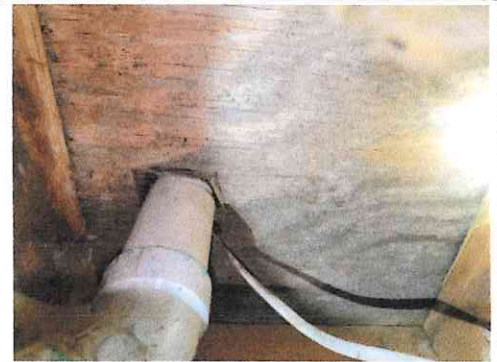
1. Needs Further Evaluation / Repair: Subfloor - Moisture Stained Subflooring - Observed moisture stained subfloor under the kitchen sink and under the rear door. The kitchen sink waste drain is actively leaking. The moisture stains under the rear door system are assumed to be from a prior leaking condition when there were opening around base of the rear door frame. The edges around the rear door frame have been heavily caulked / sealed to prevent water intrusion. Recommend having a professional contractor evaluate the moisture stained subfloor and repair as necessary.

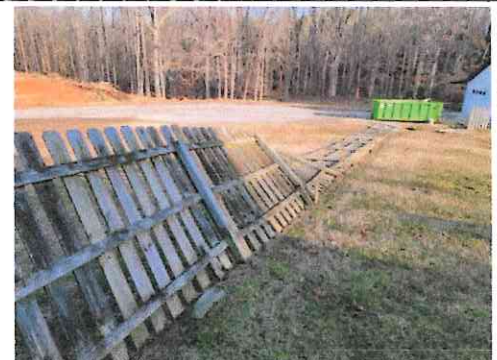
2. Needs Repair: Wood Fence - Broken Fence Laying On Ground - Observed about half of the fence broken and/or laying on the ground. The fence hasn't been provided with proper preventative maintenance and has deteriorated / rotted. The concrete holding fence posts are broken. Observed termite damaged wood fence pickets at the right side of the house close to the home. Recommend having a professional fence contractor evaluate the fence and remove / replace as necessary.

*Broken Fence removed*

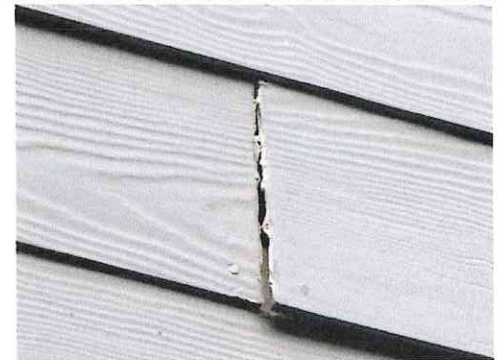
3. Needs Repair: Exterior Wall Cladding - Adverse Conditions Present -  
1) Open Siding Joints - Observed butt joints in the fiber cement siding that have opened up. Moisture can penetrate behind the exterior wall cladding at these unsealed butt joints and damage may not become apparent for a long period of time if proper preventive maintenance is not being provided. Installation standards requiring individual flashings to be installed at every lap joint on the house were implemented by the state starting with homes being permitted in 2008 were not required when this building was constructed. Consider installing flashings at the most problematic joints, but at a minimum, have a professional contractor properly maintain all open lapp joints by employing preventive maintenance measure of sealing the joints by applying a caulking sealant.

2) Loose Siding - Observed loose sections of siding on the right side of the exterior of the home. Loose sections of siding can allow water to damage the wood structure behind the siding, and the siding can be damaged during windy conditions. Have a professional siding contractor evaluate the home's entire siding application/installation and repair/replace as necessary.

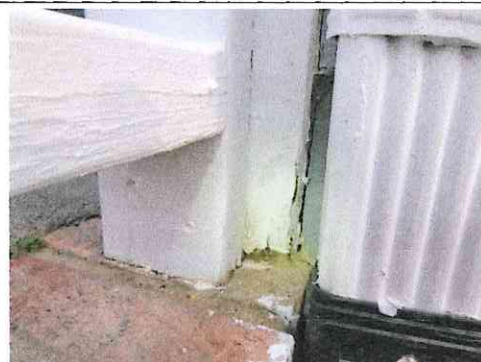
### 4. Needs Repair: Exterior Trim - Adverse Conditions Present -

1) Moisture Damaged Trim - Observed moisture damaged wood trim around the exterior of the home. Determining the extent of each individual area of damage is not within the scope of this general home inspection. Damaged wood may not be limited to just the area noted in this report. Have a professional contractor evaluate all of the exterior wood around the house making repairs as necessary.

>>> Note: Water damage at the noted areas may not be limited to the visible wood components. Damage may be present inside the walls/roof/overhangs as well. Evaluations in these areas should include opening up the areas to observe/repair any damage as a result of the moisture penetration.

2) Deteriorated Sealant - Unions of doors/window frames/exterior trim to the exterior wall cladding have areas of sealant adhesion failure present. Caulked joints that have cracked and/or separated need to be sealed in order to prevent any possibility of water intruding into the walls where damage can occur. Have a professional contractor properly prepare/reseal all areas where joints have been compromised.

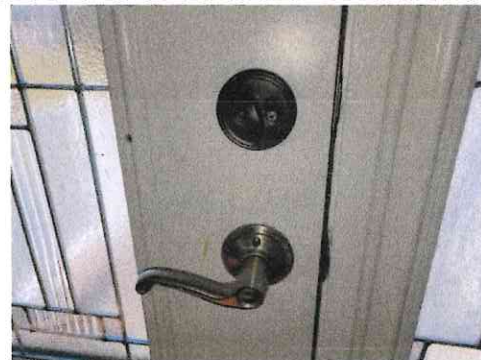
### 5. Needs Repair: Front Door - Front Door Deadbolt Not Fully/Easily Engaging -

The dead bolt locking bolt is not fully engaging/hard to engage the door jamb when locking the front door. This will prevent the door from being properly secured. Have a professional contractor make all necessary repairs or adjustments required so the dead bolt can be easily and fully extended into the jamb when locked.

*Deadbolt is engaging*

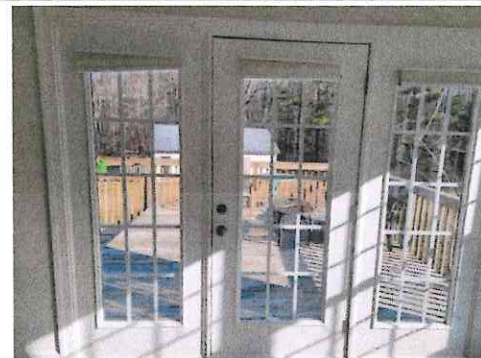
### 6. Needs Repair: Rear Door - Adverse Conditions Present -

2) Damaged Weather Stripping/Door Not Sealing - The door is not making a good seal on the weather strip insulation at the lower striker side of the door jamb where the insulation strip is deteriorated. This can allow conditioned air to leak from the home, and provide an access point for pests into the home. Damage is most likely from a pet pawing at the area.

Have a professional contractor evaluate the exterior doors and repair / replace as necessary.

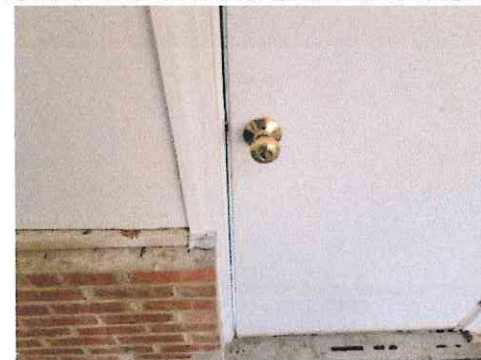
### 7. Needs Repair: Garage Side Service Door - Adverse Conditions Present -

1) Door Not Sealing - The garage side service door is not making a tight seal on the weather strip. Recommend having a professional interior trim carpenter make all necessary adjustments required so that this door can properly seal as required.

2) Minor Moisture Damage to Side Service Door - The garage side service door lower side wood jambs have minor wood deterioration/rot present. Have a professional contractor make all necessary repairs for long term serviceability.

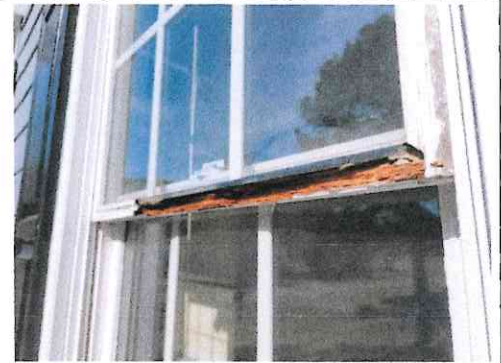
### 8. Needs Repair: Windows - Adverse Conditions Present -

1) Moisture Damage Window Frames/Sills - There are moisture damaged windows/window casings/window sills around the perimeter of the house. Long term exposure to exterior weather conditions is attributed to the current moisture deteriorated conditions noted at the time of the inspection. Conditions will worsen at a faster time interval than what it took for current conditions to become present if preventative maintenance is not provided. Determining the extent of each individual area of damage is not within the scope of this general home inspection. Have a professional contractor evaluate all windows/frames and make repairs where necessary for long term serviceability.

2) Window Screens Missing - Most of the windows around the home did not have window screens installed in the windows at time of inspection. Some screens were observed stored in the garage and crawlspace. Replace missing screens at all windows where not currently installed so that all window screens can be accounted for.

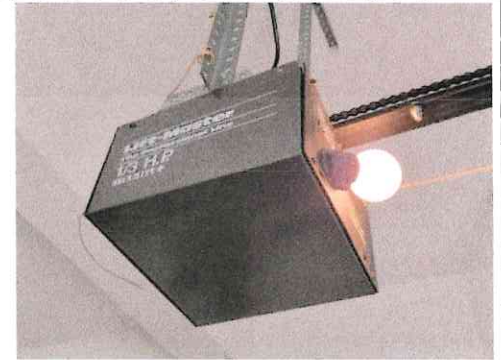
### 9. Needs Repair: Garage - Adverse Conditions Present -

1) Garage Door Opener Down Force Adjustment Needed - The garage door did not reverse motion when a small amount of resistance (three fingers alone used to stop downward motion) were applied to the door while closing. Improperly set door openers can result in damage to the door/personal property, or personal injury. Have a professional garage door installation contractor adjust the downforce on the automatic garage door opener auto-reverse function so that less resistance is required in order to reverse downward door motion.

2) Garage Door Opener Light Lens Cover Missing - The protective lens cover is missing on both garage door openers. Lenses help prevent personal injury in the event of a bulb burst. Install missing lens cover due to concerns for personal safety.

3) Openings in Wall Board - Observed an opening in the wall board in the garage. The holes appear to be made by a mouse. Openings in the drywall can allow harmful gasses to enter the home, and can allow for a fire to spread more quickly into the home should a fire occur in the garage - the majority of all reported house fires start in the garage. Have a professional contractor make repairs so that the integrity of the wall board is restored.

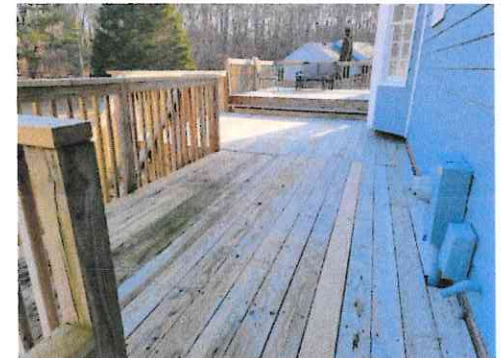
### 10. Needs Repair: Deck - Raised Wood Deck Surface Deterioration -

Manufacture of exterior wood products recommend preventive maintenance in order to extend the long term serviceability of the product. Deck boards have not been cleaned and sealed in the past and extensive surface aging/deterioration of the wood deck boards is present. The lack of preventative maintenance has allowed safety concerns to be present with splintering, warping conditions in the wood surfaces being present. Have a professional contractor specializing in exterior deck preservation provide further evaluation - repairing/replacing all damaged wood areas.

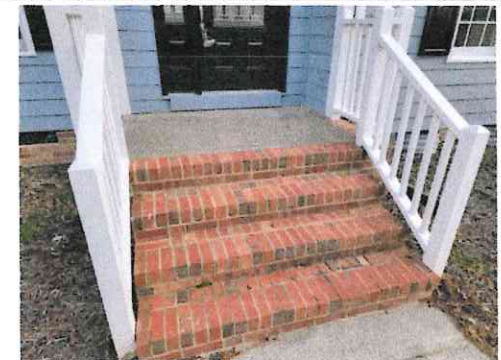
### 11. Needs Repair: Stoop - Open Mortar Joints -

The front entrance masonry steps have some openings in the mortar joints and one loose brick. Openings in these joints between the brick can allow water to intrude into openings and during extremely cold weather, freezing conditions will expand water and cause brick to crack or dislodge. Have a professional masonry contractor "point up" any open joints in the masonry exterior of the house.

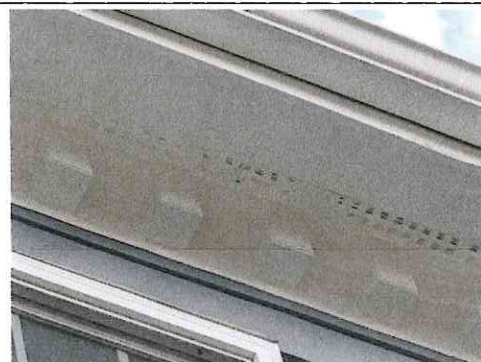
#### 12. Needs Repair: Soffit - Soffit Vents Painted Over -

The soffit vents have been painted over in places around the house. This is reducing air flow into the attic through the vent. Recommend having a professional contractor evaluate the soffit vents and repair / replace as necessary.

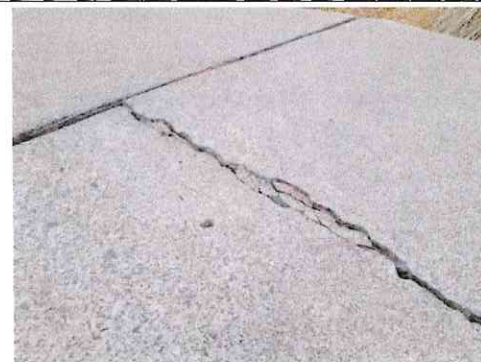
#### 13. Needs Repair: Driveway - Large Cracking/Displacement Present -

Observed large cracks and/or displaced sections in the driveway. Displacements in the cement that exceed more than 1/2" vertically and/or horizontally present a tripping hazard. Repairs should be considered due to a personal safety and liability concern. Have a professional concrete flat work contractor evaluate the driveway and repair any sections of the driveway necessary for safe passage.

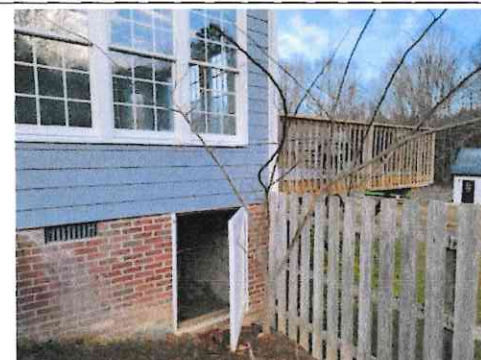
#### 14. Needs Repair: Tree/Shrub Limbs - Limbs In Contact With The House -

Observed tree/shrub limbs that are in contact/near contact with the home. Branches in contact with the house can cause damage to the shingled roof covering and water shedding off the trees can divert water toward the house. The canopy under large trees will hold higher moisture levels in them that will over time cause wood to deteriorate. Maintain large vegetation away from the house in order to prevent damage to the house and reduce higher moisture levels that can cause rot on wood surfaces.

>>> Note: Limbs over the fireplace chimney can cause poor drafting/back drafting in the fireplace.

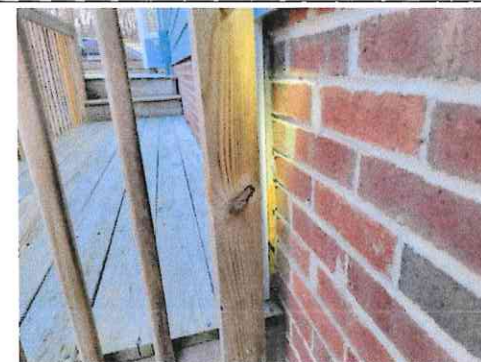
#### 15. Needs Repair: Exterior Wall Cladding - Unsealed Opening -

Observed an unsealed penetration into the exterior wall of the home. Unsealed openings can allow moisture/pests access to the foundation area and damage wood framed walls. Have a professional contractor evaluate the entire home and seal all openings as necessary.

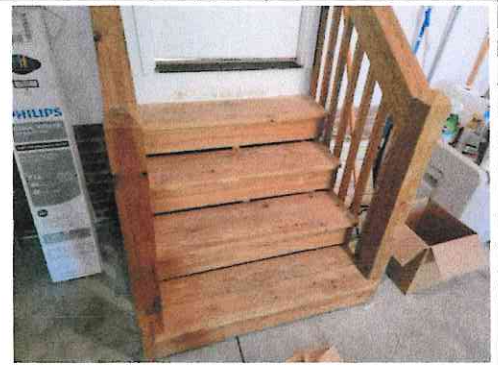
### 16. Needs Repair: Garage Steps - Loose Boards -

The garage stairs leading into the house have loose boards at stair treads. The loose boards are a tripping/slipping hazard. Recommend that a professional contractor make the necessary repairs to allow for safe use.

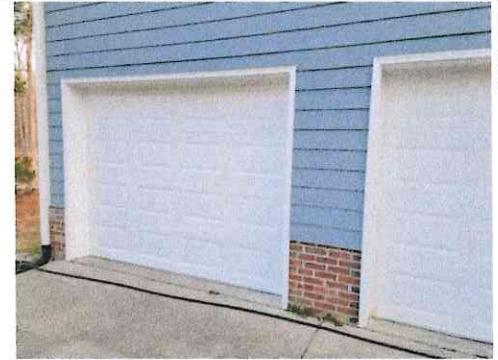
### 17. Needs Repair: Garage Door Dented / Damaged -

Observed damaged areas on the left side garage door. The garage door did not reverse motion when a small amount of resistance were applied to the door while closing. Improperly set door openers can result in damage to the door/personal property, or personal injury. Have a professional garage door installation contractor evaluate the garage doors and repair / replace as necessary.

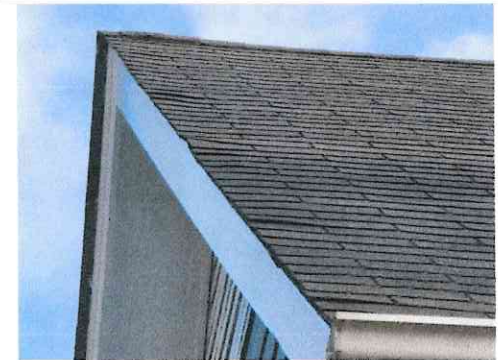
### 18. Needs Repair: Roof Covering - Raised Shingles -

Observed raised shingles on the roof. Observed one damaged shingle at the front roof. Raised shingles and damaged shingles can allow moisture to penetrate under the roof covering that can result in damage, as well as exposing the shingle to further damage during high wind conditions. Have a professional roofing contractor evaluate the entire roof and make the necessary repairs for proper installation and long term serviceability.

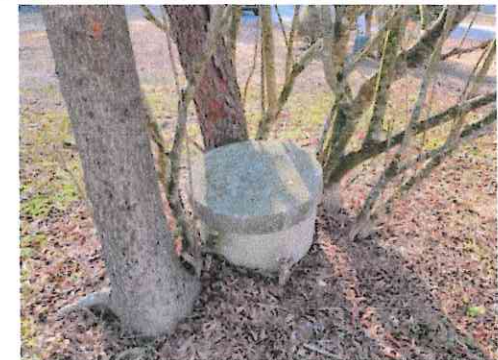
### 19. Needs Further Evaluation/Repair: Well Water Supply System Adverse Conditions Present -

The following adverse conditions were noted in the well water supply system at the time of the inspection:

- 1) Mature trees are growing directly next to the well and well housing. Tree roots can damage the well and associated plumbing.
- 2)

Limited Evaluation: The well pump is submerged and could not be observed. Inspection provides conformation that the pump was operating at the time of the inspection alone. The visible components of the well water supply system (pressure/storage tank, pressure contact relay switch and pressure gauge) were inspected and observed to be functioning properly at the time of the inspection.

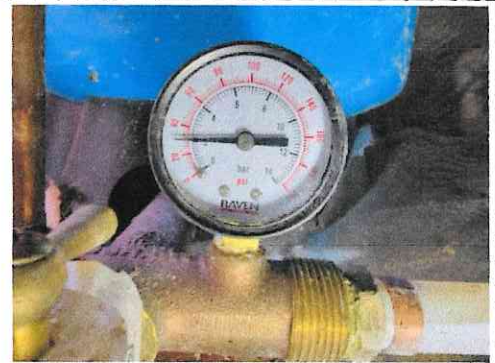
### 20. Needs Repair: Water Pressure - Low Pressure Settings on Well -

Low water pressure is currently being provided when water pressure is at the lower pressure setting of the contact pressure switch. Have a professional plumbing contractor that is familiar with well water supply systems increase the pressure setting so that a reasonable water pressure is maintained on the water supply system at all times.

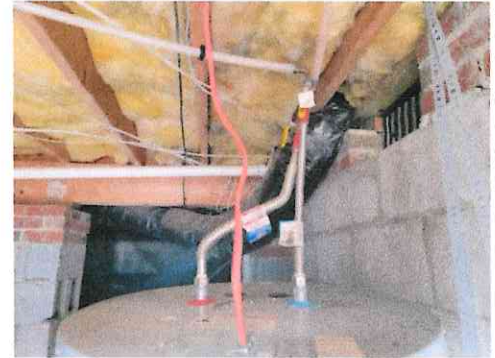
### 21. Needs Repair: Plumbing Insulation - Missing Insulation at Water Heater -

Due to the water heater being installed in an unconditioned area, insulation should be installed on all of the water lines servicing the appliance in order to protect pipes from exposure to freezing during extreme cold weather conditions. Recommend that a professional contractor evaluate the plumbing and make the necessary repairs to properly insulate lines where necessary.

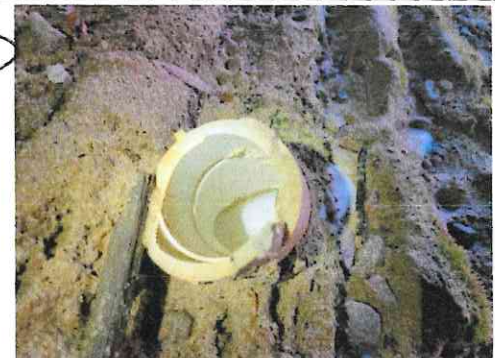
### 22. Needs Repair: Waste Plumbing - Adverse Conditions Present -

1) Broken/Open Main Waste Pipe - The main sewer clean out is broken at the top of the opening. The broken pipe is located under the deck. Open sewer waste lines will allow odors/gases to escape into the surrounding area that present a safety concern for small children. Additionally, the open waste line is a tripping hazard, and can allow debris to fall into the drain causing a clog. Have a professional plumbing contractor make the necessary repairs to the main line to ensure proper drainage and to provide a proper seal. >>> Note: Additional damage may be present below the grade surface that is not visible during the home inspection.

2) Exposed Waste Pipe Outside the Foundation - The main waste drain line drain just outside the foundation wall is exposed at the surface dirt grade. Installation requirements of plumbing waste lines call for no drainage piping (other than a cleanout) to be installed outside of or under a building in an exposed, open or unheated area. Measures should be taken such that the waste drain pipe is installed so that none of the pipe is exposed to possible damage.

*This was repaired*

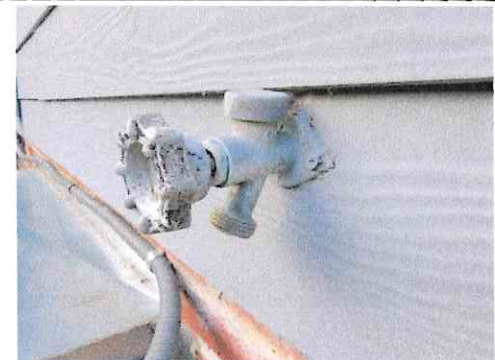
### 23. Needs Repair: Exterior Faucet - Disconnected From Plumbing / No Water Supplied -

The exterior hose faucet at the right side of the house is disconnected from the plumbing lines. The plumbing line was observed cut in the crawlspace and the supply end is capped off. No water is supplied to the hose faucet. Recommend that a professional plumbing contractor evaluate the faucets and make the necessary repairs to allow for proper operation.

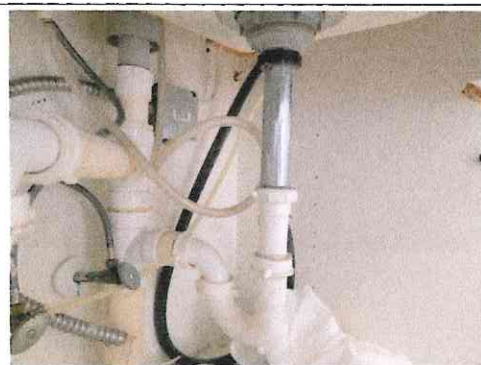
### 24. Needs Repair: Kitchen Sink - Waste Plumbing Leak -

Observed a leak from inside the base cabinet under the kitchen sink at the sink waste line. The exact source of the leak was not determined during the inspection, but dripping was occurring at this location. Recommend that a professional plumbing contractor evaluate the area and make the necessary repairs to prevent further leaking.

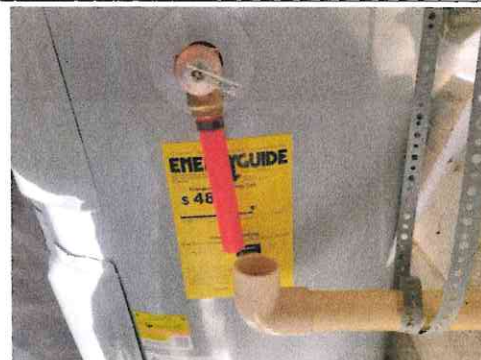
### 25. Needs Repair: Water Heater Safety Equipment - Pressure Relief Valve Drain Line Not Installed Properly -

The pressure relief valve drain line is offset / not above the lower drain line that exits to the exterior of the crawlspace. If the pressure relief valve discharges water it will go onto the ground in the crawlspace rather than through the drain line below. Recommend having a professional plumbing contractor evaluate the water heater installation and repair as necessary.

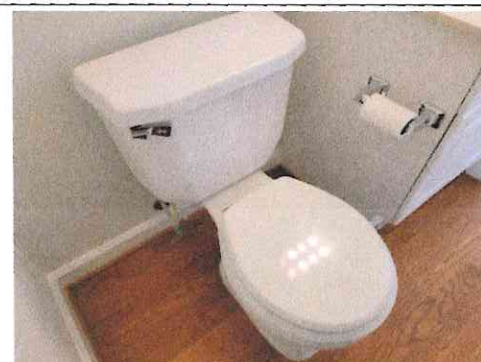
### 26. Needs Repair: Toilet - Water Supply Valve Leaking -

The water supply valve behind the toilet is leaking water onto the floor. This can cause damage to the flooring and floor structure below. The water supply valve was turned off after the inspector cleaned up all water. Recommend having a professional plumbing contractor evaluate the toilet and repair / replace as necessary.

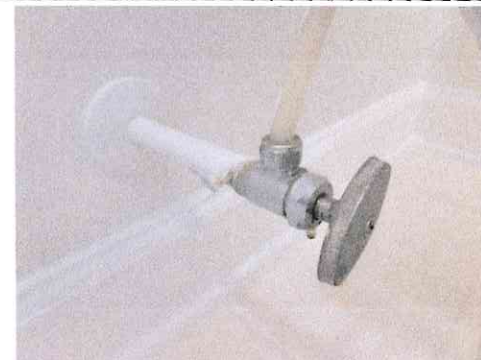
### 27. Needs Repair: Toilet - Water Supply Valve Leaking -

The water supply valve behind the toilet is leaking water onto the floor. An excessive amount of water was on the floor around the toilet before the inspector turned on the toilet valve. The toilet may be leaking from additional areas. The toilet water supply valve was turned off after the inspector cleaned up all water. This can cause damage to the flooring and floor structure below. Recommend having a professional plumbing contractor evaluate the toilet and repair / replace as necessary.

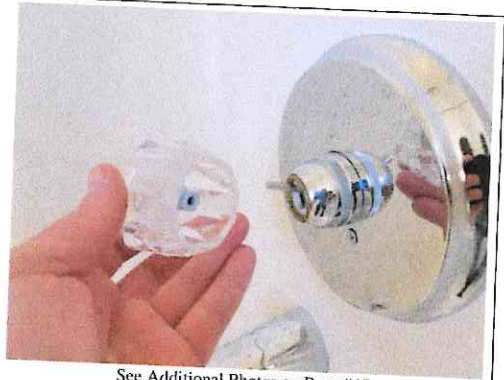
28. Needs Repair: Shower and Bathtub - Adverse Conditions Present -
- 1) The tub/shower valve handle isn't secured and the handle fell off.
  - 2) Tub/Shower Diverter Not Working Properly - The bathroom tub/shower valve does not fully divert water to the shower sprayer. This can limit use.
- Have a professional plumbing contractor evaluate the bathrooms and repair / replace as necessary.

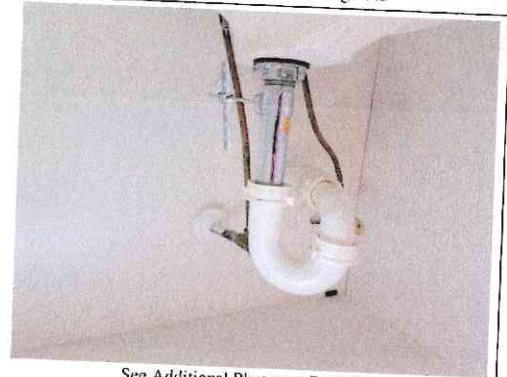
29. Needs Repair: Sink - Adverse Conditions Present -
- 1) Leak at Bathroom Sink Waste Drain Assembly - A leak was observed in the left side vanity sink waste drain trap assembly when water was draining. Continued leaking can result in damage.
  - 2) Vanity Sinks Low Water Pressure/Volume - Low water pressure/volume was observed at both vanity sink faucets and in the shower. This can limit use.
  - 3) Vanity Sink Drain Stops Not Installed - Both vanity sink drain stops are not installed in the waste drain opening and the sink basin cannot hold water.
- Have a professional plumbing contractor evaluate the bathrooms and repair / replace as necessary.

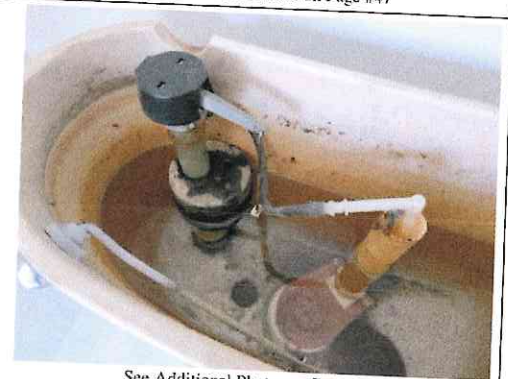
30. Needs Repair: Toilet - Adverse Conditions Present -
- 1) Bathroom Toilet Water Running - The bathroom toilet runs intermittently/continuously. This can result in wasted water and increased utility costs. The inspector turned the toilet water valve off after inspecting in order to conserve water.
  - 2) The toilet seat is broken. This can cause personal injury. Recommend replacement.
- Recommend having a professional plumbing contractor evaluate the bathrooms and repair / replace as necessary.

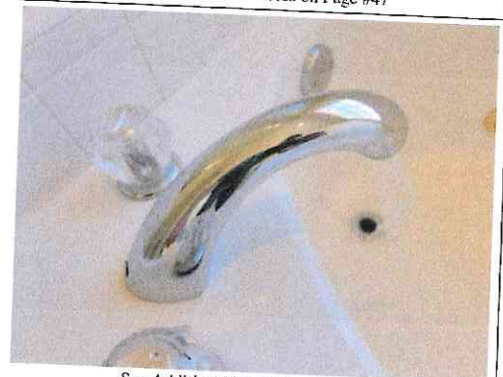
31. Needs Repair: Bathtub - Adverse Conditions Present -
- 1) The bathtub water spout is very loosely secured to the bathtub. This can damage the plumbing to the water spout.
  - 2) Bathtub Waste Drain Stop Not Installed - The bathroom tub/shower drain stop is not installed at the waste drain opening. This will prevent the tub from holding water.
  - 3) Openings In Tub Sealant - The union of the tub and tile walls need preventative maintenance (sealant) applied. Openings in the grout/caulking around the tub should be maintained sealed using an appropriate sealant. Gaps at this location can allow water to intrude under the tub and cause damage over time. Have a professional contractor fully evaluate the bathtub and make any necessary repairs to prevent possible leaking.

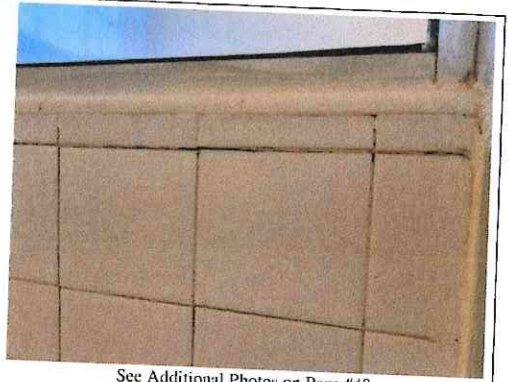
32. Needs Repair: Shower - Adverse Conditions Present -  
Gaps In Shower Sealant - The shower tile floor and walls need grout / sealant applied between all of the tiles. Cracks in the grout/caulking between the tiles should be maintained sealed using an appropriate sealant. Gaps in the shower can allow water to intrude under the shower and cause damage over time. Have a professional contractor fully evaluate the shower and make any necessary repairs to prevent possible leaking.  
2) Low Water Pressure/Volume - Low water pressure/volume was observed from the shower head. This can limit use.  
3) Loose Shower Head Plumbing - The shower head plumbing is loose in the shower wall. Loose fixtures can result in damage to the plumbing inside the wall and/or leaking.  
Have a professional plumbing contractor evaluate the bathrooms and repair / replace as necessary.

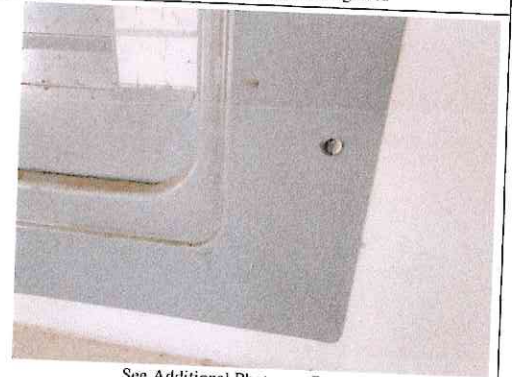
33. Needs Repair: Main Electrical Panel - Cover Panel Missing Screws -  
The main electrical panel cover is missing one of the six screws required to secure the interior cover and the screws currently being used have pointed tips. This can allow access into the panel. Have a professional electrical contractor replace missing hardware with the proper "flat" tipped machine screws due to personal safety concerns.

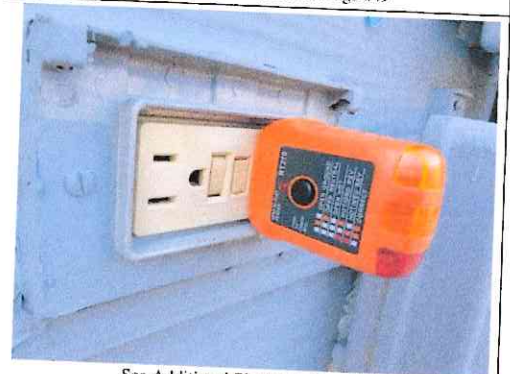
34. Needs Repair: Ground Fault Protection - Broken GFCI / Not Resetting -  
Ground fault circuits, where present and accessible, were tested by simulating a fault. The exterior outlets were observed having no power supplied to them. The GFCI outlet installed above the rear deck is broken and doesn't reset. This prevents the entire exterior outlet circuit to have no power. This condition can be due to a defective interrupter device, to a short in the electrical circuit or just that the interrupter does not have power supplied to it. Have a professional electrical contractor service this ground fault circuit so that proper operation is known to be being provided.

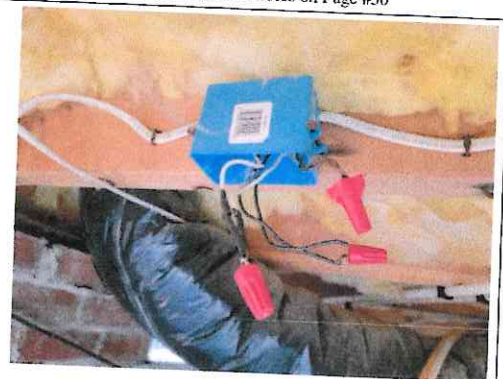
35. Needs Repair: Electrical Wiring - Open Electrical Junction Box -  
Observed one open junction box in the crawlspace. Open junction boxes expose wire connections that can be an electrical hazard. Recommend that a professional electrical contractor provide proper covers for any uncovered junction boxes throughout the home.

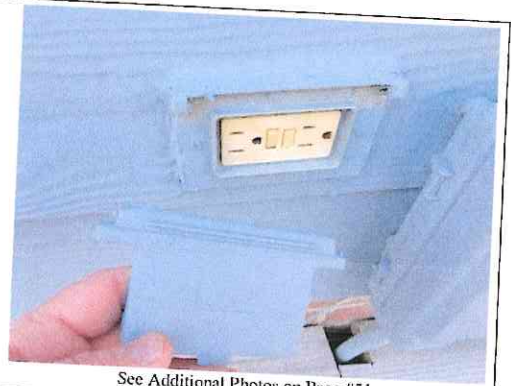
**36. Needs Repair: Outlets - Exterior Outlet Cover Damaged/Missing -**

One exterior electrical outlet at the rear of the house above the deck is not properly covered. All exterior outlets should have waterproof covers installed on them in order to prevent moisture from causing ground fault circuits to trip and provide protection for personal safety when not in use. Have a professional electrical contractor make the necessary repairs.

2) Loose Outlet - One exterior outlet next to the front door is loosely secured to the wall. Outlets will continue to become looser due to frequent use and is typically caused by removal of electrical appliances by simply pulling the electrical cords from the wall receptacle. Loose wall outlets present a safety concern due to a possible shock hazard. Loose outlets may not be restricted to locations noted in the report. Have a professional electrical contractor properly check and secure all outlets so that safe operation conditions are ensured of being provided.

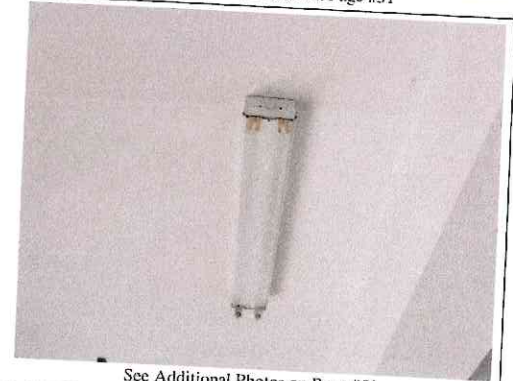
**37. Needs Repair: Lighting, Fans & Switches - Adverse Conditions Present -**

1) Lights Not Operating - The garage ceiling light fixture and the laundry room light fixture were not operating when tested. This will prevent proper lighting when needed. Have a professional electrical contractor evaluate the light fixtures throughout the home and make the necessary repairs to ensure proper operation.

2) Unbalanced Fan - The master bedroom ceiling fan wobbles when on. Unbalanced fans can cause damage to the internal components of the fan, or at a minimum create an unpleasant noise when on. Recommend that a professional electrical contractor make the necessary repairs to properly balance the fan.

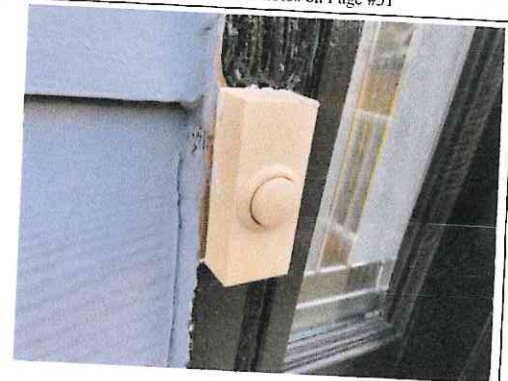
**38. Needs Repair: Doorbell - Not Operating -**

The front entrance door bell was not working at the time of the inspection. Have a professional electrical contractor service this door announcement system so that proper operation is provided when used.

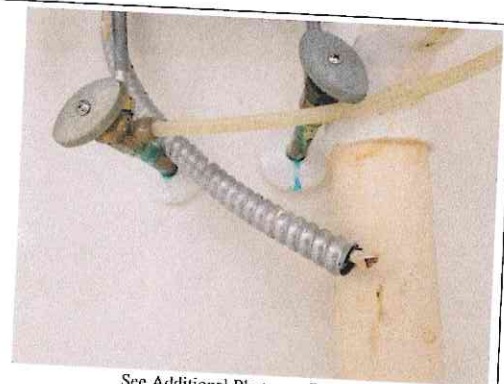
**39. Needs Repair: Electrical Wiring - Cut Wires / Exposed Electrical Wires -**

Observed wires under the kitchen sink cabinet that have been cut and are not contained in a junction box. The wires are assumed to serve a previous garbage disposal. It was not determined if the wires were live, but they were, and should be, treated as such. Loose electrical wires are an electrical hazard / personal safety hazard. Have a professional electrical contractor evaluate and properly terminate the loose electrical wires inside a covered junction box and/or remove the wires.

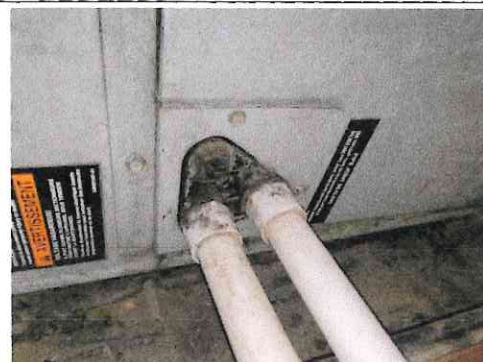
### 40. Needs Repair: HVAC Unit - Condensate Port Not Sealed -

The condensate ports are not sealed at the penetration to the air handler at the HVAC system. Air loss is occurring as a result at this penetration. Openings in the closed air duct system can have an adverse effect on the overall performance of the system. Recommend having a professional HVAC contractor evaluate the HVAC unit installation and make any necessary repairs for long term serviceability.

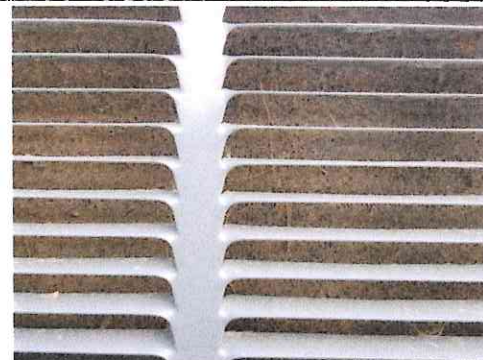
41. Needs Repair: A/C - Dirty Condensing Coil - The condensing coil (coil in the outside unit) is restricted from full air flow through it due to a build-up of any/all of the following items, dirt, landscape mulch, pet hair and/or grass clippings. Even though this system is operating within normal operating parameters (lower but acceptable), a professional HVAC contractor needs to properly clean this coil in order to remove any build-up that is restricting air flow through it in order to maximize operating performance efficiency in the system.

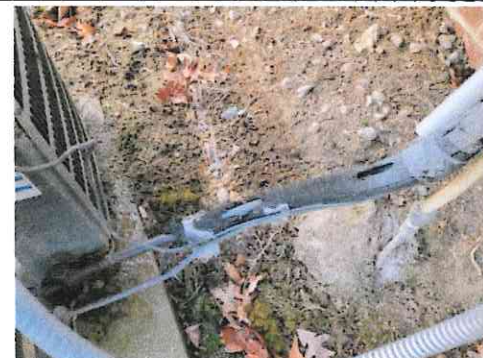
### 42. Needs Repair: A/C - Torn, Deteriorated, and/or Missing Refrigerant Line Insulation -

Observed torn, deteriorated and/or missing insulation on the high pressure refrigerant line between the foundation wall and the outside A/C unit. Insulation that is not fully covering the freon lines can have an adverse effect on the overall performance of the system. Recommend having a professional HVAC contractor replace damaged insulation on the freon line at this location.

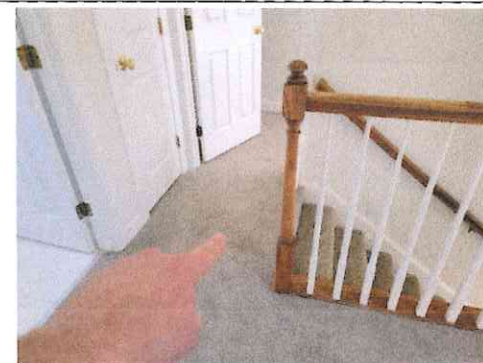
### 43. Needs Repair: Flooring - Adverse Conditions Present -

1) Floor Squeaking - Personal property, furnishings and floor coverings prevented full inspection of some floor surfaces. Where visible, floor condition is serviceable and typical for the age of the house. Observed areas in the floor system with floor noise at the top of the stairs and in the master bedroom. This results in some minor floor deflection and/or squeaking in the floor when walked on.

2) Hardwood Darkened Stains Present - Darkened areas in the hardwood flooring were noted in the dining room. Recommend consulting current owner about any history regarding the noted staining. If no explanation can be provided, further evaluation is recommended to be provided by a qualified contractor.

3) Observed damage / tears in the vinyl flooring in the master bathroom.

Recommend having a professional flooring contractor evaluate all of the floors and repair / replace as necessary.

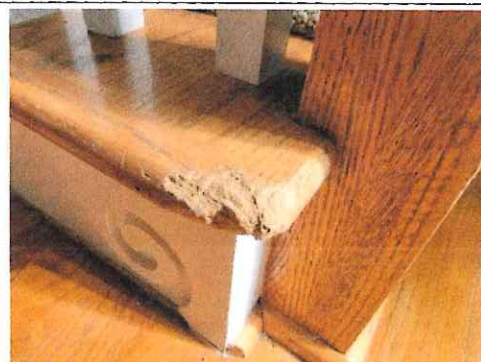
#### 44. Needs Repair: Steps & Stairways - Damaged Step -

Observed a damaged corner on the 1st step of the stairs. The damage appears to be from a dog chewing on the wood step. Recommend having a professional contractor evaluate the steps & stairways and repair / replace as necessary.

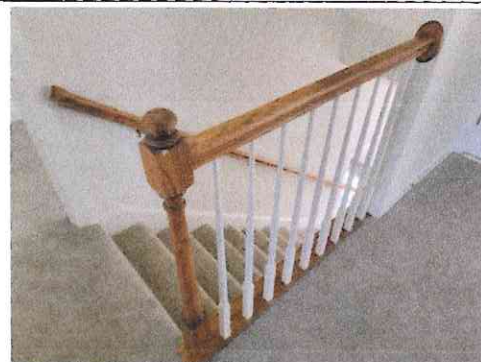
#### 45. Needs Repair: Interior Railings - Loose Handrails -

The upper stair handrail and the lower handrail leading to the attic are loose and need to be properly secured. Rails provide a sense of security/protection from falling when present. Loose rails currently present may give out if any pressure is applied to them. Have a professional contractor properly secure the rails so that proper support is provided if leaned on. Suggestion: Spindle rail spacing on interior balcony rail system is compliant with requirements at the time of original construction, but may be a hazard for children. Caution is advised when children are present. The current standard is 3 1/2" between spindles. Suggest improvements be made so that current safety requirements are provided.

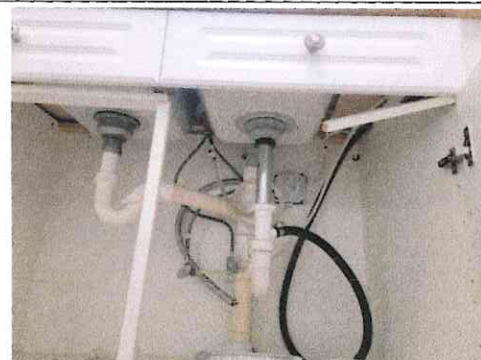
#### 46. Needs Repair: Counters and Cabinets - Damaged Kitchen Cabinet -

- 1) The frame components under the kitchen sink cabinet are broken.
- 2) Previous leaking at the kitchen sink has resulted in damage to the base of the cabinet under the sink. Damaged cabinets can limit usage.

Recommend that a professional contractor evaluate the cabinet and make the necessary repairs to ensure long term serviceability.

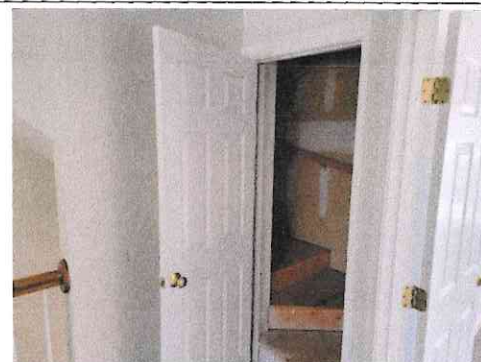
#### 47. Needs Repair: Interior Doors - Adverse Conditions Present -

- 2) The smaller attic access door panels are loosely secured to the wall. Only one of the two screws is engaging into wood.

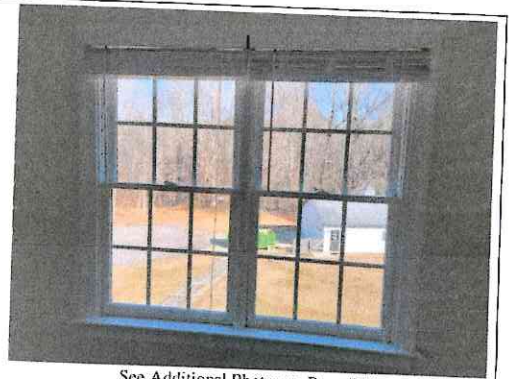
48. Needs Repair: Windows - Windows Difficult to Open - Observed many of the wood double hung windows that are hard to open/would not open (most likely from inactive use over long periods of time and/or repainting of the interior trim that has bonded sashes to the side valances) at some of the lower sashes and at many of the upper sashes. Have a professional window installation/repair contractor service/check all windows for proper/smooth operation when using and make any repairs necessary for proper operation. At a minimum, due to concerns for personal safety, at least one designated window in every bedroom needs to be assured of operating freely so that emergency egress is known to be provided.

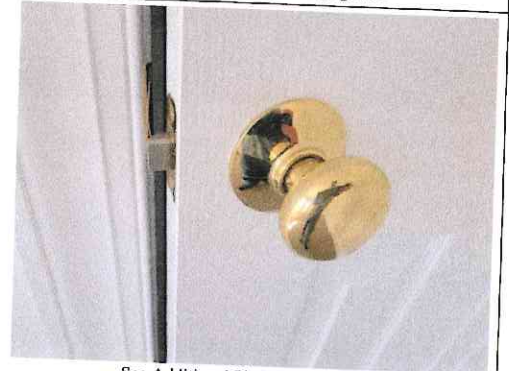
49. Needs Repair: Interior Doors - Adverse Conditions Present -  
1) Doors Not Latching - The 2nd floor front middle bedroom closet door will not latch properly when closed. Doors that do not latch properly cannot be properly secured.  
2) Doors Rub - The dining room door rubs the jamb when operated. This restriction prevents the door from closing properly.  
Have a professional interior trim contractor evaluate all of the doors throughout the home and make any necessary repairs to allow for proper operation.

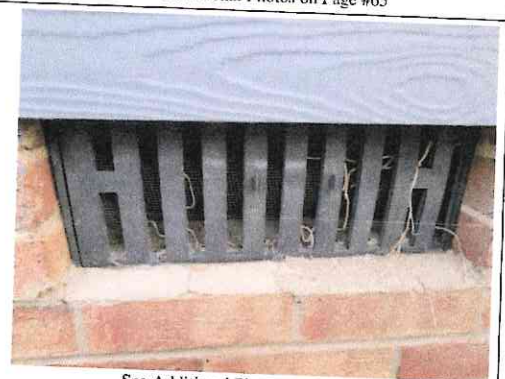
50. Needs Repair: Crawlspace Ventilation - Adverse Conditions Present -  
1) Foundation Vents Not Operating Properly - All of the foundation vents that the inspector tried to open would not open or close. This will prevent operation of the vents.  
2) Compromised Vent Locations - One foundation vent at the right side of the house has been compromised by using the vents for dish antenna cables. When vents are used for other applications, function of the vents and the venting of the crawlspace can be compromised which can result in higher moisture levels inside the foundation.  
Have a professional contractor evaluate all of the foundation vents and make any necessary repairs for proper operation of the crawlspace vents.
