Derek Harwood, PE  
Stonewall Structural Engineering, PLLC  
9203 Baileywick Rd. #200  
Raleigh, NC 27615  
(919) 407-8663

Re: Review of Proposed Foundation Repair — 100 Hawksbill Drive, Franklinton, NC 27525

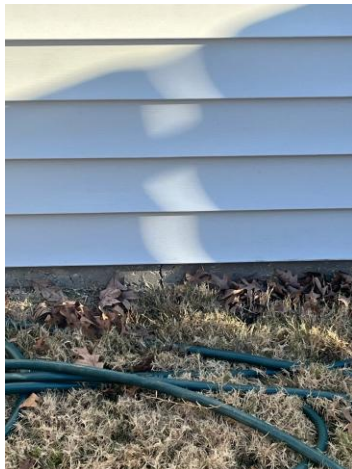
1. Foundation cracks were reported on the left and right side of the home (*see pictures 3-4*).
  - a. Measurement reported that the front left corner of the garage was down as much as approximately 1 ¼" relative to the back left corner of the home.
  - b. Measurement reported that the front right corner of the home was down as much as approximately 1" relative to the back right corner of the home.

Picture 3 – Foundation crack

The above-noted slab cracks have been the result of minor differential settlement of the interior slab which can be accelerated by inadequate management of rainwater runoff around the perimeter of a home. Soils in this area tend to expand when wetted and contract when dried. These cycles of minor movements can cause short term cosmetic damage and long-term structural damage to occur in rigid slabs which can settle into areas around the perimeter of the home which stay wetter than other portions of a structure.

**Based on our review of the information provided, the proposed foundation repair is recommended to be installed as follows (*see detail 1*):**

1. Install a series of (8) galvanized steel helical piers and (4) galvanized steel push piers to stabilize the left and right sides of the home against additional differential settlement.
  - a. Helical piers should be installed to a torque capable of developing 20 kips of allowable axial load (40 kips ultimate), or to refusal. Push piers should be driven until engagement of the structure with lift indicating adequate depth/frictional resistance.
  - b. The contractor should locate and avoid utilities prior to work.
  - c. Avoid installing piers beneath windows and doors.
  - d. Install piers at approximately 6' on-center and at the approximate locations shown in the attached repair schematic.

- e. Piers should be installed concentrically below the bearing foundation. This may require chipping the existing footing projection, so the pier bracket is flush with the side of the foundation.

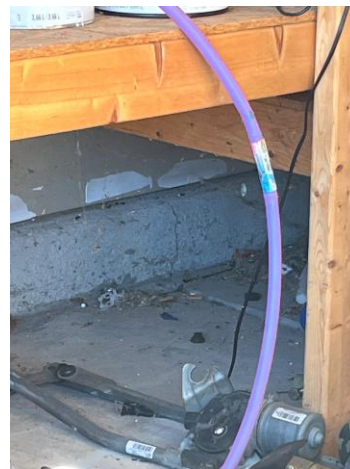
Picture 4 – Foundation crack
