# Septic System Inspection Report

Client Name JEFF GARDNER  
Prop. Addr. 154 HOYLE LN  
HENDERSON, NC 27537  
Email Address [gardnerls@yahoo.com](mailto:gardnerls@yahoo.com)  
Phone No 919 625 7053  
Agent Name HOUSEMASTER- GARRETT DALY

Date / Time of Inspection: 05/09/2024

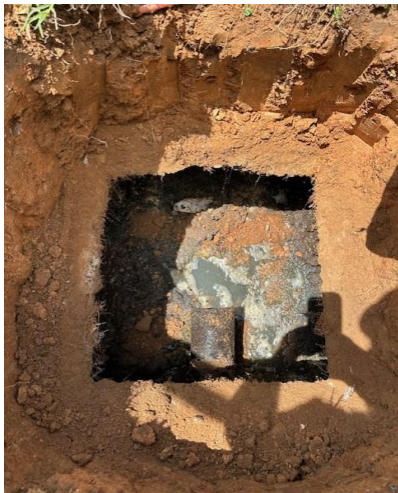
INLET TANK

Yes   X   No        Incon.        Scum and sludge layer measurements were taken. Inlet: Scum   5   In. Sludge  13  In.  
Outlet: Scum   2   In. Sludge 20+ In.

**NON BAFFLE TANK**

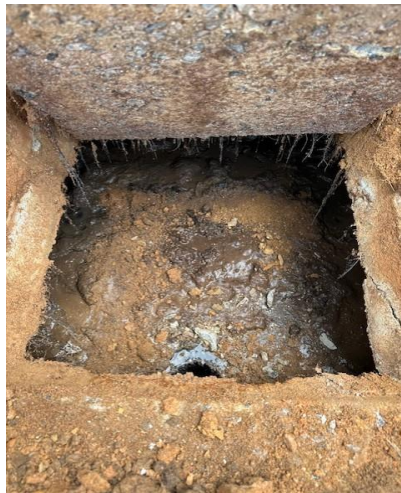
OUTLET TANK

Comments / Condition: **PVC TEE AND FILTER ARE IN GOOD CONDITION**

Comments: **WATER LEVEL IN TANK IS NORMAL**

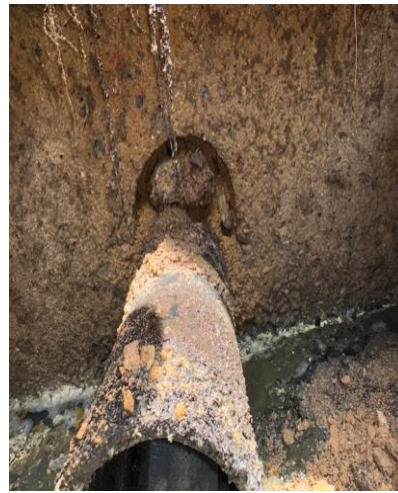
**2" HOLE FOUND AROUND INLET PIPE**

2" HOLE AROUND INLET PIPE

| <b>WE RECOMMEND CONTACTING A REPAIR PROFESSIONAL TO PATCH THE 2" HOLE AROUND THE INLET PIPE</b> | | |

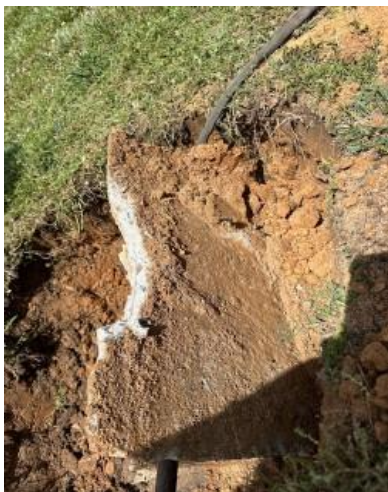
Condition of Septic Tank Lids **BOTH SEPTIC TANK LIDS ARE DETERIORATED AND HAVE BROKEN HANDLES**

DAMAGED OUTLET LID

| <b>WE RECOMMEND CONTACTING A REPAIR PROFESSIONAL TO REPLACE BOTH DAMAGED SEPTIC TANK LIDS</b> | | |

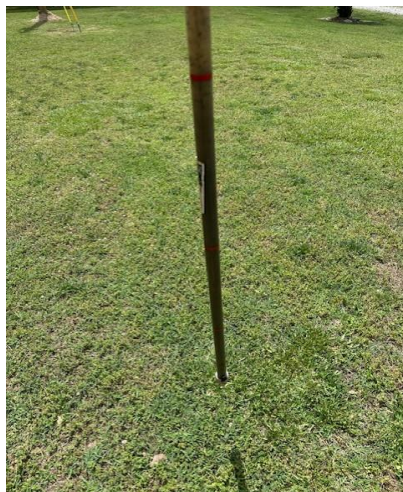
Comments: **SOLID LEVELS INDICATE TANK PUMPING IS RECOMMENDED AT THIS TIME**

OUTLET SLUDGE LEVEL

| <b>SOLID LEVELS INDICATE TANK PUMPING IS RECOMMENDED AT THIS TIME</b> | | |

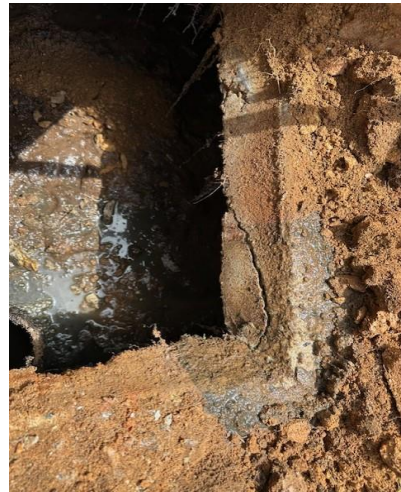
Comments: **7" CRACK FOUND ON OUTLET SIDE OF TANK**

CRACK ON OUTLET TANK

| <b>FURTHER EVALUATION OF THE 7" CRACK FOUND ON THE OUTLET SIDE OF TANK</b> | | |
| <b>IF THE CRACK IS REPAIRABLE PATCH WITH HYDRAULIC CEMENT</b> | | |

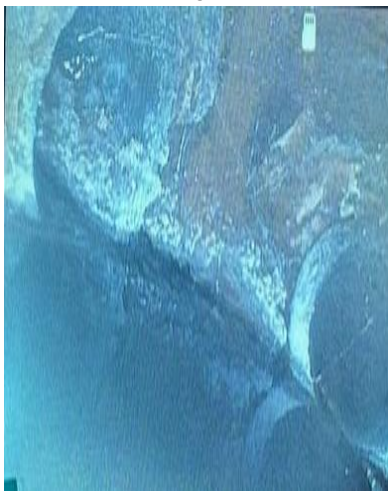
Comments: **DBOX IS DETERIORATED AND NEEDS TO BE REPLACED**

Comments: **FLOW IS NOT SPLIT EVENLY**

| <b>D BOX WAS FLOW TESTED HOWEVER DETERIORATION WAS FOUND INSIDE</b> | | |

| <b>CONSIDERATION SHOULD BE GIVEN TO REPLACING THE DBOX AND ADDING SPEED LEVELERS</b> | | |
| <b>TO ASSIST WITH EQUAL FLOW</b> | | |

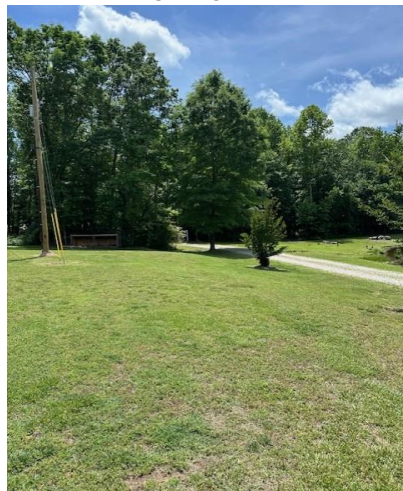
| <b>TREES IN THE VICINITY OF THE SEPTIC FIELD MAY CAUSE ROOT BLOCKAGE</b> | | |
