## SUMMARY

1315 Alpha Rd, Henderson, NC 27536

Evangeline Mitchell  
09/25/2025

Michael Eldredge  
NC HI Lic# 3527  
Eldredge Home Inspection  
9198303588  
meldredge1@gmail.com

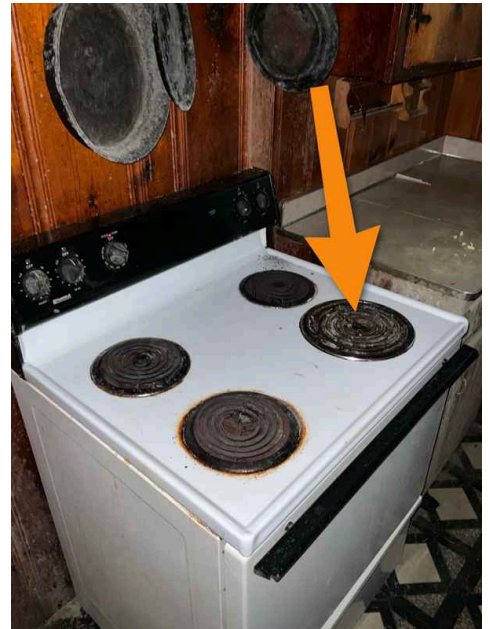
### **BURNER WAS NOT FUNCTIONAL**

The burner(s) described in the photographs did not function. An appliance repair person should be consulted to evaluate the function of the stove.

See description for this finding.

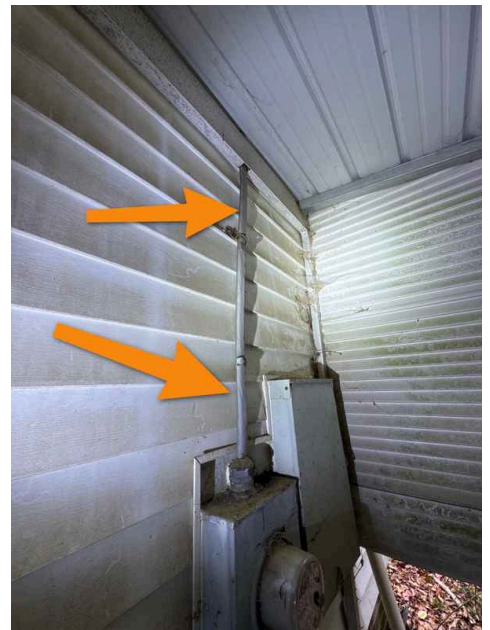
This condition presents a safety hazard that could result in serious personal injury and or property damage. A licensed electrical contractor should be consulted for repair and a complete evaluation of the electrical system.

High voltage wiring coming directly from the power company is always encased in non-conductive conduit because of the danger of this type of wiring. See description for this finding.

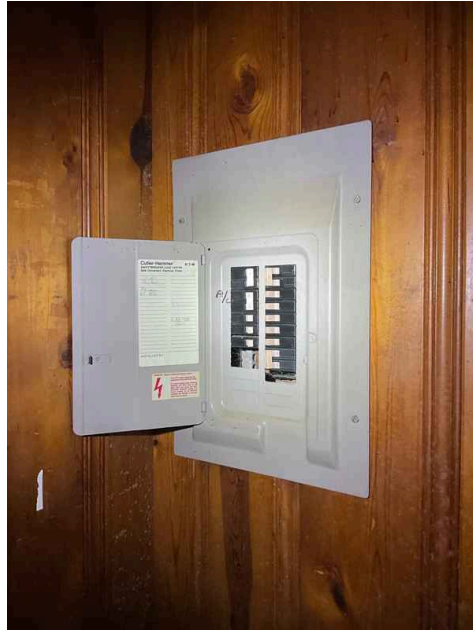
Similar findings were found here in the kitchen for the majority of the breakers.

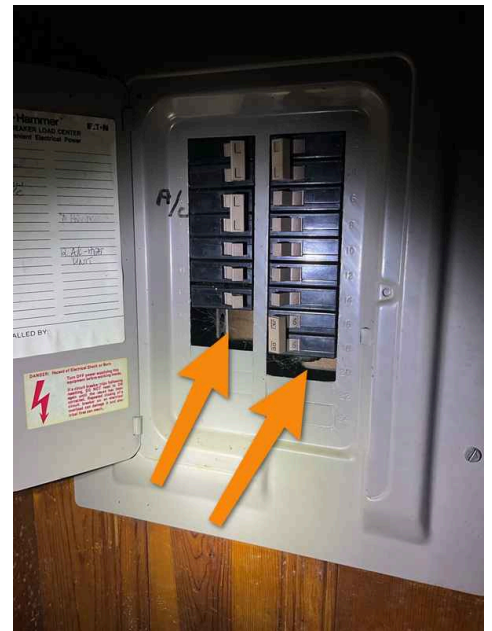
#### **KNOCK OUTS MISSING**

The electrical service panel cover is missing knock out opening plugs. The covers or plugs prevent direct contact with hot electrical circuits. This condition presents a safety hazard that could result in interrupted service and serious personal injury/death from electrocution. A licensed electrical contractor should be consulted for a complete inspection of the electrical system and for repair/replacement of the panel to ensure that it is safe and functioning properly.

See description for this finding.

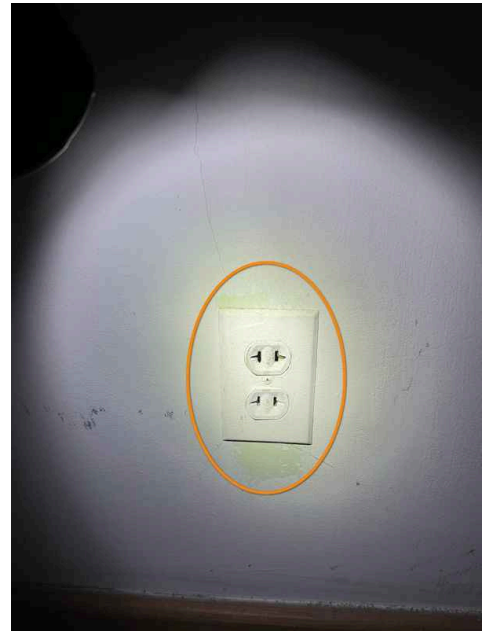
The 3 prong type receptacle(s) tested as open equipment ground. This home was built in an era where receptacles were 2 prong type without an equipment ground. An equipment ground provides an extra safety feature to prevent electrical shock hazards and property damage. Receptacles typically should not be updated to the 3 prong type without the installation of an equipment ground or GFCI protection. A licensed electrical contractor should be consulted for a complete evaluation to determine the significance of this concern and make necessary repairs to correct defects and prevent safety hazards.

See description for this finding which applies to the majority of the home.

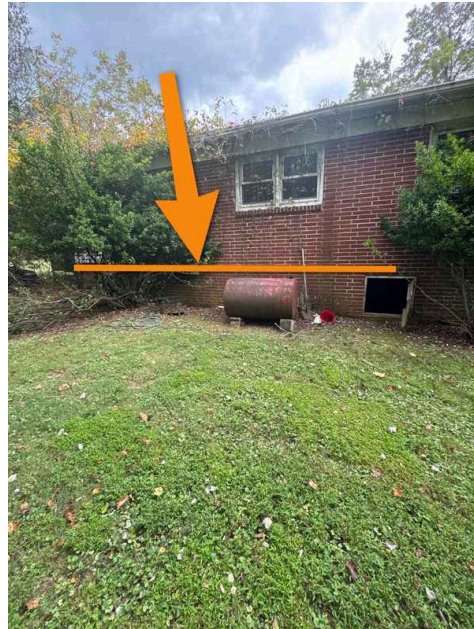
The brick veneer for this home has no visible weep system. The weep system prevents water and condensation buildup behind the brick veneer. Weep openings for homes of this era are typically installed at the foundation vent locations. A licensed general contractor should be consulted for complete evaluation to determine the significance of this concern and repair as necessary.

See description for this finding. Also, hidden damage is more likely because of the constantly overflowing gutters.

All areas of the home should be assessed for the same finding.

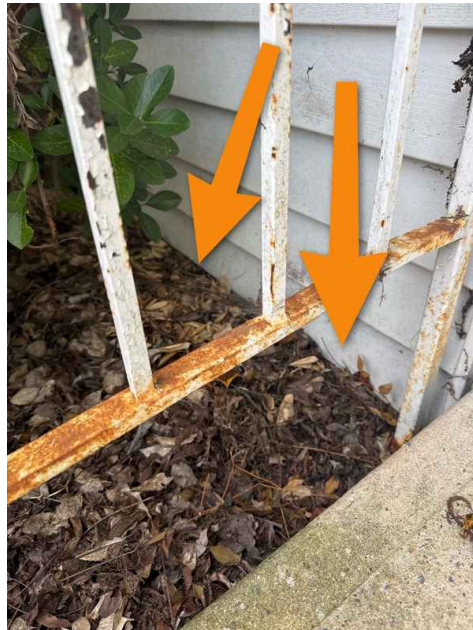
The exterior siding of the home is too close to the grade and needs repair to prevent insect and water penetration. A licensed general contractor should be consulted for a complete evaluation of the siding and to make necessary repairs. At the time of the repair, all adjacent building components should be inspected for possible evidence of water penetration and hidden damage.

The wood structure of the converted carport is below grade and very likely to be decayed.

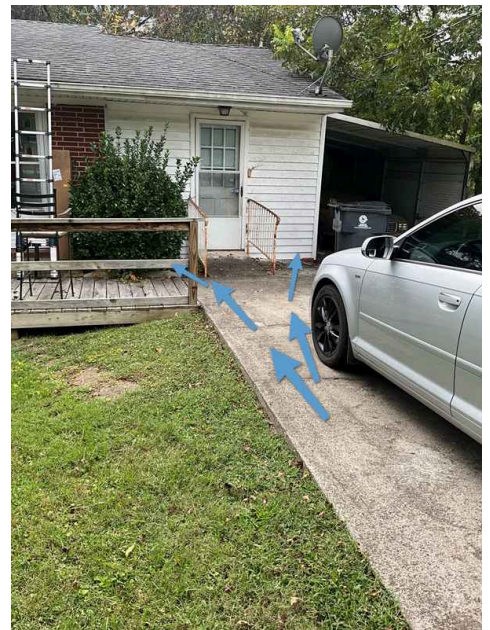
The driveway surface is sloped to encourage storm drainage back toward the home. Drainage toward the foundation and framing areas can result in damage to the siding, doors, adjacent structural components, and allow water to enter the home resulting in undesirable conditions. A licensed general contractor should be consulted for further evaluation, to determine the extent of the concern, and make necessary repairs.

See description for this finding. The structure is below grade.

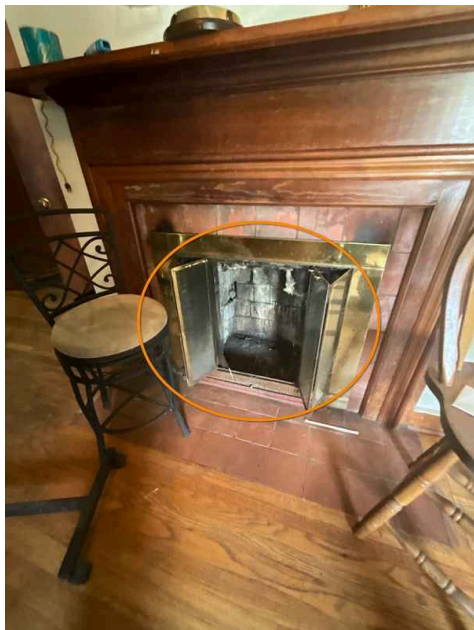
##### **FIREPLACE NEEDS REPAIR AND/OR EVALUATION**

A fireplace specialist should be consulted for the complete evaluation and repair of the fireplace.

See description and following photos. The first place is not safe for use.

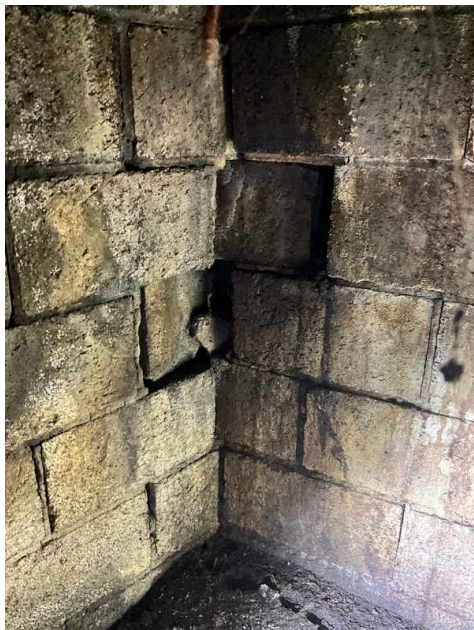
The first place is damaged. This exposes structure though to excessive heat which is a fire hazard.

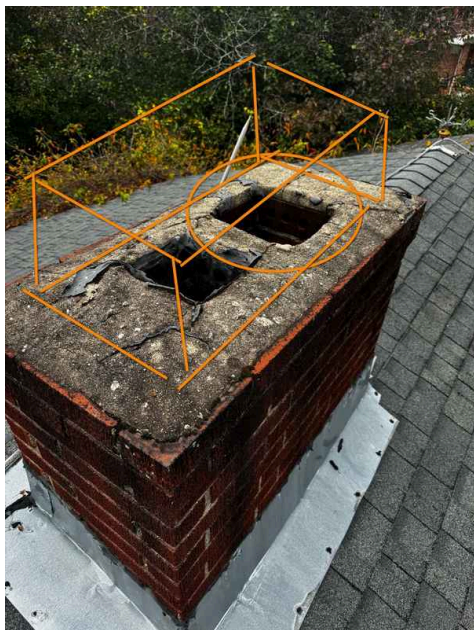
##### **SPARK ARRESTOR IS MISSING**

The spark arrestor is the screen at the top of the chimney that allows smoke and small ash passed while stopping large embers. Large embers can ignite trees etc. in the yard resulting in house fires. A chimney specialist should be consulted to repair the chimney prior to use.

Additional photo of this finding. Also the box that prevents water entry is missing.

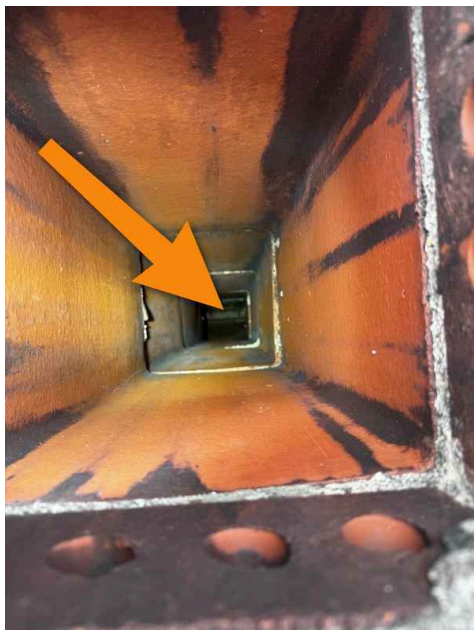
Water flows directly into the crawlspace.

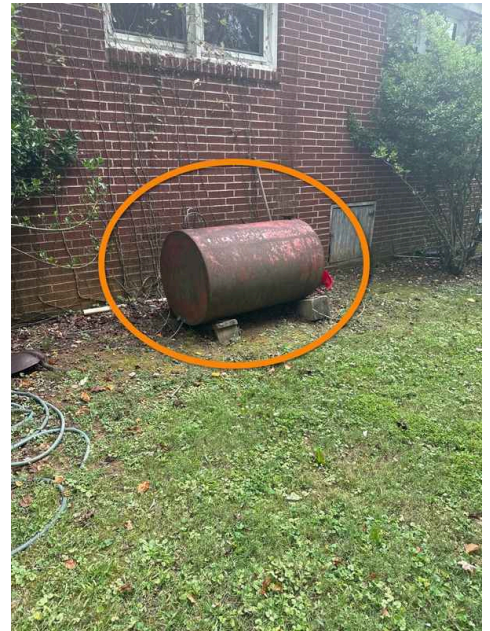
This home has an above ground oil storage tank, storage tanks are either leased from the fuel supplier or owned by the homeowner. A leaking above ground or underground oil tank can be a potential liability related to environmental contamination. Whenever an oil fuel storage system is present, the buyer should consult a licensed geologist for a complete assessment to determine the condition of the tank and if any soil contamination is present.

See description for this finding.

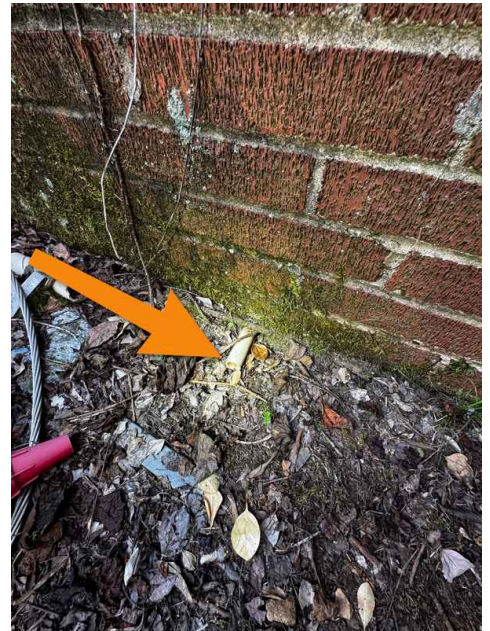
The condensate drain is too close to the foundation. The building code does not require this extension but water does often seep through the foundation from here. This can cause the soil to stay wet when the surrounding soil is dry. This wet soil expands causing a strain on the foundation system which can lead to cracking. A licensed HVAC Contractor should be consulted to extend this tubing to a proper design and length.

See description for this finding on the back middle portion of the home.

Note: the tray used at the bottom of gutter downspouts is typically effectively utilized as a repair for this finding.

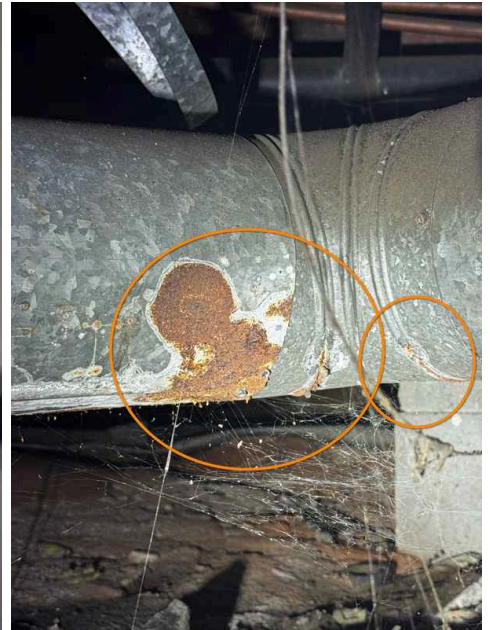
This corrosion occurs from improper draft.

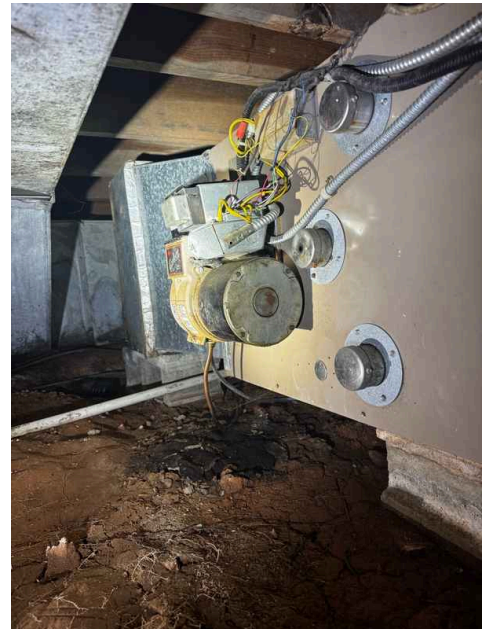
#### **HVAC CONTRACTOR EVALUATION/REPAIR IS NEEDED**

The HVAC unit should be evaluated by an HVAC contractor. The contractor should evaluate the full function of the unit and describe necessary repairs.

The furnace side was not functional.  
See flue section of the report.

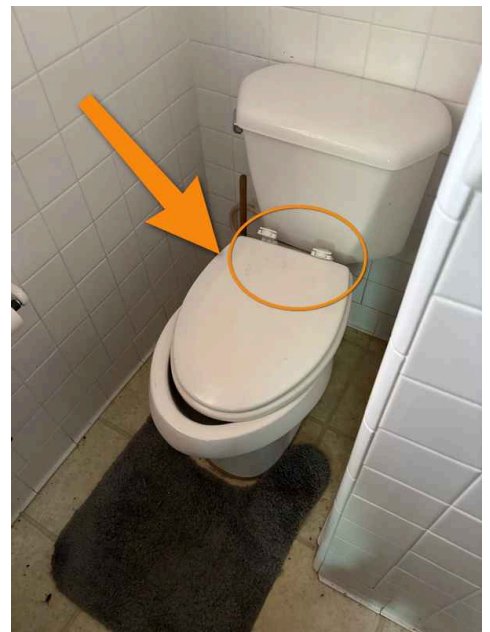
The toilet seat is not installed.

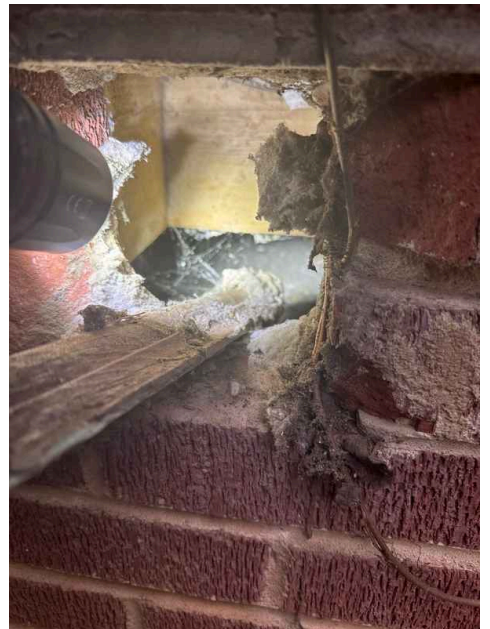
This means the hot humid air from the dryer is being directed under the carport addition.

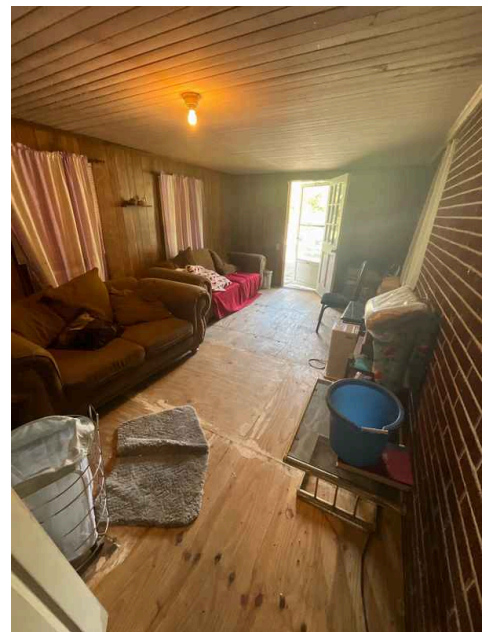
An addition was added or converted to this home. The construction for this space is not typical. It is likely that the space was not permitted. This means that defects beyond what is described here in the report are likely. The report will highlight the most significant deficiencies. As repairs are made, it is very likely that more deficiencies will be discovered. Further and further investigation is needed by a licensed general contractor.

See description for this finding. The structure of the floor is not typical. There is no climate control. There is no insulation in the floor or ceiling..

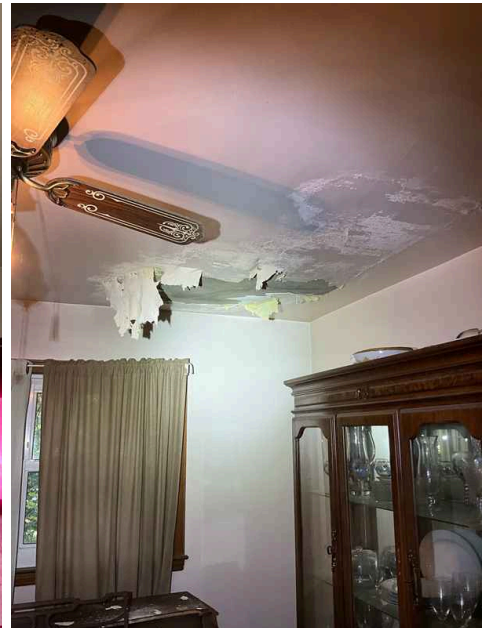
Similar findings were found here. This was a long term leak with significant damage.

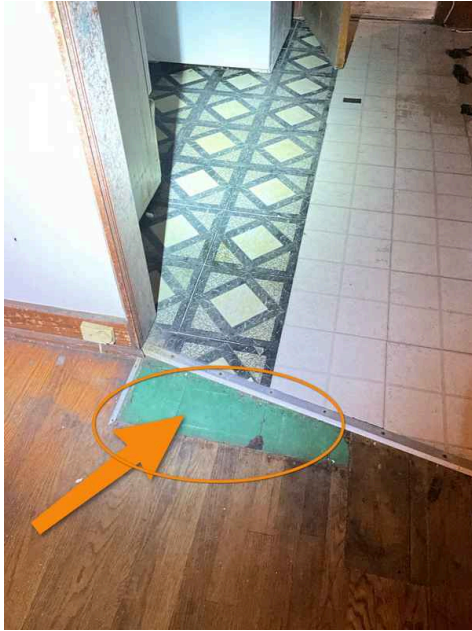
This is a material type that could be considered as a presumed asbestos containing material (PACM). Due to safety concerns this limited the inspection of all locations where the material was present. Since asbestos is an environmental and safety concern, it is recommended that an Environmental Testing company licensed for Asbestos be consulted to evaluate the significance of this concern and make recommendations for testing, removal or repairs.

The smaller 7 inch tile are typically asbestos tile.

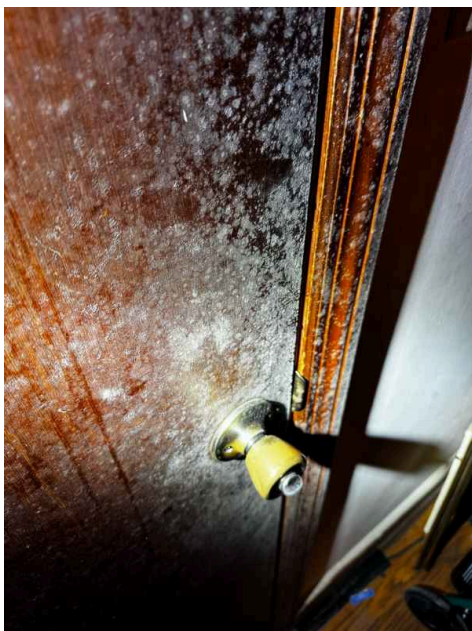
### **MOLD WAS FOUND THROUGHOUT THE HOME**

Fungal growths such as mold may possibly be present in this home based on findings described in this report. It's important to note that visible mold was not found in the living areas of this home. However, there is a history of water penetration and or condensation which can cause mold. A licensed general contractor should be consulted for a complete evaluation to determine the source of the moisture and the extent of the damage. Health related issues concerning mold are beyond the scope of the home inspection. If the buyer has additional concerns related to the presence of the fungal growths such as mold an industrial hygienist should be consulted.

See description and following photos. Mold was found on surfaces throughout the home caused by long-term leakage

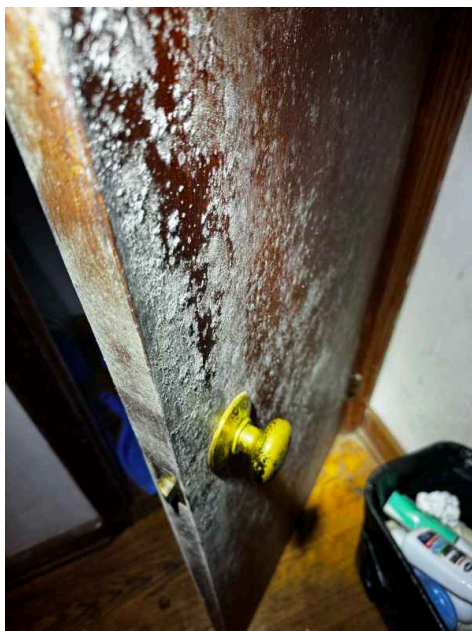
Additional photo of this finding.

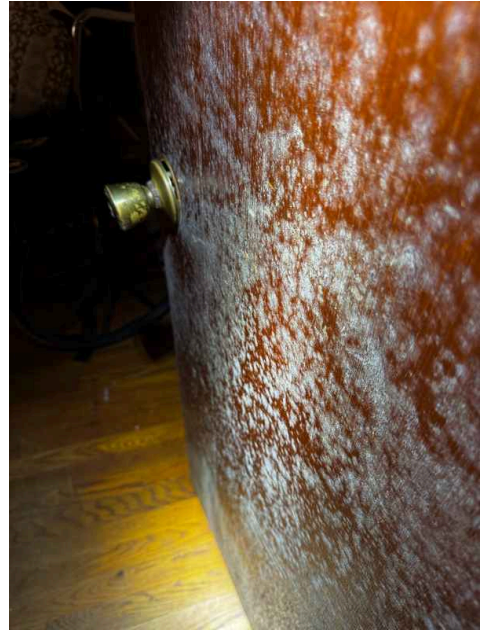
Additional photo of this finding found throughout.

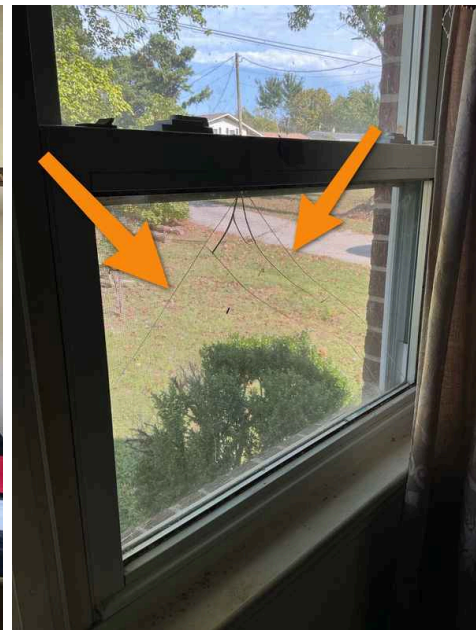
### GLASS IS BROKEN

Glass is broken. This is an important safety hazard. This glass should be replaced prior to closing.

Location of the following finding in the front left bedroom.

See description for this finding.

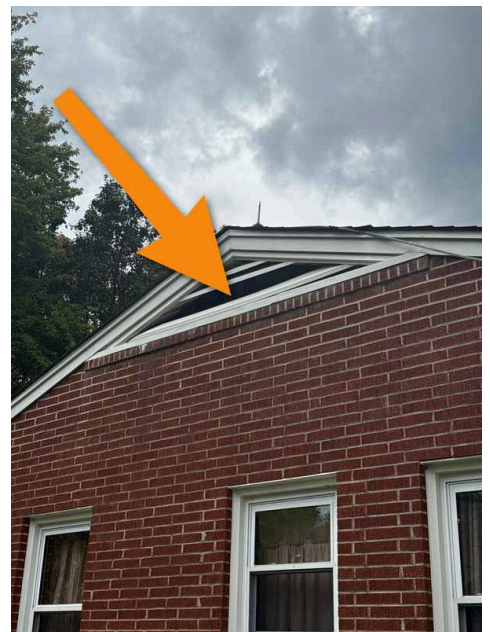
Animals can enter the attic through the opening photographed here. All repairs should be made to prevent animals from entering the attic. Animals can be dangerous and leave feces behind.

The damaged gable allows animals to enter the structure of the home.

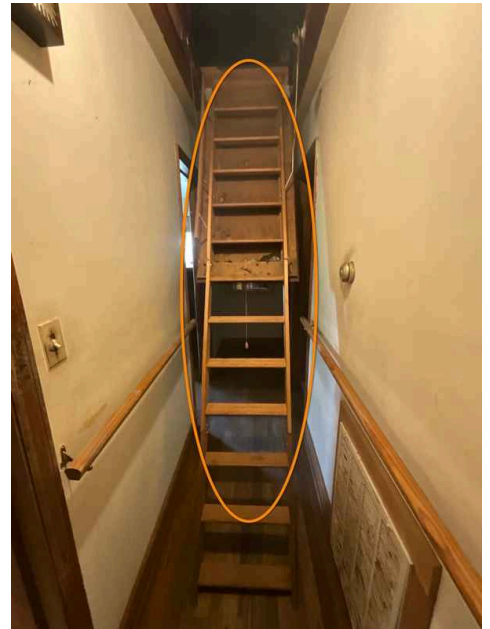
**LADDER NEEDS REPAIR**

See description for this finding. All areas of the ladder are loose and worn.

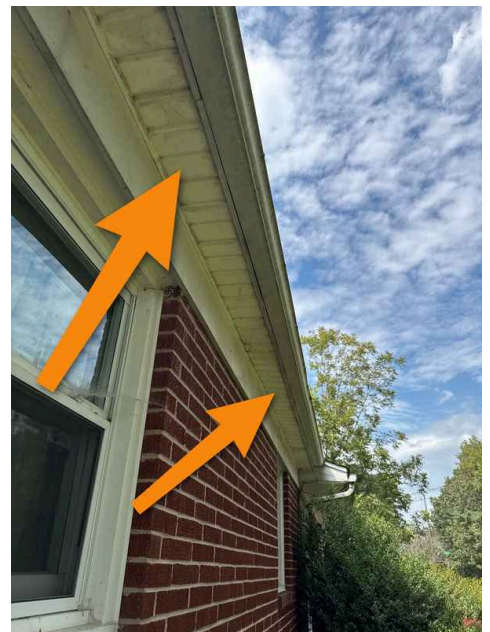
See description for this finding which applies to all areas of the home.

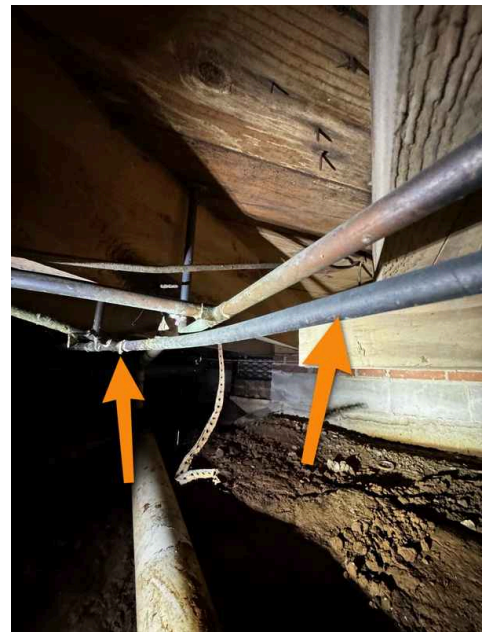
See description for this finding.

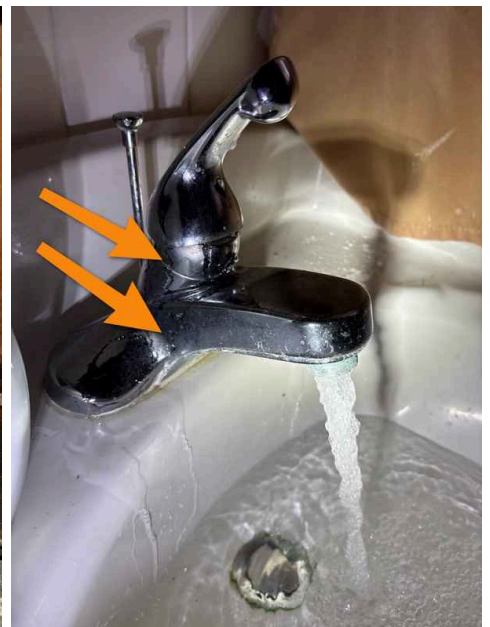
Similar findings were found here in the master bathroom.

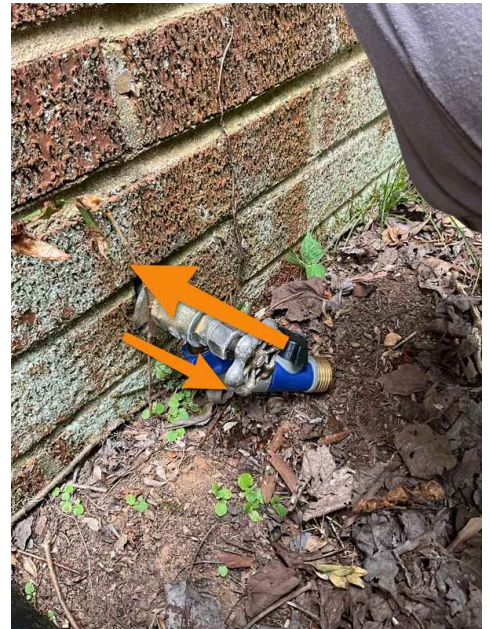
Located on the front of the home. Also the hose bib leaks.

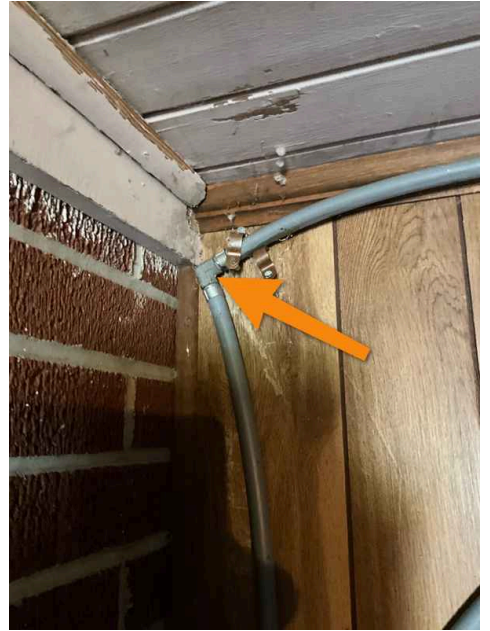
Plastic fittings found in multiple areas are more prone to burst.

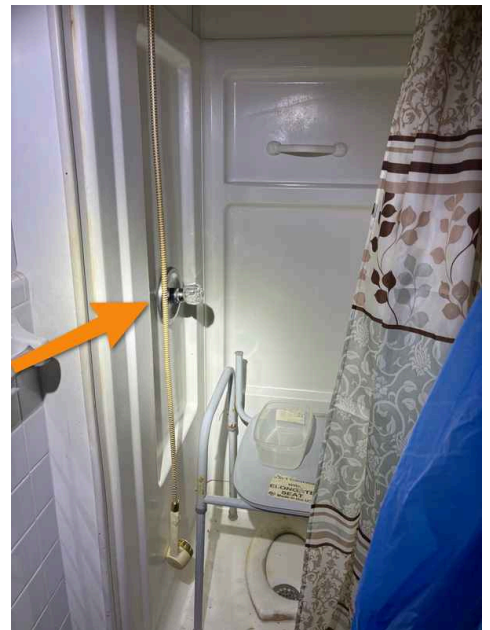
##### **PLUMBER – IS NEEDED FOR THIS REPAIR 2**

A licensed plumber should be consulted for a complete evaluation of this finding and repair to avoid leaks and property damage.

The shower faucet is not attached and not functional here in the master bathroom.

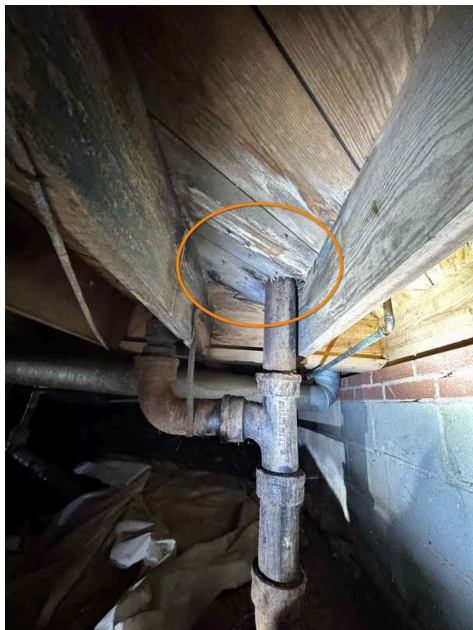
This area by the master bathroom toilet is decay. This may be coming from the toilet or the roof vent.

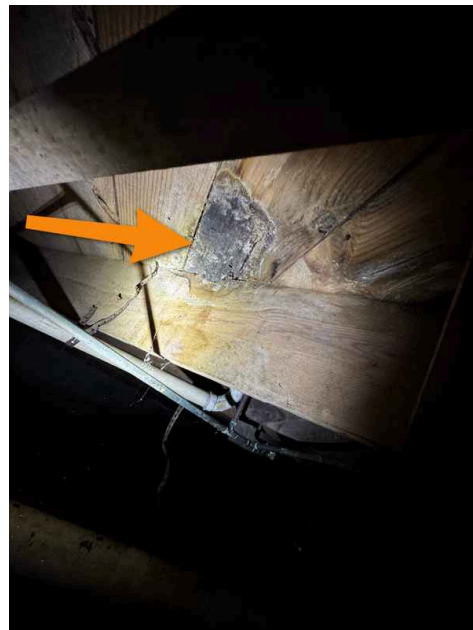
Additional photo of damage under the tub.

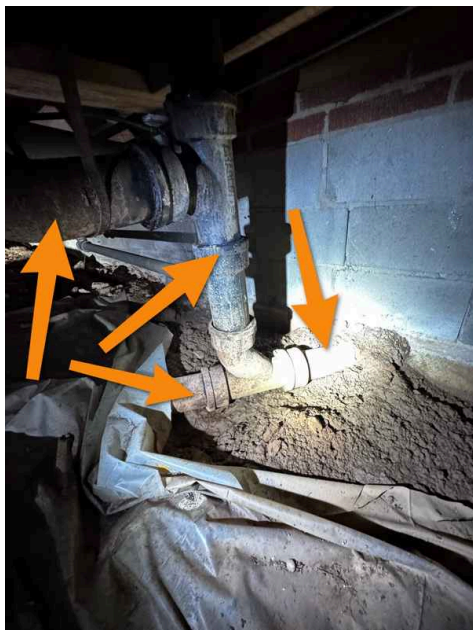
See description and following photos. This includes the pipe from the foundation to the clean outs in the yard.

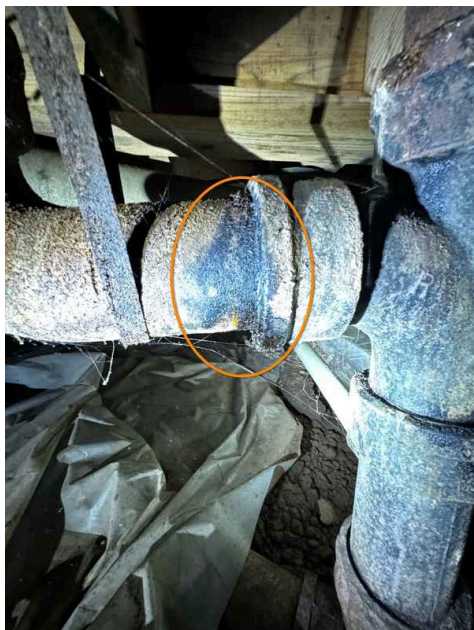
Additional photo of this finding showing leakage.

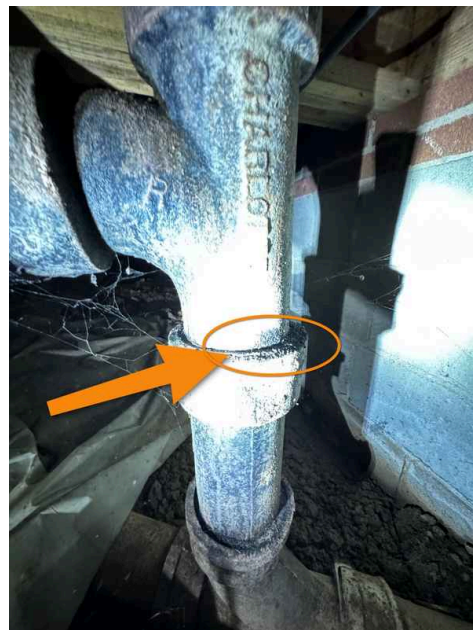
Similar findings were found here.

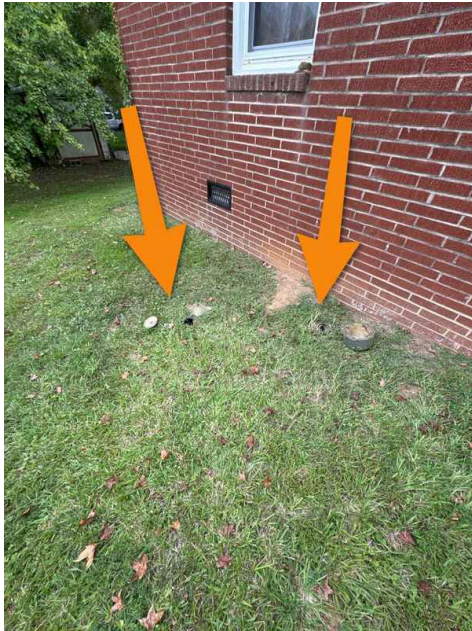
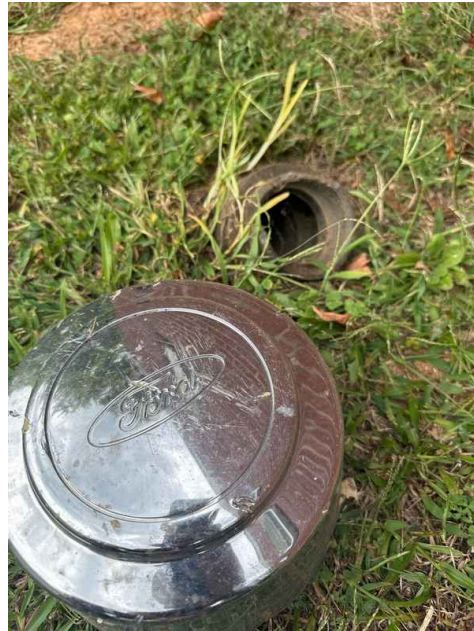
See description and following photos.

Both Plumbing fittings have damage.  
This one uses a hubcap as a cover.

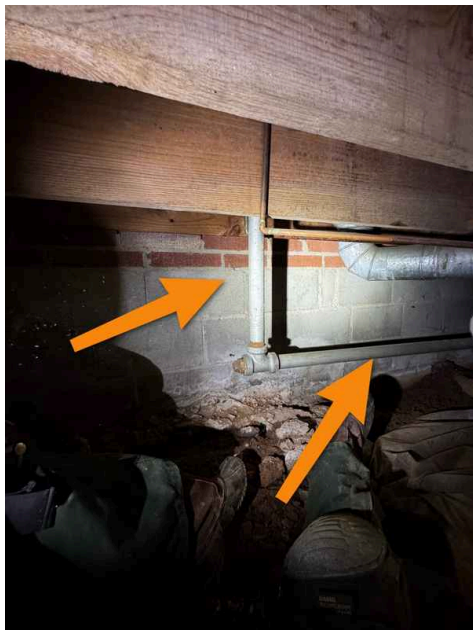
See description for this finding.

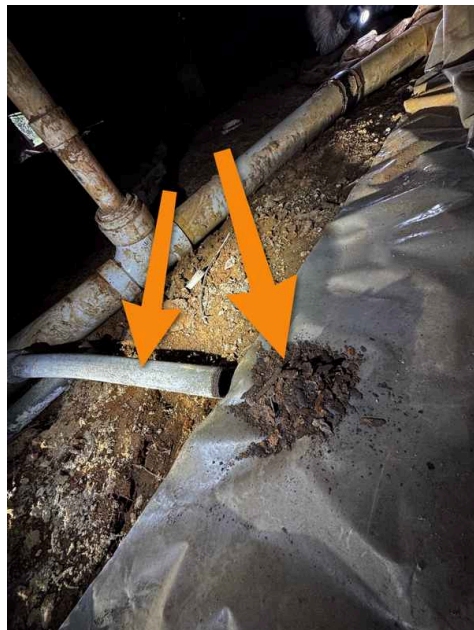
A heavily corroded galvanized pipe left over from a repair spot in the crawlspace.

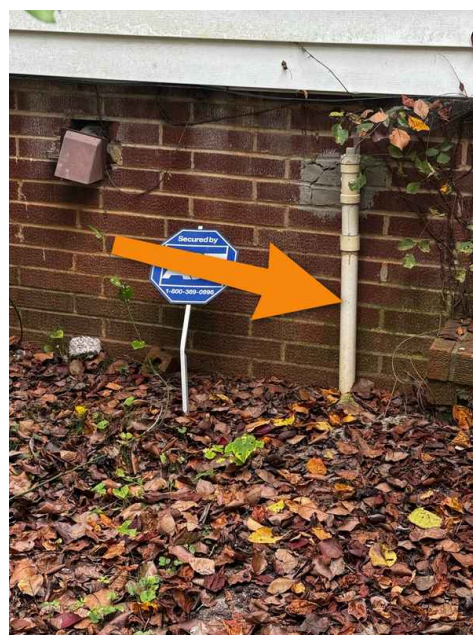
This plumbing drain on backside of home by the washer could not be confirmed for proper installation. This drain line was not connected to the main house plumbing drain system.

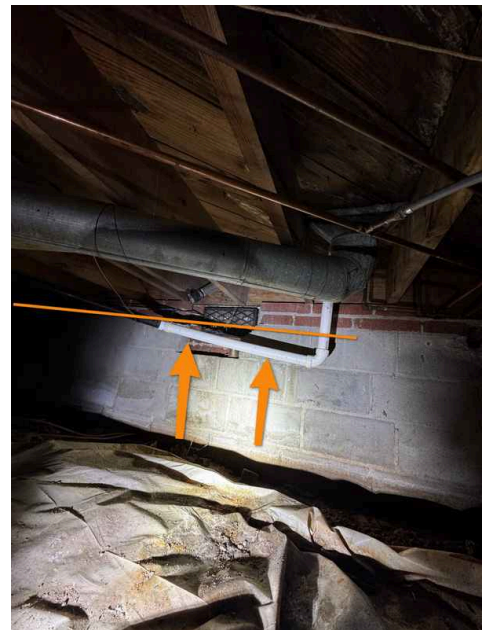
See description for this finding under the kitchen. The orange line shows the slope that the drain should make..

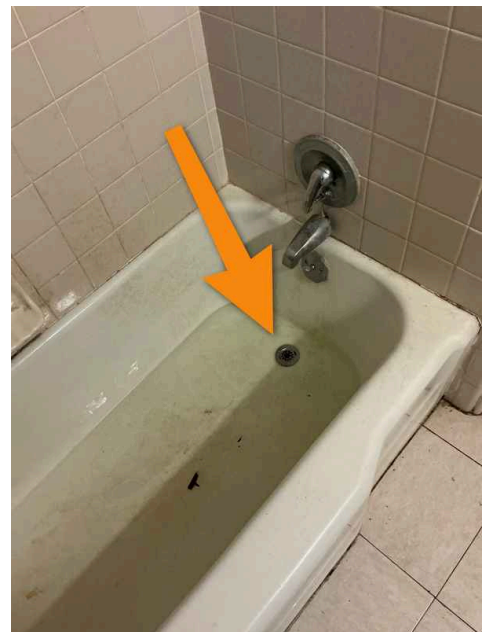
The tub located in the hallway bathroom had a very slow drain. See description for this finding.

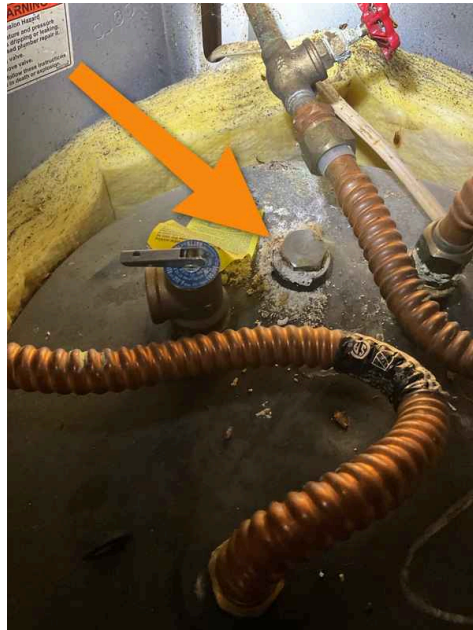
Additional photo of this finding. Corrosion is leakage.

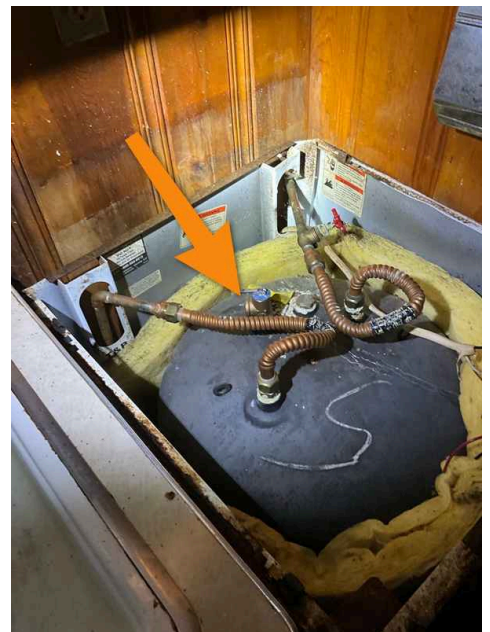
See description for this finding.

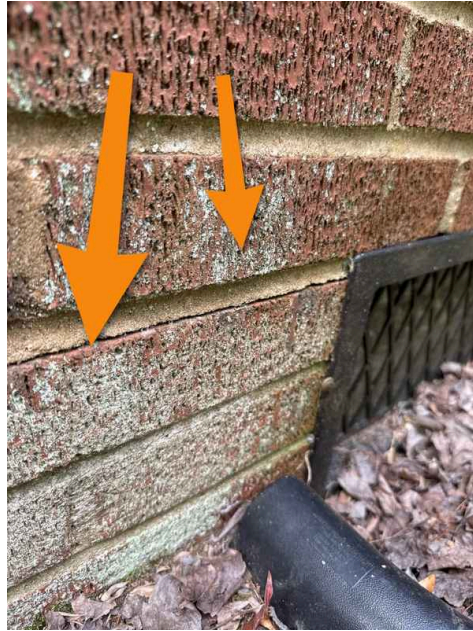
Additional photo of this finding.

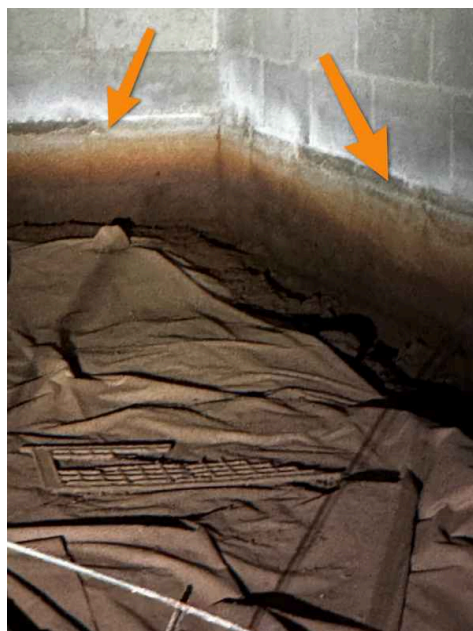
Additional photo of this finding. See gutters and grading sections of the report.

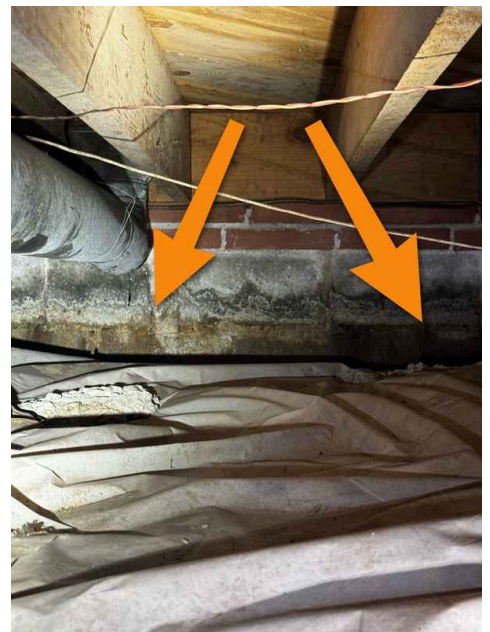
See description for this finding found across the front of the home.

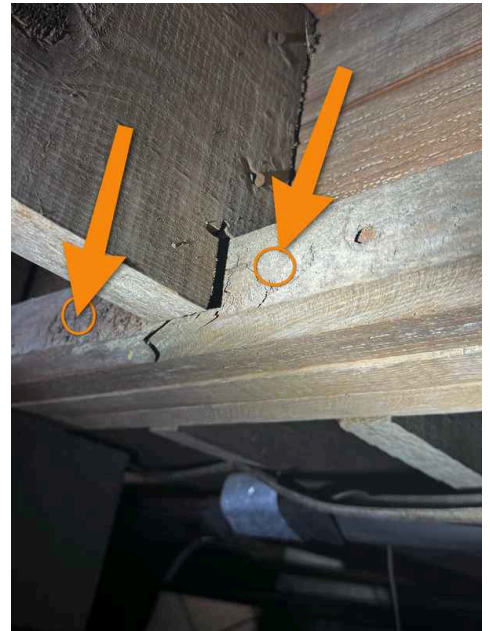
See description for this finding which applies to both sides of the main gutter across the home.

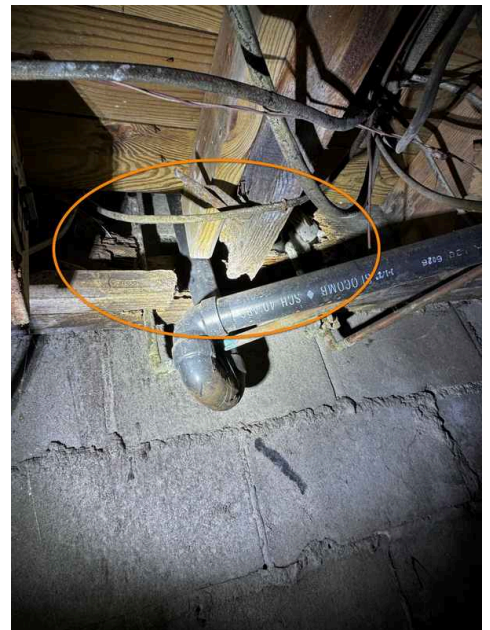
See description for this finding. Significant decay was found under the old location for the washer dryer.

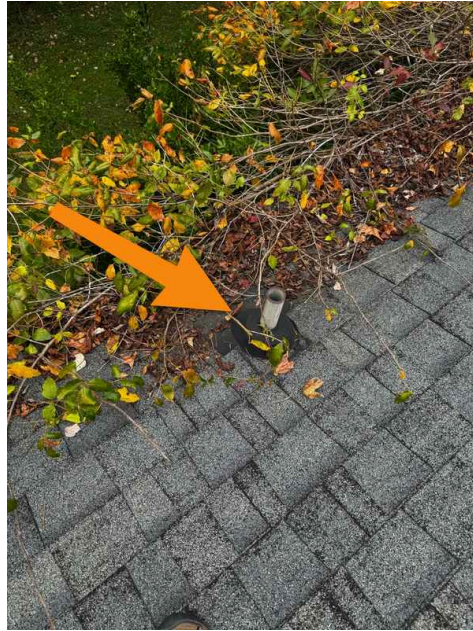
Similar findings were found here.

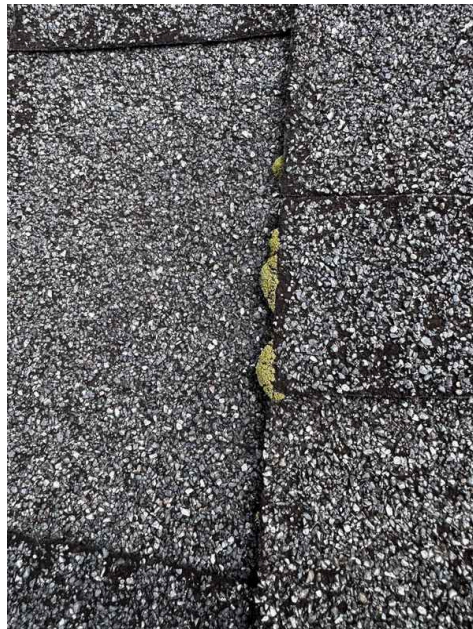
Moss was growing in many areas caused by excessive heat in the attic.

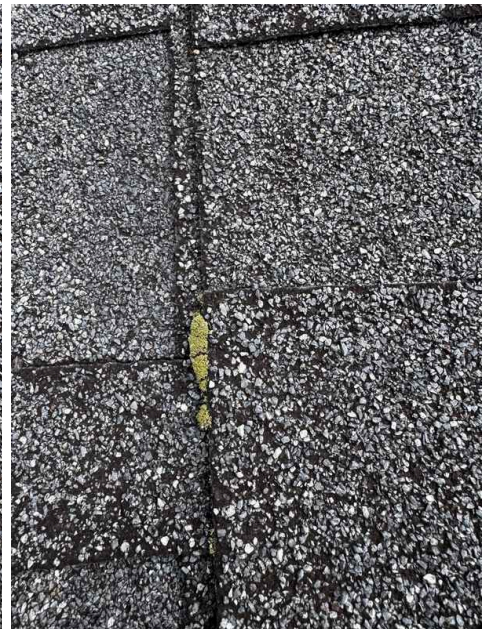
Additional photo of this finding.

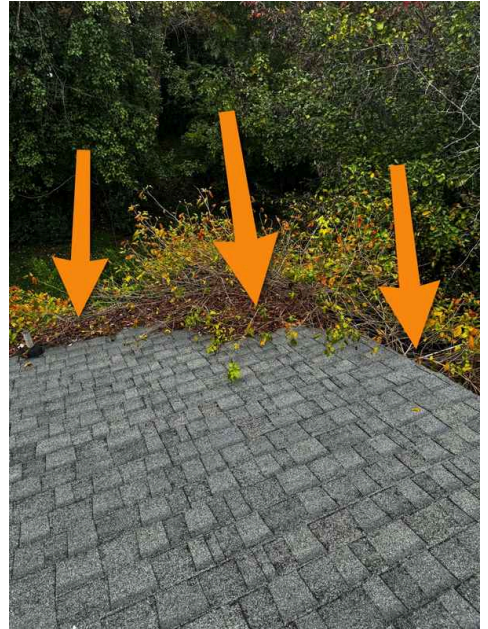
Significant decay is expected in all areas of the roof and wall where plant growth like this is located.

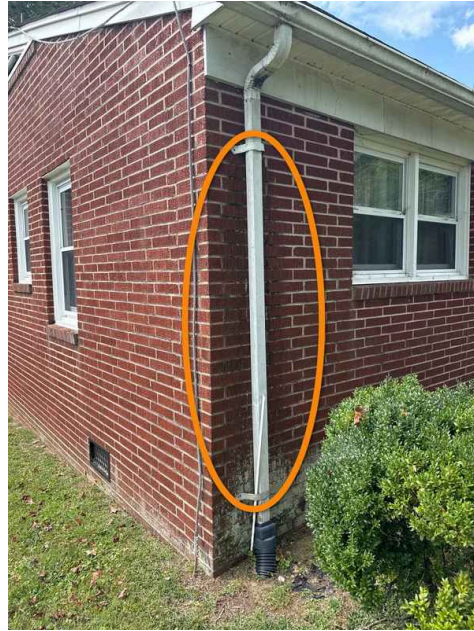
The downspout has been overflowing and clogged for a long length of time. Hidden damage behind the brick is likely.

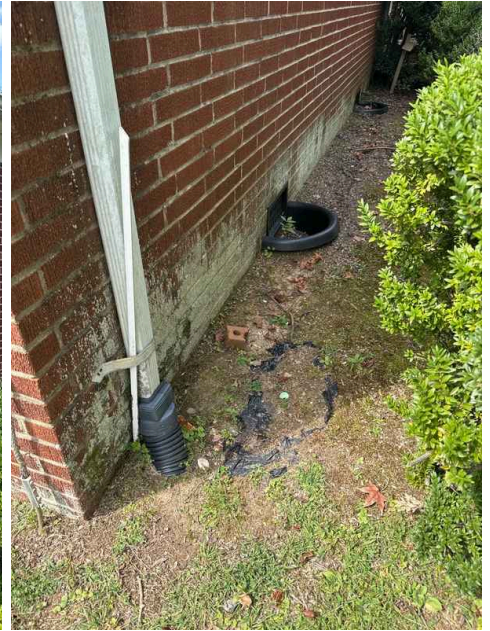
Additional photo of this finding showing erosion and water splashing against the foundation..

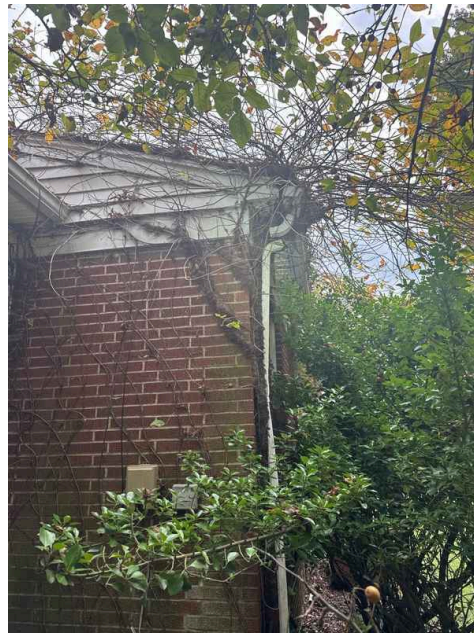
The same applies here in the back. This gutter is completely broken. This growth has been occurring for years. Hidden damage throughout the corner structure of the roof wall, etc., is expected.

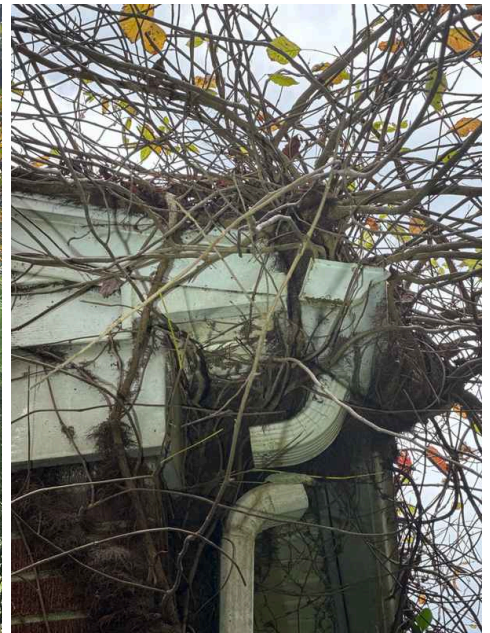
Additional photo of this finding.

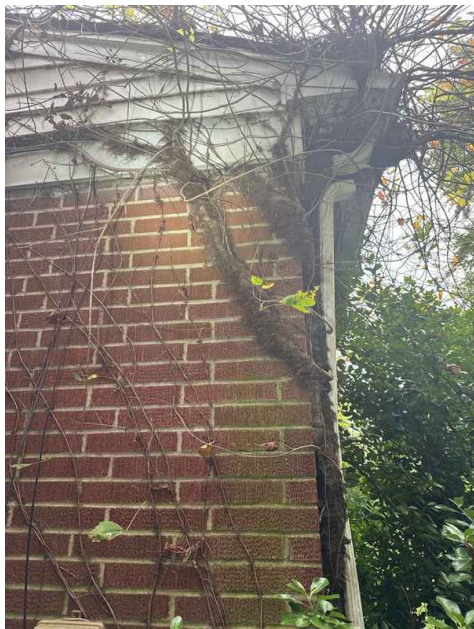
Large plants are growing into the structure of the home and coming out of the roof. Hidden damage throughout his present.

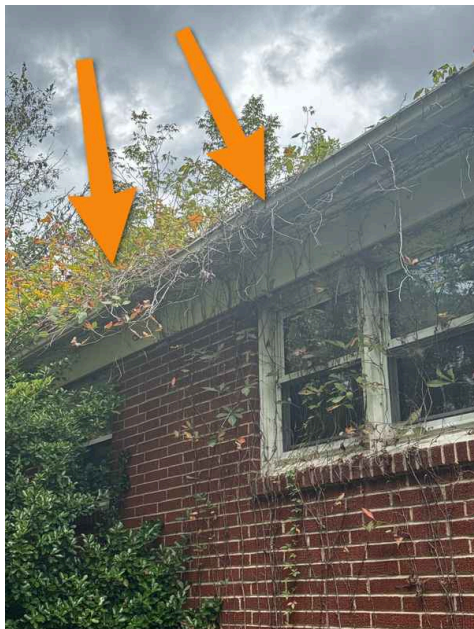
Hidden damage through all areas of the roof structure is expected.

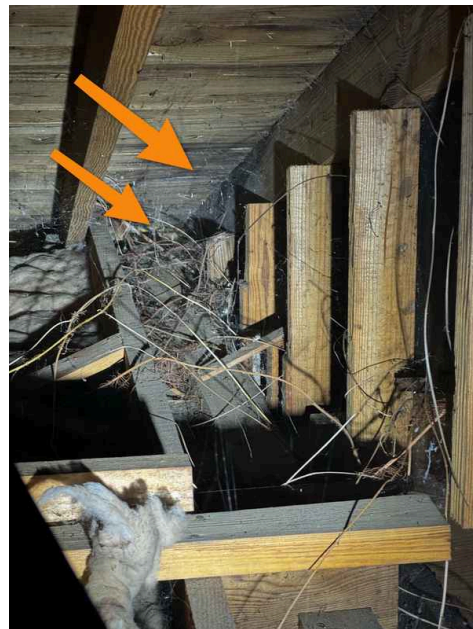
Additional photo of this finding showing decay from inside the attic.

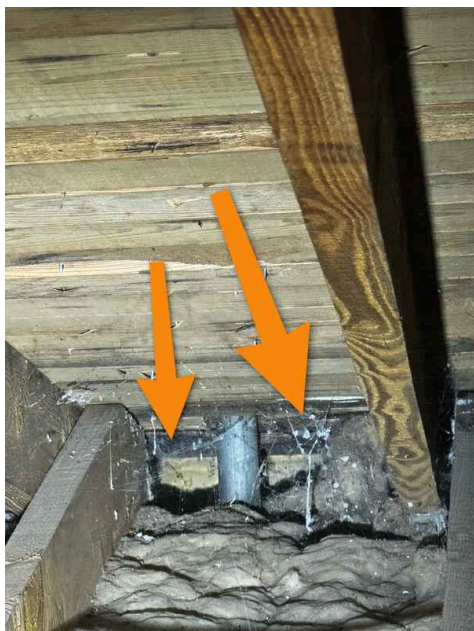
Additional photo of this finding showing decay from inside the attic.

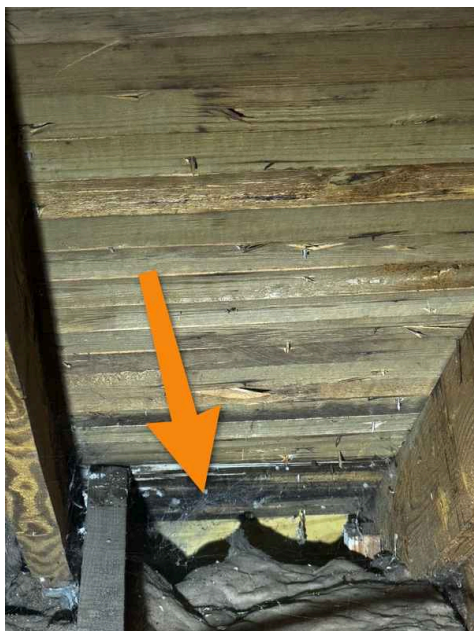
Additional photo of this finding showing decay from inside the attic.
