## SUMMARY

1315 Alpha Rd, Henderson, NC 27536

Evangeline Mitchell  
09/25/2025

Michael Eldredge  
NC HI Lic# 3527  
Eldredge Home Inspection  
9198303588  
meldredge1@gmail.com

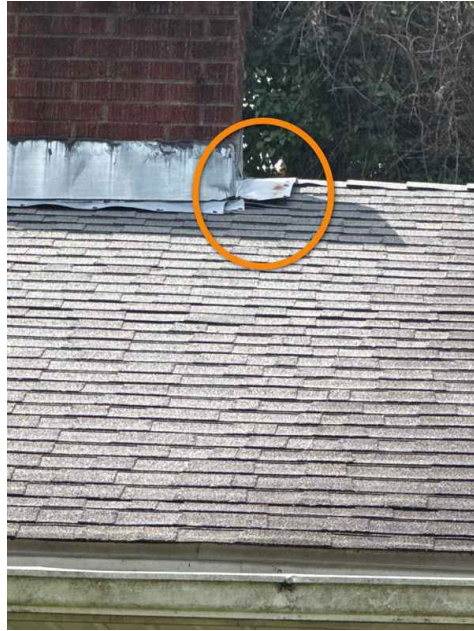
Loose and improper installation creates active roof leaks.

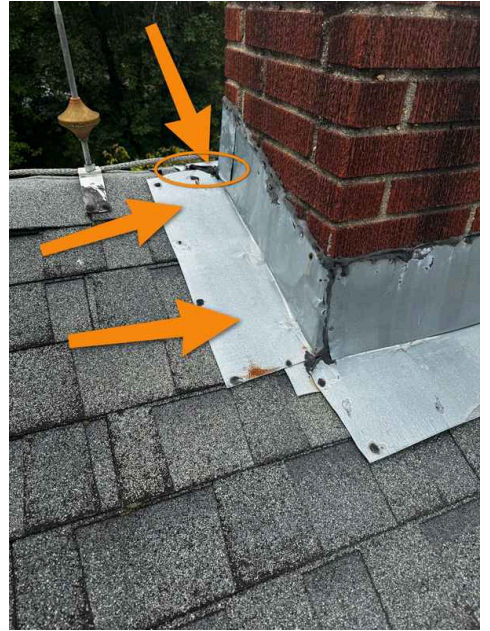
Additional photo of this finding. The flashing on the sides should be under the shingles.

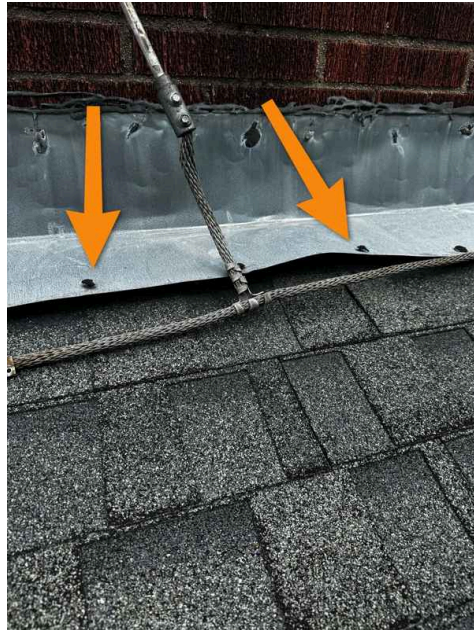
Additional photo of this finding showing more loose flashing.
