**IRM services LLC**

Prepared For: Chad Tamburro

Inspected On Mon, Jun 1, 2026 at 10:00 AM

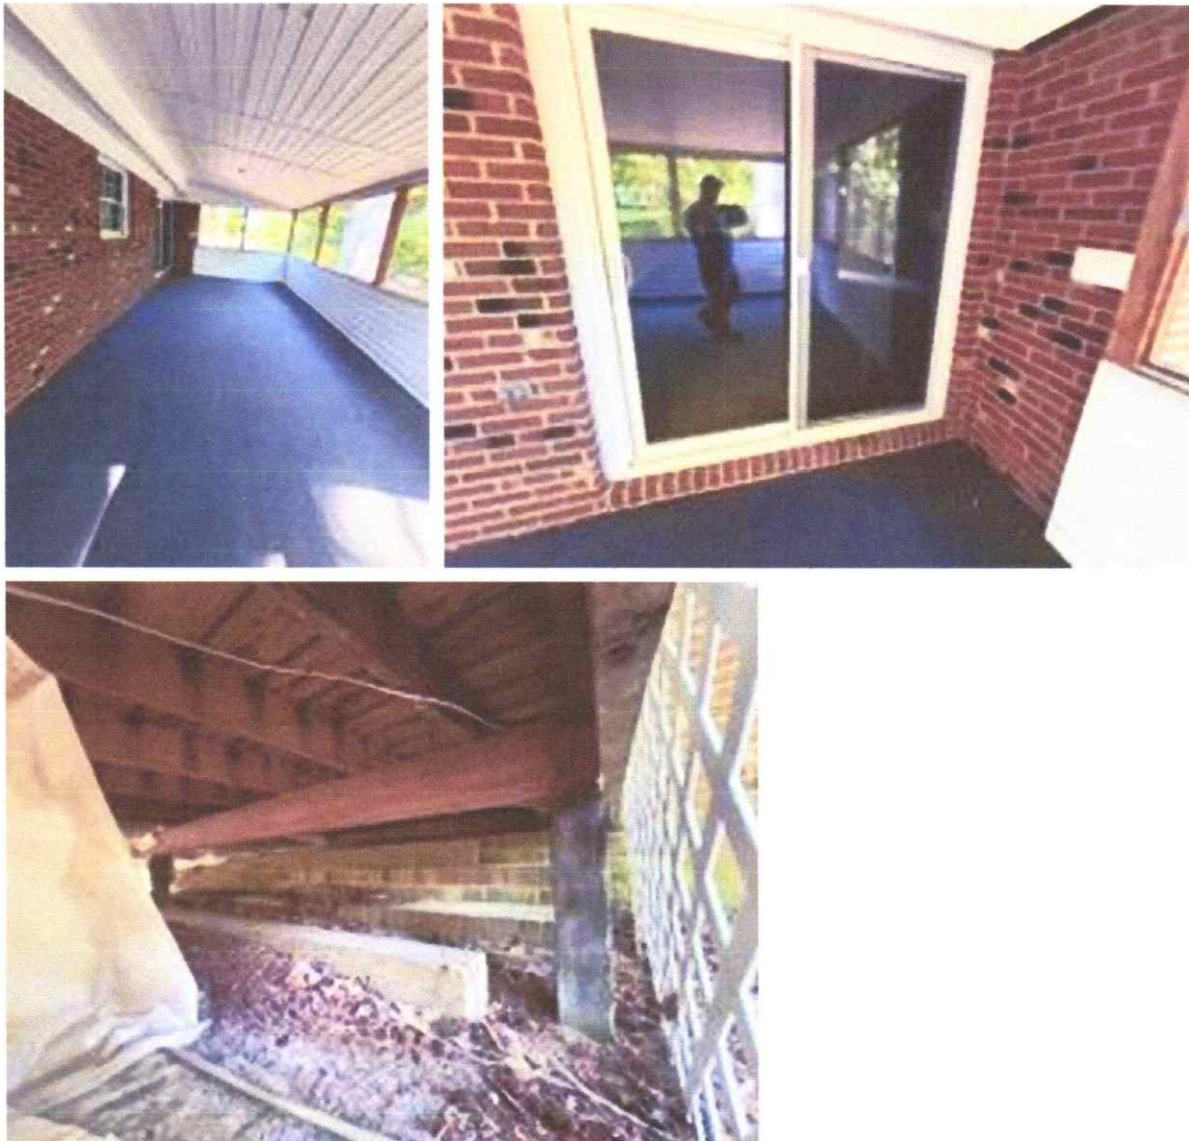
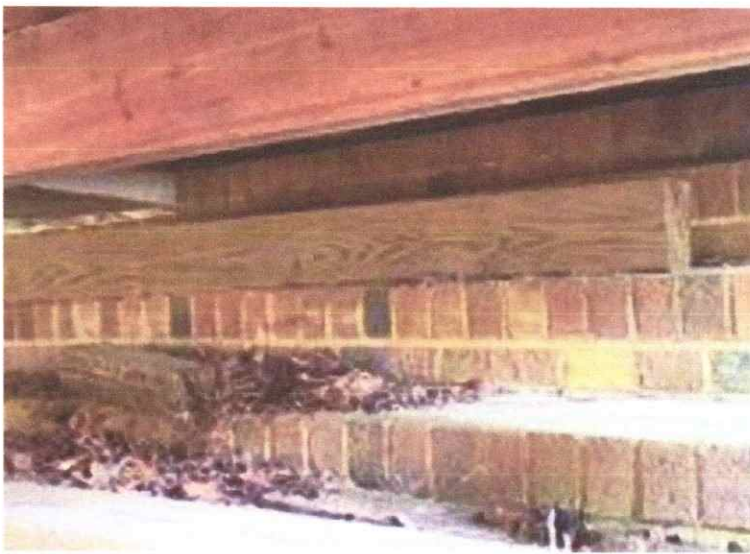
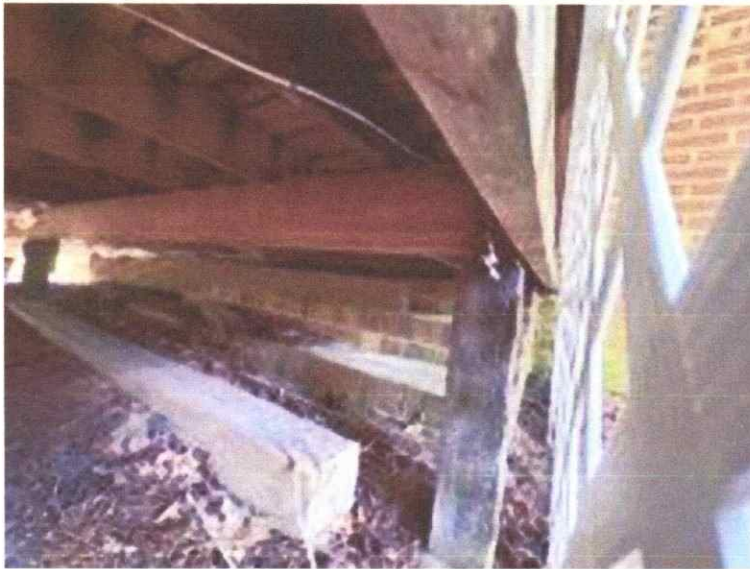
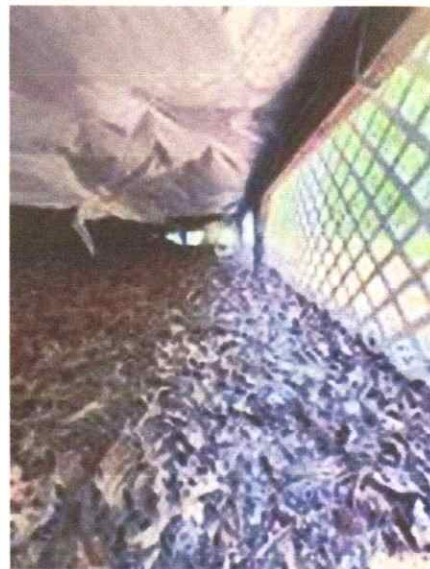
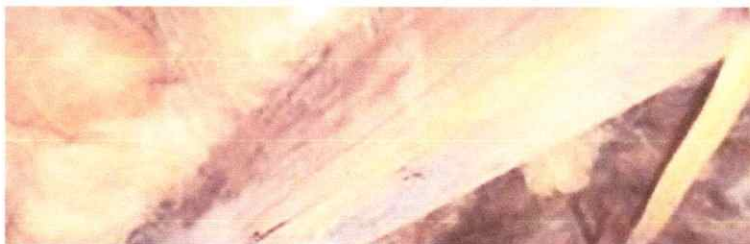
**Site: Patios/Decks****Comment 2****Repair or Replacement Needed**

Due to unorthodox install of this deck it is recommended that a licensed GC evaluate before purchasing. The plastic underneath is very unusual and can lead to issues this also limits view and causes a limitation on the inspection. The way it is supported and the damage to band joints in crawlspace also could mean that this deck may not be properly supported.

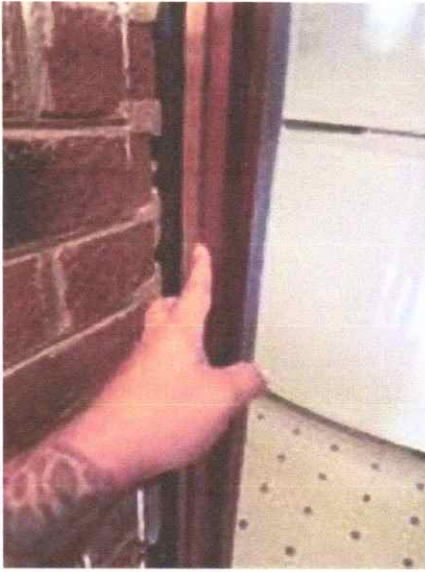
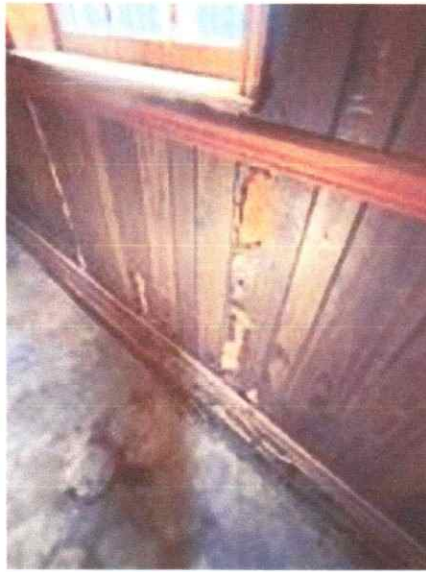
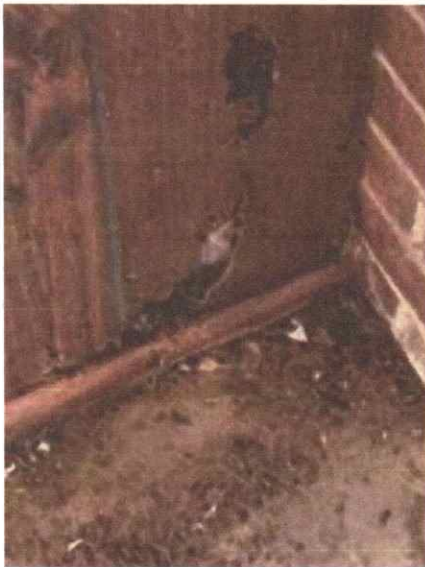
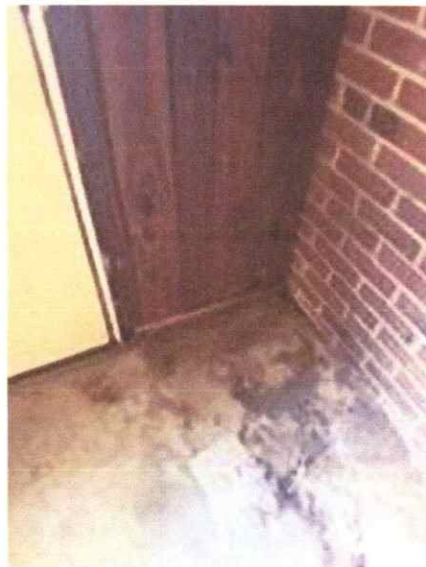
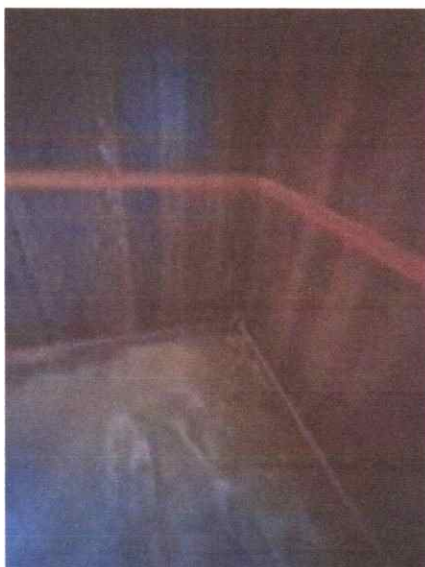
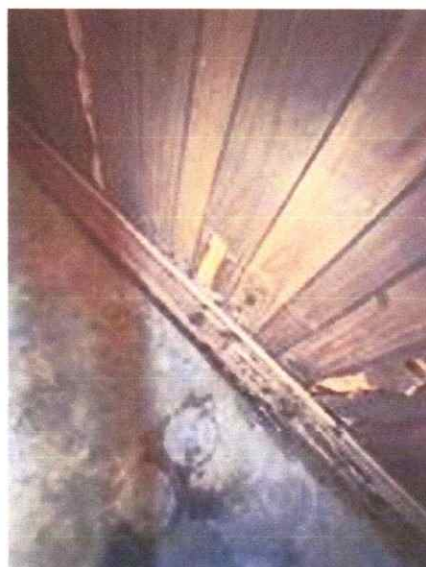
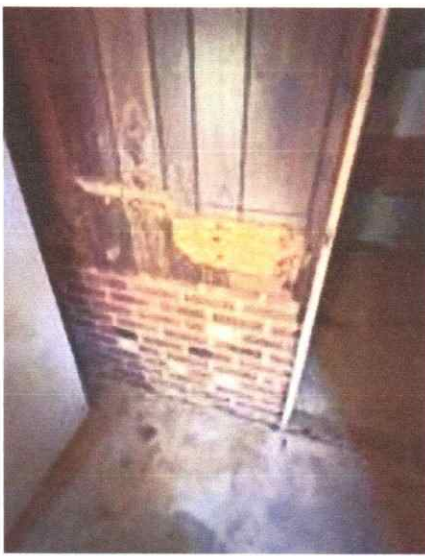
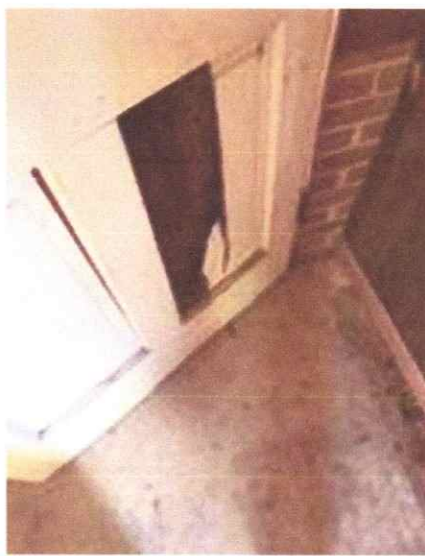
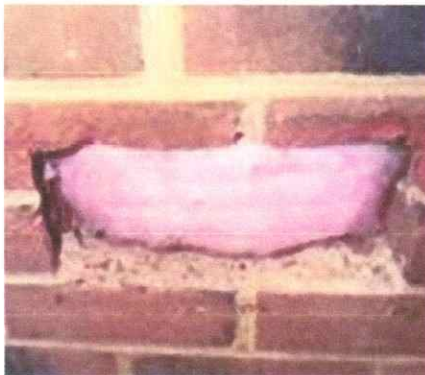
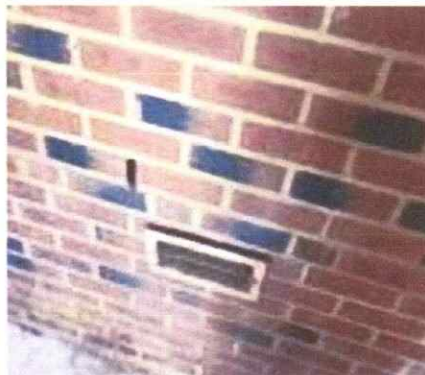
### Comment 3

Further evaluation by a licensed contractor highly recommended to evaluate and repair as needed to the closed in carport for the following but not limited to reasons.

- determining if area is properly finished or permitted is beyond the scope of an inspection.
- the space between brick home and addition is not properly sealed to prevent damage and water entry.
- suspected termite damage on panels
- possible hidden damage from Wood destroying insects.
- missing stair rail (3 or more treads require stair rail for safety.
- exterior door did not fully latch and other door is broken

- window is not closed
- vent does not go anywhere
- missing covers from receptacles and switches can be dangerous.

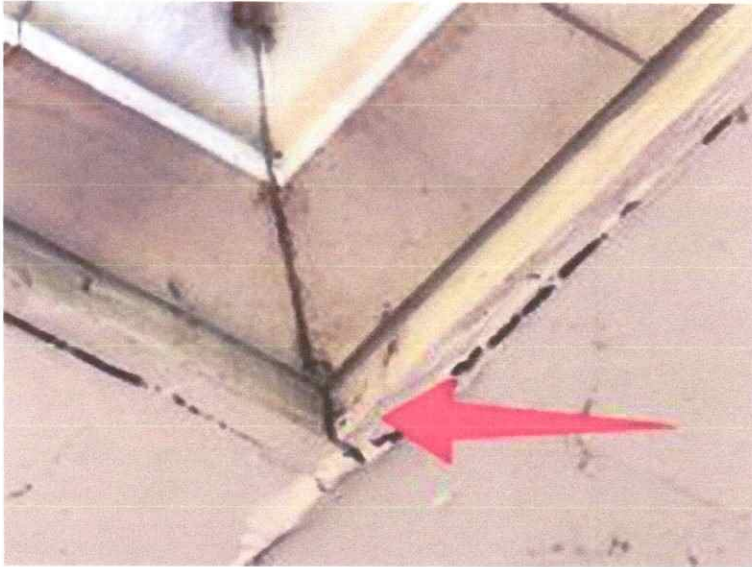
### Comment 5

Front down spout is showing signs of age and moisture. It is recommended to have a roofer evaluate. This home could use maintenance on the brick, fascia, eaves and caulking around windows and places that need it.

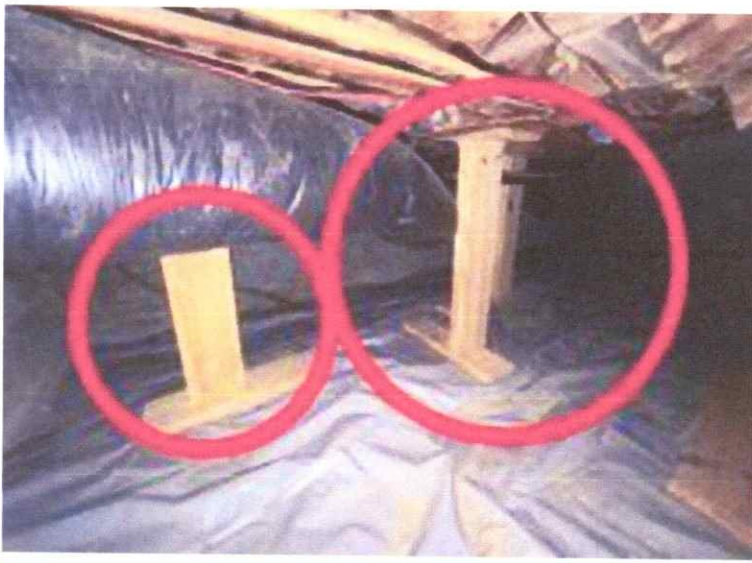
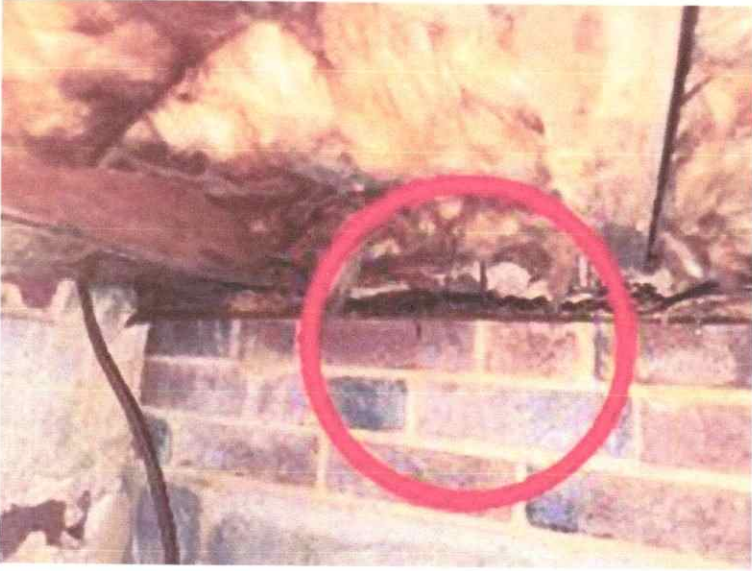
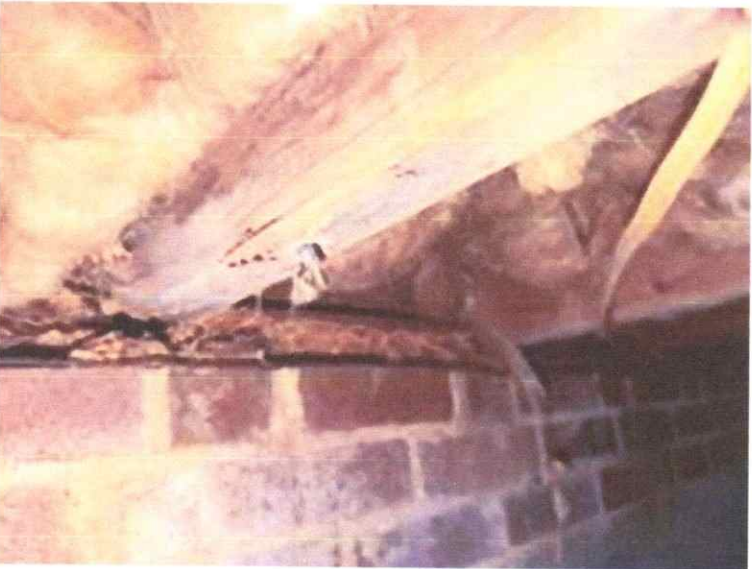
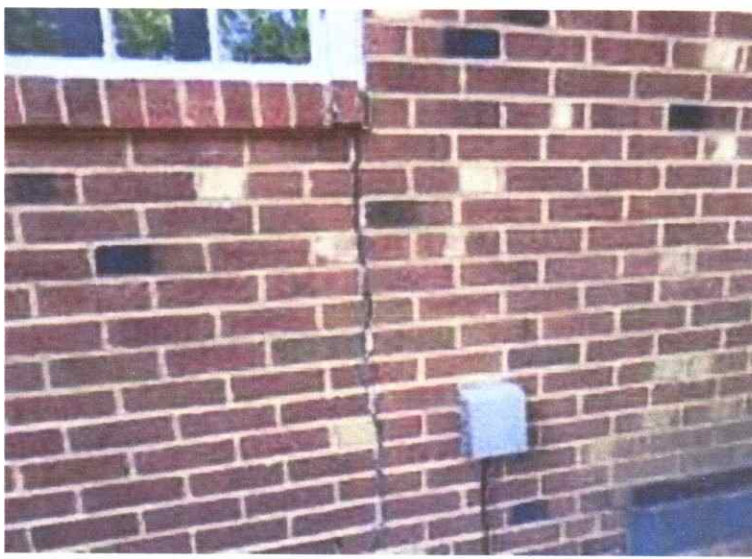
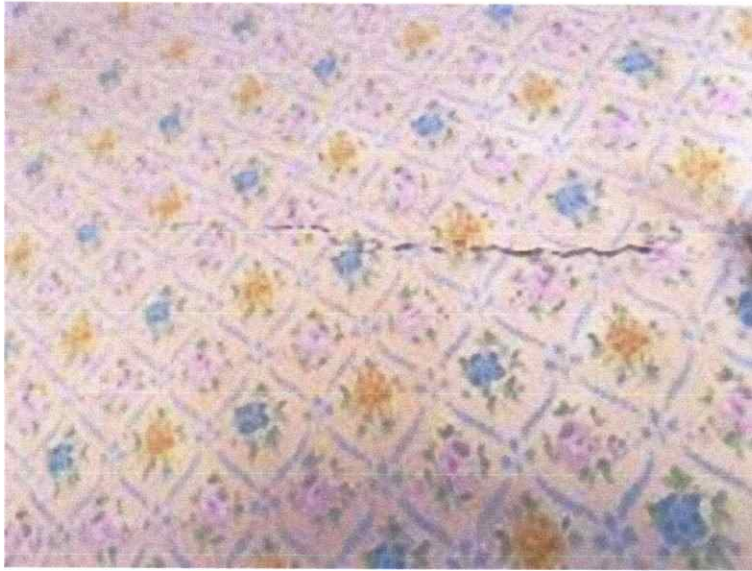
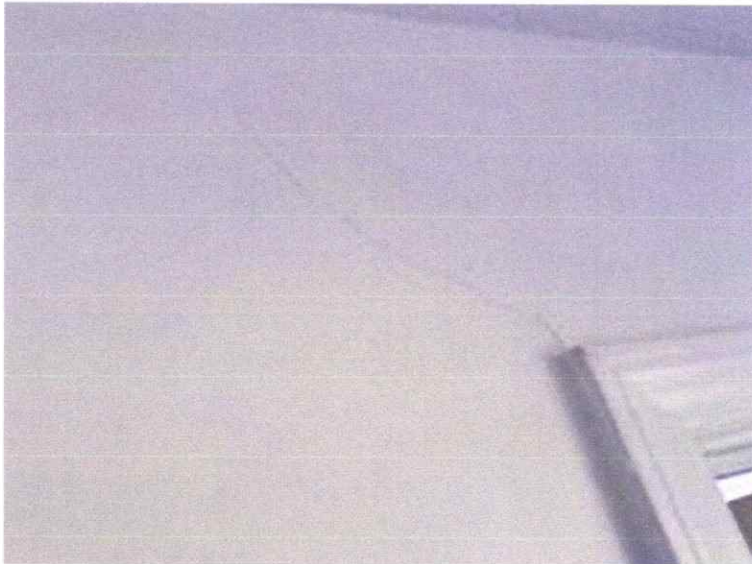
### Comment 7

It is recommended a structural engineer evaluate the supports underneath the home and damage to the rim joist. The supports are not typically installed this way. An improper structural repair could result in a structural failure. There is also cracking at the brick in back and drywall in master and bathroom floor is uneven indicating more repairs may be needed.

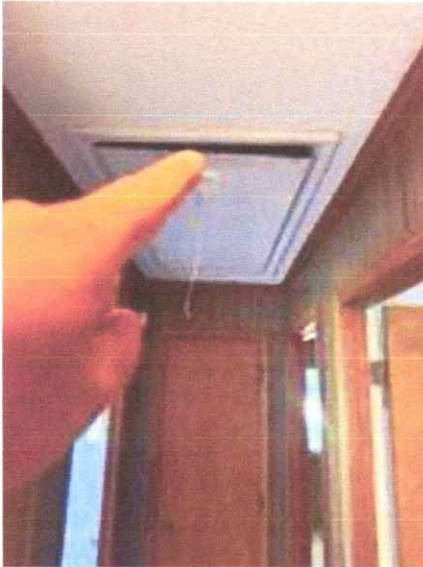
### Comment 8

The attic pull down does not go completely shut.

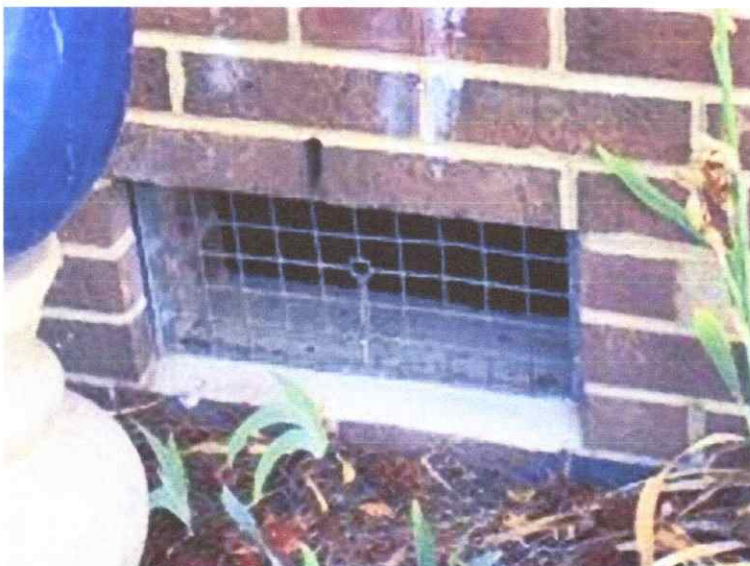
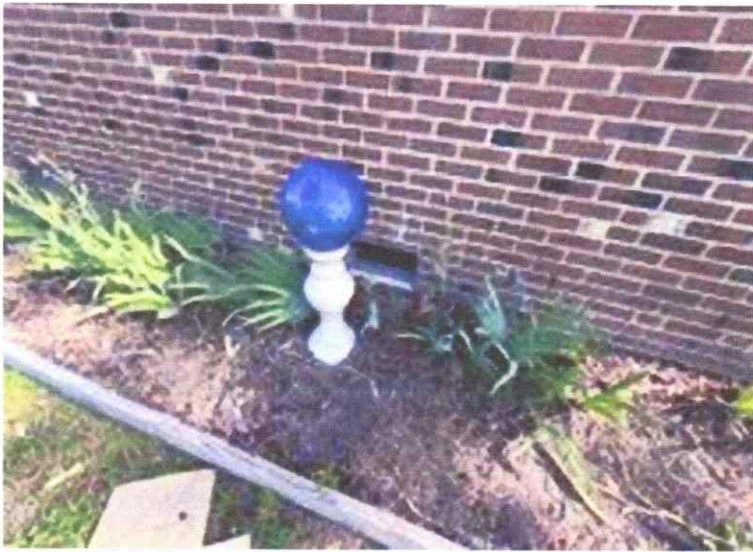
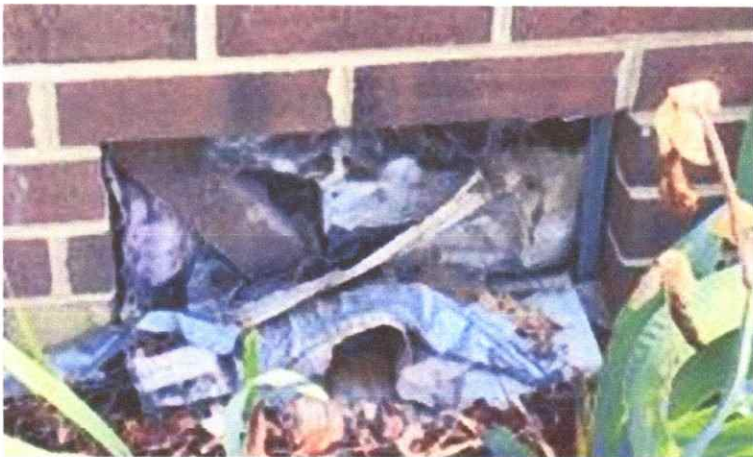
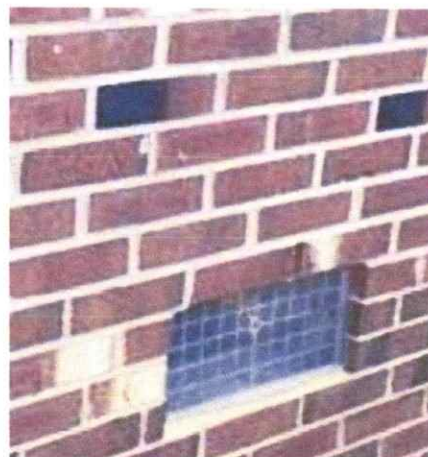
### Comment 10

Vents are missing grids and screens and may lead to pest and water entry. At least one is missing the entire vent and another is closed with plexiglass.

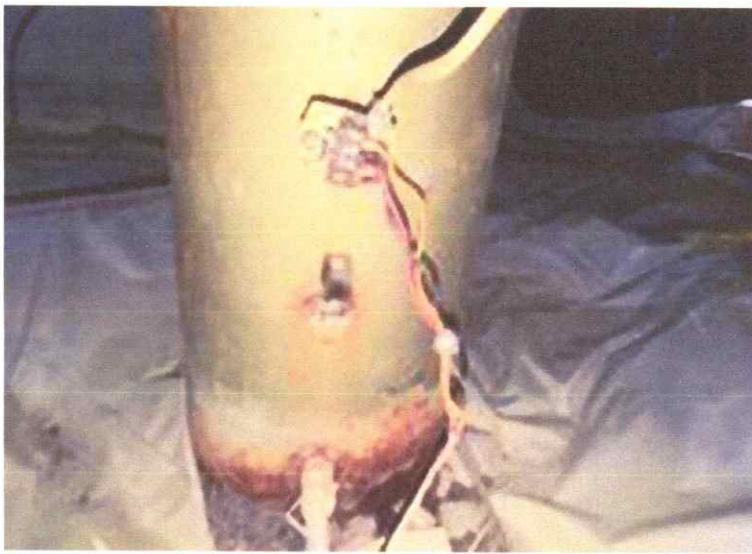
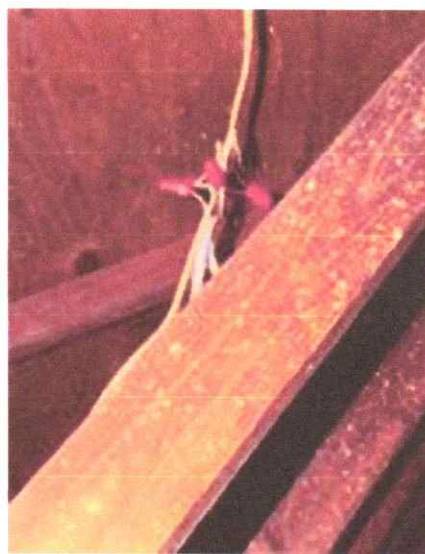
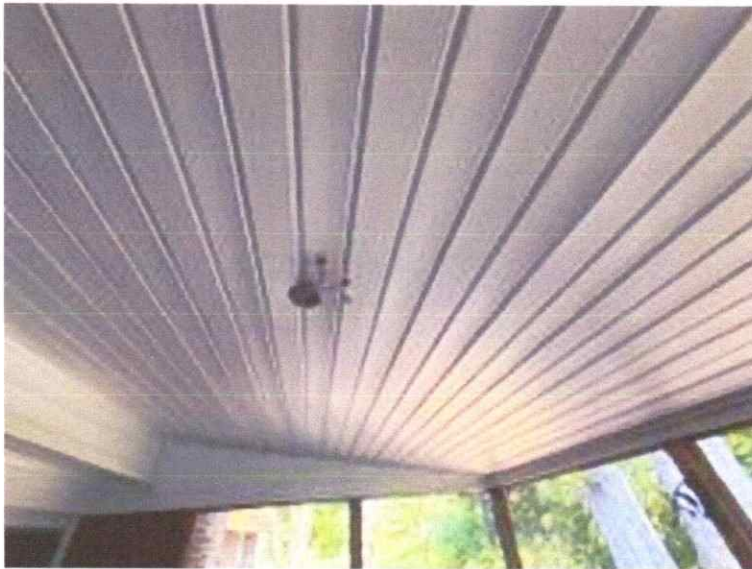
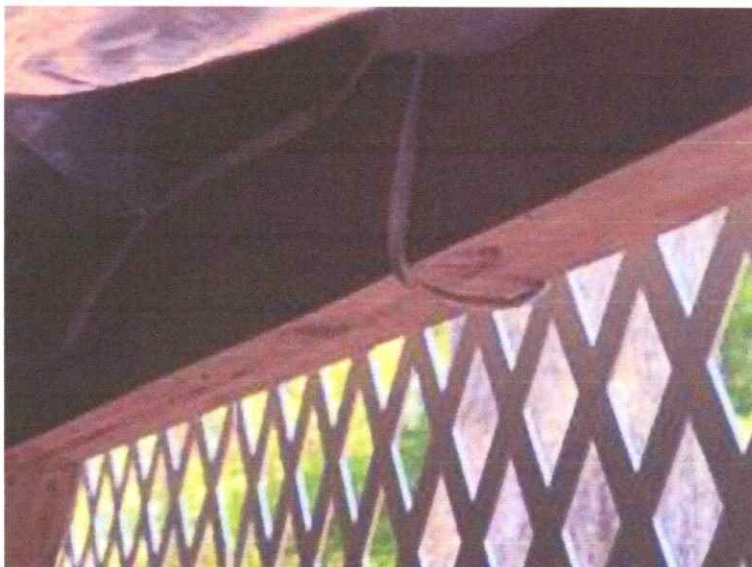
### Comment 12

Several open junctions are noted and need placed in a junction box and the exterior receptacle is not wired using exterior rated cable. For these reasons it is highly recommended an electrician evaluate and repair electrical components.

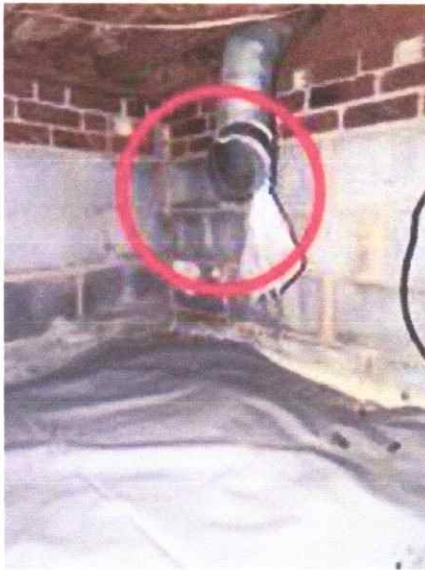
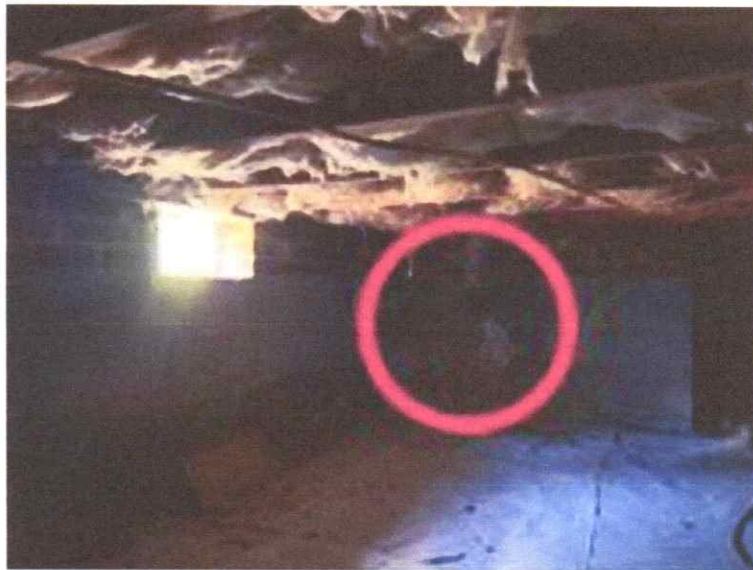
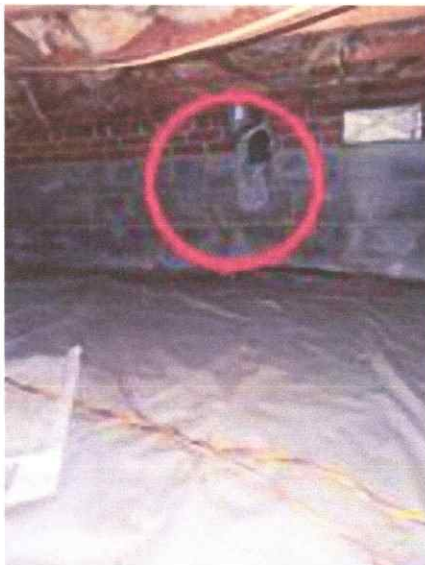
### Comment 14

There are several vents not connected and part of the old system. It is recommended to have an hvac tech evaluate and confirm there is enough vents and determine if the old ones need closed.

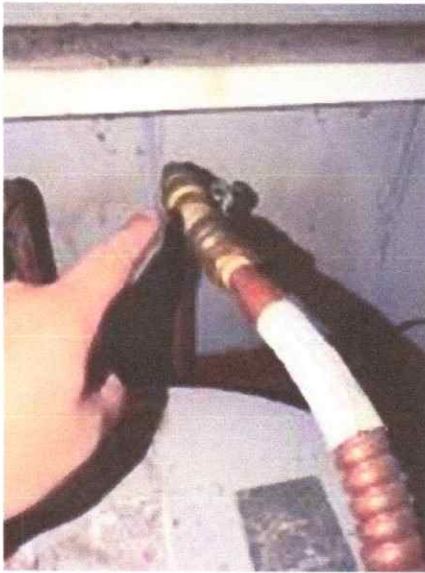
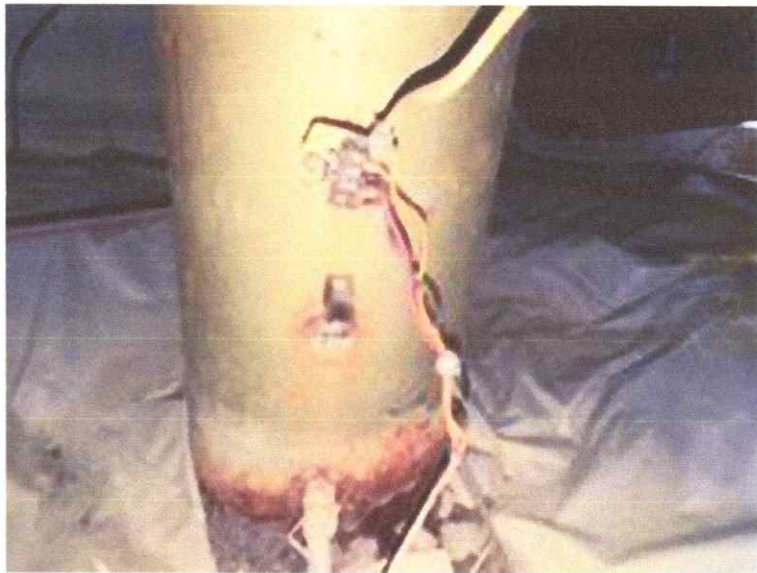
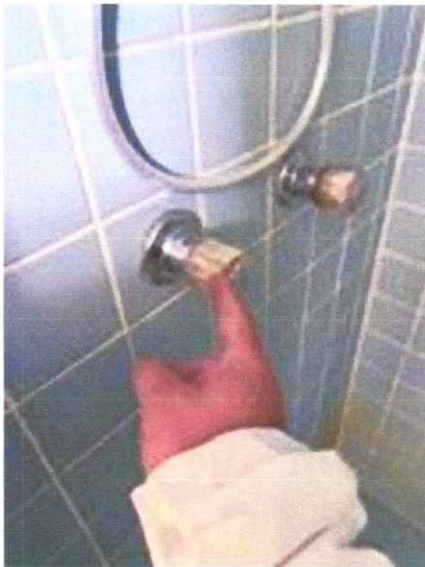
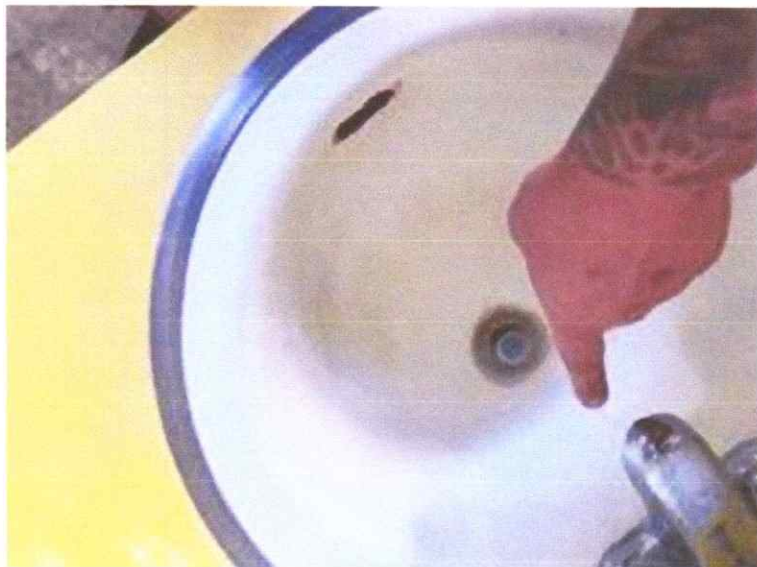
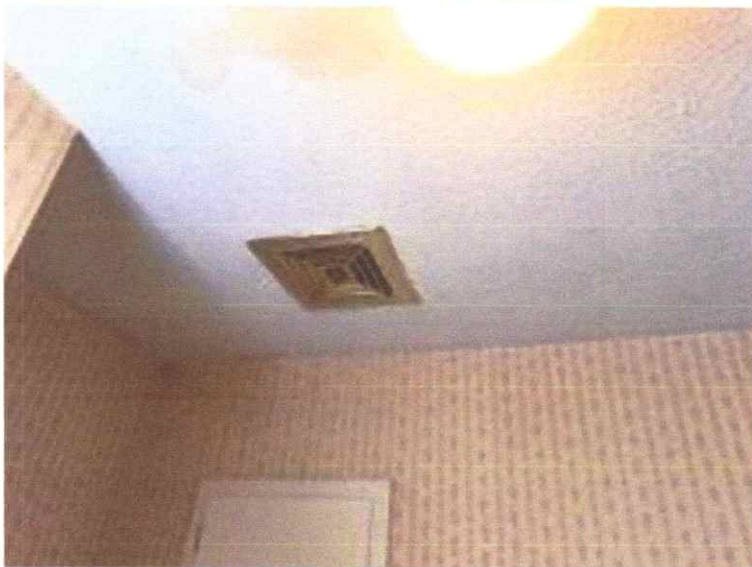
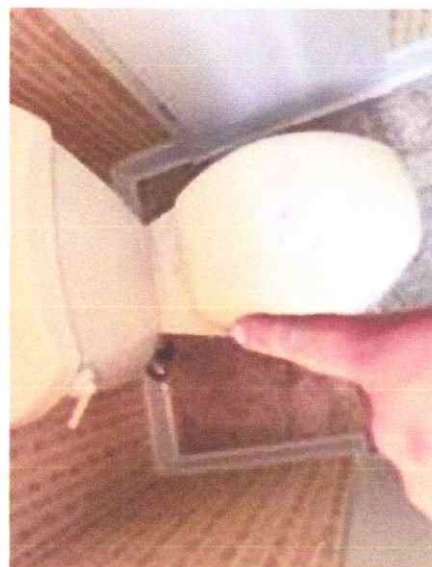
### Comment 16

The water heater and well compression tank both are leaking and need replaced. There is also missing shower head from main bathroom, due to water heater leaking hot water could not be tested, leaking

rose bib, loose toilet and dripping faucets all should be evaluated and repaired by a licensed plumber.

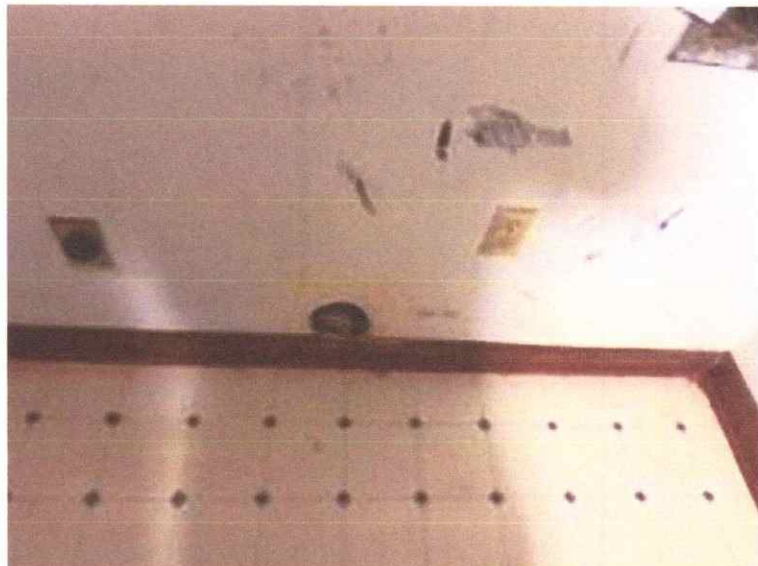
### Comment 22

Missing metal through wall transition this will need installed to safely connect dryer.

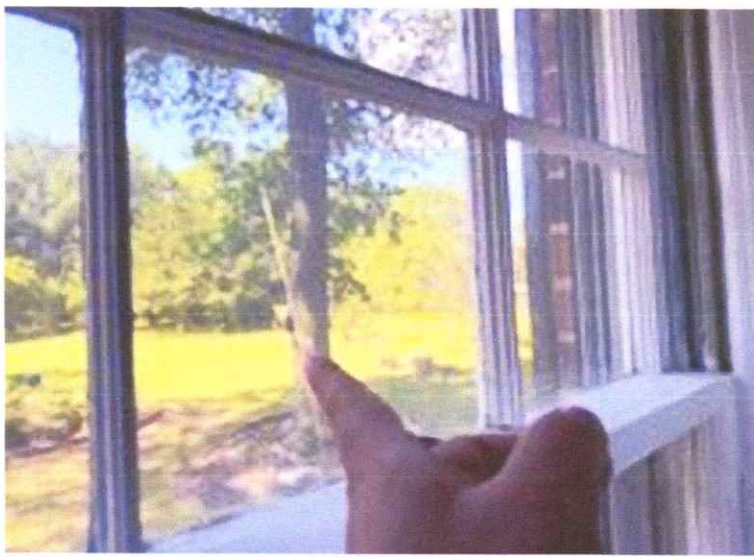
### Comment 24

There are a few windows that have broken panes and need repaired and a few that did not operate properly this a safety concern. Consult a specialist for repairs.

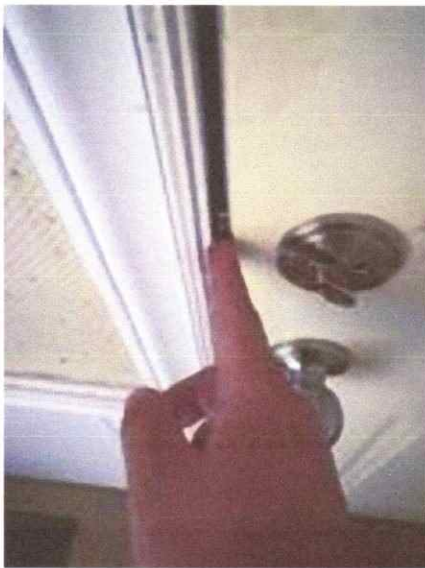
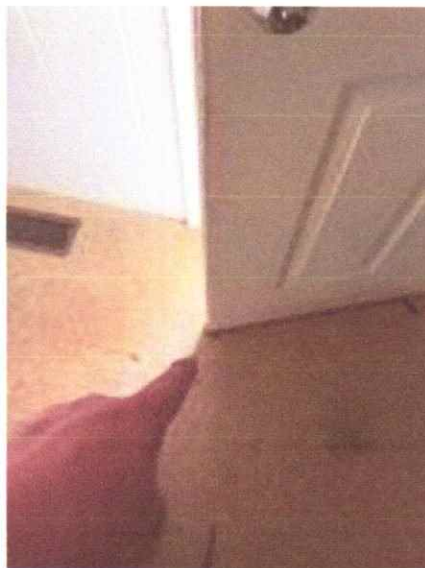
#### **Comment 25**

Front door deadbolt did not latch and rubs carpet when opening.

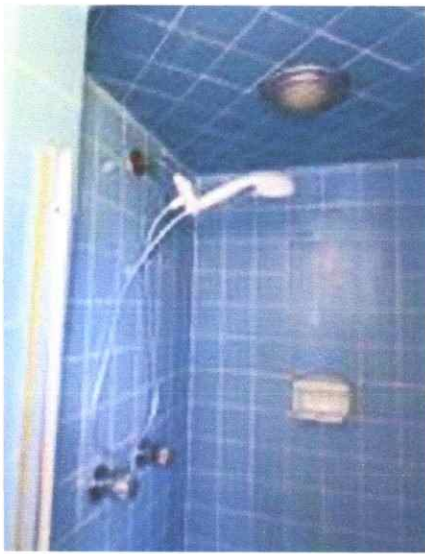
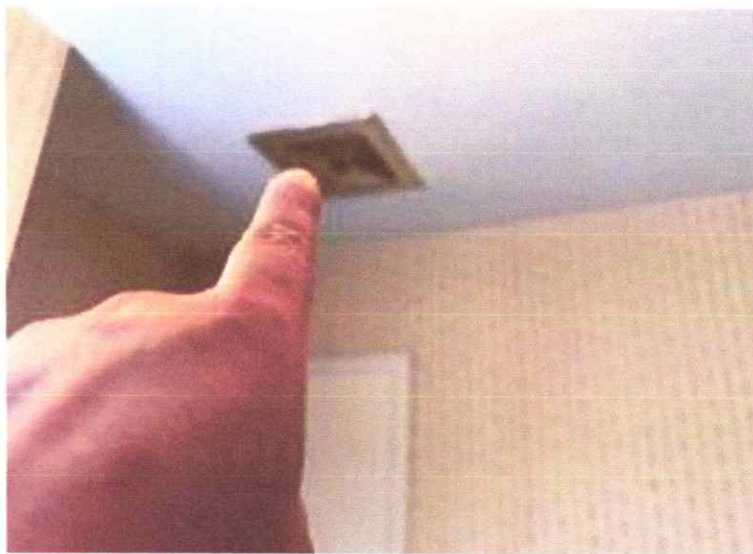
#### **Comment 26**

Master bath is not required to have an exhaust if a window can be operated however it is recommended to have one installed to prevent mold and water damage. The main bathroom exhaust is loud and failing it is recommended to replace.

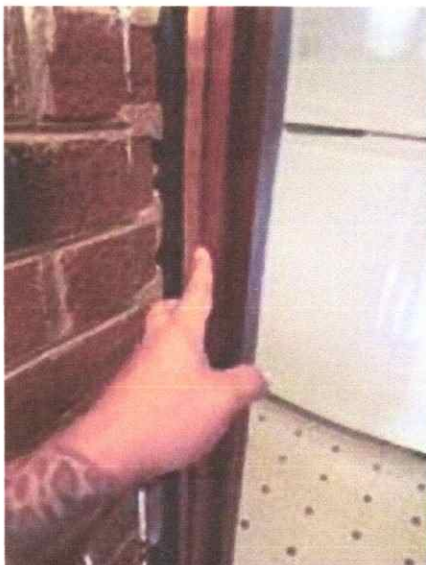
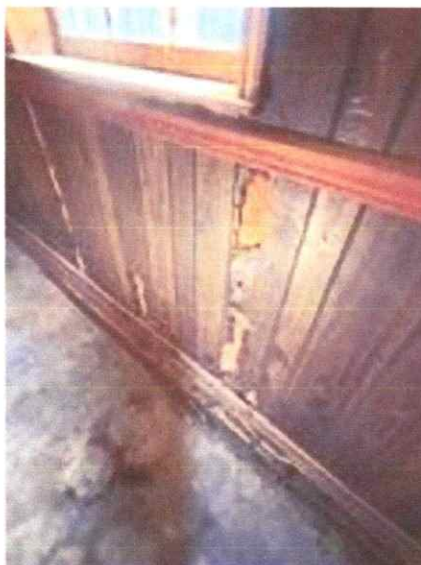
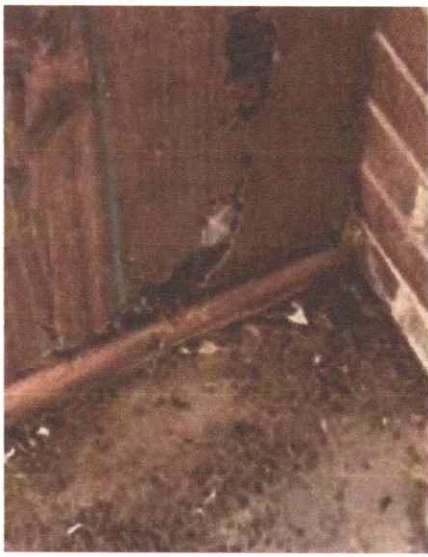
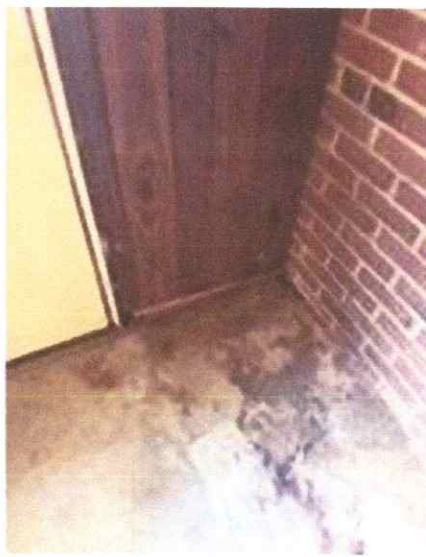
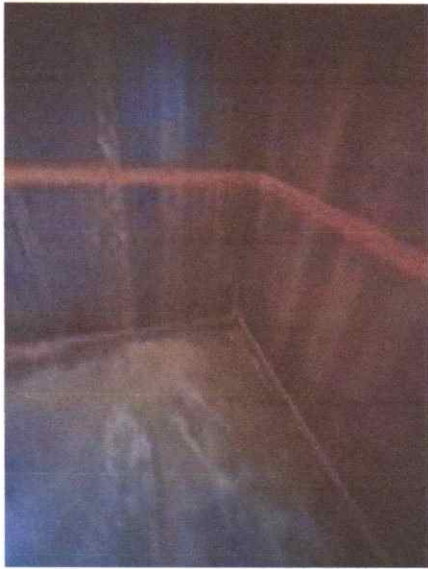
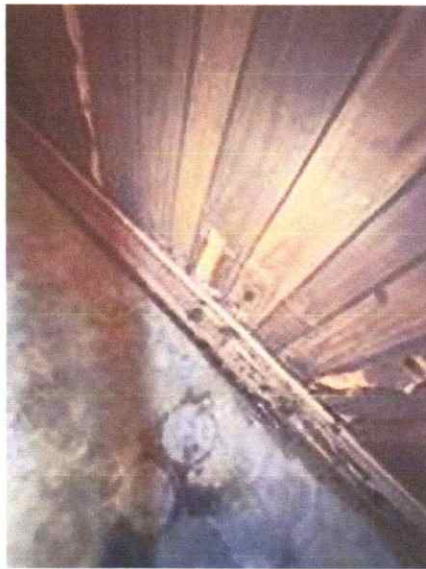
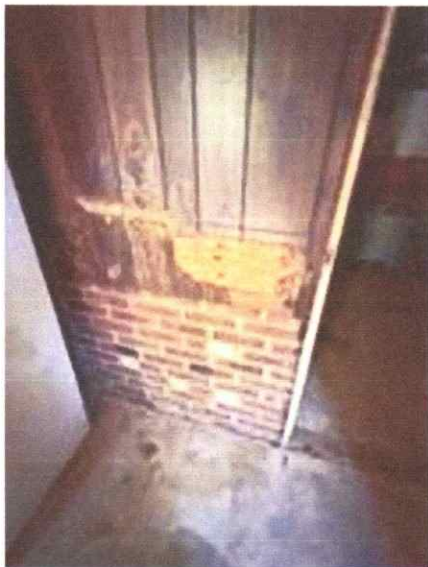
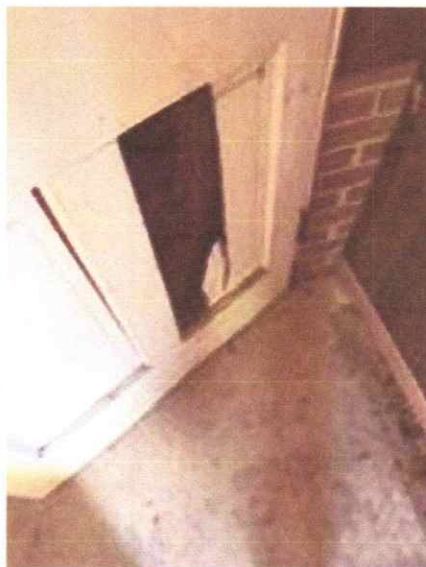
#### Comment 3

Further evaluation by a licensed contractor highly recommended to evaluate and repair as needed to the closed in carport for the following but not limited to reasons.

- determining if area is properly finished or permitted is beyond the scope of an inspection.
- the space between brick home and addition is not properly sealed to prevent damage and water entry.
- suspected termite damage on panels
- possible hidden damage from Wood destroying insects.
- missing stair rail (3 or more treads require stair rail for safety.
- exterior door did not fully latch and other door is broken.
- window is not closed
- vent does not go anywhere
- missing covers from receptacles and switches can be dangerous.

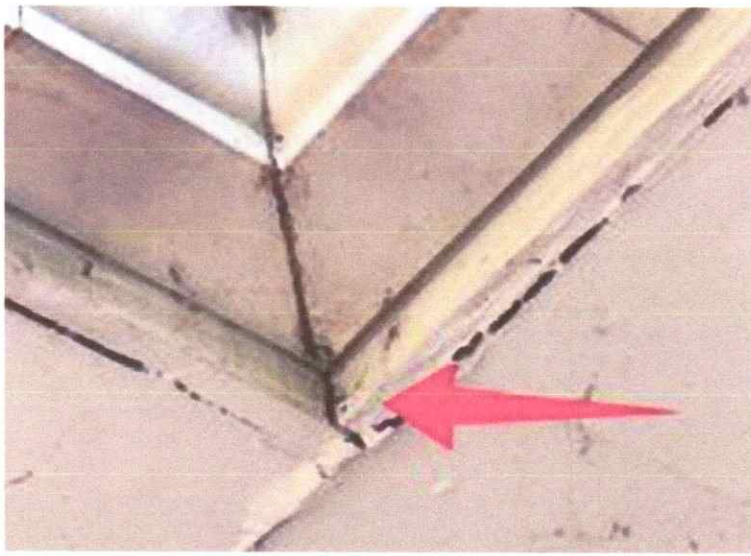
#### **Comment 5**

Front down spout is showing signs of age and moisture. It is recommended to have a roofer evaluate. This home could use maintenance on the brick, fascia, eaves and caulking around windows and places that need it.

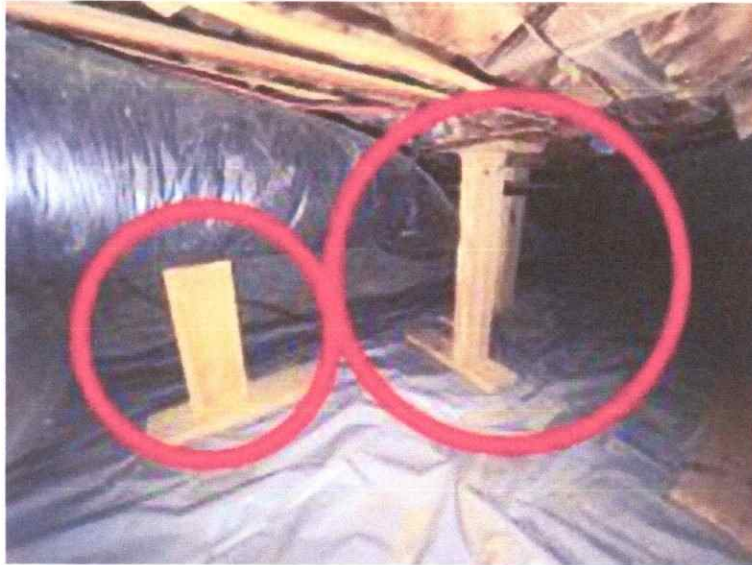
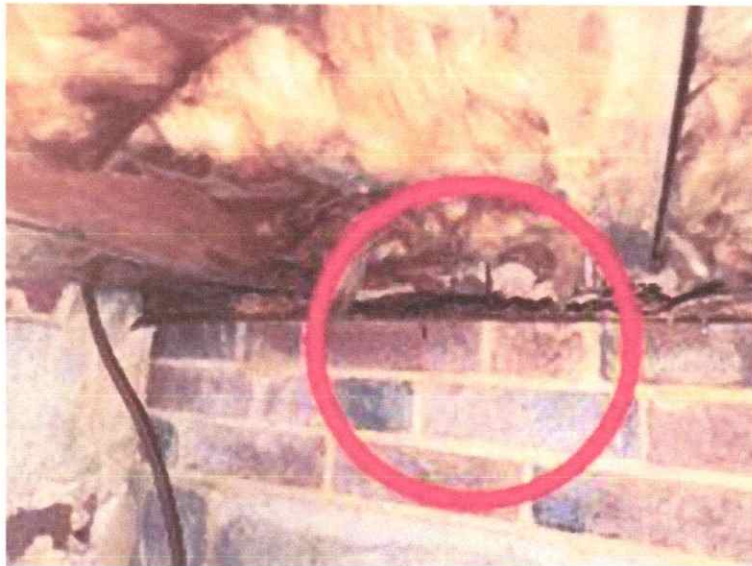
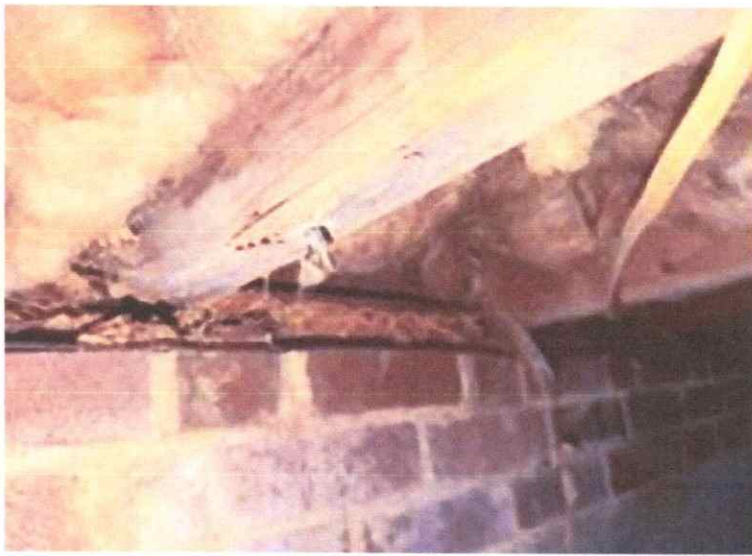
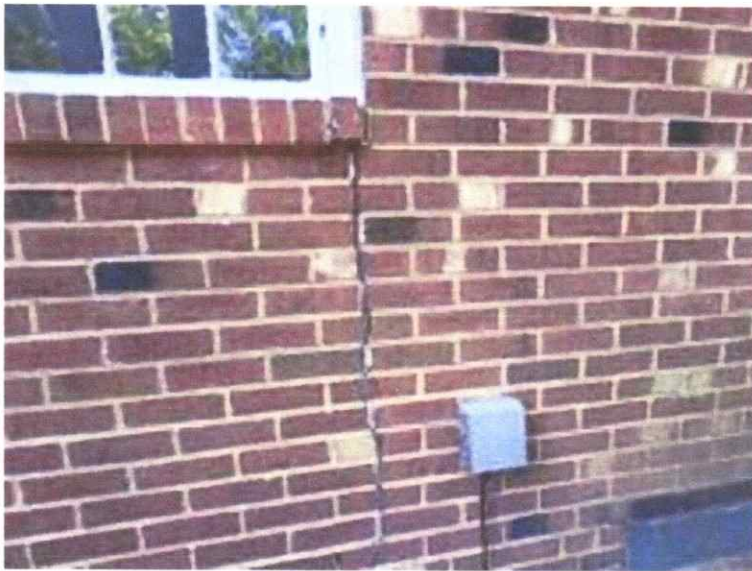
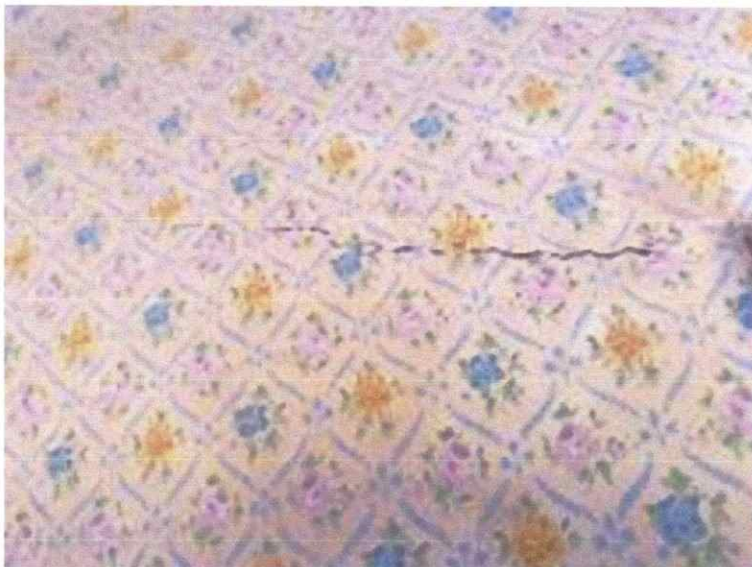
**Comment 7****Repair or Replacement Needed**

It is recommended a structural engineer evaluate the supports underneath the home and damage to the rim joist. The supports are not typically installed this way. An improper structural repair could result in a structural failure. There is also cracking at the brick in back and drywall in master and bathroom floor is uneven indicating more repairs may be needed.
