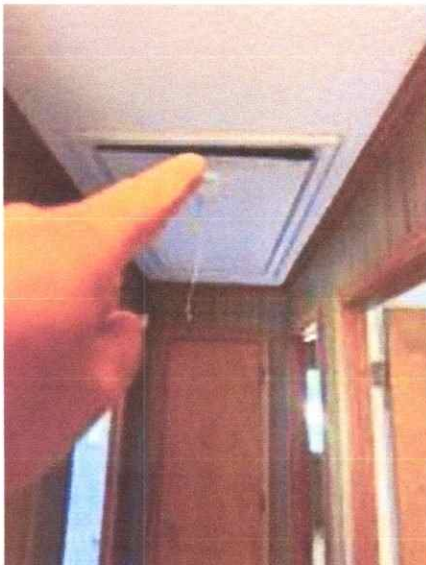
The attic pull down does not go completely shut.

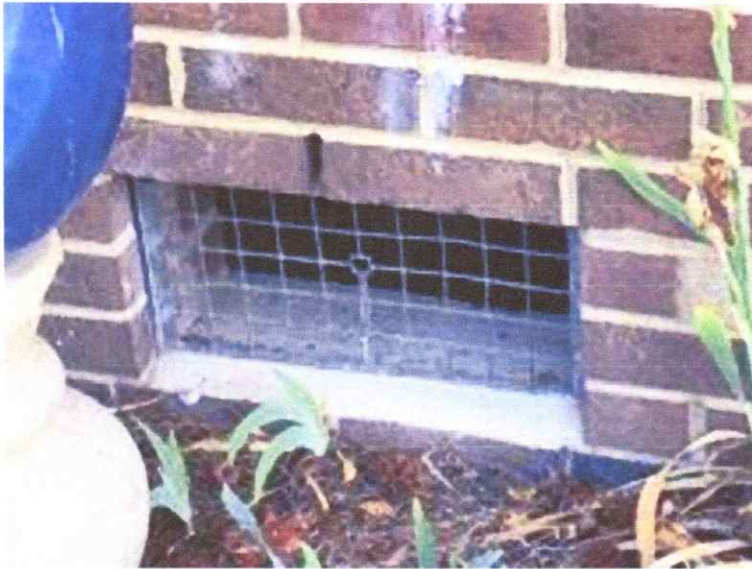
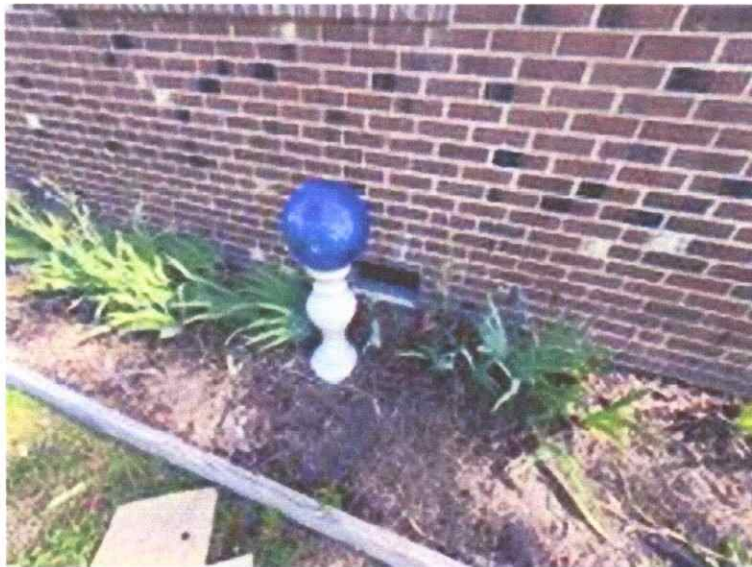
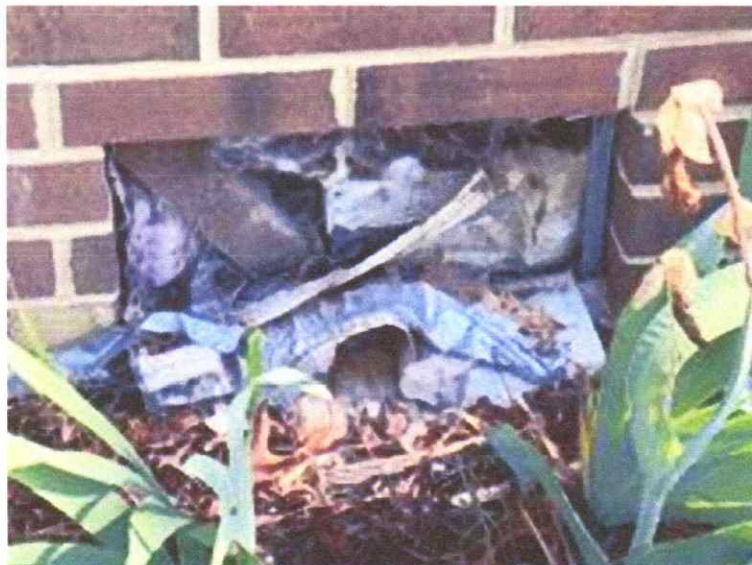
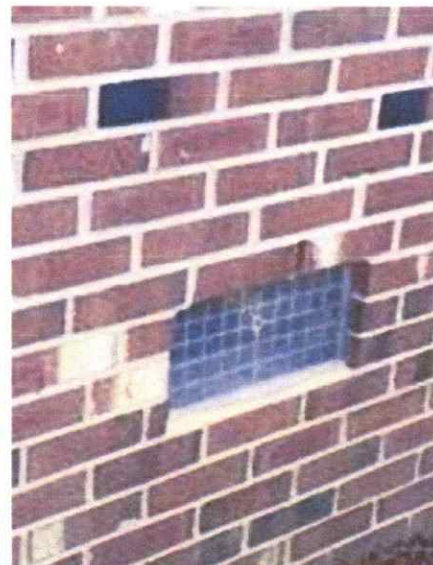
Vents are missing grids and screens and may lead to pest and water entry. At least one is missing the entire vent and another is closed with plexiglass.

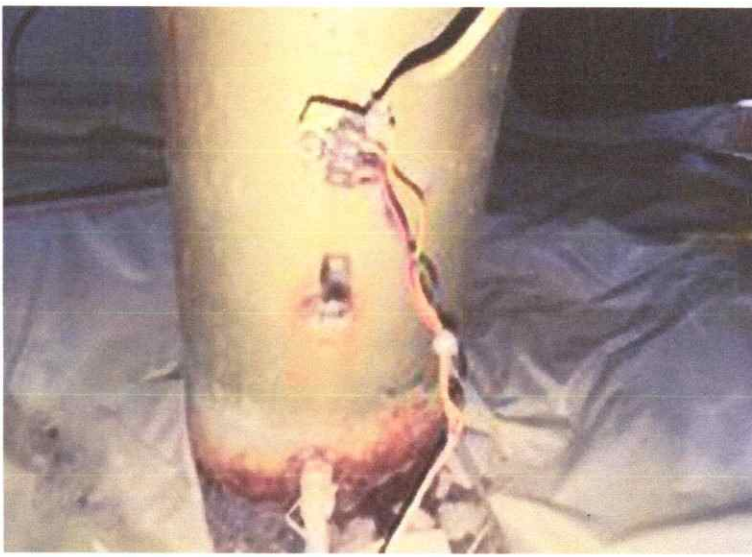
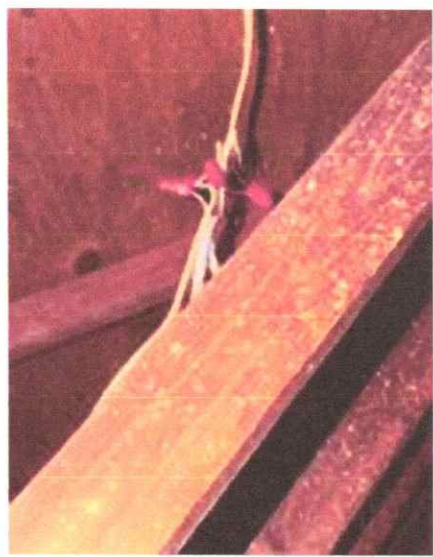
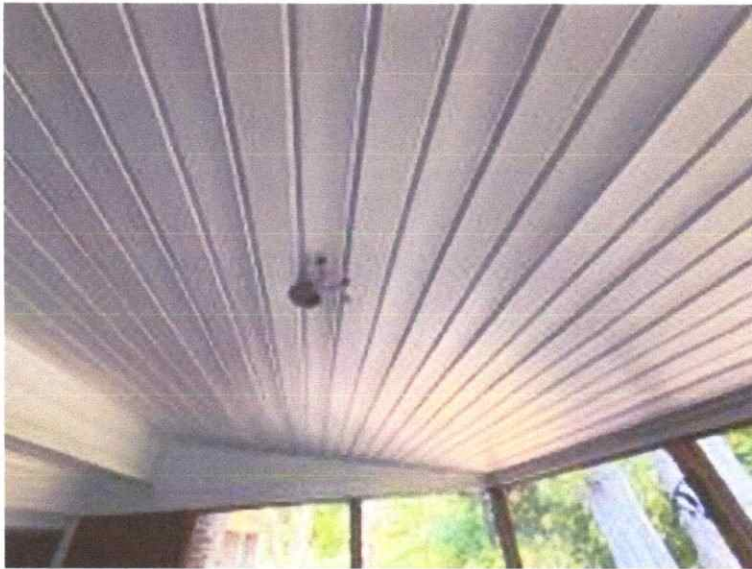
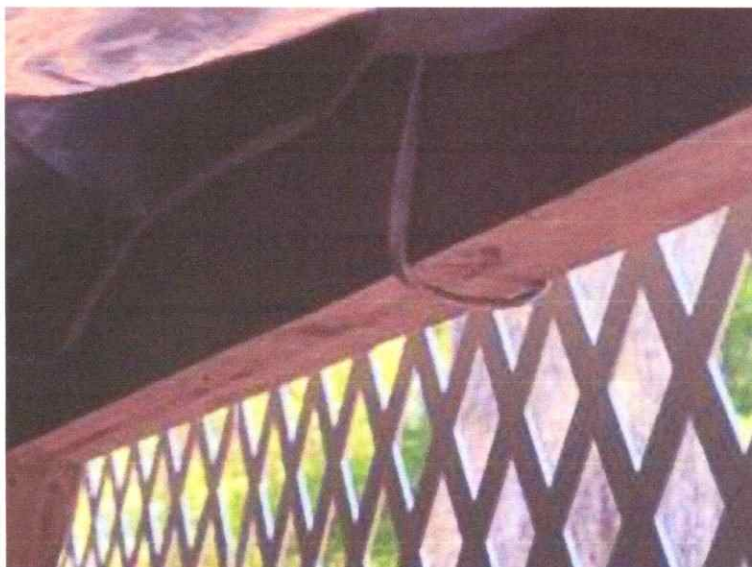
Several open junctions are noted and need placed in a junction box and the exterior receptacle is not wired using exterior rated cable. For these reasons it is highly recommended an electrician evaluate and repair electrical components.

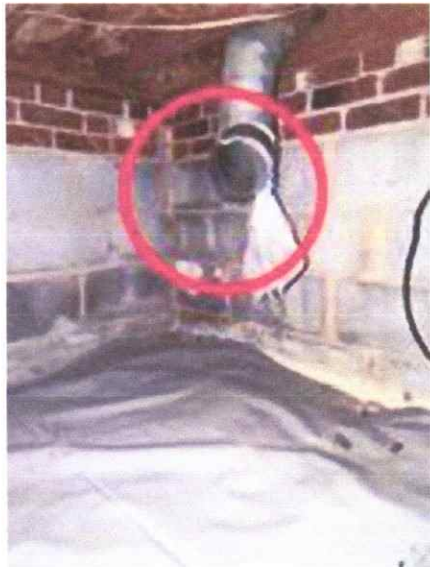
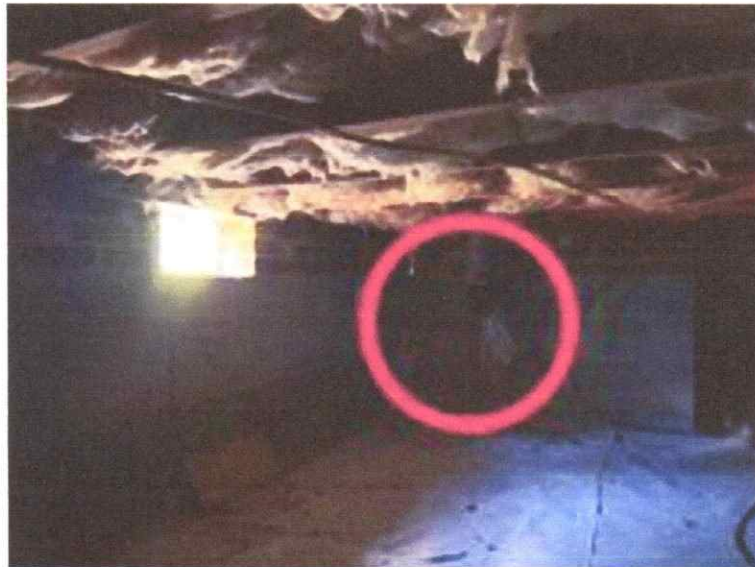
There are several vents not connected and part of the old system. It is recommended to have an hvac tech evaluate and confirm there is enough vents and determine if the old ones need closed.

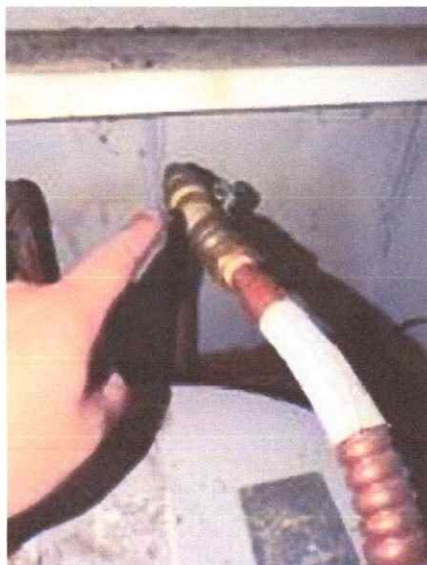
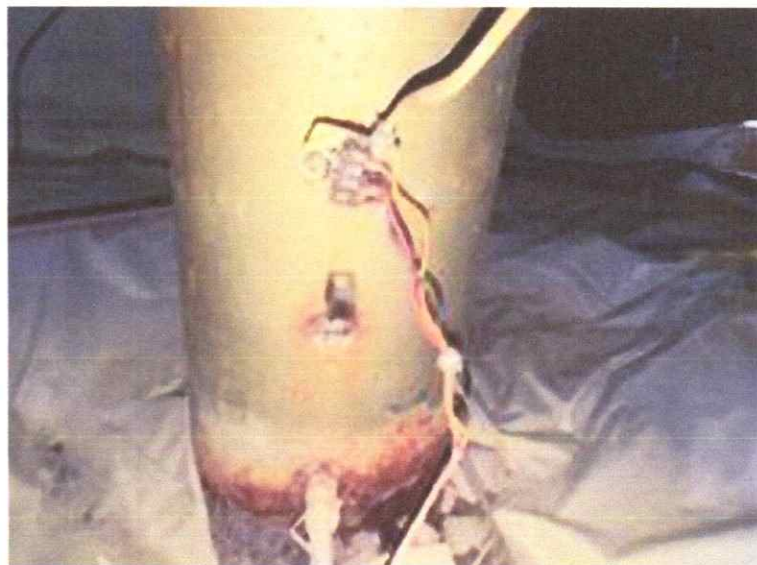
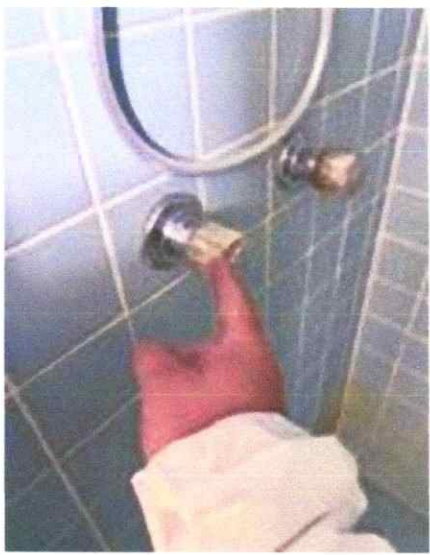
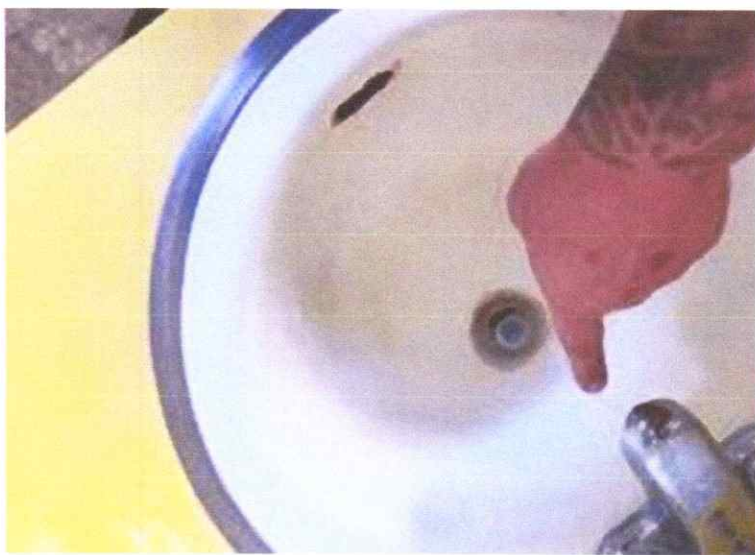
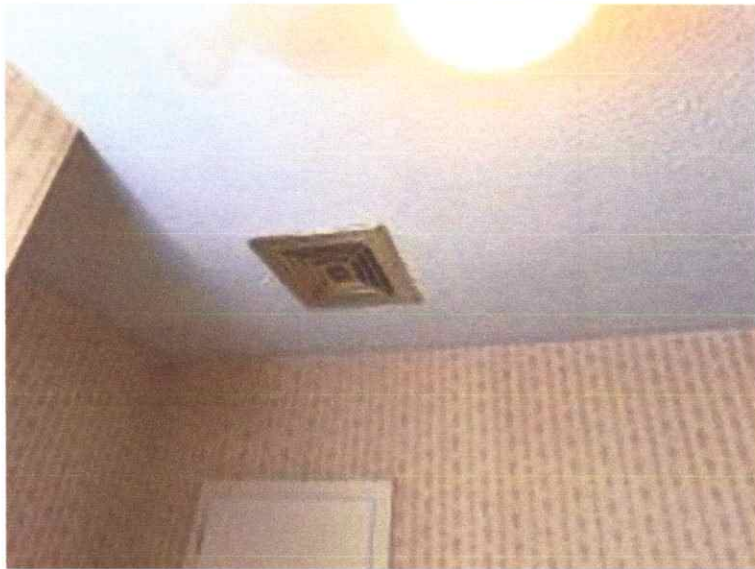
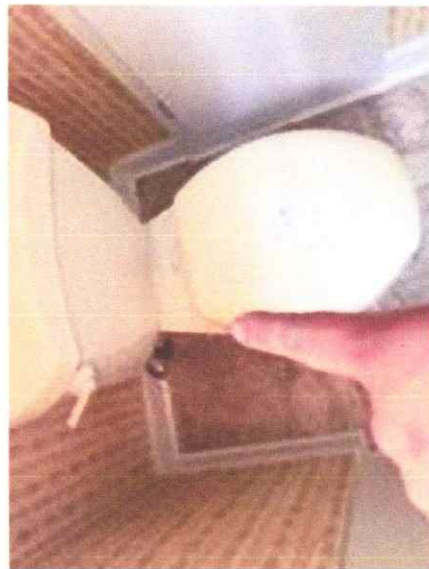
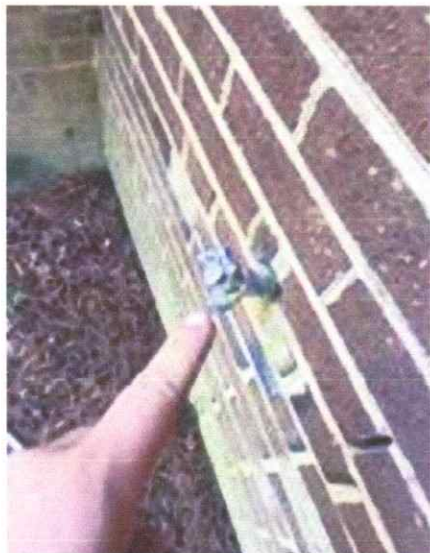
The water heater and well compression tank both are leaking and need replaced. There is also missing shower head from main bathroom, due to water heater leaking hot water could not be tested, leaking hose bib, loose toilet and dripping faucets all should be evaluated and repaired by a licensed plumber.

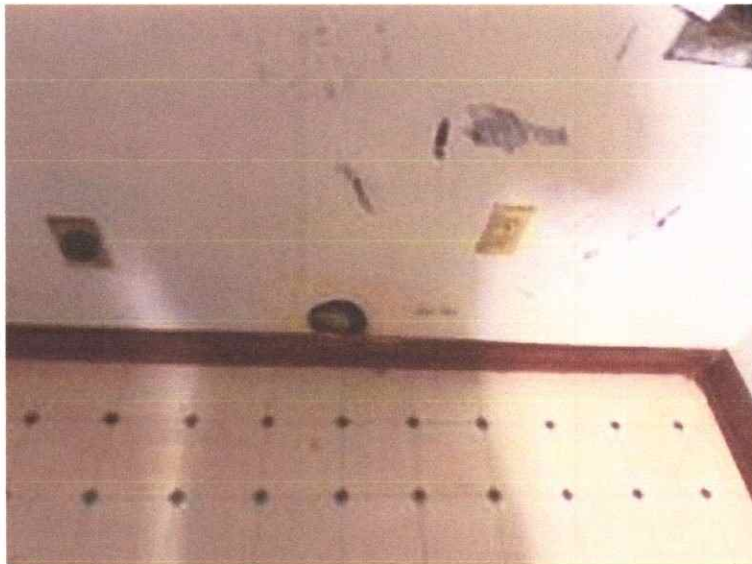
Missing metal through wall transition this will need installed to safely connect dryer.

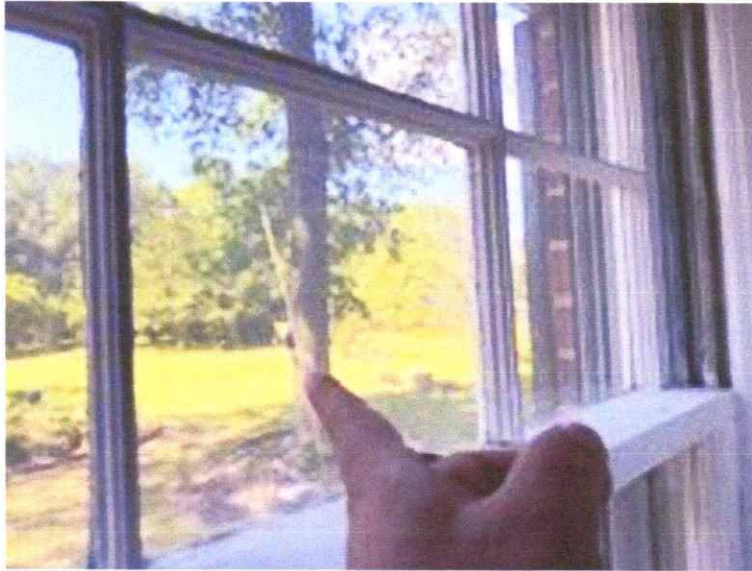
There are a few windows that have broken panes and need repaired and a few that did not operate properly this a safety concern. Consult a specialist for repairs.

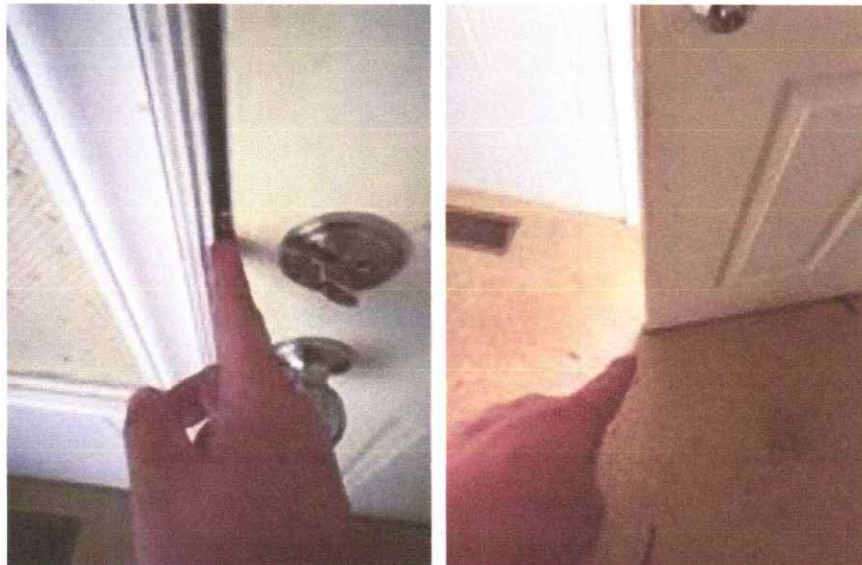
Front door deadbolt did not latch and rubs carpet when opening.

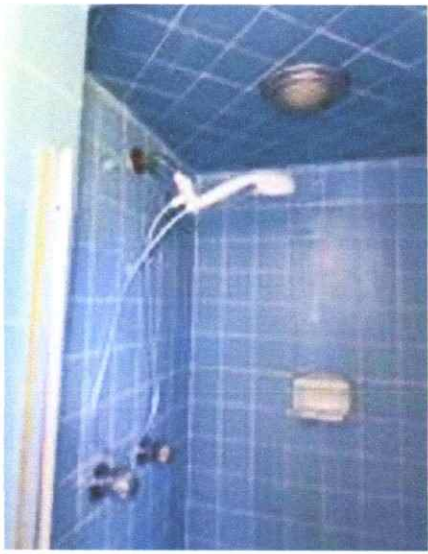
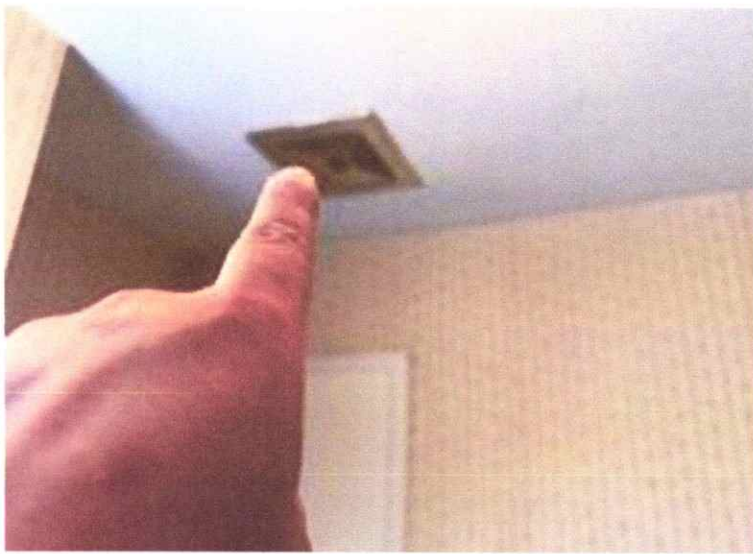
Master bath is not required to have an exhaust if a window can be operated however it is recommended to have one installed to prevent mold and water damage. The main bathroom exhaust is loud and failing it is recommended to replace.
