## SUMMARY

104 Kiowa Cove, Louisburg, NC 27549

Patt Hyatt  
05/19/2026

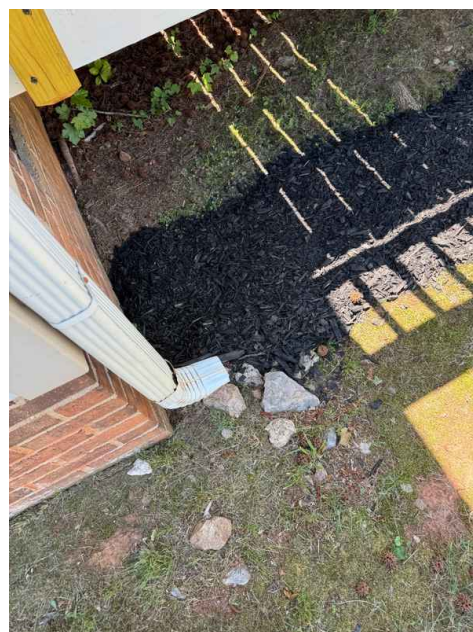
### 2.2.1 Roof Drainage Systems **LACK OF SPLASHBLOCK**

This can allow water accumulation around the foundation, which can pose risk of water entry into the crawlspace. Recommend further evaluation and recommendations for repairs as needed.

Recommendation  
Contact a qualified professional.

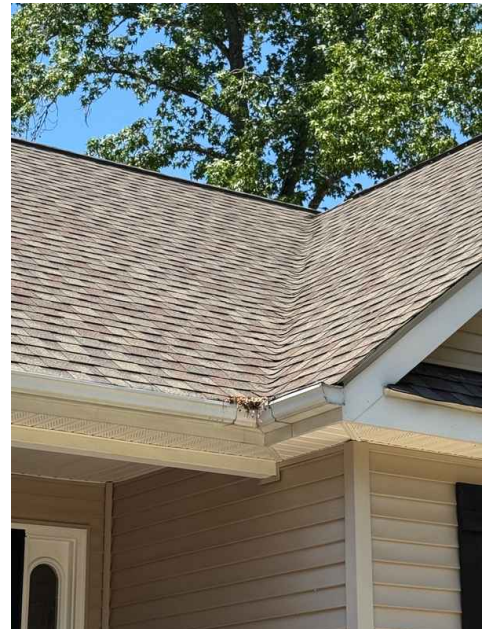
#### DEBRIS ACCUMULATION

Observed debris accumulation within the gutter system. This can cause blockages and risk of backflow to the fascia and eave of the roof. Recommend cleaning/ repair/ servicing as needed.

Contact a qualified professional.

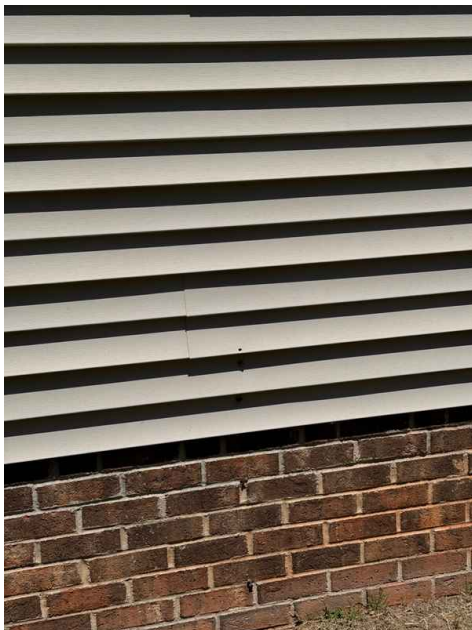
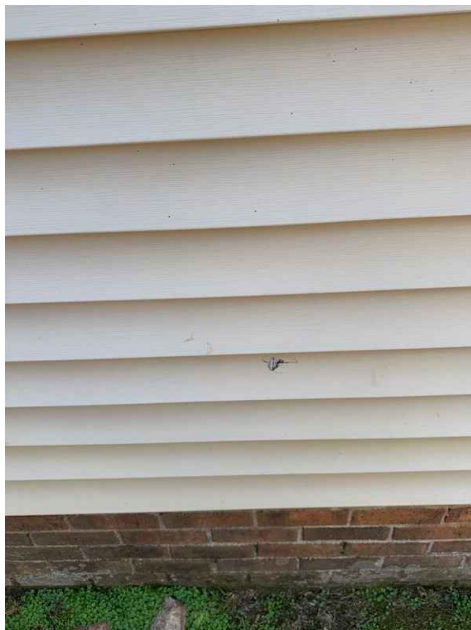
#### PHYSICAL DAMAGE

Physical damage to portions of the siding was observed. This can leave the affected areas susceptible to water infiltration. Recommend further evaluation and recommendations for repairs as needed.

Contact a qualified siding specialist.

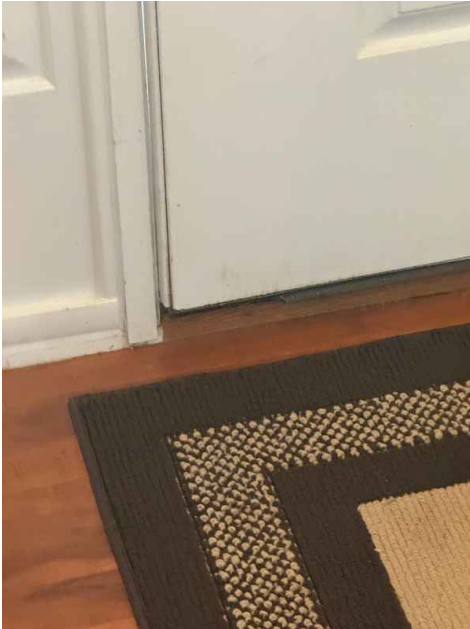
#### DAMAGED WEATHER STRIPPING

This can pose risk of energy loss. Recommend repair as needed.

Contact a qualified professional.

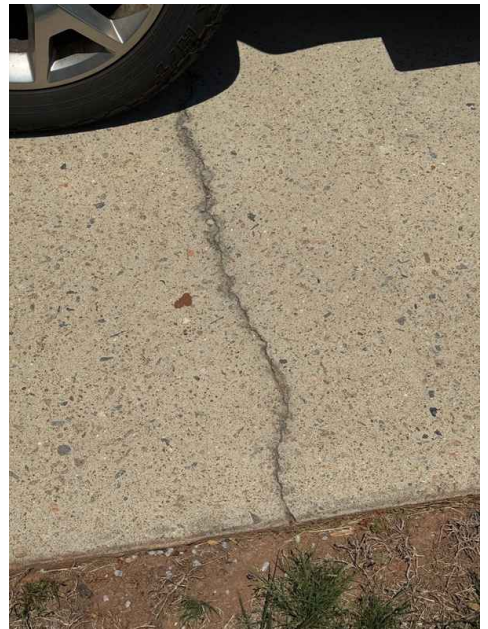
#### CRACKING

Cracking to the driveway concrete was observed. This is typically consistent with shrinkage and settlement. Recommend further evaluation and recommendations for repairs as needed.

Contact a qualified concrete contractor.

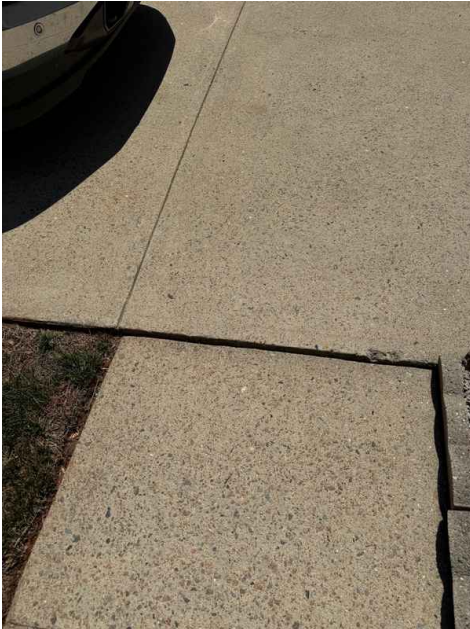
#### TRIP RISK

An upraised portion of concrete between the walkway and driveway was observed. This poses a potential trip risk. Recommend corrections as needed from a concrete contractor

Contact a qualified concrete contractor.

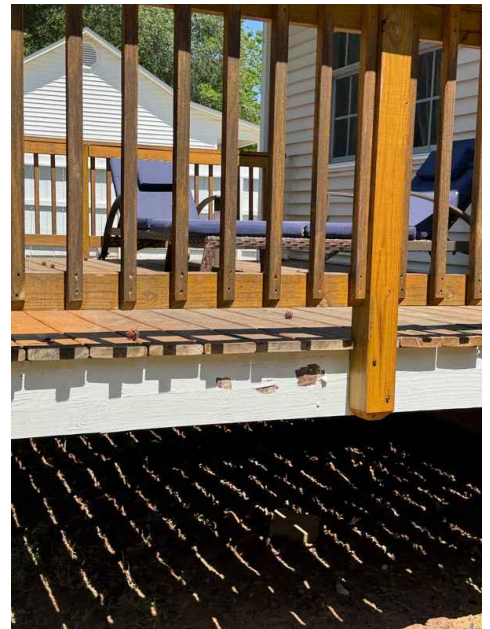
##### PEELING PAINT, SIGNS OF WEATHERING

Peeling paint and signs of weathering was observed to portions of the deck in the home. This condition can worsen with time and pose risk of deterioration. Recommend further evaluation and recommendations for repairs/ corrections from a deck contractor.

Contact a qualified deck contractor.

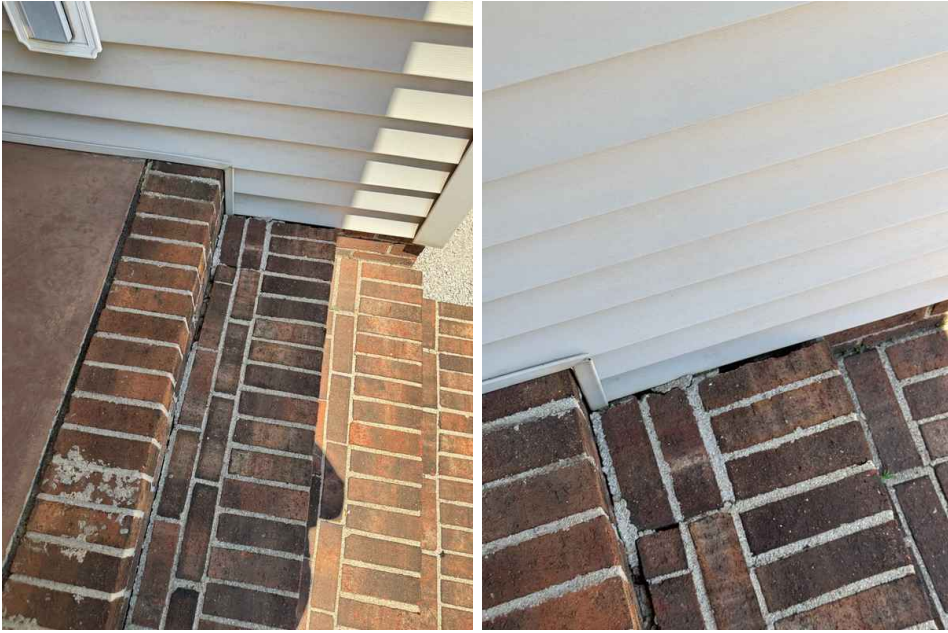
##### MASONRY/ MORTAR DEGRADATION

Masonry and mortar degradation was observed to portions of the front porch. This condition can allow water infiltration, which can cause further damage and degradation over time. Recommend further evaluation and recommendations for repairs/ corrections as needed.

Contact a qualified masonry professional.

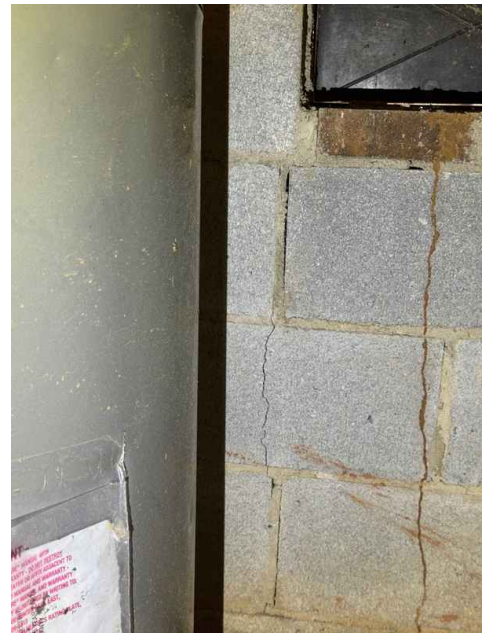
##### **CRACKING**

Cracking to masonry was observed to portions of the foundation wall. This often provides indication of settlement. Recommend monitoring the affected areas.

Recommend monitoring.

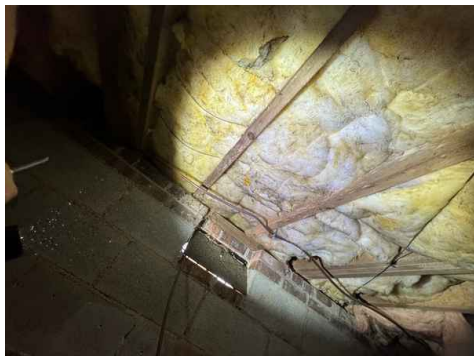
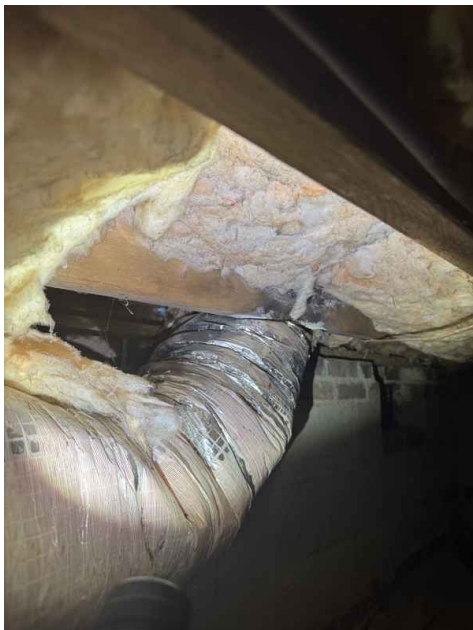
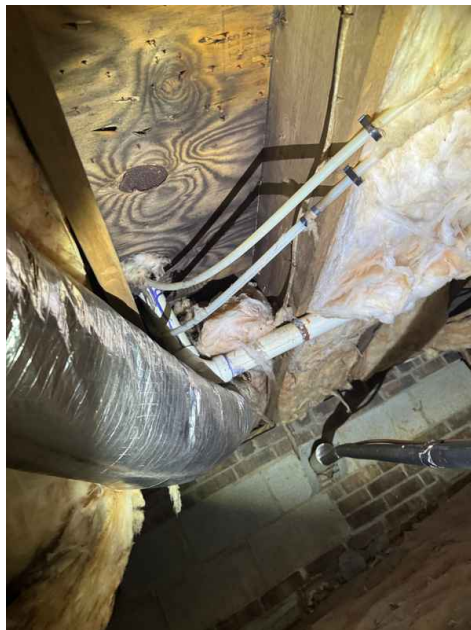
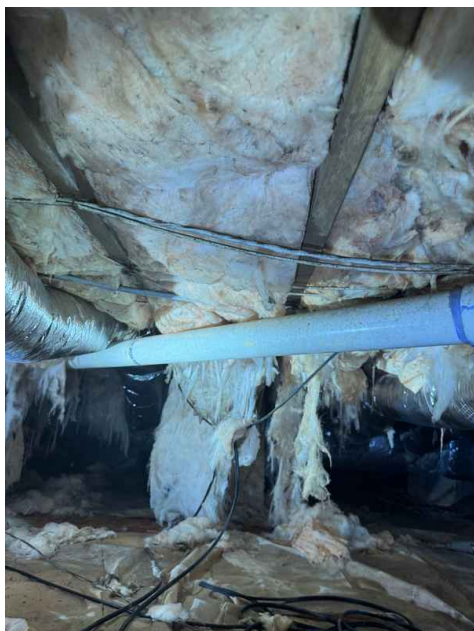
VARIOUS LOCATIONS IN CRAWLSPACE.

##### **EVIDENCE OF GROWTH AND MOISTURE RELATED CONCERNS**

Portions of the floor structure showed signs of organic growth and moisture related concerns such as discoloration and signs of decay. This condition can potentially worsen and spread if left unattended. Recommend further evaluation and recommendations from a licensed general contractor.

Contact a qualified general contractor.

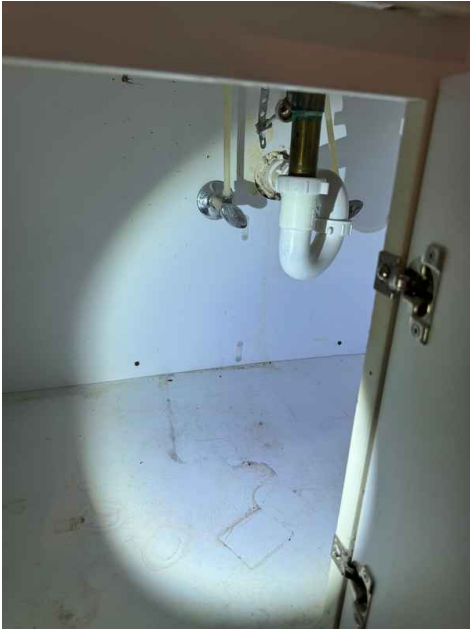
##### BATHROOM

#### STAINING

Staining around the noted drain line was observed. This condition may potentially provide indication of leak development. Recommend further evaluation and recommendations for repairs as needed.

Contact a qualified plumbing contractor.

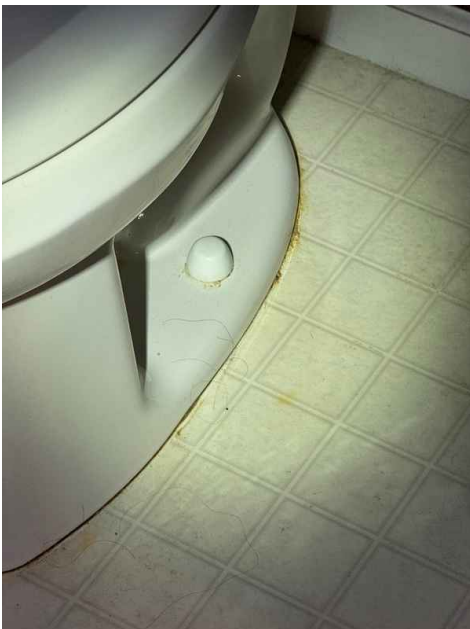
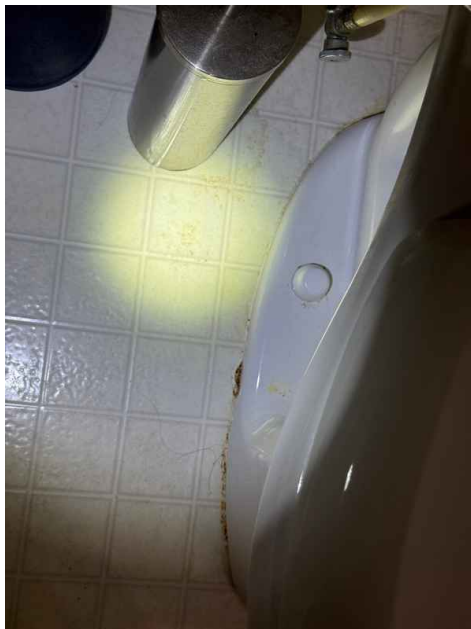
##### MASTER BATHROOM

#### **LACK OF SEALANT AND STAINING AROUND TOILET BASE**

A lack of sealant was observed around the toilet base and staining was apparent around the base. This may potentially indicate leak development, which can pose risk of damage to the floor and floor structure. Recommend further evaluation and recommendations for repairs as needed.

Contact a qualified professional.

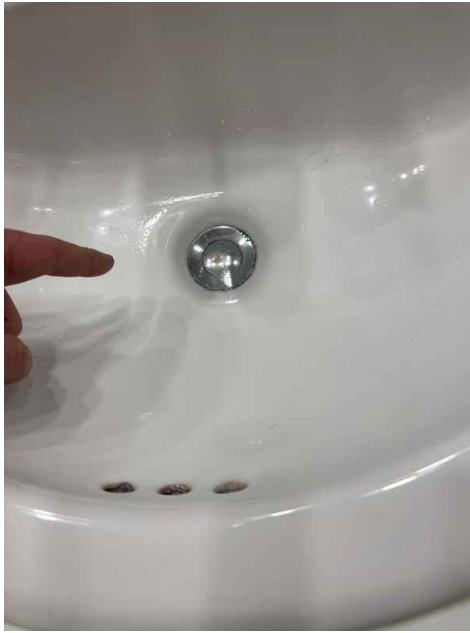
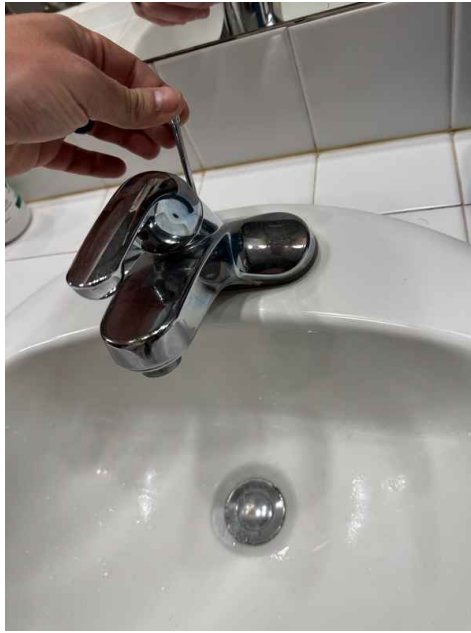
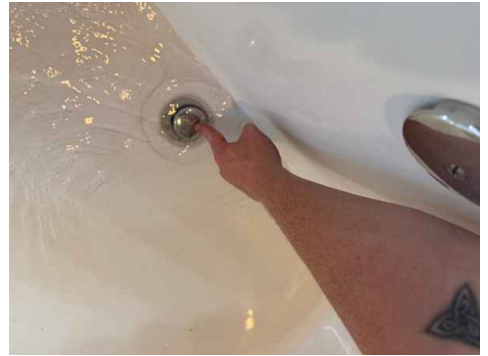
##### VARIOUS LOCATIONS.

#### **STOPPER NOT FUNCTIONAL**

Various stoppers were not functional at the time of the inspection. This condition inhibits functional use of the stoppers. Recommend repair/ correction as needed.

Recommendation  
Contact a qualified professional.

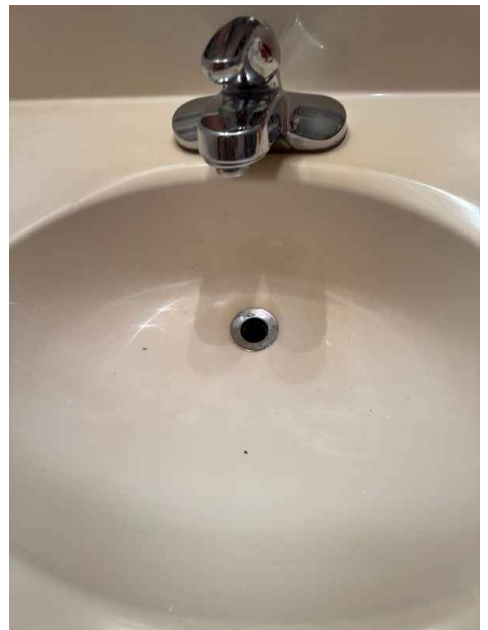
##### MISSING STOPPER

A sink stopper was found to be missing. This inhibits use of the stopper. Recommend evaluation and repair/ correction as needed.

Recommendation  
Contact a qualified professional.

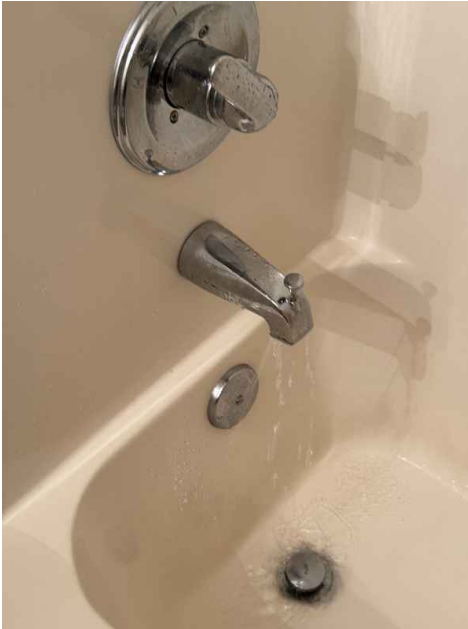
##### DIVERTER LEAK

This can inhibit functional use of the shower. Recommend evaluation and repair/ correction.

Recommendation  
Contact a qualified professional.

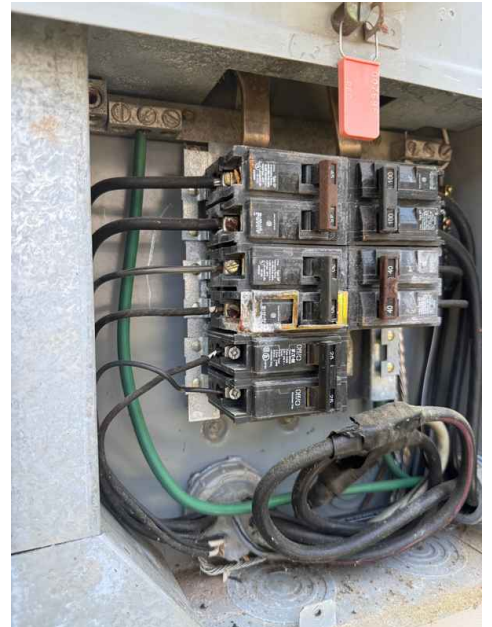
#### **CORROSION**

Corrosion to the breakers and portions of the main panel was observed. This condition may indicate water exposure, which can pose an electrical safety risk. Further evaluation and recommendations should be made from a licensed electrical contractor.

Contact a qualified electrical contractor.

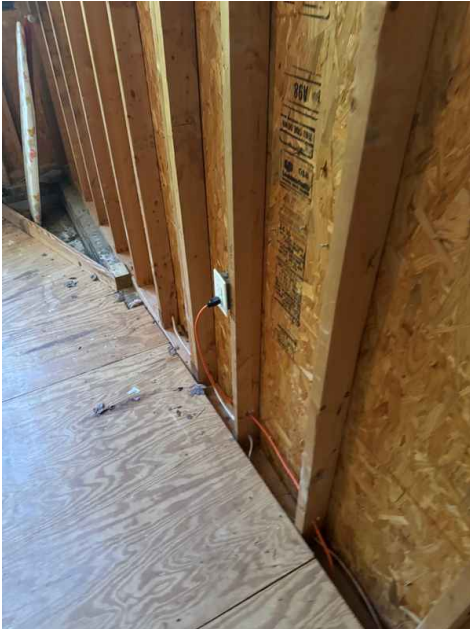
#### GARAGE

#### **PERMANENT DROP CORD EXTENSION**

A drop cord was found to be in use as a permanent extension. This is typically considered an unsafe practice. Contact an electrical contractor for further evaluation and recommendations for repairs as needed.

Contact a qualified electrical contractor.

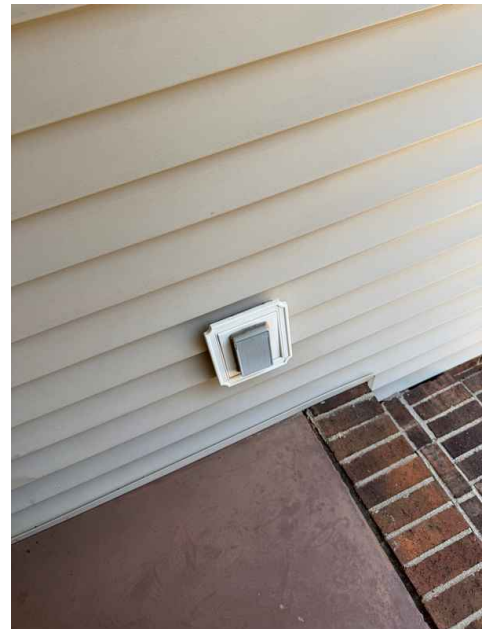
##### **OUTDATED RECEPTACLE COVERS**

Receptacle covers were found to be outdated. This poses a potential risk for rain water exposure. Recommend contacting an electrical contractor to evaluate in further detail and make repairs/ updates as needed.

Contact a qualified electrical contractor.

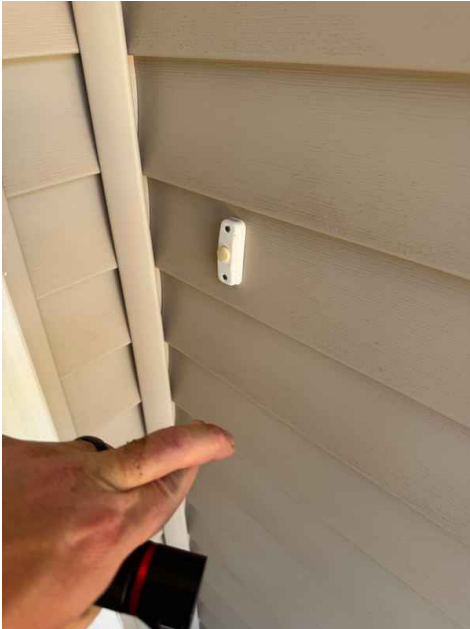
##### **DOORBELL NOT FUNCTIONAL**

The doorbell did not function as intended. This is a normal maintenance item. Recommend repair as needed.

Contact a qualified professional.

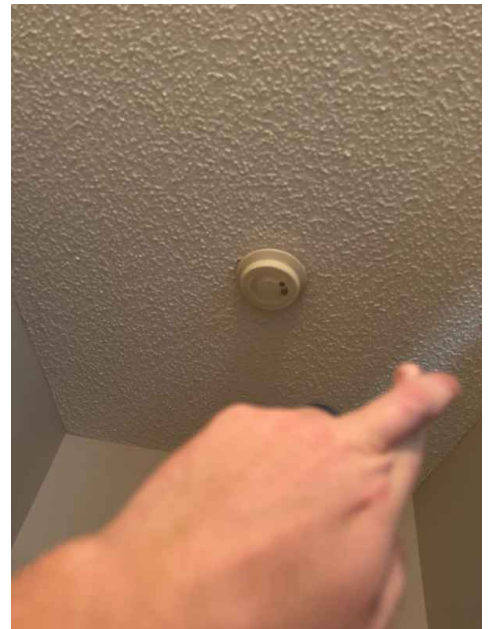
#### 8.6.1 Smoke & CO Detector **NOT OPERATIONAL**

This poses a fire safety risk. Recommend evaluation and repair/ replacement as needed.

Contact a qualified electrical contractor.

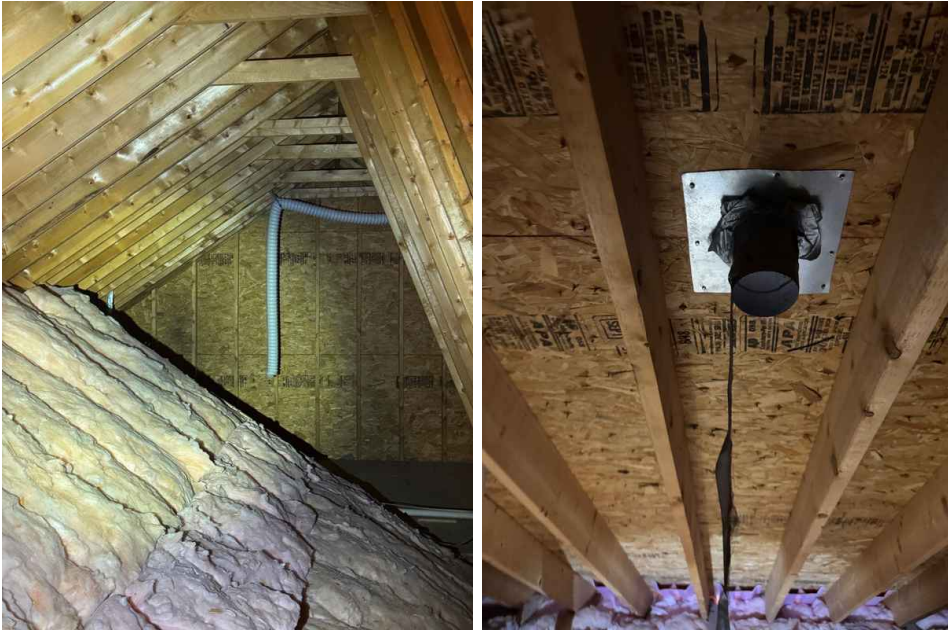
ATTIC

#### 10.4.1 Exhaust Systems **DISCONNECTED VENT**

The bathroom vent was observed to be disconnected. This can allow bathroom discharge into the attic space, which can cause elevations in humidity/ moisture. Further evaluation and recommendations should be made from a qualified contractor.

Contact a qualified professional.

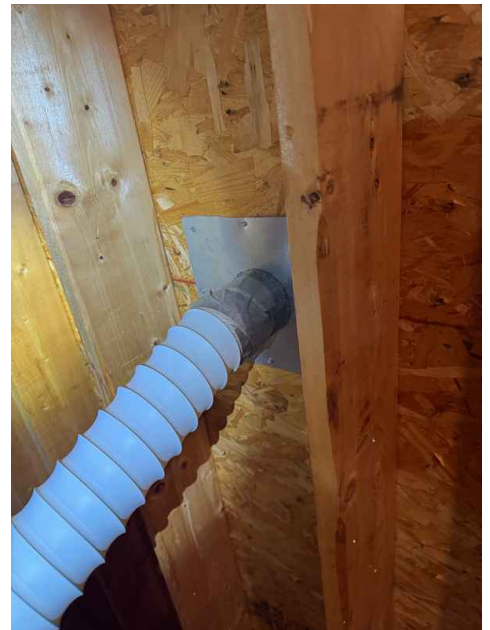
##### USE OF TAPE

Bathroom vents were found to be secured with tape. This can lead to disconnection. Recommend correction.

Contact a qualified professional.

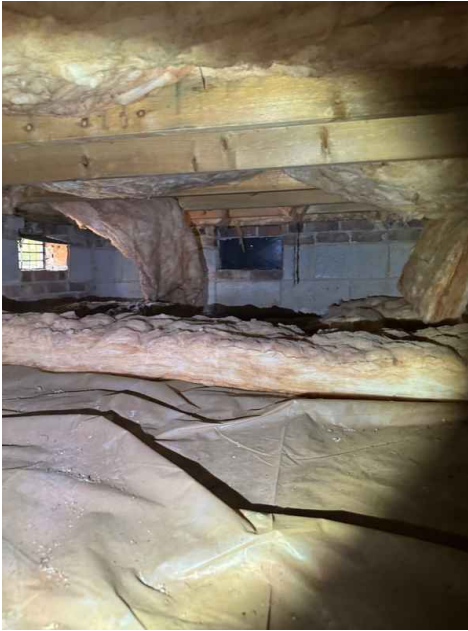
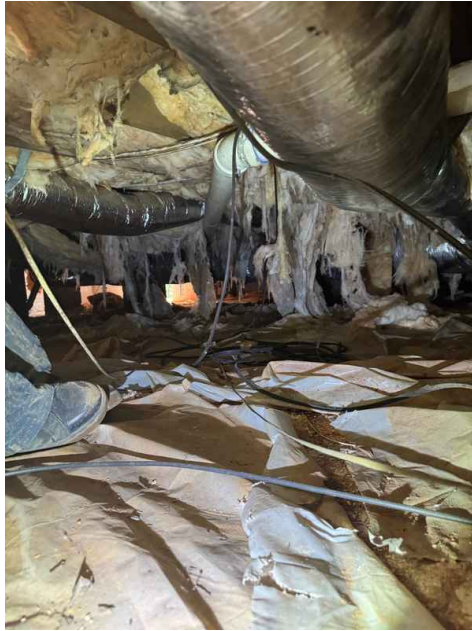
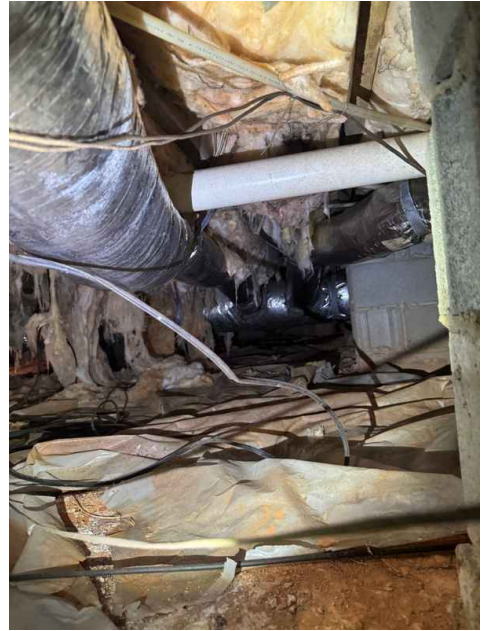
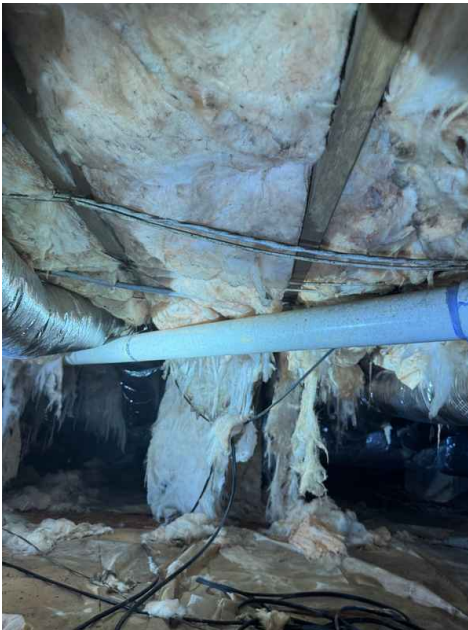
##### DAMAGED, FALLEN AND STRINGING INSULATION

Damaged, fallen and stringing insulation was observed throughout the crawlspace. This condition can potentially indicate elevations in moisture levels and can cause losses in energy efficiency. Recommend further evaluation and recommendations for repairs/ corrections as needed.

Contact a qualified professional.

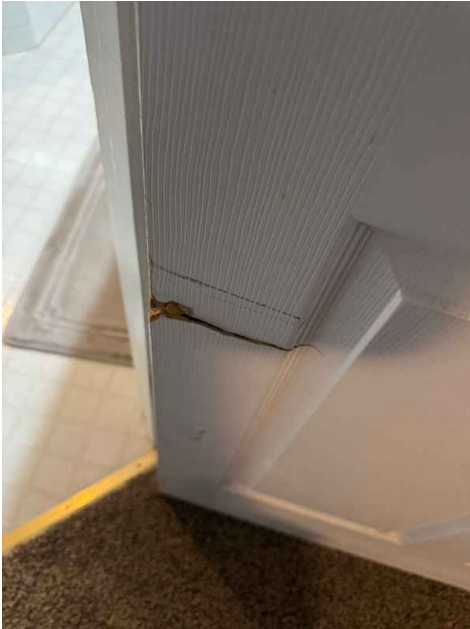
### PHYSICAL DAMAGE

This is a normal maintenance item. Recommend evaluation and recommendations for repairs as needed.

Contact a qualified professional.

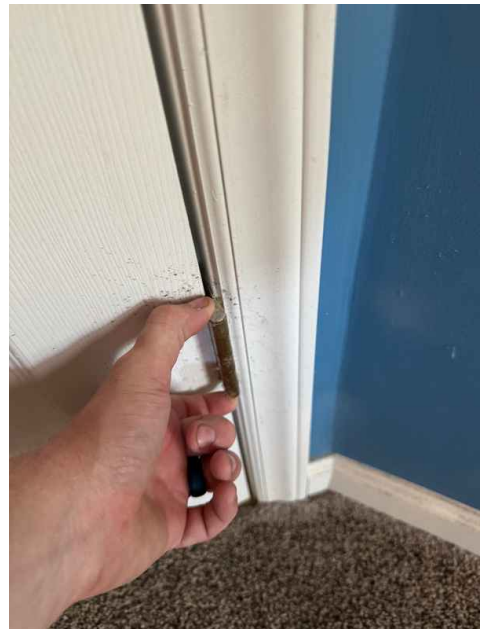
#### LOOSE DOOR HINGE

This condition can lead to door damage. Recommend repair as needed.

Contact a qualified professional.

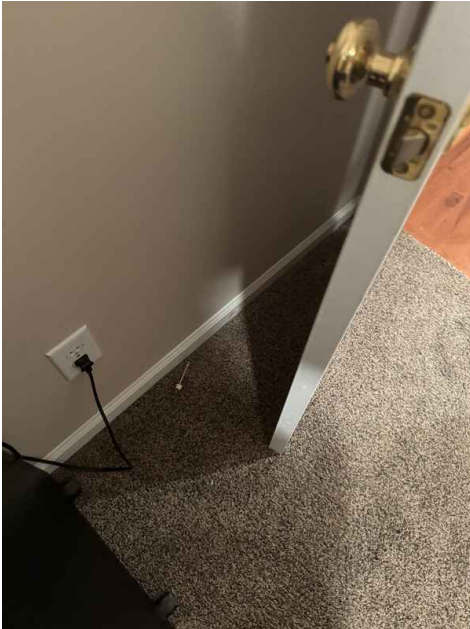
#### DAMAGED STOPPERS

This is a normal maintenance item. Recommend repair as needed.

Contact a qualified professional.

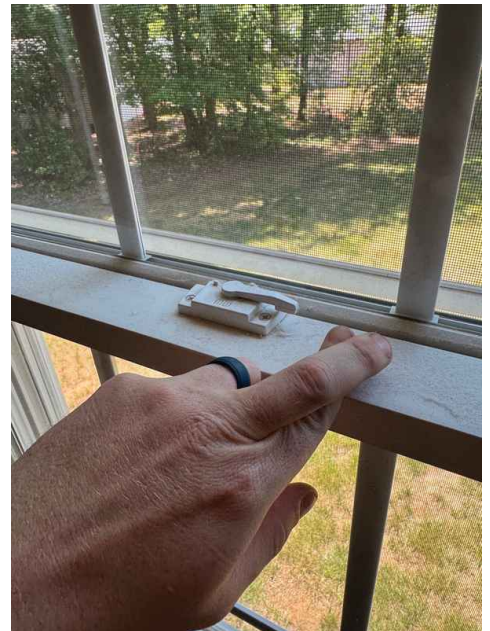
#### DIFFICULT LATCHING/ OPERATION

Some of the windows were found to be difficult to latch/ operate. This inhibits functional use. Recommend evaluation and repair as needed.

Contact a qualified window repair/installation contractor.

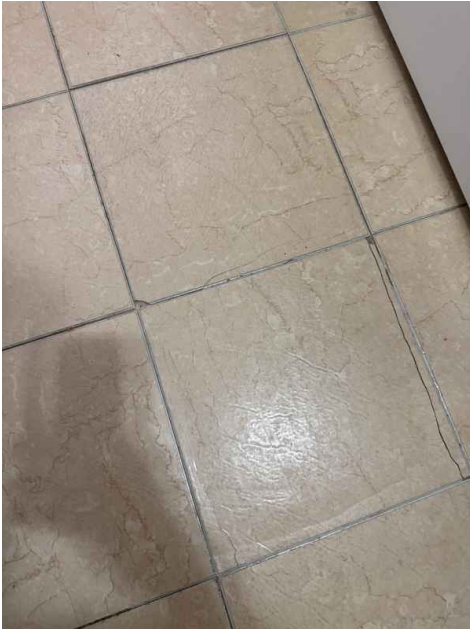
##### LAUNDRY

#### CRACKING TO TILE AND GROUT

This condition can worsen with time and pose risk of further damage. Recommend evaluation and repair as needed.

Contact a qualified professional.

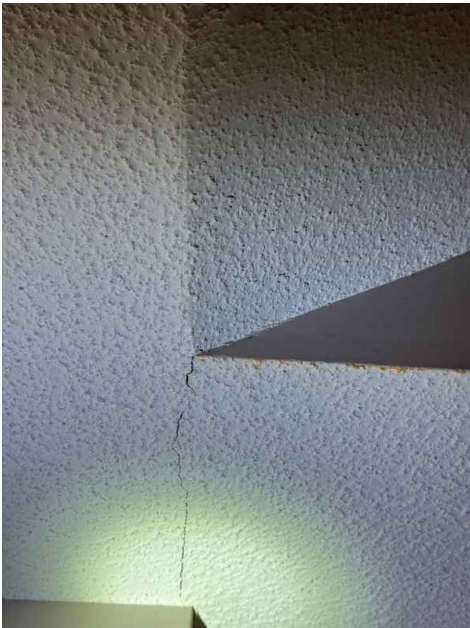
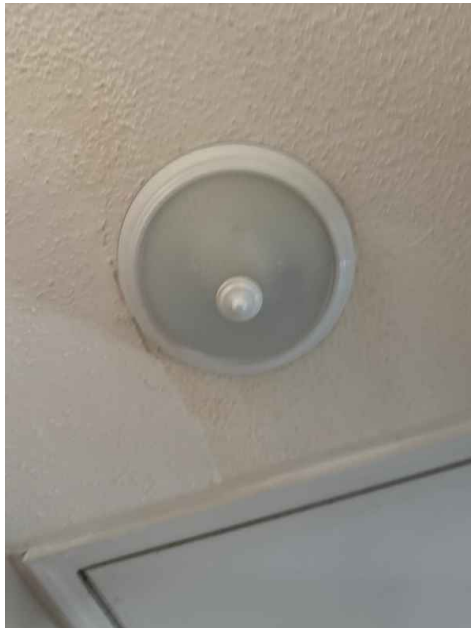
##### **CRACKING**

Cracking to the ceiling was observed. This condition often occurs from settlement. Recommend repair as needed.

Contact a qualified professional.

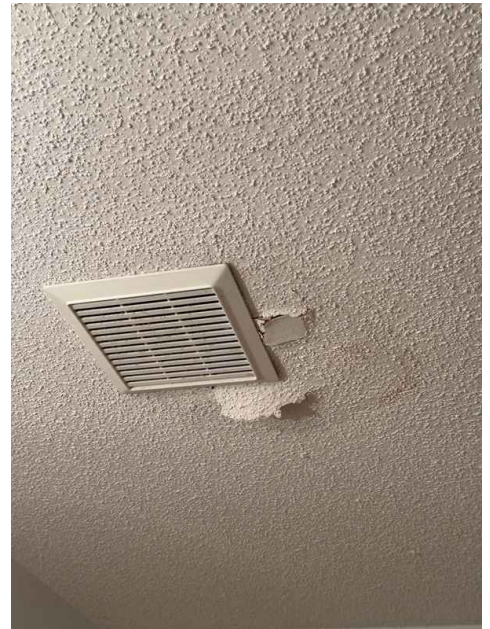
##### BATHROOM.

##### **STAINING/ DELAMINATION**

Staining and delamination was observed around the bathroom vent. This condition may indicate moisture/ humidity buildup or exposure. Recommend further evaluation and recommendations for repair as needed.

Recommendation  
Contact a qualified professional.

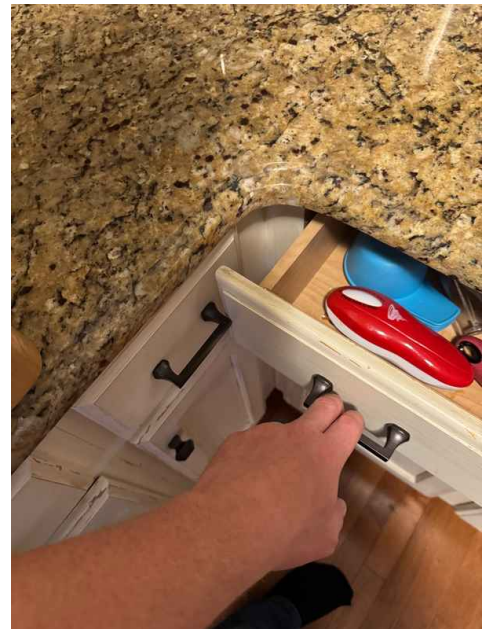
##### **CONTACT/ RESTRICTION**

This is a normal maintenance item. Recommend evaluation and repair as needed

Recommendation  
Contact a qualified professional.

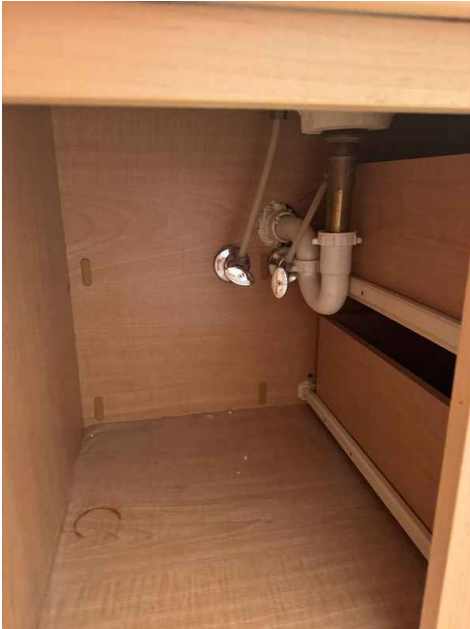
BATHROOM

##### **WARPING TO CABINETRY**

This may potentially indicate moisture exposure. Recommend repair as needed.

Recommendation  
Contact a qualified professional.

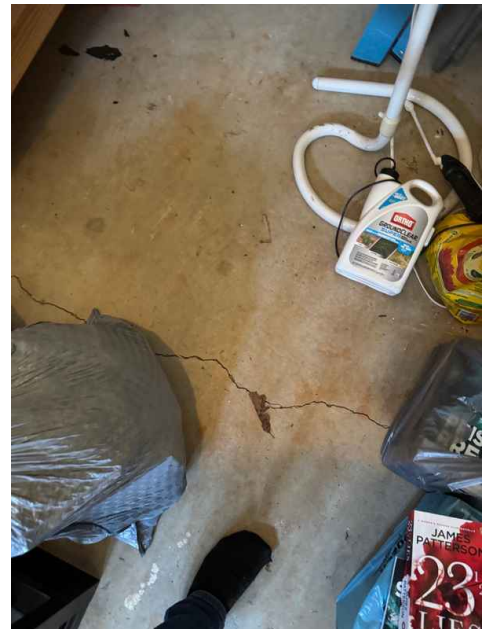
### 13.2.1 Floor **CRACKING**

Cracking to the garage floor was observed. This condition often occurs from settlement/ movement and shrinkage. Recommend evaluation and repair as needed.

Recommendation  
Contact a qualified professional.

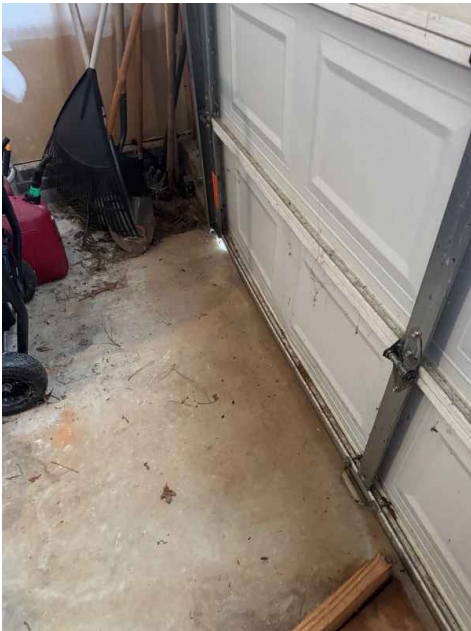
### 13.4.1 Garage Door **APPARENT DAMAGE**

Apparent damage to the garage door was observed. This condition can inhibit functional use. Recommend repair as needed.

Recommendation  
Contact a qualified professional.
