## OFFICIAL NORTH CAROLINA WOOD-DESTROYING INSECT INFORMATION REPORT

1. Seller's Name(s) \_\_\_\_\_  
Buyer's Name(s) SECU\*RE  
Address of Property 235 Joe Ayscue Rd Henderson, NC 27537  
Structure(s) Inspected: A. Main Residence Only Main B. Other \_\_\_\_\_

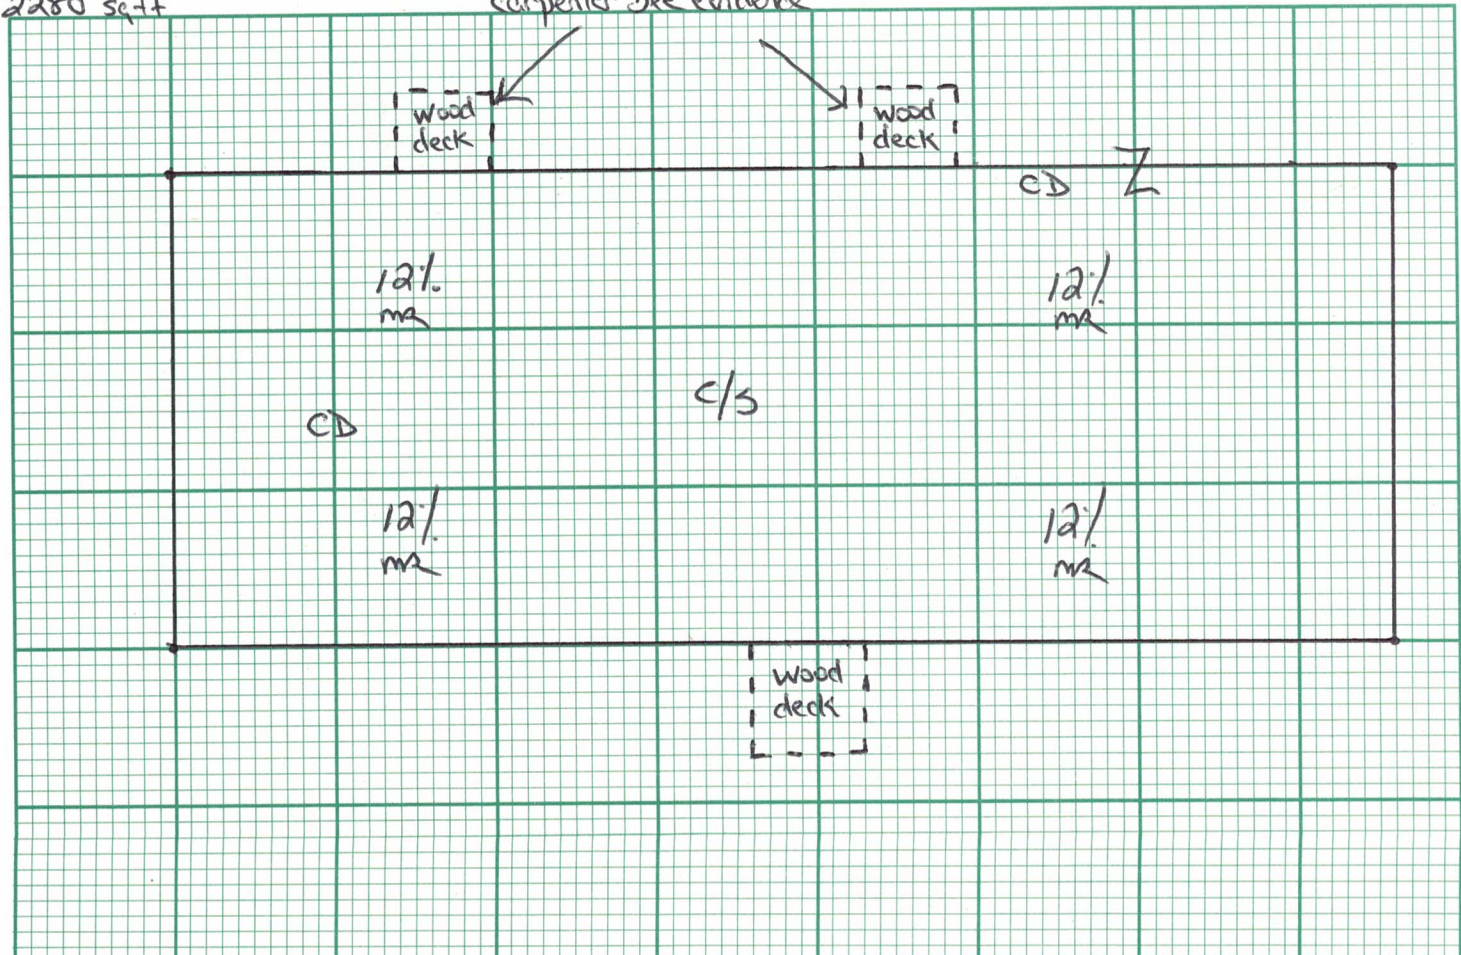
- ☒ D. Others Carpenter Bees
- ☐ 1. Control measures were performed.
- ☐ 2. No control measures were performed.
- ☐ 3. An infestation which now appears to be inactive.

Evidence found in wooden members on both small decks on rear of structure.

5. The following conditions conducive to subterranean termites were noted in this property: cellulose debris noted in crawl space.

carpenter bee evidence
