## HOME INSPECTION REPORT

Luis Turner Inspections, LLC

235 Joe Ayscue Road

Henderson NC 27537

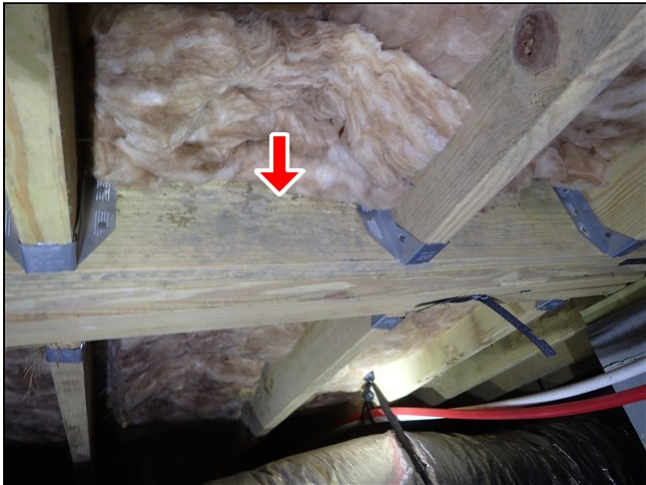
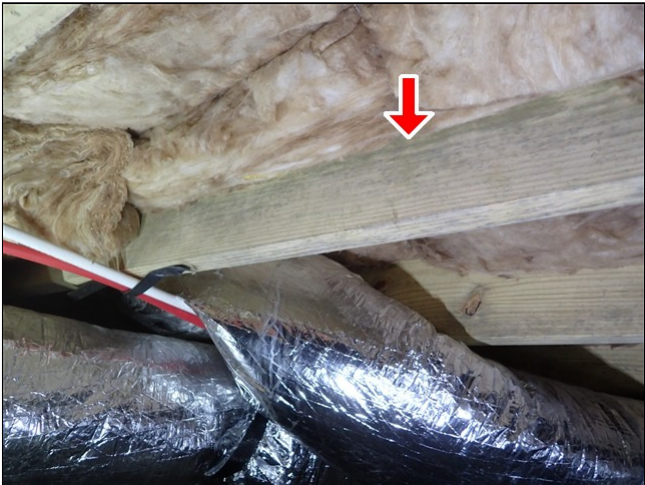
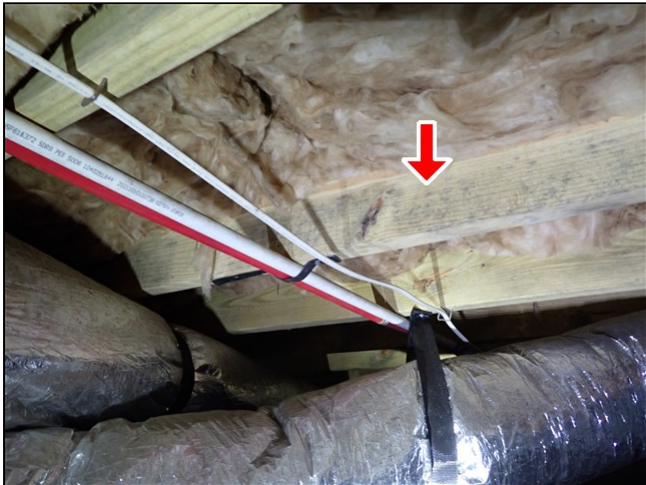
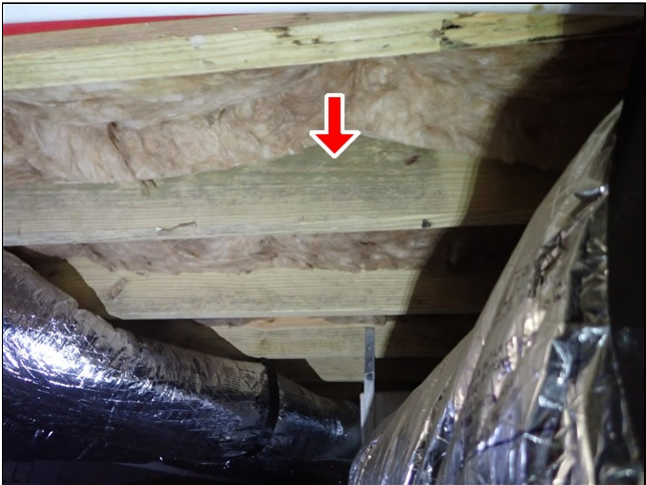
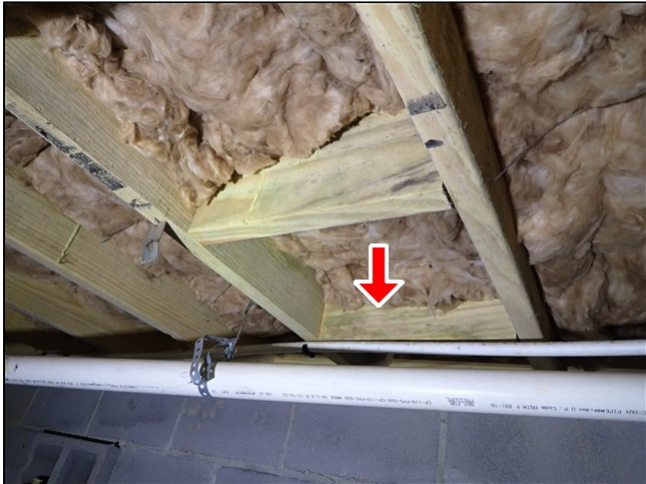
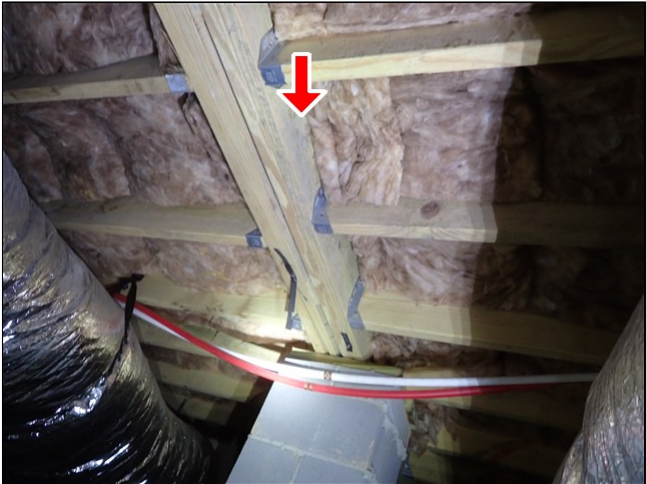
- 1 (1) Fungal growth is noted on wooden floor system in crawl space. See examples in photographs below. Further examination may reveal other areas of fungal growth on the crawl space floor system. The characterization of fungal growth and the possible impact on human health are beyond the scope of this inspection. The presence of this type of growth does indicate a moisture problem. A qualified contractor can address the presence of fungal growth. If the client has concerns regarding the presence of fungal growth, an industrial hygienist can evaluate the home, provide further information, and make recommendations as needed.

(1) Fungal growth is noted on wooden floor system in crawl space. See examples in photographs below. Further examination may reveal other areas of fungal growth on the crawl space floor system. The characterization of fungal growth and the possible impact on human health are beyond the scope of this inspection. The presence of this type of growth does indicates a moisture problem. A qualified contractor can address the presence of fungal growth. If the client has concerns regarding the presence of fungal growth, an industrial hygienist can evaluate the home, provide further information, and make recommendations as needed.

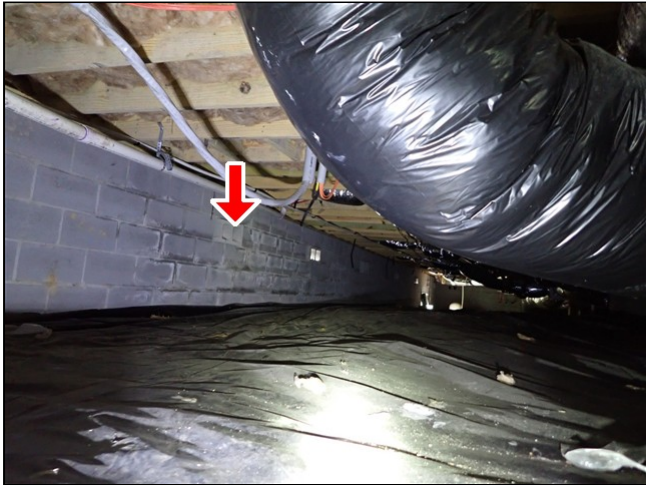
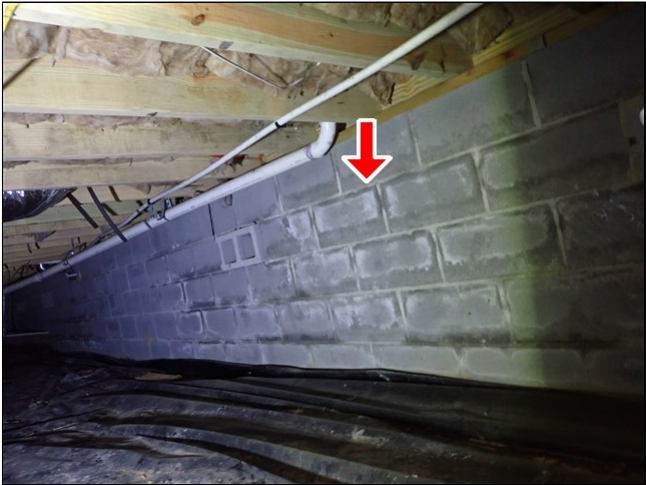
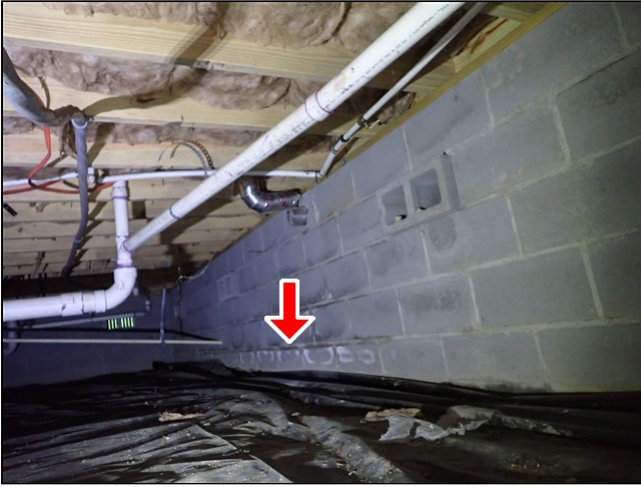
- 2 (2) Efflorescence (a white chalky residue) is noted on interior masonry wall at rear of crawl space. See examples in photographs below. The presence of efflorescence is associated with intrusion of water through the foundation walls. If the client wants additional information about this condition, a waterproofing contractor can evaluate, provide further information and perform repairs as needed.

(2) Efflorescence (a white chalky residue) is noted on interior masonry wall at rear of crawl space. See examples in photographs below. The presence of efflorescence is associated with intrusion of water through the foundation walls. If the client wants additional information about this condition, a waterproofing contractor can evaluate, provide further information and perform repairs as needed.

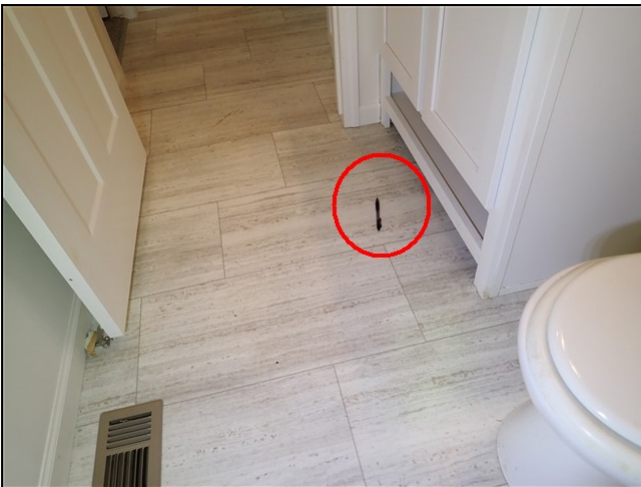
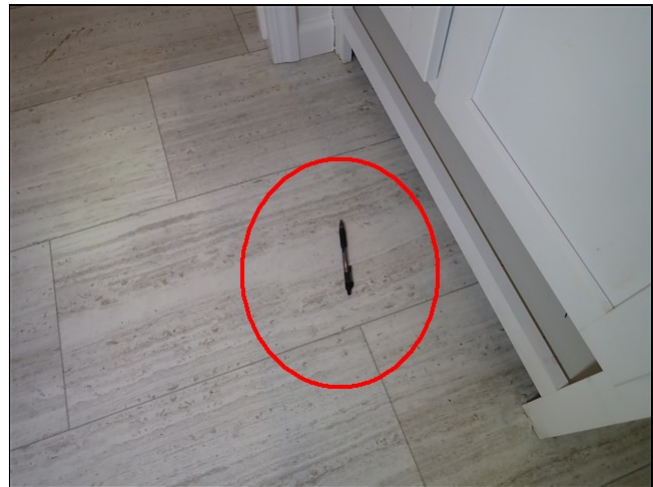
- 3 Subfloor yields to foot pressure in hall bathroom at front of vanity cabinet. See photographs below. Efforts to probe this area of subfloor in crawl space does not reveal damaged subfloor at time of inspection, but there is an issue that needs further evaluation. A qualified contractor can evaluate, provide further information and perform repairs as needed.

Subfloor yields to foot pressure in hall bathroom at front of vanity cabinet. See photographs below. Efforts to probe this area of subfloor in crawl space does not reveal damaged subfloor at time of inspection, but there is an issue that needs further evaluation. A qualified contractor can evaluate, provide further information and perform repairs as needed.

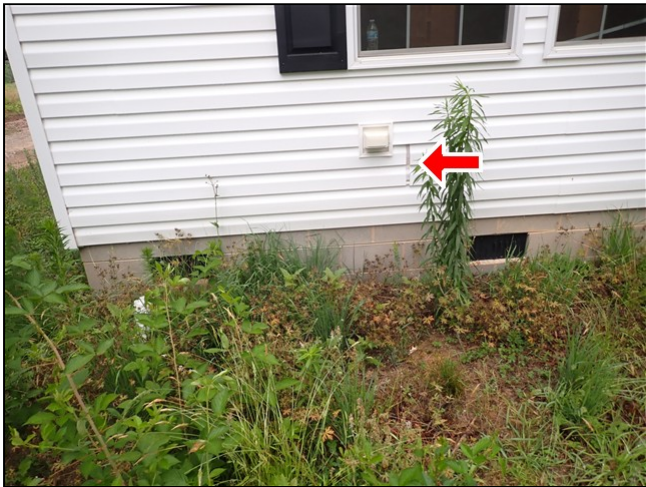
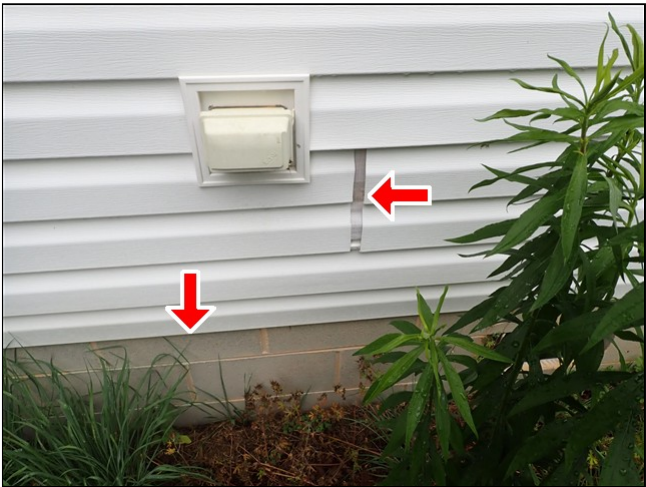
- 4 (1) A gap is noted between pieces of vinyl siding at front wall of house under master bedroom window toward left side of house. See photographs below. A qualified contractor can perform repairs.

**Comments:** Repair or Replace  
(1) A gap is noted between pieces of vinyl siding at front wall of house under master bedroom window toward left side of house. See photographs below. A qualified contractor can perform repairs.

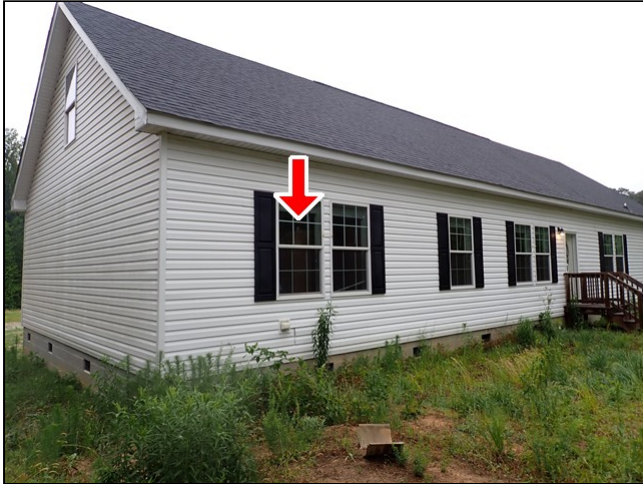
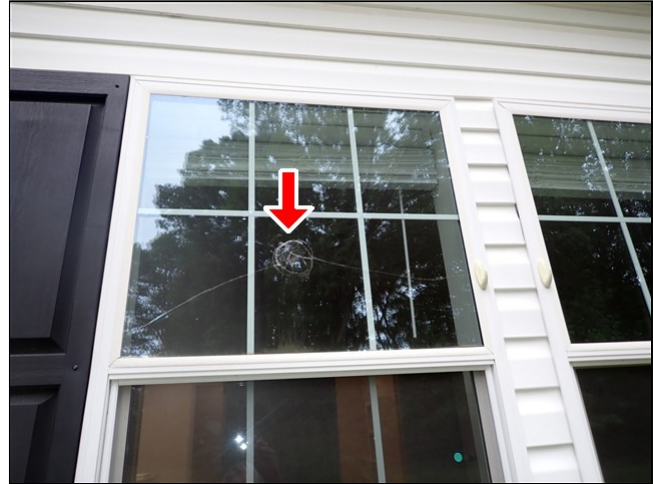
- 6 A round hole is noted at broken outer glass at upper sash of master bedroom window towards left side of house. See photographs below. A qualified contractor can perform repairs.

A round hole is noted at broken outer glass at upper sash of master bedroom window towards left side of house. See photographs below. A qualified contractor can perform repairs.

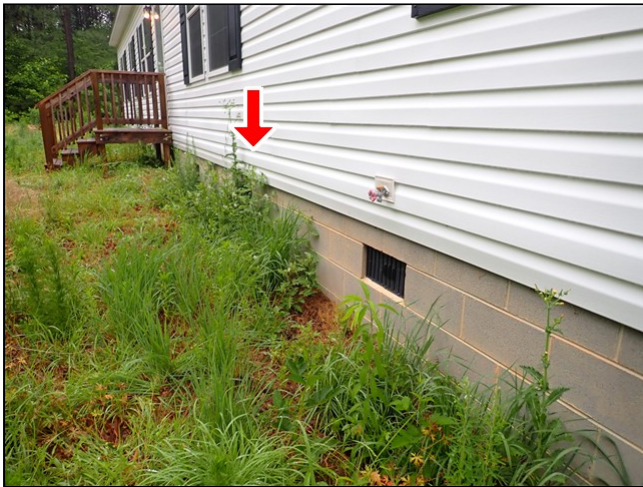
- 7 Vegetation is too close at front of house. See photograph below. The vegetation allows moisture to accumulate on building components and also provides a pathway for insects and other pests to enter the structure. A qualified contractor can perform repairs.

Vegetation is too close at front of house. See photograph below. The vegetation allows moisture to accumulate on building components and also provides a pathway for insects and other pests to enter the structure. A qualified contractor can perform repairs.

2.4 Item 1(Picture) Vegetation too close to house

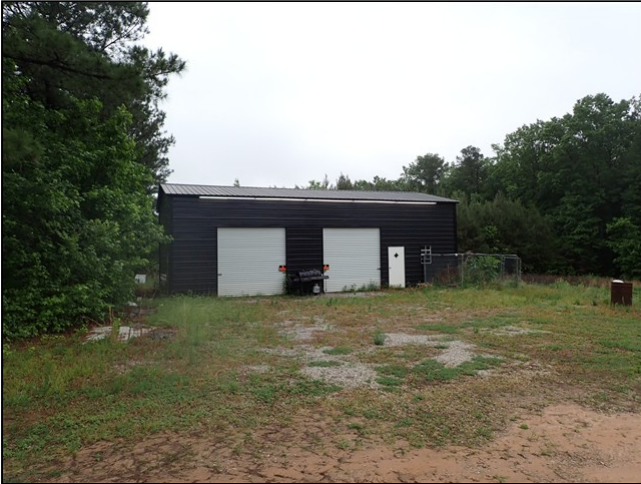
Detached garage is locked and cannot be fully evaluated. See photograph below. This comment is for your information.

2.7 Item 1(Picture) Detached garage

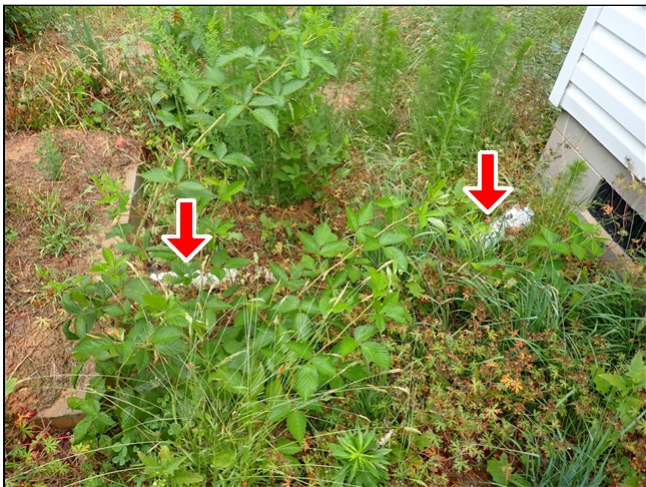
**Comments:** Repair or Replace  
(1) Septic drain pipe is exposed between foundation wall and septic tank at front of house. See photograph below. Pipe should be covered to protect against freezing and possible damage. A qualified contractor can perform repairs.

4.0 Item 1(Picture) Exposed drain pipe

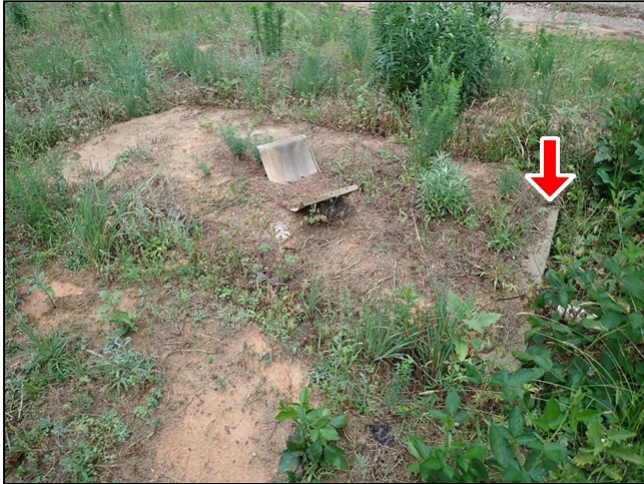
(2) Top of septic tank is exposed at front of house. See photograph below. The tank should be covered to protect against possible damage. A qualified contractor can perform repairs.

4.0 Item 2(Picture) Exposed top of septic tank

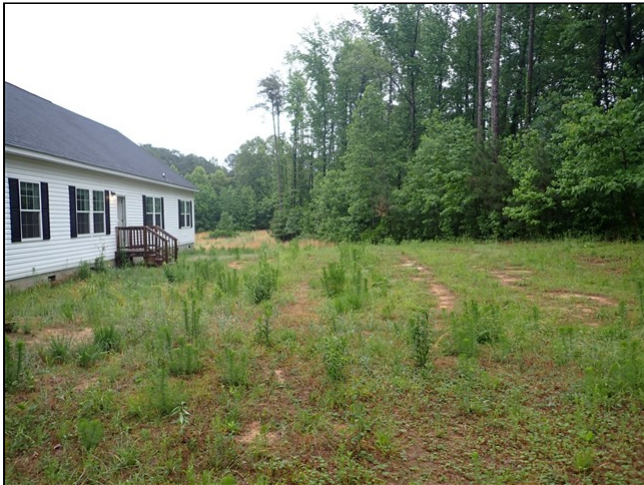
(3) The septic drain field is located in front yard. Vehicles may have driven on the drain field. See photograph below. If further information is needed, a licensed septic system contractor can evaluate the septic system, provide further information, and perform repairs as needed.

4.0 Item 3(Picture) Septic drain field

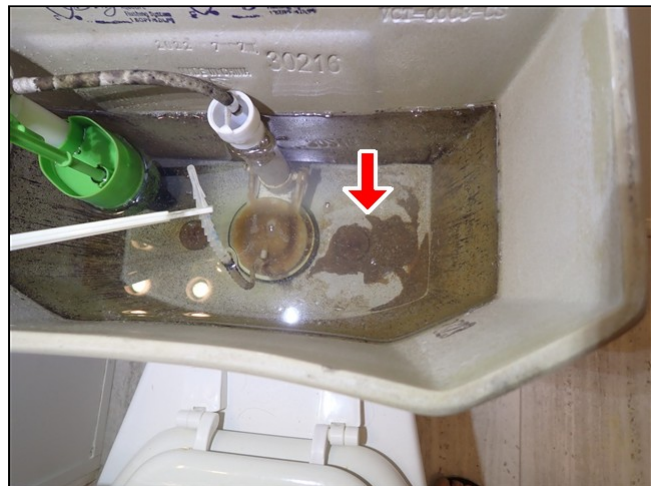
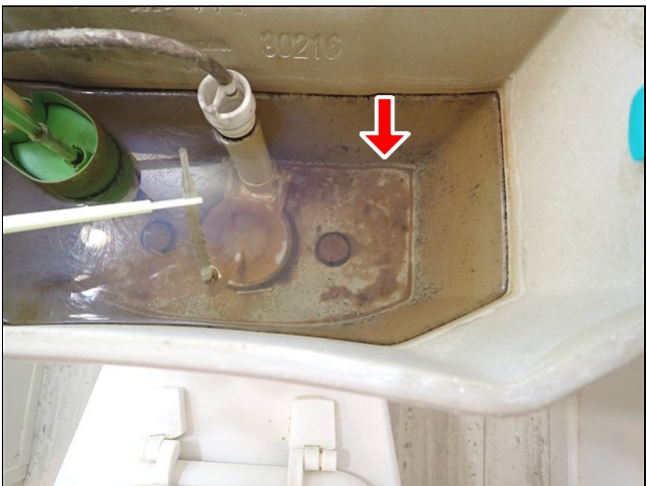
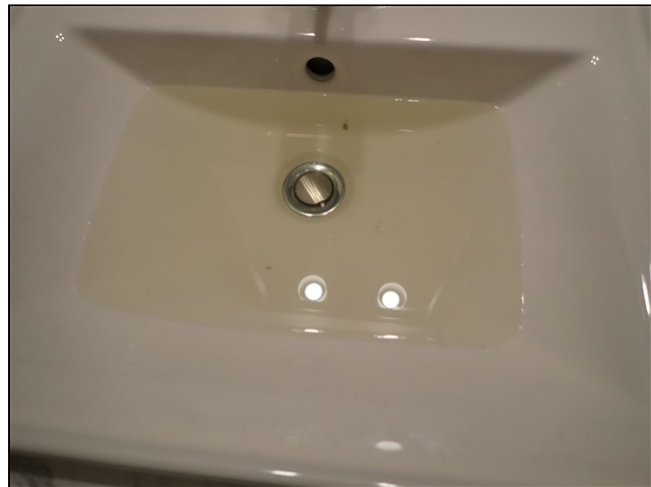
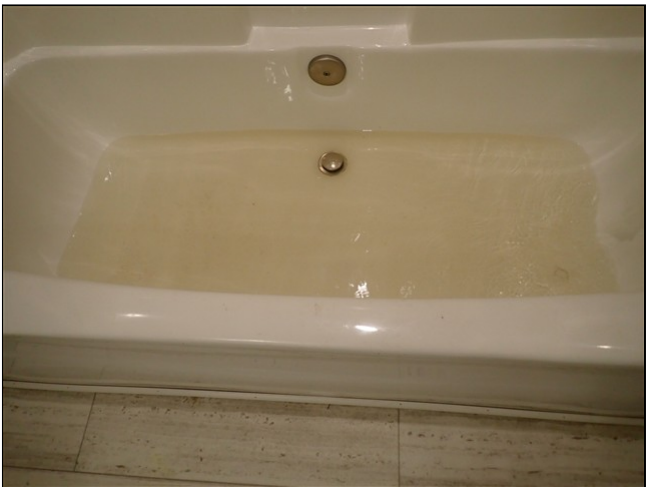
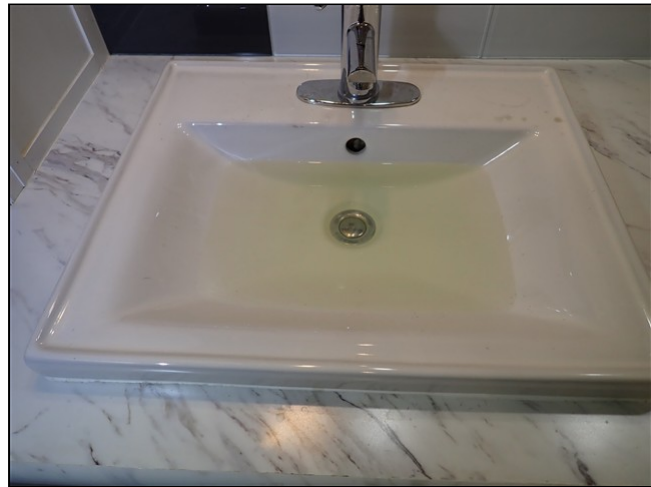
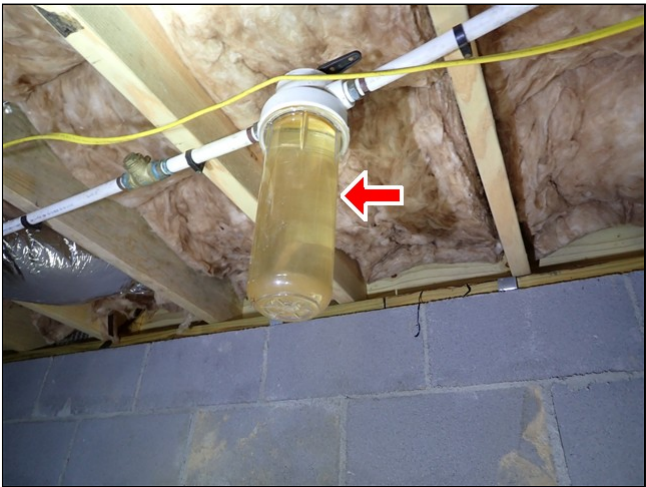
- 11 (1) Sediment is noted in each of the toilet tanks. Light brown water is noted in plumbing fixtures. This condition may be due to the absence of a sediment filter cartridge in the sediment filter case. See examples in photographs below. The abrasive quality of sediment particles can damage soft plumbing parts. A qualified contractor can perform repairs.
- 12 (2) Although the well provided water during the inspection, the water supply well is not part of the home inspection report. See photographs below. If more information is needed, a qualified contractor can evaluate the well system, provide further information, and perform repairs as needed.

(1) Sediment is noted in each of the toilet tanks. Light brown water is noted in plumbing fixtures. This condition may be due to the absence of a sediment filter cartridge in the sediment filter case. See examples in photographs below. The abrasive quality of sediment particles can damage soft plumbing parts. A qualified contractor can perform repairs.

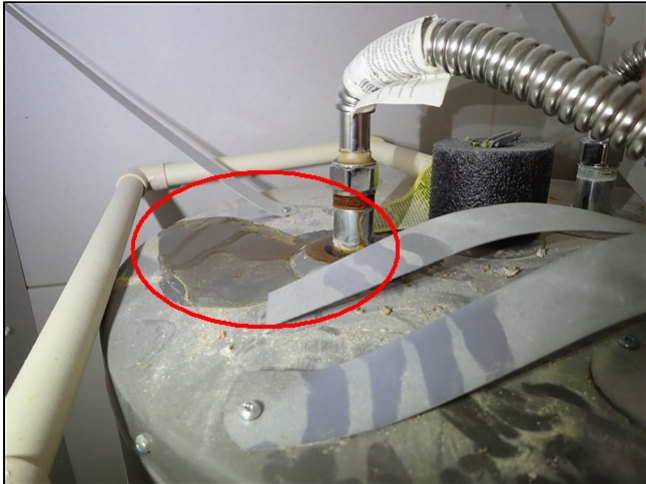
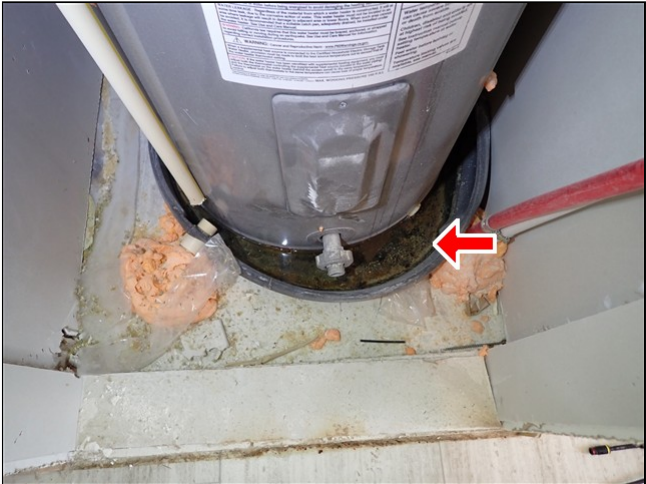
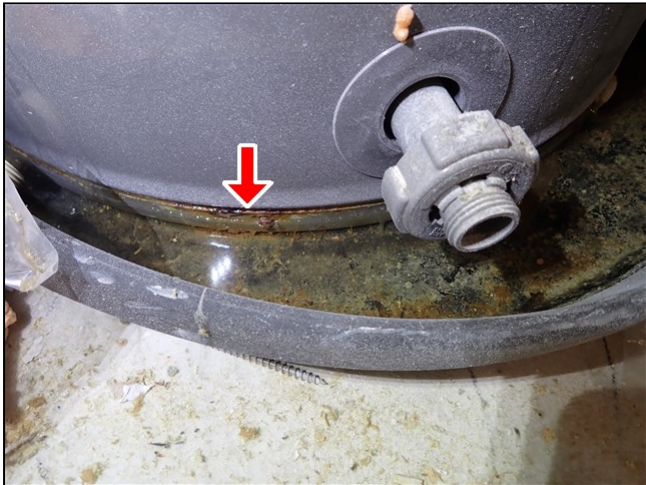
- 13 An active leak is noted at hot water pipe at top of water heater. An approximate one-inch depth of water is present in drip pan under water heater. Rusted metal is noted at bottom of water heater. See photographs below. The water is piped to exterior of house through a drain pipe. A plumbing contractor can evaluate and perform repairs.

An active leak is noted at hot water pipe at top of water heater. An approximate one-inch depth of water is present in drip pan under water heater. Rusty metal is noted at bottom of water heater. See photographs below. The water is piped to exterior of house through a drain pipe. A plumbing contractor can evaluate and perform repairs.

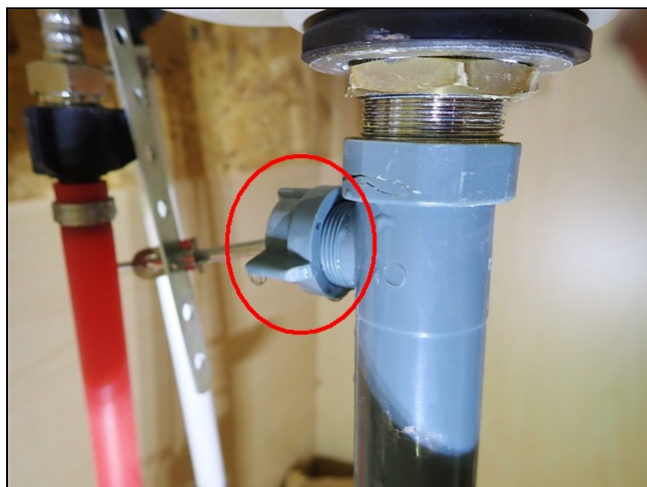
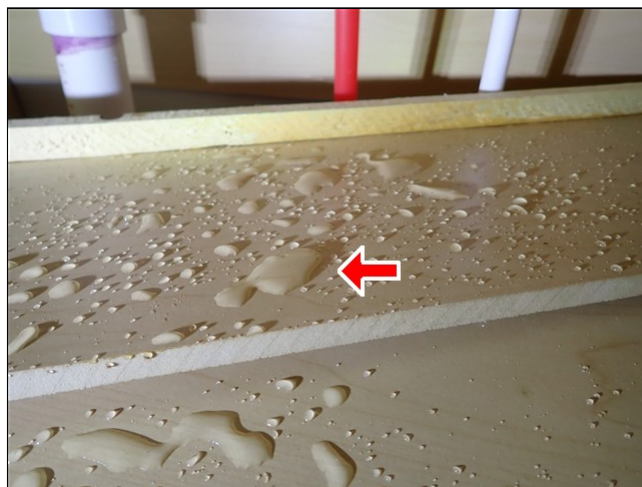
(1) A leak is noted where pop-up control lever connects to drain pipe under hall bathroom vanity basin. Puddled water is noted under the leak. See photographs below. A plumbing contractor can perform repairs.

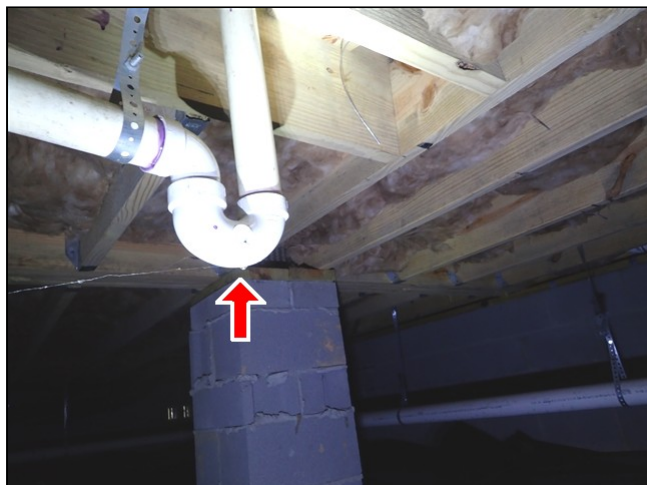
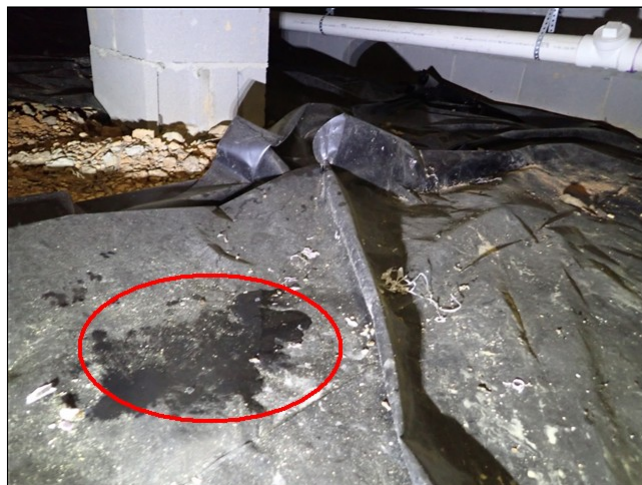
(2) An active leak is noted at drain pipe in crawl space under master bathroom bathtub. Puddled water is noted on plastic sheeting under the leak. See photographs below. A plumbing contractor can perform repairs.

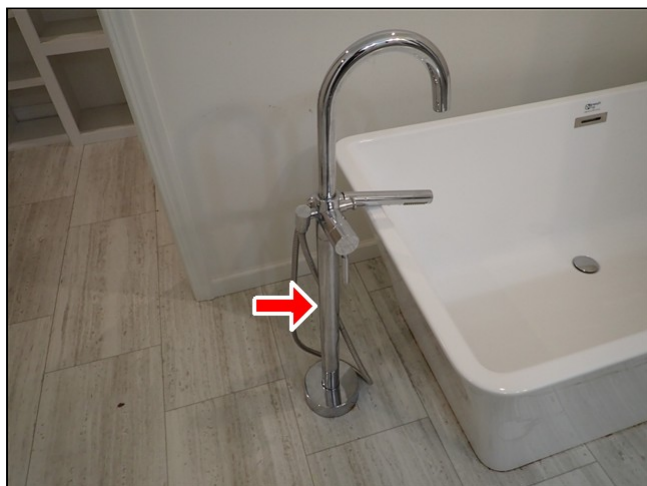
(3) Floor-mounted bathtub faucet is loose. See photograph below. Excess movement of plumbing fixtures can allow leaks to develop at connections. A plumbing contractor can perform repairs.

4.4 Item 5(Picture) Loose faucet

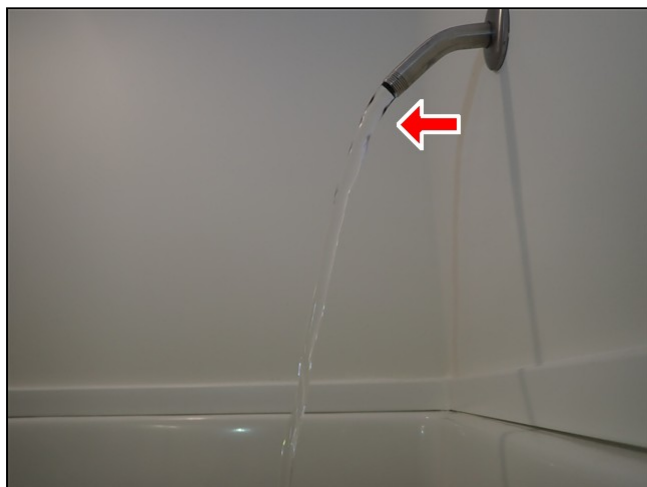
(4) Shower head is missing in hall bathroom. See photograph below. The shower does not function as intended. A plumbing contractor can perform repairs.

4.4 Item 6(Picture) Missing shower head

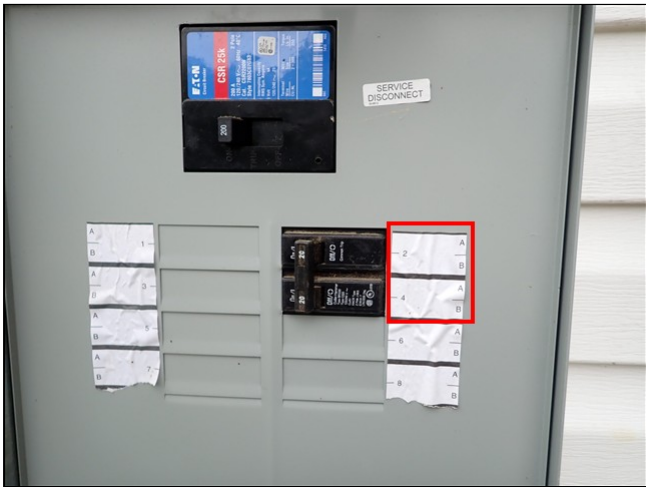
One 20 amp double pole breaker lacks label at main breaker panel. See photograph below. A qualified contractor can label breakers.

5.1 Item 1(Picture) Breaker lacks labels

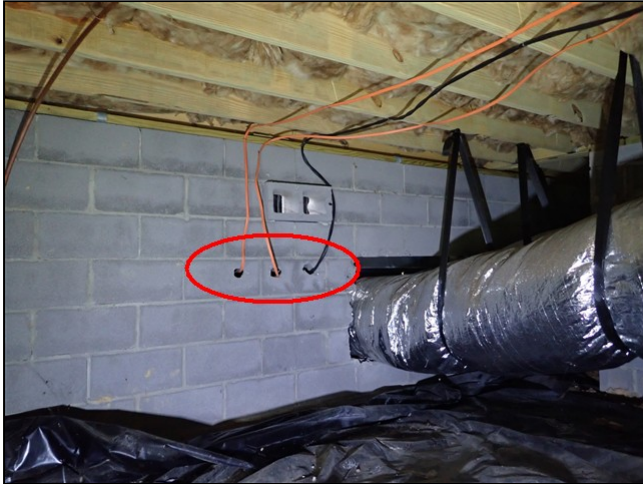
(1) Three cables penetrate masonry wall without conduit at right side wall of crawl space. See photograph below. Conduit protects the cable from cuts and punctures. An electrical contractor can perform repairs.

5.2 Item 1(Picture) Cables without conduit

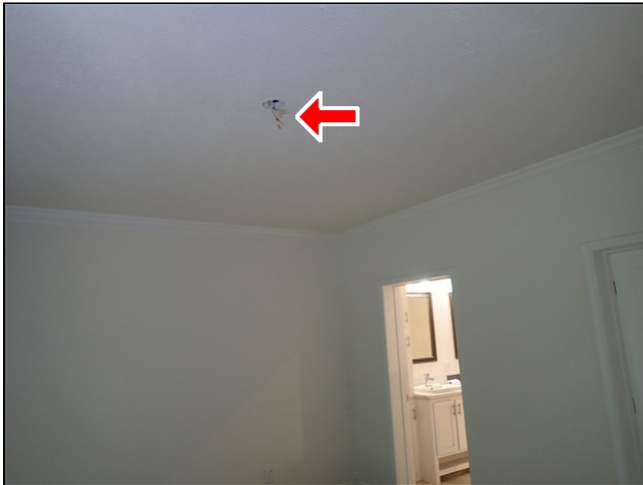
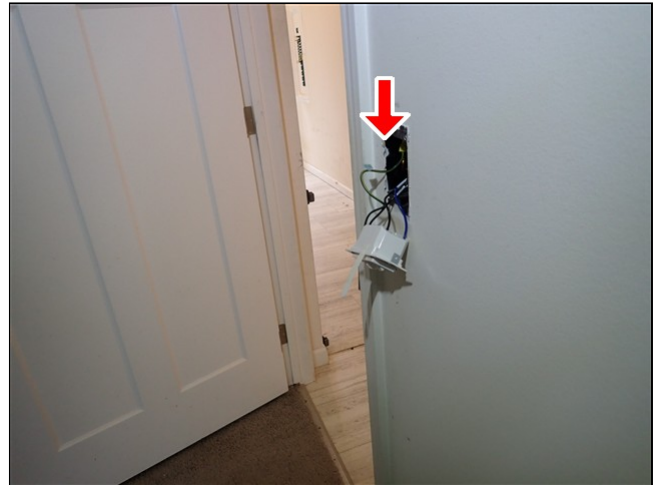
(2) Bare conductors are noted at master bedroom ceiling where ceiling fan and light fixture are missing. Bare conductors are noted at master bedroom wall switch near entry door. See photographs below. The wires can be a shock hazard if energized. An electrical contractor can perform repairs.

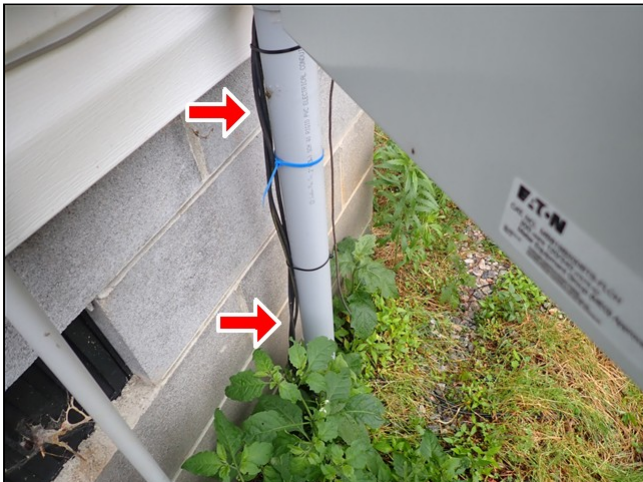
(3) Conduit pipe is missing at conductors below exterior main breaker panel. See photograph below. An electrical contractor can evaluate and perform repairs.

5.2 Item 4(Picture) Conductors without conduit

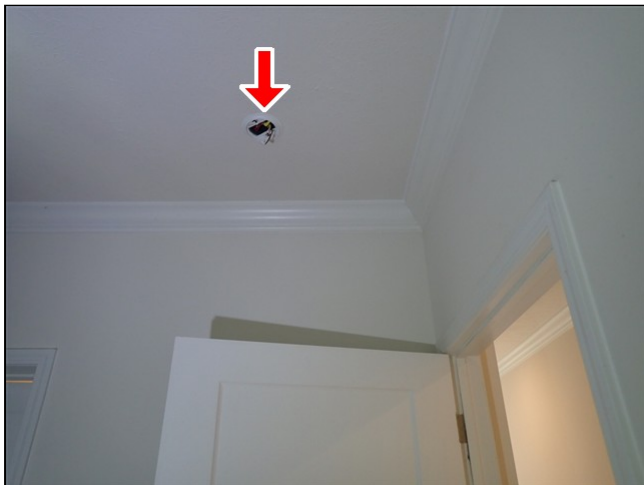
(1) Smoke detector cartridge is not installed in master bedroom. See photograph below. An electrical contractor can perform repairs.

5.6 Item 1(Picture) Missing cartridge

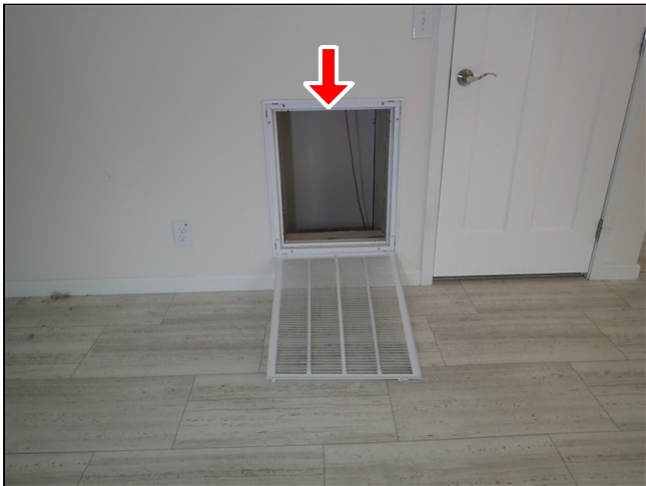
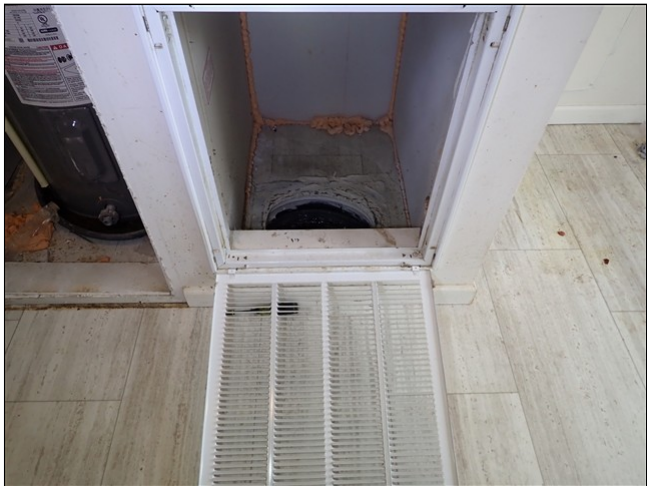
(1) Filters are missing at returns in family room and laundry. See photographs below. Dust and grit accumulates on indoor coil when system is operated without a filter. A mechanical contractor can inspect and service indoor coil as needed.

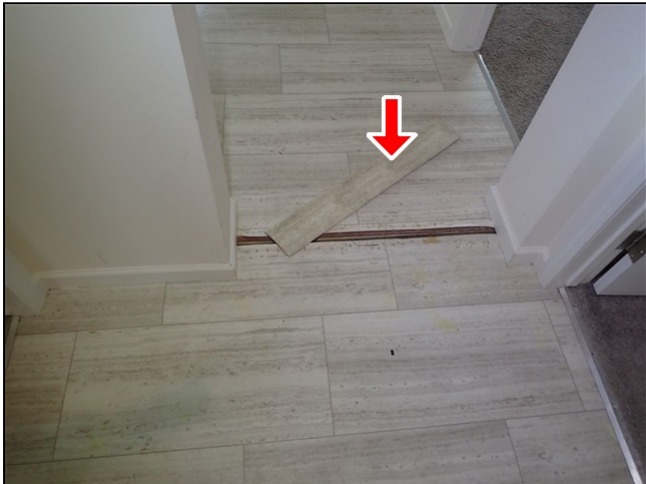
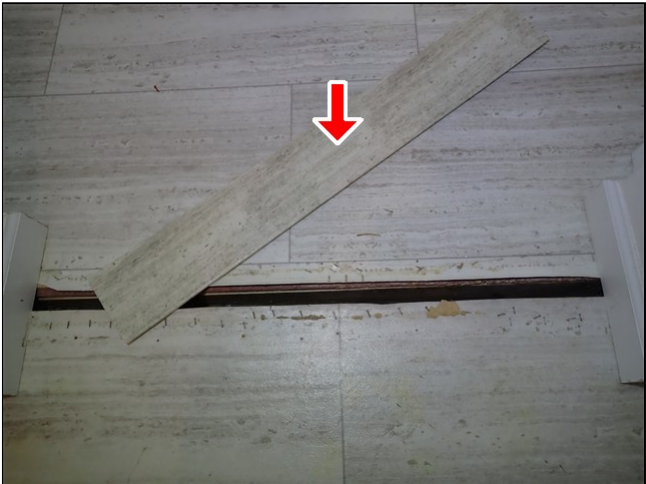
(1) Transition threshold is loose between two halves of modular house in hallway outside hall bathroom. See photographs below. A qualified contractor can perform repairs.

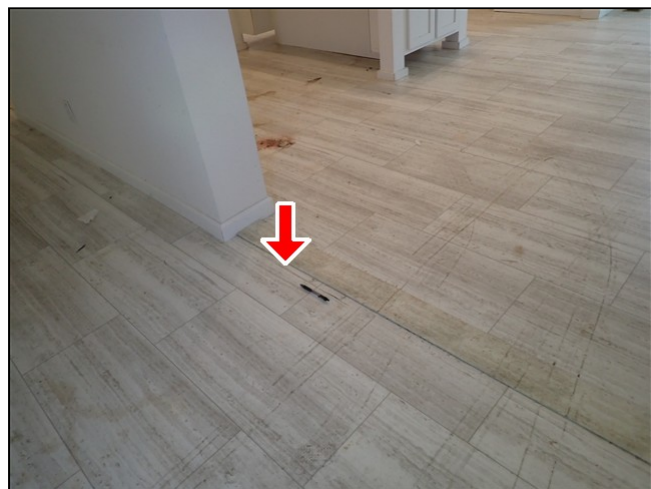
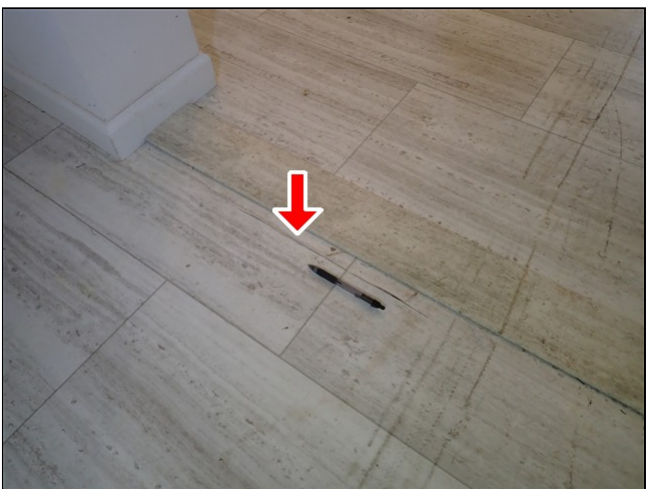
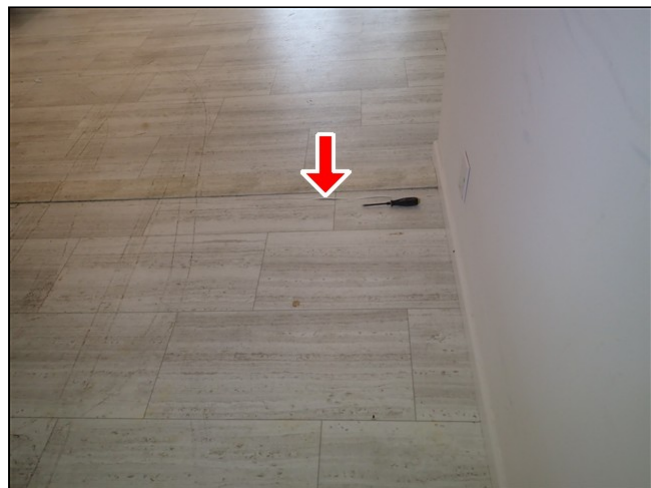
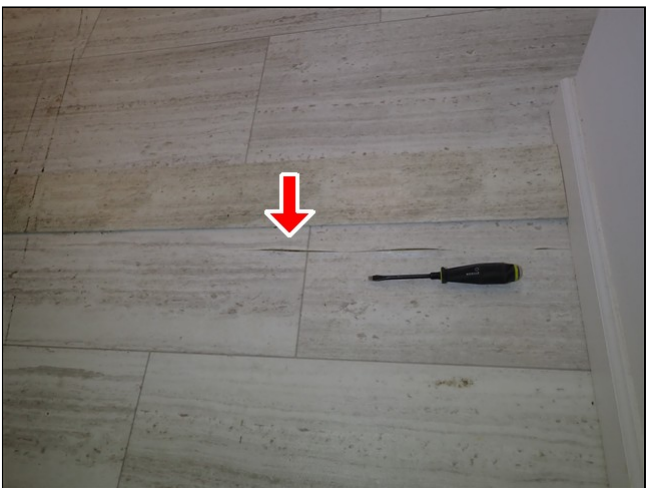
(2) Vinyl flooring is separated between living room and family room. See photographs below. A flooring contractor or qualified contractor can perform repairs.

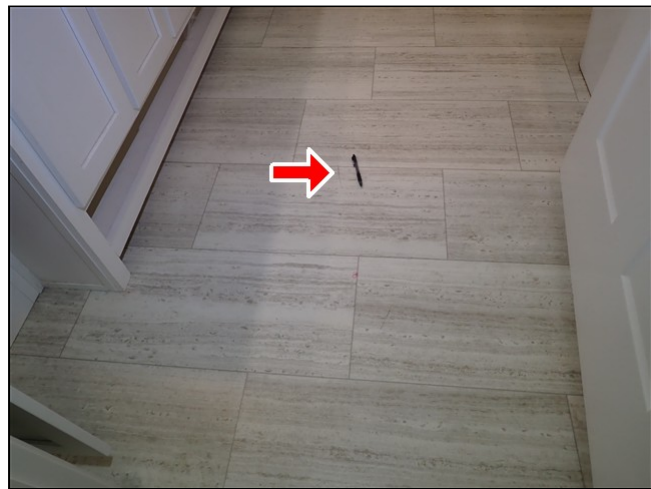
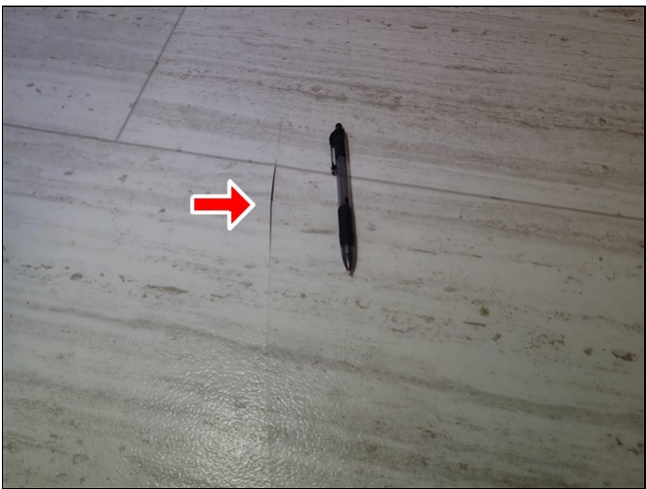
(3) Vinyl flooring is torn in master bathroom near entry door. See photographs below. A flooring contractor or qualified contractor can perform repairs.

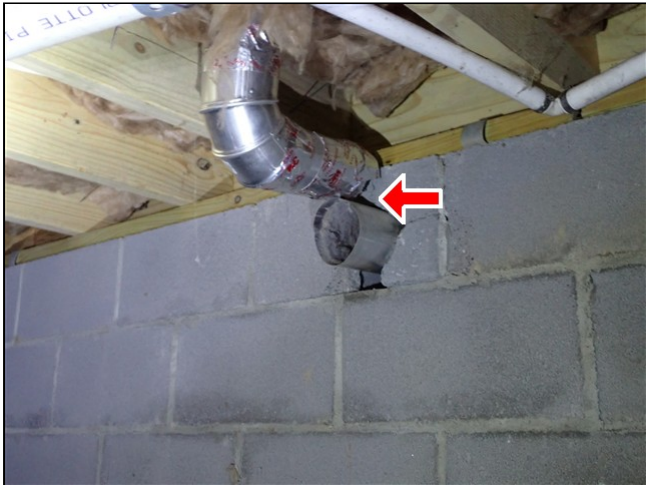
(1) Dryer exhaust tube is separated in crawl space under dryer. See photograph below. Lint and warm moist air is discharged into the living space. A qualified contractor can evaluate, provide further information, and perform repairs as needed.

9.4 Item 1(Picture) Separaed dryer exhaust tube

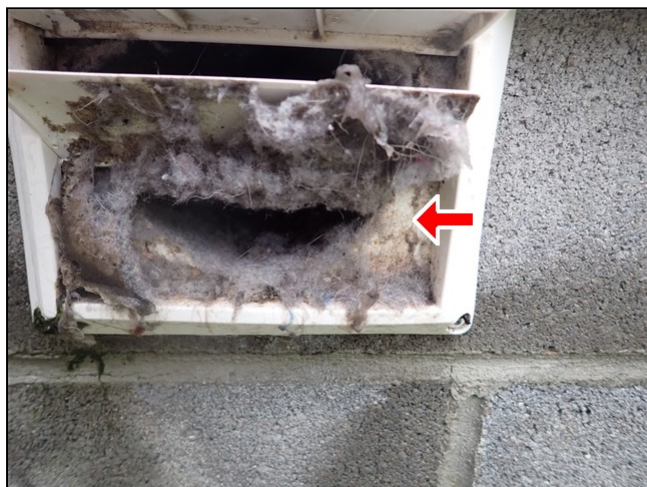
(2) Lint is present in exterior dryer exhaust vent tube. See photograph below. Accumulation of lint in dryer exhaust tube is a fire hazard. A qualified contractor can evaluate the tube and perform repairs.

9.4 Item 2(Picture) Lint in dryer exhaust vent

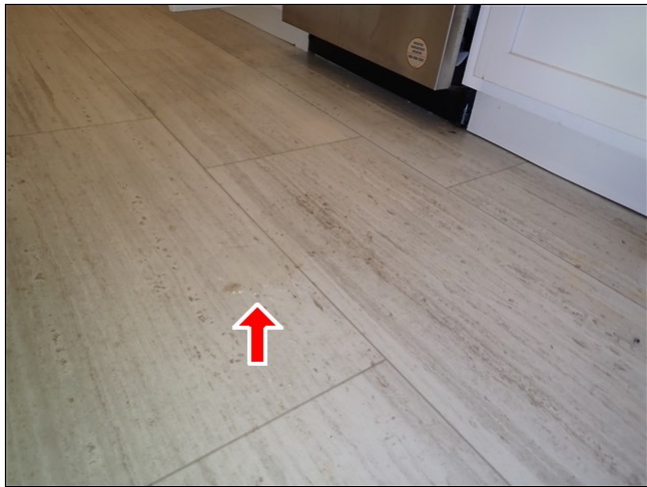
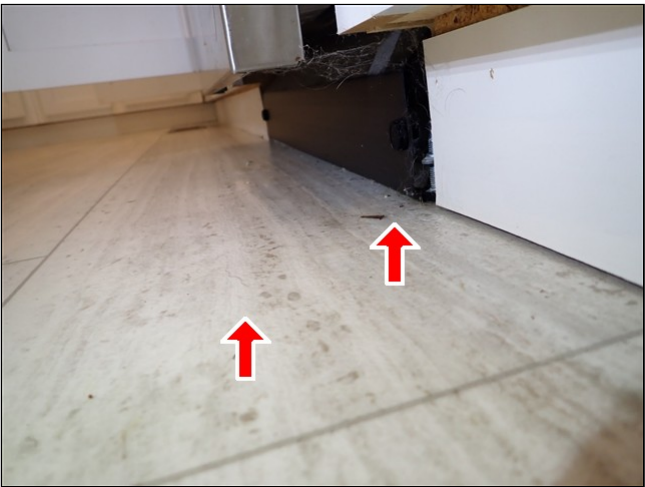
- 36 Puddled water is noted on floor during operation of dishwasher. See photographs below. Evidence of leaking water was not observed in crawl space at time of inspection. A plumbing contractor can evaluate, provide further information, and perform repairs as needed.

**Comments:** Repair or Replace  
Puddled water is noted on floor during operation of dishwasher. See photographs below. Evidence of leaking water was not observed in crawl space at time of inspection. A plumbing contractor can evaluate, provide further information, and perform repairs as needed.
