Ambassador Inspections  
Brennan Smith  
[BrennanSmith2896@outlook.com](mailto:BrennanSmith2896@outlook.com)  
Brennan Smith: 984-255-3633  
Robert Smith: 919-339-5633  
PO Box 337  
Bunn, NC 27508

| Property Address | |
|---|---|
| Street: | 939 Cheves Rd |
| City: | Zebulon |
| Location of Septic Tank and Septic Tank Details | |

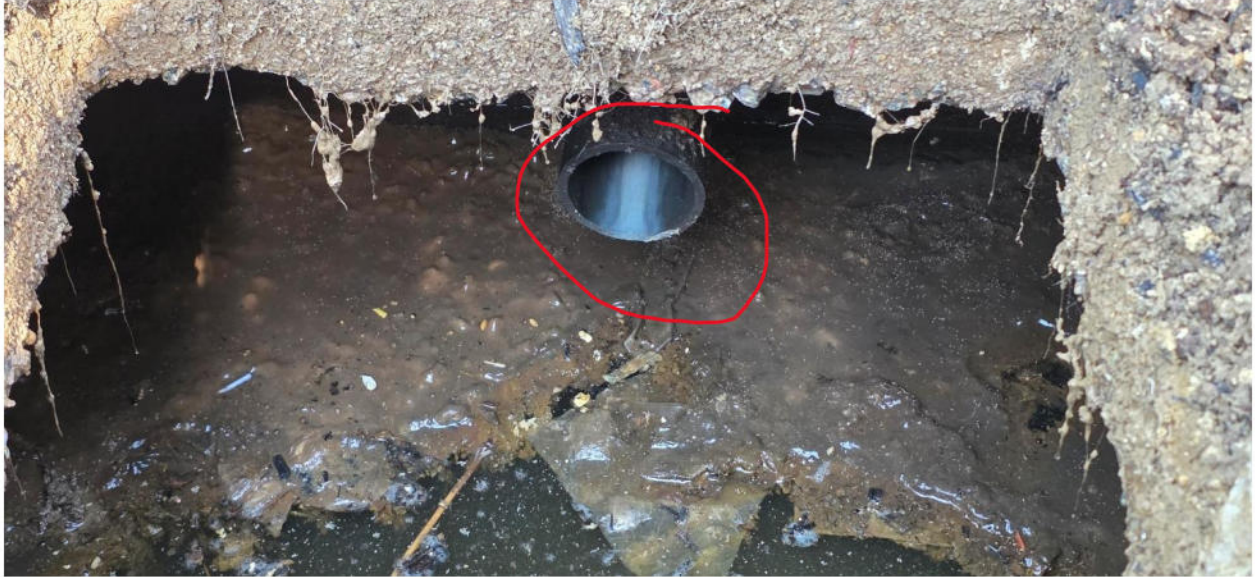
This is the inlet end of the septic tank with the inlet pipe. The septic tank needs to be pumped.

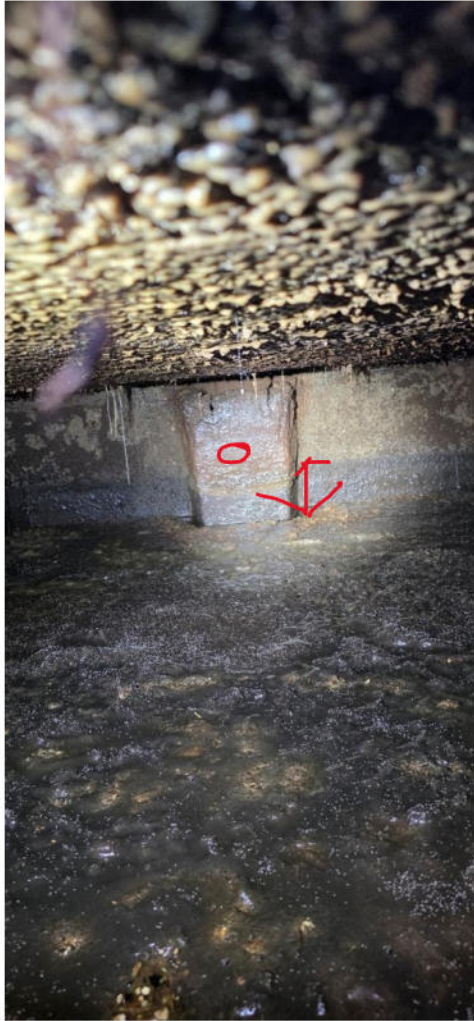
| Is water level in tank relative to tank outlet description: | *** The water level appears to be 6 inches below the outlet pipe. |
| Evidence of tank leakage description: | ***The water level appears to be 6 inches below the outlet pipe. Recommend doing a leak test to see if the leak is within allowable limits. |

This is the outlet end of the septic tank with the outlet tee. The outlet tee is in fair condition. The water level appears to be 6 inches below the outlet pipe. Recommend doing a hydrostatic leak test to see if the leak is within allowable limits.

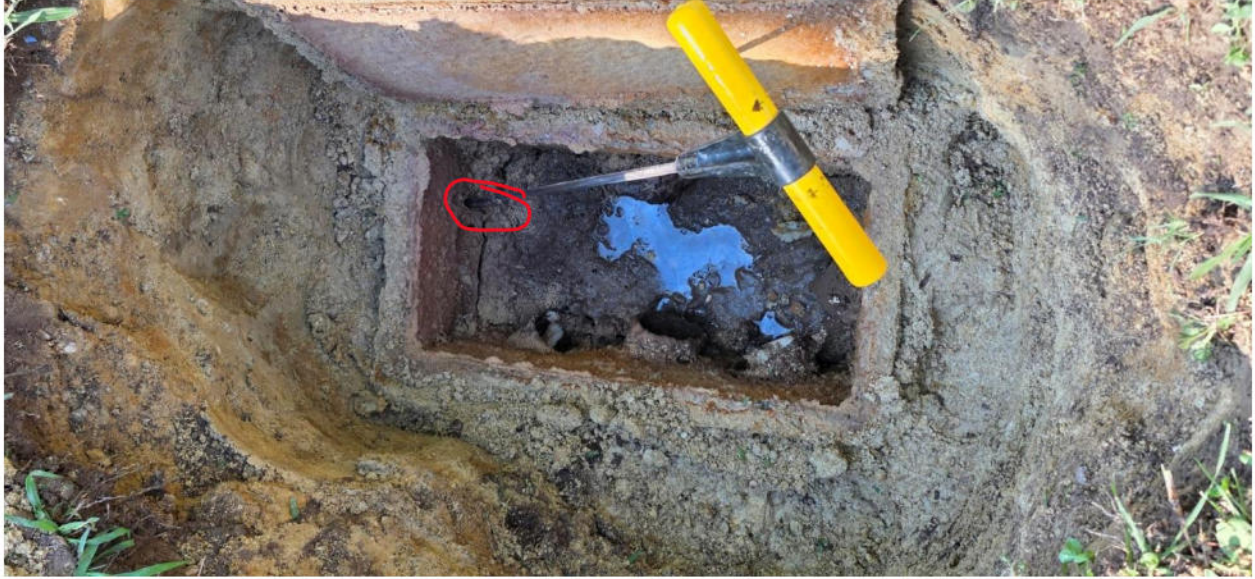
| Distribution box description: | *** Rectangular concrete box that is corroded and needs to be replaced. Recommend contacting a licensed septic company to come out and see what can be done to fix the issue. |

This is the distribution box. It is corroded and needs to be replaced.

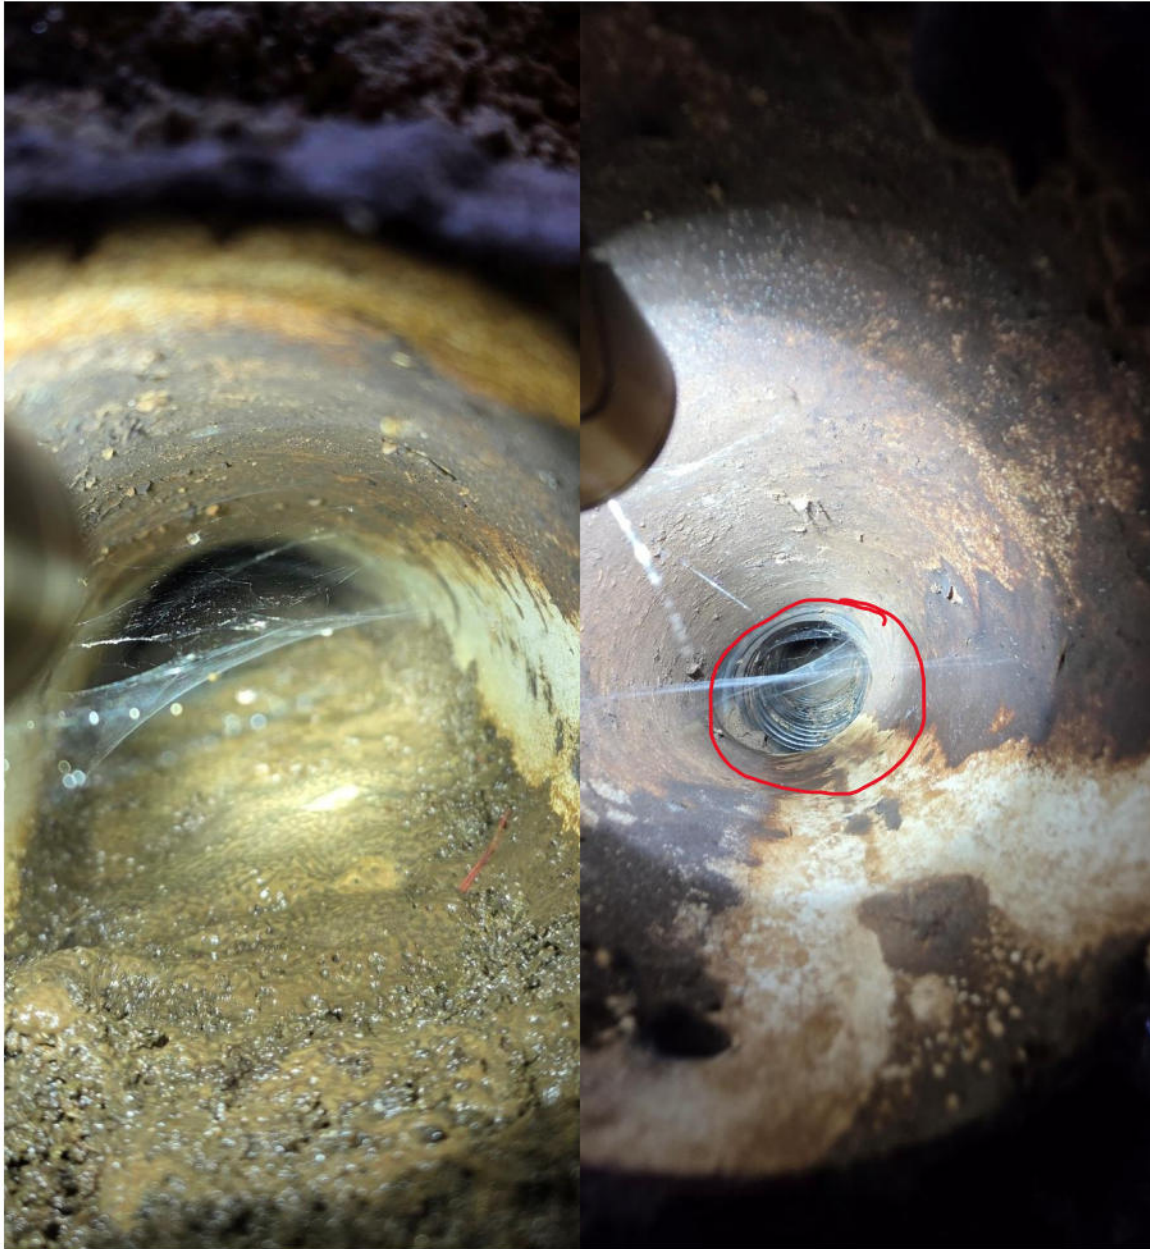
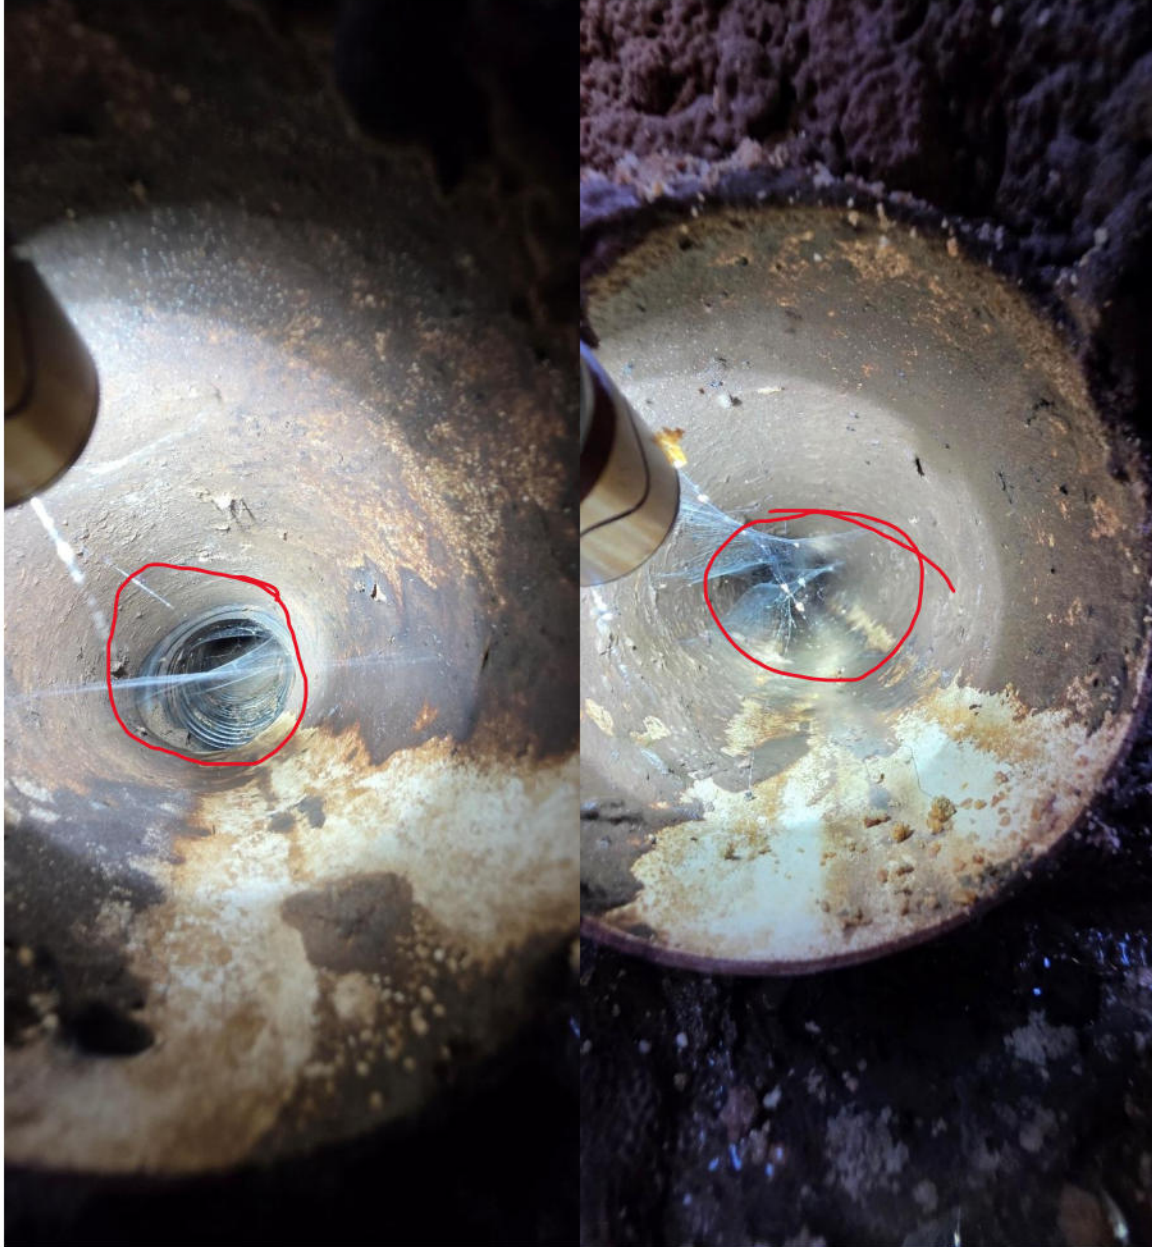
| <b>Other pertinent facts noted during inspection:</b> | ***The leach lines are full of mud and solids. Recommend contacting a licensed septic company to come out and see what can be done to fix the issue. |

The leach lines have mud and solids in them. Recommend contacting a licensed septic company to come out and see what can be done to fix the issue.

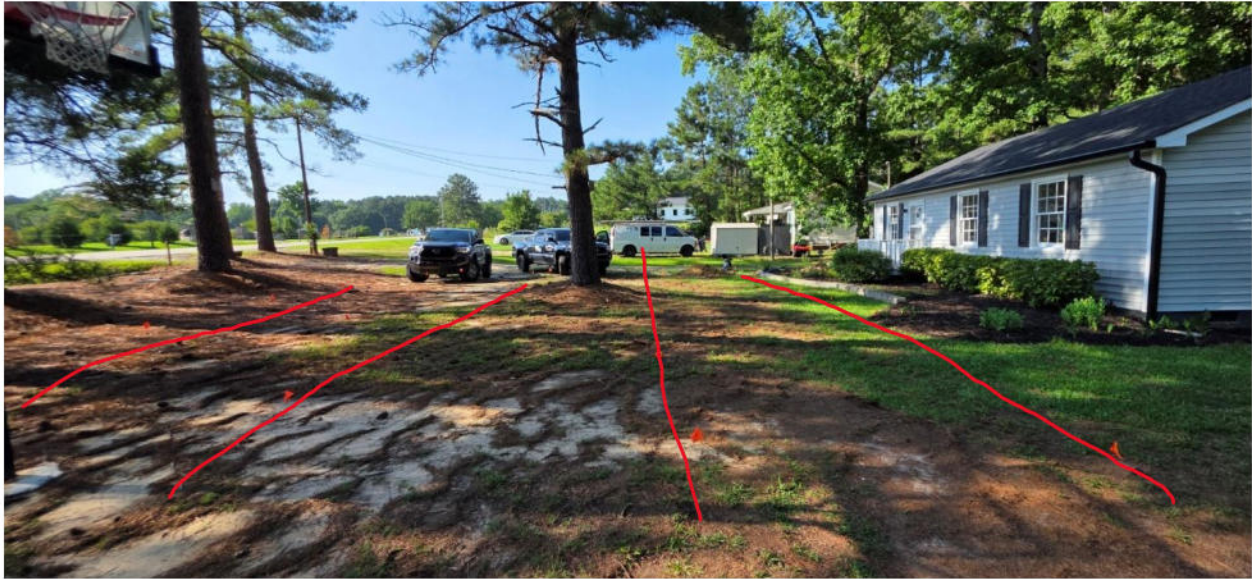
| <b>System conditions description:</b> | *** There are trees in the leach field. |

This is the leach field. There are trees in the leach field.

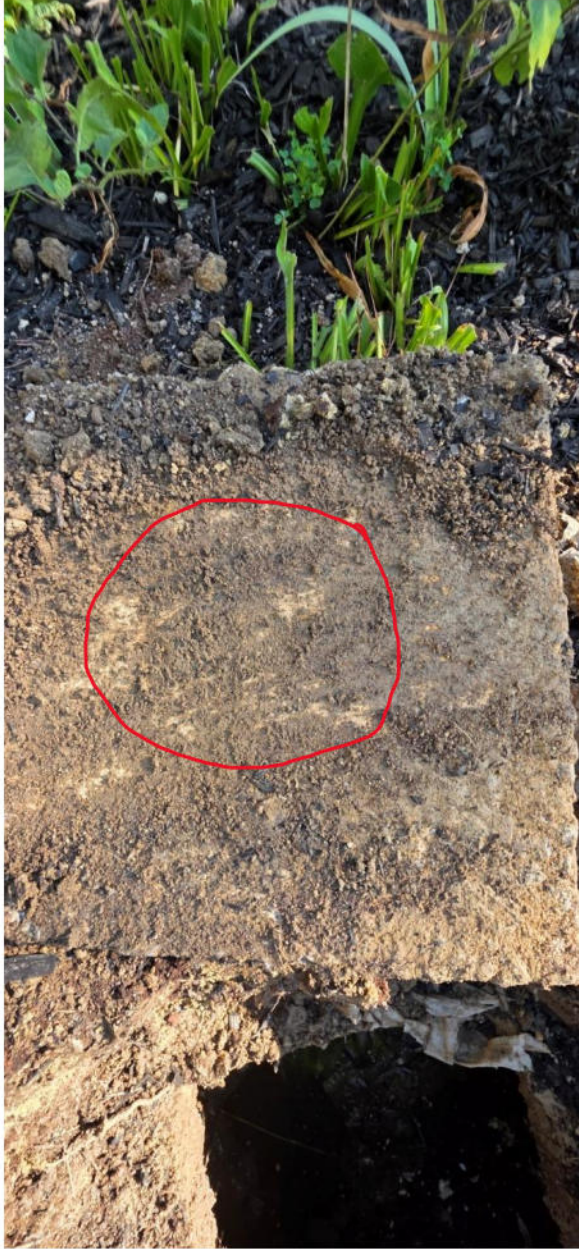
| Property Address | |
|---|---|
| Inlet tank lid description: | Square concrete lid with no handle. |

The inlet end lid has no handle.

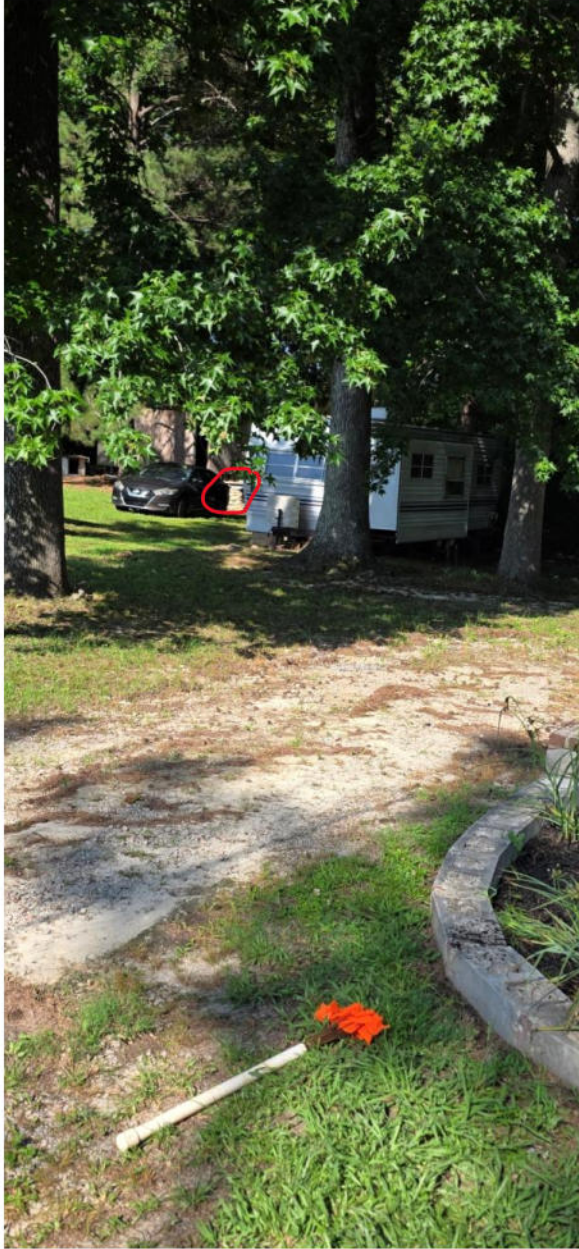
The house shares a well with 2 other properties. The well is on the neighbor's land in the backyard.
