| Property Address | |
| Street: | 120 Carolina Ave |

| Client Information | |
|---|---|
| Inspection Details | |

| Well Test | |
|---|---|
| Location of Septic Tank and Septic Tank Details | |

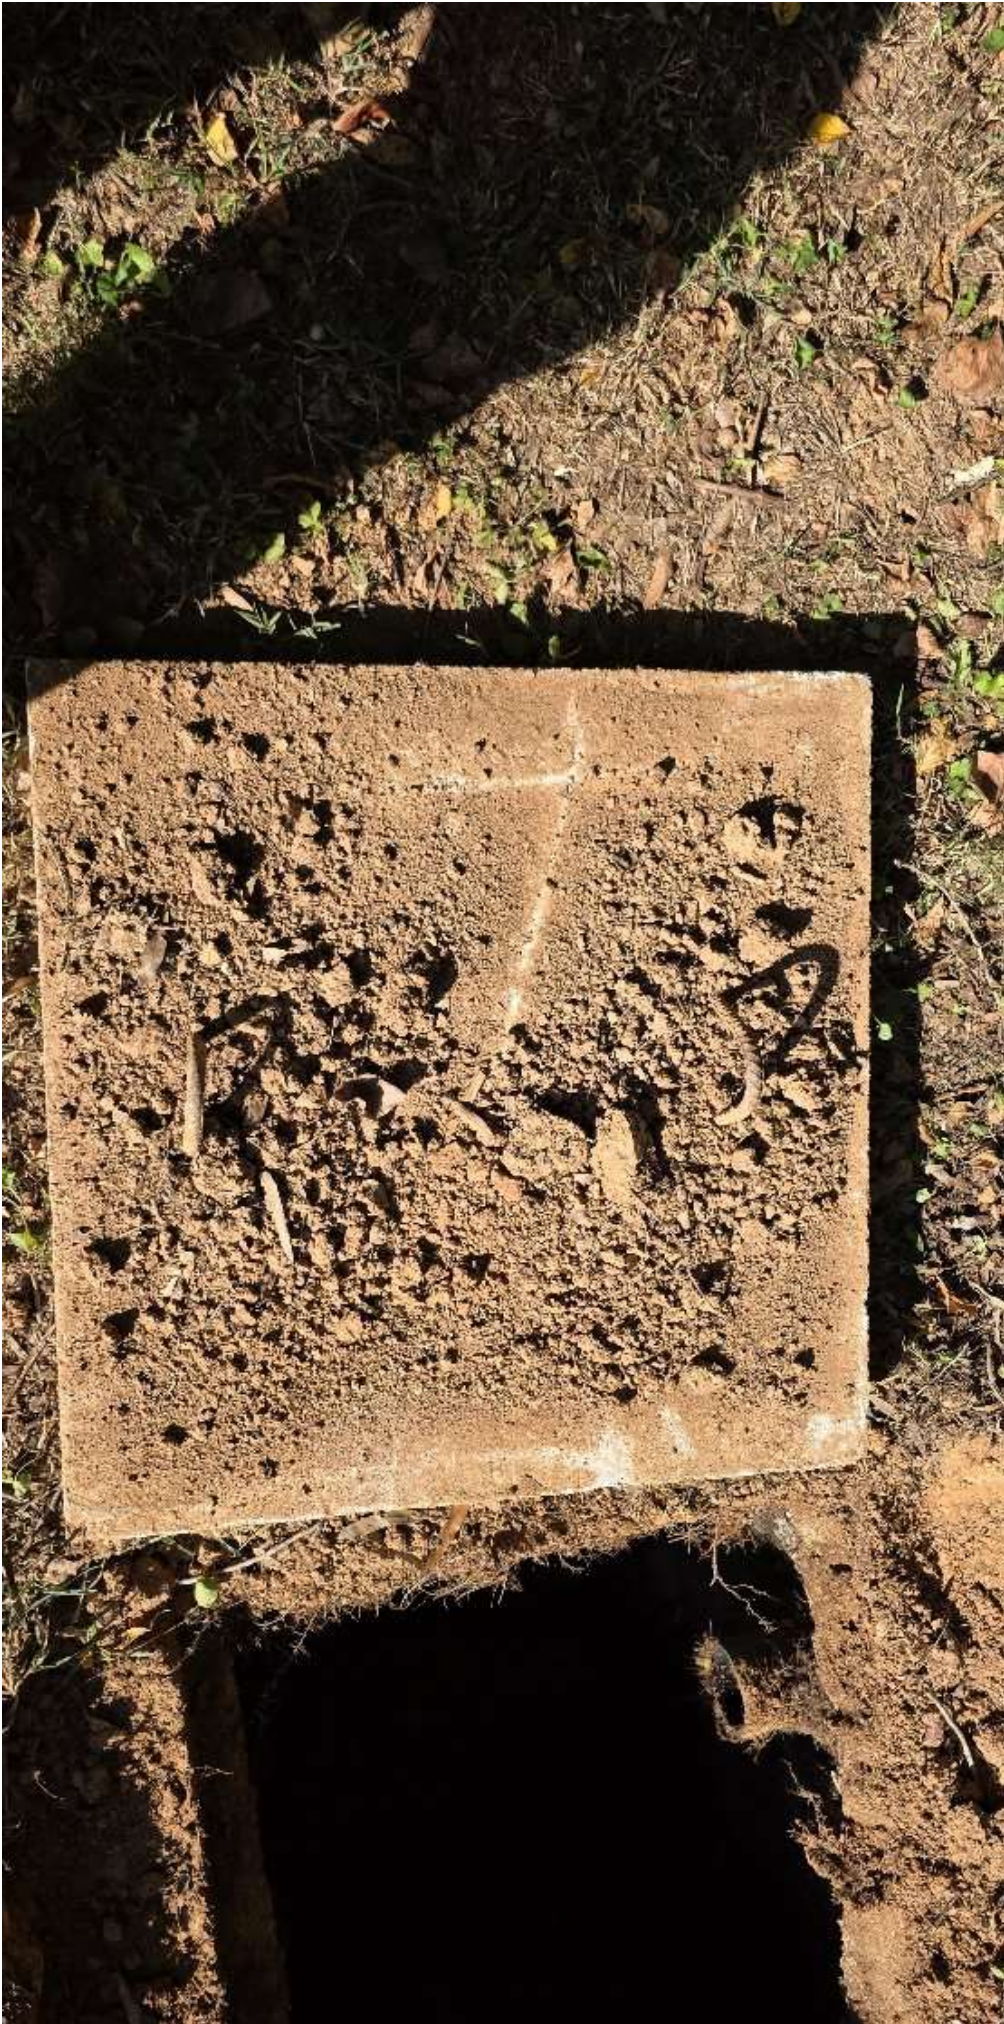
| Well Test | |
|---|---|
| Inlet tank lid description: | Square concrete lid in good condition. |

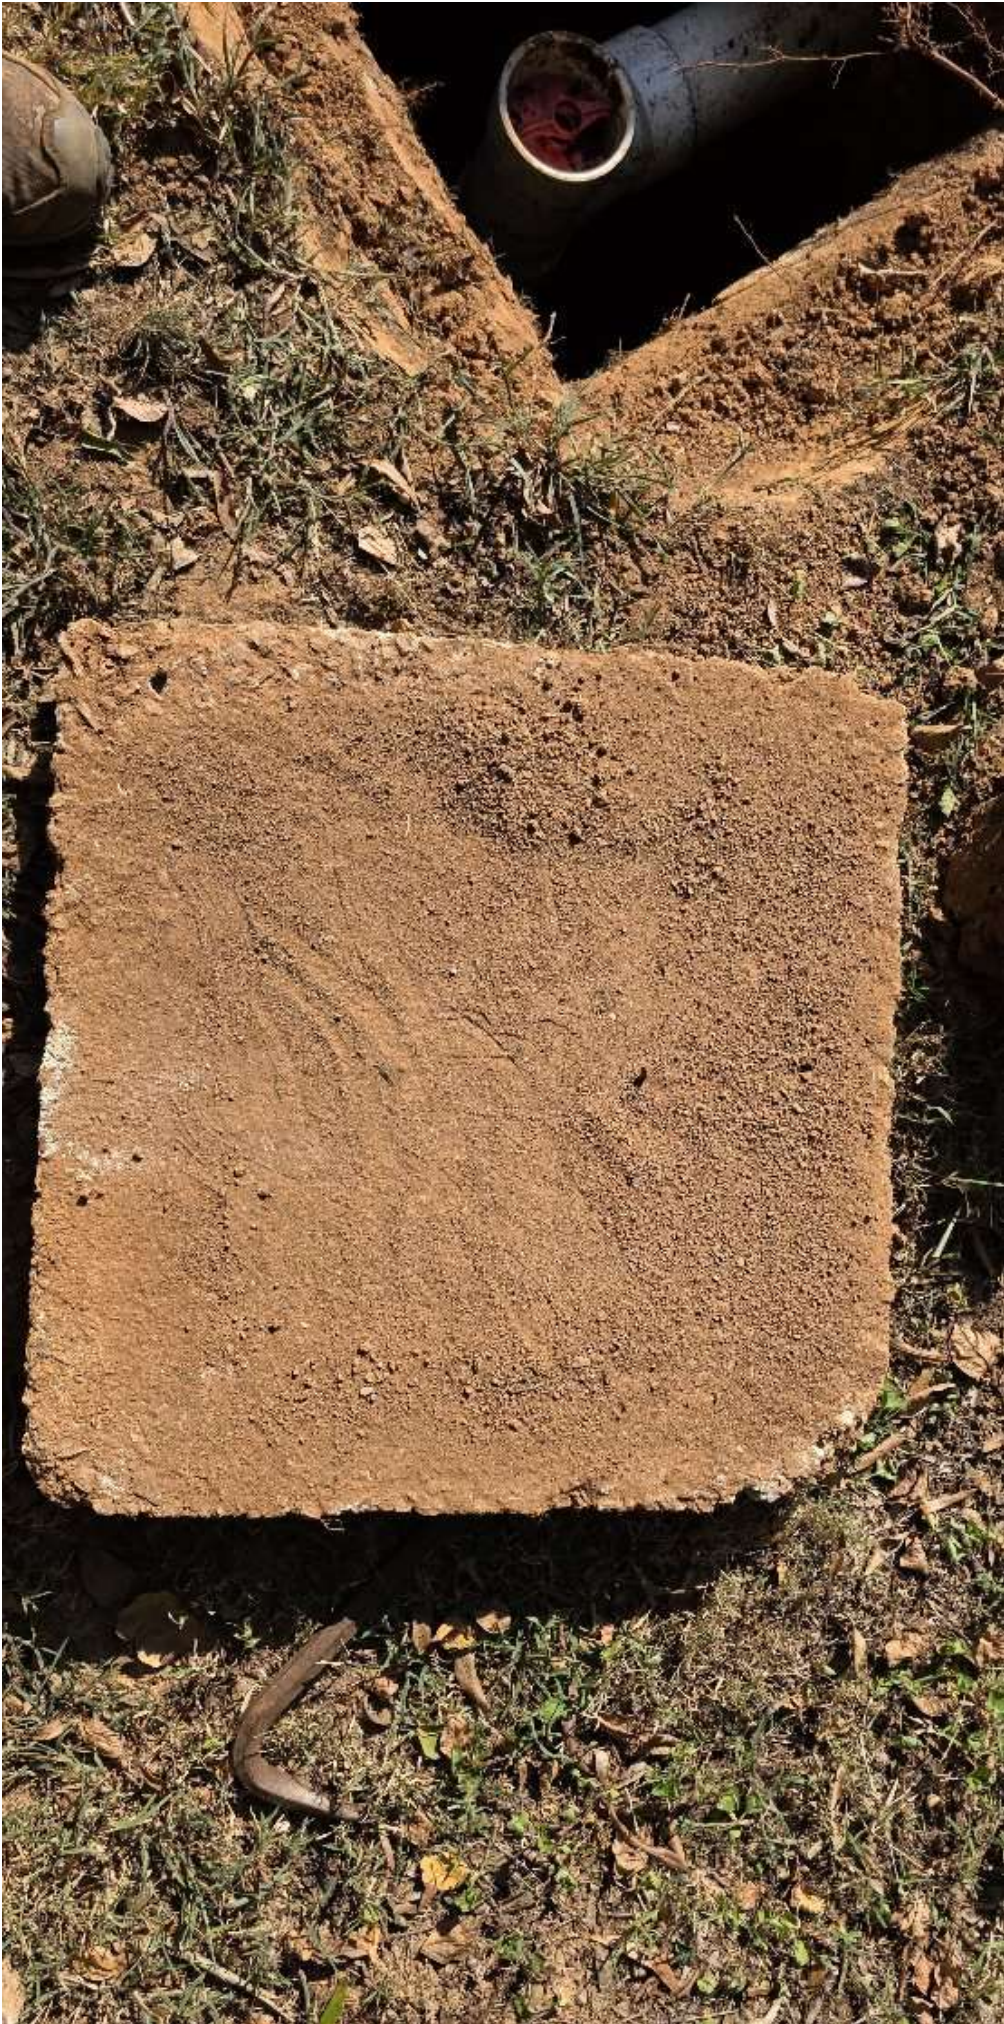
| <b>Outlet tank lid description:</b> | Square concrete lid that is missing a handle. |

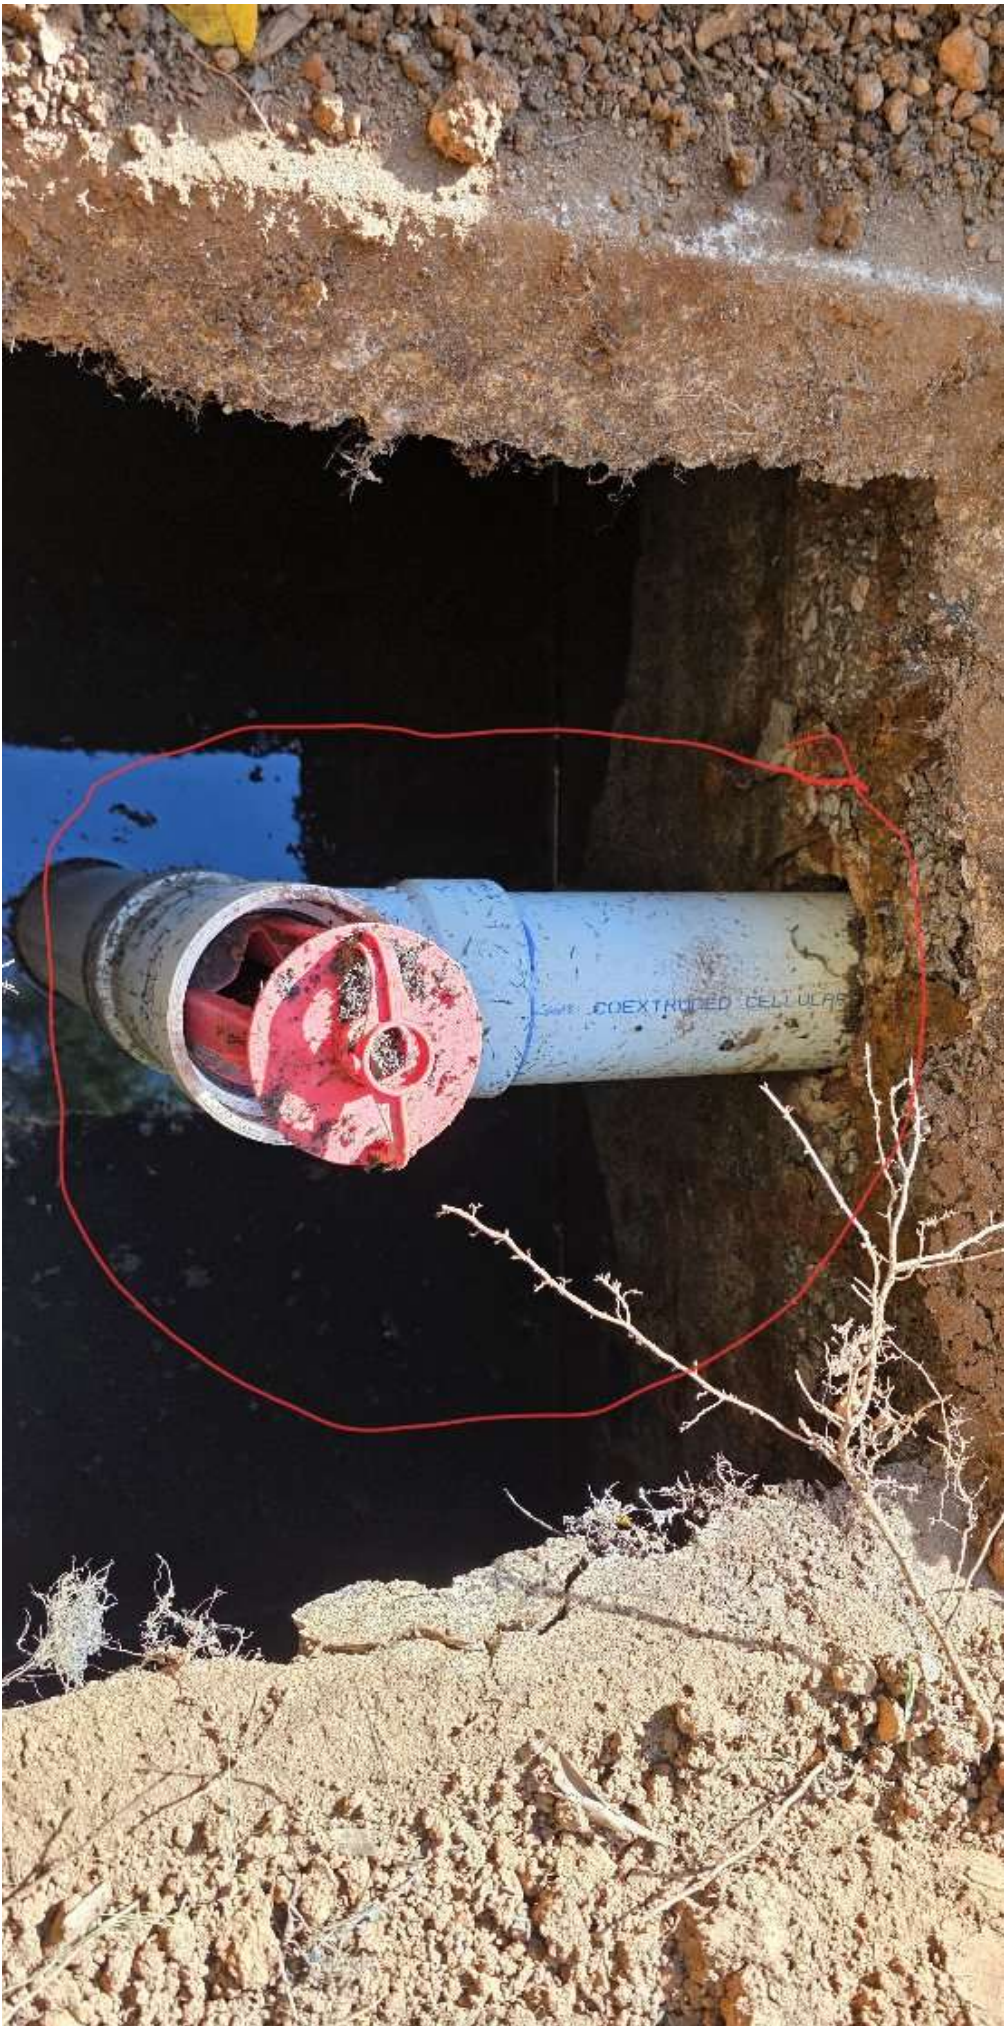
| <b>Outlet T description:</b> | Plastic tee in good condition. |

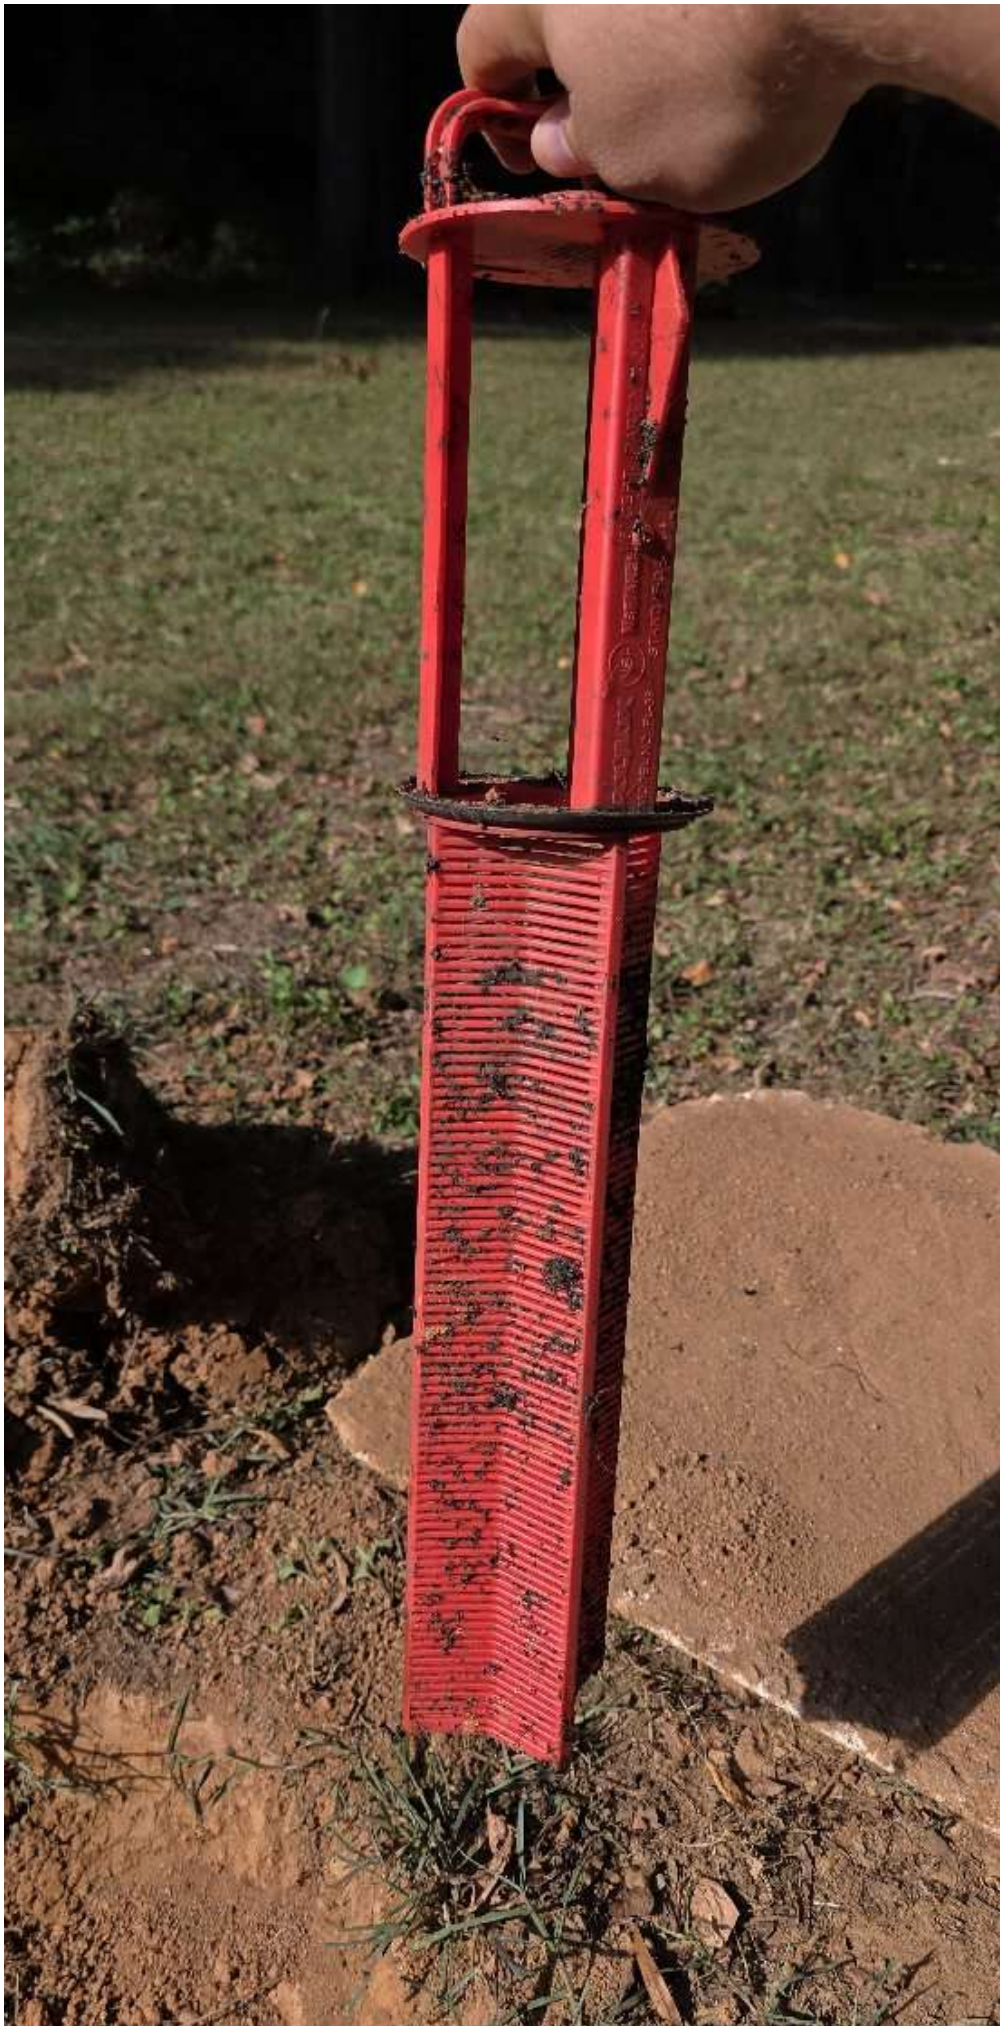
| <b>Condition of filter:</b> | Good condition. |

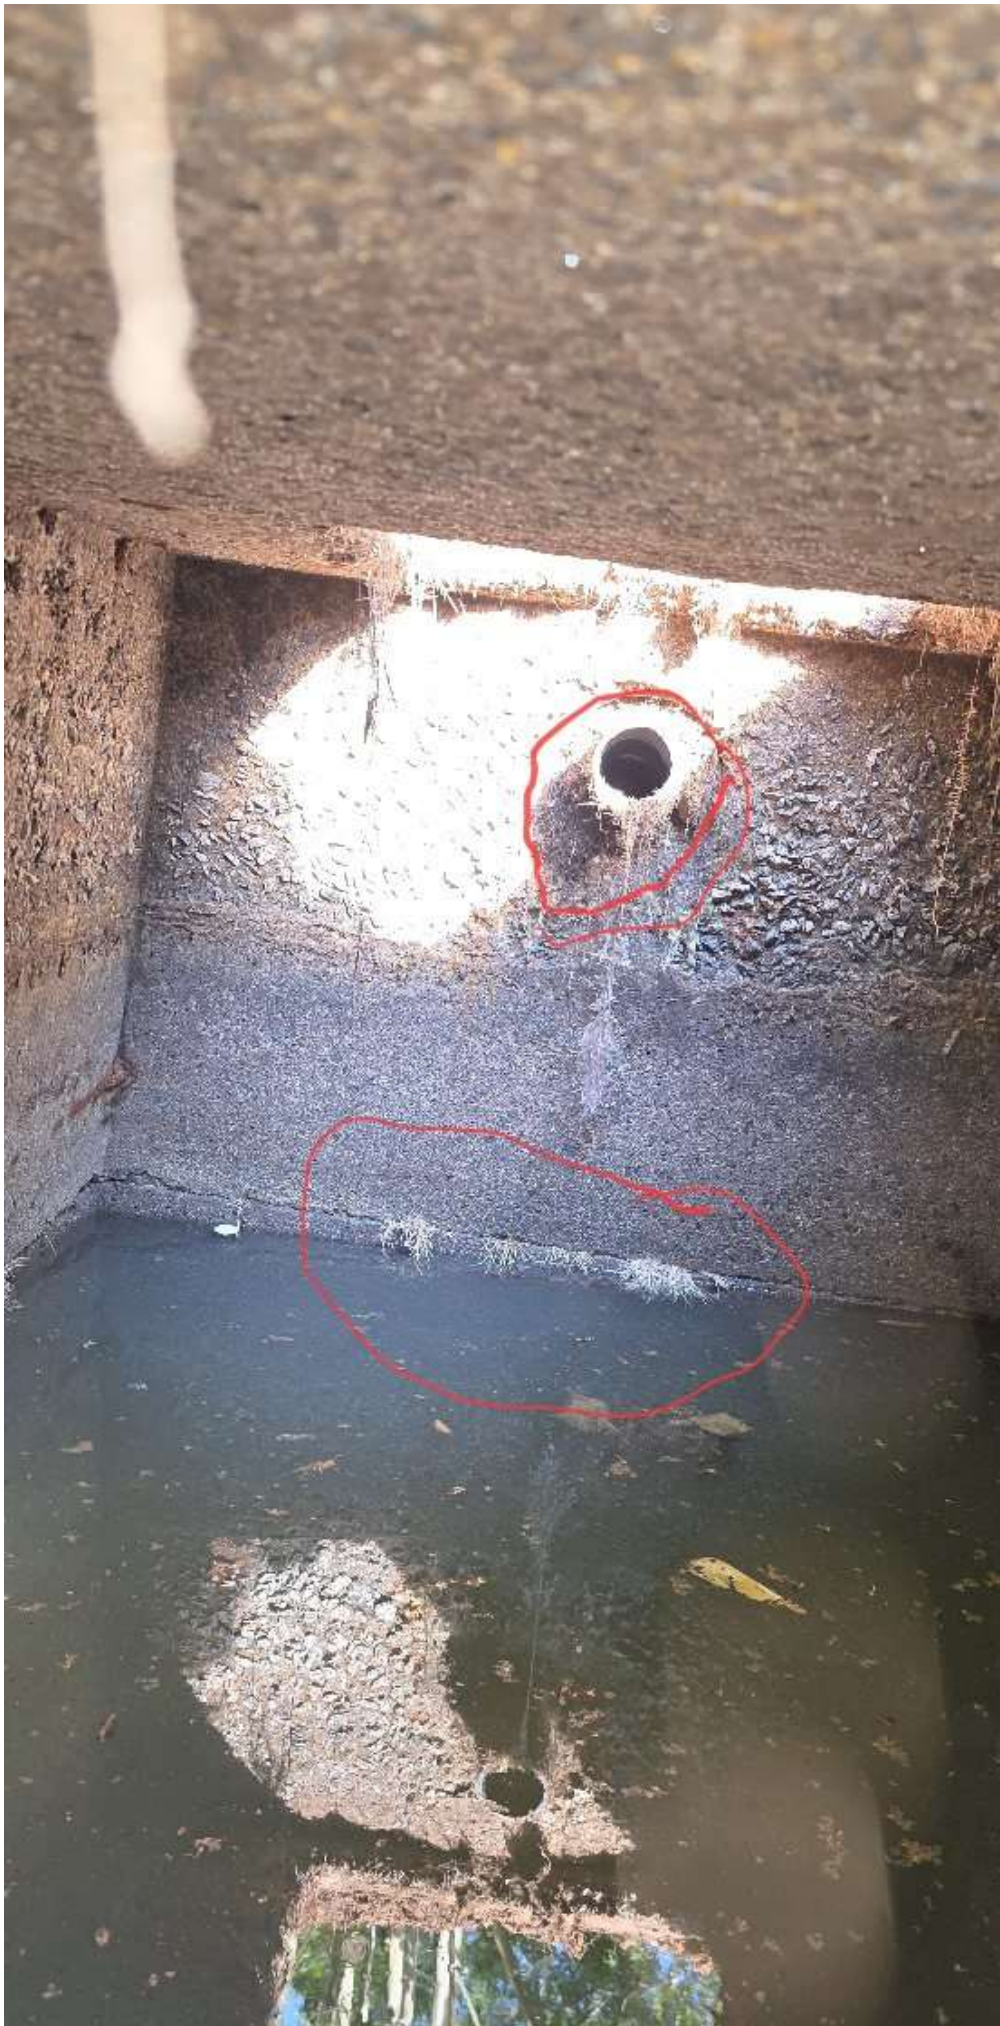
| <b>Roots present in tank?</b> | Yes |

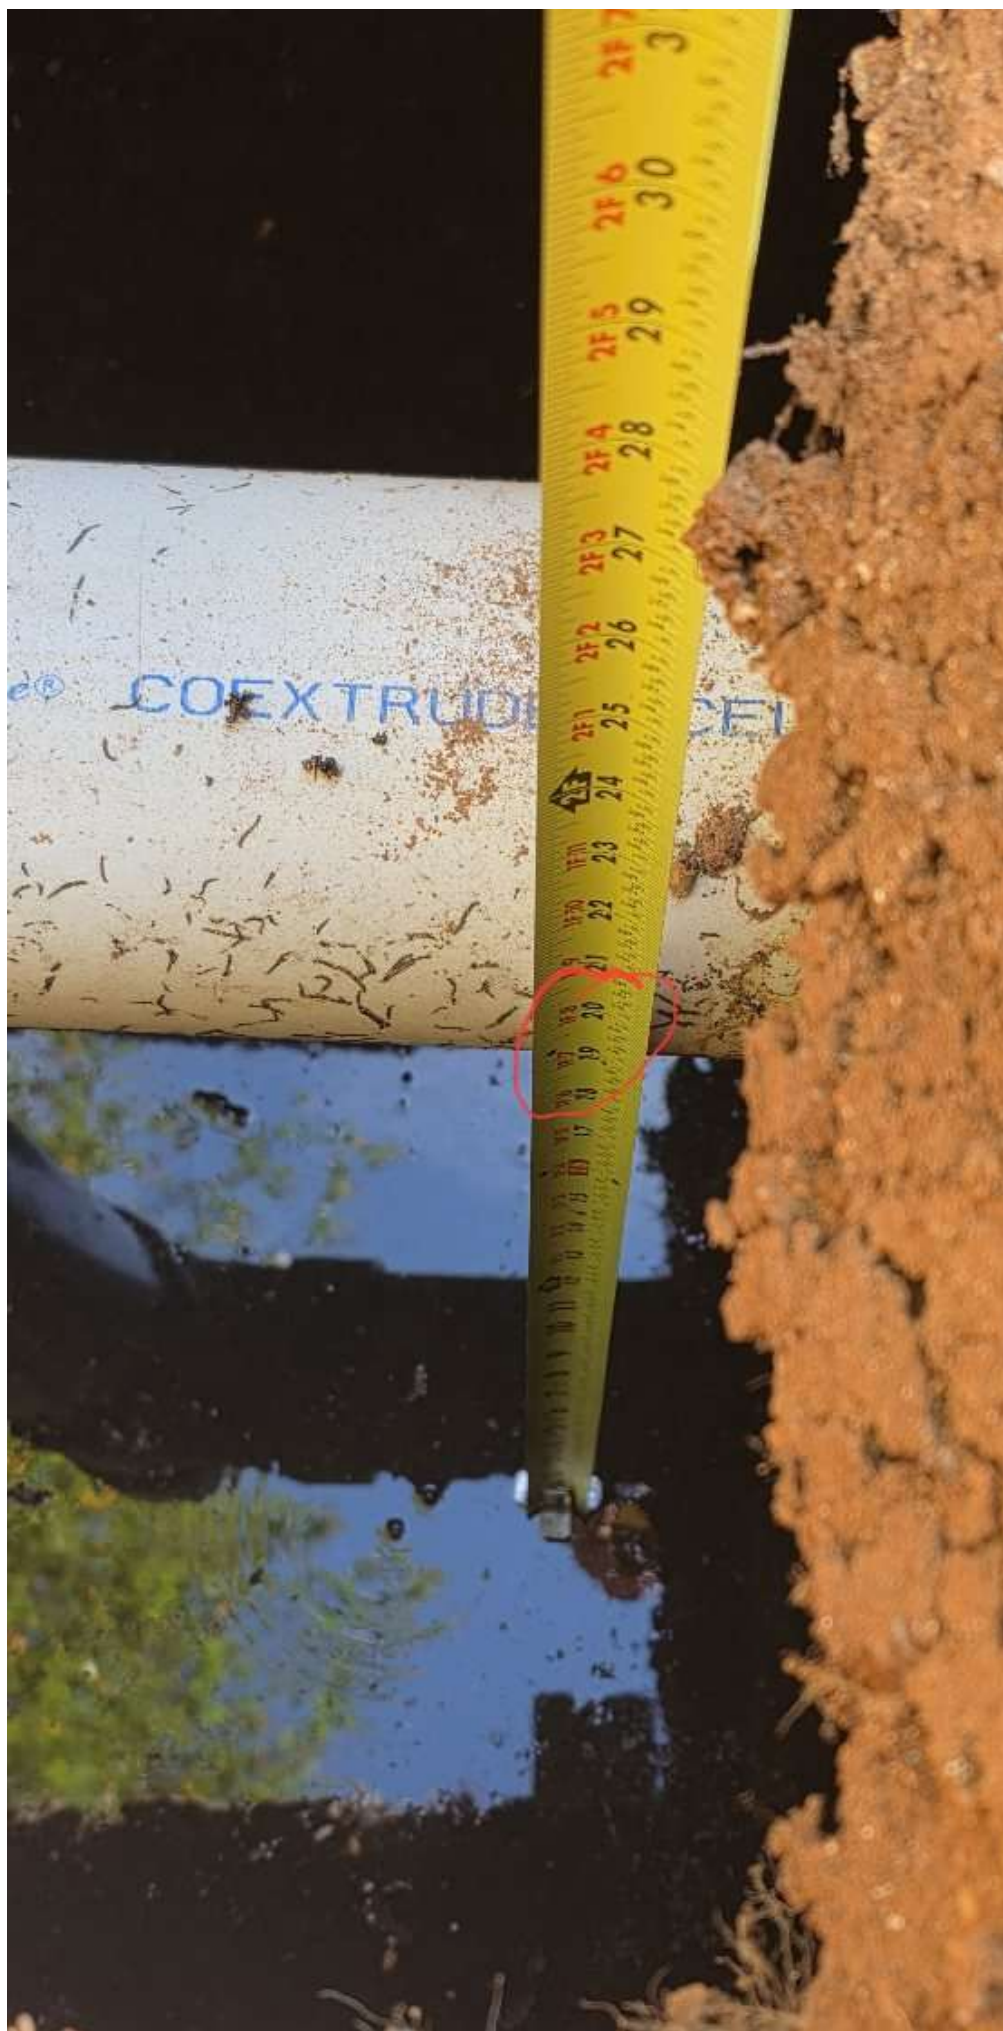
| Evidence of tank leakage? | Yes |

| <b>Evidence of tank leakage description:</b> | ***The water level is 20 inches below the outlet pipe. Recommend doing a leak test to see if the leak is within allowable limits. |

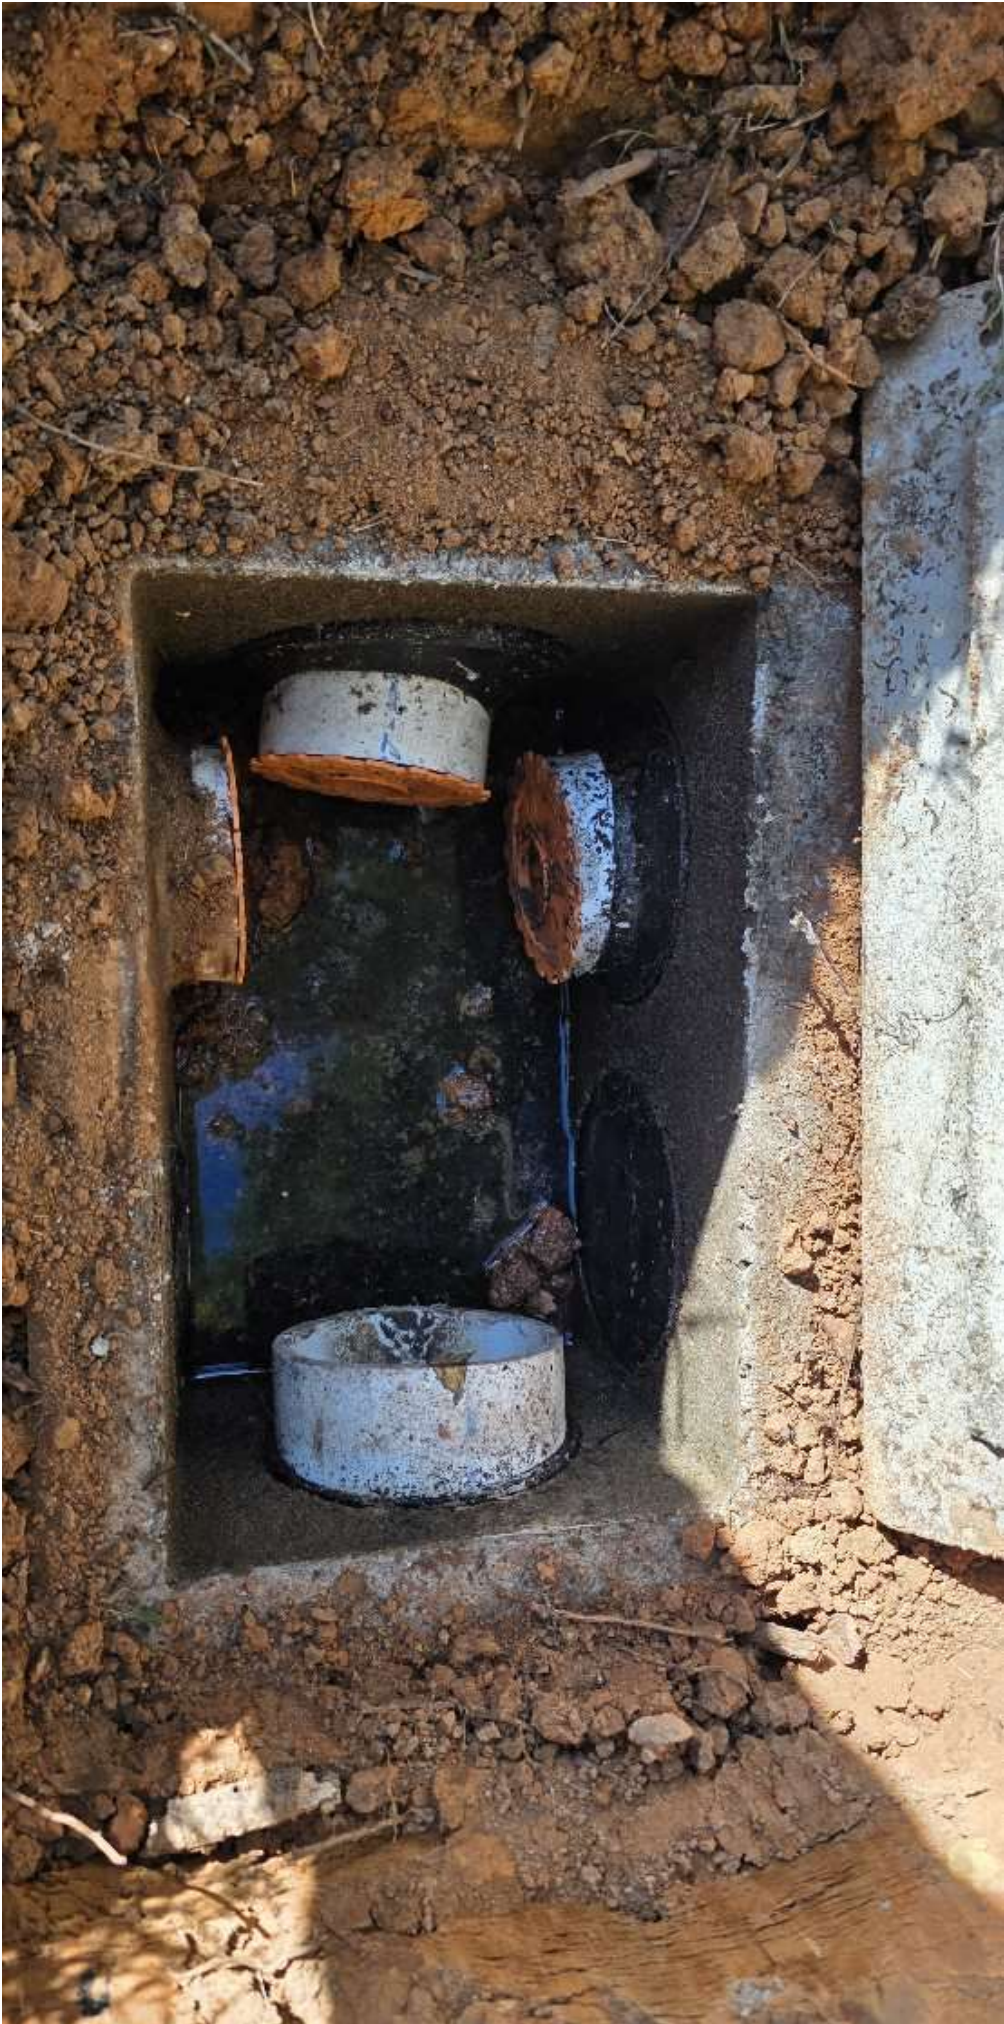
| <b>Distribution box description:</b> | Rectangular concrete box that is in good condition. |

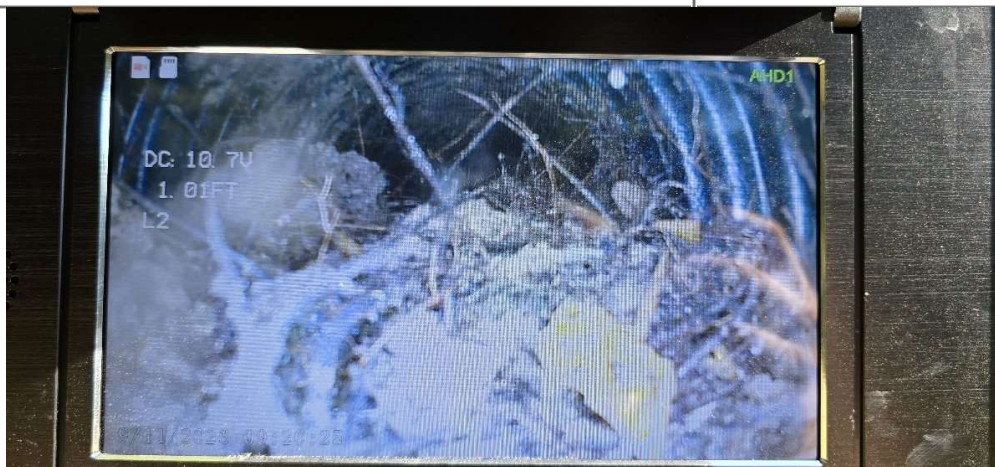
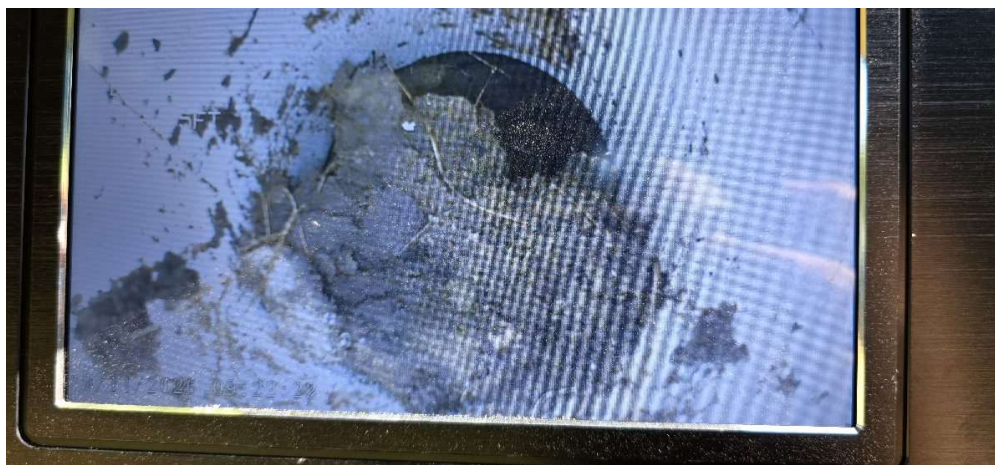
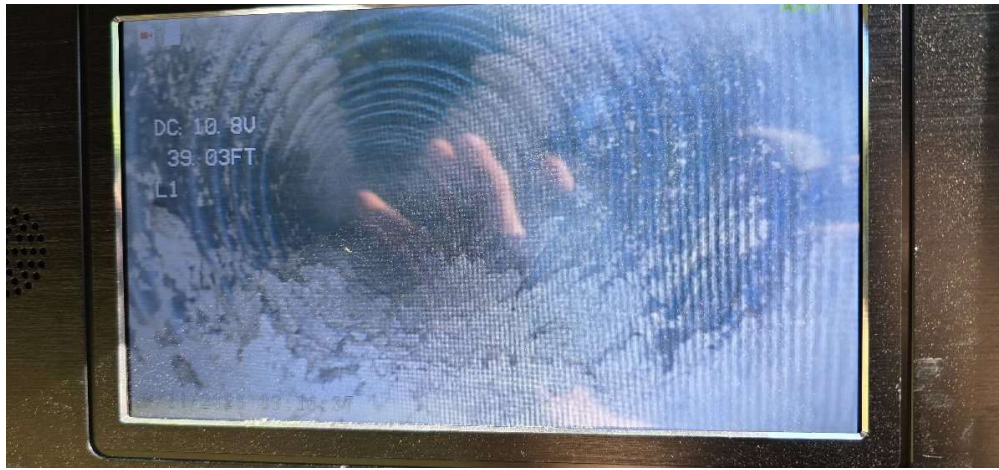
| Dispersal Field | |
|---|---|
| Leach line condition: | <p>***The leach lines are full if solids and roots. The leach lines will not function properly. Recommend contacting a licensed septic company to come out and see what can be done to fix the issue.</p> <p>.</p> |

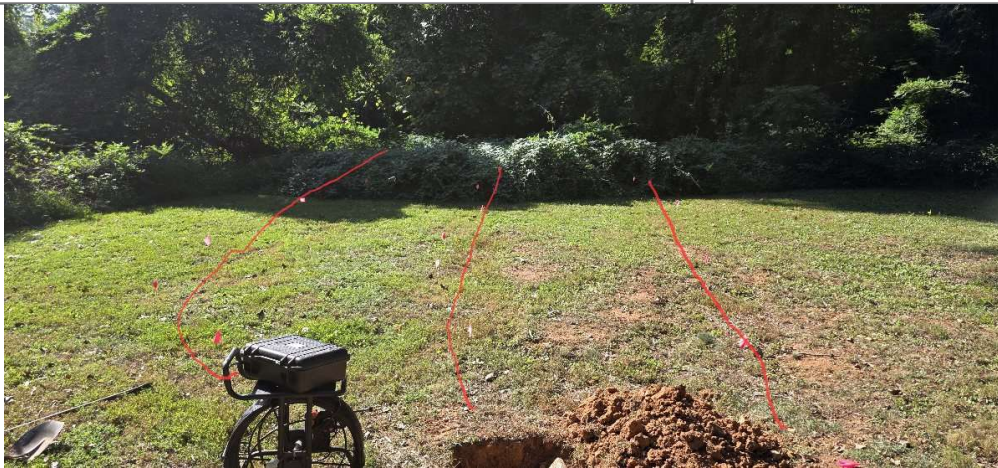
| <b>Vegetation, grading and/or drainage noted that may affect the conditions the system or system components present?</b> | Yes |

| <b>Summary:</b> | <p>****1. The water level in the septic tank is 20 inches below the outlet pipe. Recommend doing a leak test to see if the leak is within allowable limits.</p> <p>2. The outlet tee and filter are in good condition.</p> <p>3. The distribution box is in good condition.</p> <p>***4. The leach lines are full of roots and solids. The leach lines will not function properly. Recommend contacting a licensed septic company to come out and see what can be done to fix the issue.</p> <p>****5. There are trees in the leach field.</p> <p>.</p> |
