# INSPECTION REPORT

1.4.1 This house is approximately 80 years old and was built in 1946

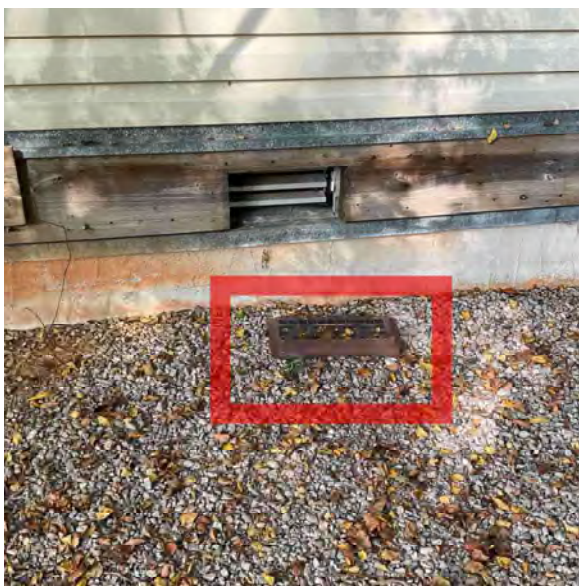
2.2.1 **Crawl space vent has a loose cover. Have a qualified contractor repair/correct to prevent rodent and pest intrusion. (Exterior Rear)**

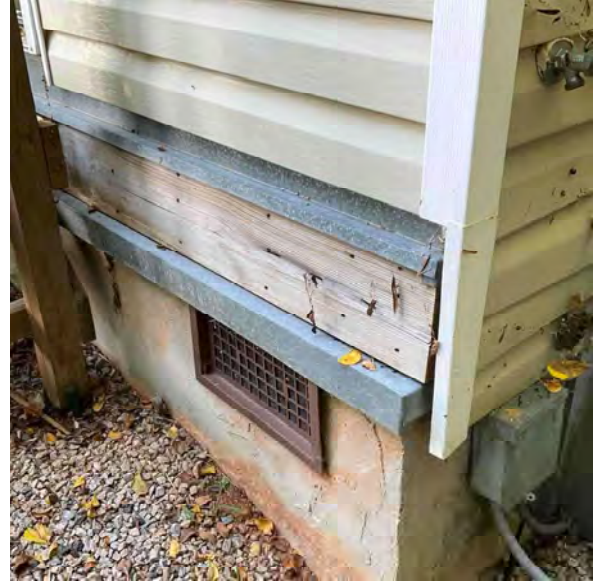
**2.2.2** Around the rear of the home, they were exposed boards between the foundation and siding. This is not consistent with typical building practices. Current configuration could lead to accelerated deterioration of the wood and surrounding components. Have a licensed general contractor assess to determine level of concern and what remedies are needed. All work performed should be conducted by qualified contractor and supervise by licensed general contractor. (Exterior Rear)

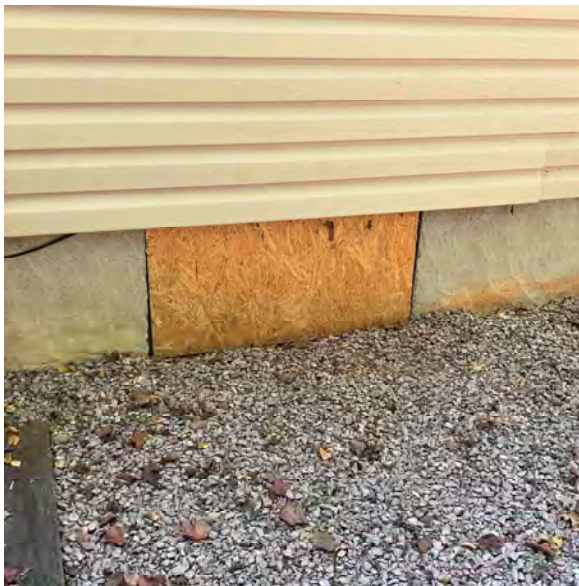
**2.2.3** Crawl space opening is covered with OSB, which is not a material design for exterior exposure. Current configuration will decay. Have a qualified contractor correct as needed. (Exterior Left)

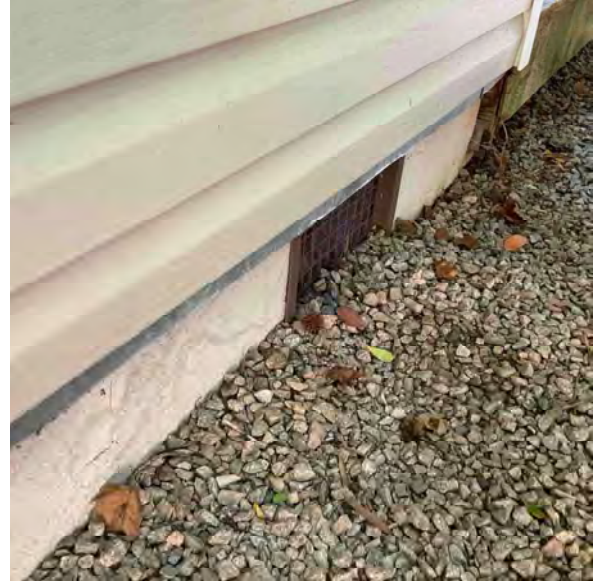
2.2.4 The crawlspace vent(s) are / is at the same level as the grade of the landscape. Have a qualified contractor install window wells or provide clearance to reduce moisture intrusion into the crawlspace and subsequent damages. (Exterior Front)

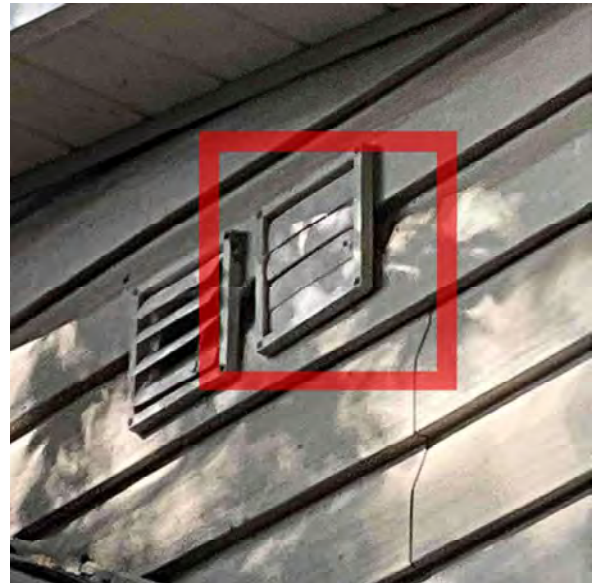
2.3.1 Exterior exhaust vent is not opening when in use and may be obstructed or clogged. A non-functioning vent could prevent moist air from exiting the bathroom and lead to undesirable living conditions. Have a qualified contractor correct to ensure proper functionality. (Exterior Rear)

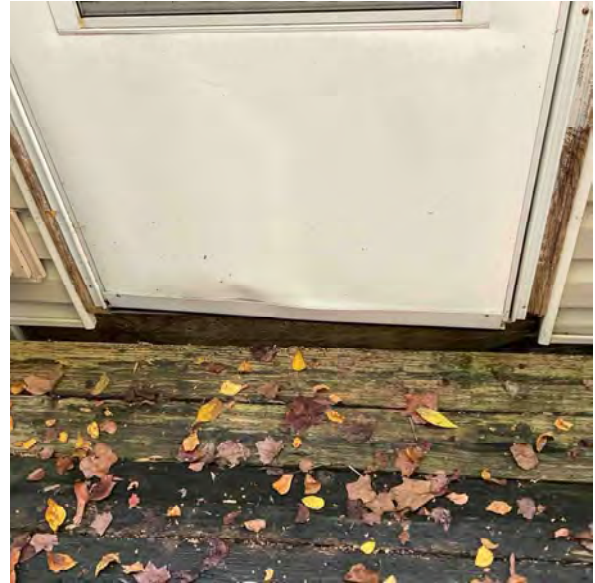
**2.3.2 The substructure underneath the electrical panel and side door is exposed. Proper siding and covering and flashing as needed to prevent subsequent damages. Have a licensed general contractor evaluate, investigate for hidden damage and correct as needed. (Exterior Left)**

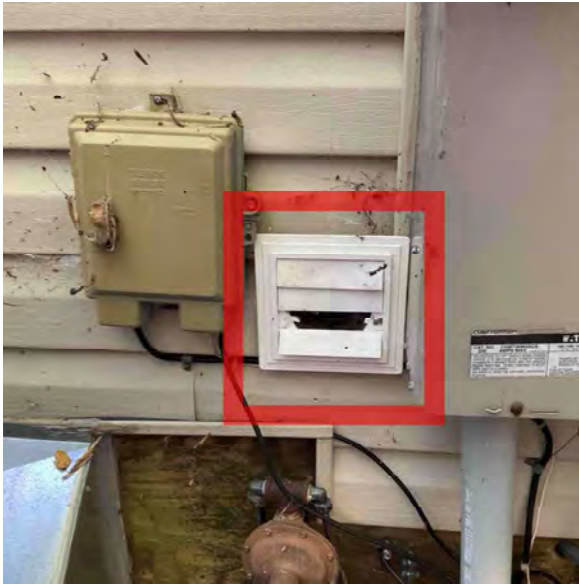
**2.3.3 The dryer vent has a damaged louver. Have a qualified contractor, correct as needed for proper condition and to prevent pest entry (Exterior Left)**

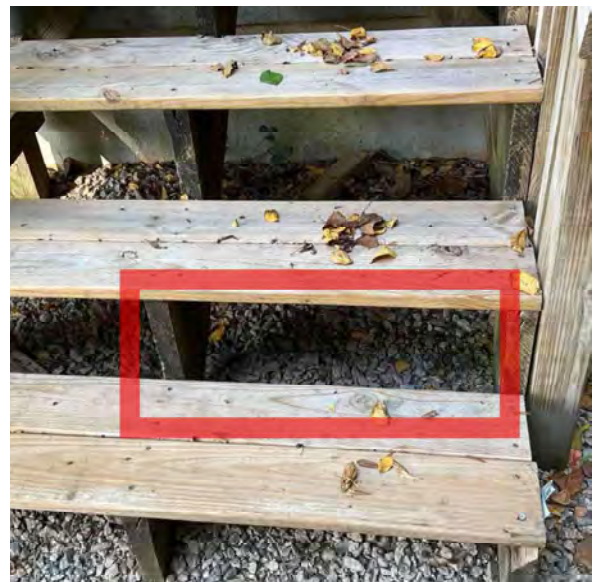
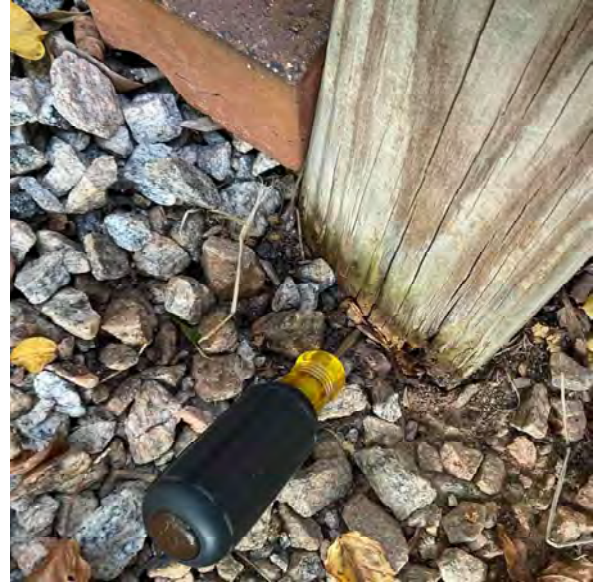
**2.5.1** The wood entry stairs have some noted safety and/or structural concerns that could lead to personal injury. Further evaluation by a licensed general contractor is required to assess the deck and to determine appropriate corrective actions to provide adequate functionality and safety.

- The handrails and posts on the staircase to the porch are loose/wobbly and present a safety hazard
- Open risers present trap hazard
- Damage was noted at the bottom of a post (Exterior Rear)

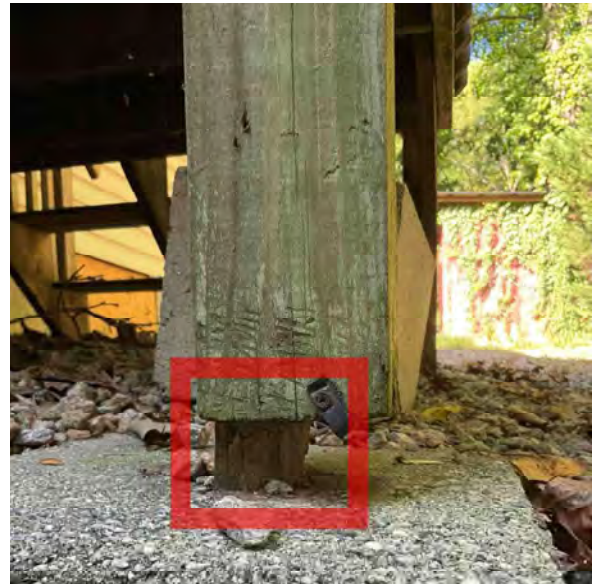
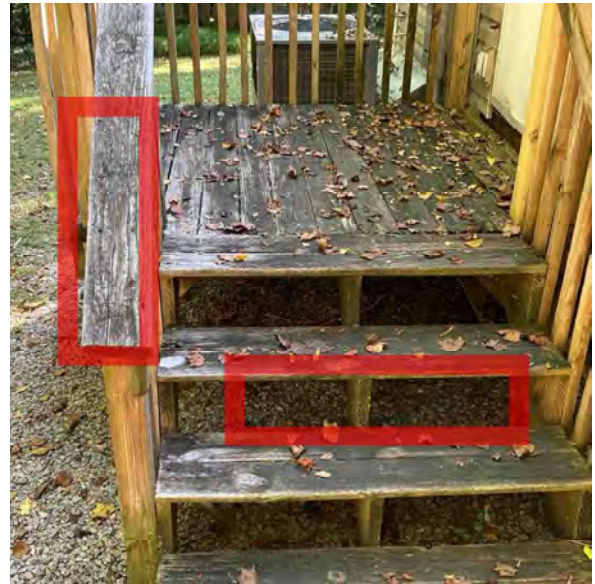
**2.5.2 The side wood porch has some noted safety and/or structural concerns that could lead to personal injury. Further evaluation by a licensed general contractor is required to assess the deck and to determine appropriate corrective actions to provide adequate functionality and safety.**

- The footings are above grade, and the posts are not properly secured
- The joist are supported by nails alone. Typically hangers or ledger are required for proper support and strength.
- Support posts were not attached using bolts or bearing directly under girder which is needed for intended support
- There are open risers in the staircase, which presents a trap hazard, and the handrail is too wide and not graspable.
- Damaged boards were noted on the stairs and platform (Exterior Left)

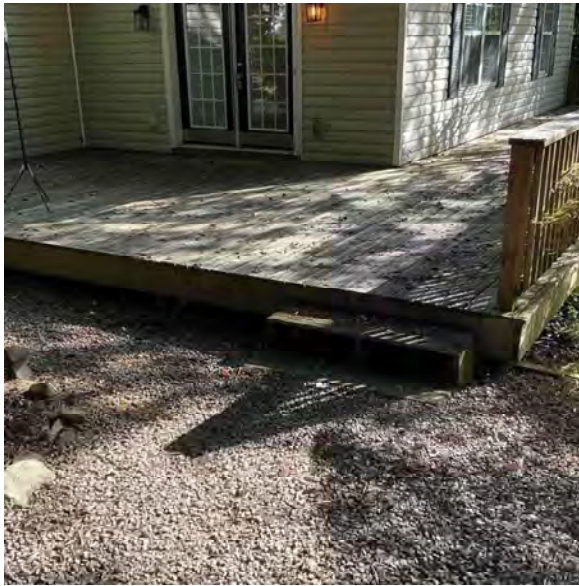
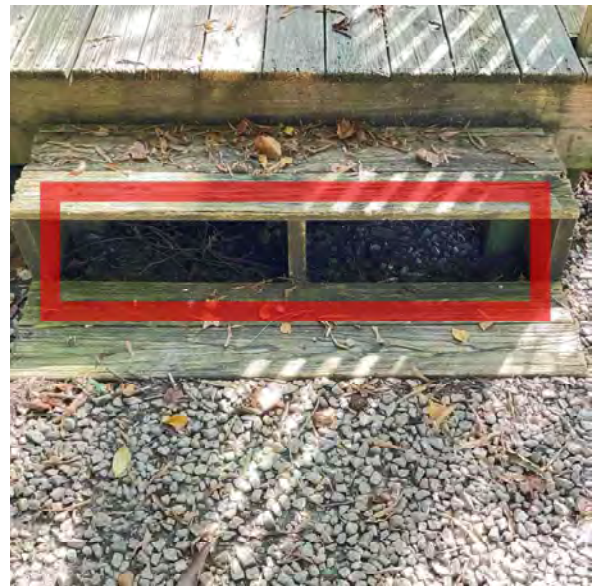
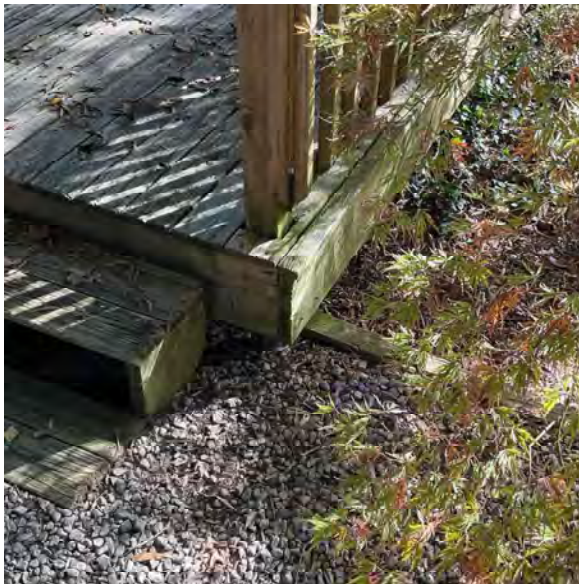
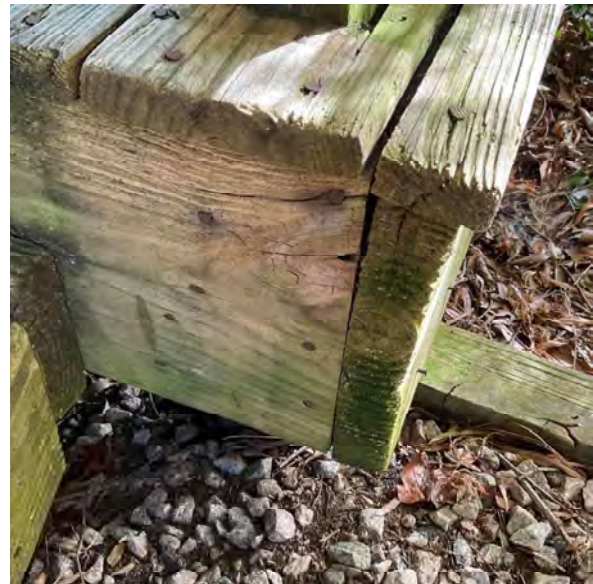
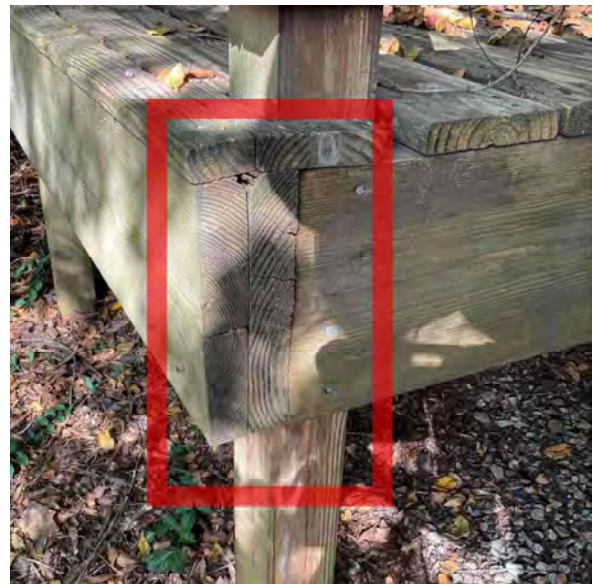
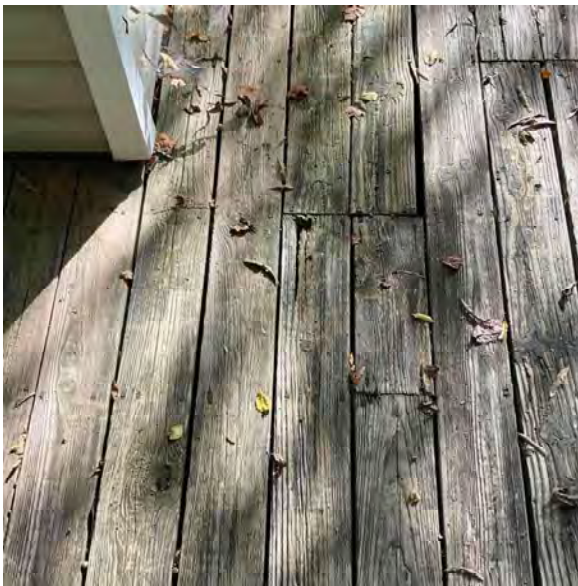
**2.6.1 The wood deck has multiple noted safety and/or structural concerns that could lead to personal injury. Further evaluation by a licensed general contractor is required to assess the deck and to determine appropriate corrective actions to provide adequate functionality and safety.**

- There were "open risers" present between the stair treads creating a potential trip/fall hazard.
  - Support posts were not attached using bolts or bearing directly under girder which is needed for intended support
  - There were damaged boards noted on the deck floor
  - Underneath the deck, there were multiple stacks of blocks and bricks suggesting there is overspend joists, damaged wood, and or deflection.
  - Rust and corrosion was noted on and around several bolts / fasteners that can lead to weakening and failure
- Exterior Front
  - Exterior Right

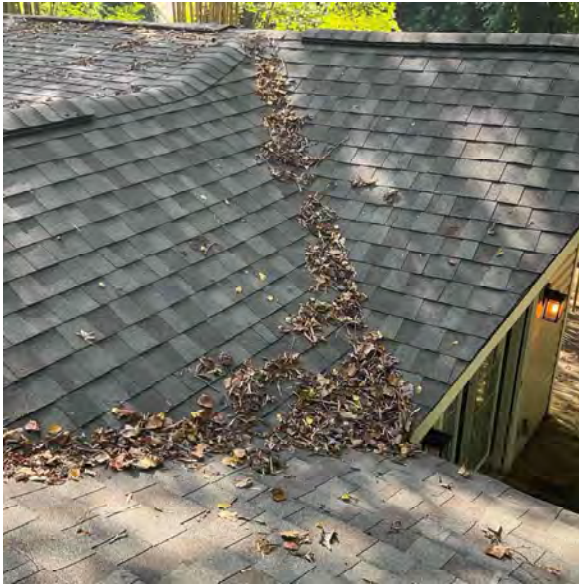
**3.3.1 There is tree debris in the roof valleys. Have a qualified contractor remove tree debris off roof to prevent accelerated shingle deterioration and damage.**

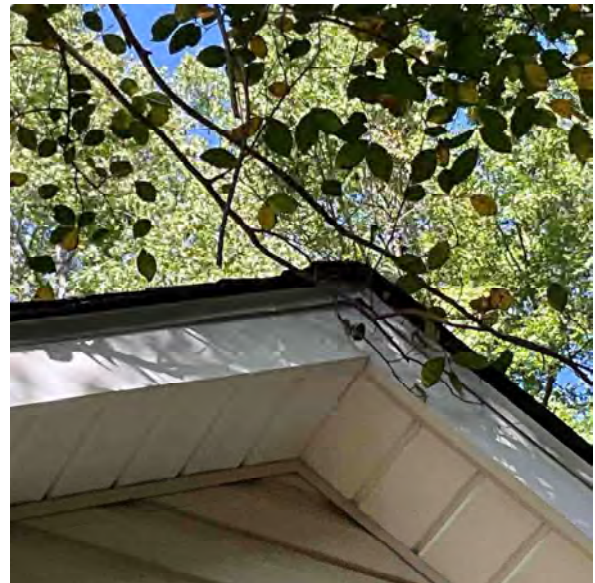
**3.3.2 There are tree limbs in contact or hanging over the roofing surface. This can lead to accelerated deterioration and promote animal / pest activity. Have a qualified contractor assess and trim back the tree limbs that are touching the rear slope of the house to reduce damage to the roof covering and accessories. (Exterior Rear)**

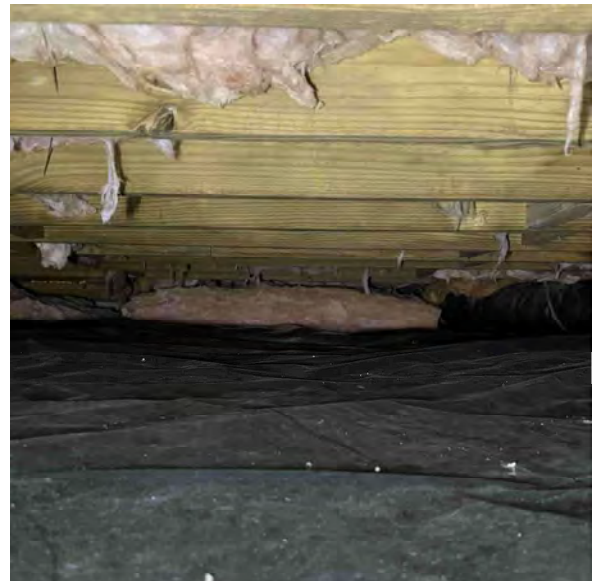
6.2.1 Limitation: The inspector could not enter the front and middle part of the crawlspace due to low hanging wood members and air ducts. Therefore, structural concerns and plumbing in that area could not be inspected. If the buyer wishes further evaluation, consult a licensed general contractor that specializes in crawlspaces.

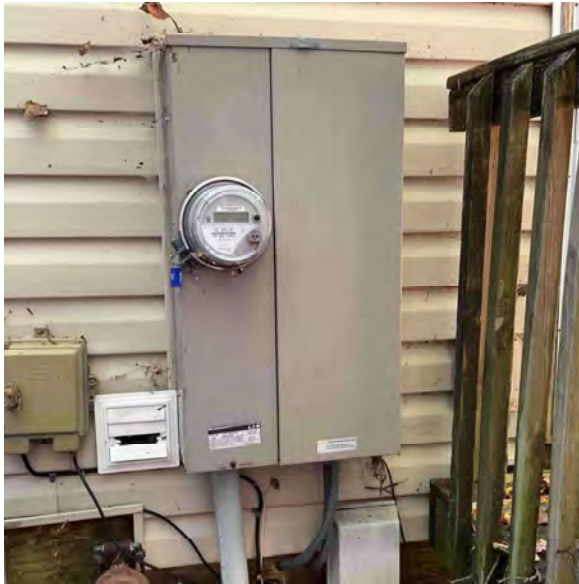
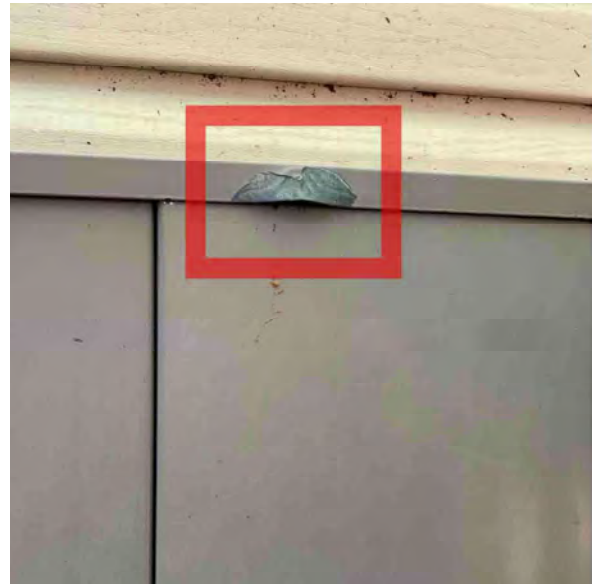
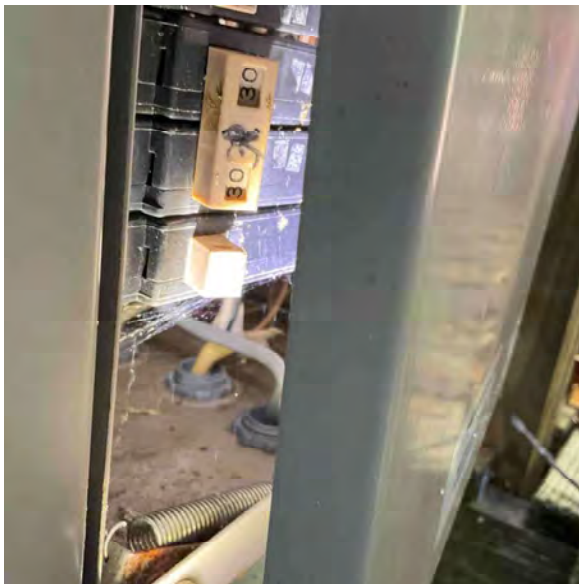
**7.5.1** The door to the electrical panel was unable to be opened during the inspection. Signs of forced entry were noted at the top of the distribution panel. Through a slight opening, it was noted that there was no cover plate protecting the exposed wires behind the panel door. Have a licensed electrician gain access and fully evaluate the electrical panel. Any deficiencies found should be corrected by a licensed electrician.

**Limitation:** due to the lack of access to the distribution panel, determining the service size, conduction material, and observations of potential deficiencies were unable to be completed. These exclusions are not limited to examples provided. (Exterior Left)

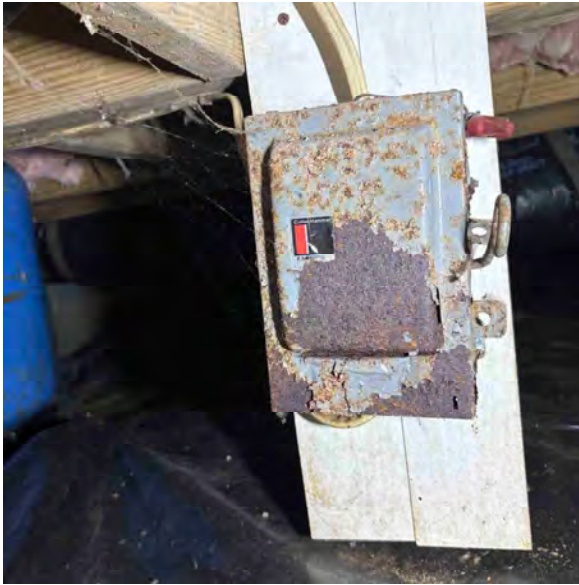
7.6.1 The disconnect box for the well water storage tank is rusted and there are exposed wires. Have a licensed electrician replace as needed for proper condition. (Crawlspace)

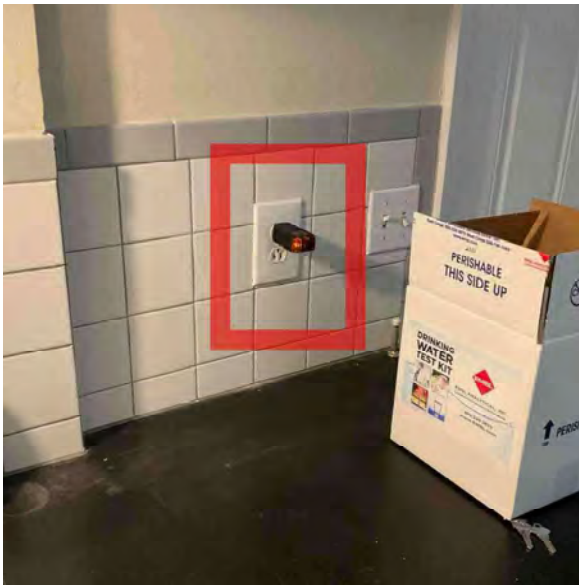
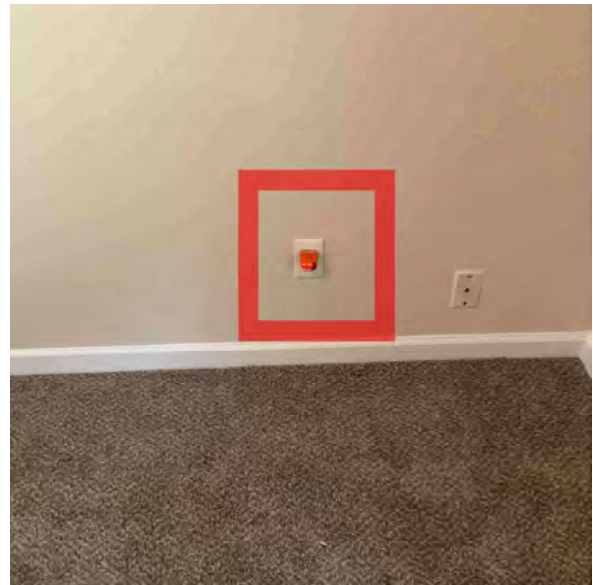
7.7.1 The receptacle(s) are loose (not tightly secured to the box). A licensed electrician should correct as required for electrical safety.

- Front Bedroom
- Kitchen

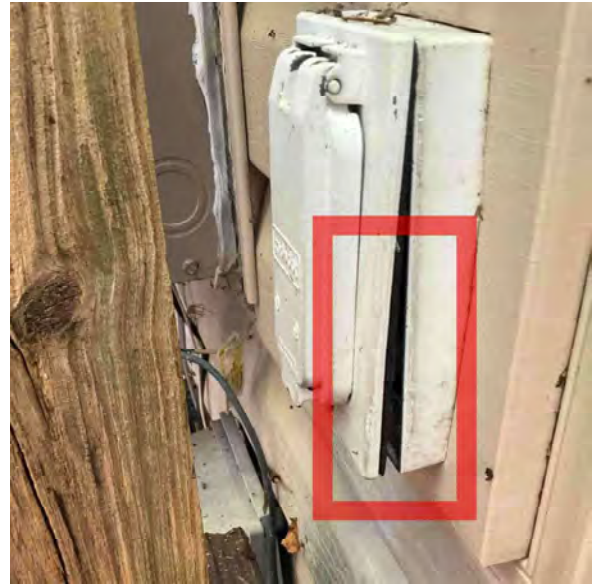
**7.7.2 The receptacle has an open gap that can allow moisture penetration and subsequent damages. A licensed electrician should correct receptacle as required for electrical safety. (Exterior Left)**

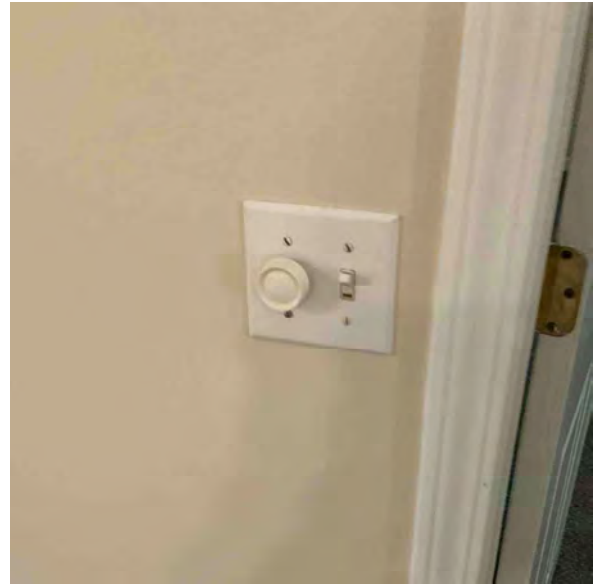
**7.8.2 The light in the dining room flickered and would not incrementally illuminate with the dimmer switch. Have a licensed electrician correct as needed for proper functionality. (Dining room)**

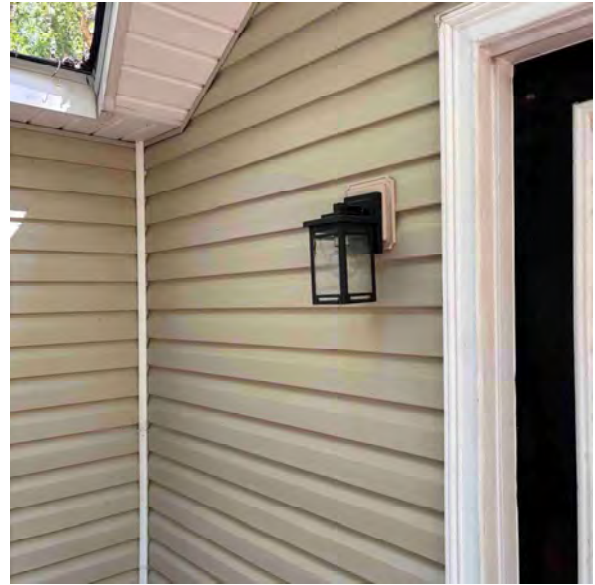
**7.8.4 Light did not responding to the switch. Check/install bulb first prior to evaluating the fixture. Have a licensed electrician evaluate and repair as needed to allow safe and proper operation. (Exterior Front)**

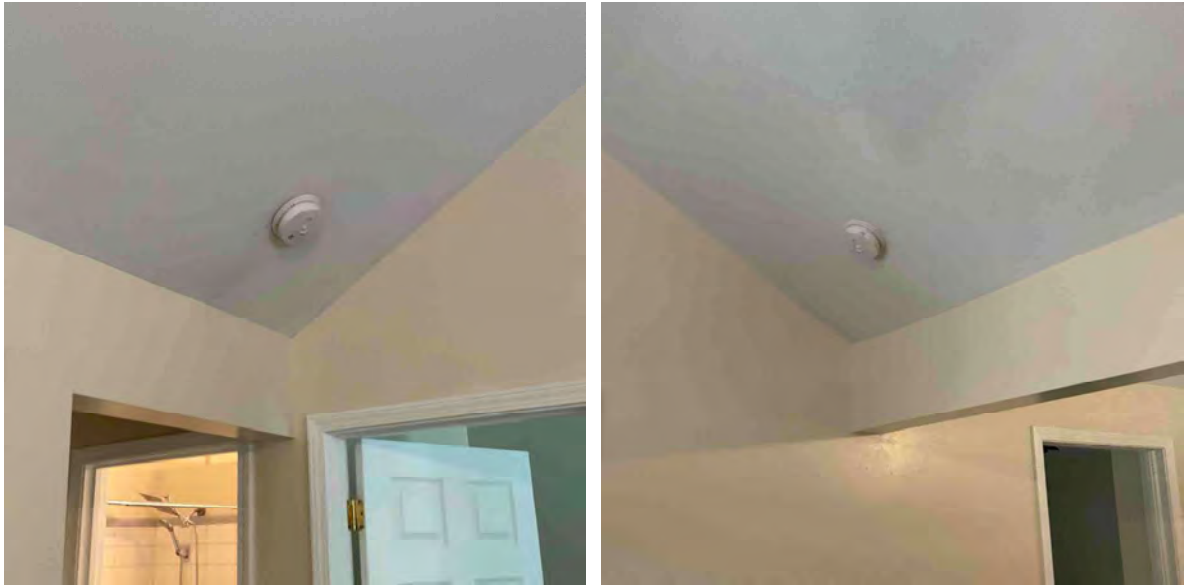
**7.11.1 Smoke detector were not operating properly at the time of inspection. Check battery first. If problem persists, have a licensed electrician repair to improve safety. The National Fire Protection Association recommends replacing all smoke detectors when they are 10 years old. Confirm age of detectors and of CO monitors when replacing batteries, replace if detectors are out of date to provide intended protection. CO monitors should be in service on every floor. (Family Room)**

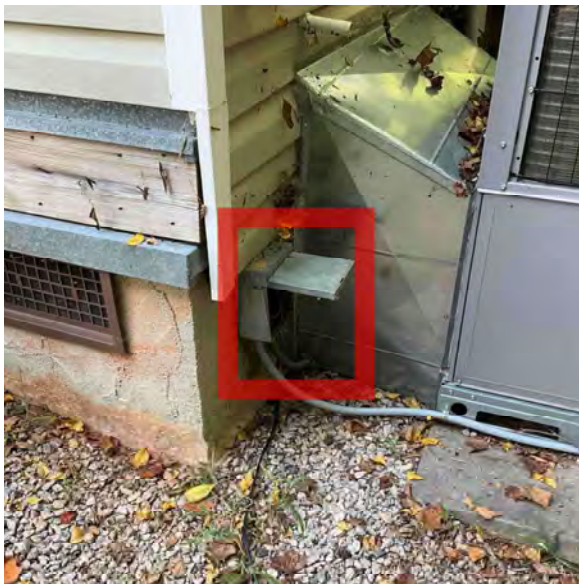
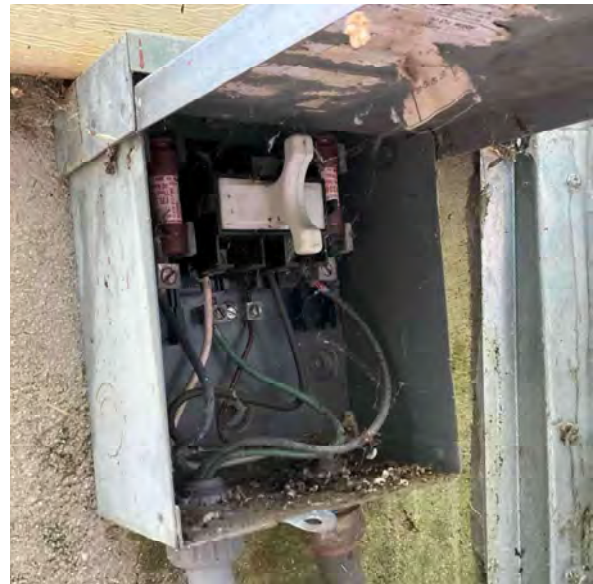
8.3.1 **The air conditioners electrical disconnect has a missing panel cover. The exposed wiring presents a shock hazard. A licensed HVAC technician or licensed electrician should further assess and correct as required for safety. Additionally, this disconnect is directly below two water faucets. Although these boxes are designed for exterior exposure, direct running water is not recommended. Have a licensed electrician assess to determine if relocation is necessary and make any needed corrections. (Exterior Left)**

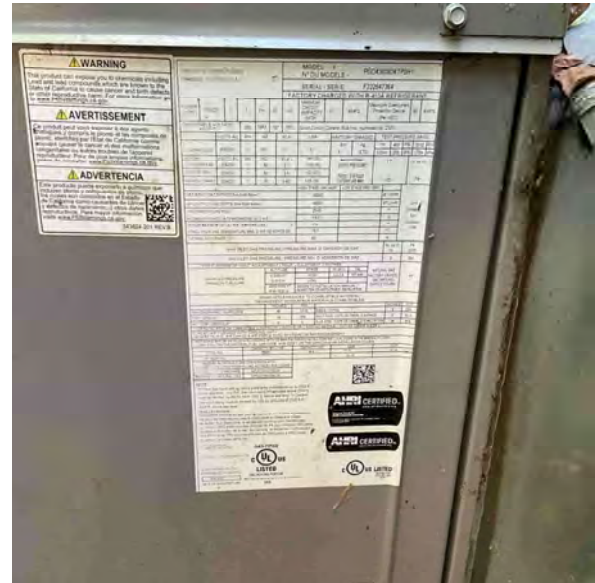
8.3.2 A typical life expectancy for an air conditioner is 10 to 15 years. The exterior air conditioner in this home is approximately 4 years old.

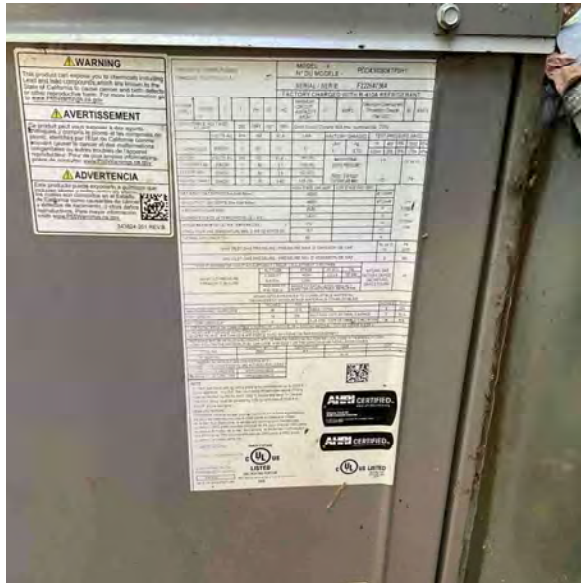
8.4.1 The gas pack furnace unit has labeling indicating it is set up for a natural gas fuel source. However, the only fuel supply located was a propane tank on the property. No labeling or indication was found describing the modifications needed to change from natural gas to propane. These fuel sources require modifications to ensure proper functionality and prevent undesirable environmental conditions, including carbon monoxide. A licensed HVAC technician should be consulted to evaluate the system and ensure these modifications have been made. If it's determined that modifications are needed, they should be made prior to using the unit for safety. (Exterior Left)

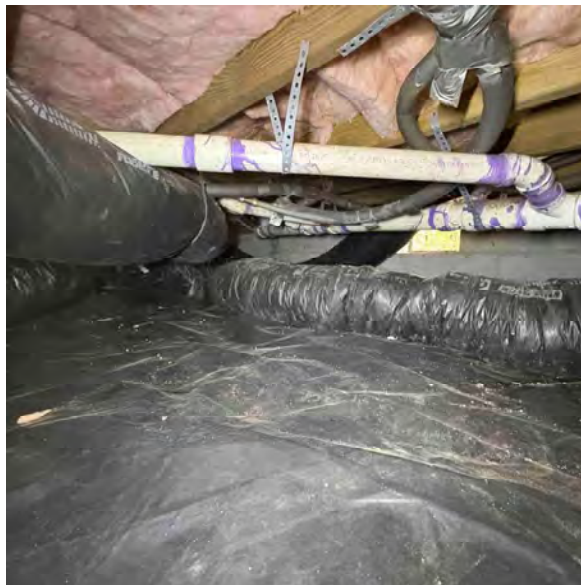
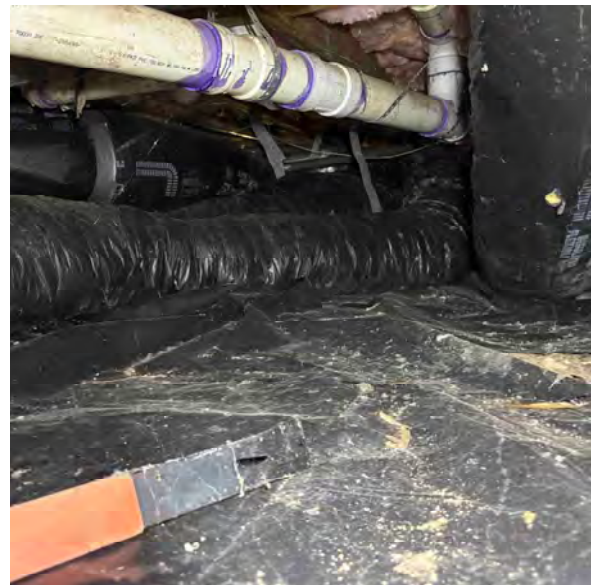
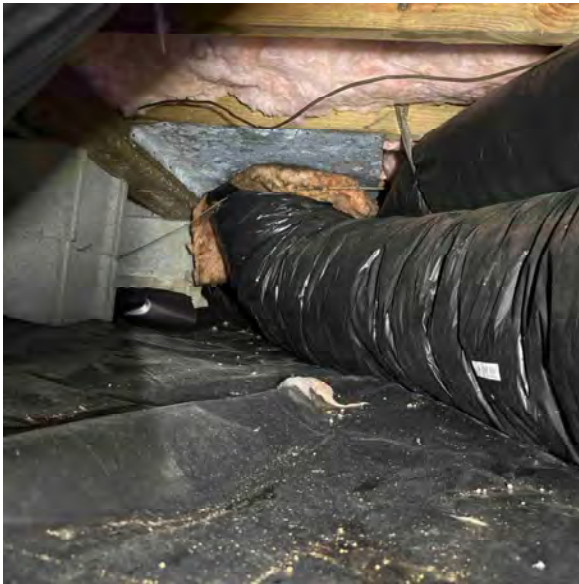
8.5.1 There were noted ventilation ducts not supported by straps and in contact with the ground in the crawl space. This can cause deterioration to the insulated covering, leading to undesirable living conditions. Have an HVAC contractor repair as needed. (Crawlspace)

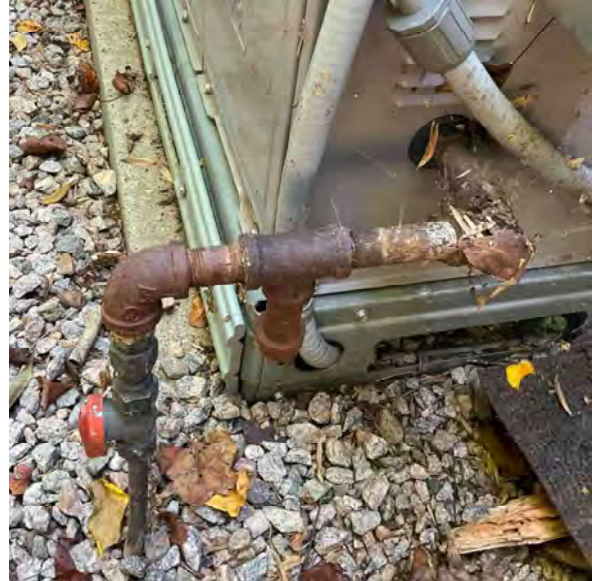
8.6.1 The metal gas line is rusted. Rust can cause damage to gas line leading to leaks and subsequent hazards. Have a licensed plumber or licensed HVAC technician to evaluate to determine what repairs are needed an correct. (Exterior Left)

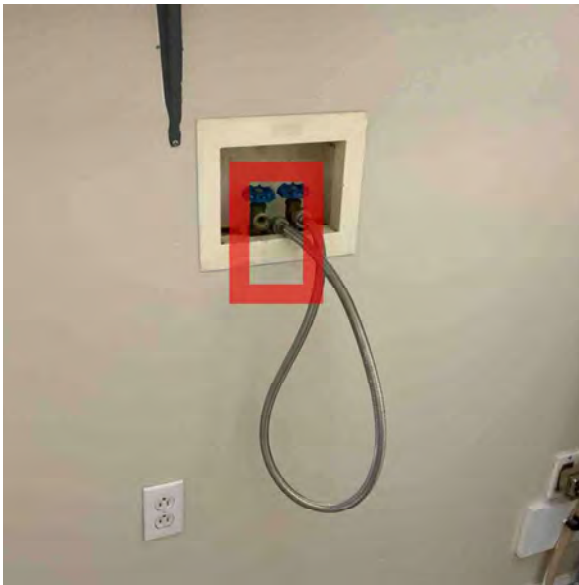
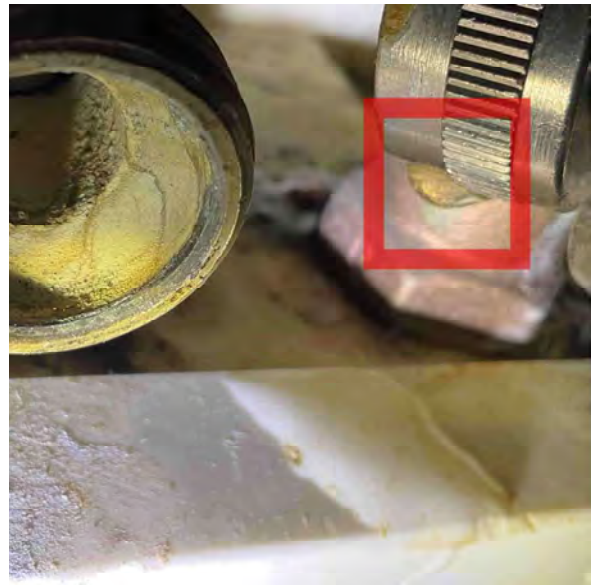
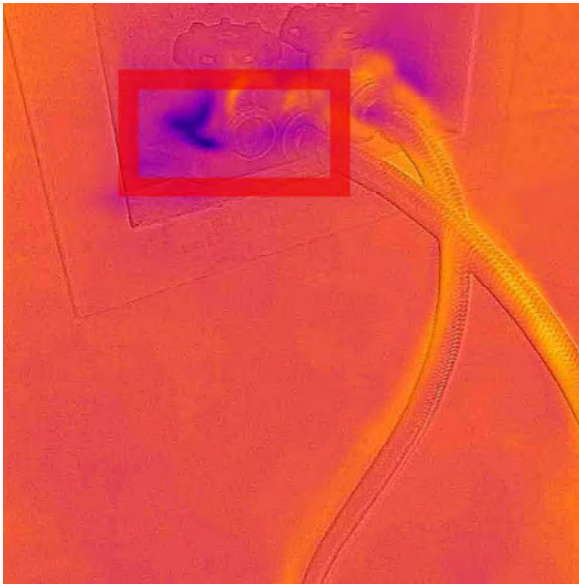
9.4.1 **The distribution piping valve for the washer connection is leaking. A licensed plumber should repair as required to prevent water damage. (Laundry area)**

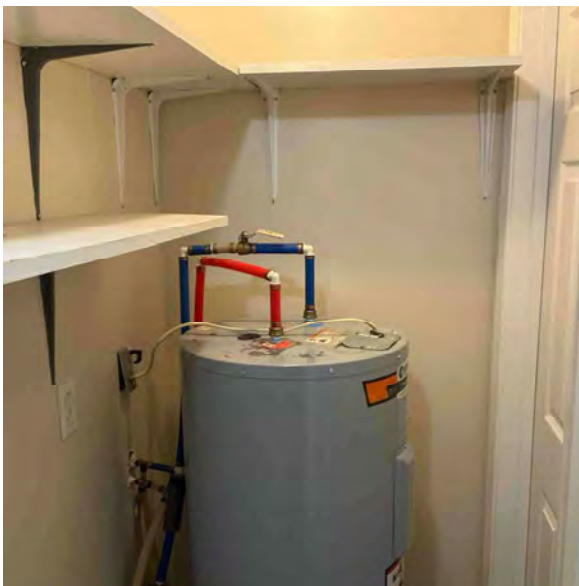
9.6.2 **There was no expansion tank present for the water heater. An expansion tank is designed to handle the thermal expansion of water as it heats up in the water heater, preventing excessive water pressure and prolonging the life of the unit. If water pressure gets too high they can damage valves and plumbing fixtures, joints and supply pipes and the water heater itself. Recommend having a licensed plumber install as needed. (Laundry area)**

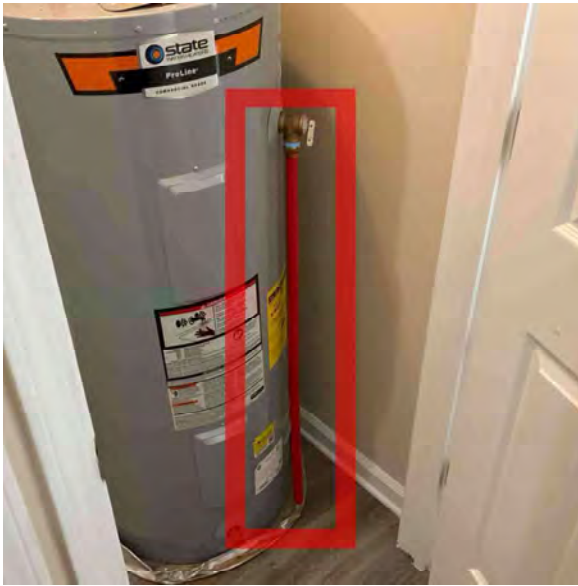
9.6.3 The pressure relief discharge piping material is PEX. When PEX is used for discharge piping, then it must be one nominal size larger than the relief valve outlet, and the flexible tubing should be fastened in place. Currently it is slid behind a gas line, which does not provide adequate fastening. Have a qualified plumber assess and correct as needed. (Laundry area)

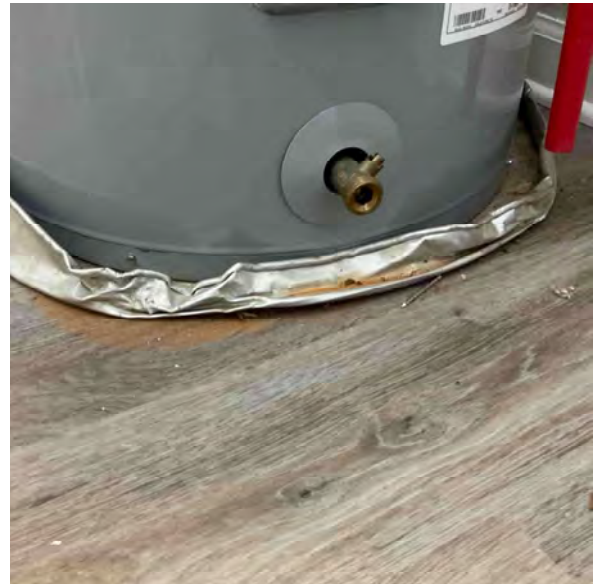
9.6.4 The pan below the water heater is damaged and may not contain water as intended. Have a qualified contractor correct as needed. (Laundry area)

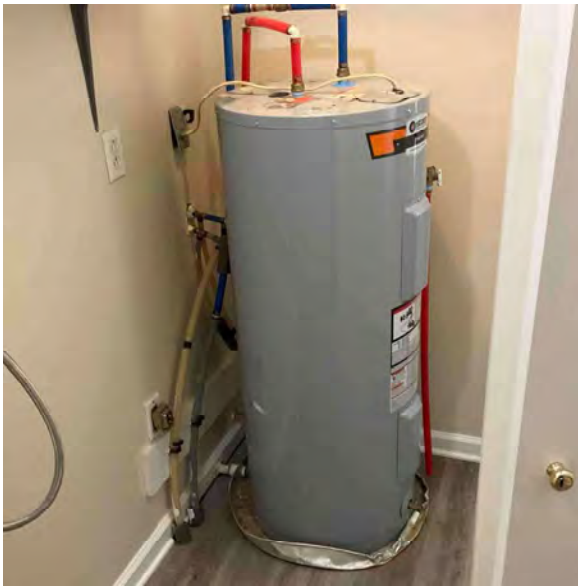
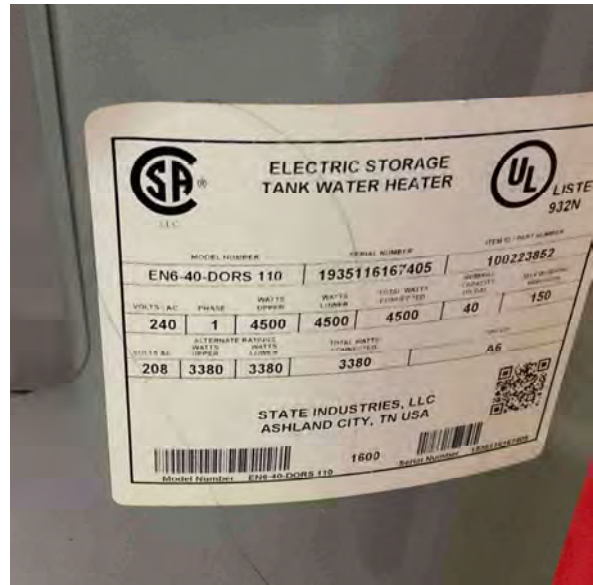
9.6.5 A typical life expectancy for a typical water heater is 10 to 15 years. The current water heater is approximately 7 years old.

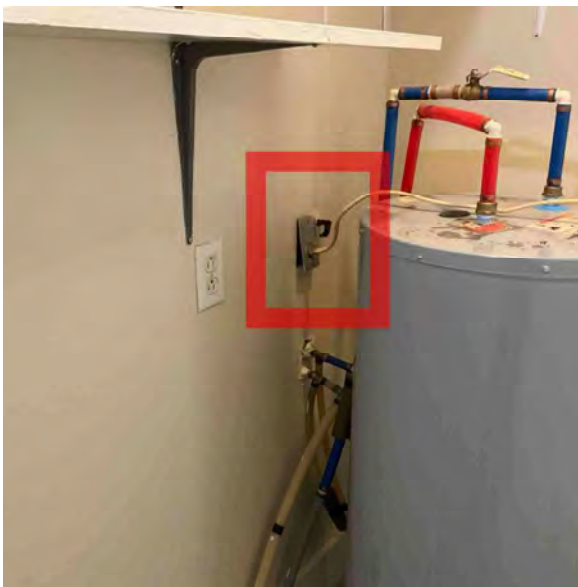
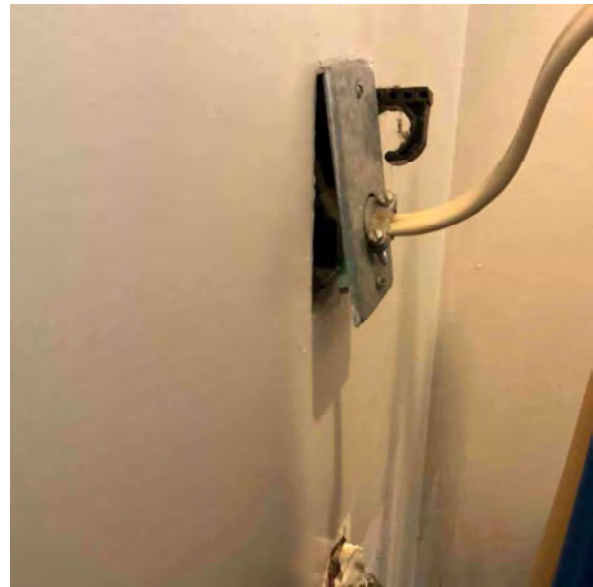
9.6.6 The wall cover for the electrical to the water heater has an open gap. This presents an electrical hazard. Have a licensed plumber or a licensed electrician, correct as needed for safety. (Laundry area)

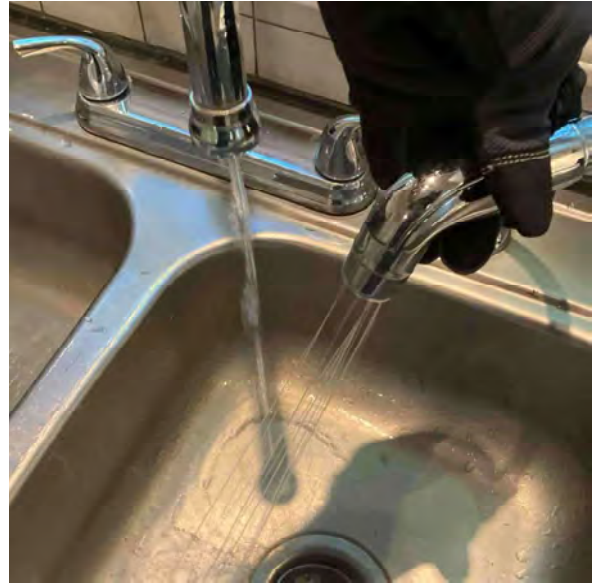
**9.7.1 The accessory spray nozzle for the kitchen sink did not fully divert water from the main faucet. This could have an adverse effect on water pressure and functionality. Have a licensed plumber repair/replace as needed for proper functionality. (Kitchen)**

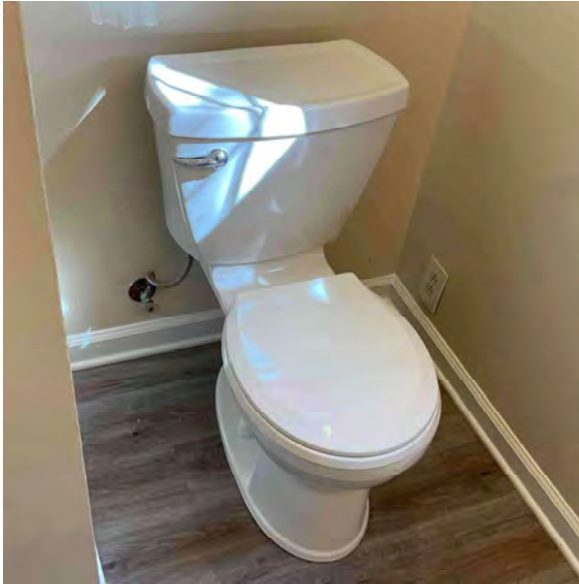
9.8.1 The toilet is loose at the base /floor. Any movement of the toilet can damage the wax seal, leading to leaks and damage to surrounding components. A licensed plumber should repair as required to prevent potential leaks and subsequent water damage. When repairs are performed, and damaged materials found should be repaired by a qualified contractor. (Hall Bath)

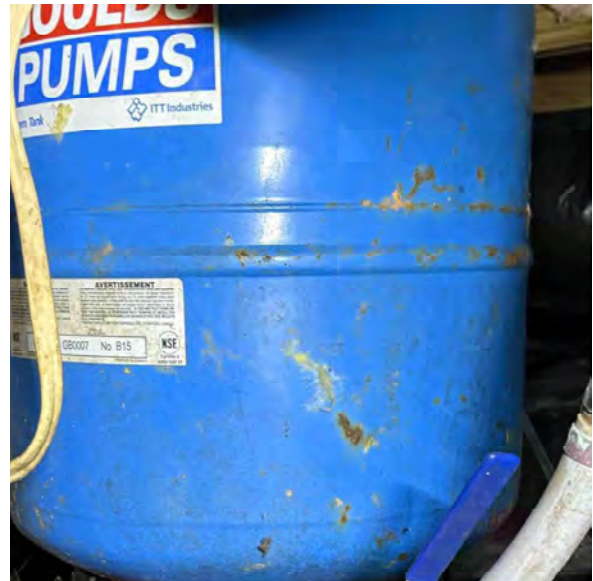
9.10.1 The storage tank is rusted. A qualified plumber should repair or replace as required to ensure proper function. (Crawlspace)

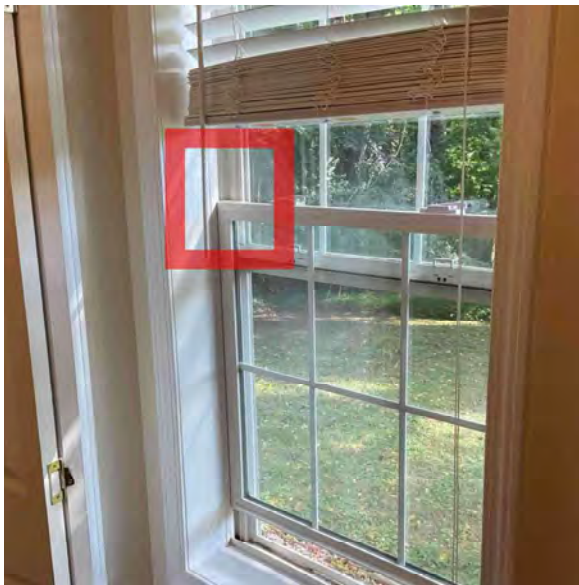
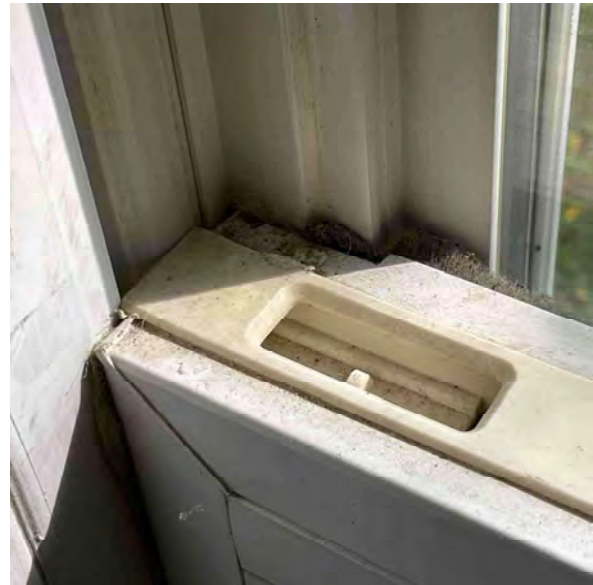
10.3.1 **The window jamb latch hardware is damaged. Have a window specialist adjust/repair as needed to ensure proper functionality and security. (Rear Bedroom)**

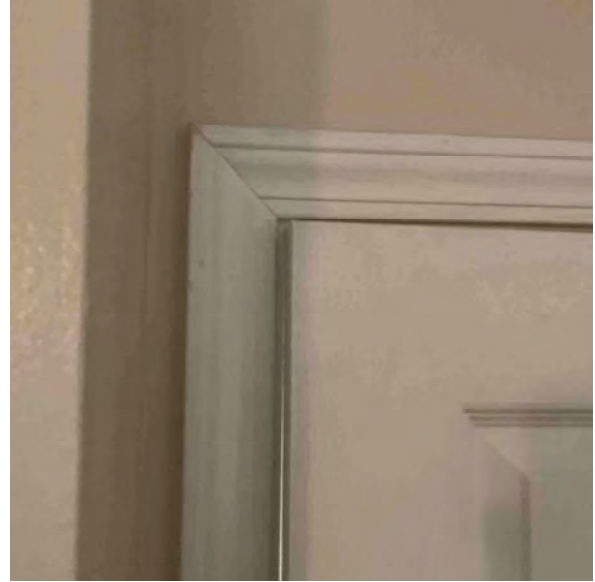
**10.4.1 The door binds and will not close. Have a qualified contractor repair/adjust for improved functionality and prevent damage to door frame. (Front Bedroom)**

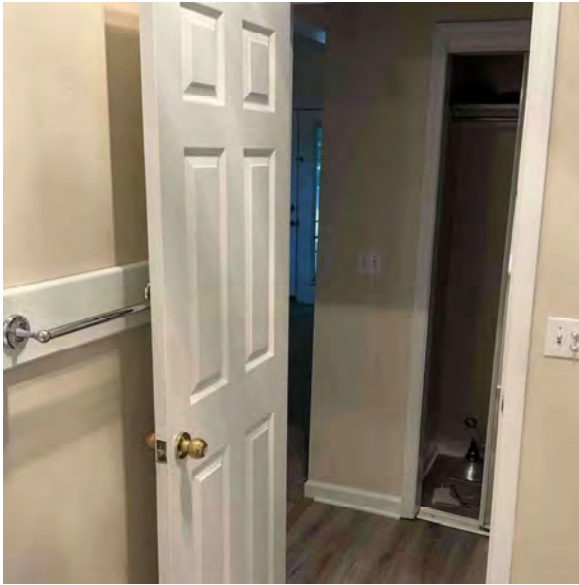
10.4.3 The door is not properly balanced. It will not stay in the shut position and opens automatically. Have a qualified contractor correct/adjust the door to provide proper balance. (Hall Bath)

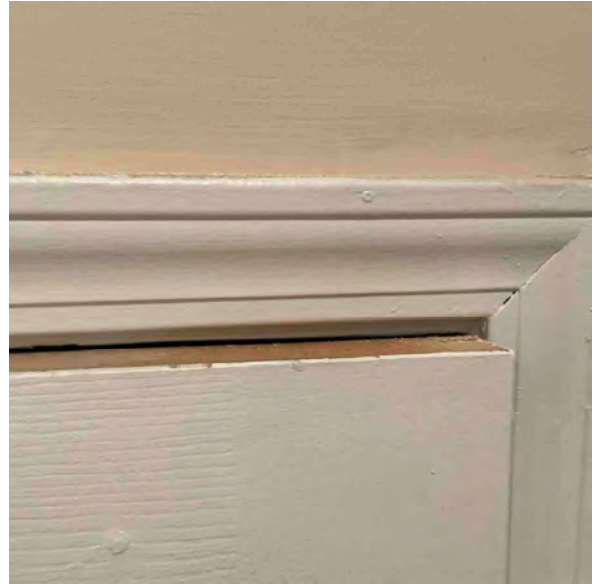
10.4.4 The door binds and will not close. Have a qualified contractor repair/adjust for improved functionality and prevent damage to door frame. (Hall Bath)
